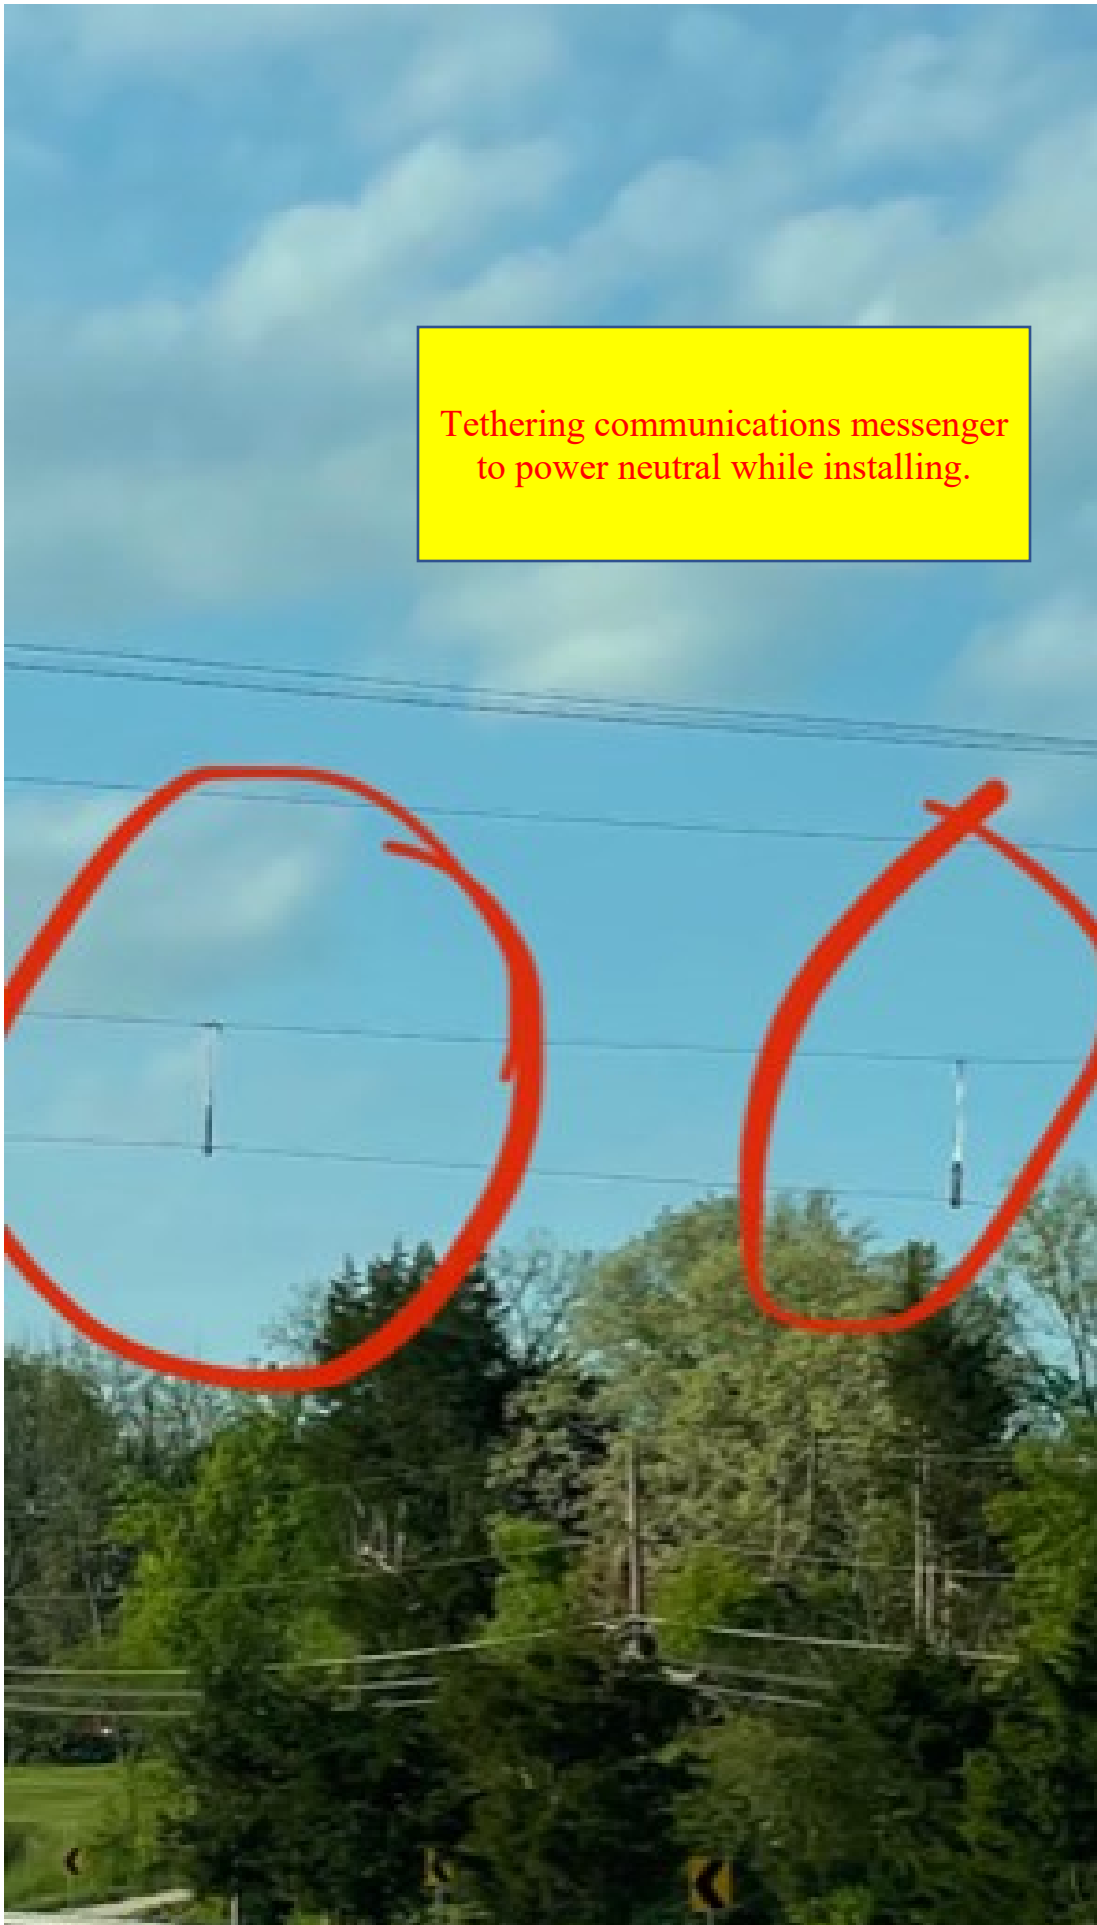
Tethering communications messenger
to power neutral while installing.

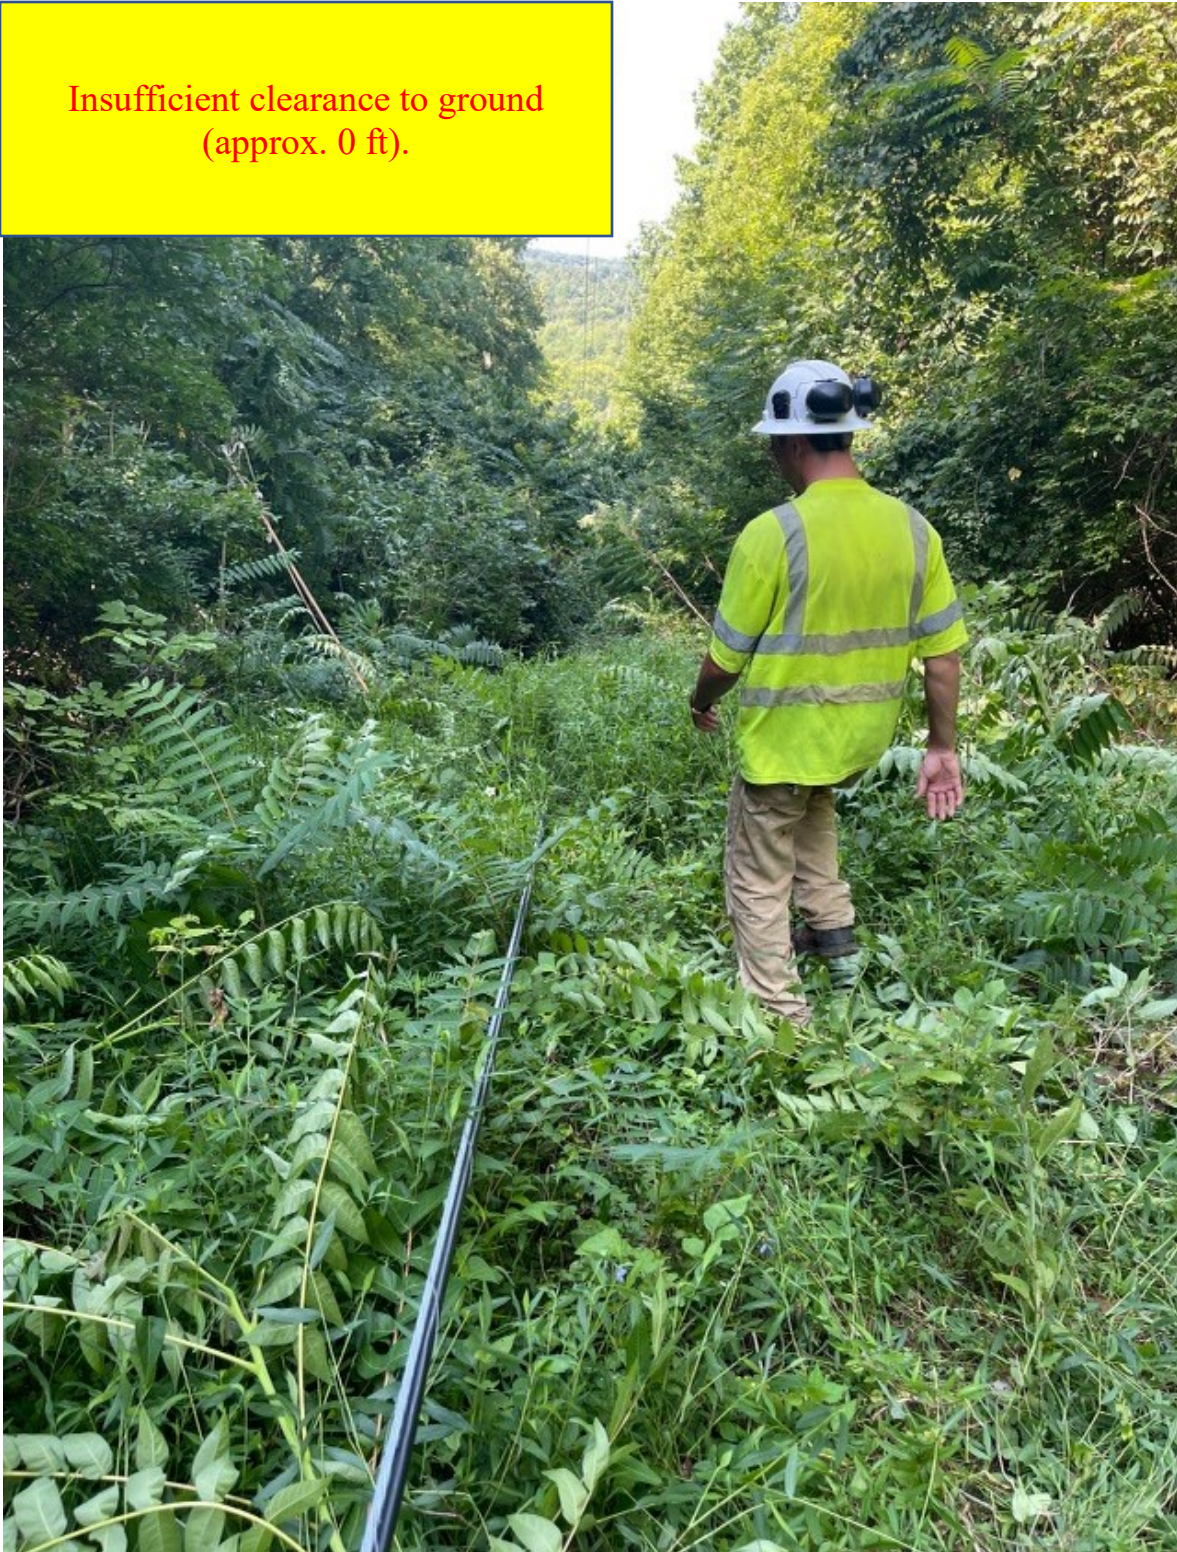
Insufficient clearance to ground
(approx. 0 ft).

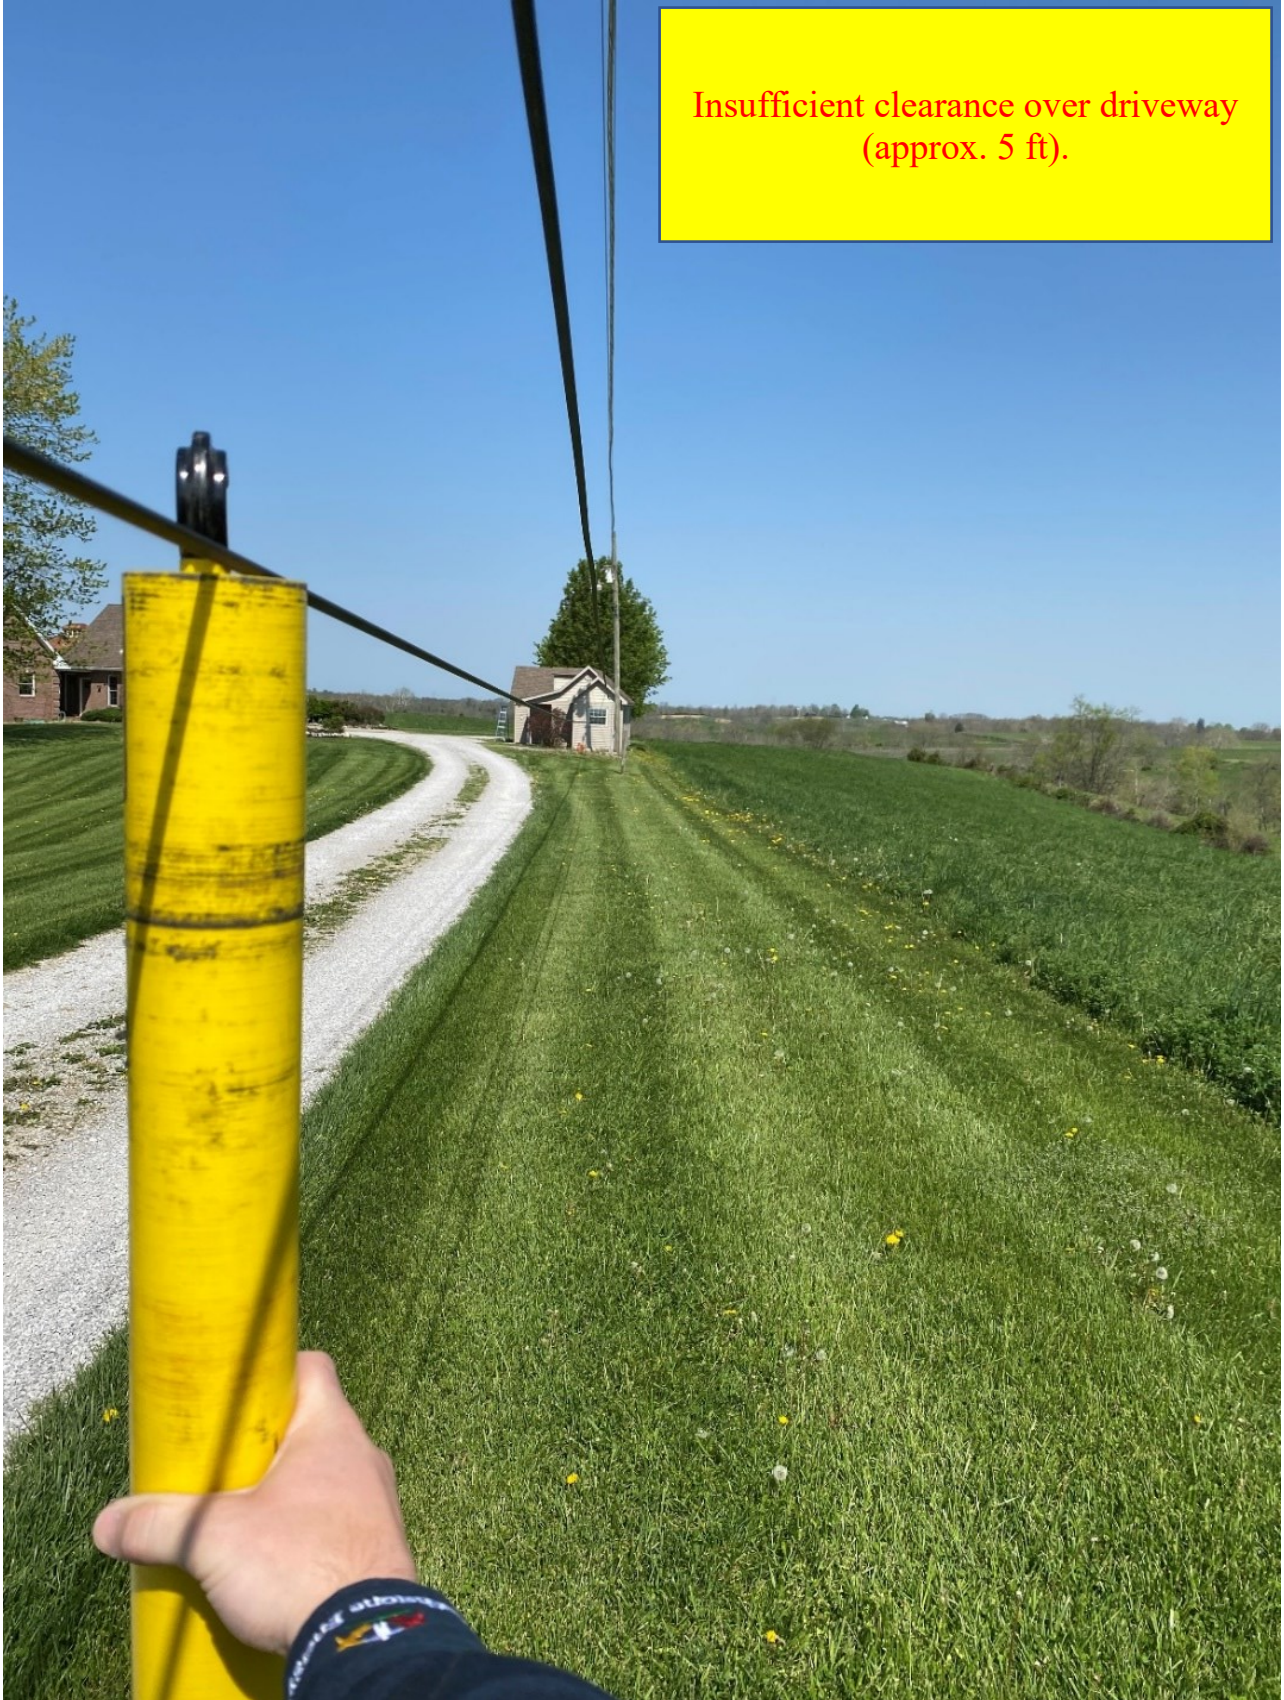
Insufficient clearance over driveway
(approx. 5 ft).

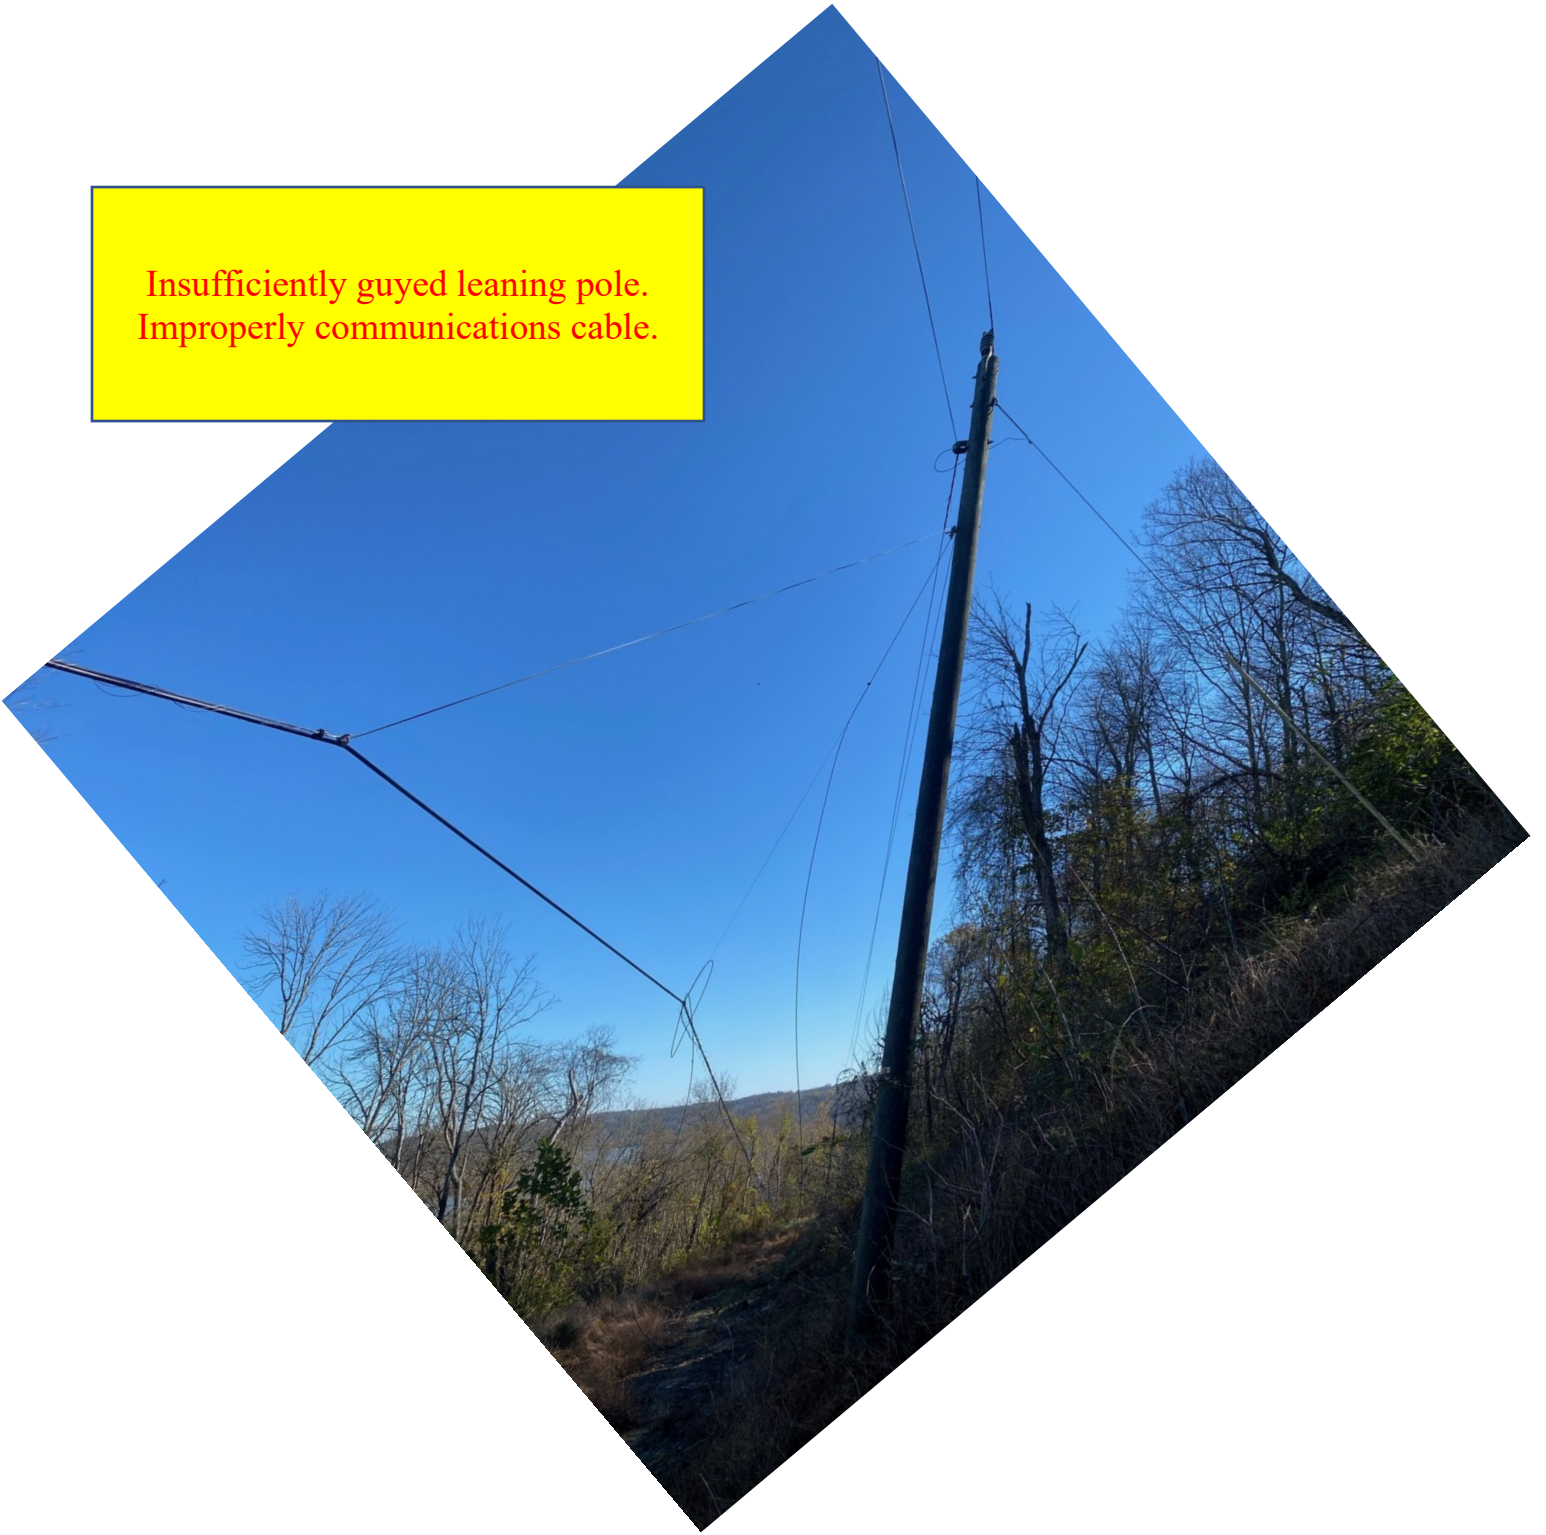
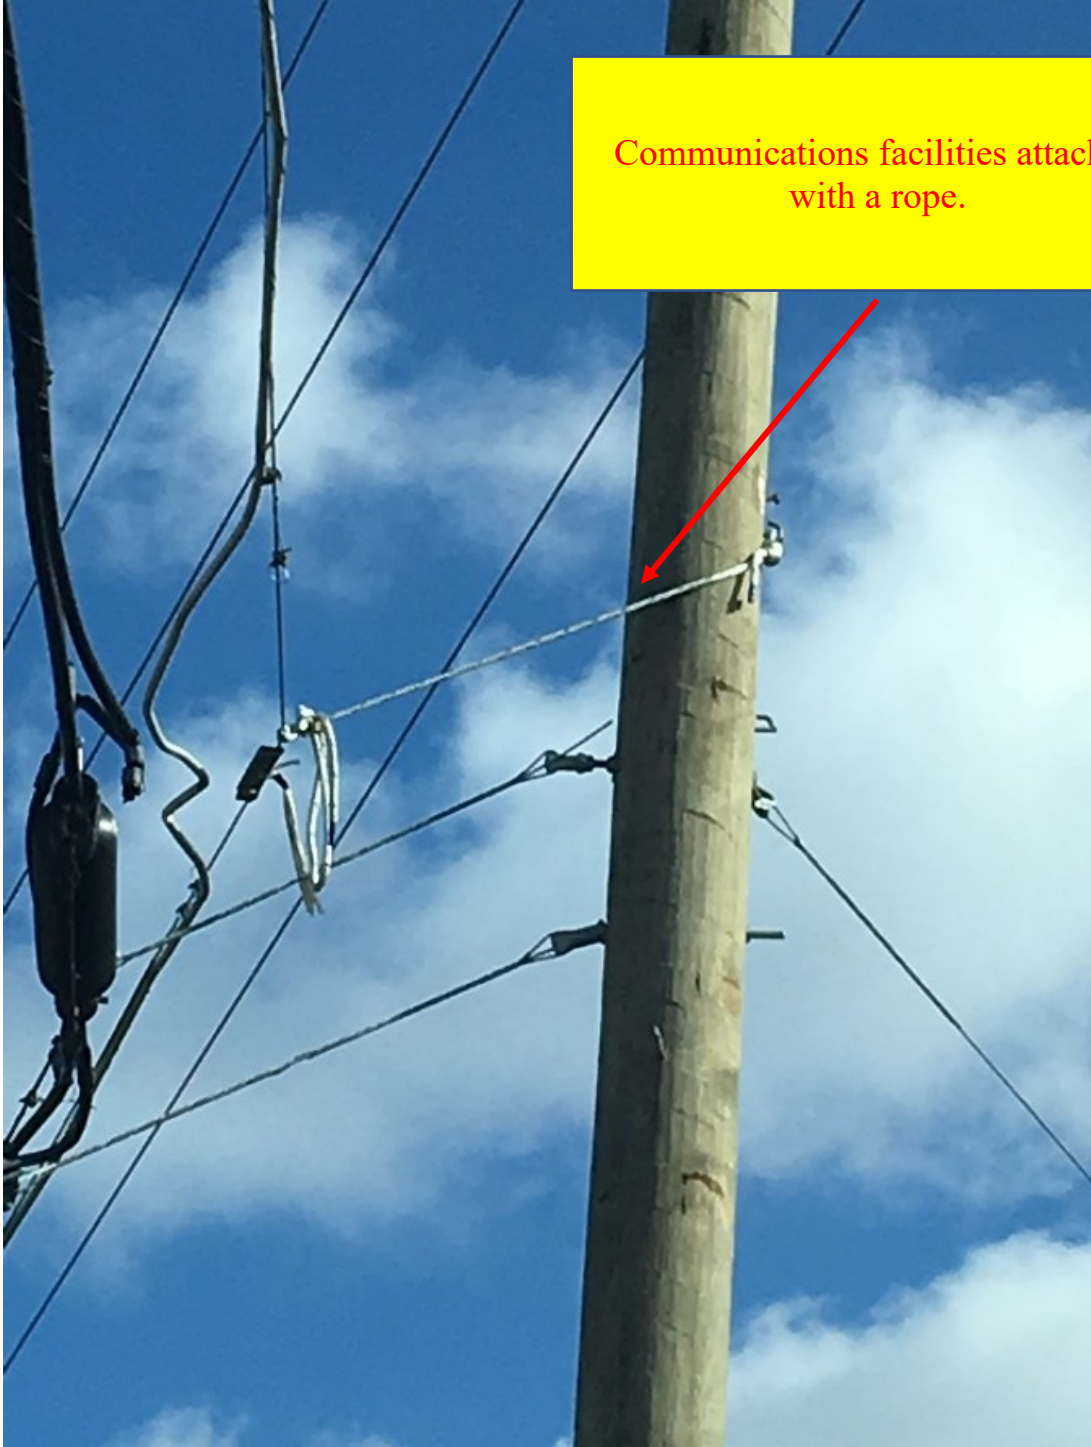
Insufficiently guyed leaning pole.
Improperly communications cable.

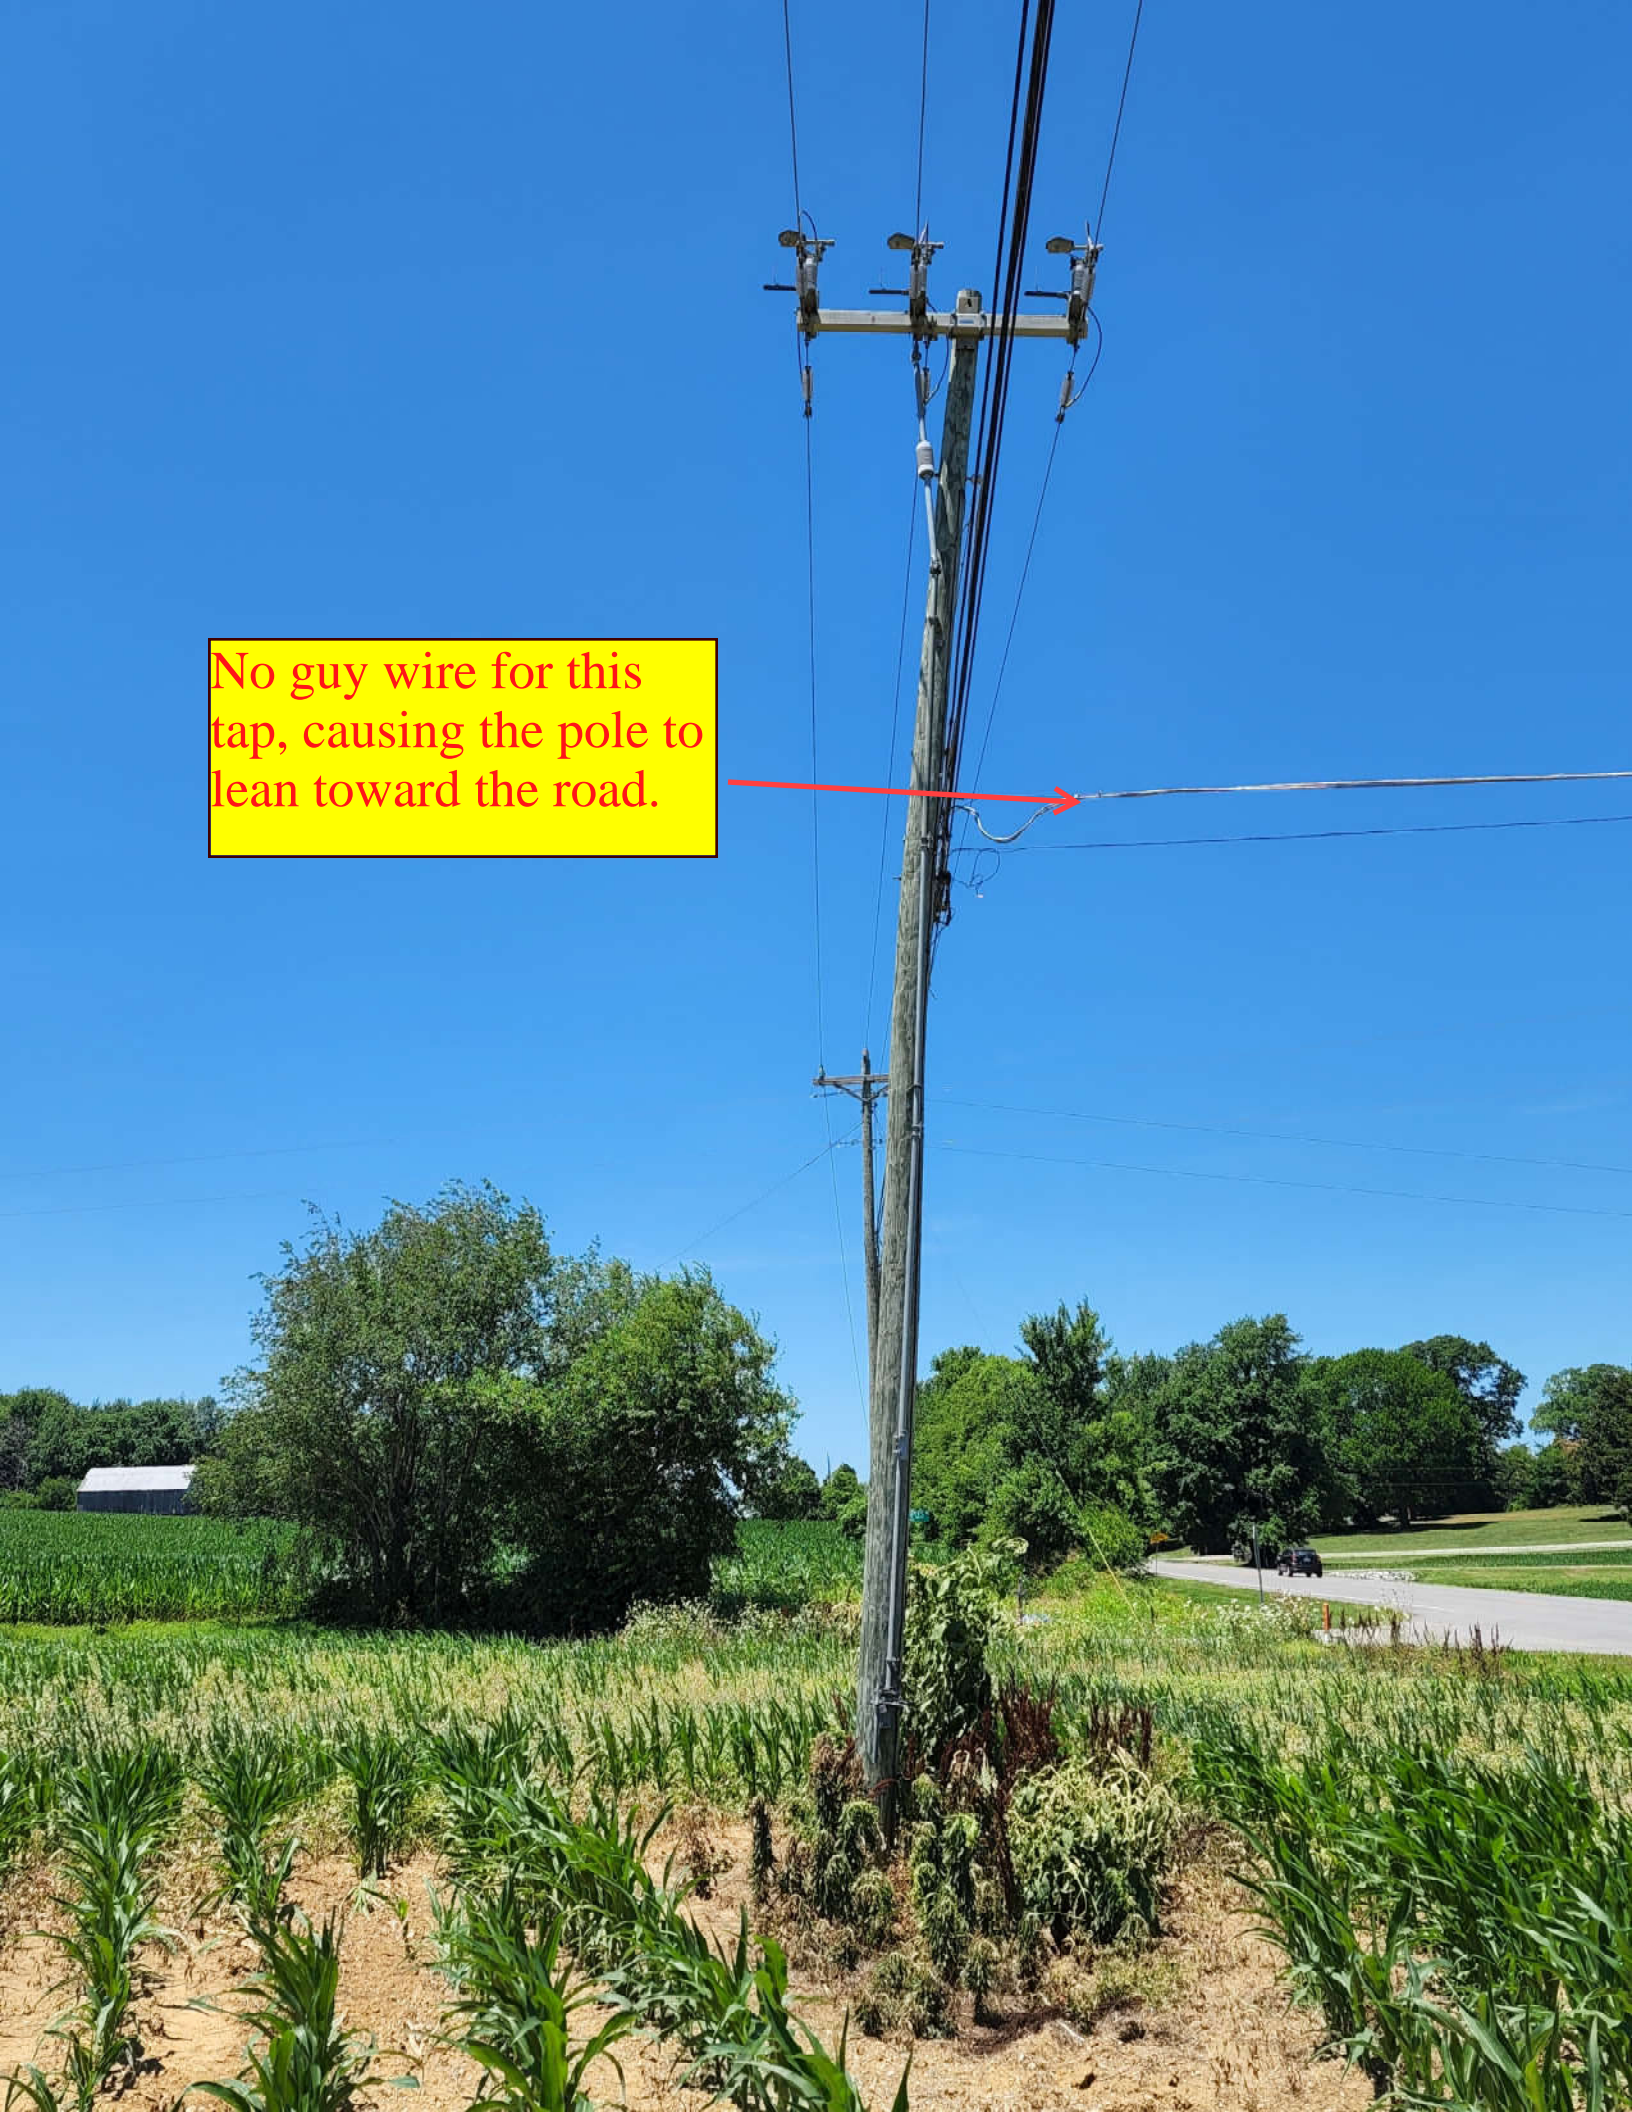
Insufficient guying on cables leaving the powerline route causing pole to lean.

No guy wire for this tap, causing the pole to lean toward the road.
