GH4 Bearing Issue

Case No. 2022-00402

Attachment 1 to Response to PSC-PH-1 Question No. 9

Cane Run 7 – Steam Turbine Generator Fault

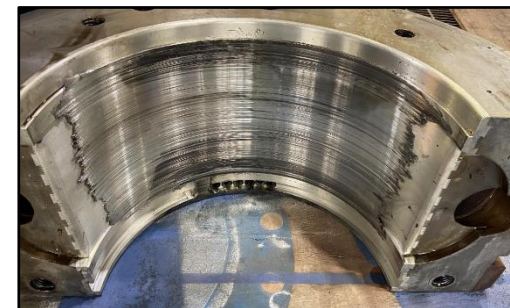
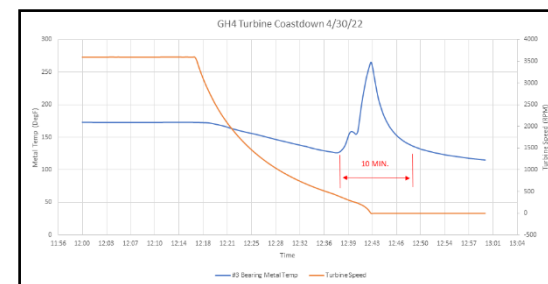
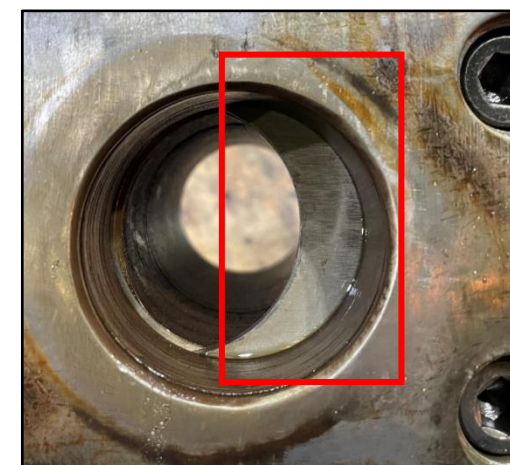
- Analysis of shutdown revealed temperature spike on #3 Turbine Bearing indicating bearing wiped during unit shutdown.
- Inspection of the bearing validated indication. Bearing sent to Cincinnati Babbitt for repair and MD&A brought on site to machine journal.

- Findings include an incorrectly installed shim (likely during 2020 Turbine Major) restricting lube oil flow to the bearing. This is the likely root cause.

- Other minor bearing work conducted and lube oil flushed.
- Unit returned to service on 5/18/2022 at 08:15.
- As of 7/1/2022 this accounts for 72.2 % of the plant EFOR.
