EXHIBIT AG 1-68

DIRECT TESTIMONY

JACOB FREEMAN

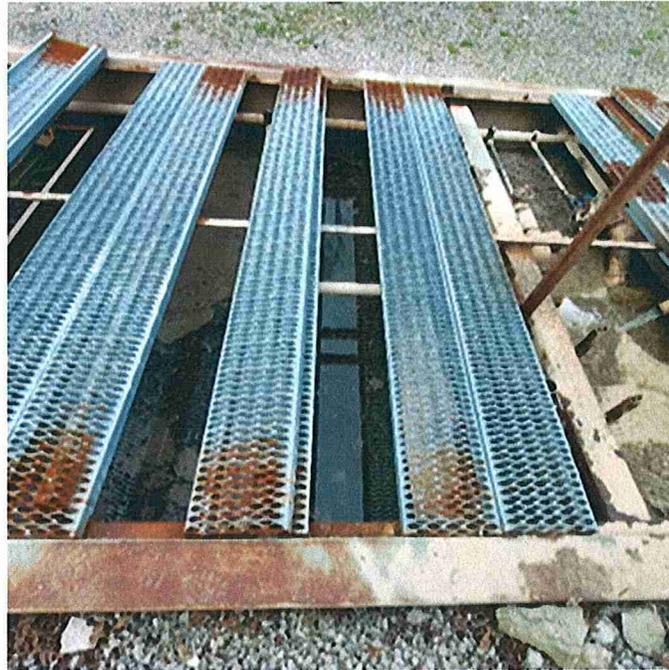
1 of repair or replacement to prevent air leaks and reduced treatment. No remote monitoring
2 system was present on the site.

4 A. The attached picture show deterioration on the grating and the tanks.

5
6 *Rusted grating and tanks at time of acquisition.*
