Arcadia Pines (Wastewater) – No discharge/No permit
Engineering Memorandum
Date: October 5, 2019

Brocklyn-Kentucky (Wastewater)
Engineering Memorandum
Date: December 26, 2018

Carriage Park (Wastewater) – No discharge/No permit Engineering Memorandum

The Delaplain Disposal – Delaplain WWTP KY0079049
Kentucky
Engineering Memorandum
Date: September 11, 2020

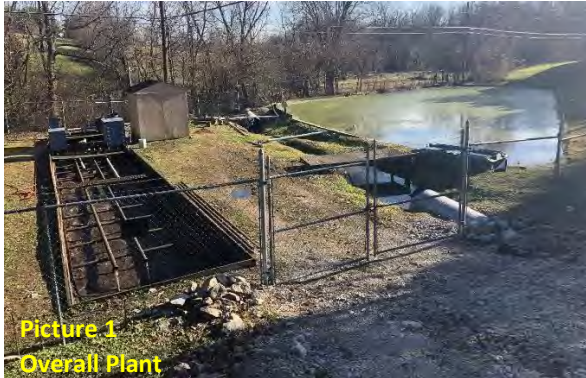
The wastewater treatment facility is made up of a standard extended aeration activated sludge facility. It doesn't appear this system has an active permit to operate. The permit appears to have expired on May 31, 2018. The plant consists of an aeration tank, clarifier, polishing earthen cell, and chlorine disinfection. The aeration appeared to have a reasonable appearance for a mixed liquor however, the clarifier had a lot of floc and sludge at the surface. It is my understanding they are utilizing chlorine tablets for disinfection. This discharge from the clarifier is pumped to the polishing cell. After a period of storage in the polishing cell, the pond discharge gravity flows into the chlorine tablet feeder and contact chamber. The contact chamber is also acting like a re-aeration tank to meet dissolved oxygen requirements. (See Appendix 1 for overall picture)

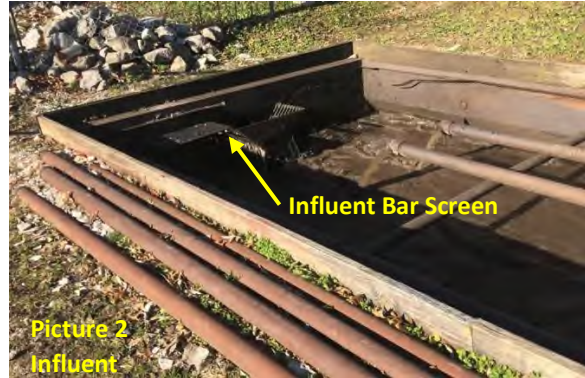
Various items of concern exist as this facility. There is no flow equalization at this facility. The incoming gravity flow enters directly into the aeration tank at the influent manual bar screen. (Appendix Picture 2)

Improvements: Install flow equalization, replace aeration system, replace sludge return lines, sludge judge polishing cell, evaluate the polishing cell to determine the benefit of this part of the treatment, regrade around perimeter of polishing cell with gutter system to redirect water if staying in use, install ultraviolet disinfection, and repair and repaint re-aeration tank to extend life of tankage.

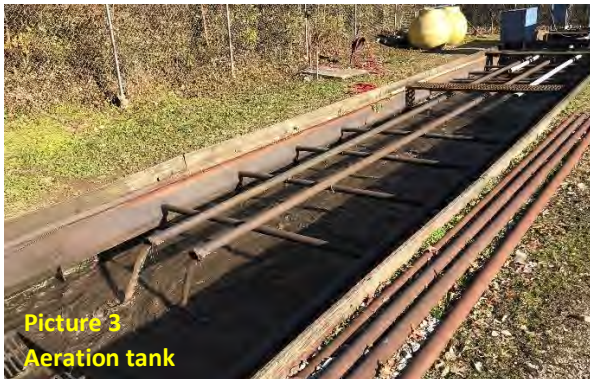
While the aeration appeared to be reasonable operating, standard testing parameters were not performed when we were present to determine the quality of the mixed liquor. Due to the upkeep of the remaining portions of the facility, I do not believe the diffusers have been checked and/or cleaned in some time. Additionally, in review of the EPA's Echo violations listed, the facility is starting to violate limits more often and may be due to non-maintenance of the equipment. Additionally, the tank size appears to be borderline on having the aeration tank volume necessary to serve the 168 customers served. Further measurements will be necessary to determine if the current capacity is adequate or an expansion is necessary. (Appendix Picture 3)

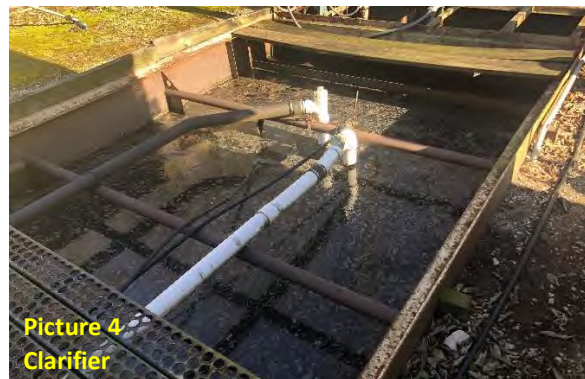
The clarifier appears to be working properly. However, the supernatant water of the clarifier had a large amount of floc and/or sludge coming to the surface. While this might be an operational issue in regards to control of the mixed liquor and return sludge flow, the clarifier is not operating at an optimal level. The clarifier discharge is pumped to the polishing cell for final treatment. (Appendix Picture 4)

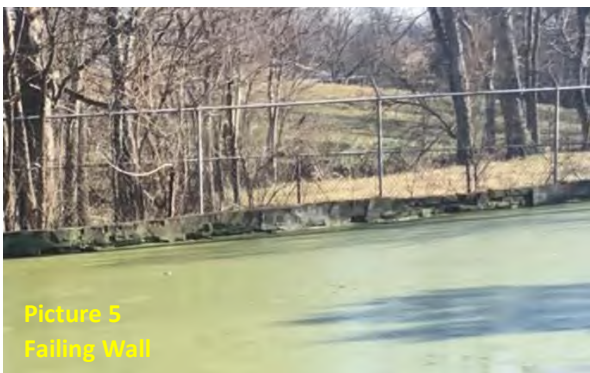
The polishing cell is a poorly designed treatment structure. A deteriorating concrete block wall (Appendix Picture 5) is partially surrounding the pond while the remaining pond surround is earthen. The earthen portion of the pond is allowing overland flow from yards to drain directly into the pond which will bring additional pollutants into the cell and contaminate the effluent. (Appendix Picture 6) Having overland flow will also increase the effluent flow during rain events and will increase chemical usage in the disinfection process. The pond has various issues of concern. To review the operational affects of this polishing cell, it also requires the review of the clarifier. The clarifier has a lot of sludge and floc in the supernatant water of the clarifier above the sludge blanket. This supernatant is pumped

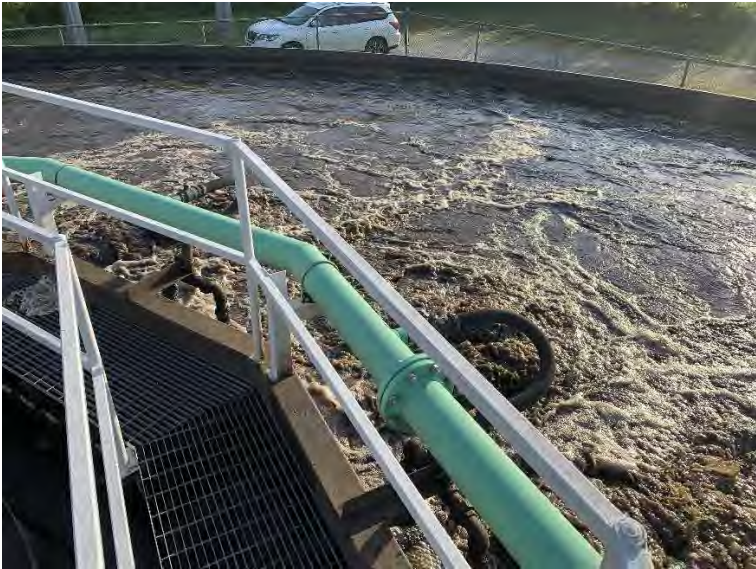
Aeration Tank

The comminutor is no longer utilized, and the manual bar screen appears to result in overflows periodically from the uncleaned bar screen rack. The air pattern in the aeration tank indicates relatively turbulent mixing conditions using coarse bubble diffuser design that would likely not be improved significantly with diffuser replacement. It was unclear whether the surge tank is utilized or if the surge tank transfer pumps are in working condition. The existing gaseous chlorine and gaseous sulfur dioxide systems were in working condition according to the operators (however the chemical solution feed lines were not evident).

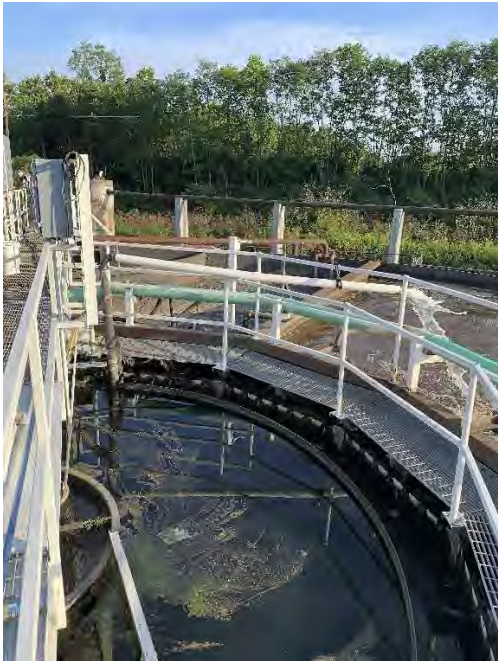
Circular Clarifier

- The existing clarifier has a 10' depth and a 25' diameter. Because the 10-State Standards require 12' deep clarifiers, this tank is not acceptable as a secondary clarifier for activated sludge systems. At the maximum 10-State Standards surface overflow rate of 1,000 gpd/sf, the 25' diameter clarifier can only handle peak flows up to about 490,000 gpd. The peak daily flow and peak hourly flows to the plant significantly exceed this flow rate at this time, so the clarifier is very undersized for use in an activated sludge application.

- This improvement is expected to minimize solids carry over into the clarifier during peak flow events relative to existing conditions.
- We recommend the addition of current density baffles to the side wall of the clarifier (in addition to the above described roughing MBBR and EQ tank improvements) to improve clarifier performance and to allow for regulatory acceptance of surface overflow rates in excess of the typically allowable surface overflow rates. The new roughing MBBR could be used in conjunction with the use of the new EQ tank for temporary clarification to achieve temporary treatment during installation of the current density baffles.

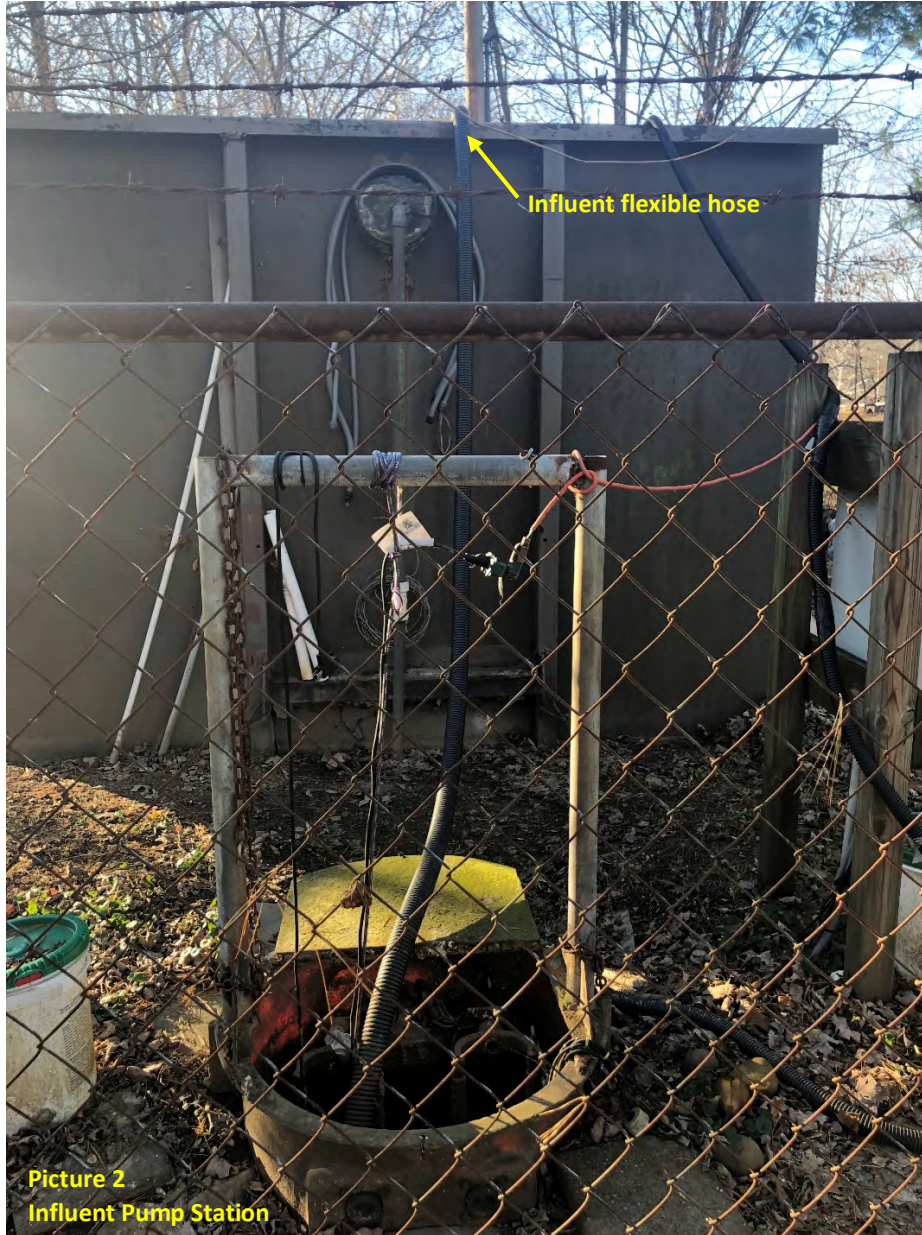
Picture 2
Influent Pump Station

The influent pump station will need to be overhauled in order to ensure reliability. The size of the influent pumps are unknown. The pumps will need to be pulled, inspected, and evaluated for capacity. The facility is using a flexible black hose instead of a metal and or buried pipe that will help avoid freezing and break down from sun exposure. This pipe should be replaced. Additionally, the operator believes there is inflow and infiltration issues in the system. Additional capacity should be added to the influent pump station to provide more consistent flow to the plant if additional analysis confirms this need. (Appendix Picture 2)

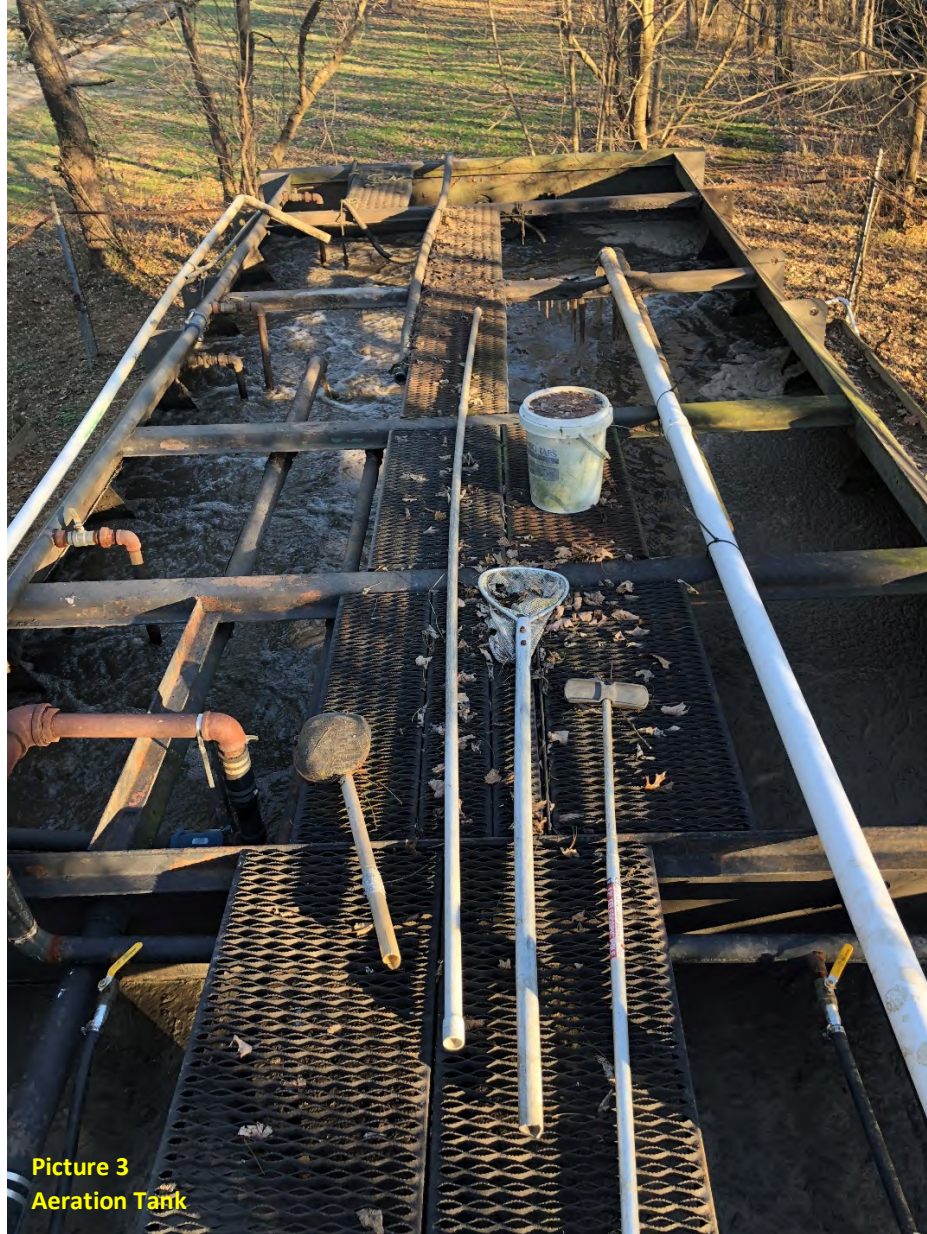
While the aeration appeared to be reasonable operating, standard testing parameters were not performed when we were present to determine the quality of the mixed liquor. Due to the upkeep of the remaining portions of the facility, I do not believe the diffusers have been checked and/or cleaned in some time. Additionally, in review of the EPA's Echo violations listed, the facility is starting to violate limits more often. It appears monitoring reports were not submitted for the first 3 quarters of 2018. Seeing this, it is difficult to determine the actual improvements necessary for repairs. However, I estimate the aeration tank being approximately 25'x 12'x8' deep. This would provide around 18,000 gpd capacity which is close to the 20,000 gpd capacity listed on the permit. Understanding that there are only 34 customers, I anticipate this producing a normal flow rate of around 6,800 gpd. Therefore, the aeration tank appears to be sufficient from a sewage flow rate. (Appendix Picture 3)
