Engineering Memorandum

Randview (Wastewater) – No discharge/No permit Engineering Memorandum Date: February 8, 2020

River Bluff (Wastewater) – KY0043150

Springcrest Sewer – Springcrest Wastewater Disposal System Kentucky Engineering Memorandum Date: September 11, 2020

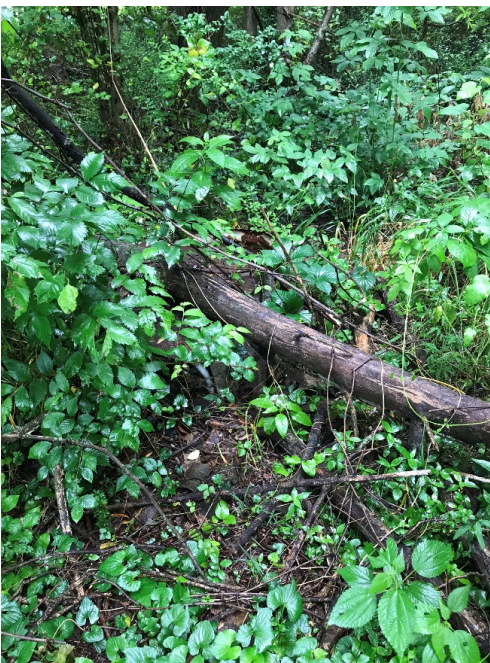
Tree fallen on lift station 1

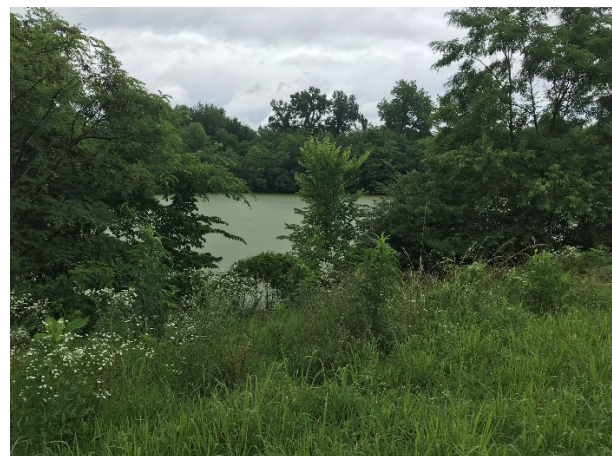
During our visit to the lagoon, various site components were showing signs of failure and minimal maintenance. The system is setup oddly of two lagoon cells that are approximately 2,000 feet apart. A representative of the sewer system stated that one of the lagoons has a lift station at the effluent that pumps to the second lagoon cell. Investigation will be needed to determine capacity of the components to determine if the system can function as it is today. The two Lagoon cells have limited access due to minimal maintenance around the perimeters of each lagoon cell. Heavy vegetation berm cutting will be needed to avoid possible failure and/or leaking of the lagoons. From pictures, we were unable to evaluate the integrity of the berms. The perimeter fencing needs repairs at multiple locations.

Unmaintained Lagoon

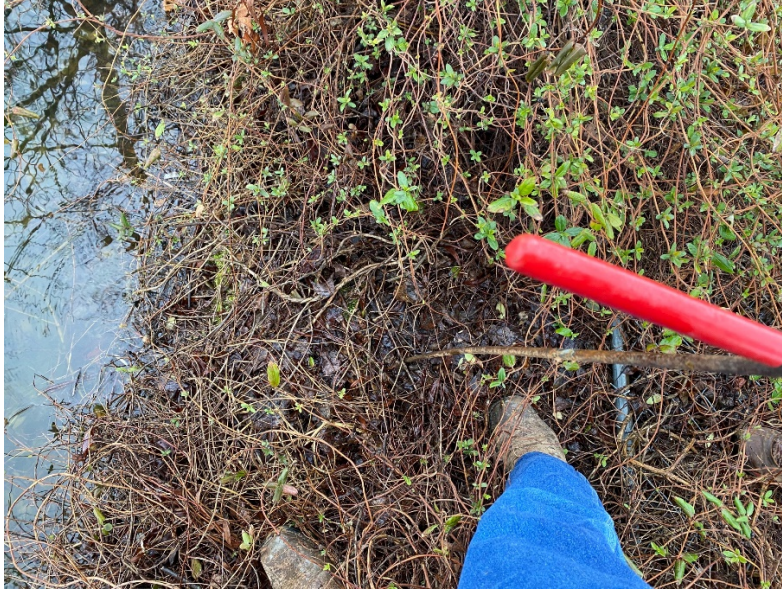
Lagoon Berm vegetation and sewage overflow

Improvements: Remove all berm vegetation for further inspection and possible repair. The perimeter fence needs repair. Inspection of the lateral field and compare to any design plans that the Health Department. Repair lateral field and discharge pipe as needed. Repair inside berms where erosion is occurring.

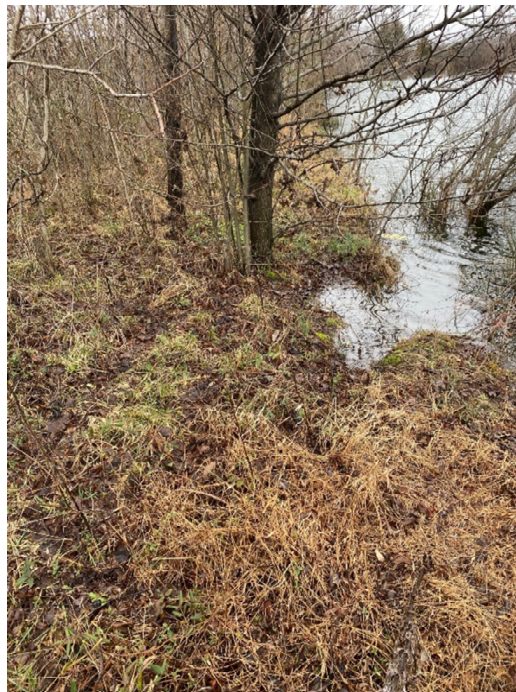
Lagoon Berm vegetation

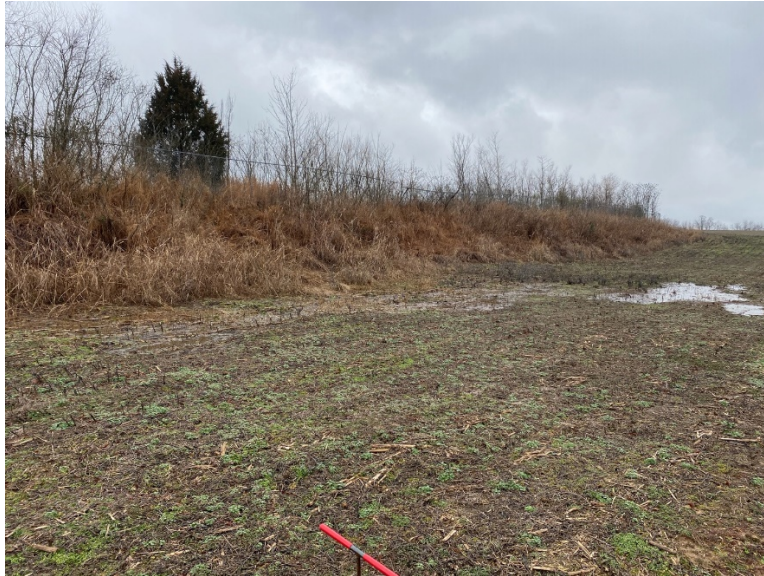
We reviewed documents at the local Health Department whom provided original plans for construction. The plans showed a subsurface drain field. This field was wooded a few short years ago but recently was cleared by a local farmer and is now in crops. Probing was completed and it was found that the drain field indeed has farming operations over it and most likely is overly compacted and in a state of failure. During the same visit, the lagoon was overflowing the berm and into the crop fields. Most likely due to an overly compacted drain field. This area will need to be repaired and taken out of farming operation. Lastly, it was found that the overflow to the drain field had been broken off and floating in the lagoon. This will also need repaired immediately.

Lagoon seepage and overflow into crop field

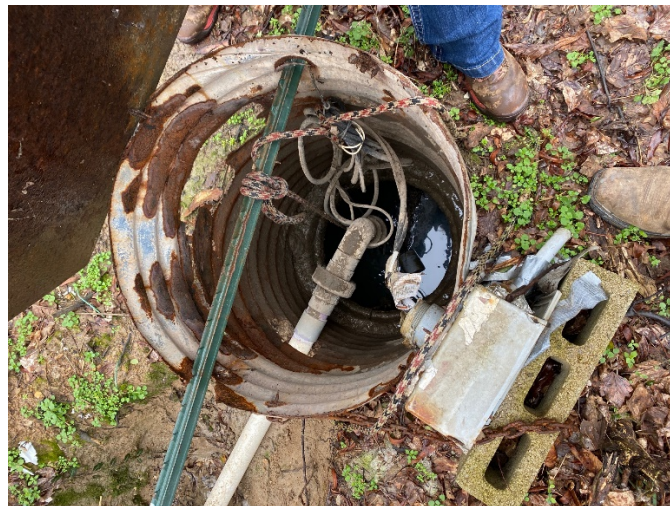
An inspection was made and we were able to find a second lift station. This second lift station is made of a corrugated metal pipe and wires and piping hanging from a fence post that was punched through the side of the pipe. This is a safety and reliability issue and needs replaced.

Non-standard/failing lift station 2

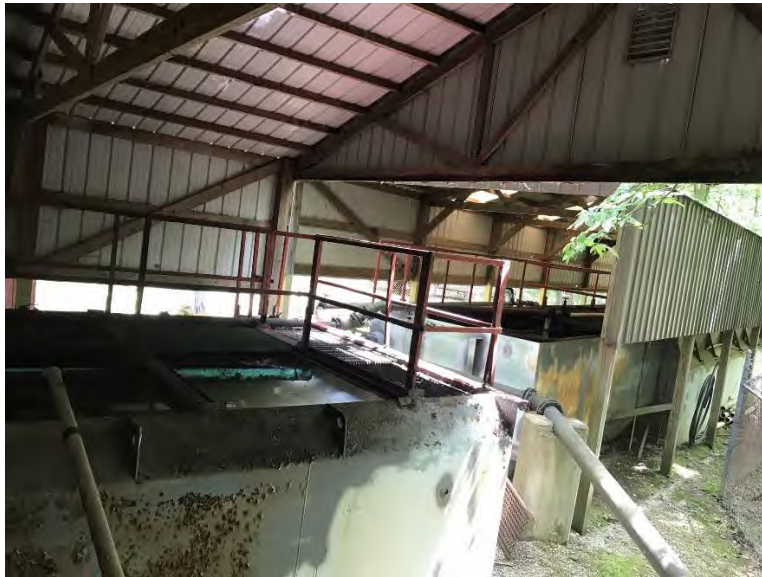
The plant is an activated sludge system with grinding, activated sludge, chlorine disinfection, and dichlorination. The metal tanks holding the wastewater treatment components are showing various signs of aging, and all of them are developing severe amounts of rust. All the control panels on site seem to be in declining condition and will need electrical inspections to ensure they meet all safety requirements. Most will probably need to be either repaired or replaced. The system currently has two blowers installed, and both need to be inspected and either replaced or repaired if necessary. There is an influent lift station. An inspection should be completed after acquisition to determine shape of pumps as well as if they are the properly installed. The return, skimmer, influent, and effluent lines appear to be PVC. Some of the older returns are still in place but appear to have corroded to a level that would deem them inoperable. An inspection of each line should be completed upon startup and replaced as needed.

Treatment Tanks are rusting and have gone unmaintained

Improvements: Due to the extent of the failure to maintain the systems by the previous owners, I recommend the improvements be staged. The first phase of improvements should include the inspection and replacement of blowers/service filters as needed, lift station pump inspection and repair/replacement, installation of Mission monitoring/generator quick connect/flow meter, inspection and replacement/repair of control panels, and inspection and replacement of diffusers that have failed. After a period of operation and facilities evaluations regarding capacity and permit limits, a second phase will be put into action to either expand or replace the current treatment facility in its entirety.

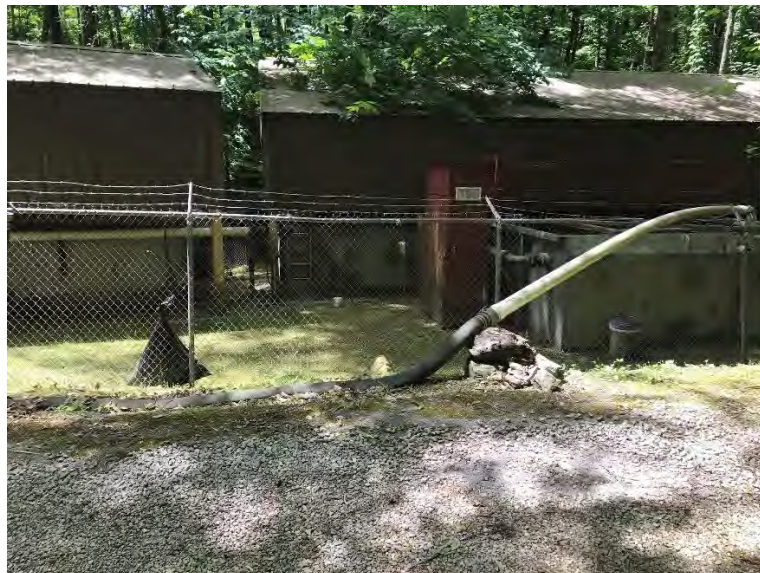
The facility's influent pipe appears to be laying across the chainlink fence and held down by the 3 strand barb wire. This is not a typical installation. The pipe should be properly buried to avoid freezing, sun damage of the PVC, and to protect the system from vandalism.

Influent PVC line is fastened to the top of the fence and should be properly buried.

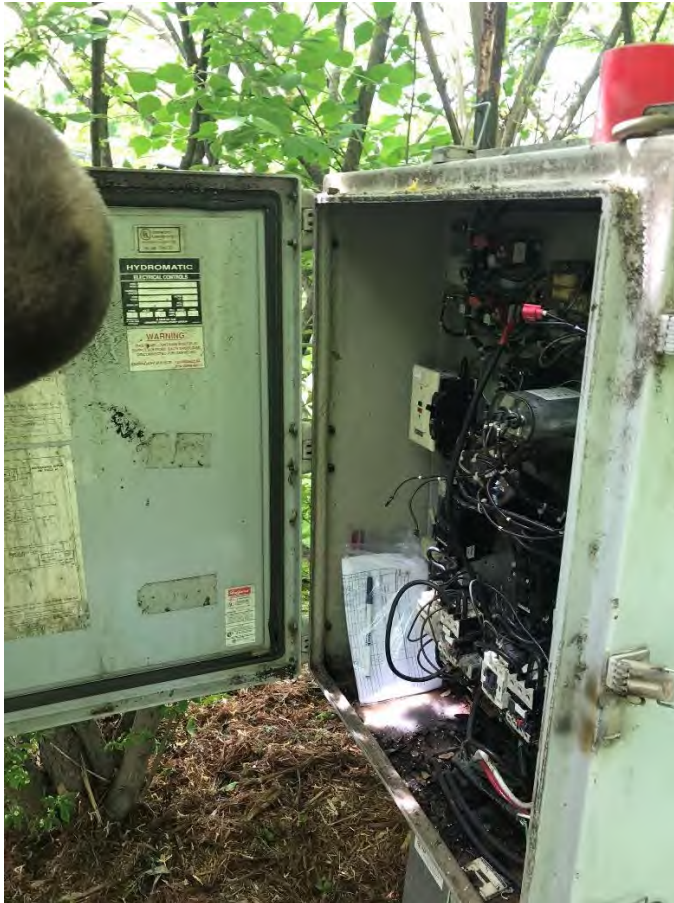
The system does have two lift stations. This lift station have been poorly maintained. Pumps should be pulled and inspected. A safety inspection should be completed on the control panels to ensure reliability.

Lift station control panels appear to be poorly wired and are a safety concern.

Improvements Required: Inspection lift stations for quality, performance and safety. Perform smoke testing, evaluate system and create GIS mapping for future maintenance needs.

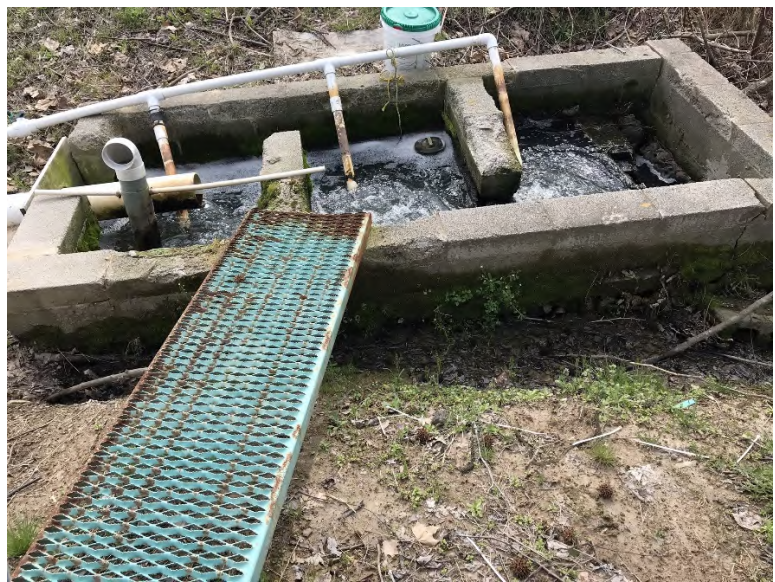
Structurally, the existing steel wastewater facility is severely rusted and will need a thorough inspection, painted and potentially patched if the tank remains in service. Additionally, the chlorine contact chamber was constructed out cinder blocks, has limited walls to maximize contact time, and is degrading.

Chlorination Contact Chamber not up to code

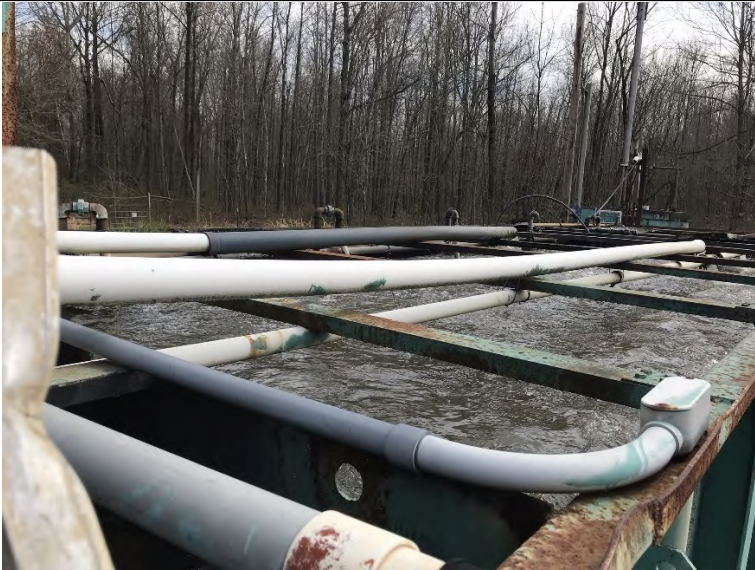
PVC lines need to be replaced

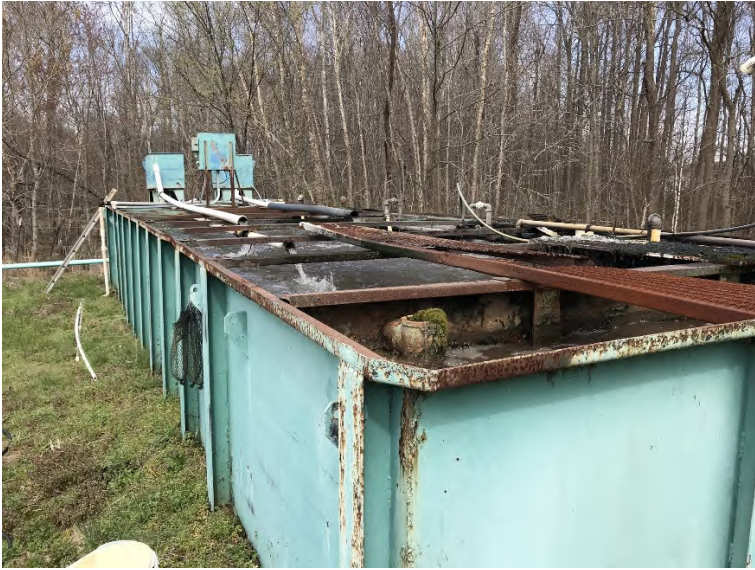
Activated Sludge – Extended Aeration tank beginning to rust/fail

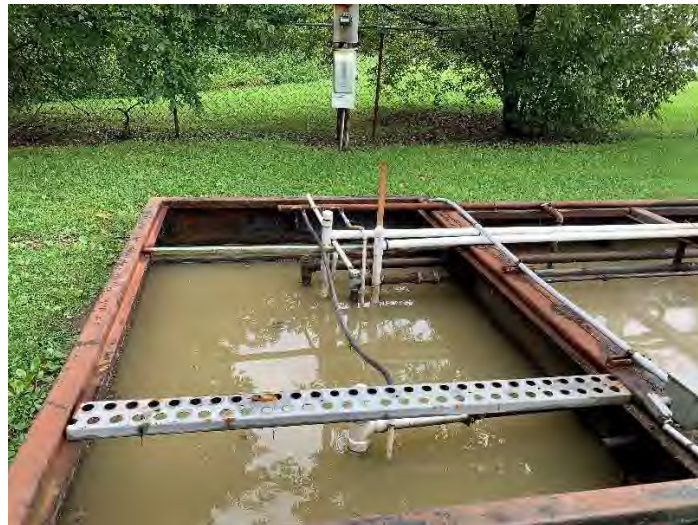
- The operator believes it is necessary to turn off aeration during wet weather events to minimize the loss of solids and to retain a healthy biomass.
- The tertiary treatment basin (rapid sand filter, contact tank and dechlorination tank) is highly corroded.

**Clarifier Performance During Wet Weather
(and No Aeration in Aeration Tank)**
