**COMMONWEALTH OF KENTUCKY
BEFORE THE PUBLIC SERVICE COMMISSION**

**ELECTRONIC APPLICATION OF)
BLUEGRASS WATER UTILITY)
OPERATING COMPANY, LLC FOR AN) Case No. 2022-00432
ADJUSTMENT OF SEWAGE RATES)**

DIRECT TESTIMONY

JACOB FREEMAN

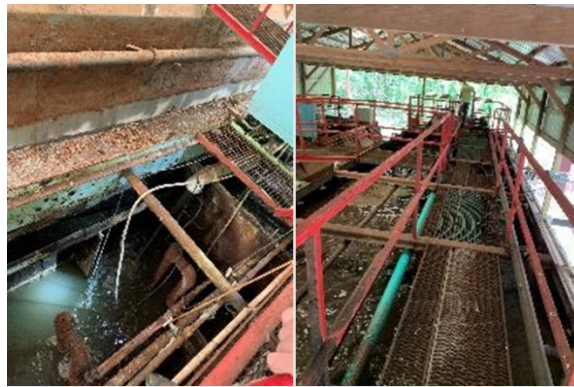
5 A. The River Bluffs facility had a long history of non-compliance, especially for ammonia
6 and suspended solids. Much of the steel treatment equipment and the structure of the
7 treatment plant itself were severely corroded, causing suboptimal performance and raising
8 concerns about plant safety. Additionally, the wiring in the control box at the lift station
9 was in such poor condition that it raised electrocution concerns. The influent system was
10 also in poor condition, with major components improperly installed.

14 *Severe corrosion and rust found throughout the River Bluffs facility.*
15
16

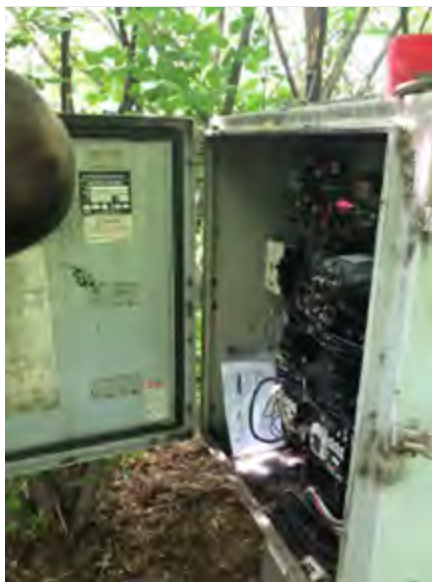
Unsafe wiring in the lift station control box.

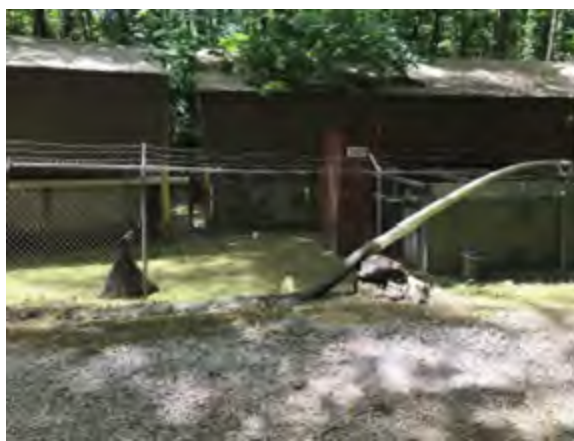
Improper influent line installation.

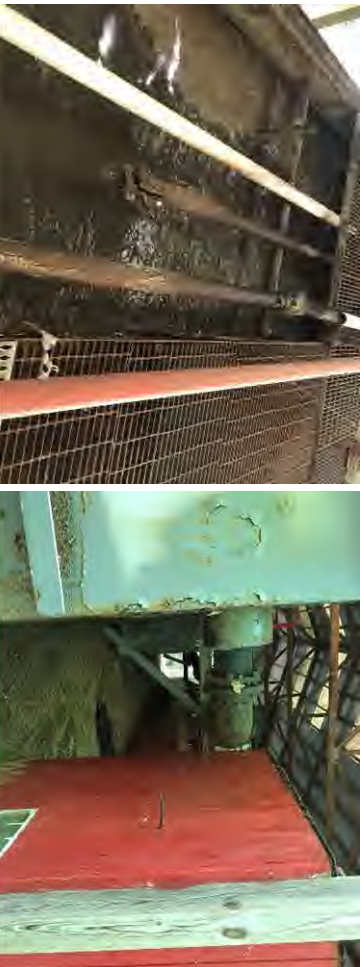
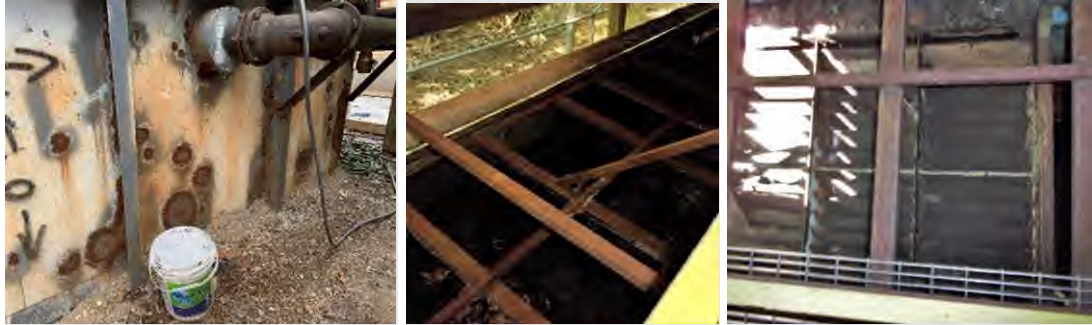
1 significantly worse condition than had been initially identified in both the prior rate case
2 testimony and the third-party engineering partner's pre-acquisition evaluation. For
3 instance, while steel deterioration had been noted, the scope of steel work required at the
4 facility had been significantly underestimated. Specifically, a substantial amount of the
5 steel infrastructure, including the steel tanks, the aeration piping, walkways, handrails, and
6 interior tank baffling, was in a severely deteriorated condition.

Examples of severe rust damage present throughout the facility before repairs

A. Yes. Bluegrass Water realized that repairs would necessarily include: (1) replacing damaged catwalks; (2) patching tank leaks; and (3) replacing damaged sections of wastewater plant piping and air headers. As the system was evaluated during operations, however, it became clear that the number of air leaks and the deteriorated aeration diffusers had reduced the efficiency of aeration treatment. As a result, replacement of the aeration

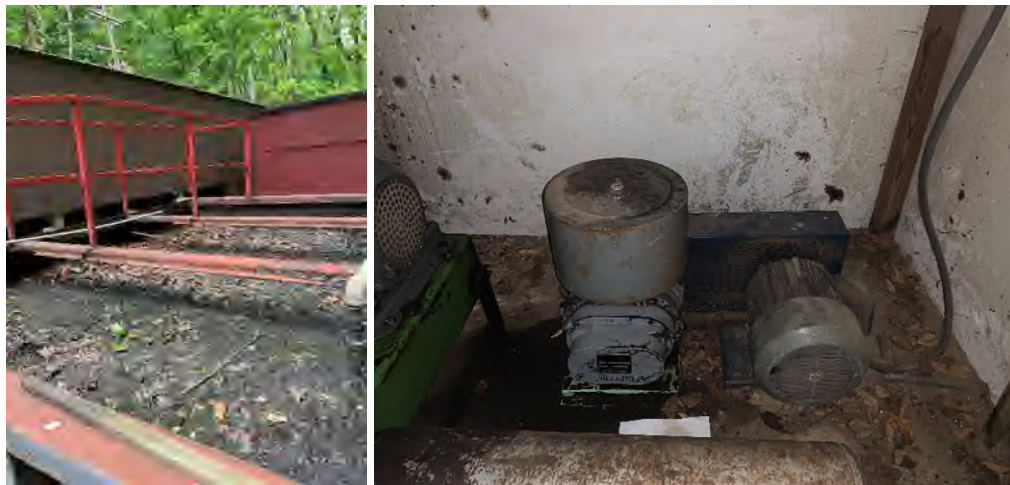
A. Yes. In addition to the issues with rust and deterioration throughout the plant, it became apparent that much of the equipment had prematurely reached the end of its useful life due to past operational neglect. For example, the sludge holding tank was completely filled with solid impacted sludge. The solid sludge resulted in a blower failure due to the air

1 system pushing into a “dead head” of solid sludge. As a result, air could not escape through
2 the sludge, backpressure increased and one of the blowers burned out.³ After Bluegrass
3 Water commenced operations, the blower was temporarily repaired and the sludge holding
4 basin pumped out. That said, however, the other blower has also reached the end of its
5 useful life and will also need to be replaced. The delivery of the new blowers and controls,
6 which were originally slated to arrive on 7/29/2022, have been repeatedly postponed by
7 suppliers citing COVID-related supply chain delays.

8
9 *Sludge-holding tank full of impacted sludge and damaged blowers.*

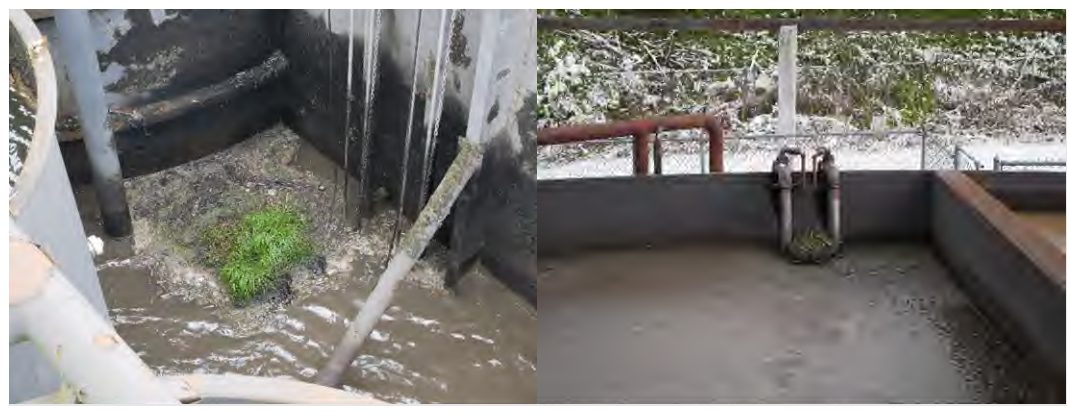
12
13 *Vegetation growth on accumulated sludge and nuisance solids in the plant.*

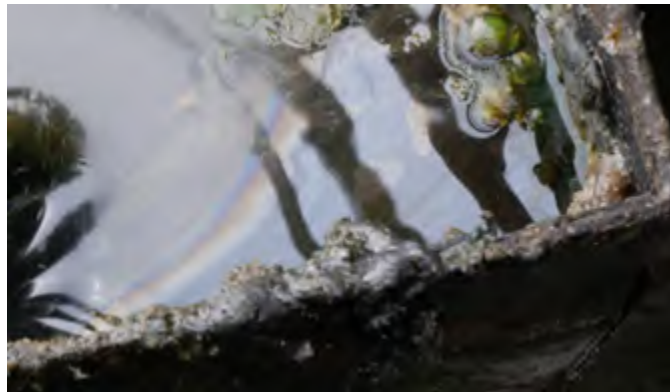
8 *Oil sheen on wastewater indicating failure in pretreatment from commercial clients.*

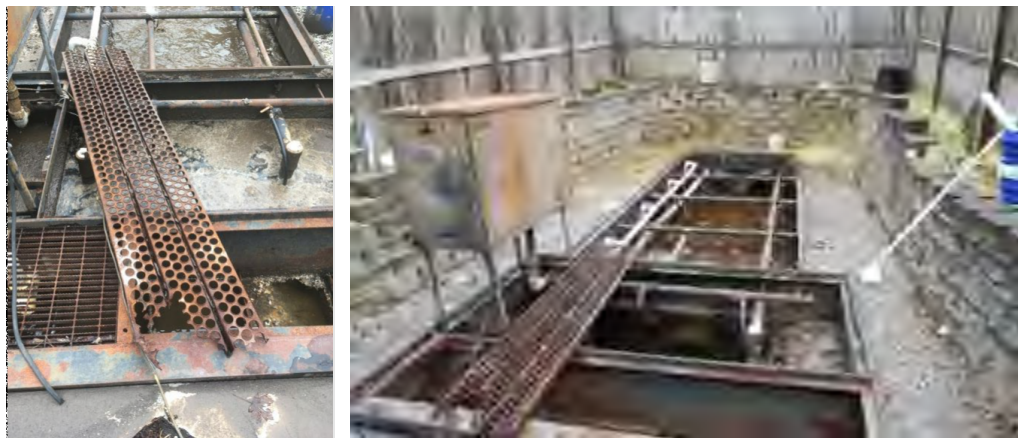
9
10 *Rust damaged walkways and no guard rails around aeration basin. Also note minimal aeration*
11 *activity due to poor condition of aeration system, and minimal area for expansion due to*
12 *retaining walls.*

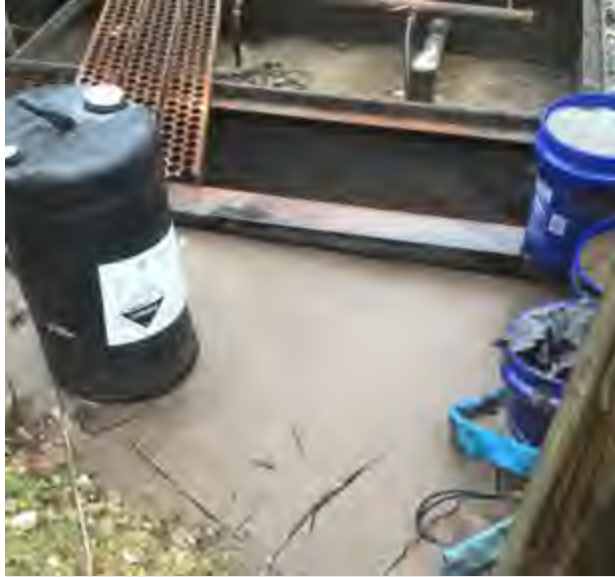
Sludge accumulation inside of fenced area around plant due to plant overflow.

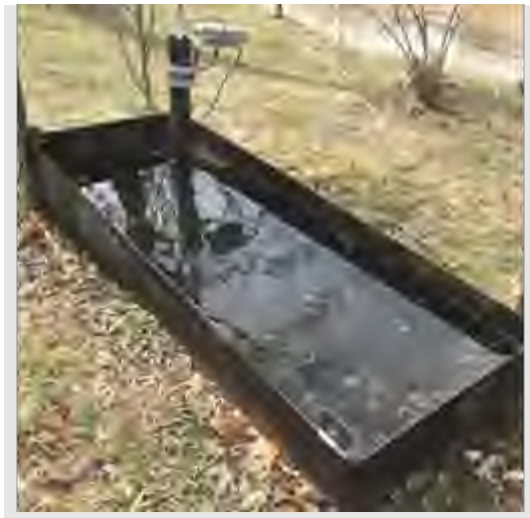
4 A. Attached is a picture of the Herrington Haven weir box. Importantly, as previously
5 mentioned, the picture demonstrates that the V-notch weir is completely submerged due to
6 the amount of sludge in the weir box. The photo also shows the significant amount of rust
7 on the weir box as well as the poorly installed UV unit on the back corner.

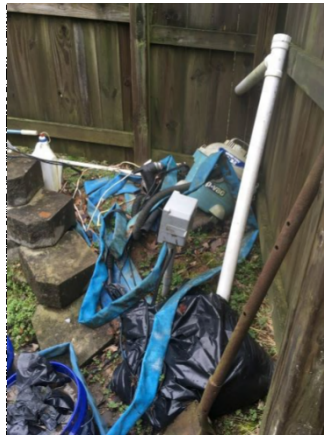
3 A. Inside the fenced area at Herrington Haven there were piles of trash and damaged
4 equipment which had not been properly disposed of. Similarly, the significant sludge
5 accumulation throughout the facility indicates that regular operations activities were not
6 being completed at the site.

7
8 *Piles of trash left inside fenced area.*

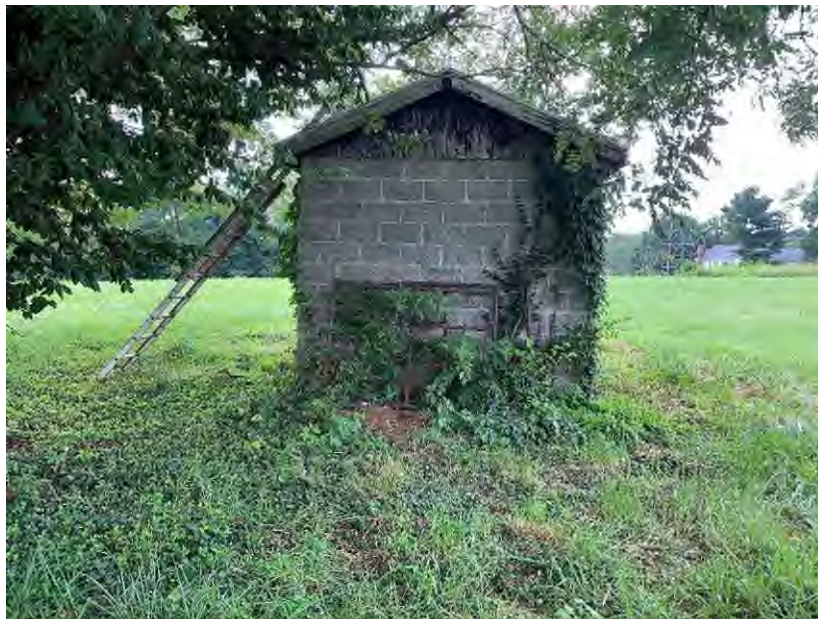
Overgrowth on control structure.

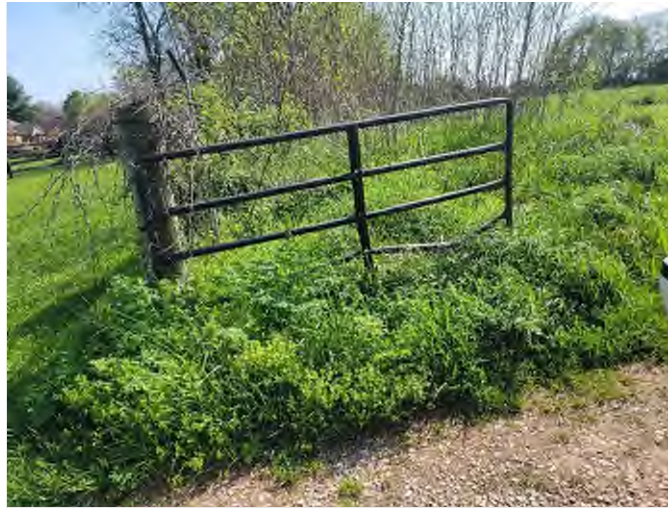
6
7 *Condition of facility gate at acquisition.*

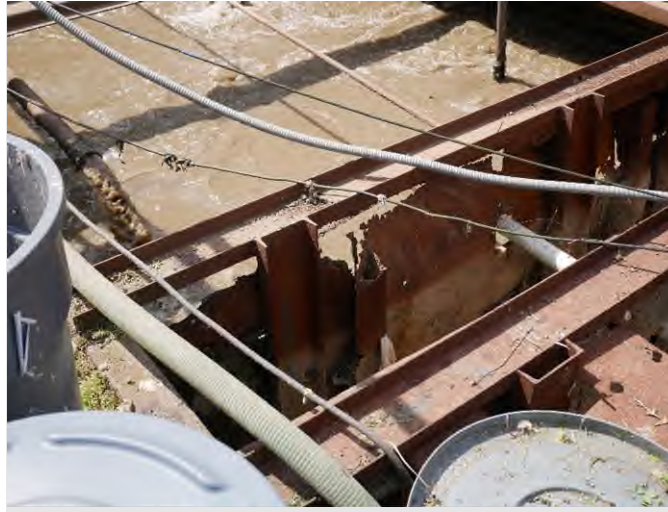
1 A. Yes. The following picture not only shows the deterioration of the steel tank bulkhead
2 walls it also demonstrates: (1) the poor condition of the aeration diffusers and drop pipes
3 as well as (2) wiring simply strung across the tank.

4
5 *Woodland Acres steel tank deterioration.*
6

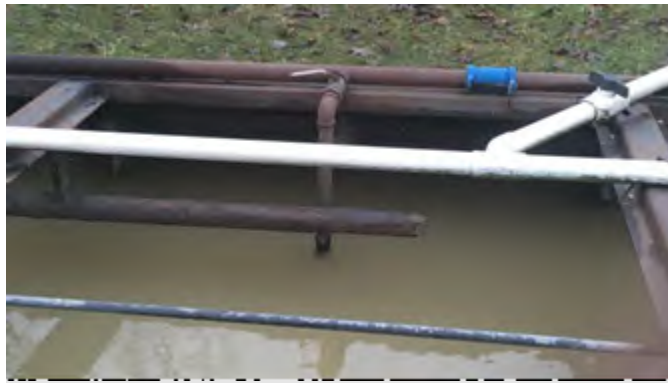
6 A. The first picture shows the broken sludge return pipe which prevented returned sludge from
7 mixing into the aeration basin. The second picture depicts the coarse aeration pattern in
8 the aeration basin.

9
10 *Broken sludge return pipe.*

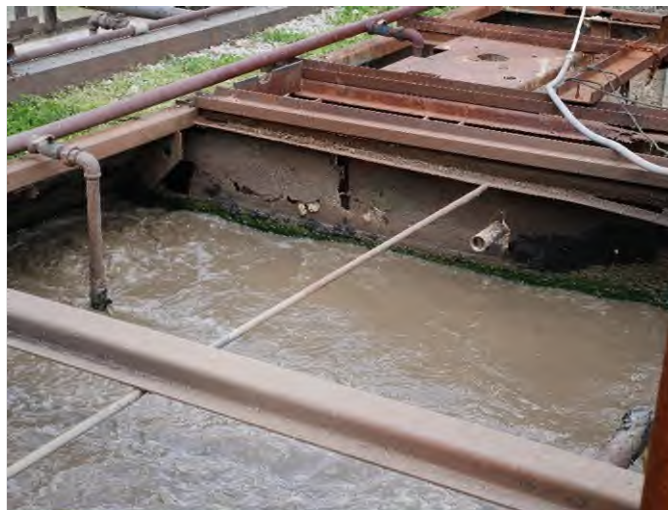
11
12 *Coarse aeration pattern and severe rust in aeration basin.*

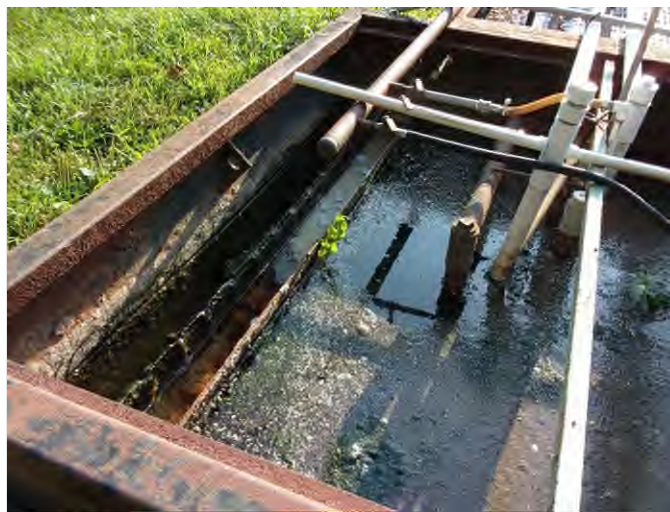
Woodland Acres clarifier.

14 A. Yes. The following picture shows the mat of pin floc in the clarifier as well as some
15 vegetation growing in the pin floc.

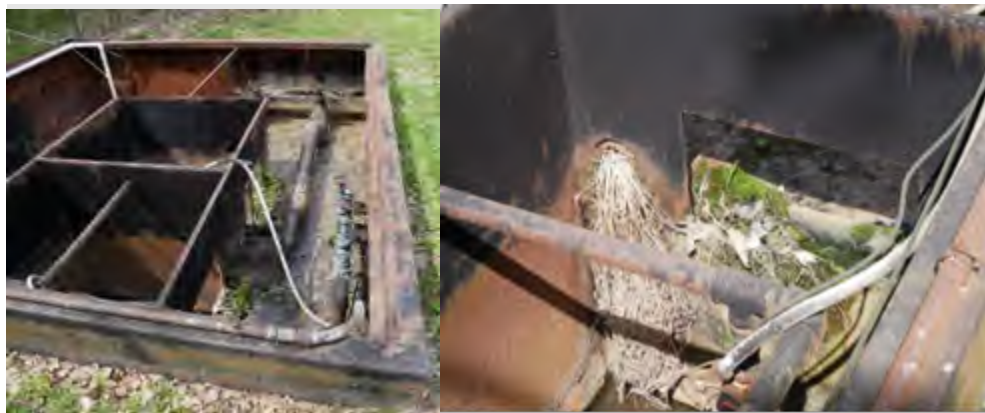
13
14 *Woodland Acres sand filter.*

11 A. Yes. The attached pictures show the accumulation of sludge and vegetation in the
12 Woodland Acres sand filter.

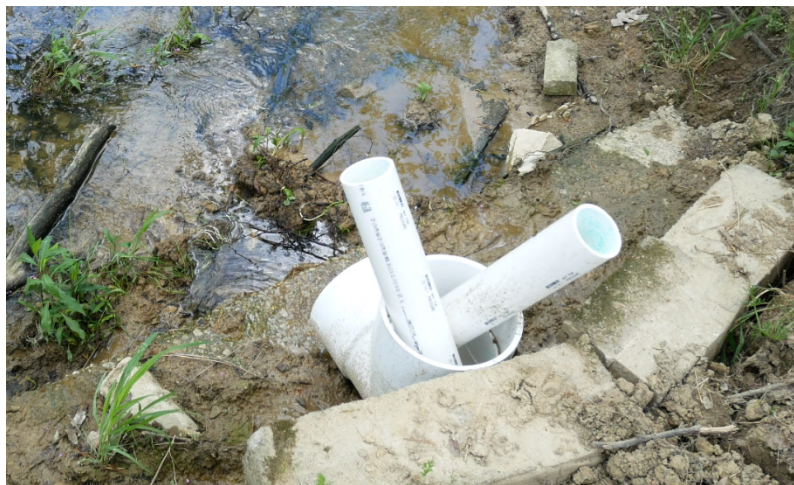
8 *Woodland Acres dechlorination system. Also, note deposited sludge in receiving waters*
9 *confirming the issues with the clarifier and sand filter leading to TSS exceedances.*

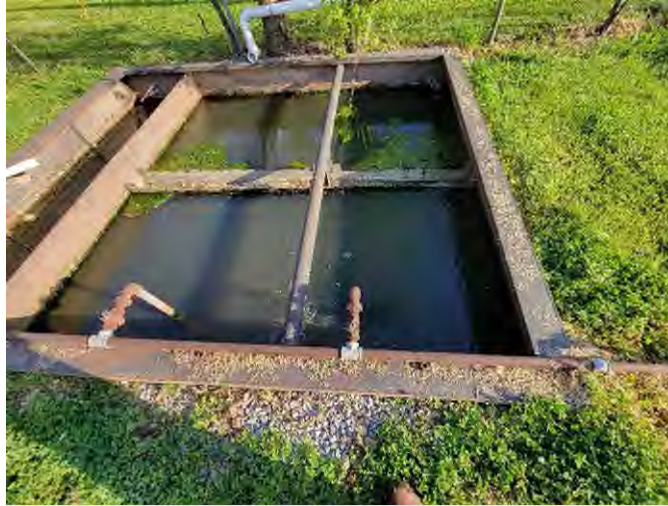
4
5 *Woodland Acres digester.*

2 A. Yes, the following picture shows the poor condition of the Woodland Acres digester,
3 including the deteriorated tankage and the growth of vegetation.

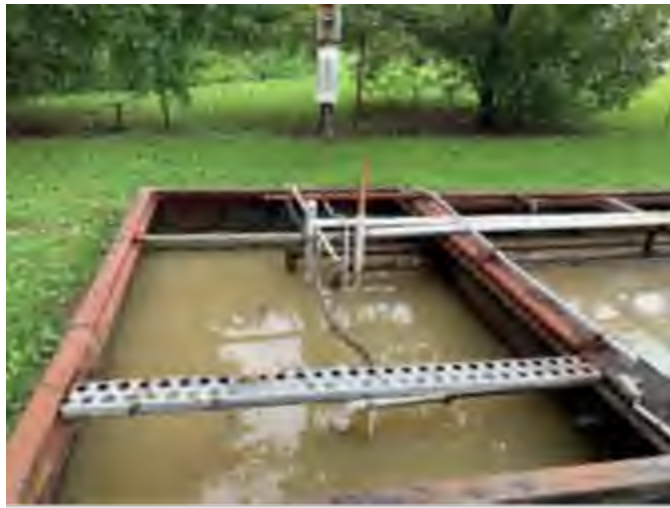
3 A. Yes. The following picture demonstrates the condition of treatment when aeration is
4 turned off during a rainstorm in an effort to preserve sludge and microbiology.

5
6 *Woodland Acres treatment basin during a rainstorm.*
7

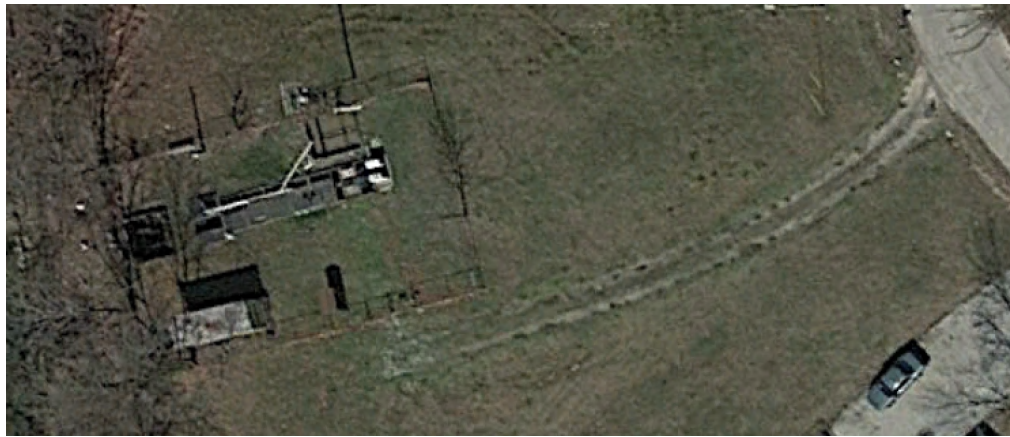
5
6 *Dirt access road with little gravel visible in aerial photos.*

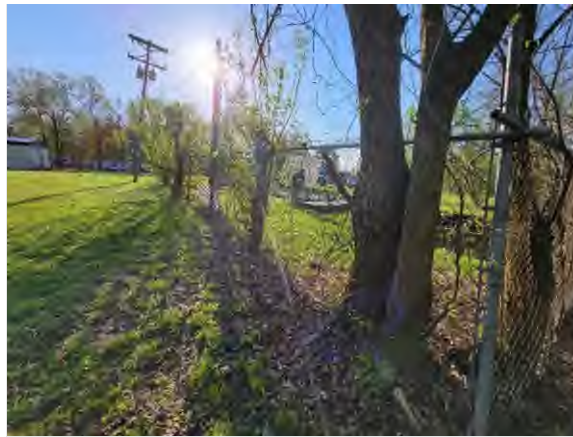
7
8 *Trees and vegetation causing damage to facility fencing.*

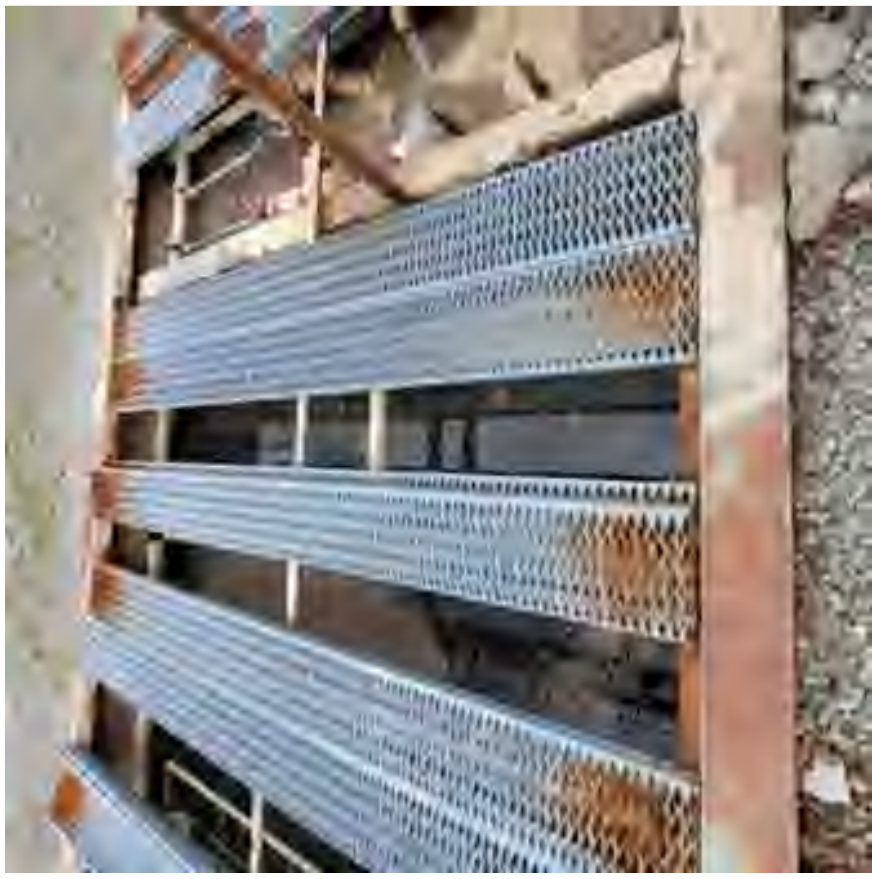
4 A. The attached picture show deterioration on the grating and the tanks.

5 *Rusted grating and tanks at time of acquisition.*

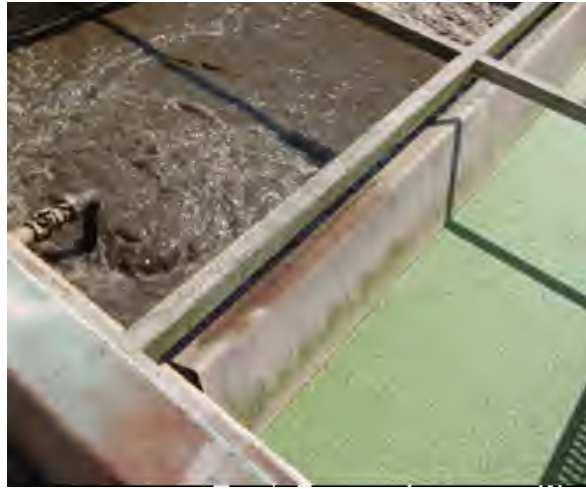
1 A. Yes. The attached picture of the Darlington Creek clarifier shows the layer of duckweed
2 growing on the clarifier at the time that the system was acquired.

3
4 *Thick layer of duckweed in clarifier indicating scum return failure.*

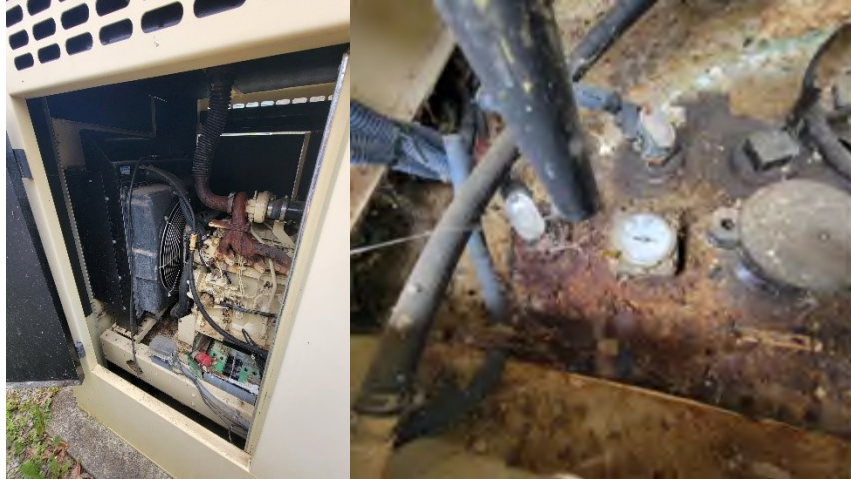
Rust and damage to the interior of the on-site generator.

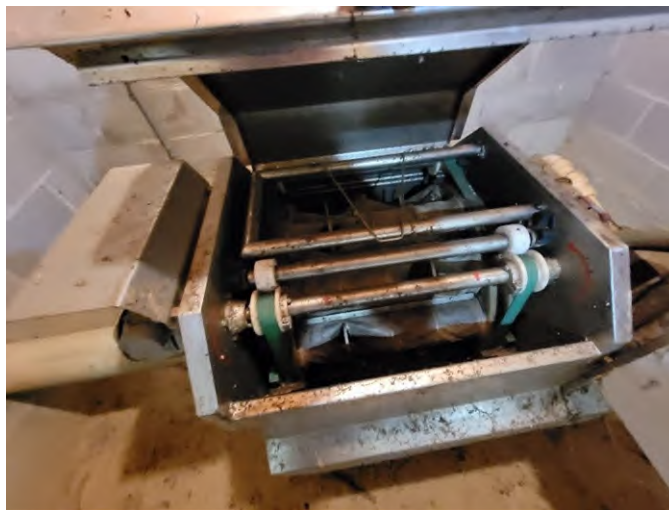
Damaged membrane on interior of tertiary filter.
