Great Oaks-Kentucky (Wastewater, KY0080845)

Engineering Memorandum

Date: February 19, 2019

Herrington Haven Subdivision – Herrington Haven WWTP KY0053431
Kentucky
Engineering Memorandum
Date: September 11, 2020

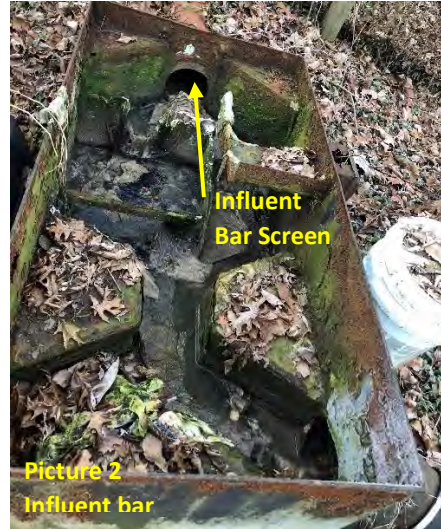
There is no flow equalization at this facility. The incoming gravity flow enters directly into a bar screen box structure that has failed and the bar screen has been removed. (Appendix Picture 2.) This structure should be repaired.

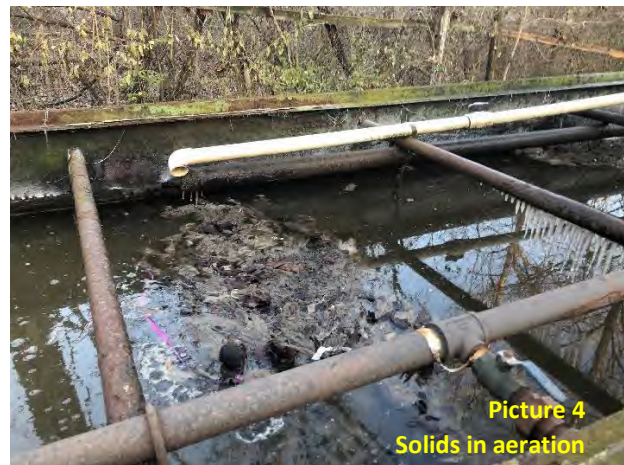
The aeration tank sits above the surface. It has a number of large rust holes that show obvious signs of failure. These holes could be patched. However, I have concerns on the integrity of the remaining structure as it is not typical for the plant to rust completely through to this extent. (Appendix Picture 3.) Additionally, the facility liquid in no way has a resemblance of a mixed liquor. Items that should have been caught by the bar screen are piled on the surface of the water. The facility was not running upon arriving or leaving the site. I believe this portion of the treatment facility has completely failed. (Appendix Picture 4.)

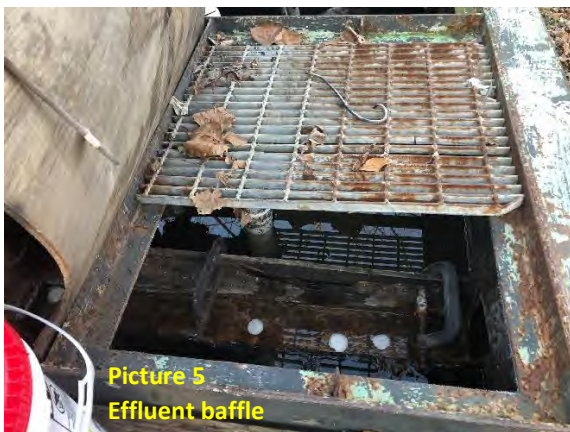
The clarifier has received a number of patch repairs. The baffle for the effluent consists of treated lumber held in place by vise-grips on a rusted through baffle. (Appendix Picture 5.) The clarifier sludge returns were not running while we were on site. The operator did turn on the skimmer temporarily while we were there and it appeared working. However, the integrity of the structure and piping is in poor shape. The wiring of the control panel is exposed, not fastened, and is a safety issue for anyone working on this facility or on the plant. (Appendix Picture 6.)

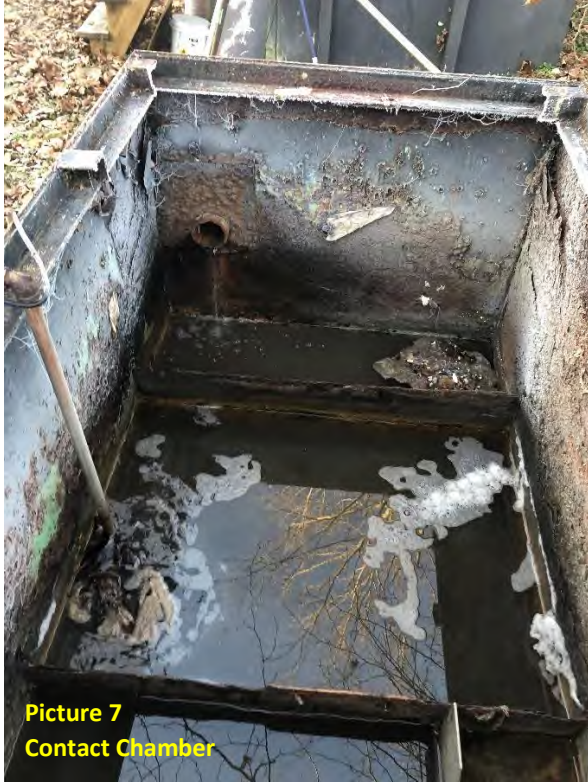
The contact chamber does not have typical baffling and may experience short circuiting. This facility has seen violations of both residual chlorine and E. Coli. This facility is obviously struggling to meet limits with its current setup. Upgrades should consist of converting to ultraviolet. (Appendix Picture 7)
