PRELIMINARY ENGINEERING REPORT

PHASE 12 WATER SYSTEM IMPROVEMENTS

NICHOLAS COUNTY WATER DISTRICT

BE Project No. 20016

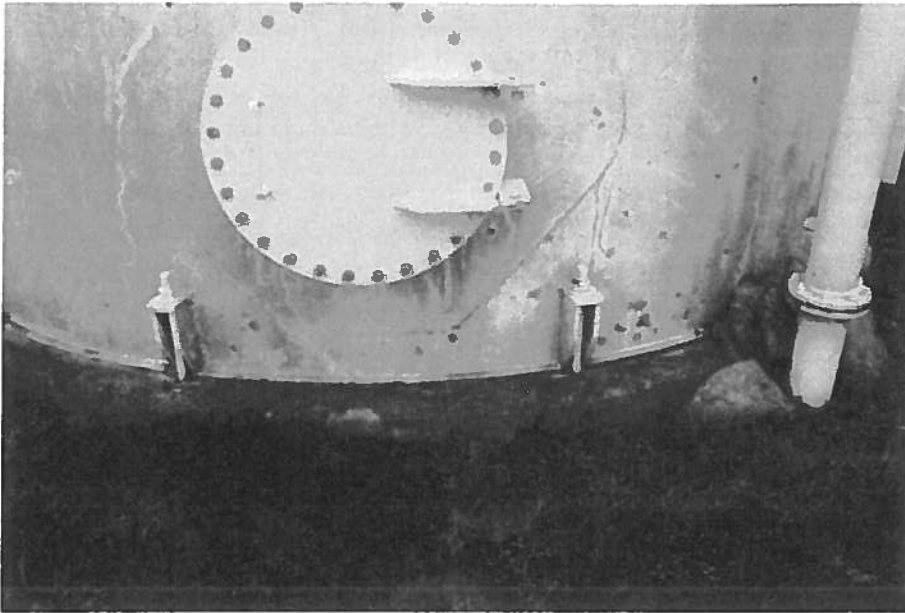
Foundation and Manway

- Over all condition of the exterior should be considered good with several small random areas of spot corrosion.
- Base plates are in fair condition. The flexible sealant has deteriorated in some areas due to the growth of vegetation between the base plate and the foundation.
- Foundation is in good condition. A section of the foundation is covered with grass.
- Anchor bolts are in good condition with some small corrosion spots.

3. Power Wash Exterior 3000psi min. to remove all loose material and debris.
4. Spot Repair cleaning **SP 3 Power Tool Cleaning** on all corrosion areas.
5. Apply one coat of Rustoleum 9800 3-4 mils.
6. Clean off all debris from the foundation.
7. Caulk or Grout baseplate to concrete.

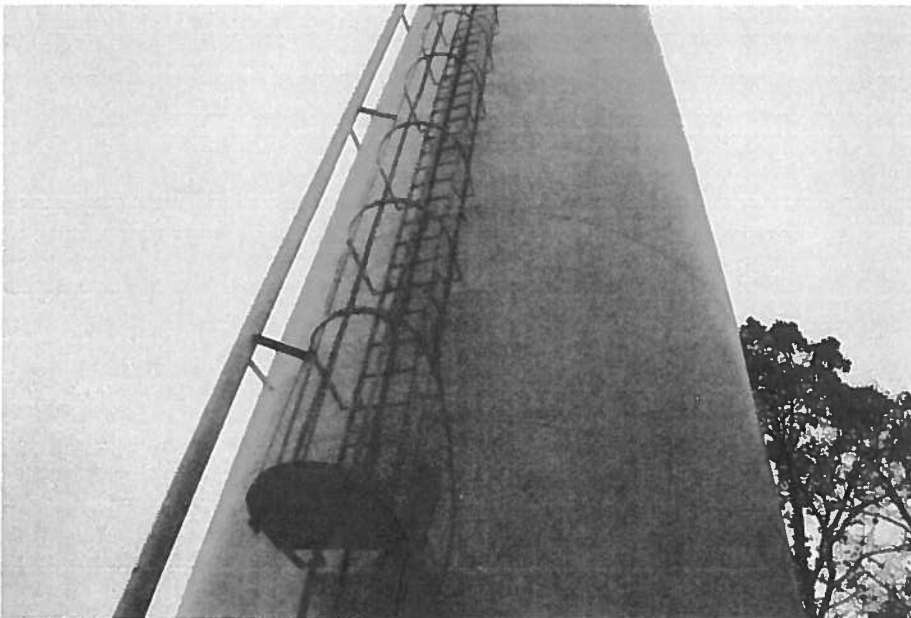
Sidewall and ladder

- Sidewalls are in good condition with some random areas of corrosion to the substrate and heavy mildew on the bottom sheets.
- Sidewall man way hatch (2) 24" is in good condition with light corrosion on nuts, bolts.
- Roof portion of the tank is in good condition some small random areas of corrosion and coating deterioration from UV attack.
- Roof Vent is in good condition with minor corrosion found along the entire surface. The screen is in place. (24" diameter).
- Overflow pipe is in good condition with delamination and corrosion on its bottom angle.
- Exterior ladder is in good condition.
- Site perimeter is in good condition with light vegetation on all four sides.
- Site is fenced and locked.
- Tank site was properly maintained.

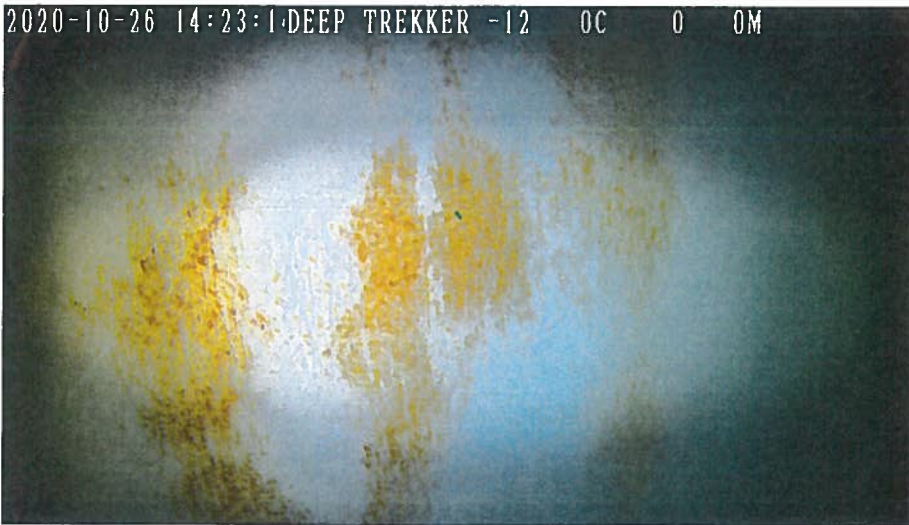
Sidewall - Lower

- Overall condition of the interior should be considered fair to poor. Moderate corrosion found throughout the interior.
- Interior floor is in fair condition with approximately 2" or less of sediment.
- Interior sidewalls is in fair to poor condition with widespread pinhole corrosion found in the middle section. Pinhole depth is shallow in appearance. The upper and lower sidewalls have a few random spots.
- Ceiling portions of the tank should be considered good with a few pinhole corrosion spots.
- Overflow inlet attached to the sidewall is in good condition with minor corrosion spots.
- Interior roof vent has moderate corrosion.
- No interior ladder was found.
- Outlet pipe is in fair condition with minor corrosion on edges.
- Interior man-way has moderate corrosion along the edges and collar portion.

At present the interior coating system is in fair to poor condition without adequate protection to the steel substrate. The corrosion spots throughout the interior will only increase and deepen if repairs are not taken within the next 1-3 years. Due to the widespread corrosion, System Officials should consider a full abrasive blast on the interior and new three-part coating system. A new system should last 20-25 years.

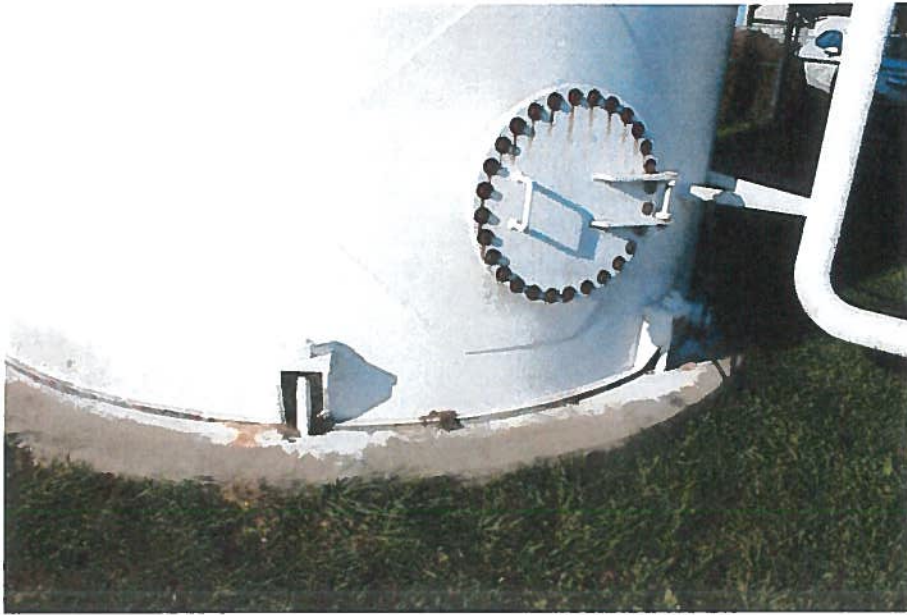
Manway and Foundation

- Foundation is in good condition. A section of the foundation is covered with grass.
- Anchor bolts are in good condition with some small corrosion spots.

4. Power Wash Exterior 3000psi min. to remove all loose material and debris.
5. Spot Repair cleaning **SP 3 Power Tool Cleaning** on all corrosion areas.
6. Apply one coat of Rustoleum 9800 3-4 mils.
7. Clean off all debris from the foundation.
8. Caulk or Grout baseplate to concrete.

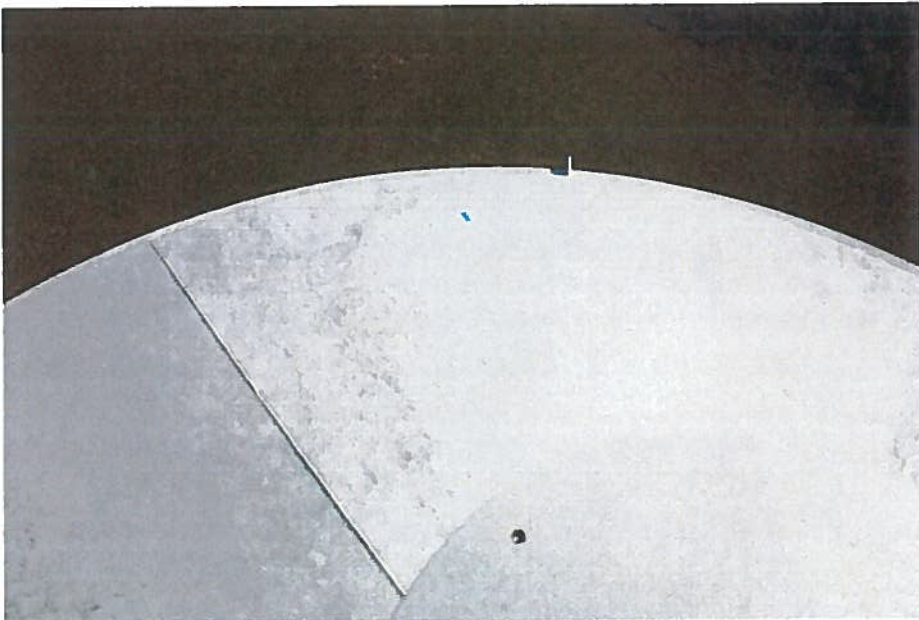
- Roof portion of the tank is in good condition some small random areas of corrosion and coating deterioration from UV attack. Antennas are attached.
- Roof Vent is in good condition with minor corrosion found along the entire surface. The screen is in place. (24" diameter).

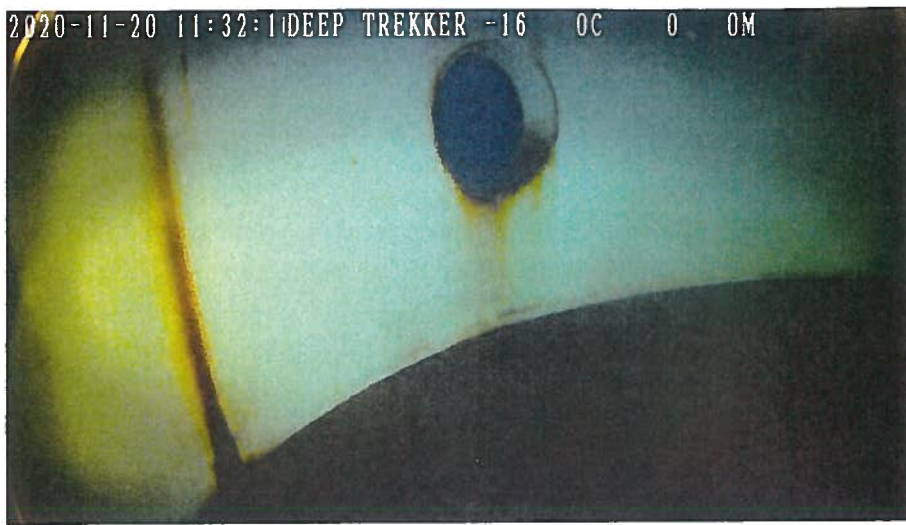
Interior Floor and Manway

- Overall condition of the interior should be considered fair. Moderate corrosion found throughout the interior.
- Interior floor is in fair condition with approximately 1" or less of sediment.
- Interior sidewalls are in fair condition with widespread pinhole corrosion found in the middle section. Pinhole depth is shallow in appearance. The upper and lower sidewalls have a few random spots.
- Ceiling portions of the tank should be considered fair with random pinhole corrosion spots.
- Inlet pipe is attached to the sidewall is in fair condition with random corrosion spots.
- Interior roof vent has moderate corrosion.
- No interior ladder was found.
- Float is not operational.
- Outlet pipe on the floor is in poor condition with heavy corrosion.
- Overflow Pipe is in good condition with minor corrosion.
- Interior man-way has moderate corrosion along the edges and collar portion.

1. Surface Preparation **SP-10 Near White Blast to 100% of the interior.**
2. Apply three coats of immersion grade **epoxy 15-20** mils DFT.
3. Repair float assembly.

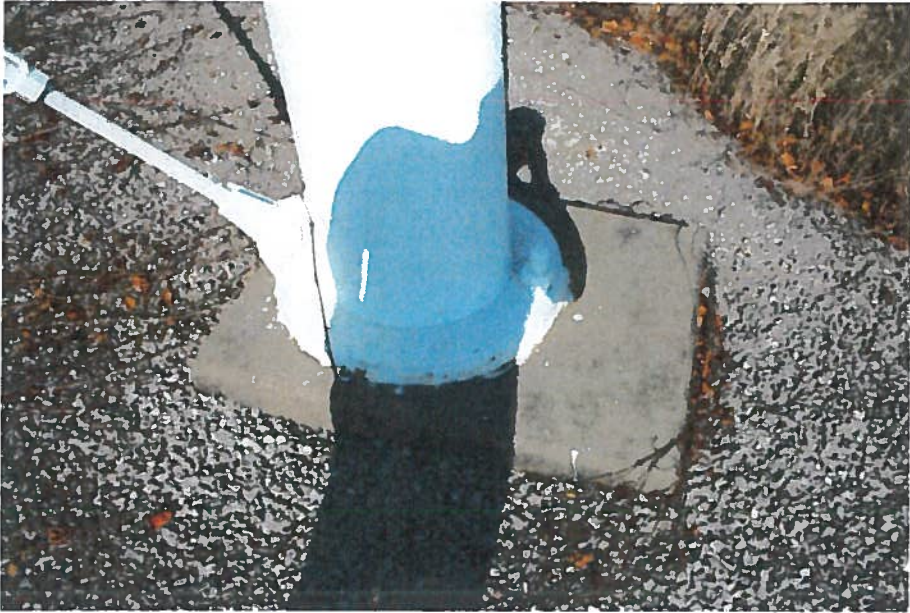
- Foundation is in good condition.
- Anchor bolts are in good condition with some small corrosion spots.
- Columns are in good condition, some mildew staining.

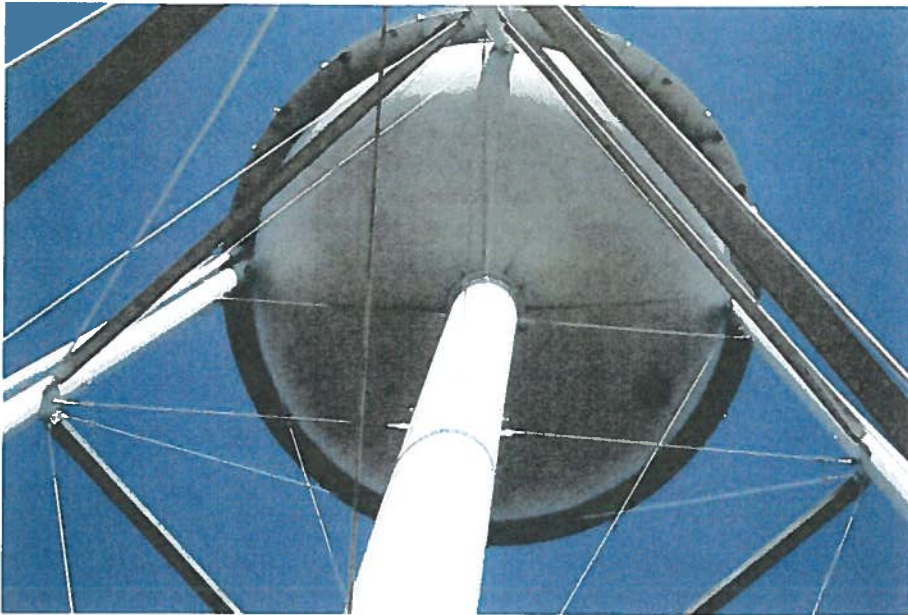
- Lower Container is in good condition with some mildew staining.
- Balcony is in good condition, some spots of corrosion. Antennas attached.
- Sidewalls are in good condition.

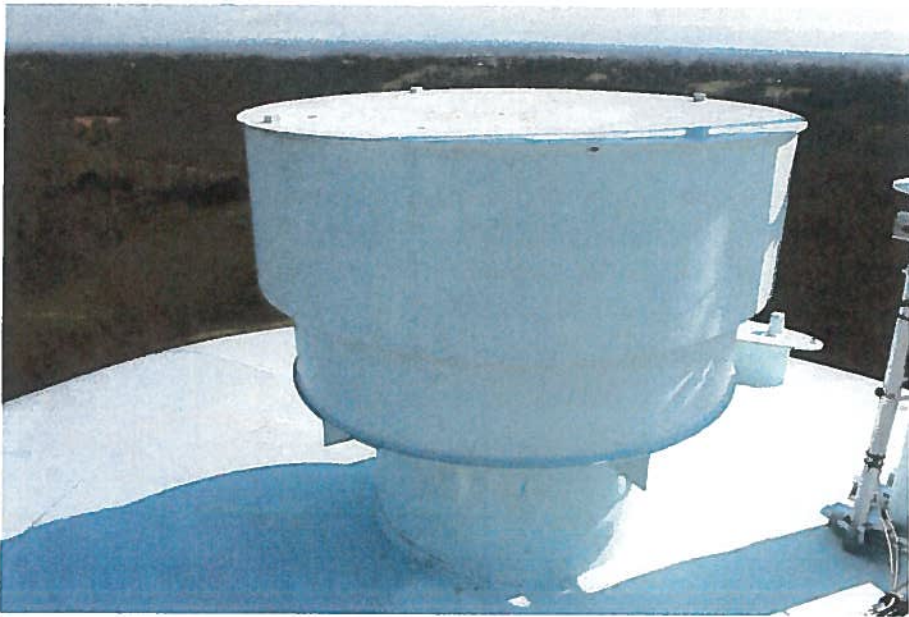
- Roof Vent is in good condition with minor corrosion found along the entire surface. The screen is in place. (24" diameter).
- Overflow pipe is in good condition with some random spots of corrosion.

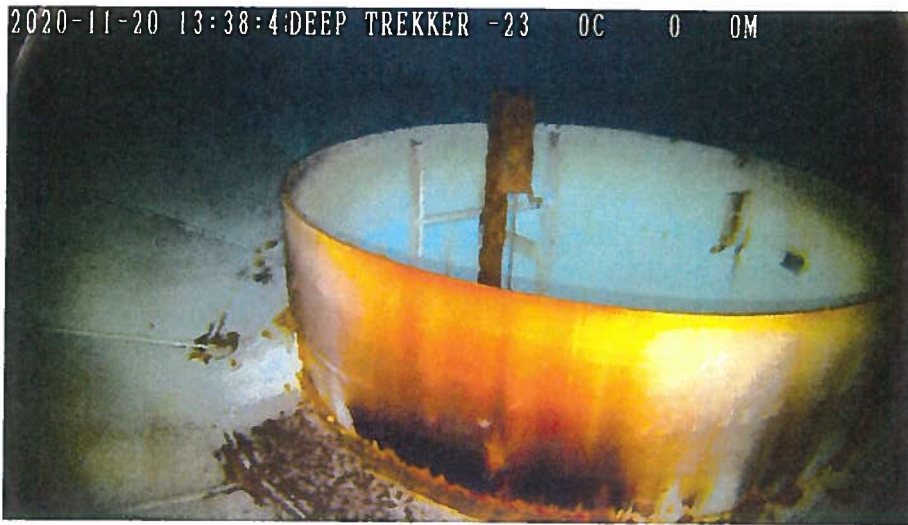
Interior Floor

- Overall condition of the interior should be considered fair. Moderate corrosion found throughout the interior.
- Interior floor is in fair condition with approximately 1" or less of sediment. A few random corrosion spots.

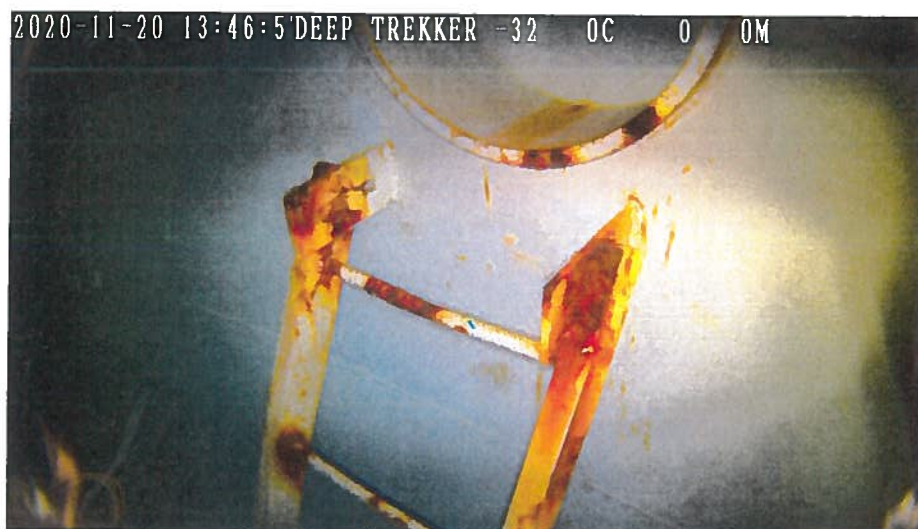
Interior Ladder

- Interior for ladder is in fair to poor condition with heavy corrosion.
- Ceiling portions of the tank should be considered fair with random pinhole corrosion spots. Corrosion is centered primarily around the roof vent.

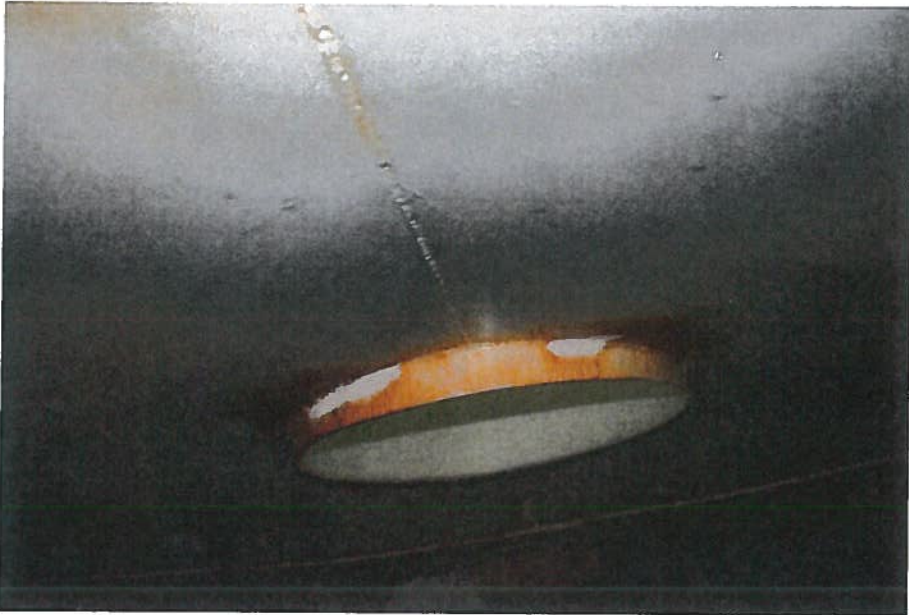
Ceiling Vent

- Interior roof vent has moderate corrosion.
- Float is not operational.
- Overflow Pipe is in good condition with minor corrosion.
- Interior man-way has moderate corrosion along the edges and collar portion.

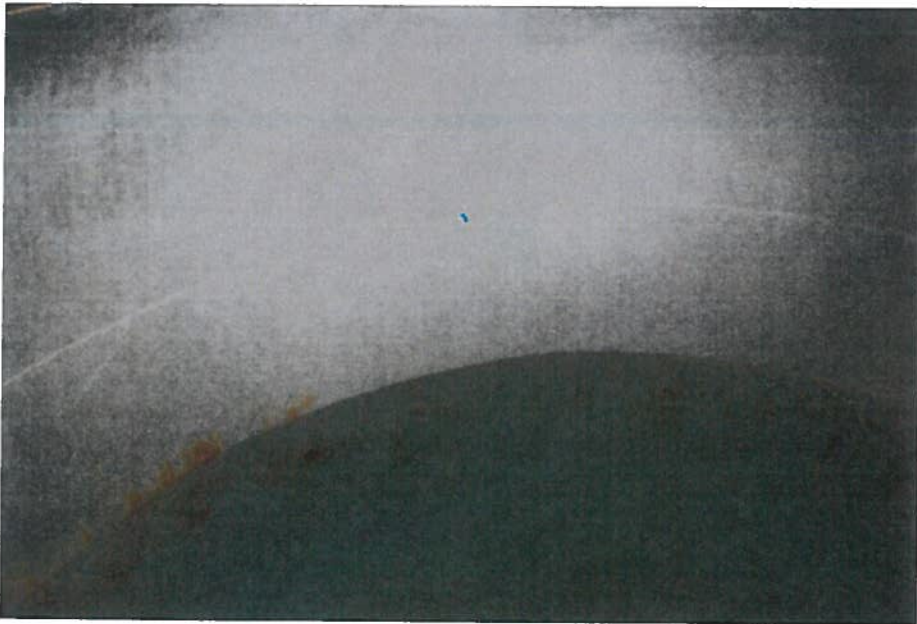
Upper Sidewall

- Interior Riser Pipe is in good condition with a few random pinhole corrosion spots. The safety cable support has heavy corrosion.
- Interior sidewalls are in fair condition with widespread pinhole corrosion found in the middle section. Pinhole depth is shallow in appearance. The upper and lower sidewalls have a few random spots. Heavy mineral staining.
