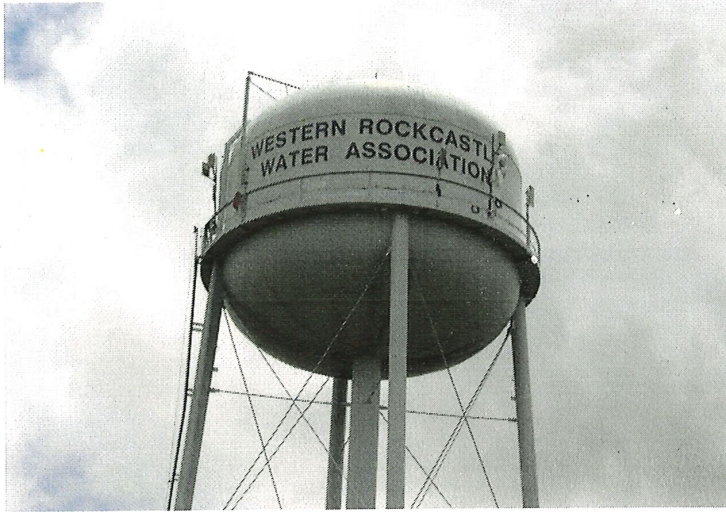
Photo shows the northeast section of the water bearing portion of the tank and the tank logo.

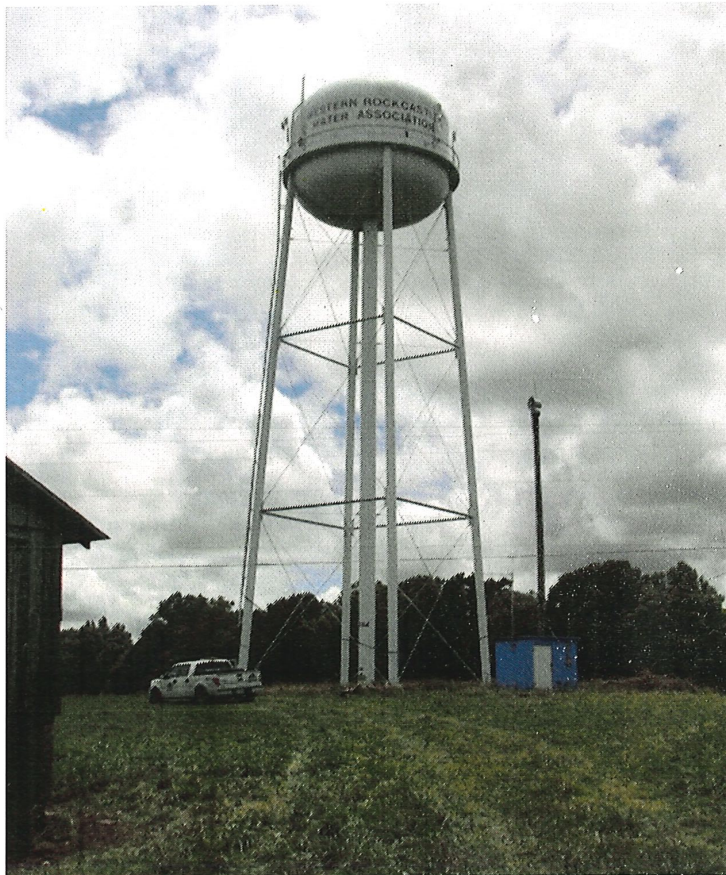
Photo shows an overall view of the northeast section of the tank and site. The tank has three panels and two struts.

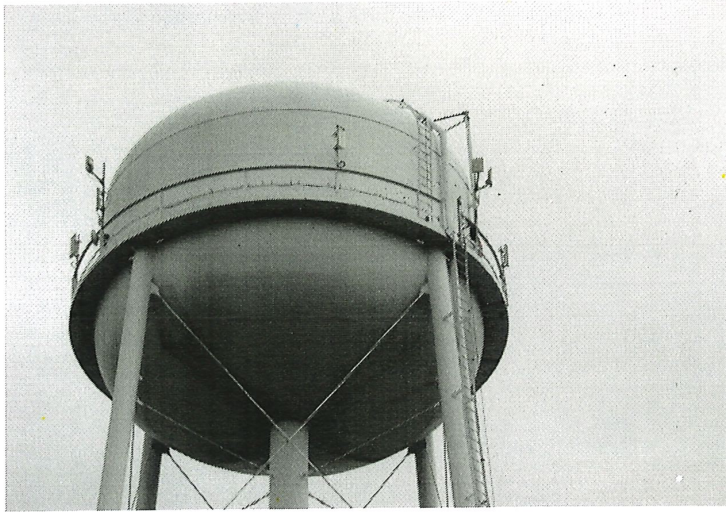
Photo shows the south section of the tank bowl. Mildew can be seen along the belly.

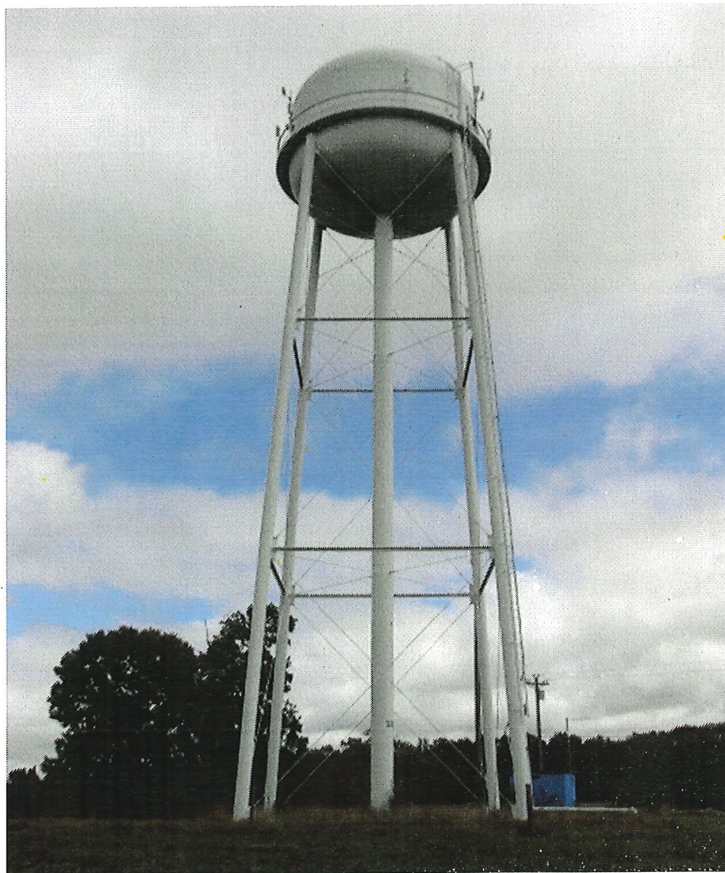
Photo shows an overall view of the south section of the tank and site. The tank is in the middle of a pasture with only a barn close by.

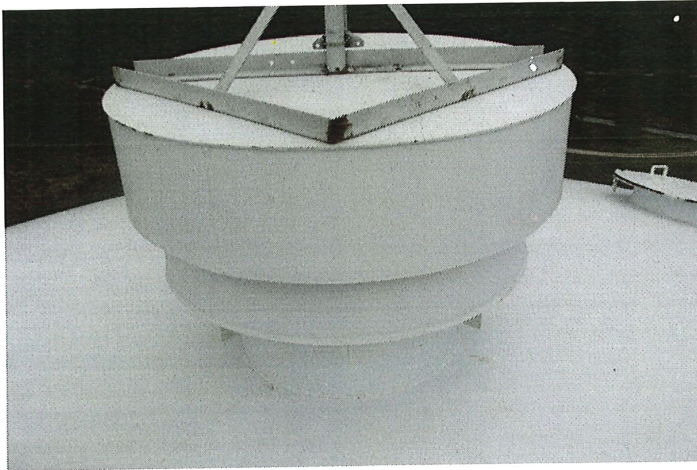
Photo shows the 24" roof vent and steel cover.

- M. Remove the existing 24" diameter steel vent pipe cover. Bolt an aluminum cover to the existing steel pipe flange.
- N. Install a new stainless steel insect screen between the bolted flanges on the 6" overflow pipe.

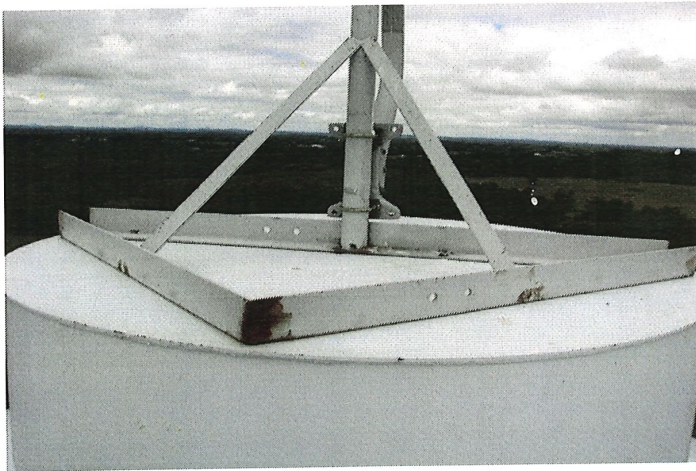
Photo shows an antennae mounted to the vent cover. The antennae should be moved to a stand-alone support welded to the roof cap plate to provide easier vent access.

- J. Install an 18' diameter corral on the roof of the tank. Relocate all antennas to the corral. Remove the cables from the leg ladder siderails. Bundle the cables and support them to the ladder standoffs.

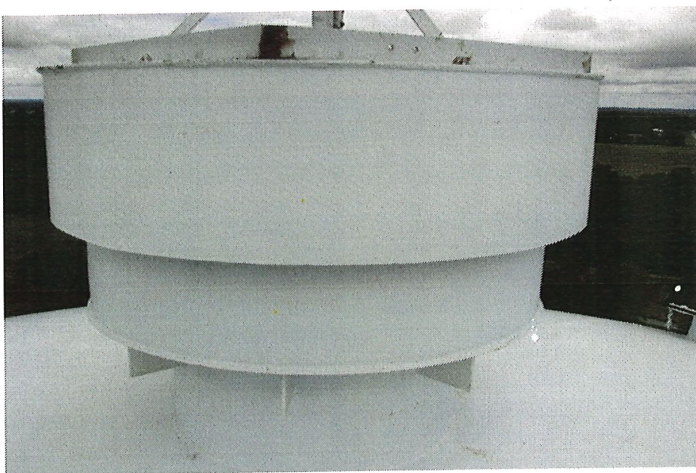
Photo shows the 42" steel vent cover and 24" roof vent neck.

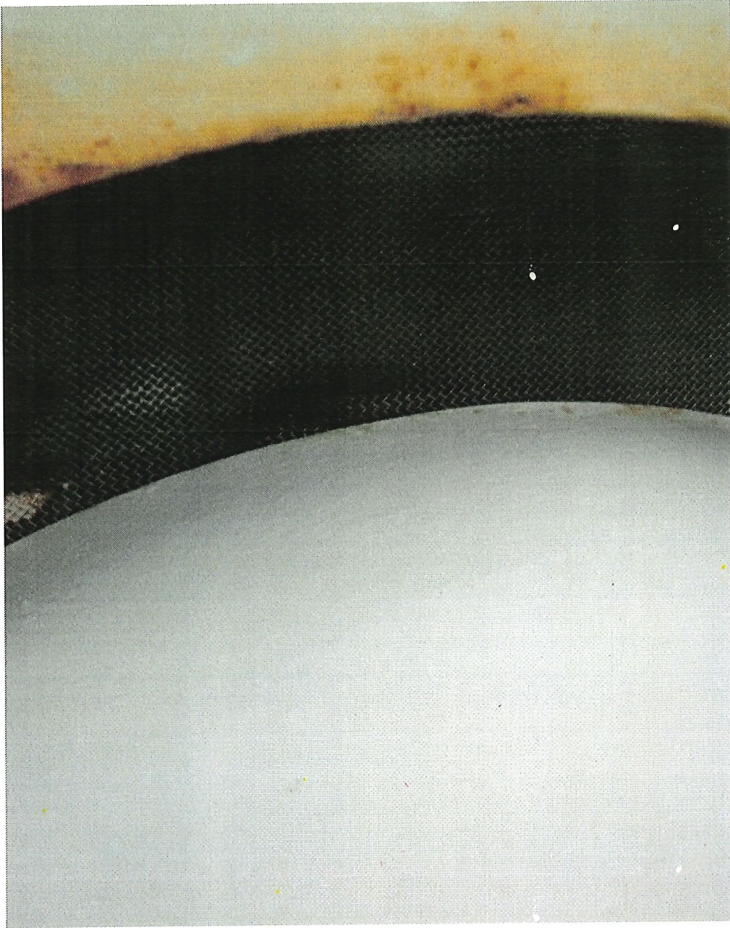
Photo shows the roof vent insect screen properly installed. Blotchy corrosion is visible along the vent frame.

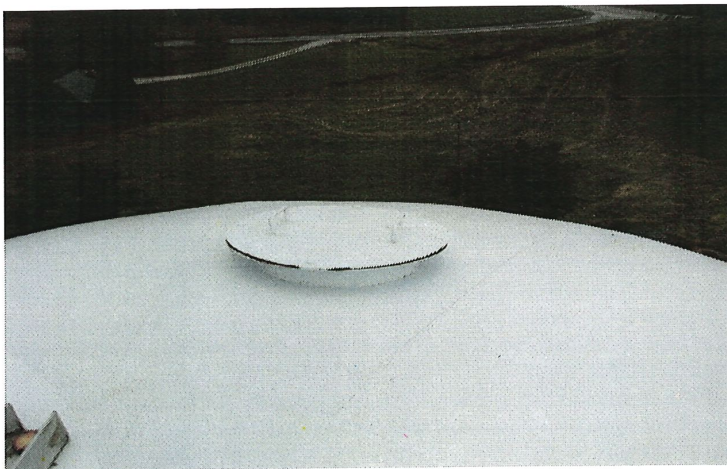
Photo shows the 24" flanged secondary roof manway. Coating coverage is very good.

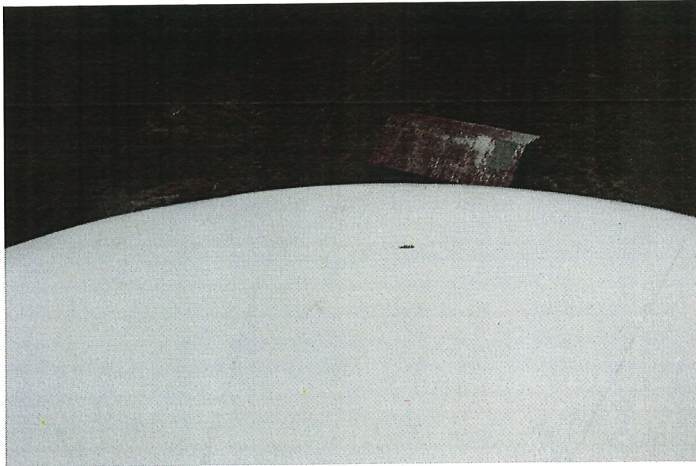
Photo shows the northeast section of the roof finger panels. A small active corrosion cell is visible.

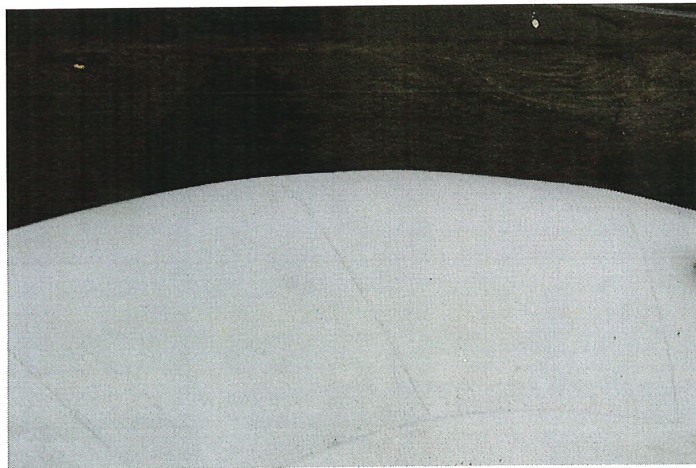
Photo shows the north section of the roof finger panels. The existing coating system in this area has become chalky and dull.

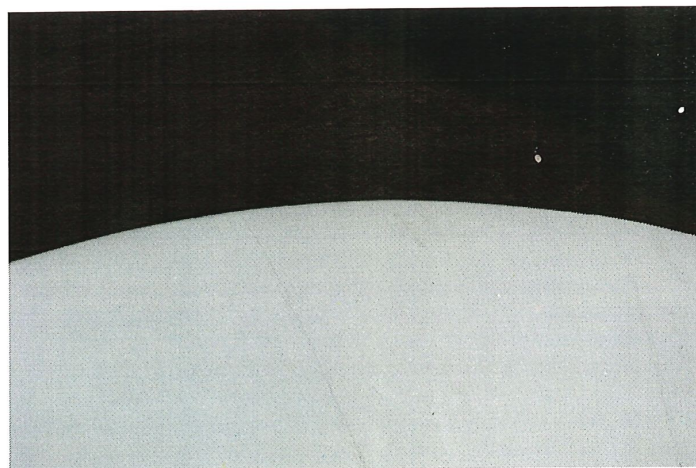
Photo shows the existing faded blue coating system applied to the west section of the roof finger panels.

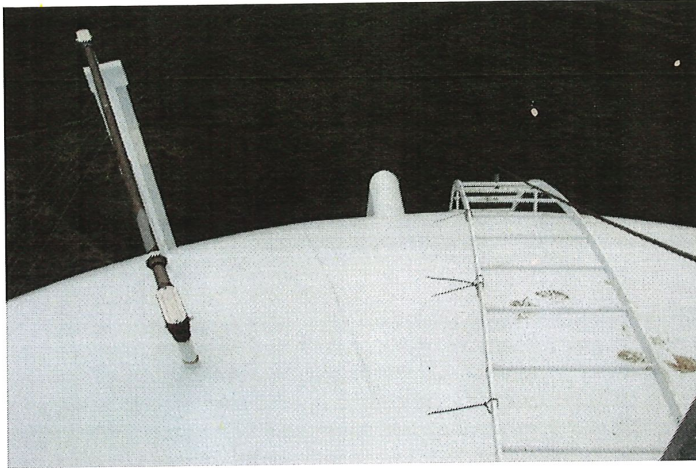
Photo shows the southeast section of the roof finger panels, roof ladder, and water level indicator system. The coating has faded but continues to protect the steel.

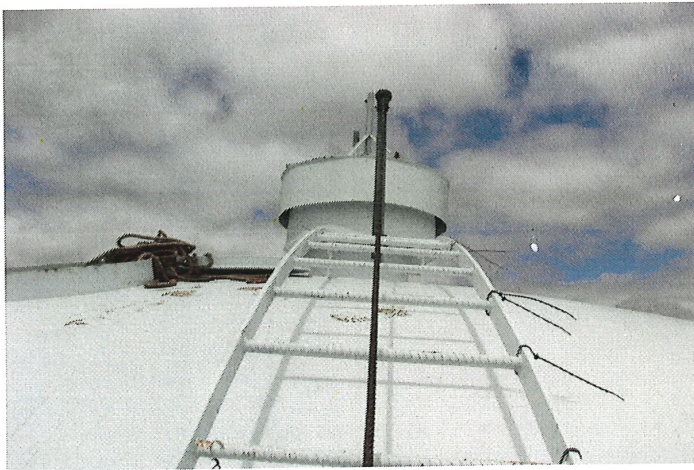
Photo shows the roof ladder equipped with a cable style climber safety device.

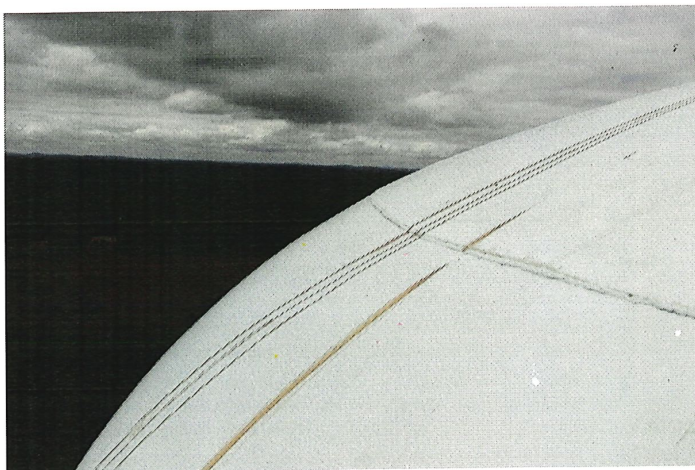
Photo shows the south section of the upper knuckle. The existing coating system has become chalky and dull.

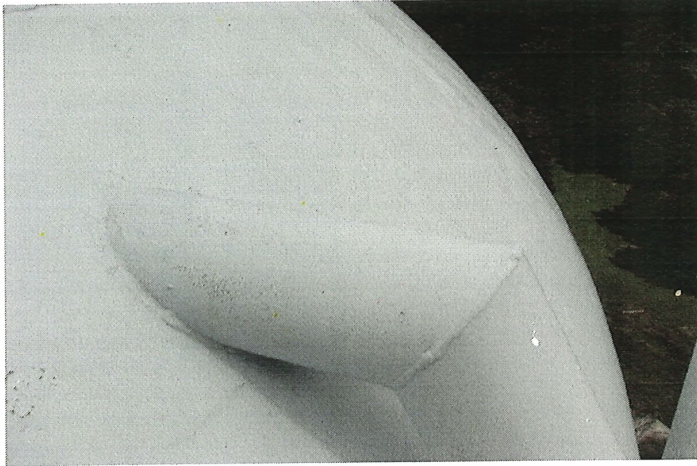
Photo shows the east section of the upper knuckle and overflow egress point. No active corrosion was noted.

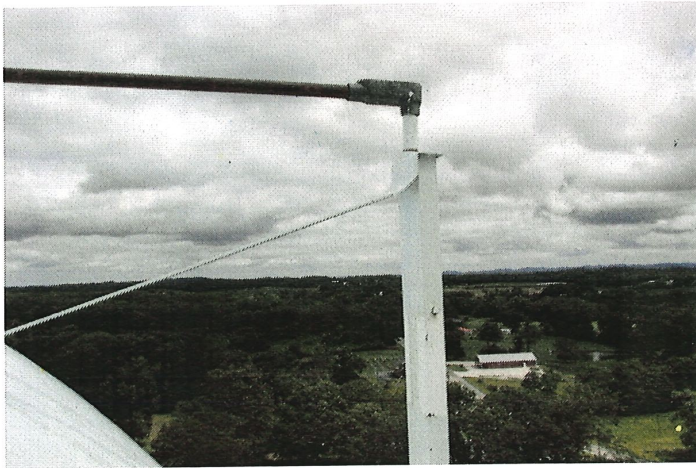
Photo shows the water level indicator system. The target board and piping should be removed and the holes patched if the system is no longer being used or if a SCADA system is in operation.

- H. Install a 42" tall handrail around the opening at the top of the riser pipe to prevent a fall.
- I. Remove the inoperable level indicator and float if a SCADA system is being used. If there is no SCADA system then replace all cables with new stainless steel cables.

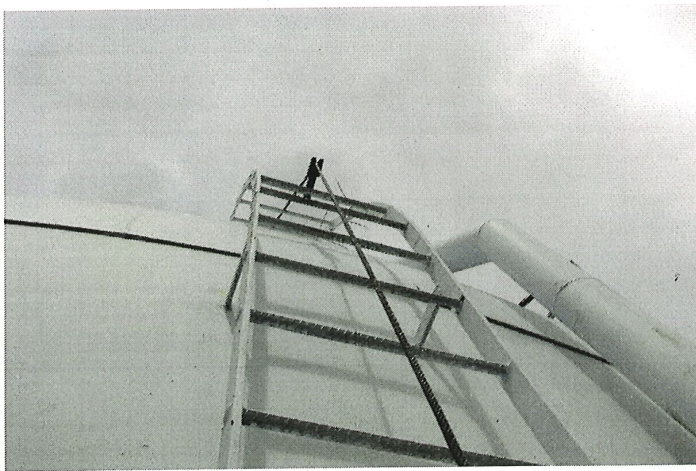
Photo shows the east section of the shell, roof ladder, and overflow pipe. The coating continues to protect the steel.

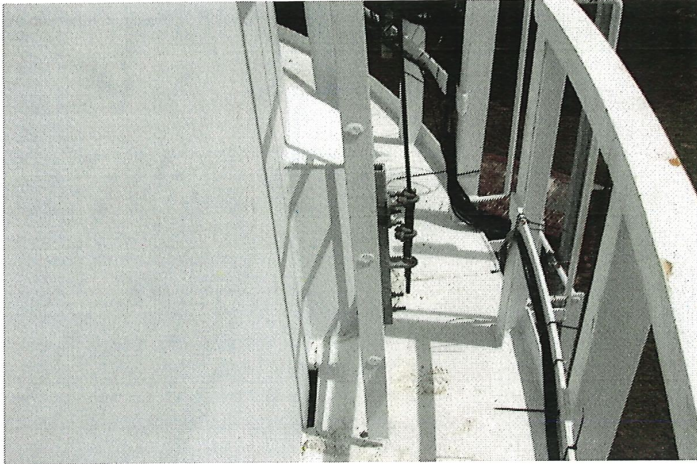
Photo shows the southeast section of the lower shell, balcony floor, and handrail. Small areas of localized corrosion can be seen.

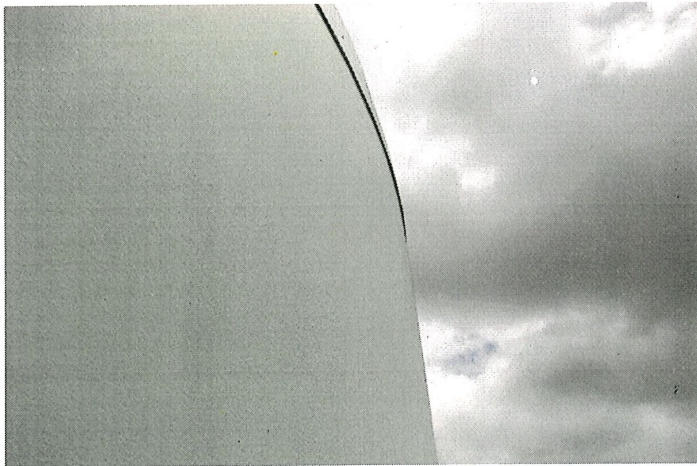
Photo shows the existing urethane finish coat along the south section of the shell. The steel substrate remains protected in this area.

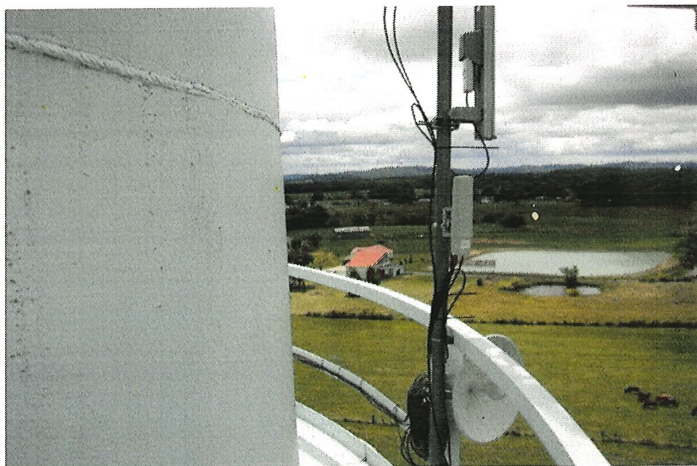
Photo shows an antennae mounted to the south section of the balcony handrail. Installing a roof corral and relocating all antennas should be considered.

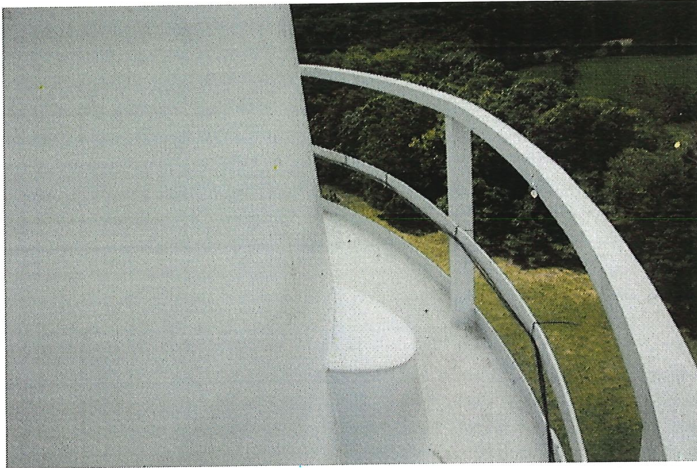
Photo shows the northwest section of the lower shell and balcony. The existing coatings system in this area has become chalky and dull.

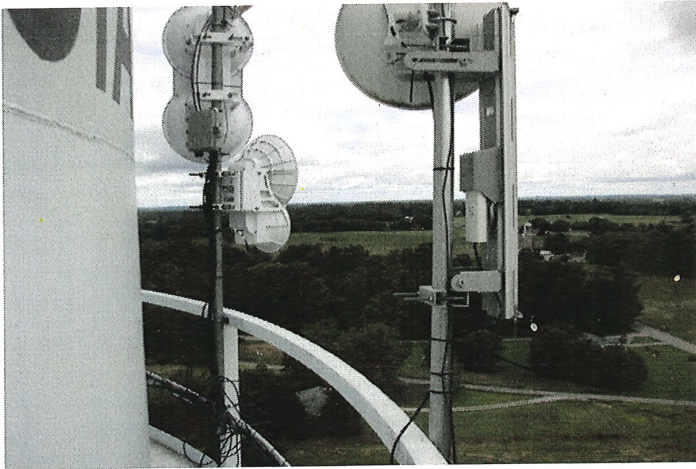
Photo shows two antennas mounted to the north section of the balcony handrail.

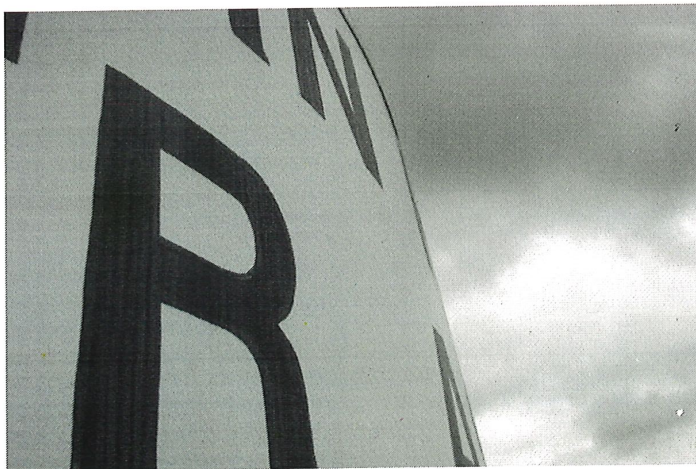
Photo shows the northeast section of the shell and tank logo.

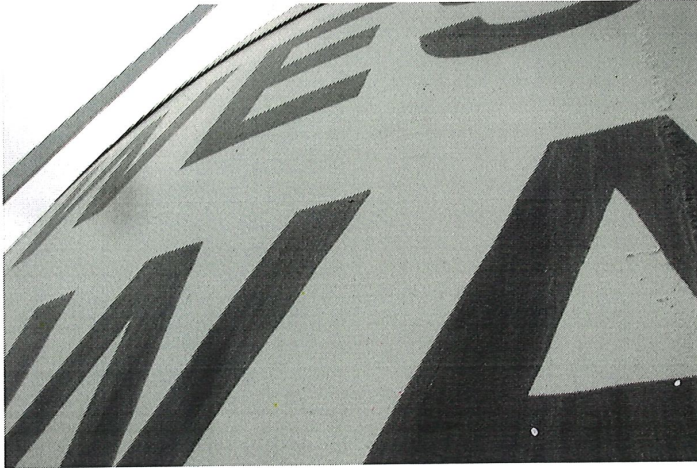
Photo shows another view of the northeast facing tank logo.

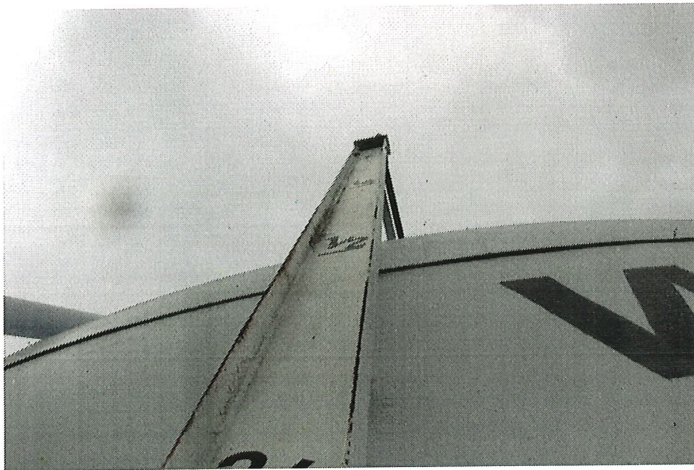
Photo shows the deficient water level indicator target board. The board should be removed if an active SCADA system is in place.

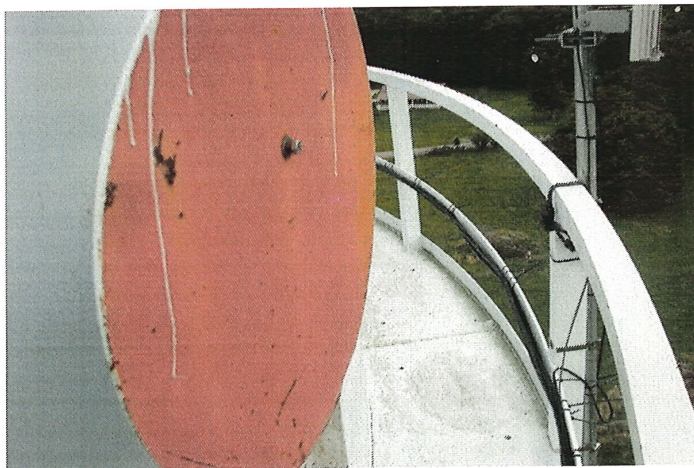
Photo shows the water level indicator target. The target should be at the top with the tank empty.

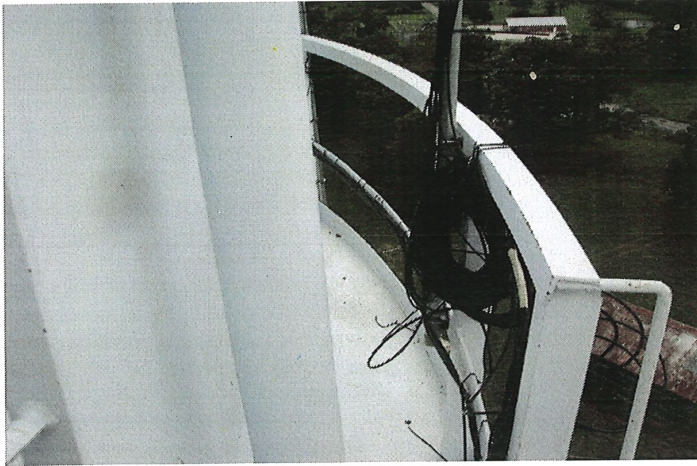
Photo shows a large bundle of antenna wire along the east section of the balcony.

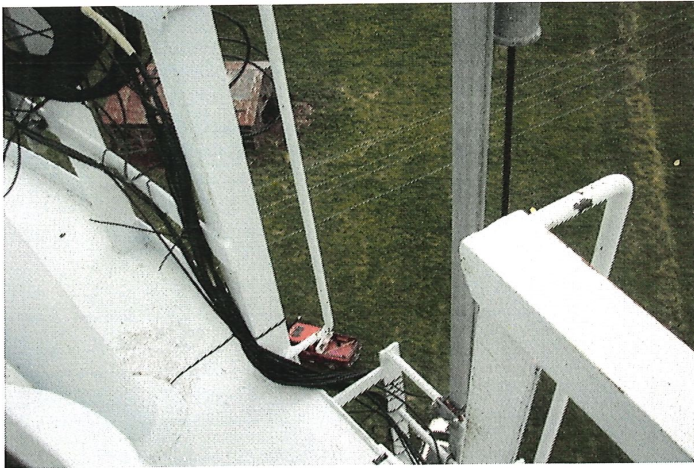
Photo shows the 26" balcony opening with grab bars. Safety chains should be installed along the opening.

- G. Install removable stainless steel chains across the opening in the balcony handrail at the top of the leg ladder. Lower the top bracket of the fall prevention cable so a climber can safely step onto the balcony.

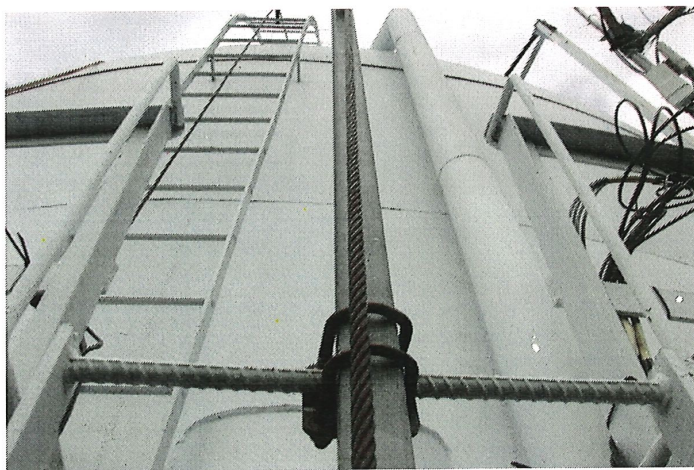
Photo shows the upper bracket for the tower ladder cable style climber safety device. The bracket should be lowered to allow a climber easier access to the balcony.

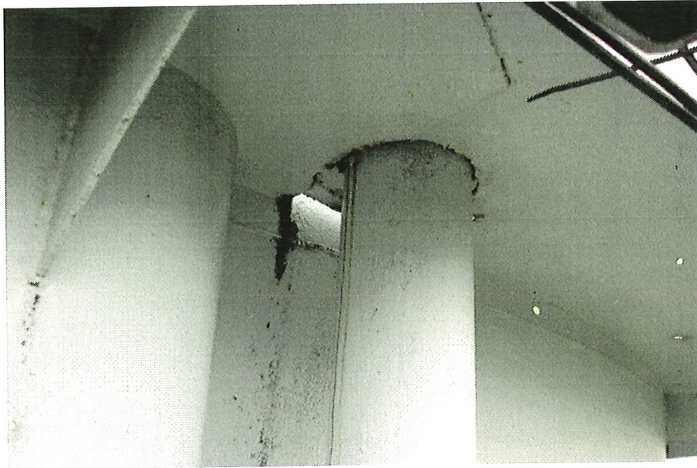
Photo shows the overflow pipe and underside of the balcony. Minor corrosion is present.

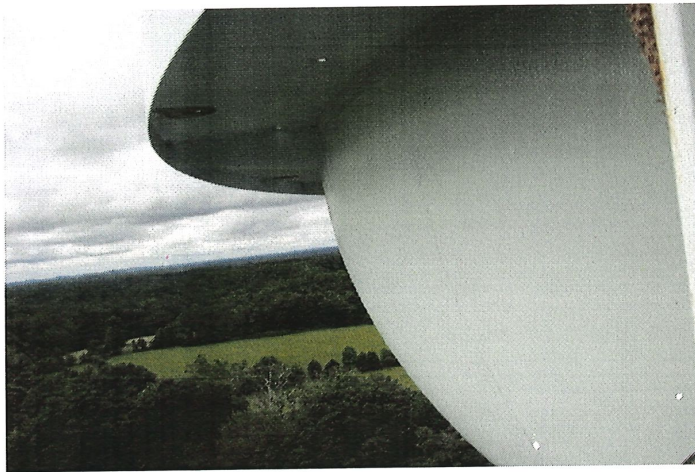
Photo shows the south section of the lower knuckle. The existing coating system in this area has become chalky and dull.

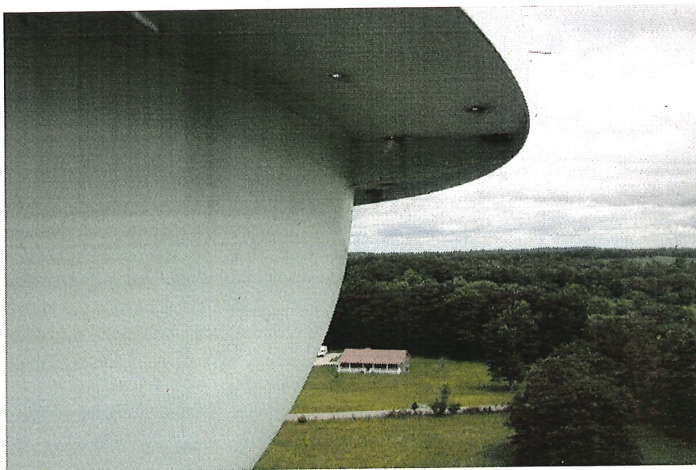
Photo the east section of the lower knuckle. The urethane finish coat in this area continues to protect the steel substrate.

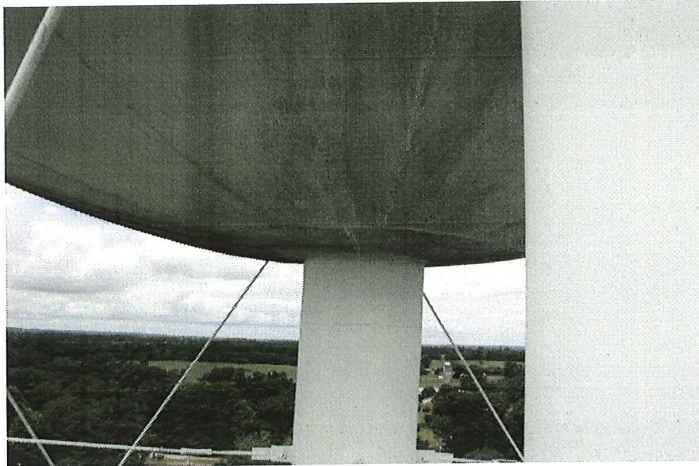
Photo shows mildew present along the belly and upper riser.

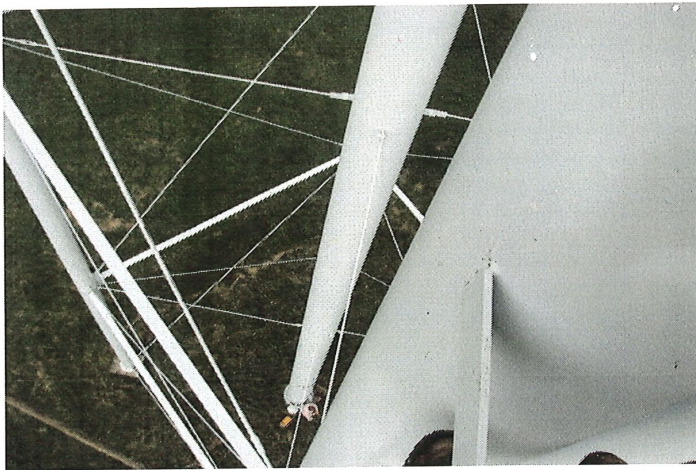
Photo shows an overall view of the riser, riser stay rods, and windage rods. All rods appear to be properly adjusted.

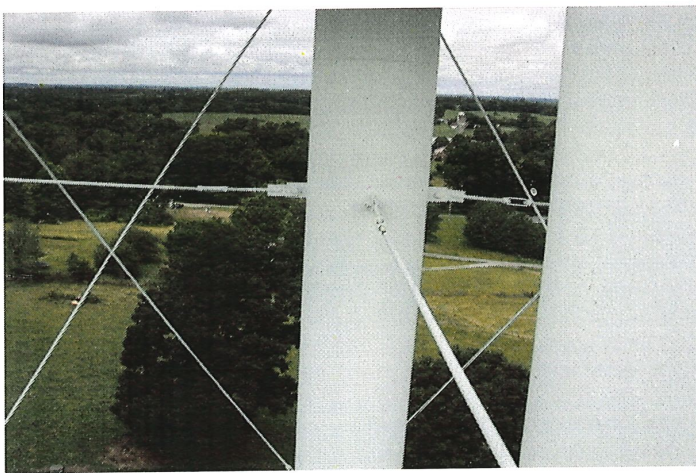
Photo shows the middle section of the riser and riser rods. All connections appear sound.

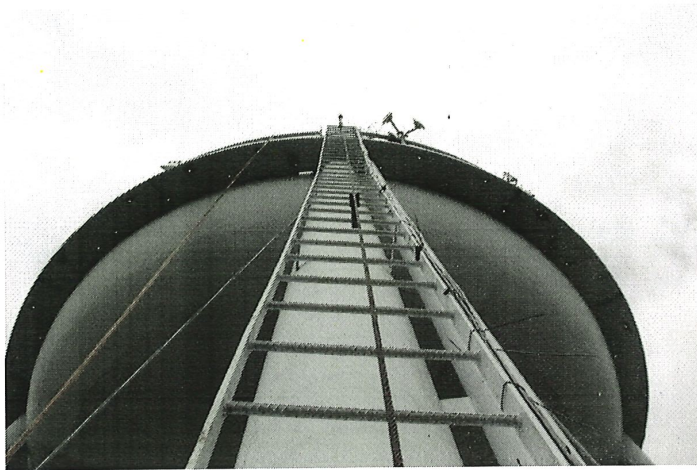
Photo shows the upper section of the tower ladder equipped with a cable style climber safety device.

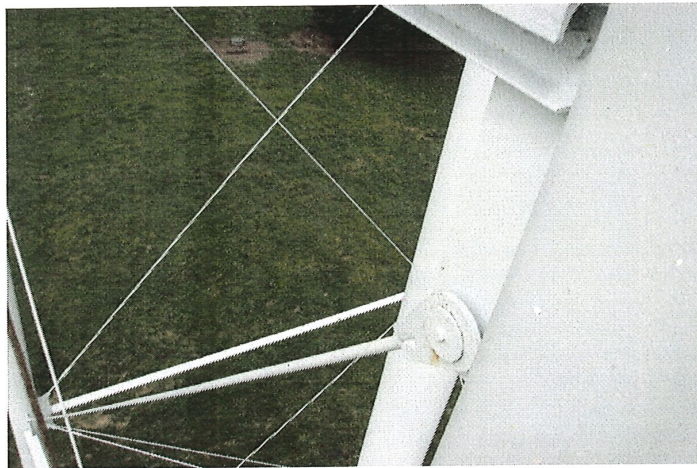
Photo shows a minor area of rust bleed along the upper windage rod to leg connection.

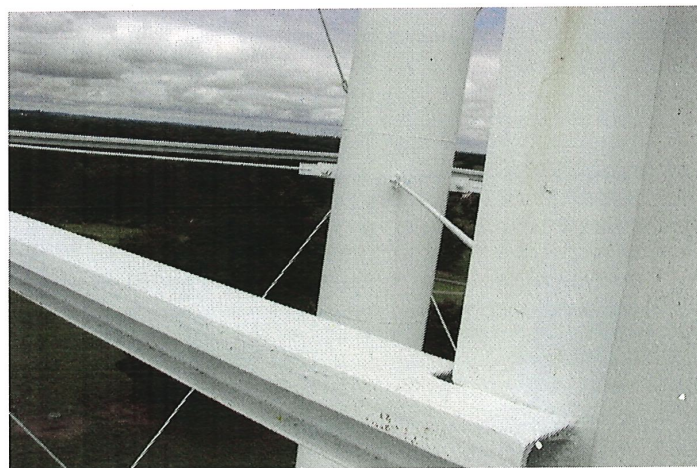
Photo shows minor rust bleed along the upper strut pinned connection point.

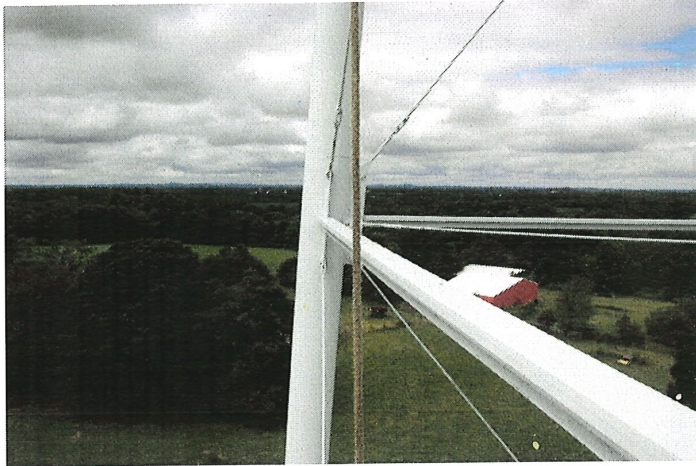
Photo shows the south facing upper strut. All member alignment is within tolerance.

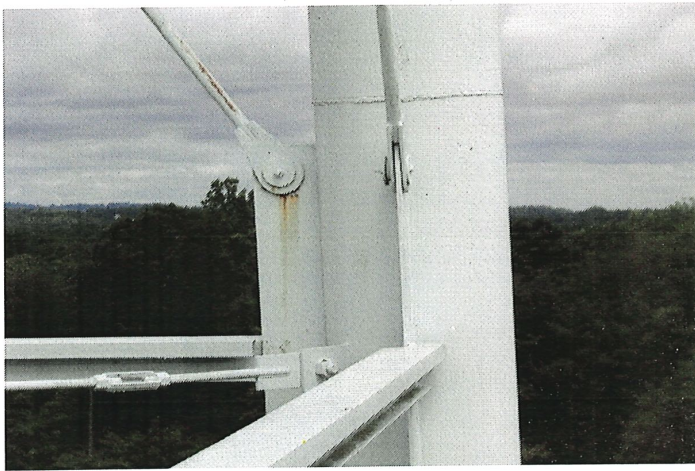
Photo shows crevice corrosion and rust bleed present along the northeast upper windage rod to leg pinned connection.

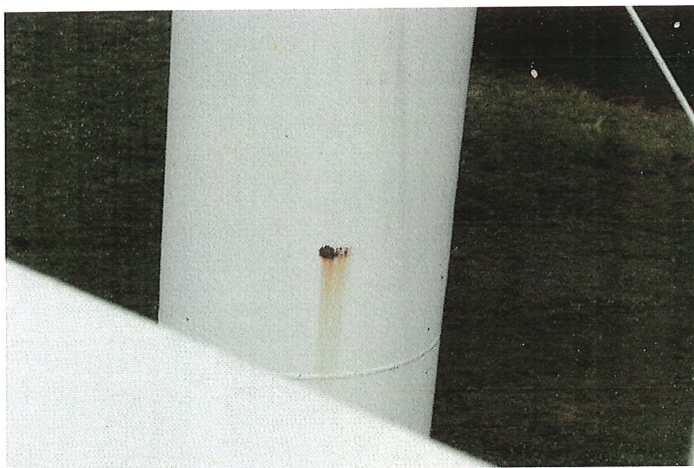
Photo shows an active corrosion cell present along the middle section of the riser.

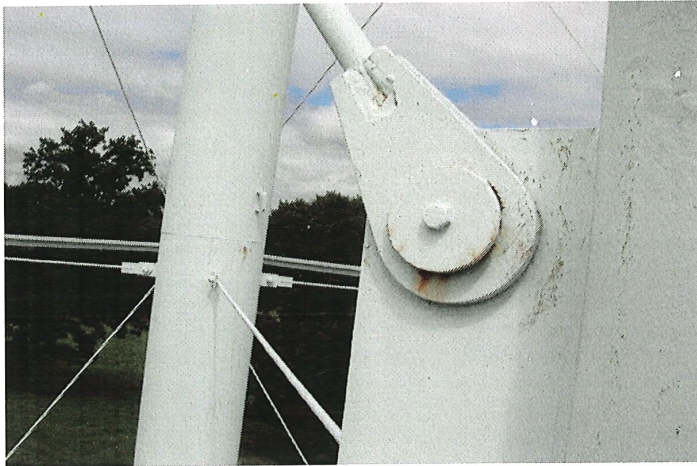
Photo shows crevice corrosion present along the southeast middle windage rod to leg pinned connection.

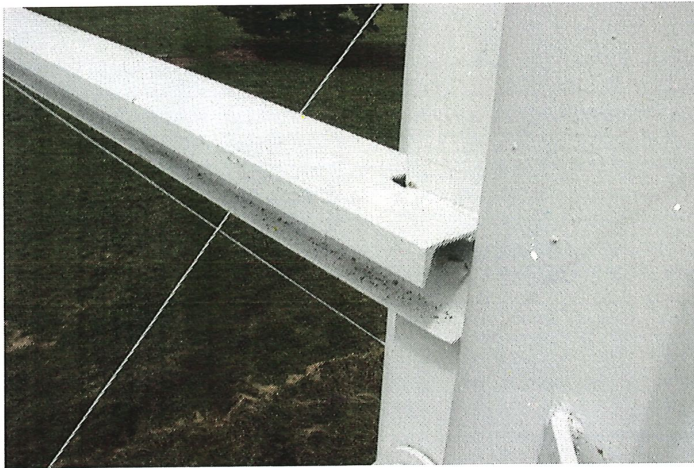
Photo shows the southeast lower strut to leg connection point. All pinned and bolted connections appear sound.

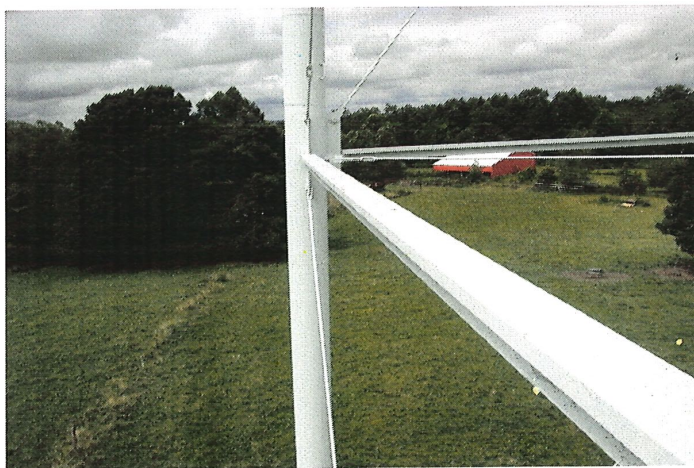
Photo shows the south facing lower strut. The finish coat has lost its gloss but continues to protect the steel.

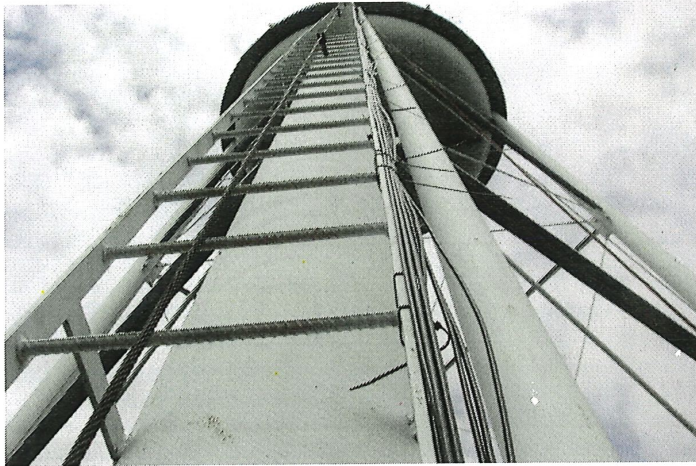
Photo shows the lower section of the tower ladder. All cables should be removed from the ladder side rail since this is an OSHA violation.

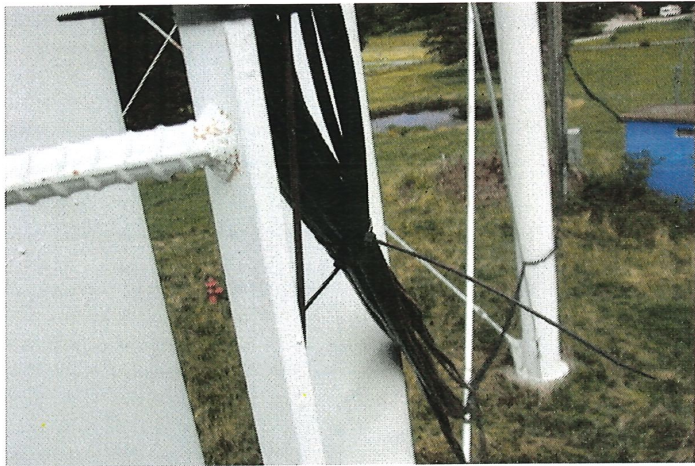
Photo shows the antennae cables zip tied to the ladder rail. Conduit clips should be installed along a leg every ten feet and all cable relocated away from the ladder.

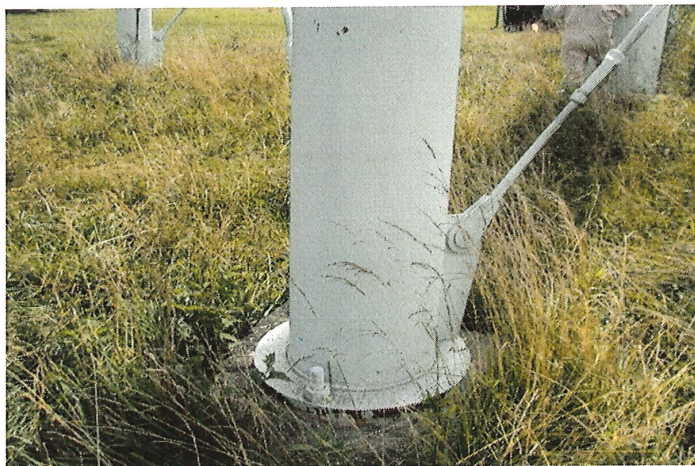
Photo shows the northeast lower leg, windage rod connection, and exposed foundation. The concrete is in sound condition.
