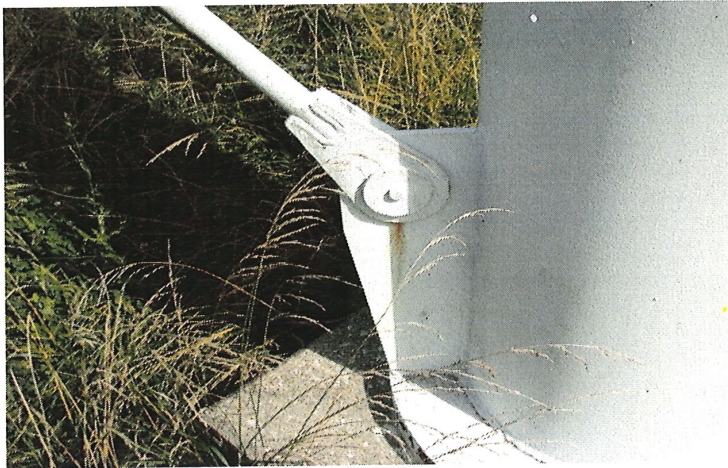
**Photo shows minor rust bleed present along the northeast lower windage rod to leg connection point.**

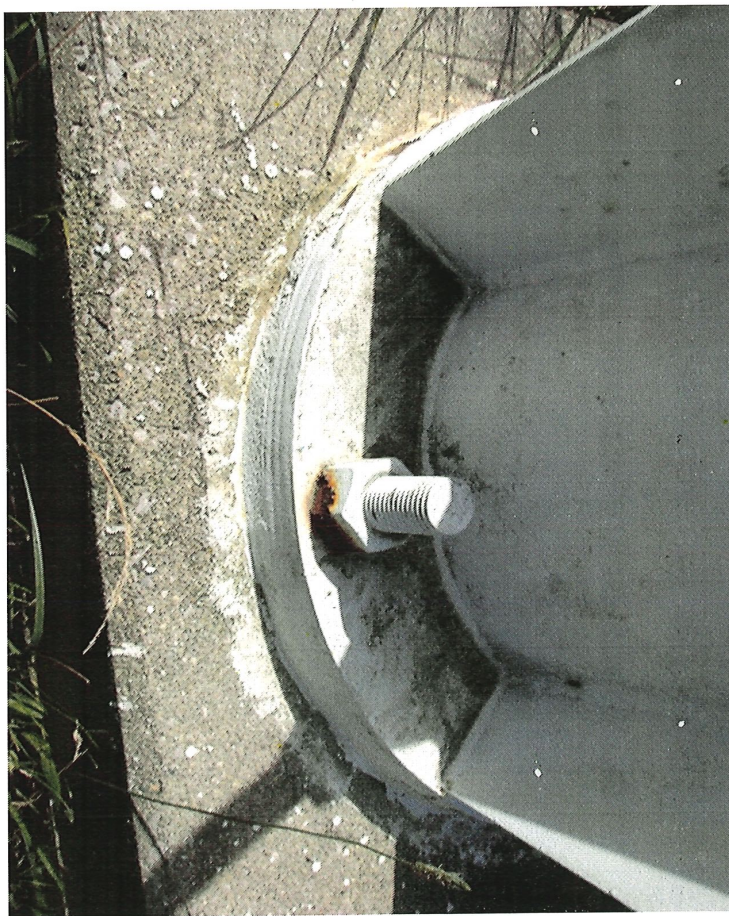
**Photo shows the 1.75" column anchor bolts. Each leg has 2 anchor bolts. Minor rust is visible along the nut to column flange interface.**

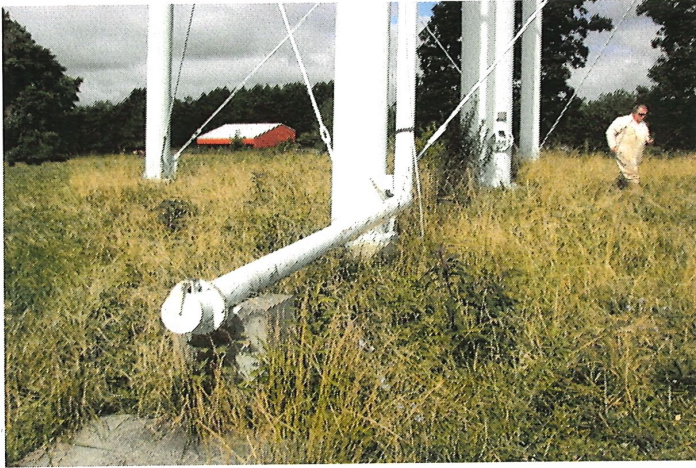
**Photo shows the lower section of the 6" overflow pipe along the southeast leg.**

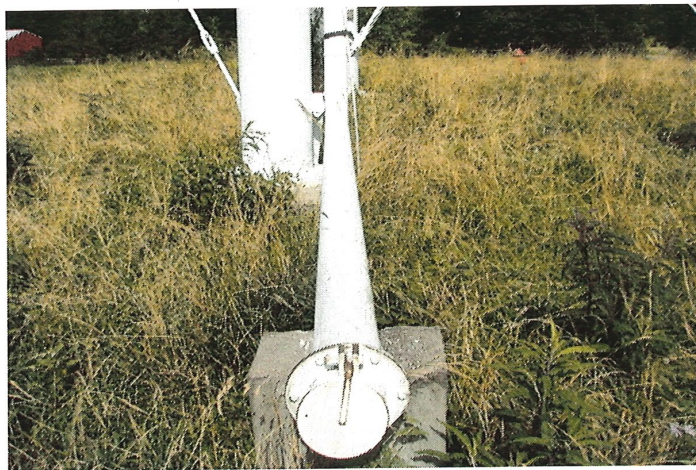
**Photo shows the overflow pipe is equipped with a flanged flapper valve.**

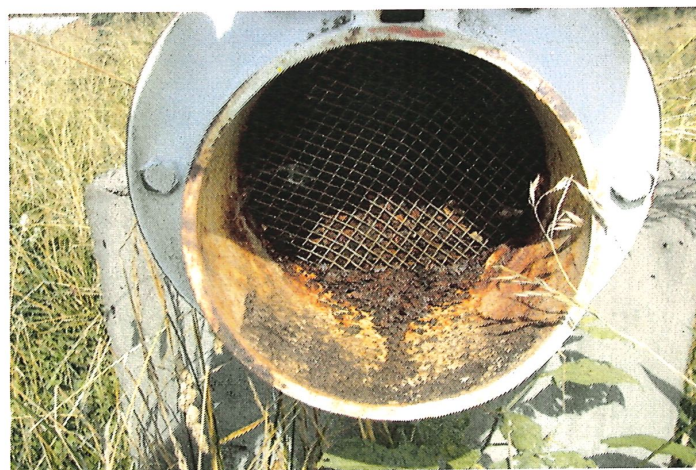
**Photo shows the overflow pipe insect screen. Loose rust and paint chips should be removed from the interior of the screen to prevent clogging.**

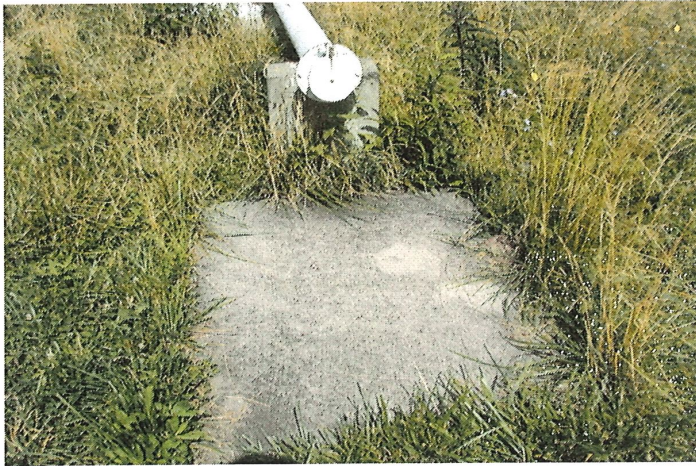
**Photo shows the 6' X 4' concrete overflow splash pad.**

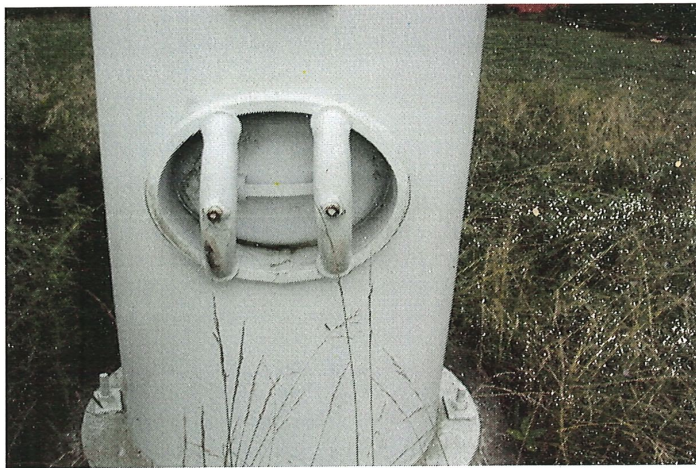
**Photo shows the 18" oval riser manway. A new 30" bolted flanged riser manway with stainless steel bolts and brass nuts should be considered.**

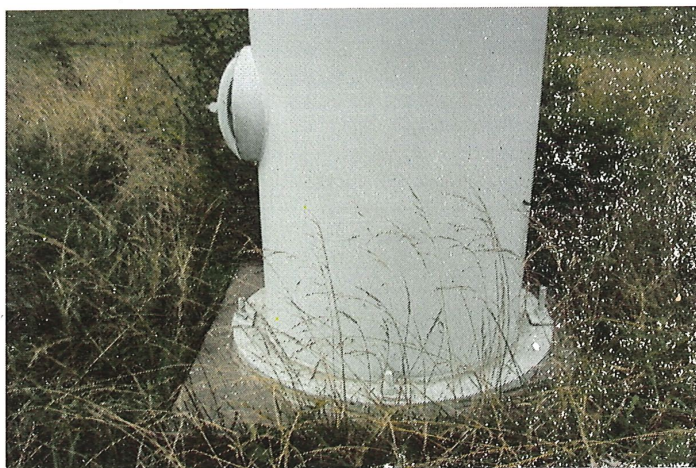
**Photo shows the lower section of the riser and exposed concrete foundation. The concrete is in sound condition.**

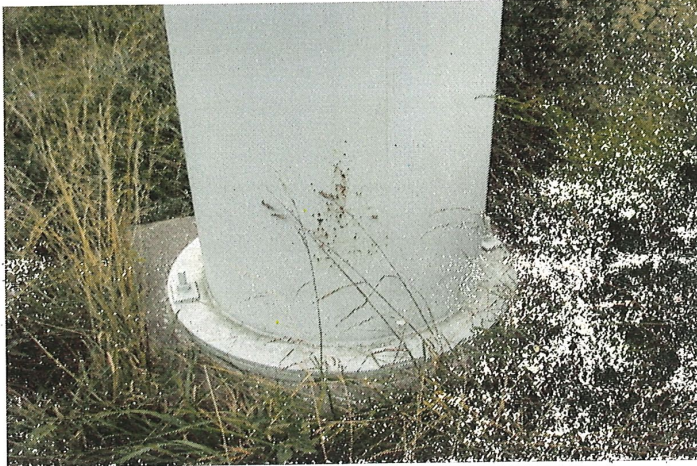
Photo shows active corrosion present along the lower section of the riser.

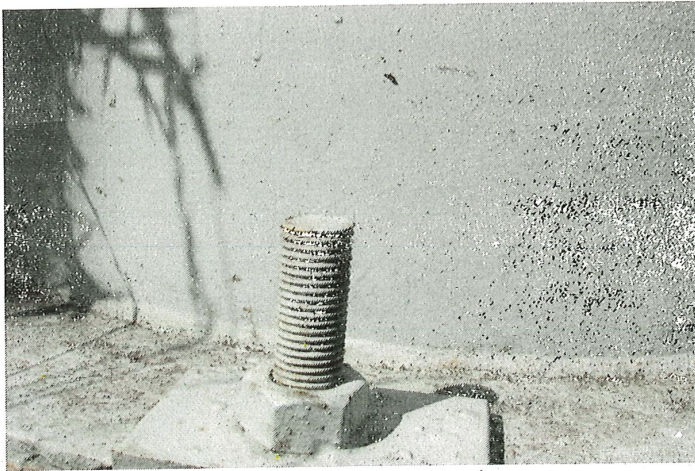
Photo shows one of four 1" diameter riser anchor bolts.

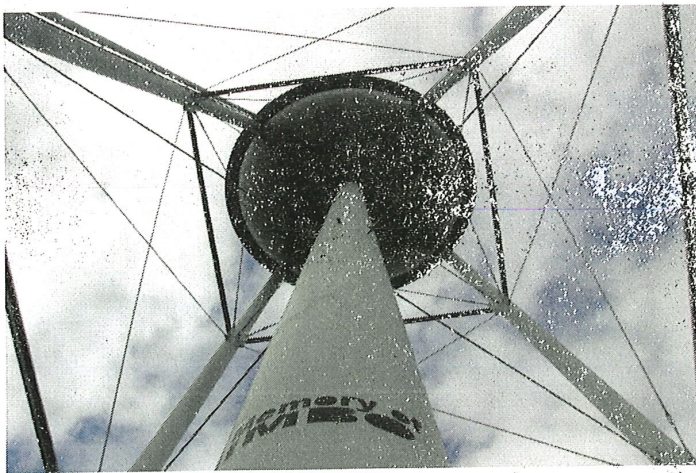
Photo shows an overall view of the 3' riser pipe. The existing coating system along the riser have become chalky and dull.

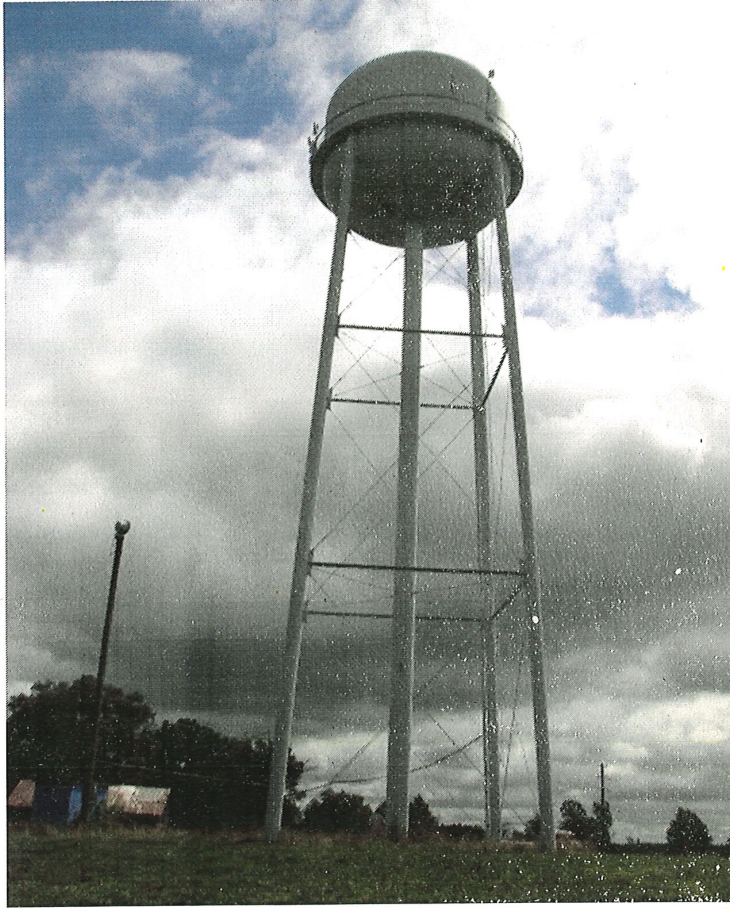
**Photo shows an overall view of the west side of the tank. The tank measures 129' to the high water level.**

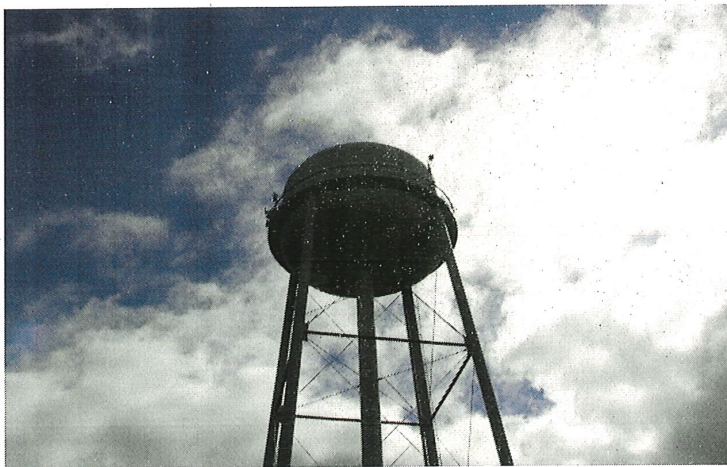
**Photo shows the west section of the water bearing portion of the tank.**

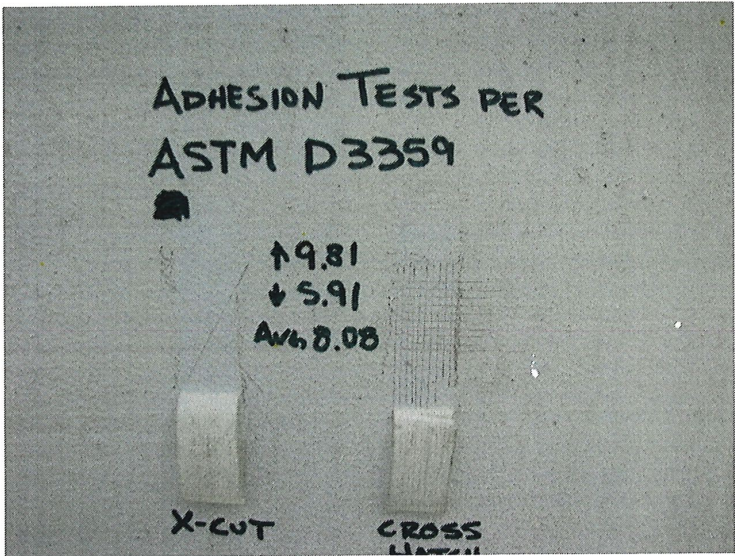
Photo shows the results of adhesion tests performed per ASTM D3359. The rating is a 4B. The tank is a candidate good candidate for over coating. The DFT in the test area ranges from 5.91-9.81 mils and averages 8.08.

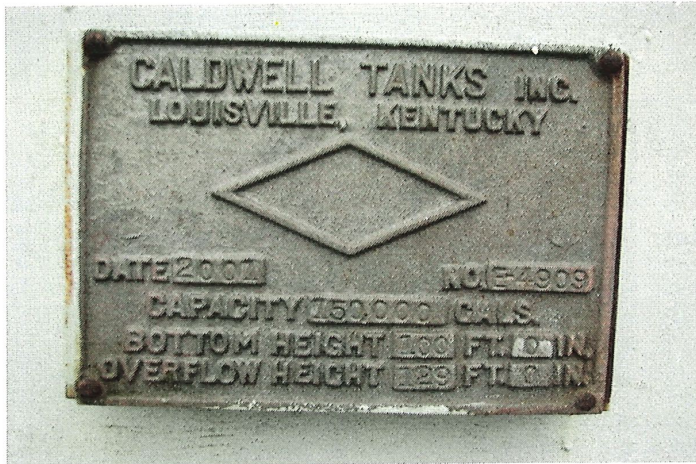
**Photo shows the tank nameplate. The tank was constructed by Caldwell Tanks in 2001.**

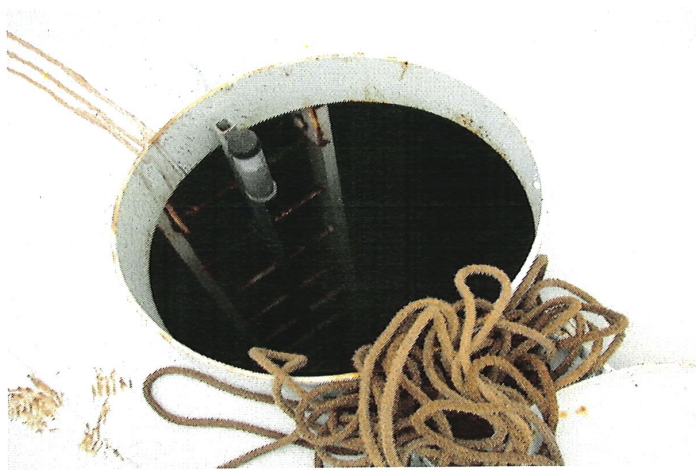
**Photo shows the 30" circular roof manway. Minor corrosion is present along the hatch frame.**

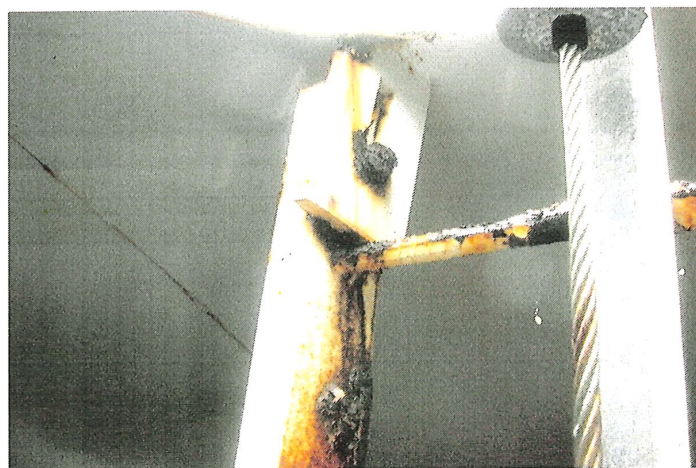
**Photo shows the interior ladder to roof connection. New stainless steel bolts, washers, and nuts should be installed to replace the heavily corroded existing ones.**

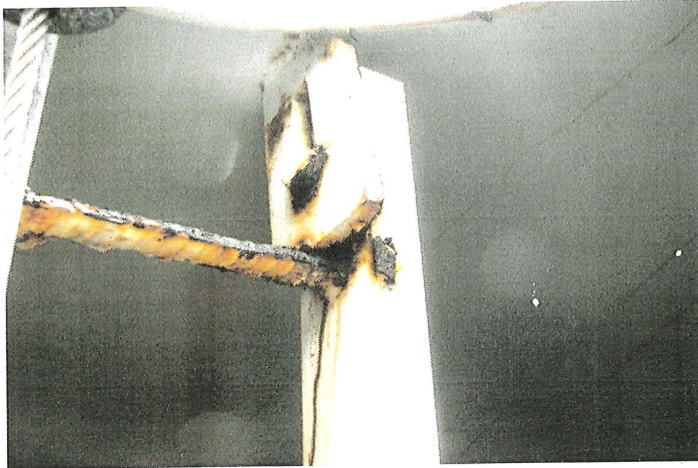
**Photo shows the other ladder to roof connection point. Stainless steel hardware should be installed at this connection as well.**

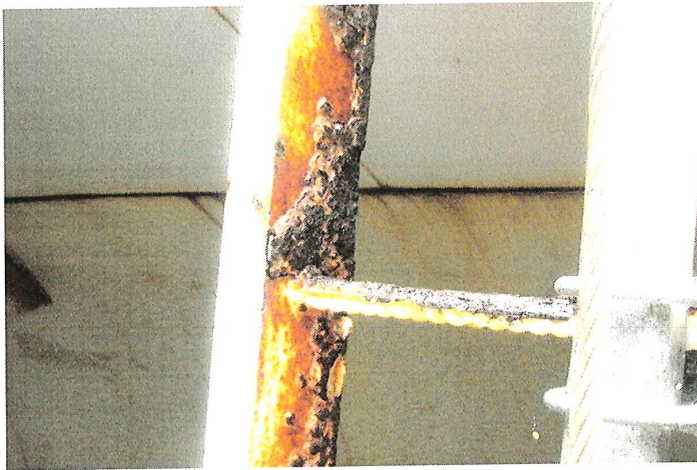
**Photo shows heavy corrosion present along the upper section of the ladder rail and rungs.**

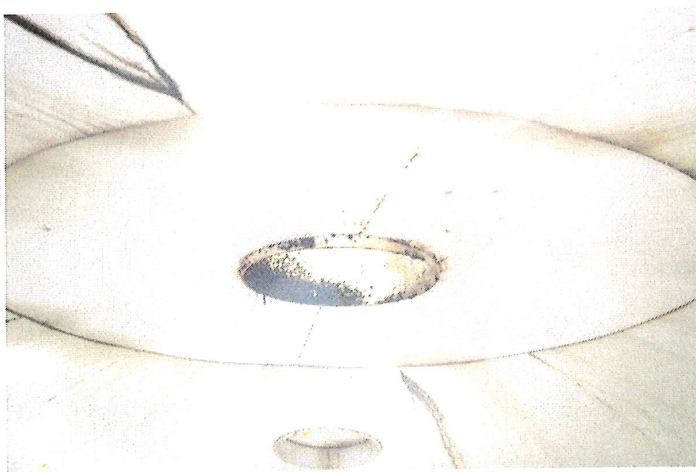
**Photo shows the roof cap plate and vent neck opening. Active corrosion is visible especially inside the vent pipe.**

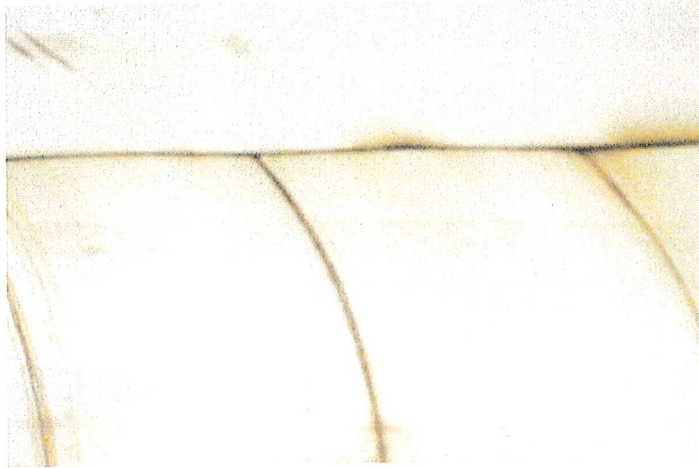
**Photo shows the north section of the roof finger panels. Corrosion cells and rust bleed can be seen along the lapped and welded seams.**

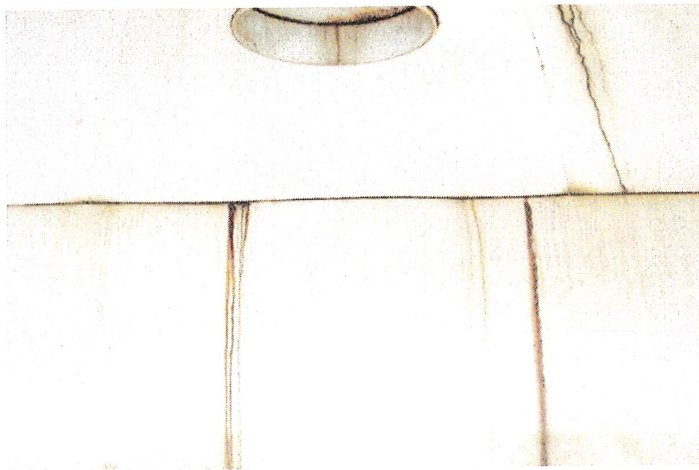
**Photo shows active corrosion present along the northwest portion of the roof finger panels.**

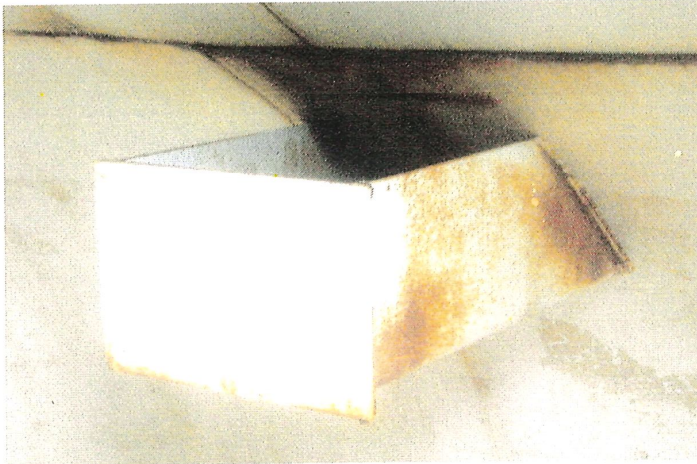
**Photo shows general corrosion present along the overflow weir box.**

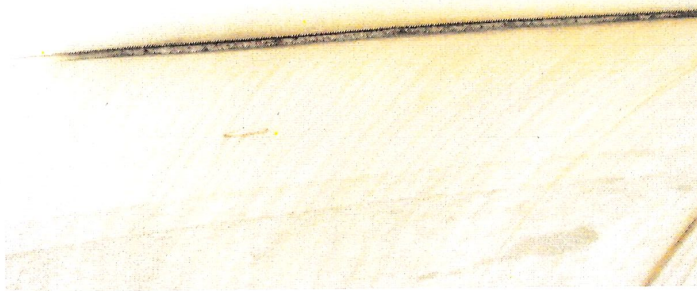
**Photo shows a roof lap seam. All roof lap seams should be sealed with a flexible caulking compound.**

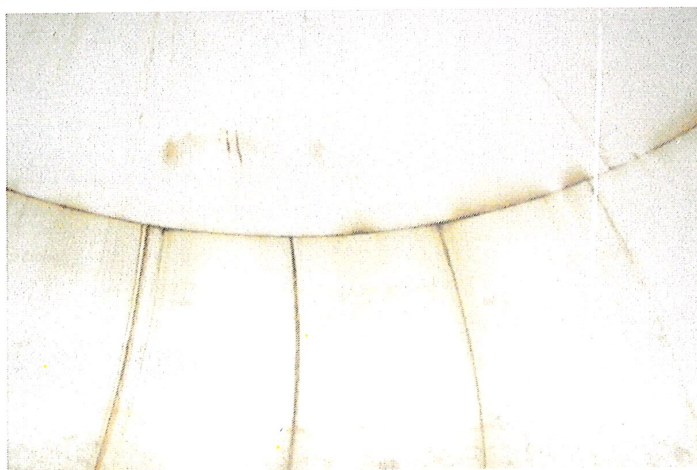
**Photo shows the south section of the roof finger panels and upper knuckle. Rust bleed and staining is present throughout. All lapped seams should be sealed to prevent crevice corrosion.**

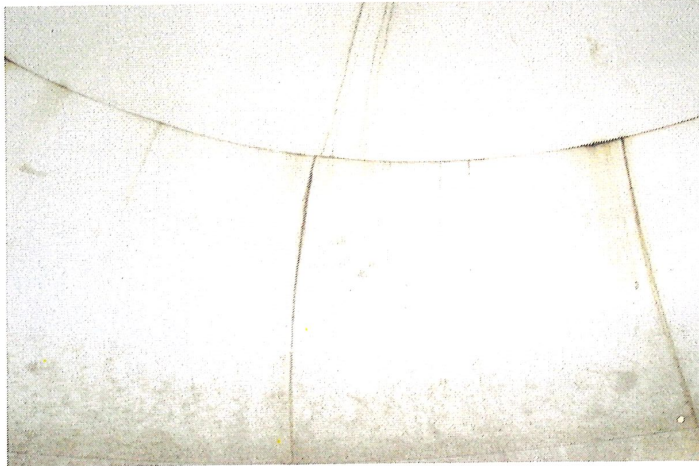
**Photo shows staining and rust bleed present along the east section of the roof finger panels and upper knuckle.**

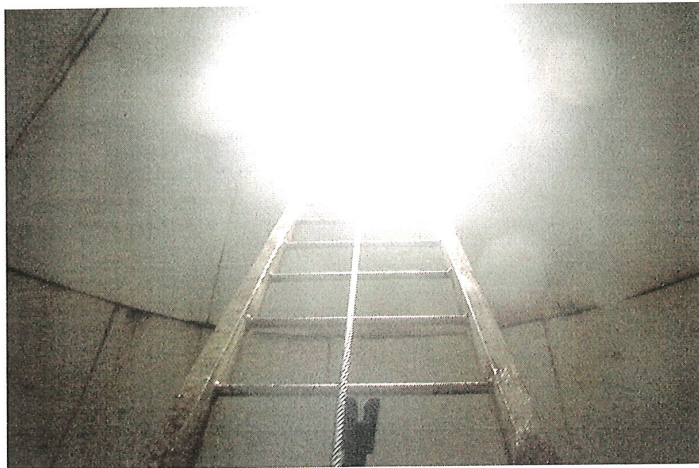
**Photo shows the interior ladder equipped with a stainless steel cable style climber safety device that is in sound condition.**

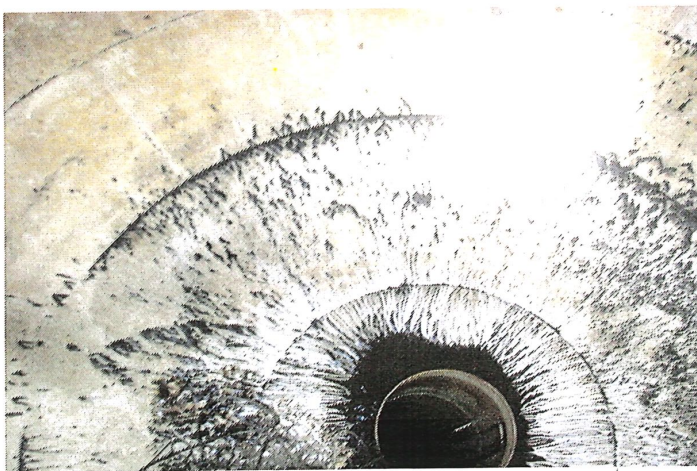
**Photo shows an overall view of the bowl prior to cleaning.**

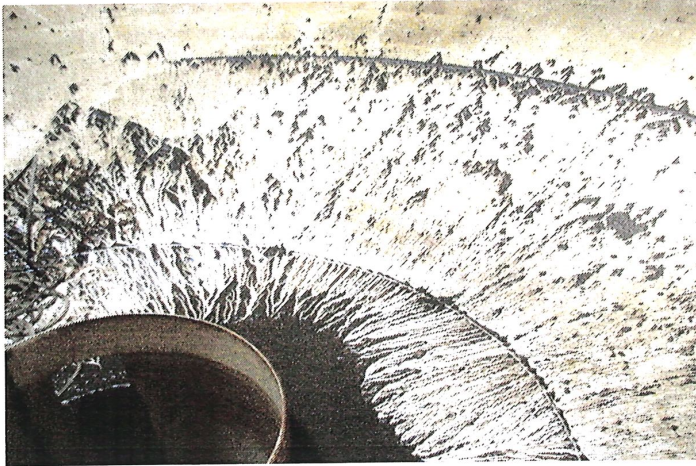
**Photo shows sediment and staining present along the floor prior to high pressure water cleaning.**

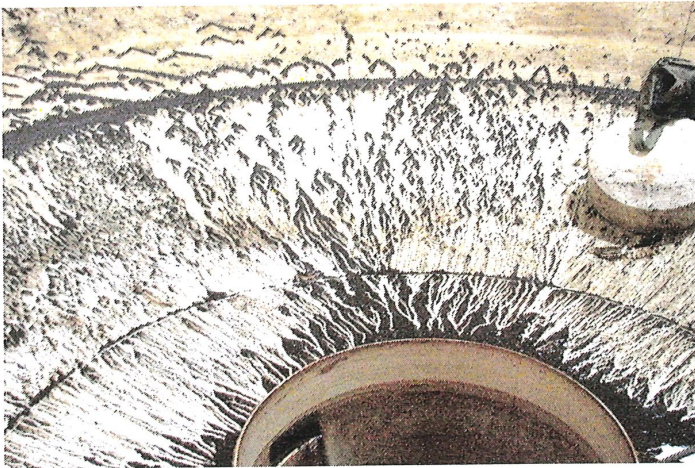
**Photo shows another view of the floor prior to sediment removal.**

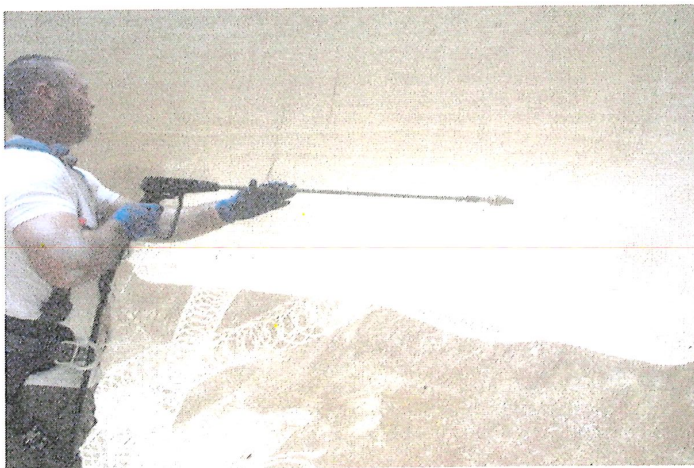
**Photo shows a worker using a 4,000-psi pressure washer to remove staining along the lower knuckle. Contrast can be seen between cleaned and uncleaned areas.**

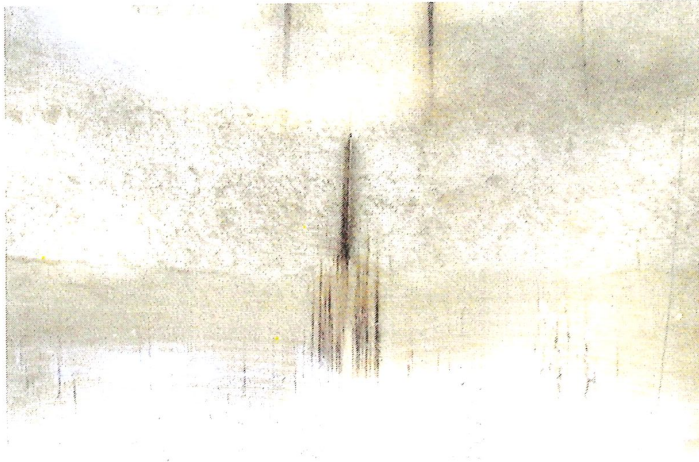
**Photo shows staining and active corrosion cells present along the north shell and sail plate.**

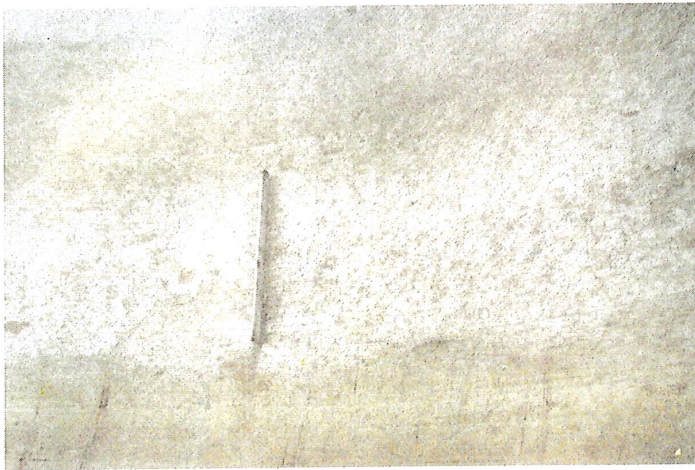
**Photo shows the northwest section of the shell and sail plate. Staining can be seen throughout.**

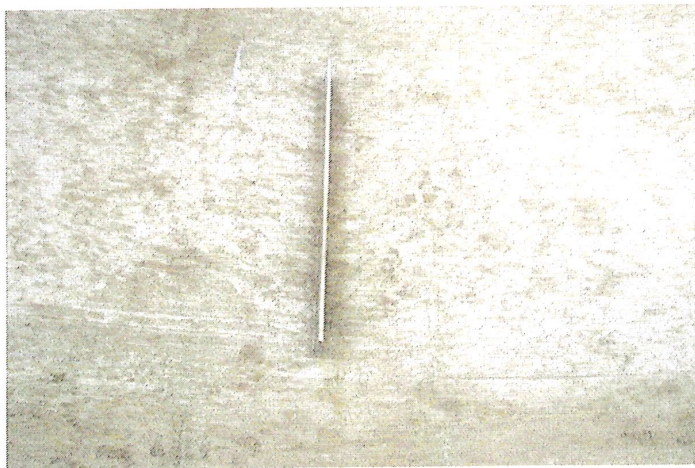
**Photo shows staining present along the southwest shell and sail plate. The existing coating system in this area continues to protect the steel substrate.**

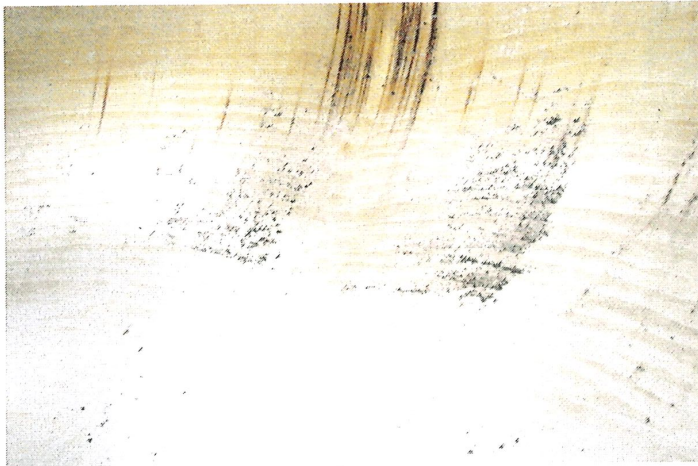
**Photo shows delamination of the top coat and active corrosion cells present along the north section of the lower knuckle after cleaning.**

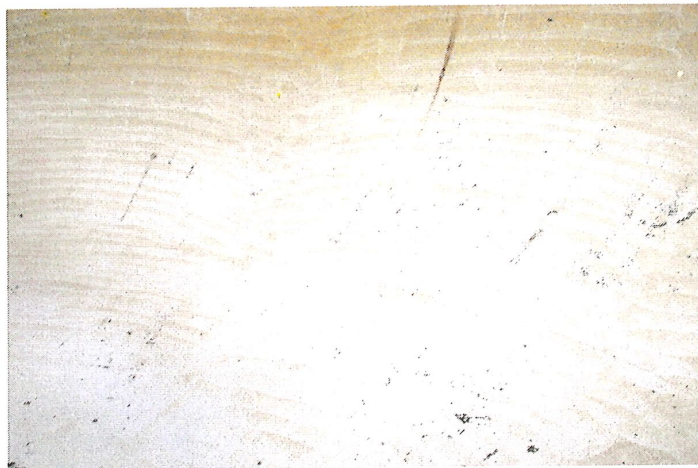
**Photo shows the west section of the lower knuckle after cleaning. Delamination to the steel and between coats is visible.**

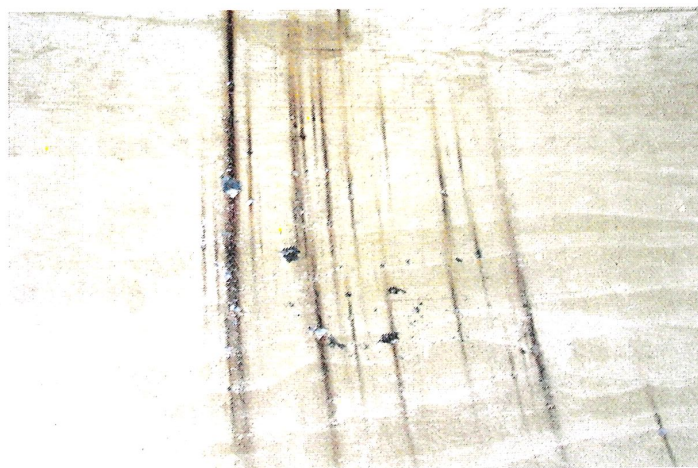
**Photo shows an area of active corrosion cells and pitting present along the southwest section of the lower knuckle.**

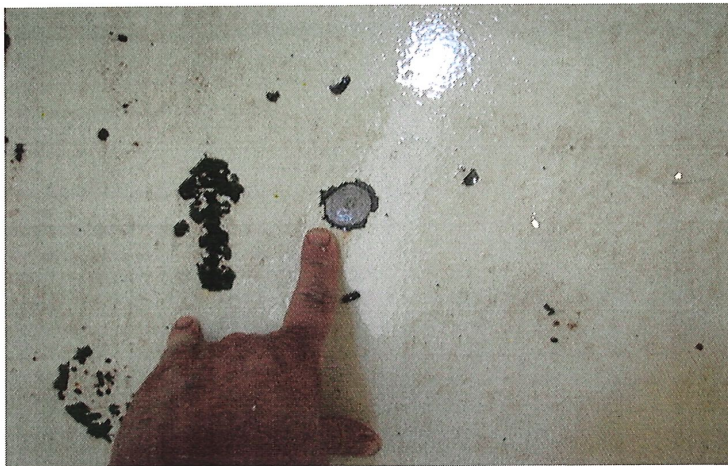
**Photo shows a pit found along the south section of the lower knuckle. Some metal loss has occurred.**

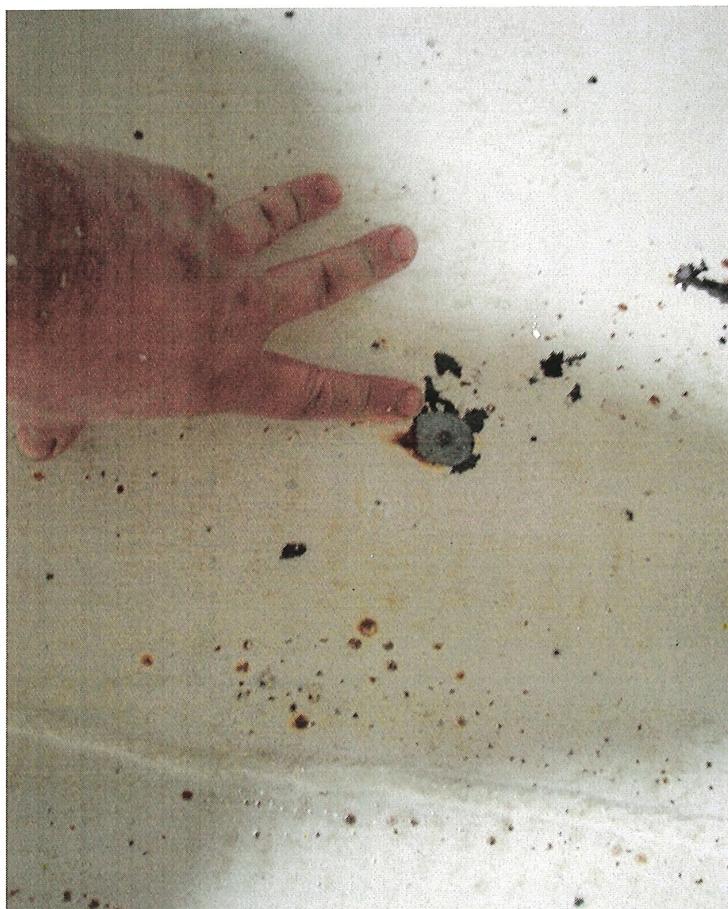
**Photo shows metal loss occurring in another pit found along the south section of the floor.**

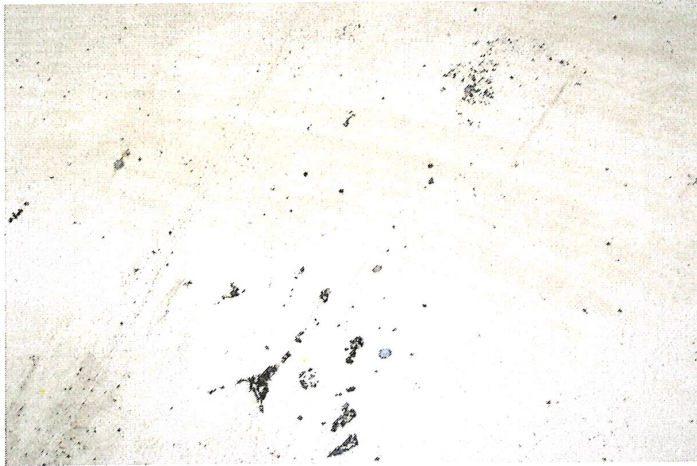
**Photo shows the east section of the lower knuckle after cleaning. Delamination and pitting is present throughout.**

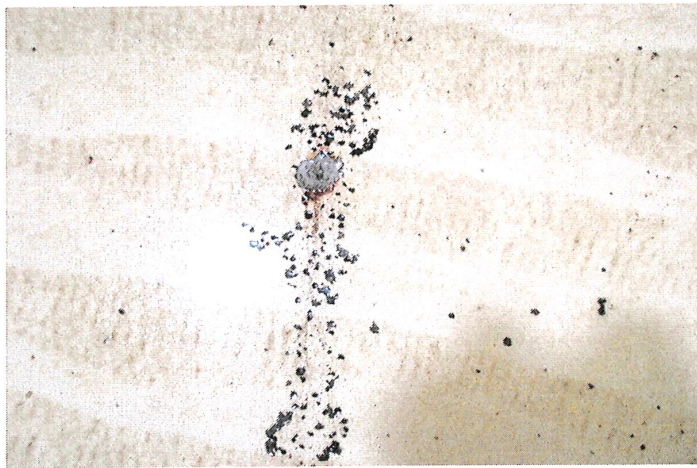
**Photo shows an area of pitting along the east section of the lower knuckle.**

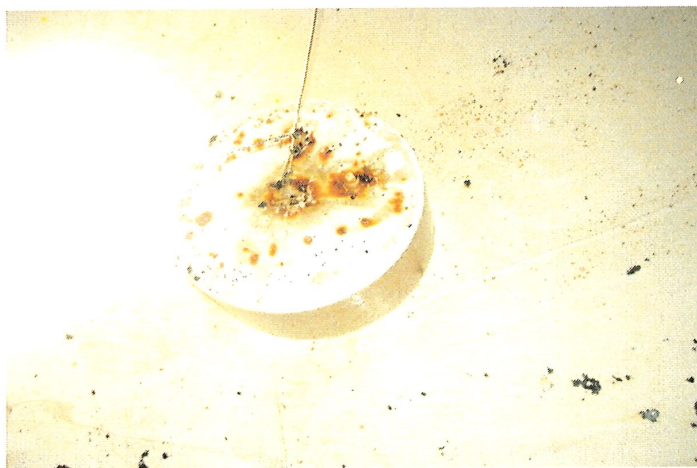
**Photo shows the deficient water level indicator float. Active corrosion cells can be seen.**

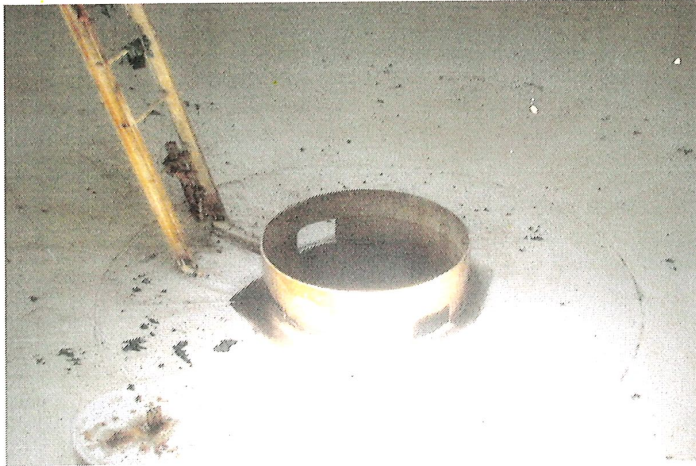
**Photo shows the floor and riser opening after all sediment has been removed. A 42" handrail should be installed around the riser opening.**

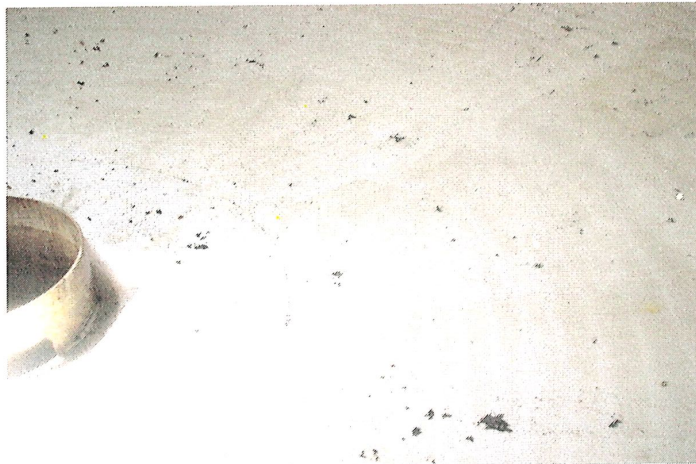
**Photo shows the south section of the floor after high pressure water cleaning. Delamination of the top coat can be seen.**

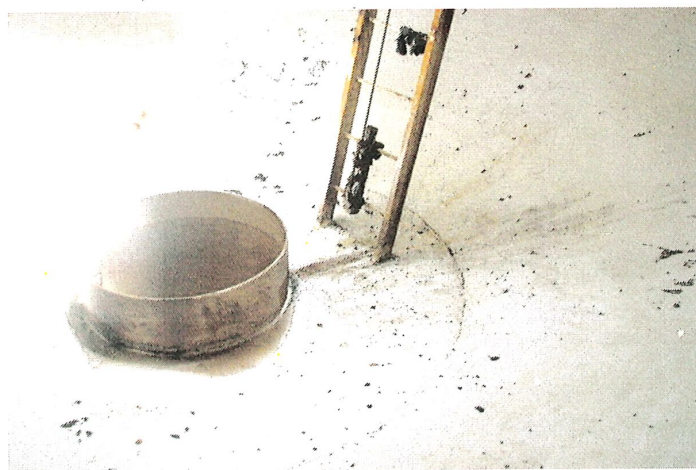
**Photo shows another view of the floor after sediment removal. Delamination and pitting can be seen throughout.**

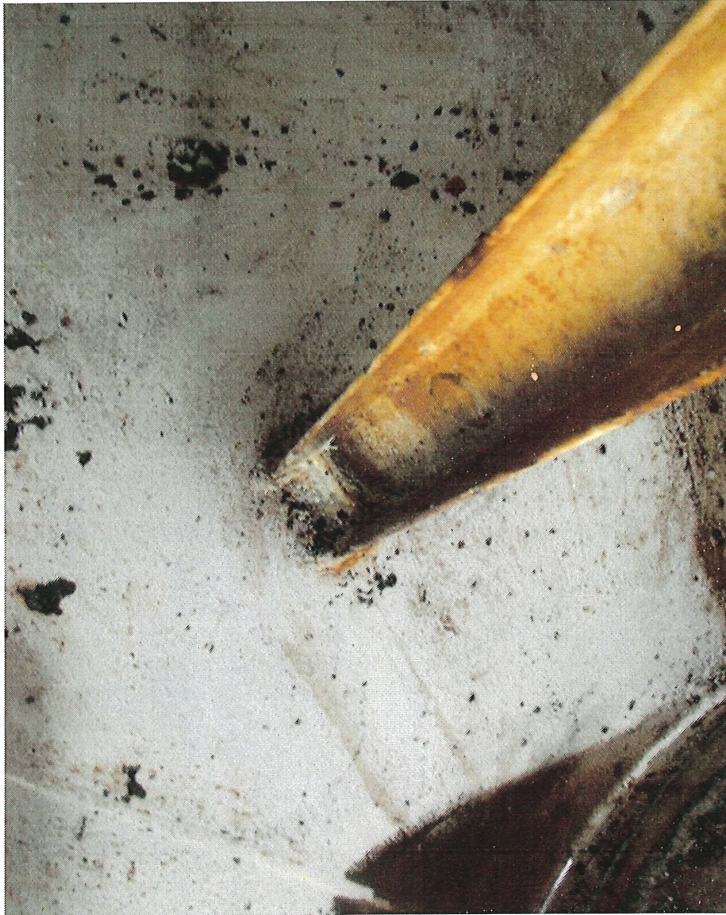
**Photo shows the ladder to floor connection point. Delamination of the existing top coat can be seen in this area.**

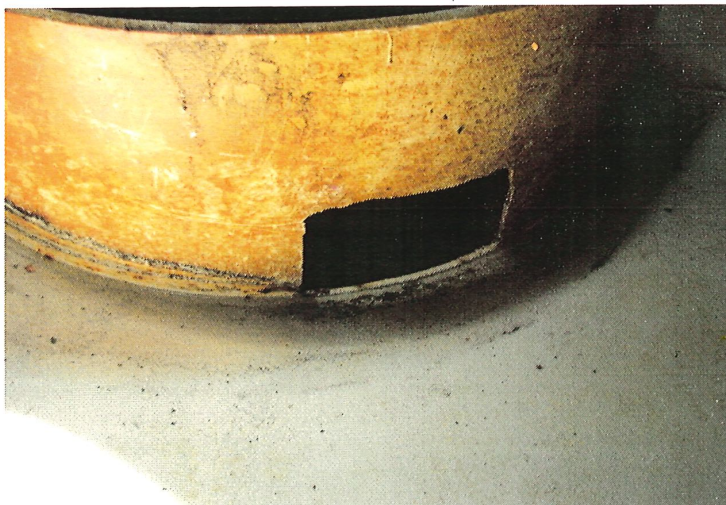
**Photo shows the riser mud drum and drain hole.**

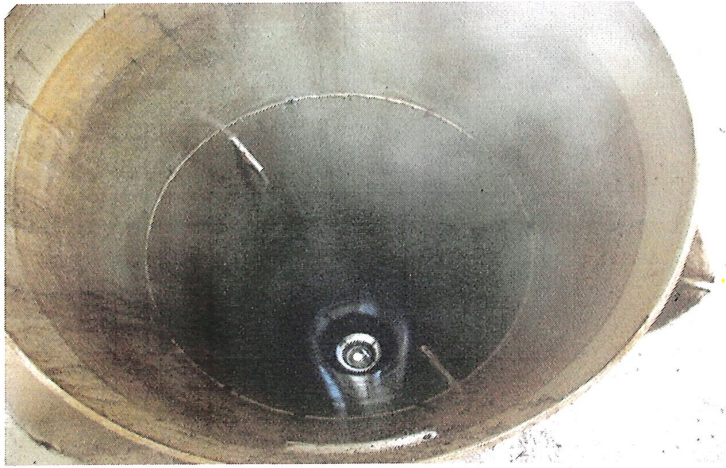
**Photo shows the upper section of the riser. There is no ladder in present.**

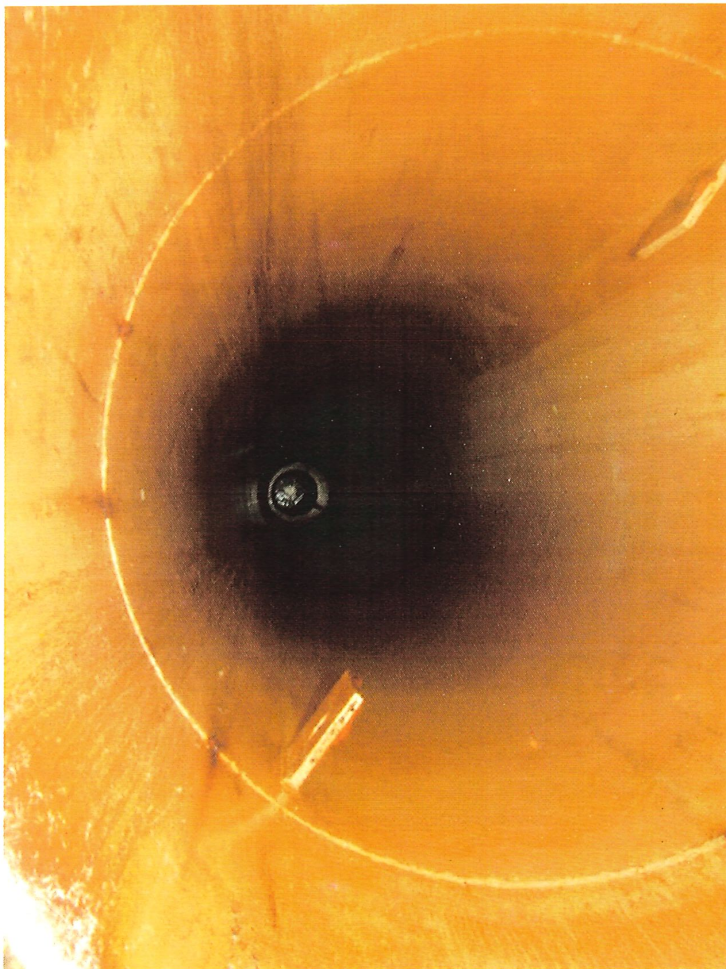
**Photo shows heavy staining along the upper section of the riser. Active corrosion cells are visible along the weld seams.**

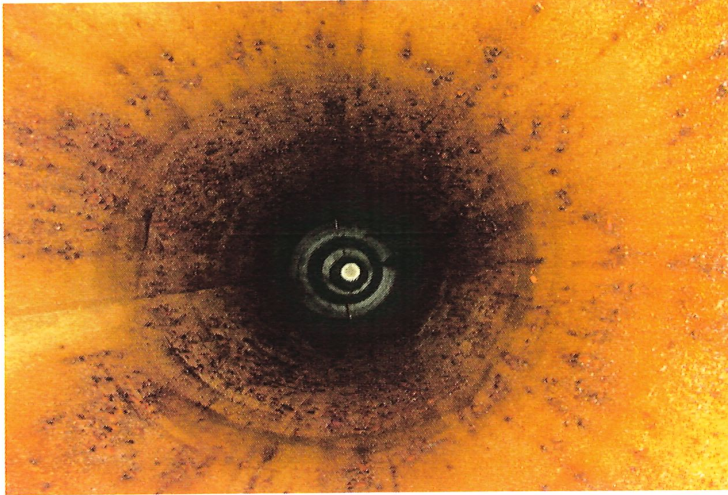
**Photo shows active corrosion cells and heavy staining throughout the lower section of the riser.**

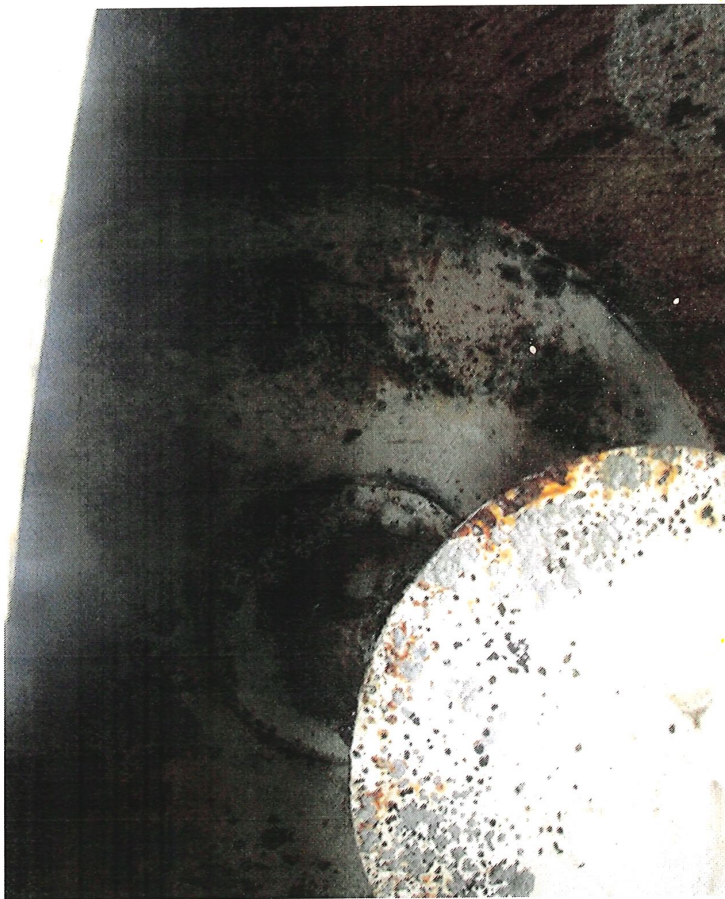
**Photo shows the riser floor after all sediment has been removed. Pitting is present throughout the floor and milk stool cover.**
