Phase I Environmental Site Assessment

Frontier Solar Site

Marion and Washington Counties, Kentucky

19 January 2024

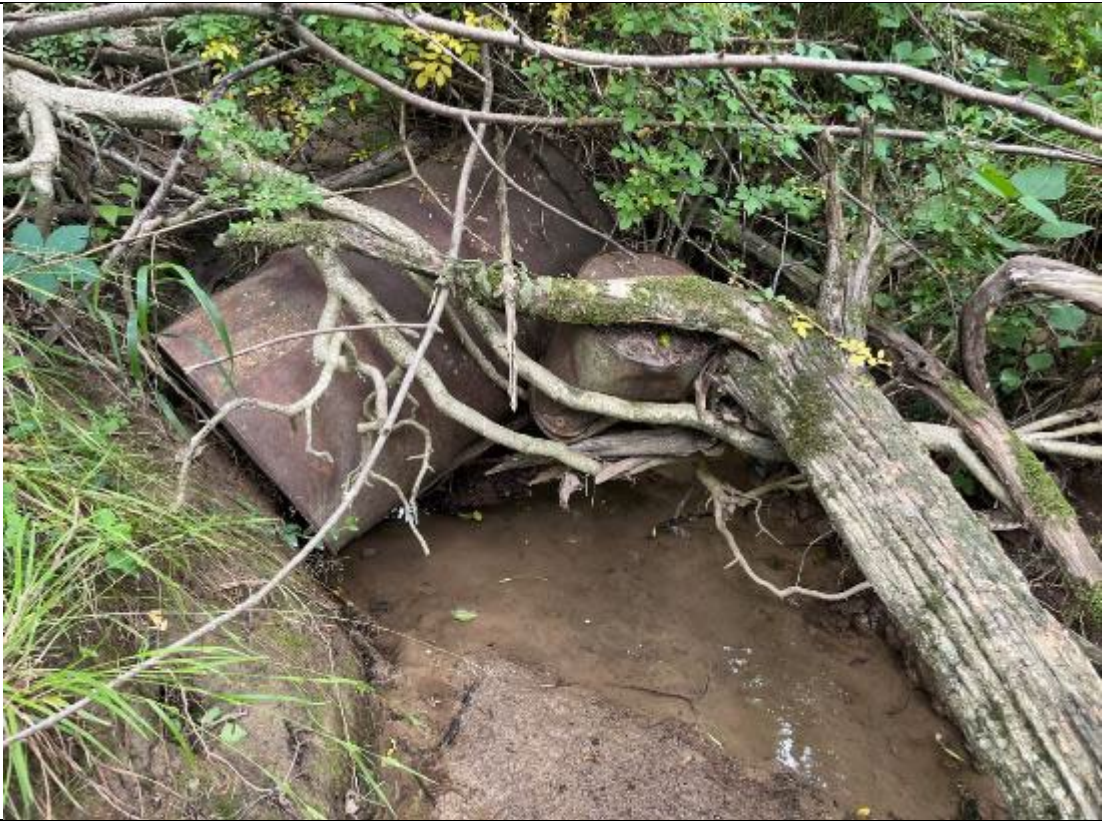
Photograph: 5 View of an empty metal 55-gallon drum.

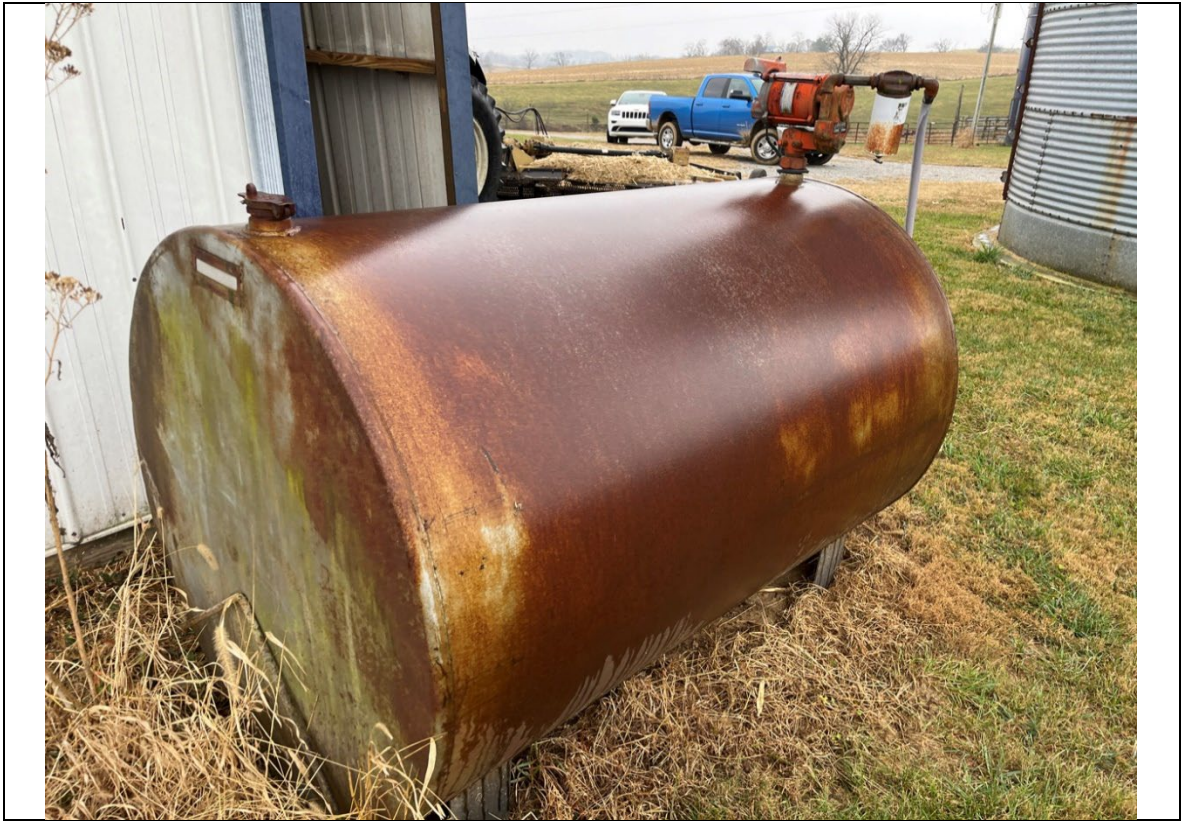
Photograph: 9 | View of an AST located within the northern portion of the Site.

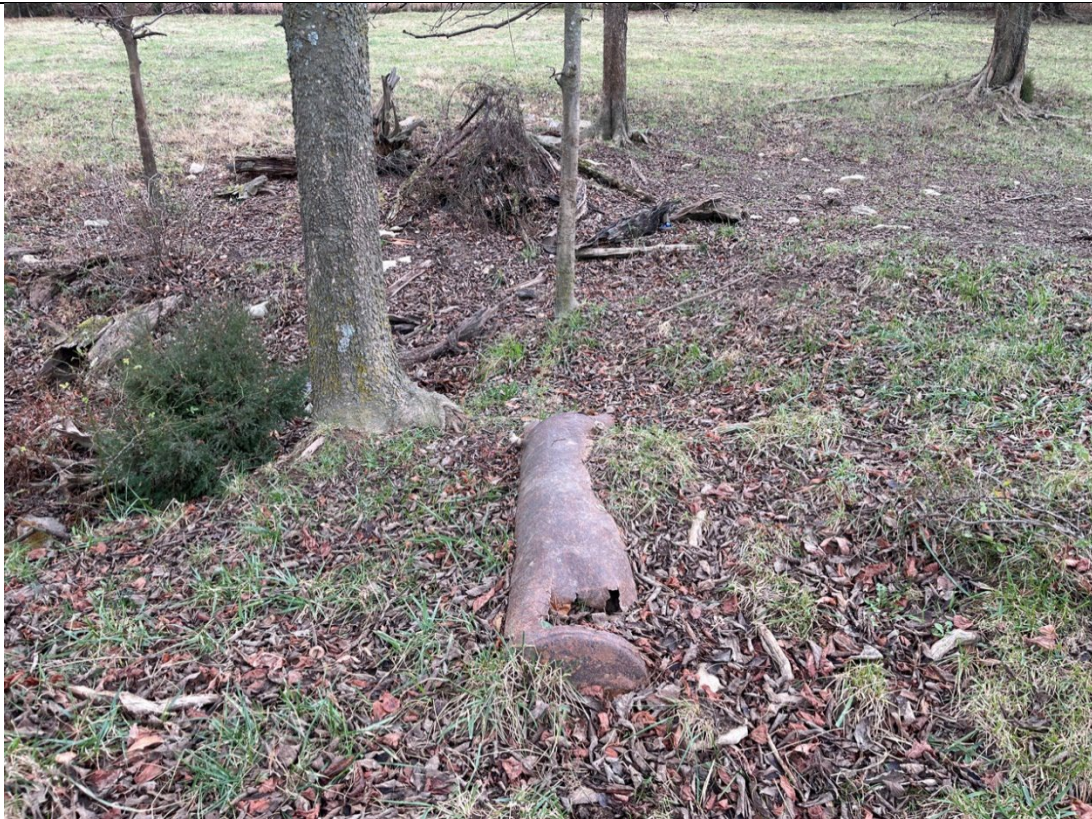
A punctured and buried approximately 100-gallon AST was observed east of the residence located within the northern portion of the western segment of the Site. No significant staining or other indications of spills or releases was observed. However, due to the ASTs unknown former or current contents and its duration on the Site, the punctured AST represents a REC for the Site.

Photograph: 13 View of the punctured tank located within the northern portion of the Site.

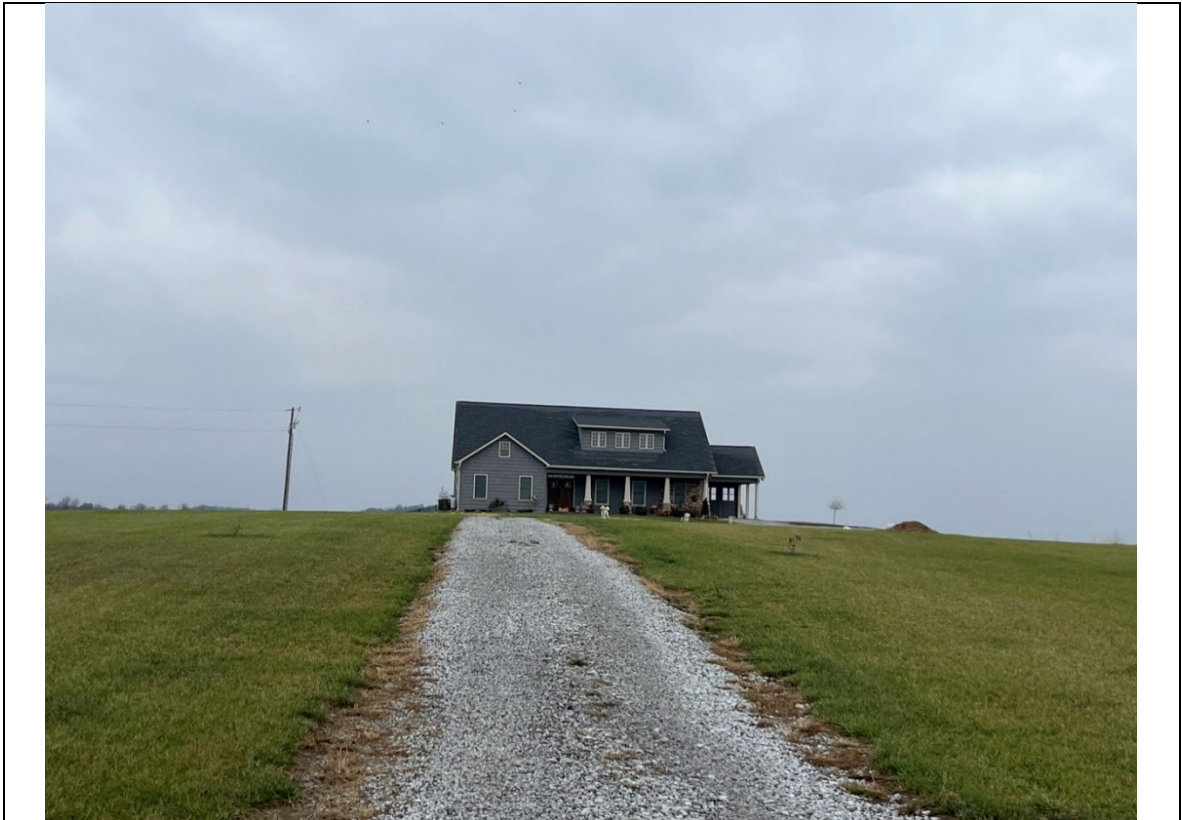
ERM observed seven pole-mounted transformers within the vicinity of the residential buildings throughout the Site. No staining, distressed vegetation, or other visual indicators of a release was observed in the vicinity of the transformers. However, given that installation date of the transformers is unknown, it is possible for the units to contain PCBs. If the transformers are to be removed during development, the dielectric fluid should be tested for PCBs prior to disposal.

Photograph: 18 | View of the easternmost residence and a pole-mounted transformer.

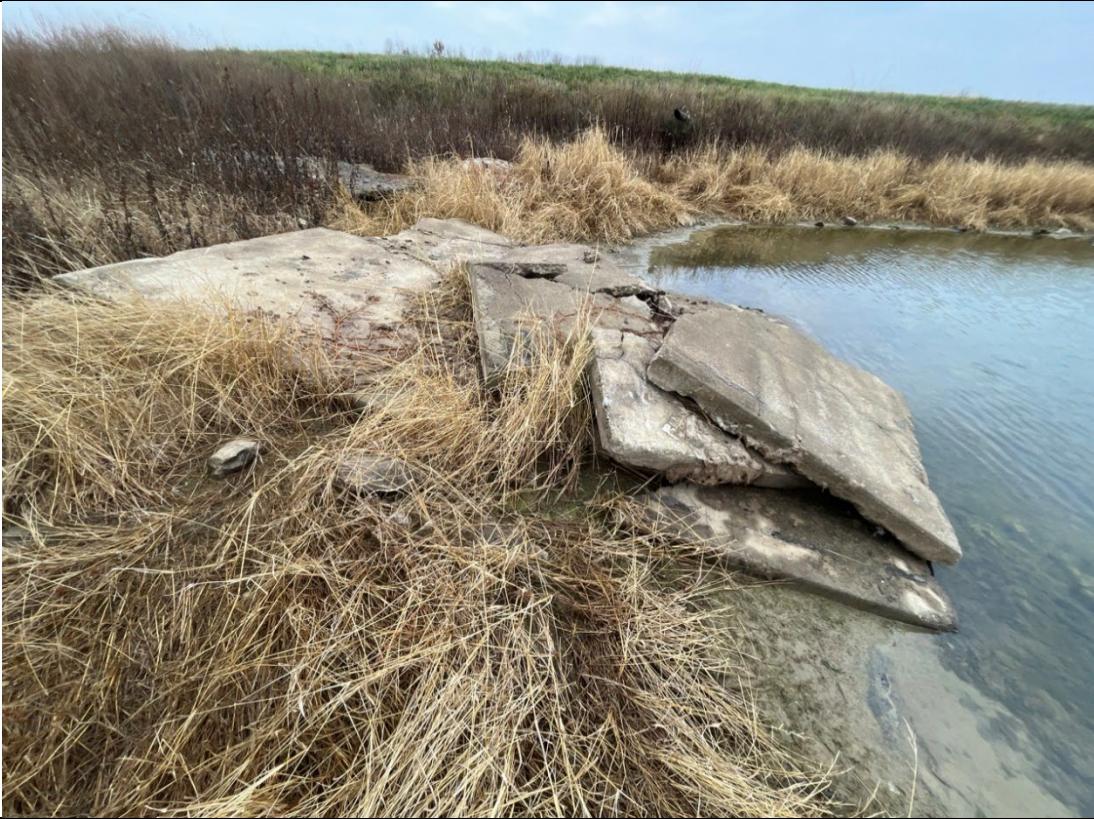
Photograph: 19 | View of discarded concrete.

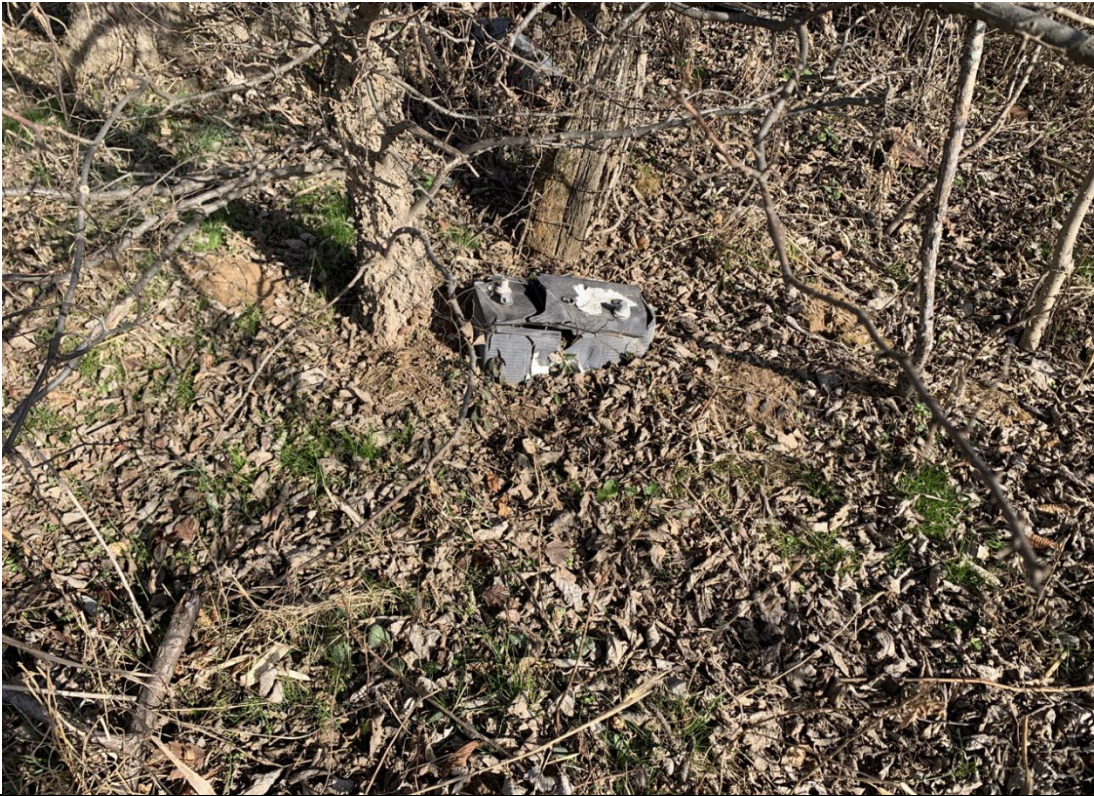
Photograph: 23 | View of a deteriorated battery found near barn

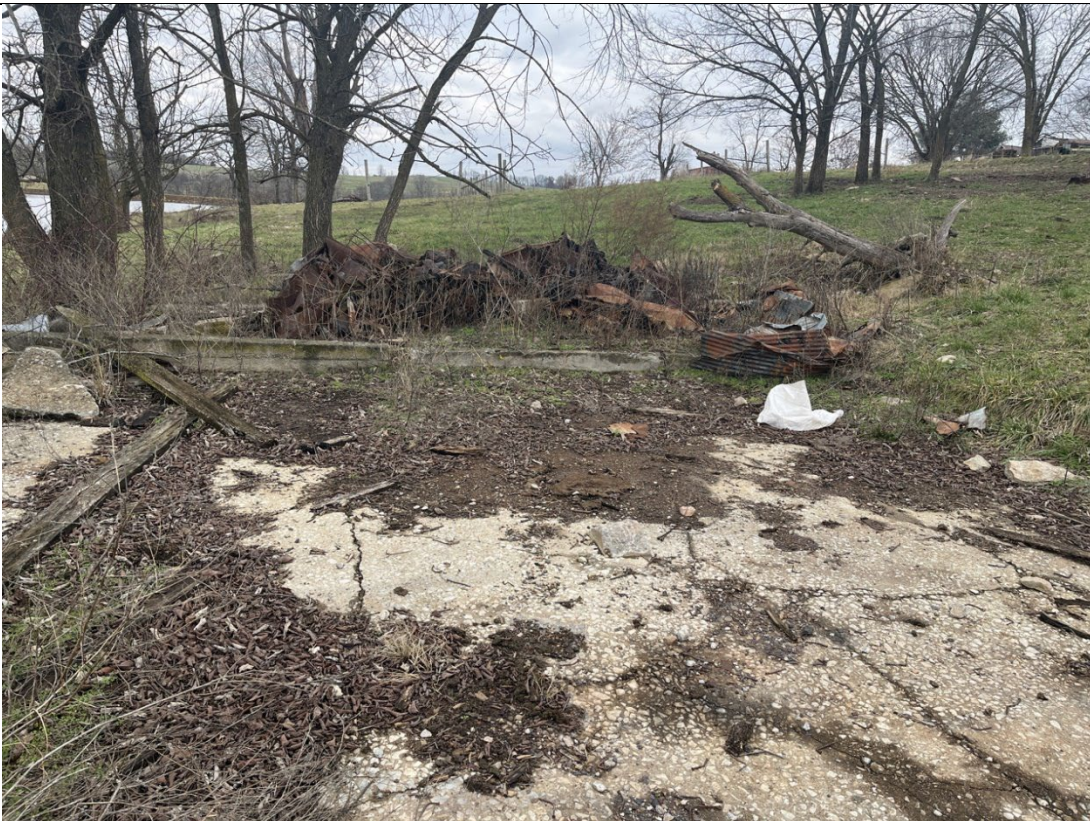
Photograph: 30 | View of concrete foundation with building debris present.

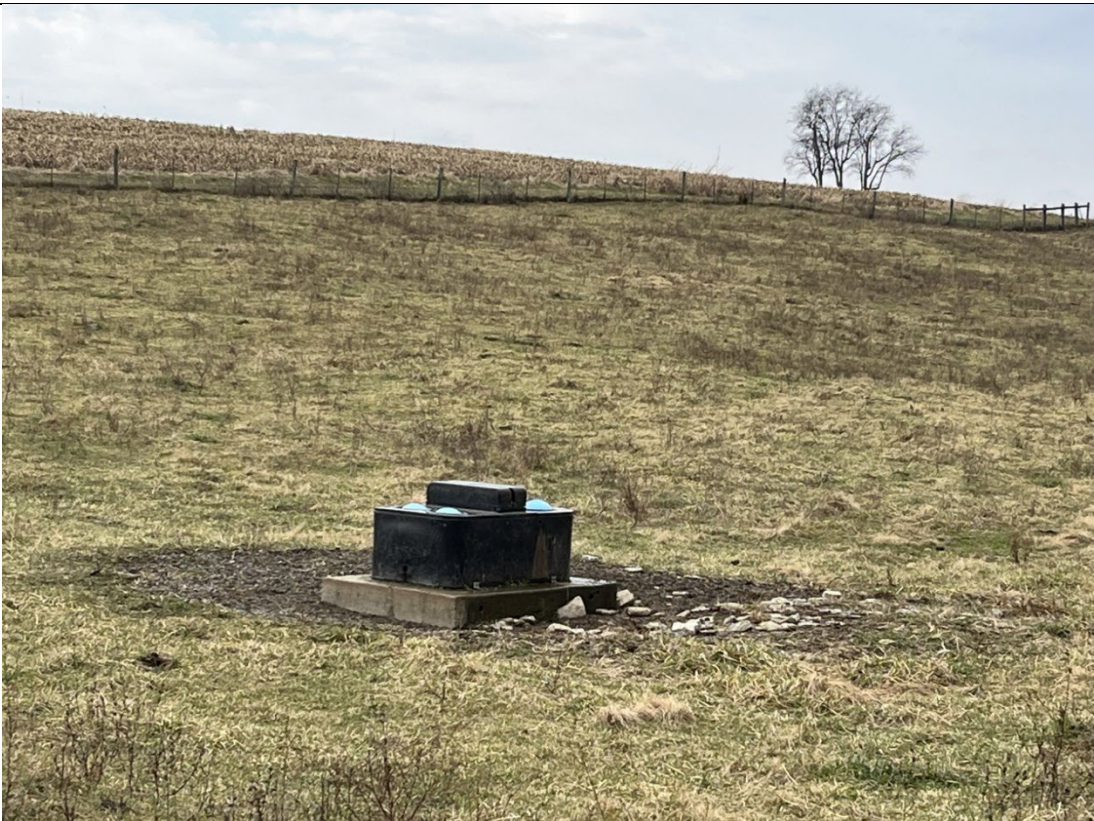
ERM observed two water well pumps near surface waters within the northern portion of the Site, several open wells and cement cattle wells were observed throughout the Site. One groundwater well was identified on the Site in the EDR water well search on the northern Site boundary within the western segment. Five state groundwater supply wells were mapped within one mile of the Site. Any groundwater wells at the Site impacted by planned development should be abandoned according to applicable state and local regulations.

Photograph: 32 | View of possible well along Maraja Ln.

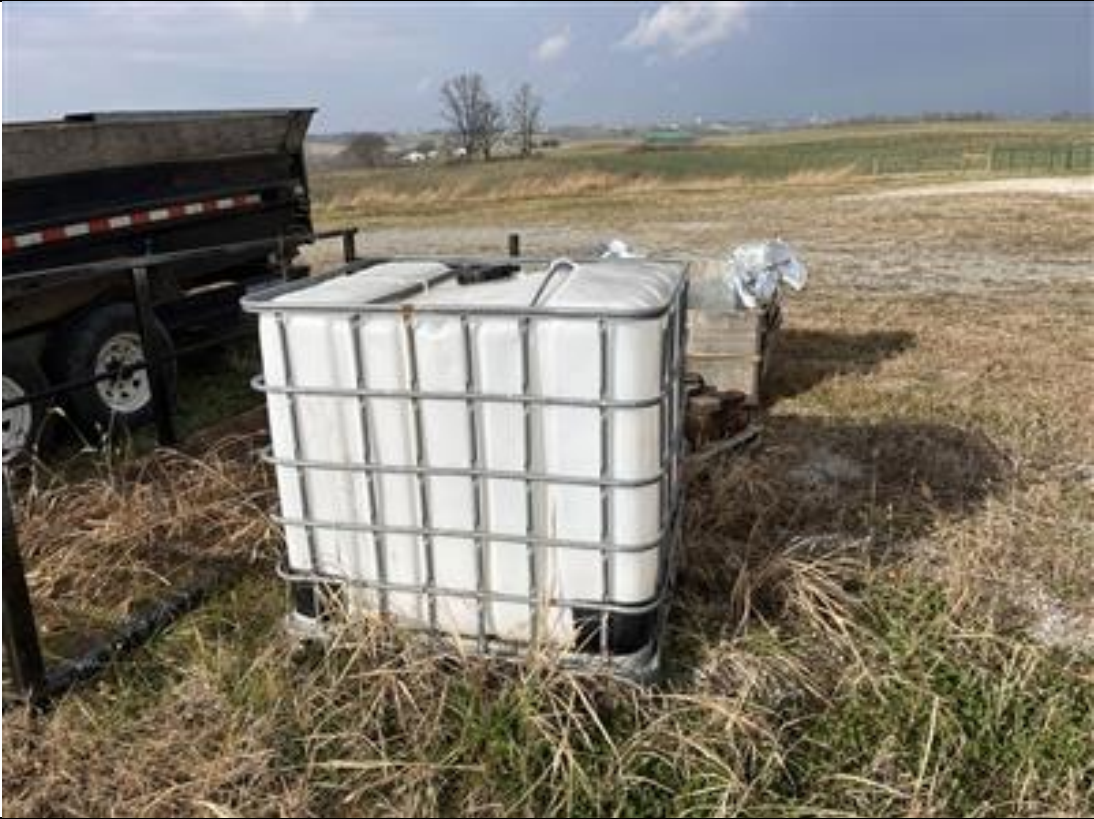
Photograph: 33 | View of miscellaneous AST on site, no label.
