# Subsidence Review

## Weirs Creek Solar Project Hopkins and Webster Counties, Kentucky

July 2023

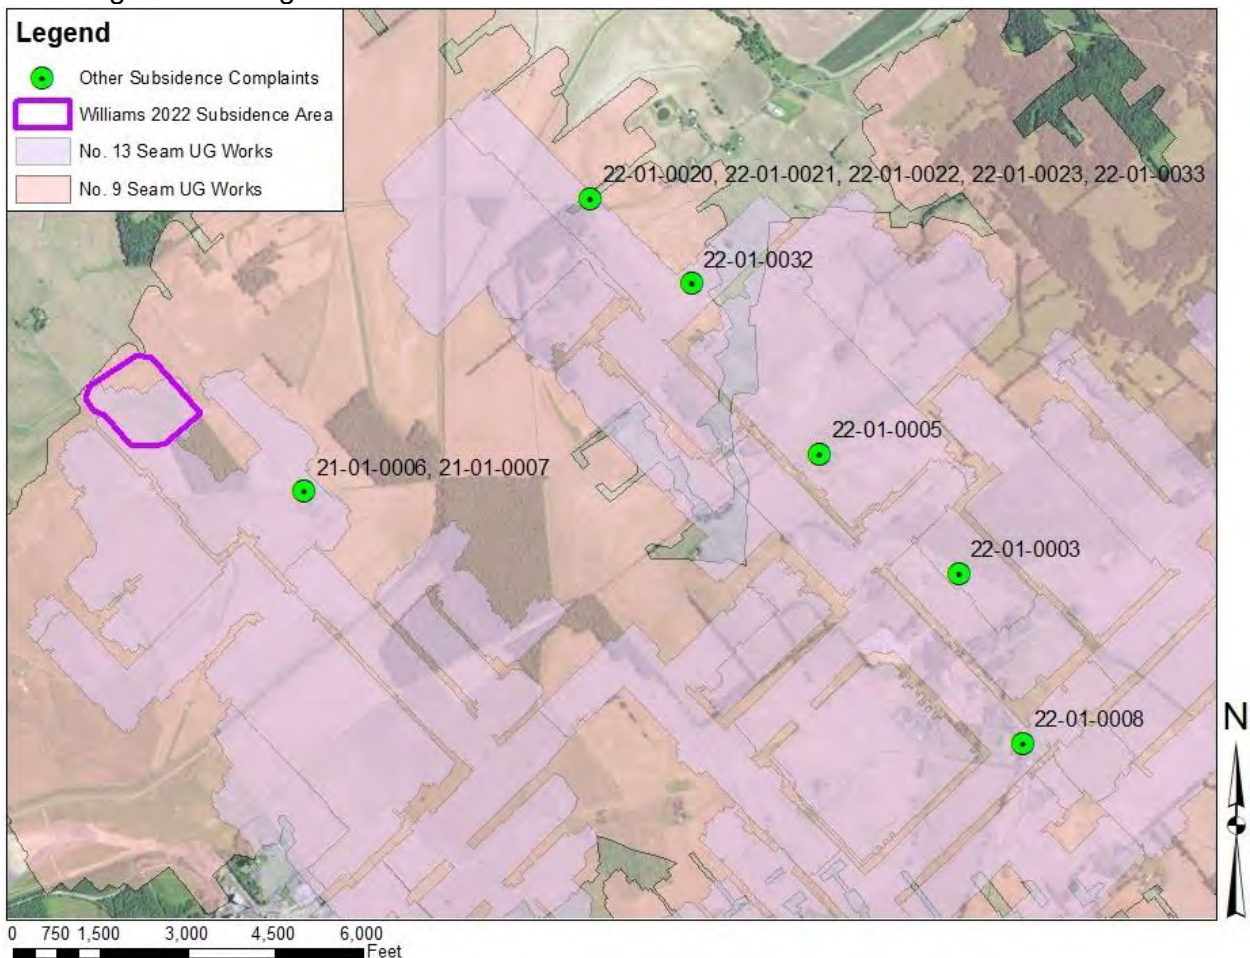
Figure 5. 2020 Aerial photograph showing other nearby subsidence complaints, and their relation to underground mining in the No. 9 and No. 13 coal seams.

The area around the Williams property was searched for previous complaints or violations related to subsidence. Eleven other subsidence complaints have been filed relating to Webster County Coal LLC, Permit No. 917-5013 (Figure 5). All twelve complaints were filed within an approximately 18 month time span, and are located within less than three linear miles of each other. The five complaints located within the area of the northernmost point in Figure 5 have all been determined to contain subsidence caused by the underground mining associated with Webster County Coal LLC, Permit No. 917-5013. The other complaints are still under investigation, and no determination has been made.

One violation has been issued to Webster County Coal LLC, Permit No. 917-5013 for subsidence. Notice of Non-Compliance (NNC) 13-2539 was issued on October 18, 2022 for subsidence damage to State Highway 1340 near the northernmost subsidence complaints in Figure 5.

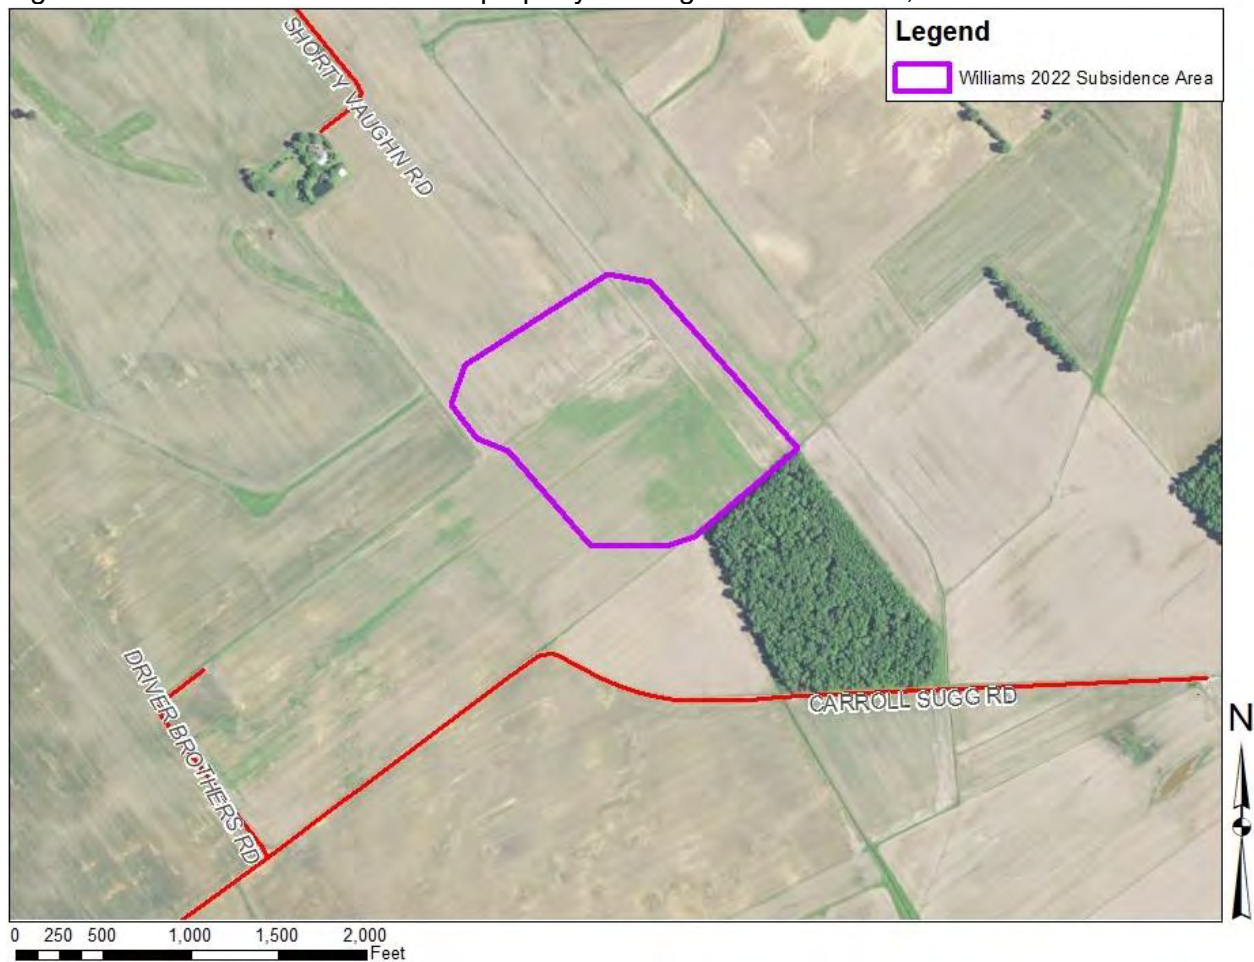
Figure 6. Site sketch of the Williams property investigated on June 20, 2022.

A site visit was conducted by Environmental Scientist IV Steve Lewitt, Environmental Control Manager Randall Ousley, Environmental Scientist I Johnathan Stumpf, and Environmental Engineer II Terry Cates (hereafter referred to as DMRE staff), on June 20, 2022. Due to the recent dry weather in the area, no low lying wet areas were observed at the time of this site visit. The area investigated is shown in Figure 6.

DMRE staff obtained elevation data along transects through the area of concern. Elevation readings were obtained using an Arrow Gold RTK GNSS Receiver, which has survey grade accuracy down to 1 centimeter. A total of six transects were surveyed through the area of concern, and will be discussed later in this report. This concluded the June 20, 2022 site visit.

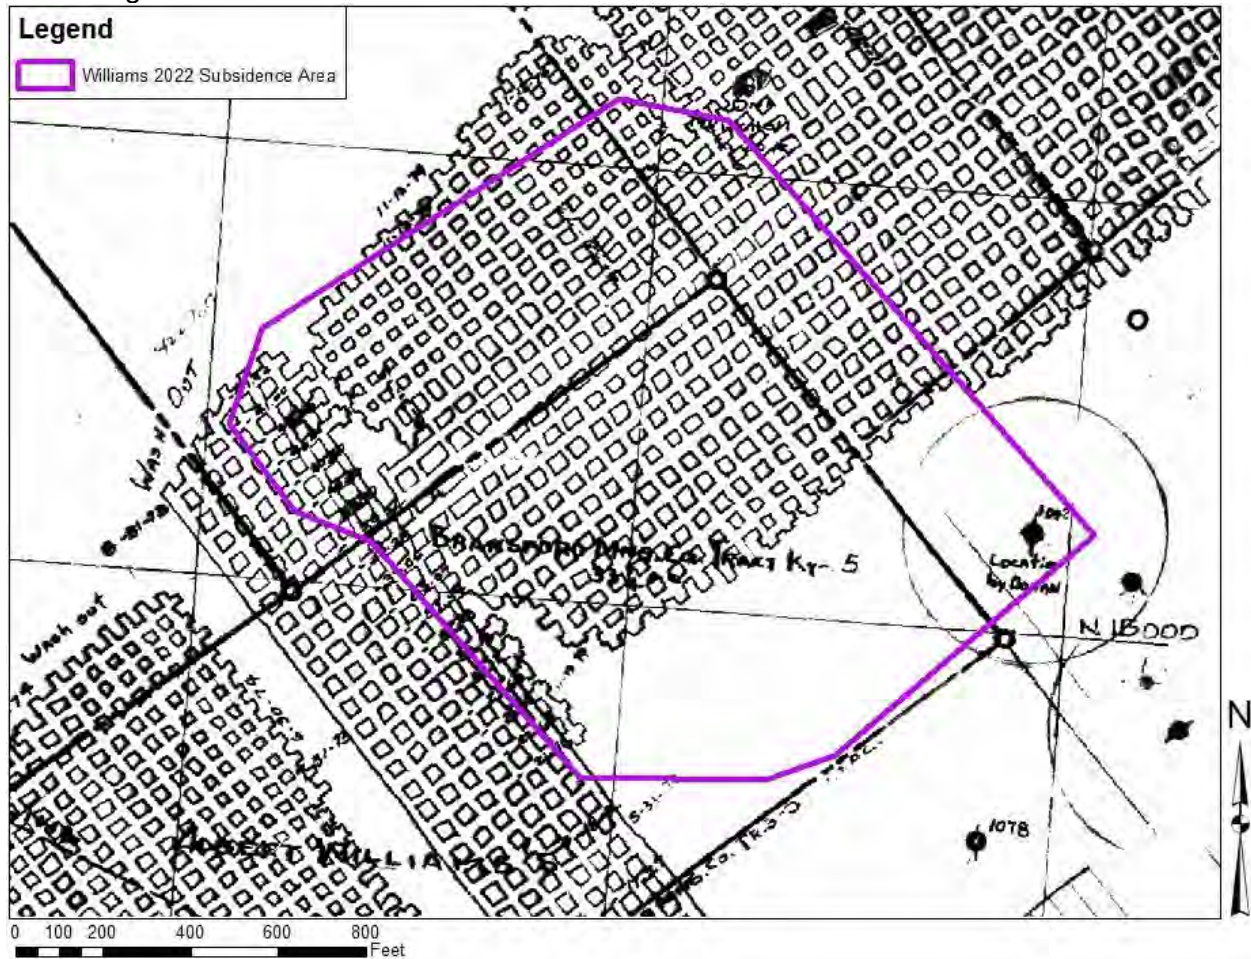
Due to the age of the mining in the No. 9 seam, a subsidence plan for this mining could not be found. The No. 9 seam mining directly beneath the Williams property was conducted pre-law, meaning that current mining regulations were not in place at that time, and a subsidence plan for the area would not have been required. Measurements performed on the underground mining map, dated 1989 showed the area to have entry widths of approximately 18 feet, and coal pillars of approximately 40 feet x 40 feet in size (Figure 11). This means that the extraction rate in the No. 9 seam beneath the Williams property was approximately 52.4%.

Figure 11. Webster County Coal LLC, Permit No. 917-5013 1989 Mine Map, dated 1989, showing the mining conducted in the No. 9 seam below the Williams subsidence area.

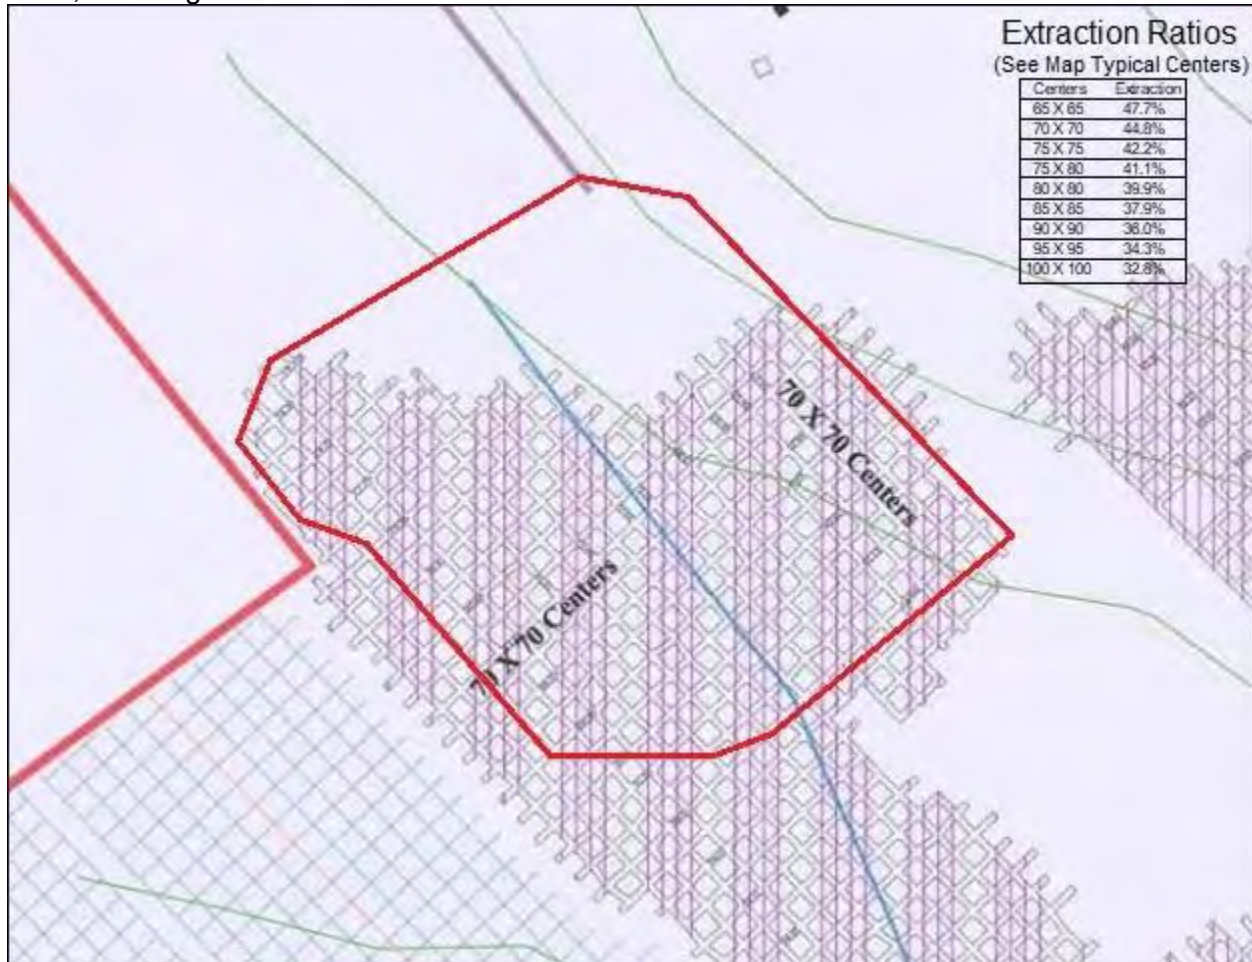
The subsidence protection plan in the Webster County Coal LLC, Permit No. 917-5013 Minor Revision #26 permit application, which over permitted the No. 13 seam underground mining previously permitted by Webster County Coal LLC, Permit No. 917-5023, states that an extraction ratio no greater than 50% will be utilized throughout the entirety of the mine. The extraction rate under the Williams property was approximately 44.8% according to the 2013 underground mine map submitted to DMRE and dated February 7, 2014 (Figure 12).

Figure 12. Webster County Coal LLC, Permit No. 917-5023 2013 Mine Map, dated February 7, 2014, showing the extraction rate in the No. 13 seam below the Williams subsidence area.

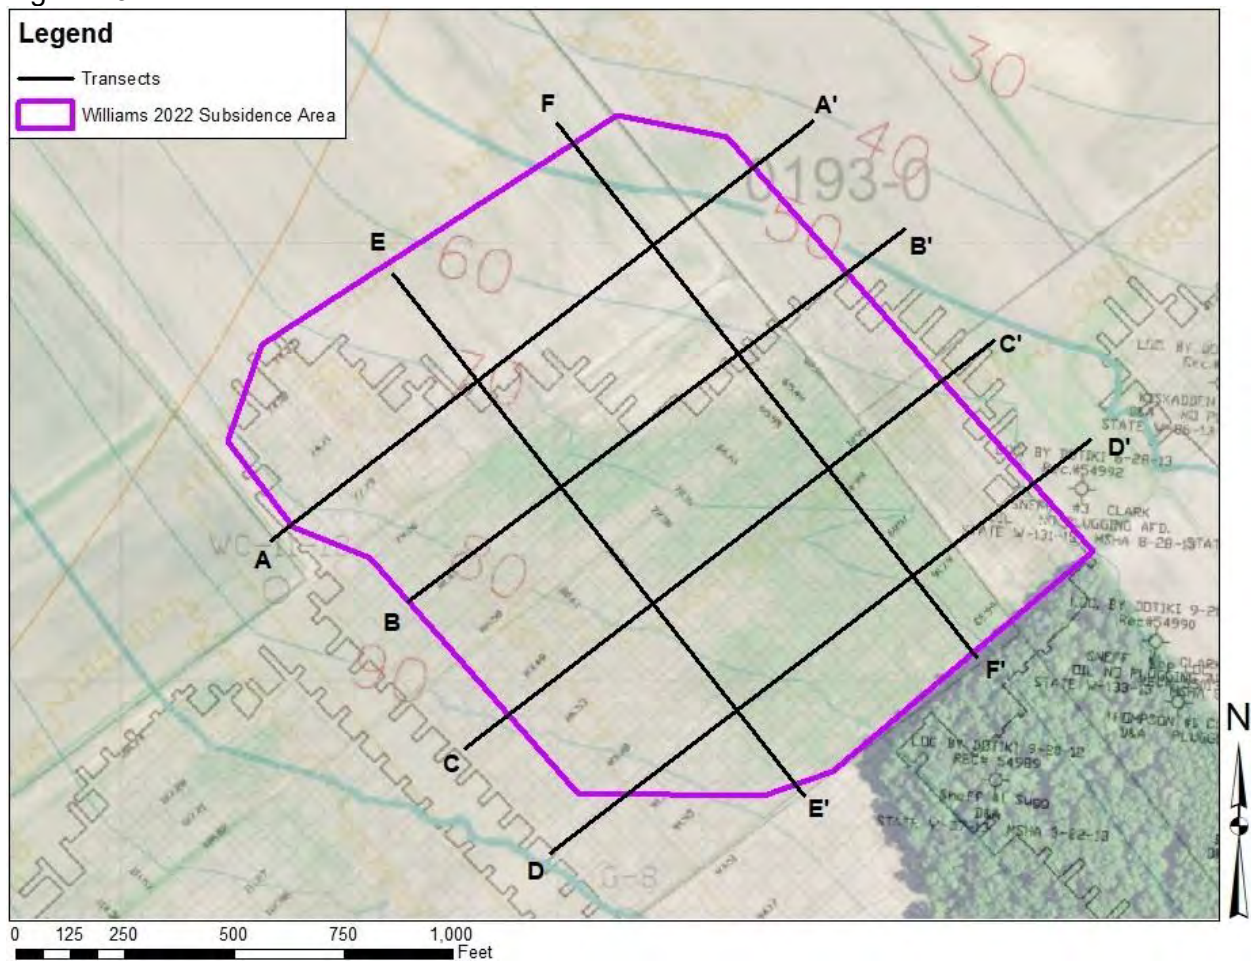
Figure 13. Plan view of the Wade Williams subsidence area and transect locations.

Data was collected at various points along the transects surveyed during the June 20, 2022 site visit. Points were logged at approximate distances of 20 to 30 feet, as well as at places where features, such as ditch lines, needed to be documented. At each point, the longitude, latitude and elevation were recorded using an Arrow Gold RTK GNSS Receiver that has a survey grade accuracy of 1 cm. The data was later processed to determine if there was any significant change in elevation. Along each profile line, the elevations that were collected in the field were compared to elevations acquired from LiDAR data from 2014 and 2020<sup>10</sup>. Profile lines of the three data groupings, 2014, 2020 and 2022, were drawn using AutoCAD software and are attached. Figure 13 shows a plan view of the transects surveyed on the Wade Williams property. Figures 14 through 19 show cross sections A-A' through F-F'.

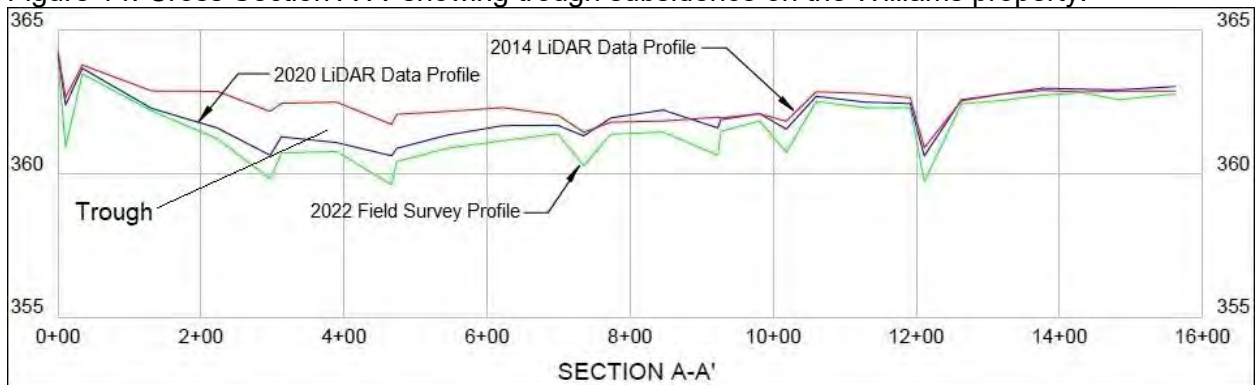
Figure 14. Cross Section A-A' showing trough subsidence on the Williams property.

Cross sections A-A' through F-F' indicate that trough subsidence has occurred above the underground works beneath the Williams property (Figures 14 through 19). Differences in the 2014 LiDAR data and the data collected during the June 20, 2022 site visit show that the surface elevation in this area is now two to three feet lower than it was in 2014. Mining in the No. 13 seam was conducted in 2014, and the landowners first noticed subsidence in the area in 2022.

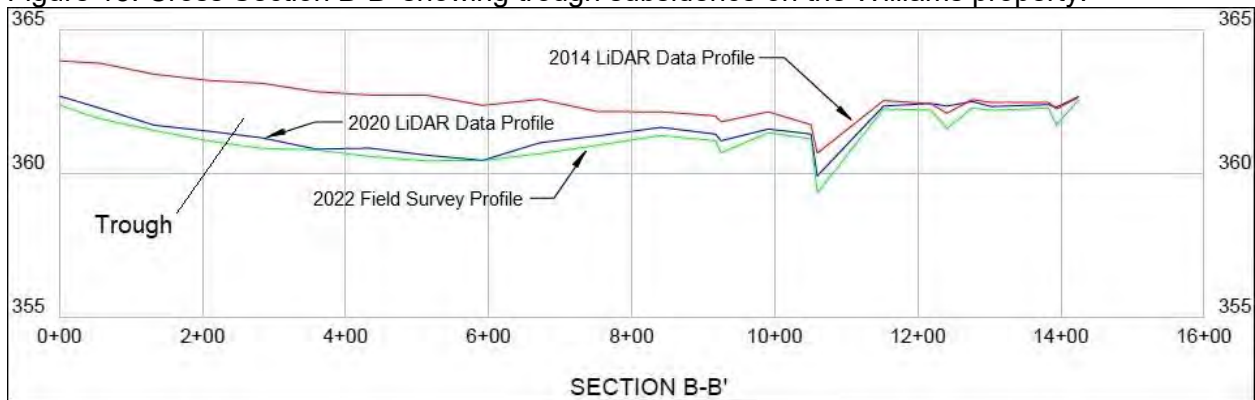
Figure 15. Cross Section B-B' showing trough subsidence on the Williams property.

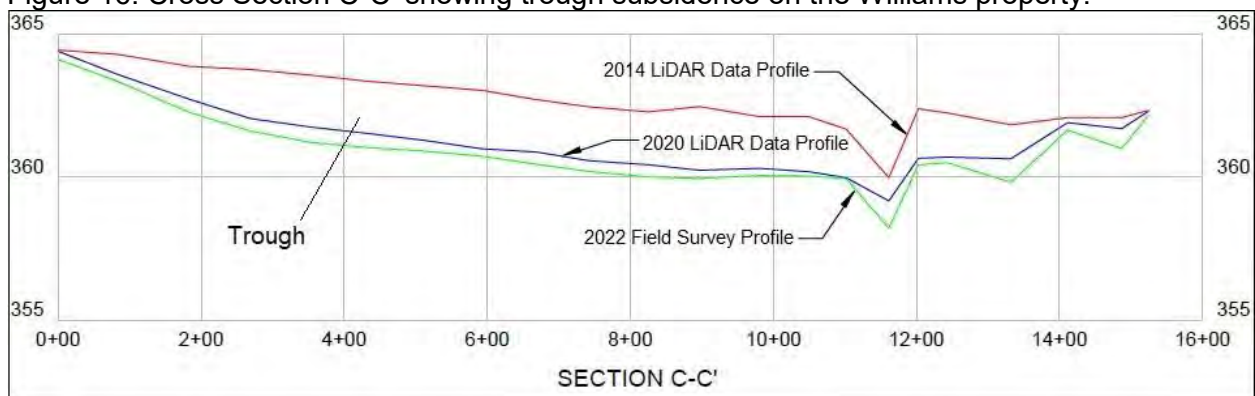
Figure 16. Cross Section C-C' showing trough subsidence on the Williams property.

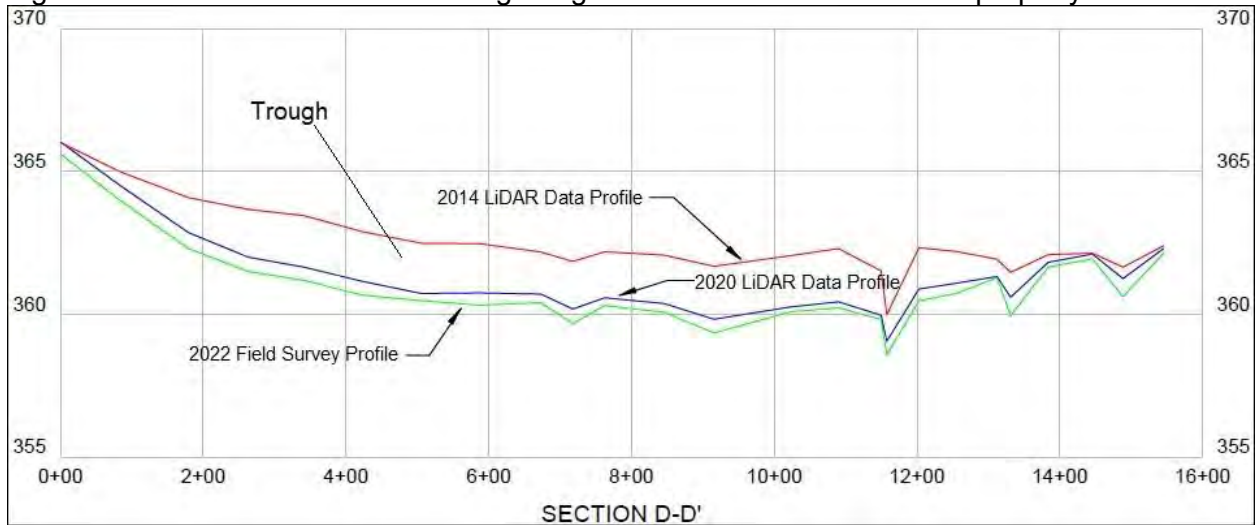
Figure 17. Cross Section D-D' showing trough subsidence on the Williams property.

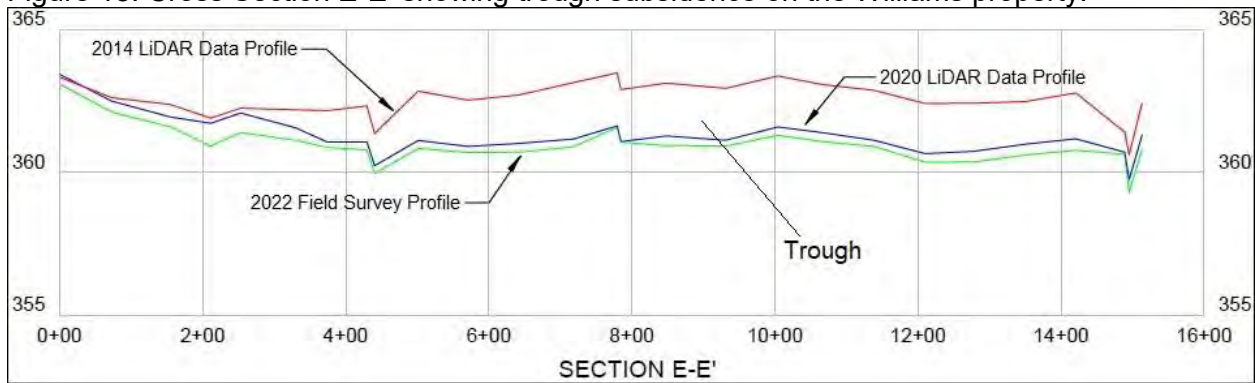
Figure 18. Cross Section E-E' showing trough subsidence on the Williams property.

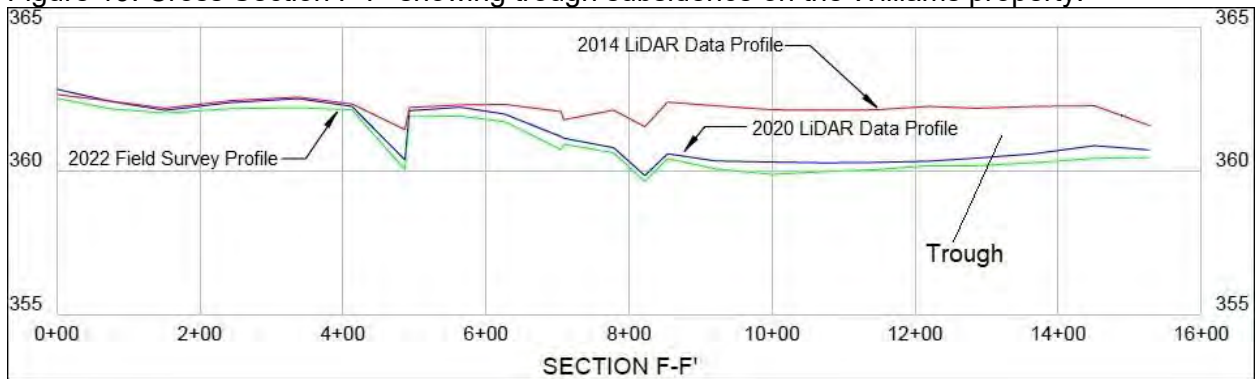
Figure 19. Cross Section F-F' showing trough subsidence on the Williams property.
