| EASTERN KENTUCKY POWER COOPERATIVE (EKPC) |
| J.S. COOPER GENERATING STATION |
| JOB NO. 43-24-0331a |

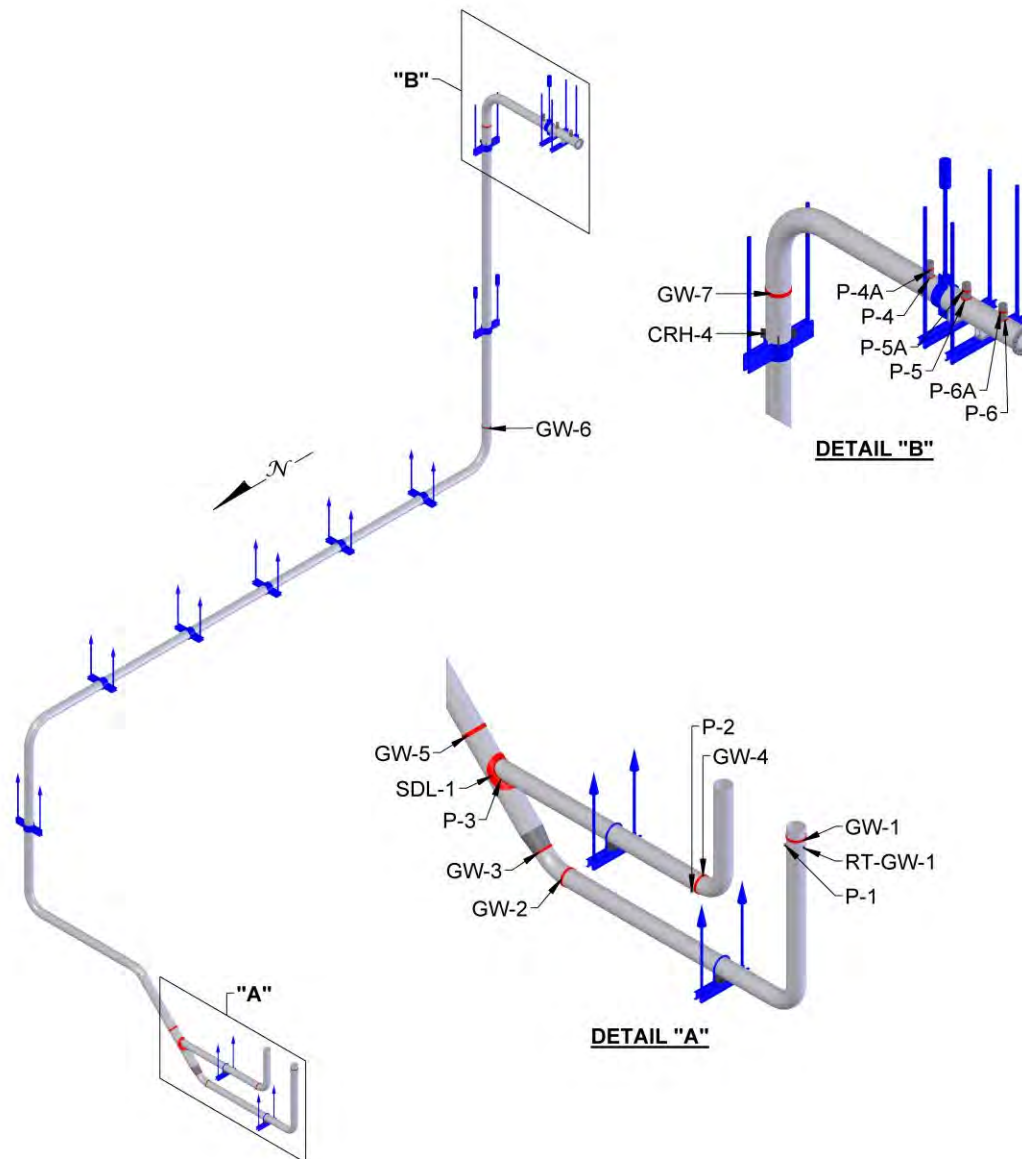
Fig. 30. Sketch of the inspection locations on the Cold Reheat piping system.

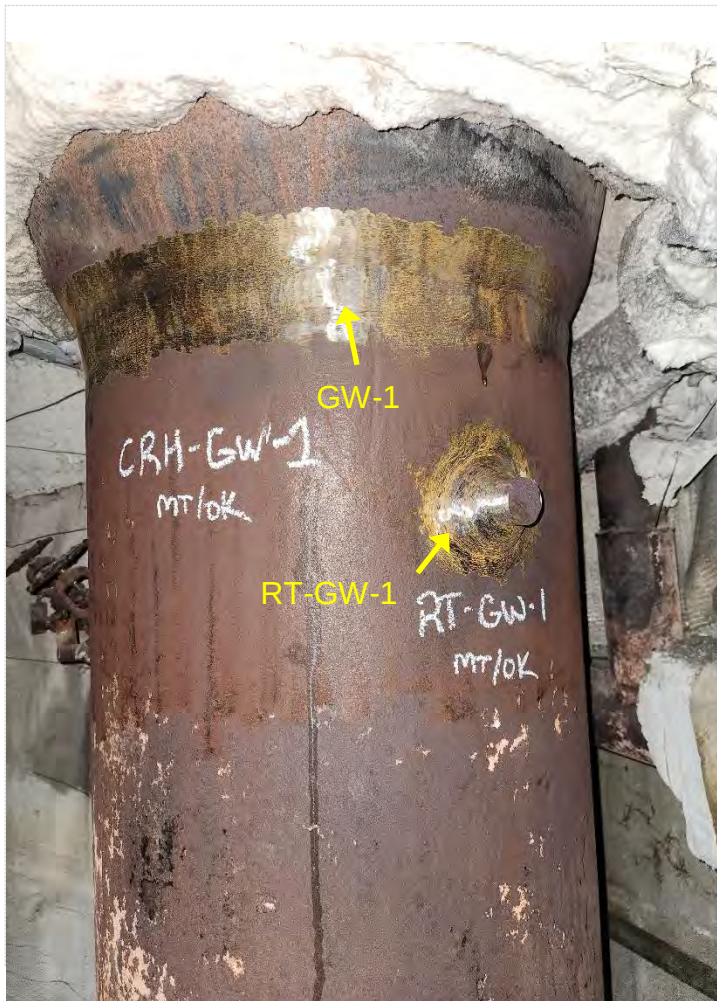
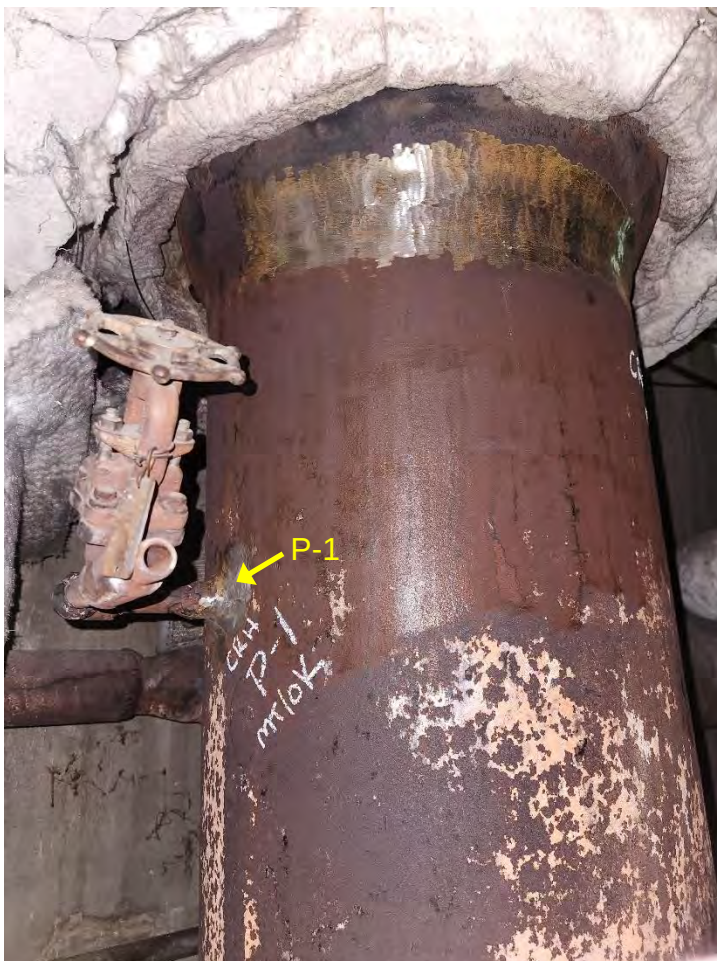
Fig. 31.

Photographs of the inspection locations on the Cold Reheat piping system.

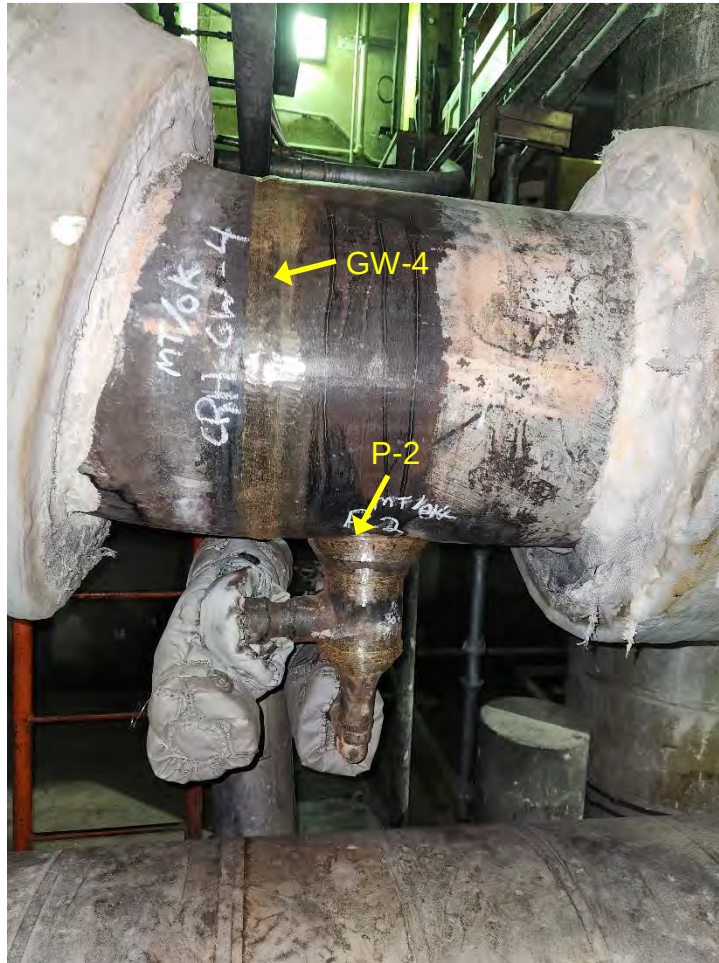
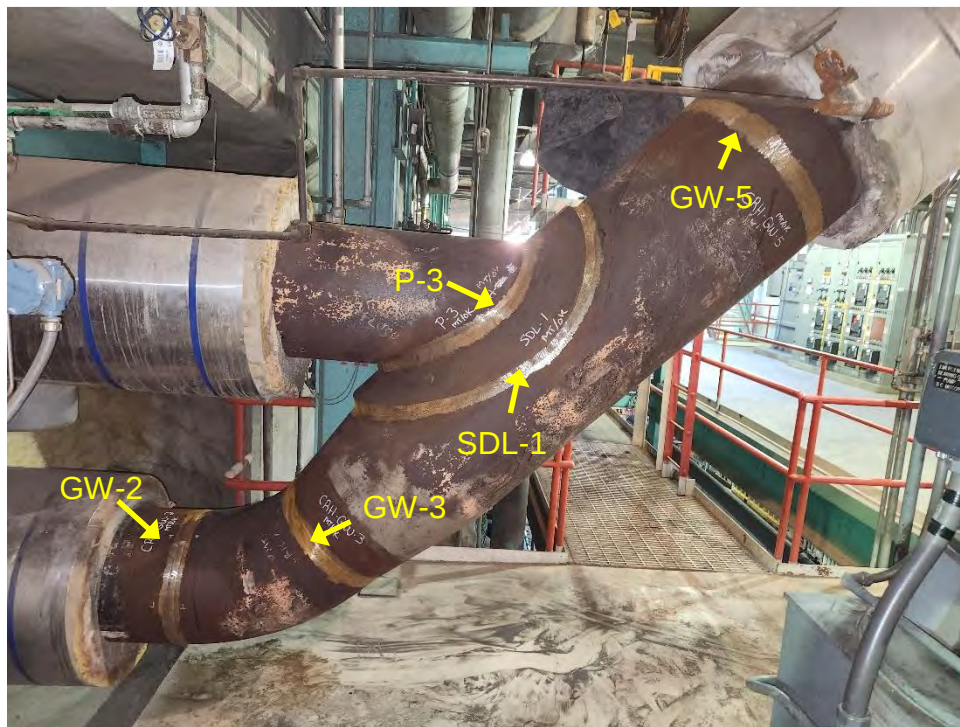
Fig. 32. Photographs of the inspection locations on the Cold Reheat piping system.

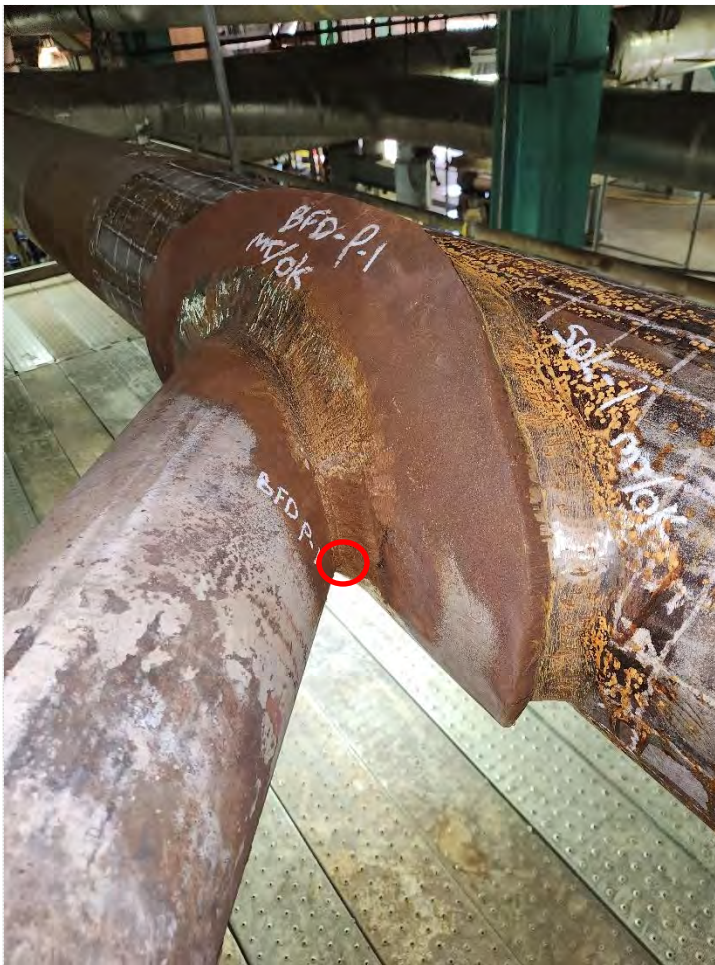
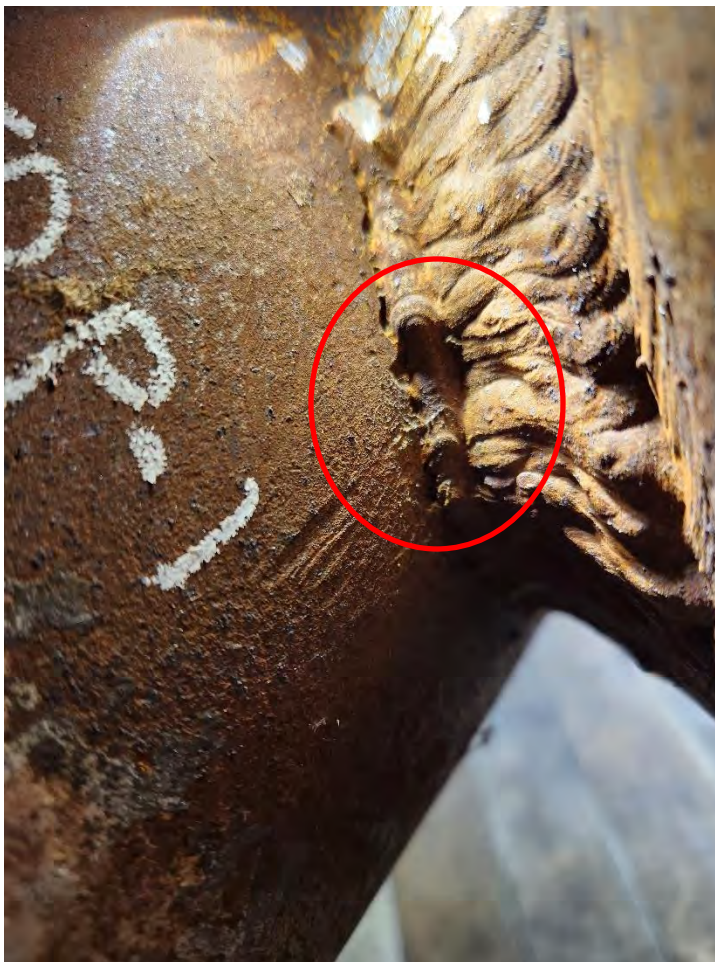
Fig. 38.

Photographs of the undercut location on the Boiler Feedwater Discharge piping system.

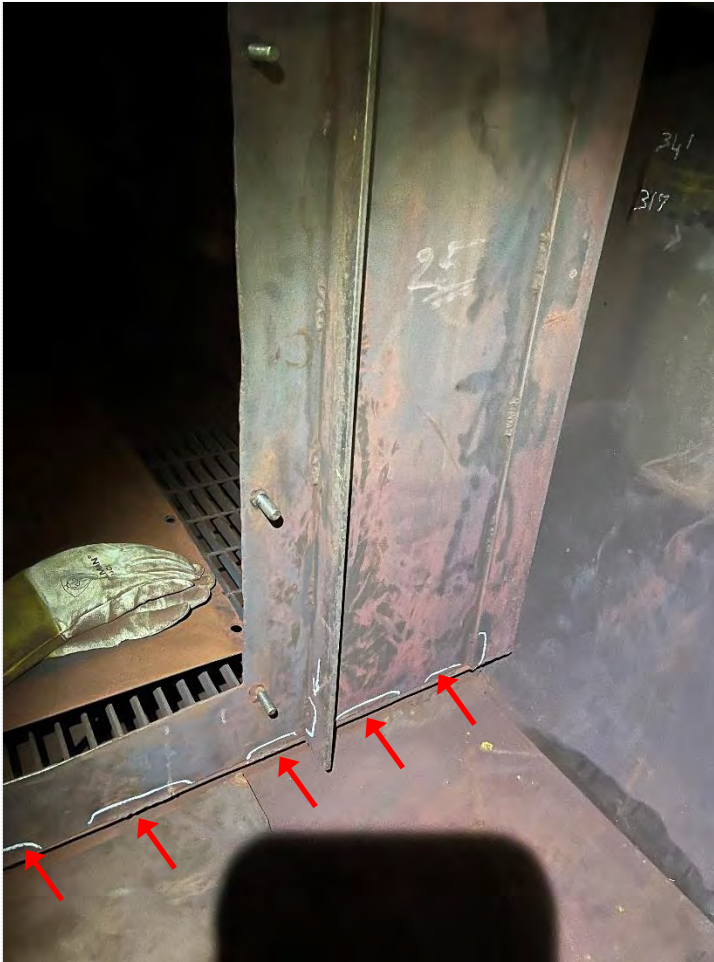
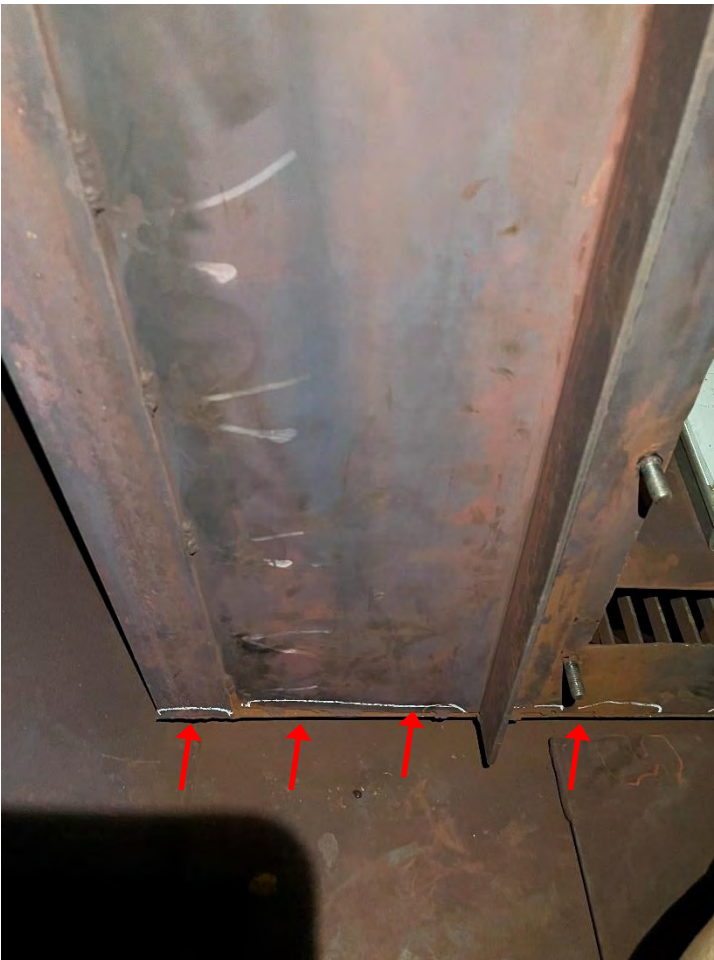
Fig. 45.

Photographs of the broken welds on the deaerator heater.

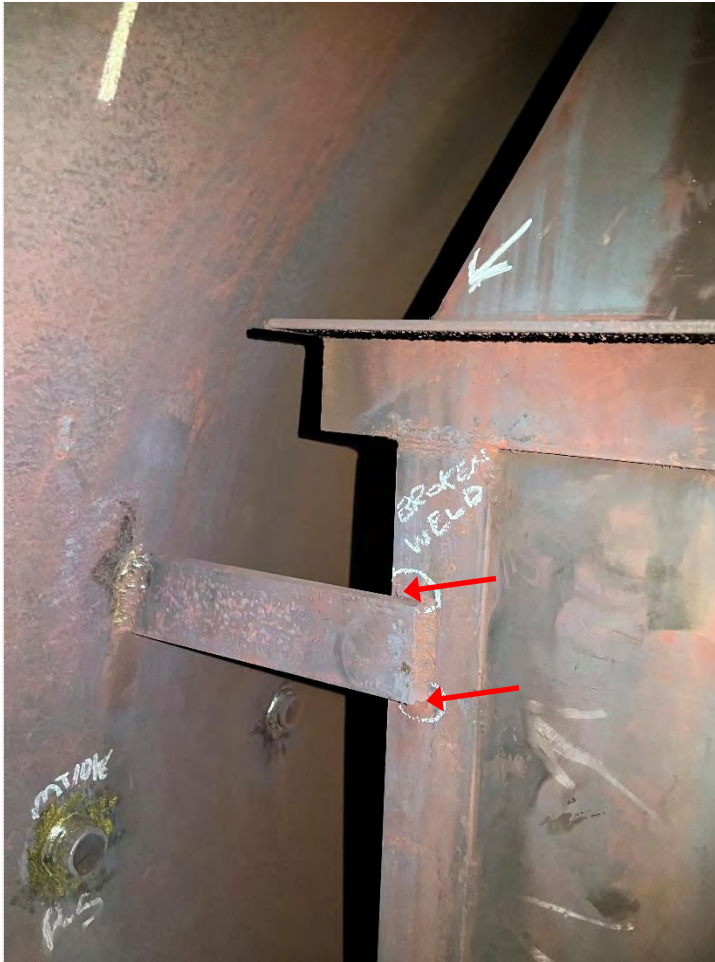
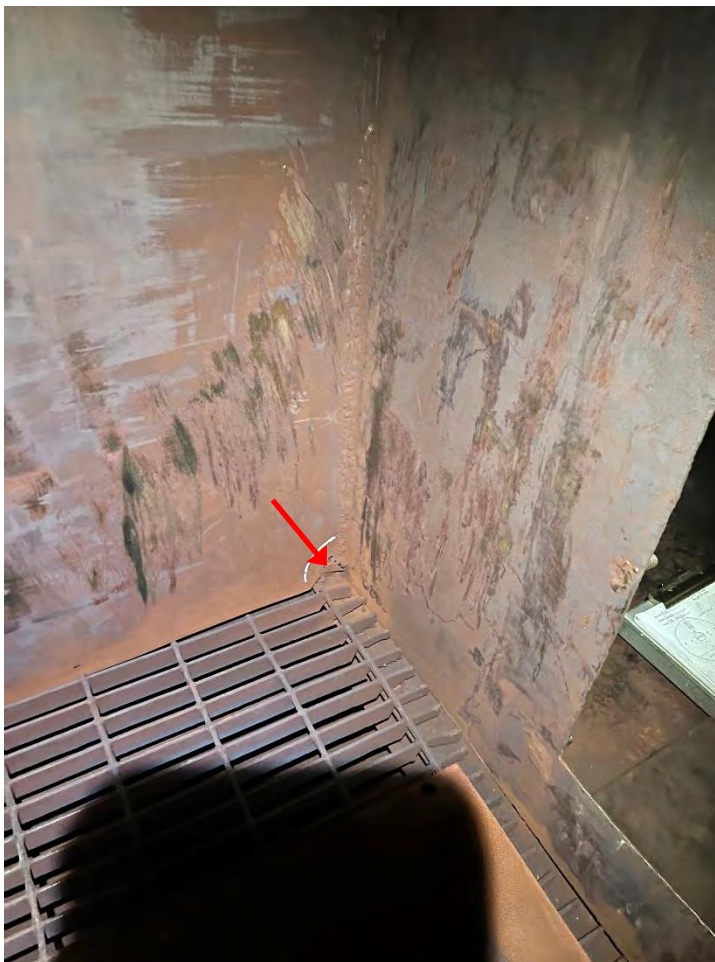
Fig. 46.

Photographs of the broken welds on the deaerator heater.

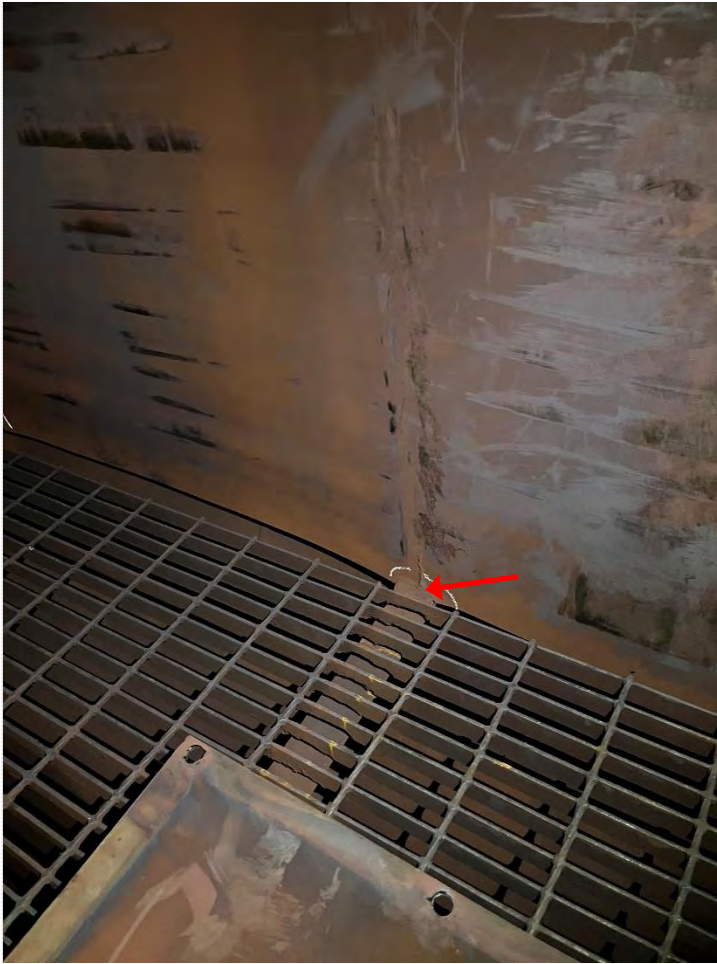
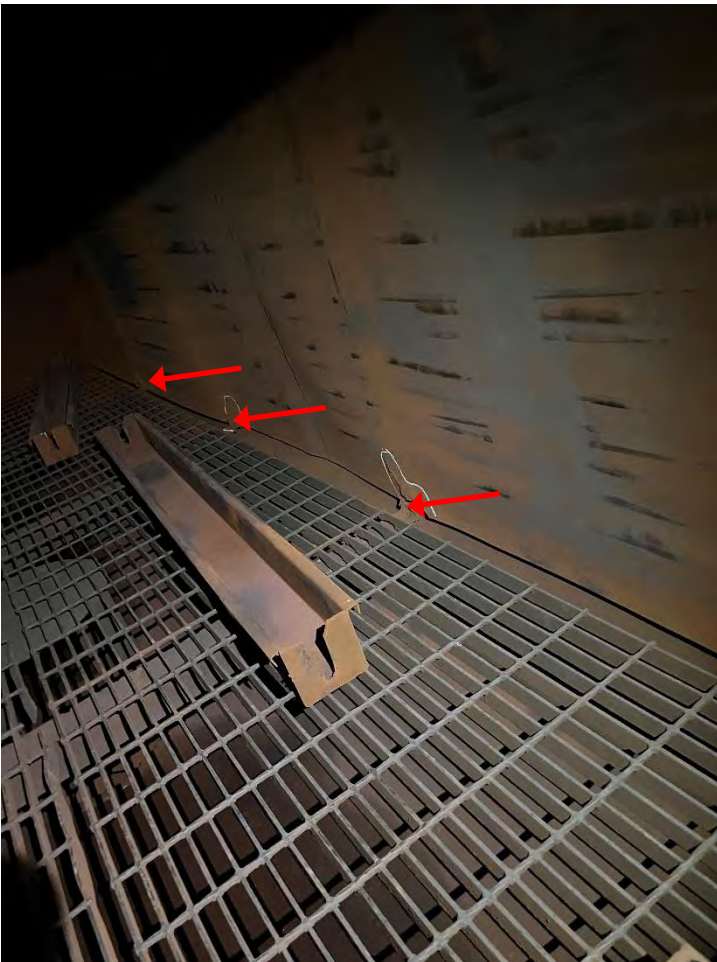
Fig. 47.

Photographs of the broken welds on the deaerator heater.

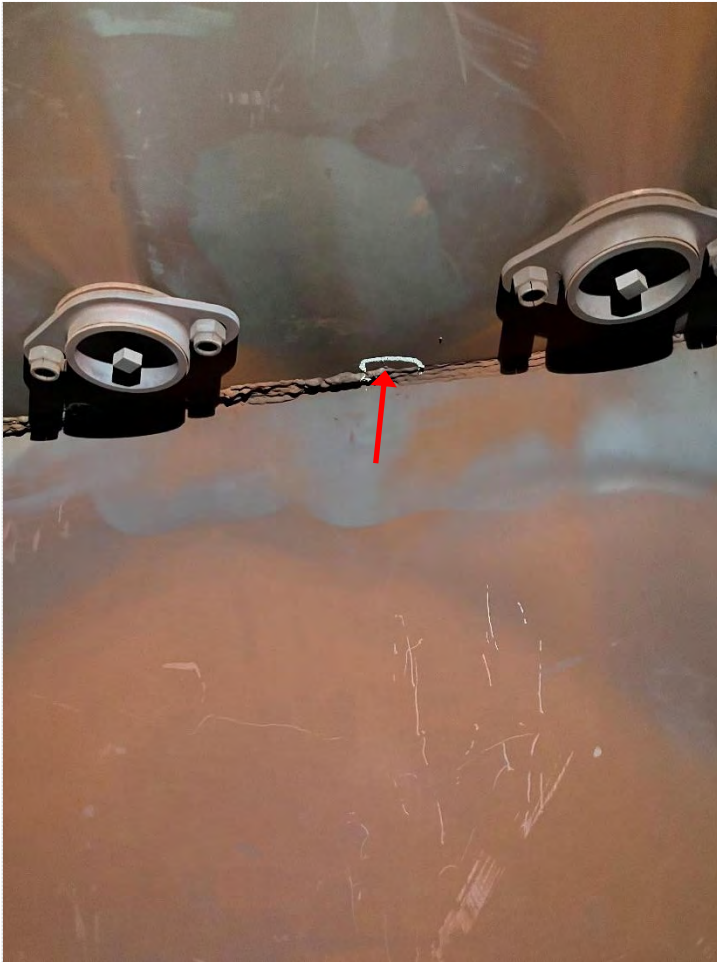
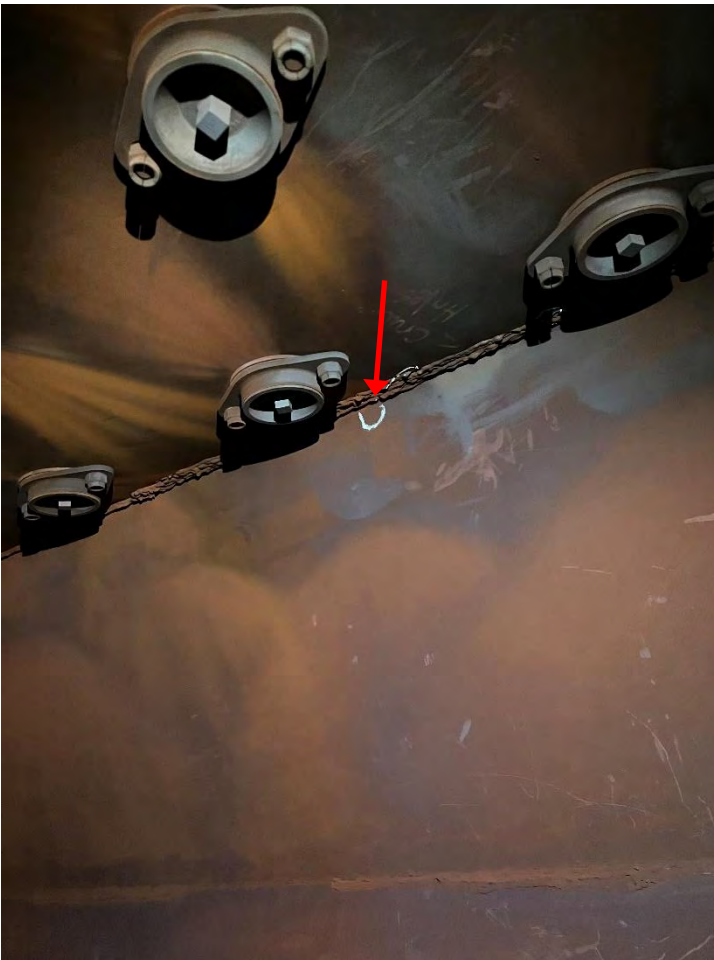
Fig. 48.

Photographs of the broken welds on the deaerator heater.

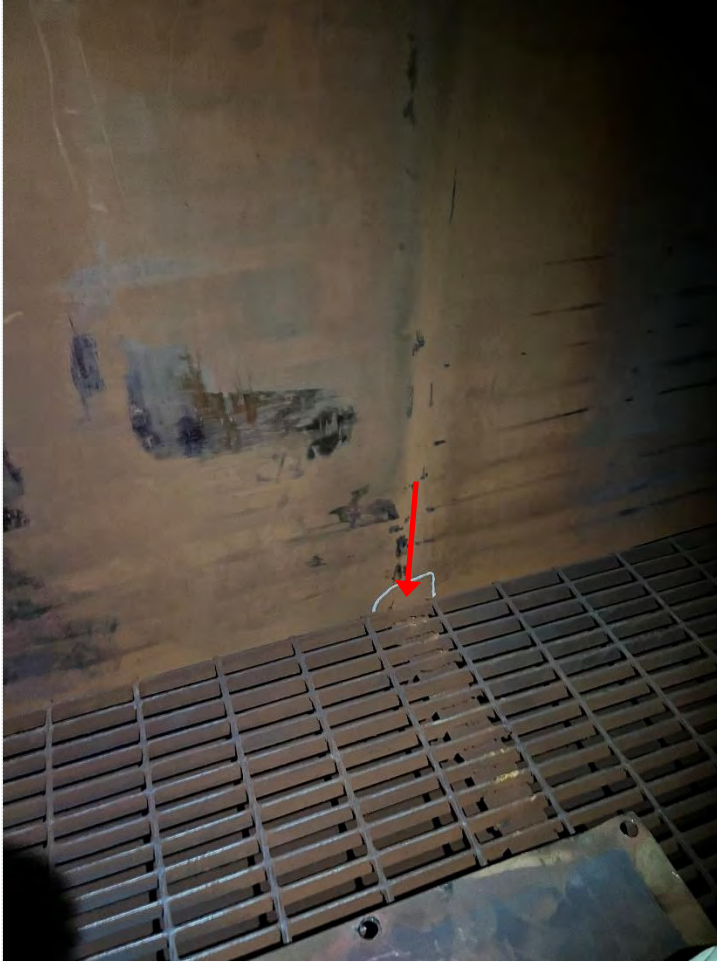
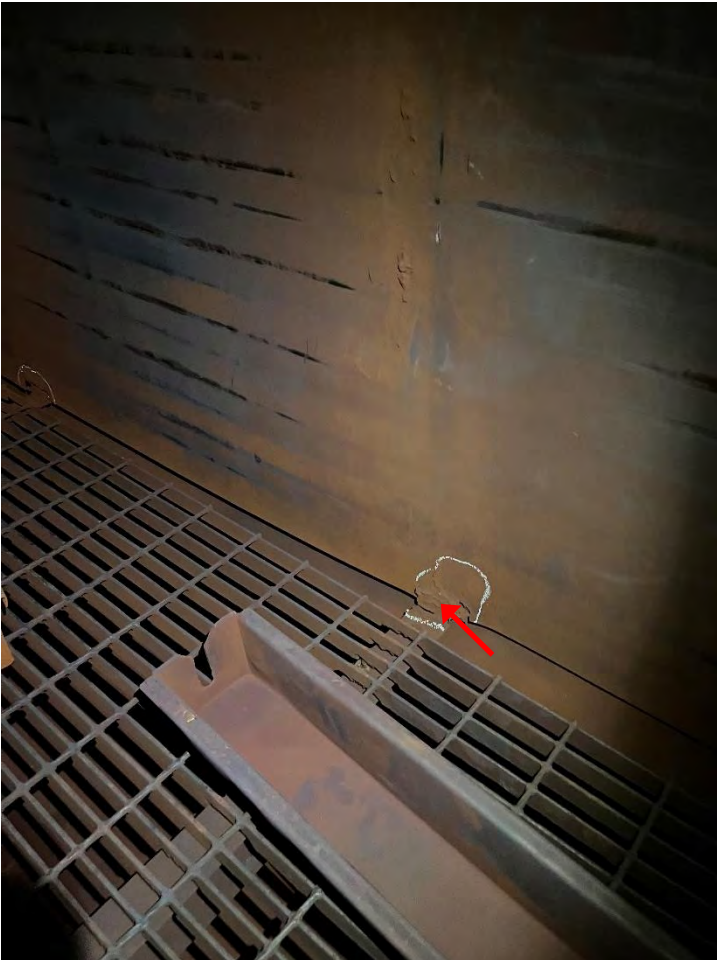
Fig. 49.

Photographs of the broken welds on the deaerator heater.

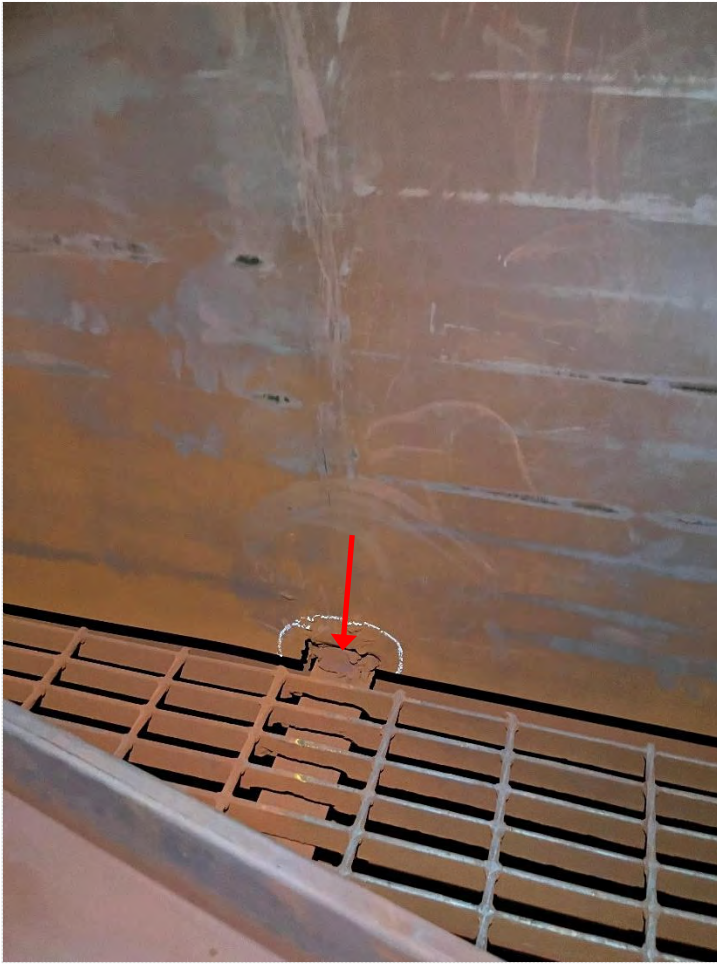
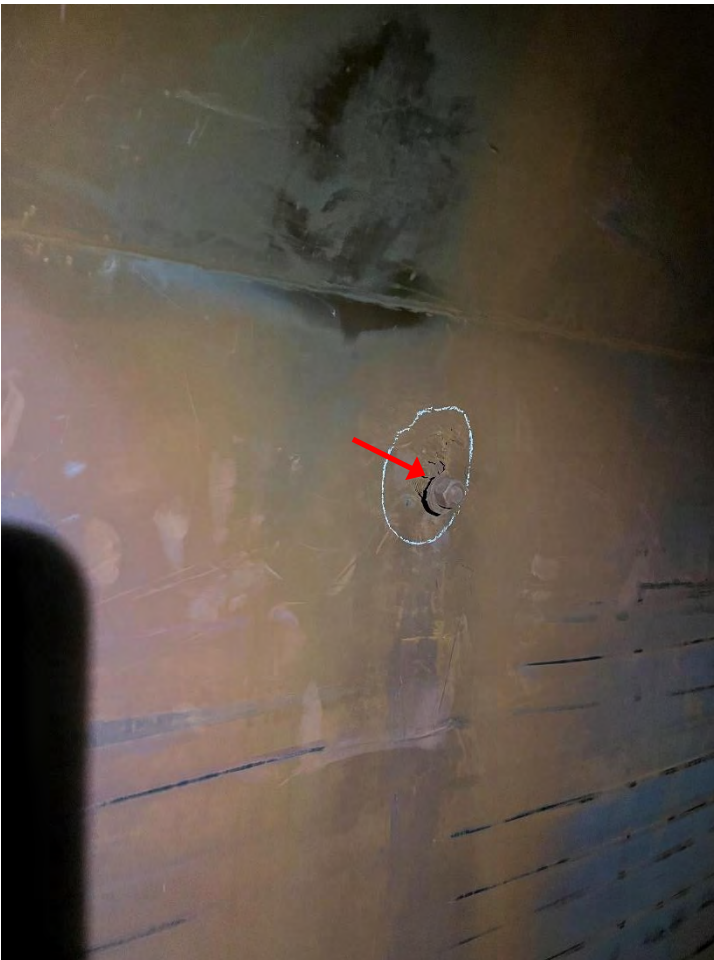
Fig. 50.

Photographs of the broken welds on the deaerator heater.

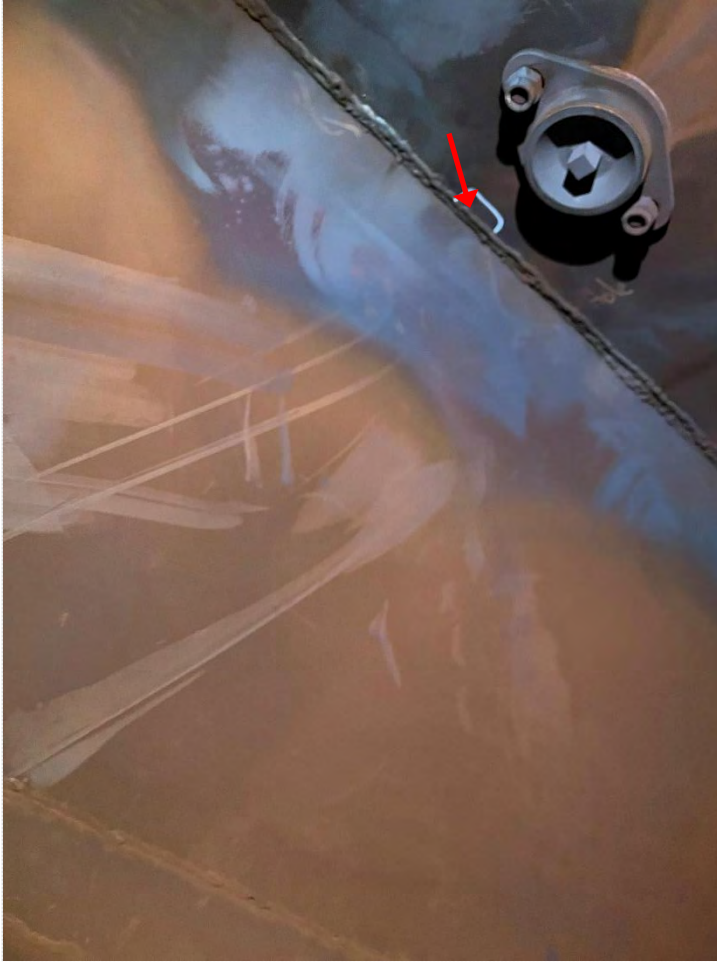
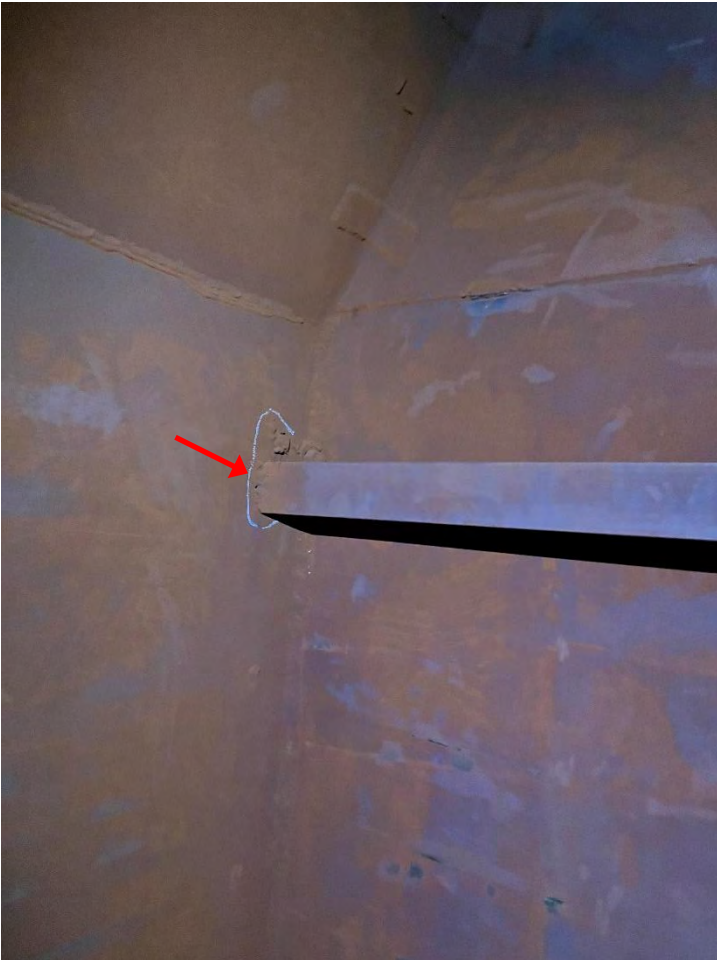
Fig. 51.

Photographs of the broken welds on the deaerator heater.

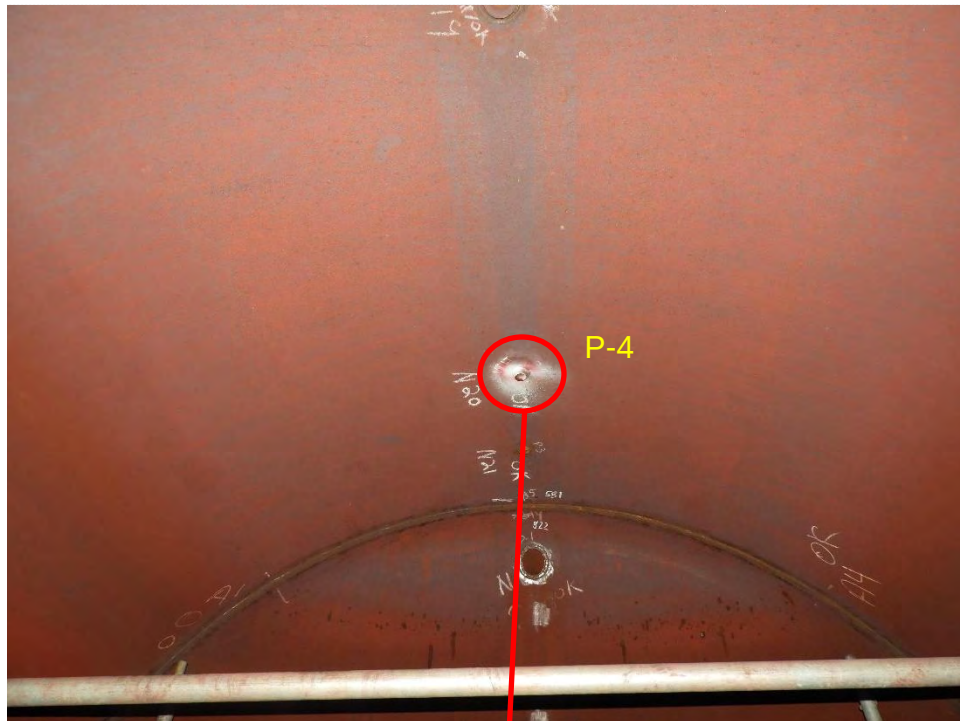
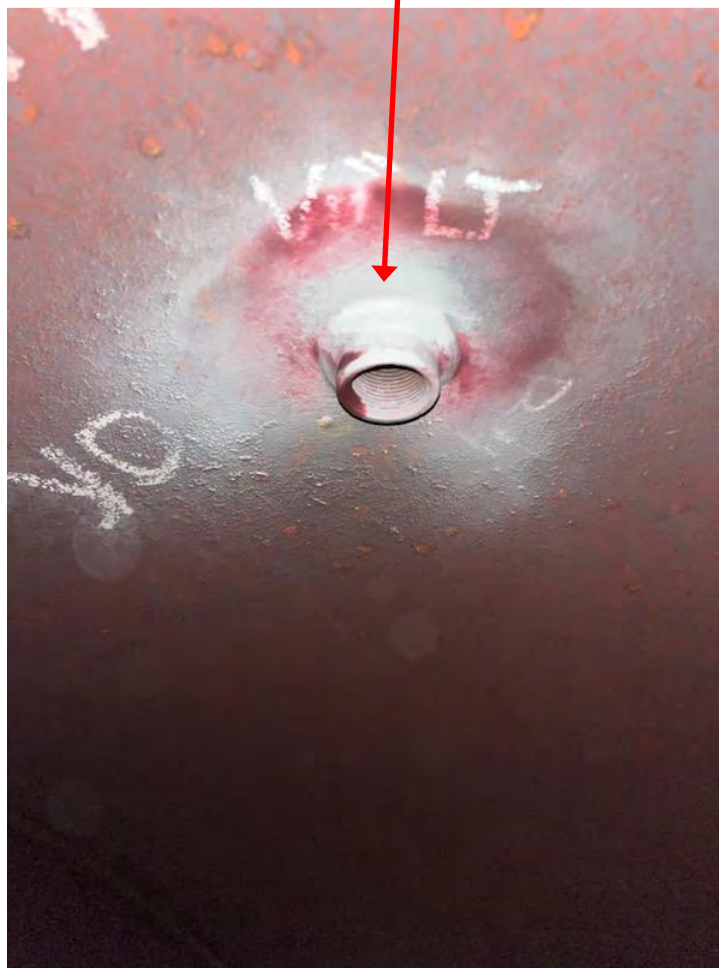
Fig. 61. Photographs of the indication at penetration No. P-4 on the deaerator storage tank.

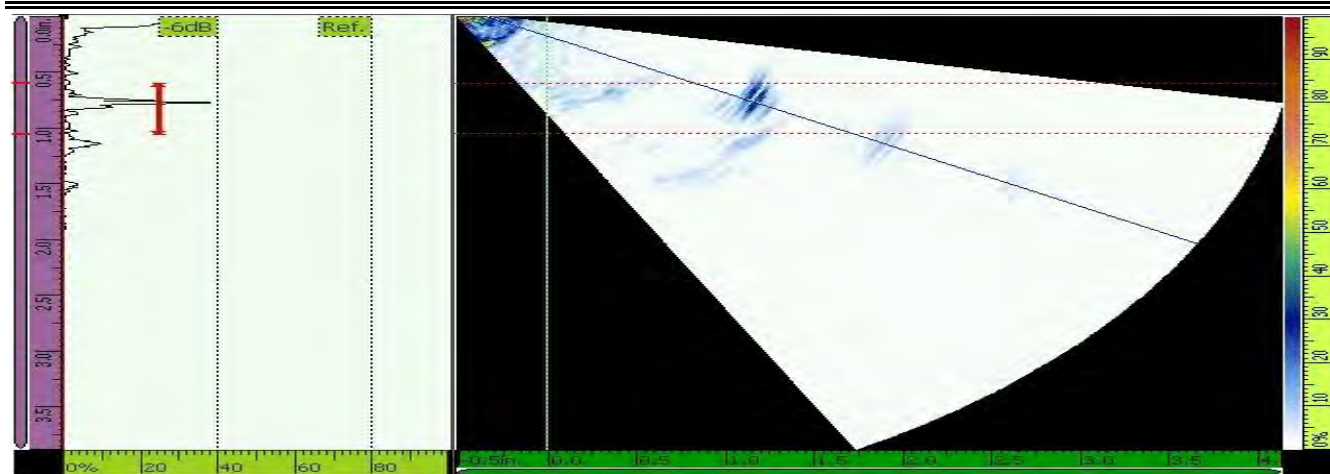
Above LPA image is of typical 360° non-relevant root signal/root geometry.  
No service-related indications detected.  
Only one side was scannable due to asbestos insulation on downstream side of weld.

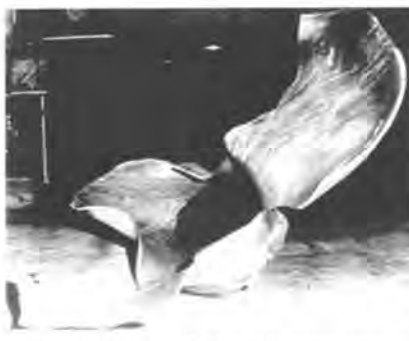
1. Failure of this 12-in. OD hot reheat pipe was attributed to microstructural transformation, which occurred during welding

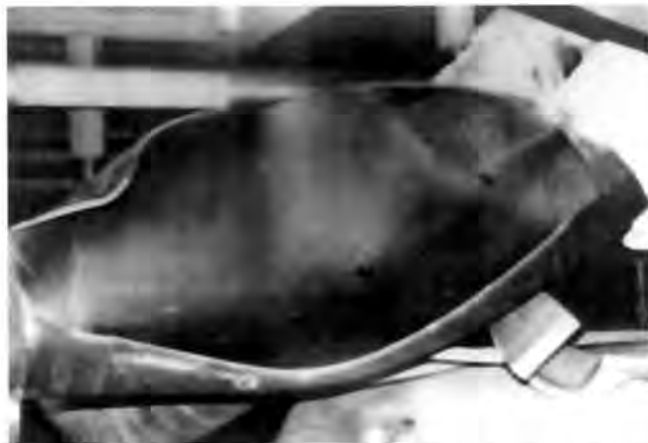
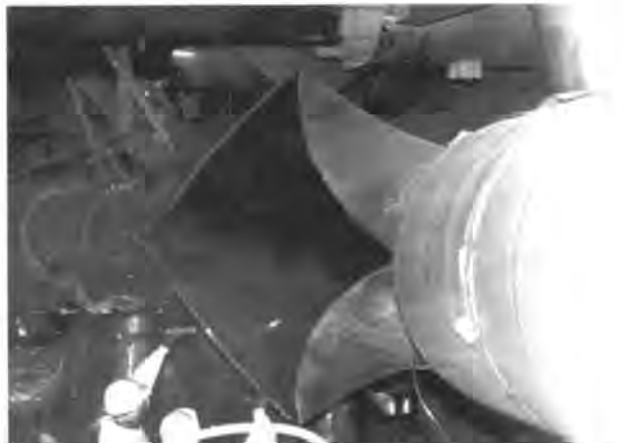
2, 3. Catastrophic failures—such as these ruptures in large-diameter, seam-welded pipe—were initiated at the cusp of the seam weld. Cracks occurred at both sides of the seam welds

other cases, failures at plants in Texas and California were initiated at the cusp of the seam weld (Figs 2, 3). Other sections were unaffected by the failures.

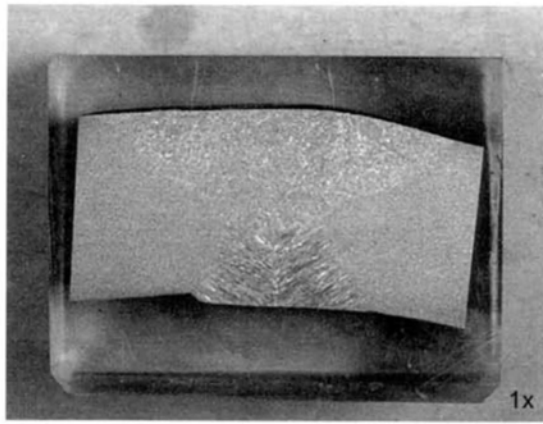
4. Defects introduced during the pipe manufacturing process are not always apparent at magnifications of 1x or even 10x

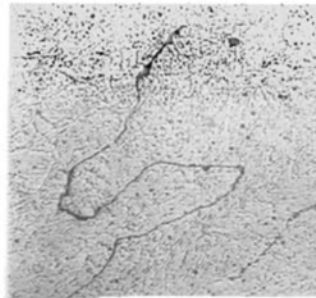
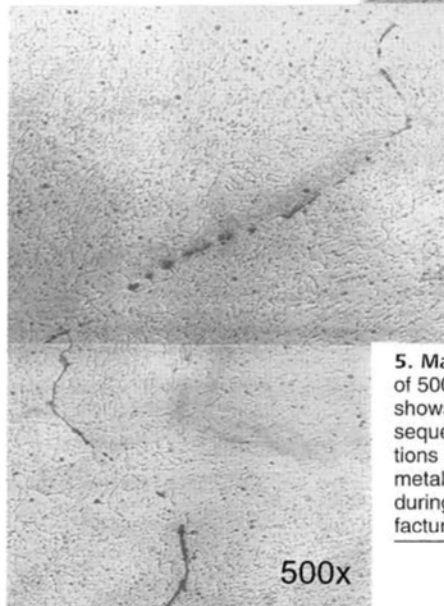
5. Magnification of 500x clearly shows inconsequential indications in the base metal introduced during the manufacturing process

defect was hard to see at a magnification of 10 diameters, but was easily viewed by a 500-diameter magnification (Figs 4, 5). This example is typical of the imperfections found in base metals and plates used for seam-welded pipe, and would not result in progressive cracking.

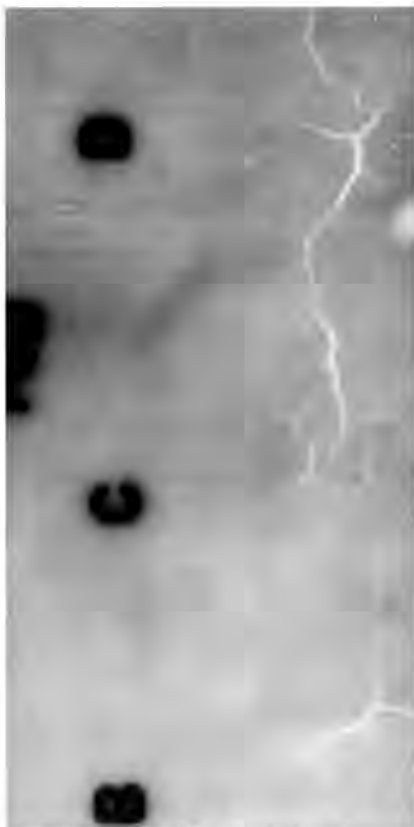
**Fabrication defects.** Spider-web-type fissures in the inner arc of a pipe bend were discovered on seam-welded low-alloy steel piping in a hot reheat system during the final stages of erection decades ago. Weld probe samples revealed fissuring that extended about 80% into the pipe wall. Fissures were also apparent on radiographic films (Fig 6).

A metallurgical evaluation established that the fissures occurred when the fabricator removed buckles that had developed on the inside arc of a pipe bend during the bending operation. Apparently this was accomplished by heating the local buckled pipe surface areas with rosebuds, a type of

6. Radiographic films illustrate surface fissuring on the inside arc of a pipe bend

Plant personnel removed the fissures by grinding and followed with repair welding in accordance with American Society of Mechanical Engineers B31.1 code on pressure piping covering powerplants. Re-inspections performed in 1985 and 1998 confirmed that the repairs were sound.
