East Kentucky Power Co-Op - John Sherman Cooper
Unit 2 Boiler

Boiler INSPECTION REPORT

November, 1, 2021

Gecko Job Number: 2021-02275

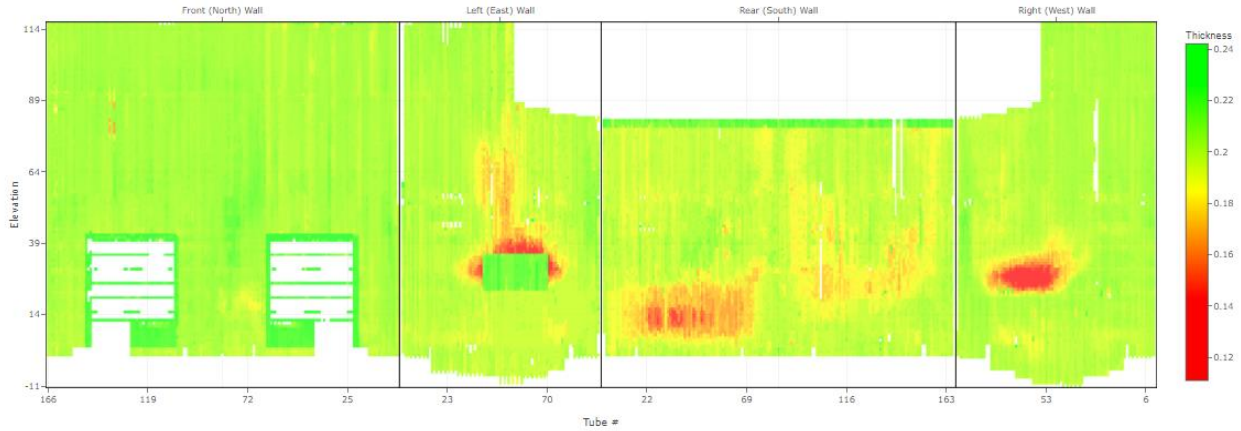
Waterwall:

Thickness	Location
0.111 in	Right (West) Wall, Elevation: 27.0ft - Tube #: 58
0.114 in	Right (West) Wall, Elevation: 28.0ft - Tube #: 63
0.116 in	Left (East) Wall, Elevation: 36.0ft - Tube #: 60

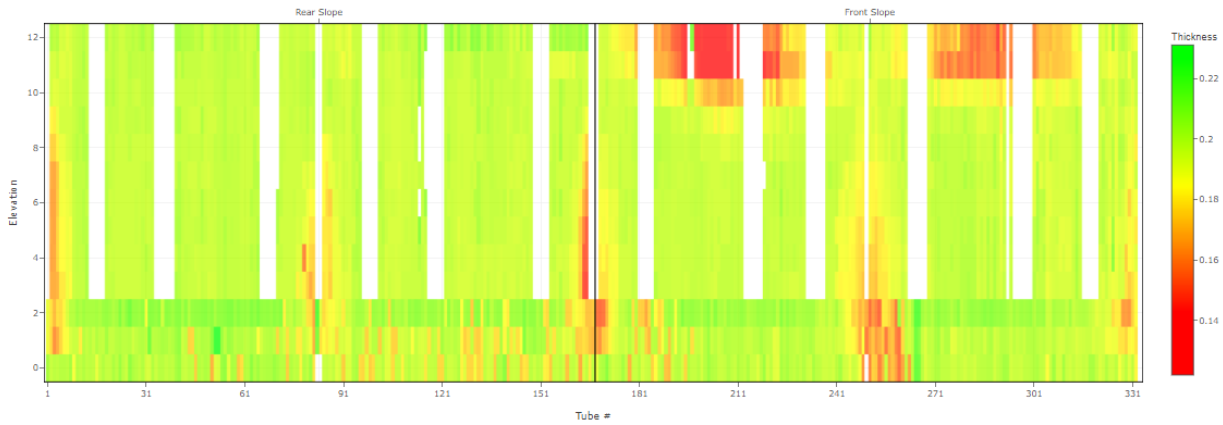
Slopes:

Thickness	Location
0.122 in	Front Slope, Elevation: 11.0ft - Tube #: 204
0.122 in	Front Slope, Elevation: 11.0ft - Tube #: 206
0.125 in	Front Slope, Elevation: 12.0ft - Tube #: 201

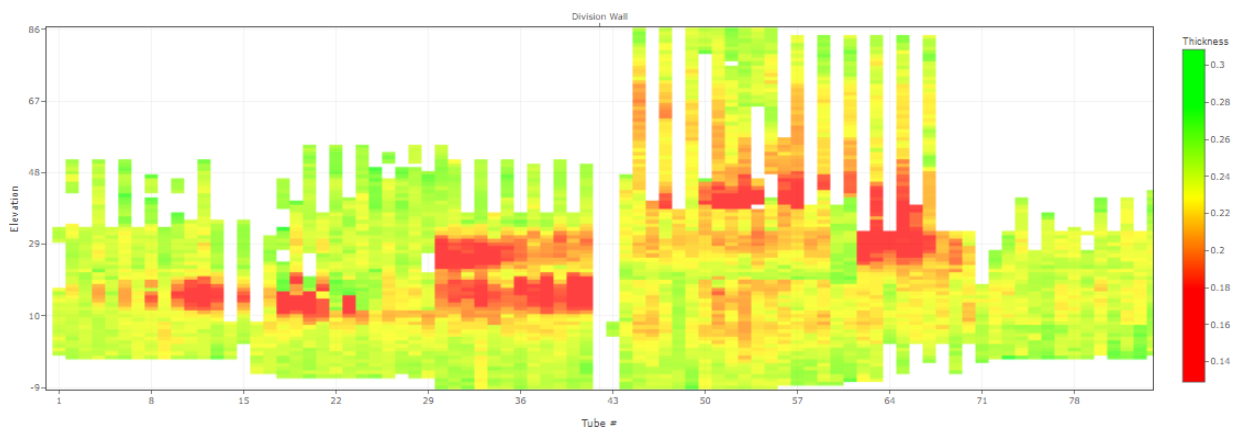
Division wall:

Thickness	Location
0.129 in	Division Wall, Elevation: 14.0ft - Tube #: 20
0.133 in	Division Wall, Elevation: 15.0ft - Tube #: 20
0.136 in	Division Wall, Elevation: 29.0ft - Tube #: 62

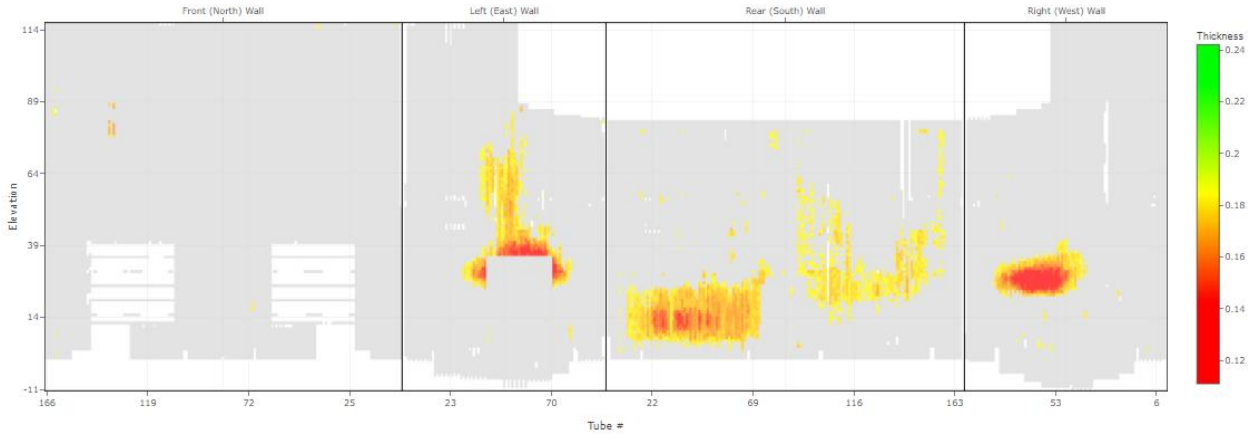
Waterwalls 0.111" - 0.185"

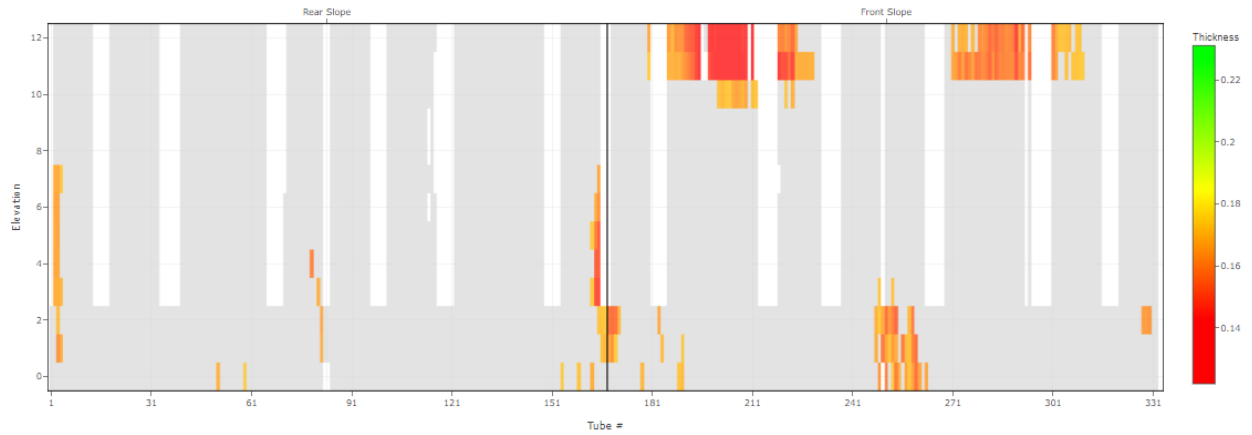
Slopes 0.122" - 0.171"

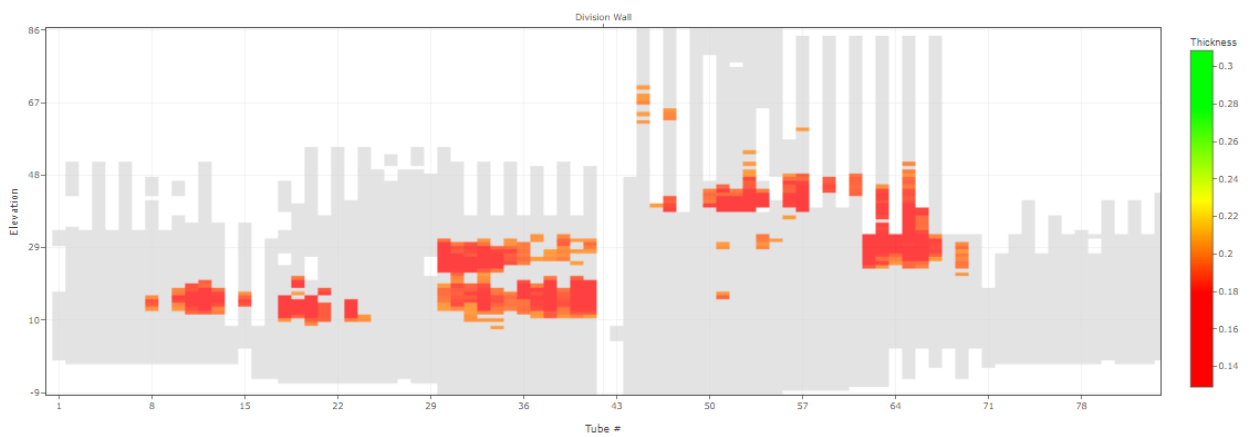
Division wall 0.129" - 0.203"
