INSPECTION REPORT

CUSTOMER : EKPC - Cooper
REPORT NO. : 55294-IR1

REPORT DATE : 04/20/16
PAGE : 2 of 4

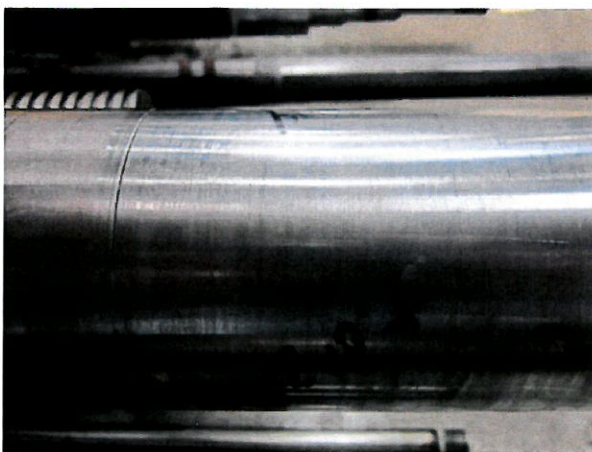
Photo 1: Typical Bearing Journal Wear

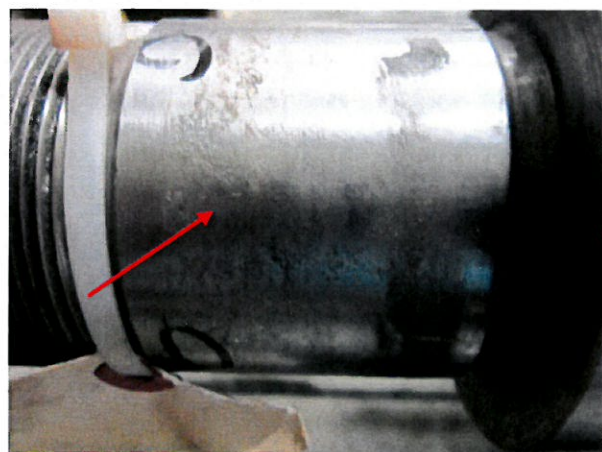
Photo 2: Shaft Fretting On Thrust Collar Fit

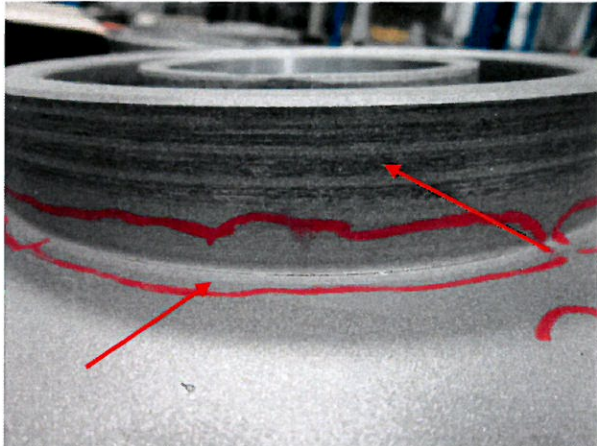
Photo 3: Typical Impeller Wear And Indications

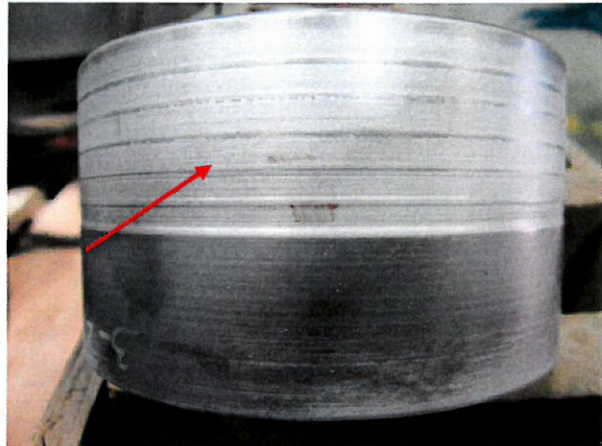
Photo 4: Typical Wear On Spacer Sleeves

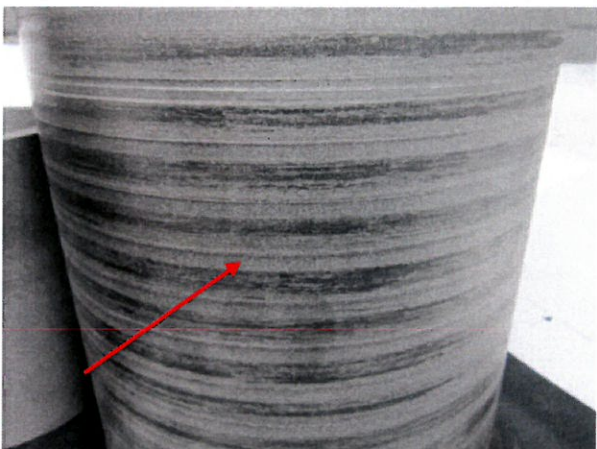
- 3) Pressure Reducing Sleeve
 - a) There is moderate circumferential wear and grooving on the sealing turn resulting in excessive running clearance to the pressure reducing bushing.
 - b) The sleeve fit bore measures close to the expected design diameter, but is lightly fretted and worked out of round.
- 4) Spacer Sleeves
 - a) All of the spacer sleeves have moderate contact grooving on the wear turns. .
 - b) The fit bores and axial lengths all measure to the appropriate design dimensions.
- 5) Impeller Lock Nut and Pressure Reducing Sleeve Lock Nut
 - a) Both shaft nuts have pulled spanner holes and light mechanical damage from disassembly.
 - b) Both shaft nuts have light to moderate wear on the outer turn from contact with the stuffing box bushing.

Photo 5: Wear On Pressure Reducing Sleeve

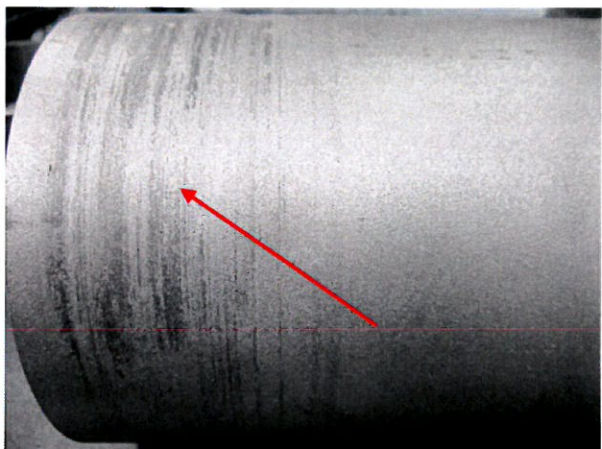
Photo 6: Typical Wear On Shaft Nuts

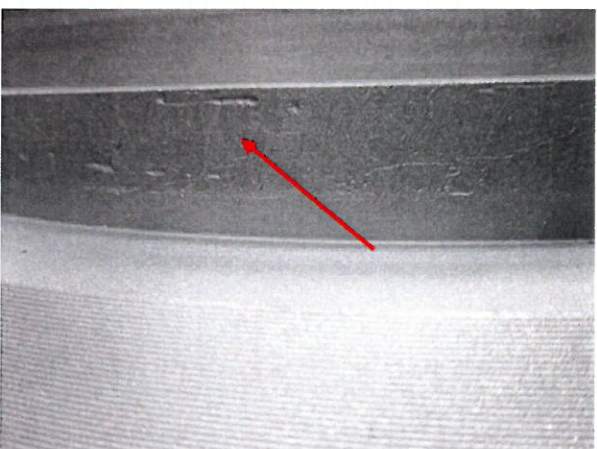
- a) Both gasket faces have some very light water erosion or pitted areas; for the internal gaskets, it looks like there are wash or drag marks on the fit turn to the discharge diffuser.
- b) Similar to the discharge diffuser, there is light working damage from the gasket spacer.
- c) There is a very small area of overlay weld at the flange to fit turn interface. It can only be assumed that this was an attempt to get a metal to metal seal on the inside of the flange face. The weld has started to corrode.

Photo 7: Light Wash Or Drag Marks On End Head

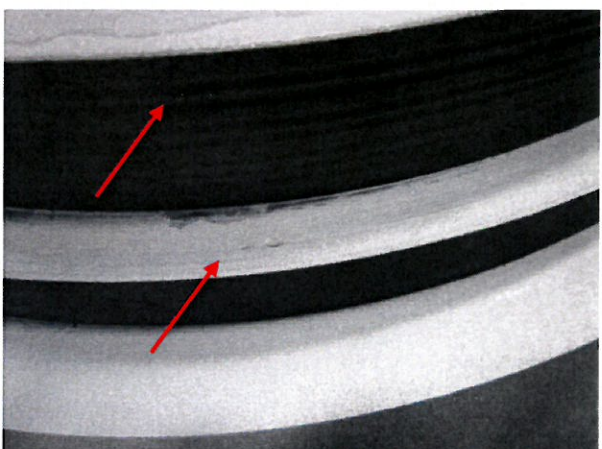
Photo 8: Gasket Face Damage On End Head

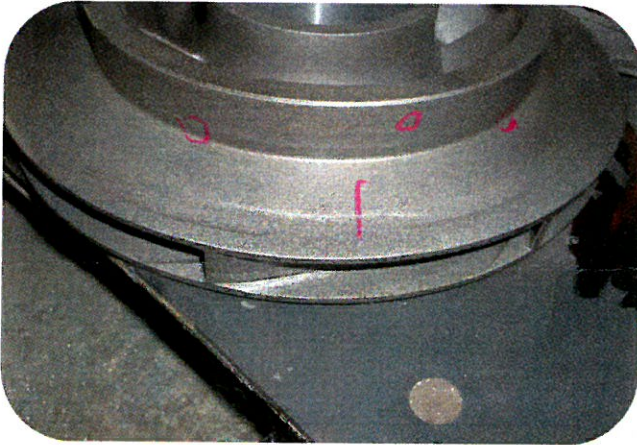
Linear indications found on hub turn from 1/16" – 3/16".

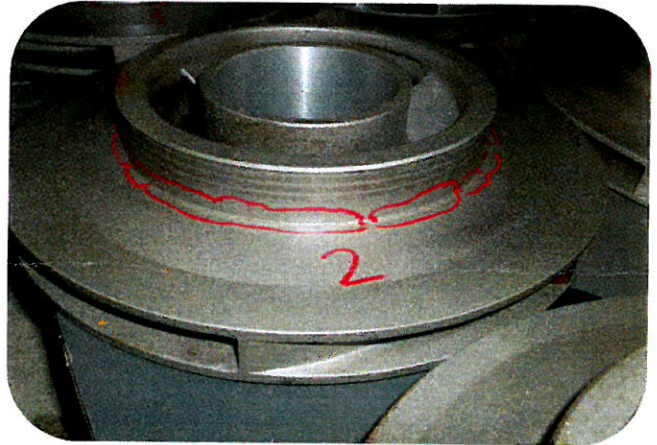
Linear indications found on hub turn and vane outlet from 1/16" – 4".

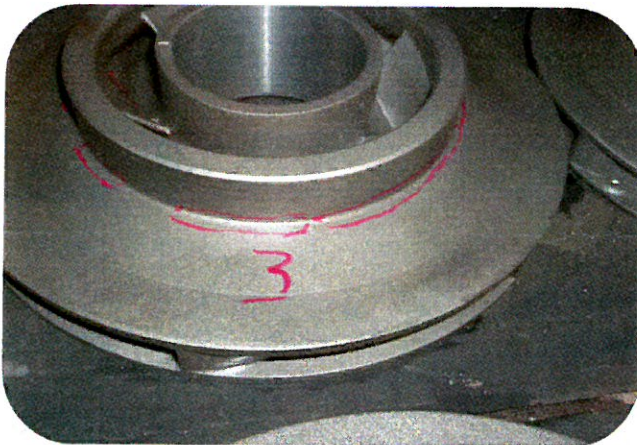
Linear indications found on hub turn from 1/16" – 4".

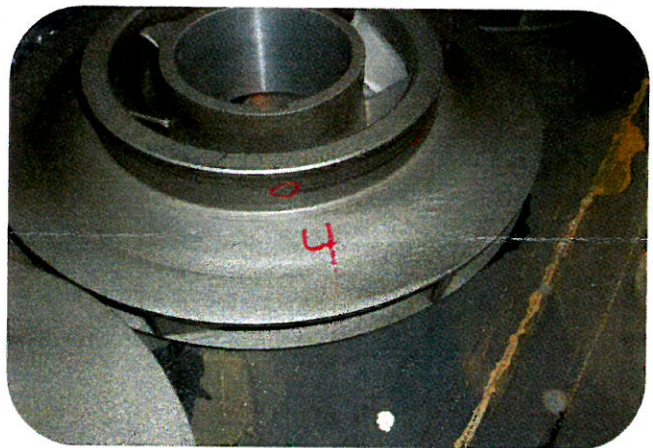
Linear indications found on hub turn from 1/16" – 3/16".

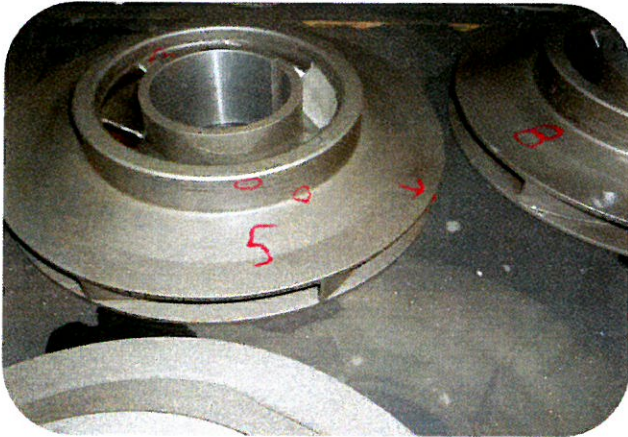
Linear indications found on hub turn and vane outlets from 1/16" - 1/4".

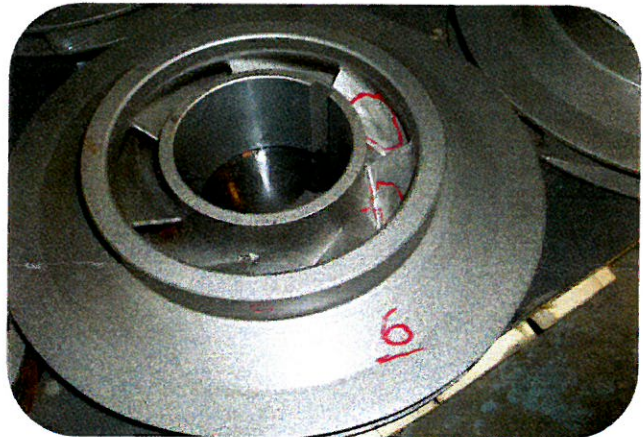
Linear indications found on hub turn and vane inlets from 1/16" - 1/2".

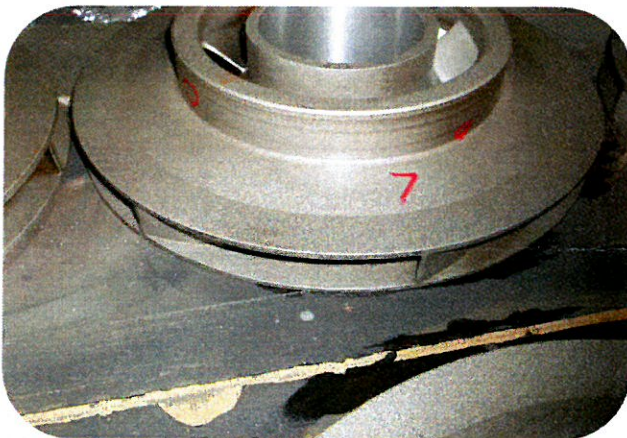
Linear indications found on hub turn from 1/16" - 1/8".

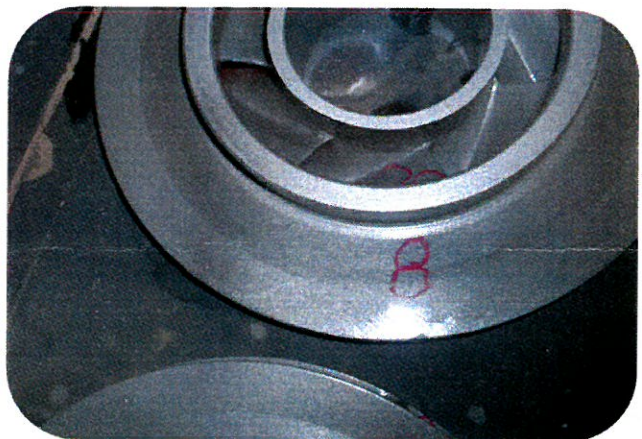
Linear indications found on hub turn and vane inlet from 1/16" - 1/4".

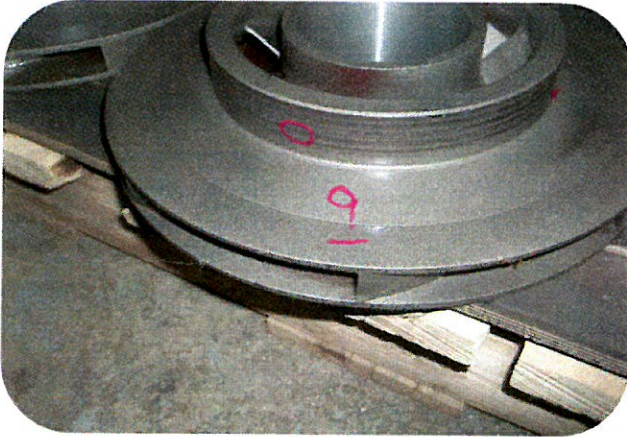
Linear indications found on hub turn from 1/16" – 1/8".

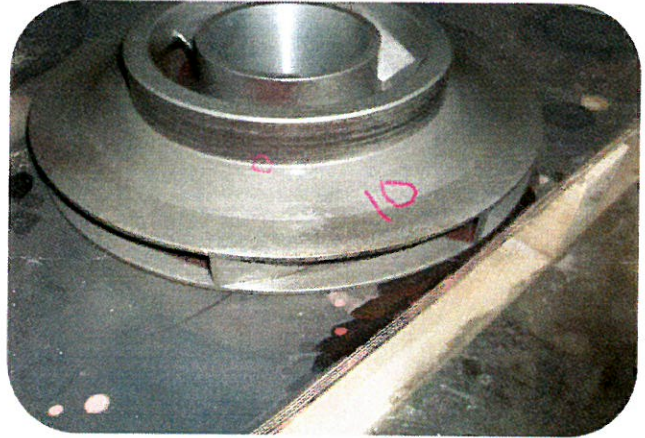
Linear indications found on hub turn at 1/4".

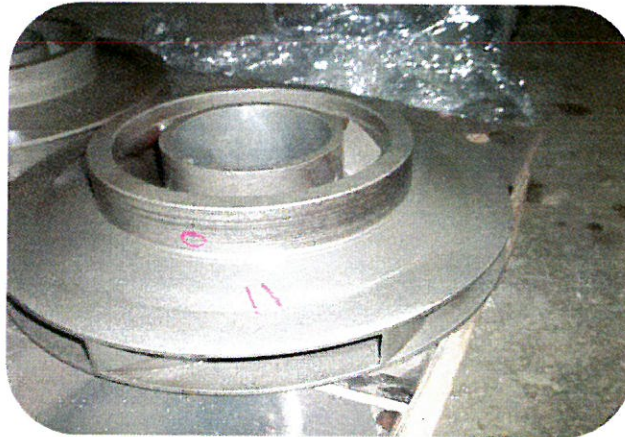
Linear indications found on hub turn from 1/16" – 3/16".
