MARCH 2024
INSPECTION OF
HIGH-ENERGY PIPING SYSTEMS AND PRESSURE VESSELS
UNIT NO. 2
J.S. COOPER GENERATING STATION
EASTERN KENTUCKY POWER COOPERATIVE
SOMERSET, KENTUCKY

April 12, 2024

Report No. 18577

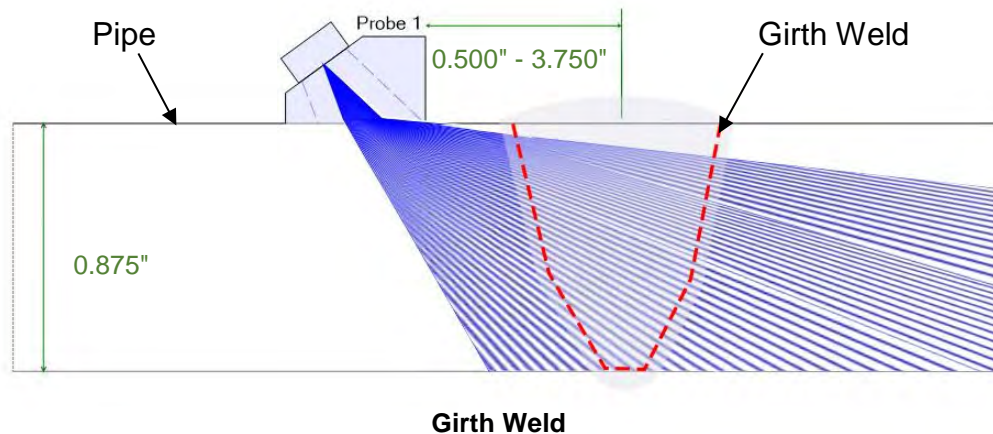
The ultrasonic phased-array examination revealed the following recordable subsurface indications:

- Girth weld No. GW-7 - An inclusion type indication found transverse at the 11:30 position on the downstream side of the weld. Approximately 1.125" at depth with a through wall height of 0.125". Appears to be an original defect from manufacturing; **Acceptable**. This area should be monitored during future inspections.

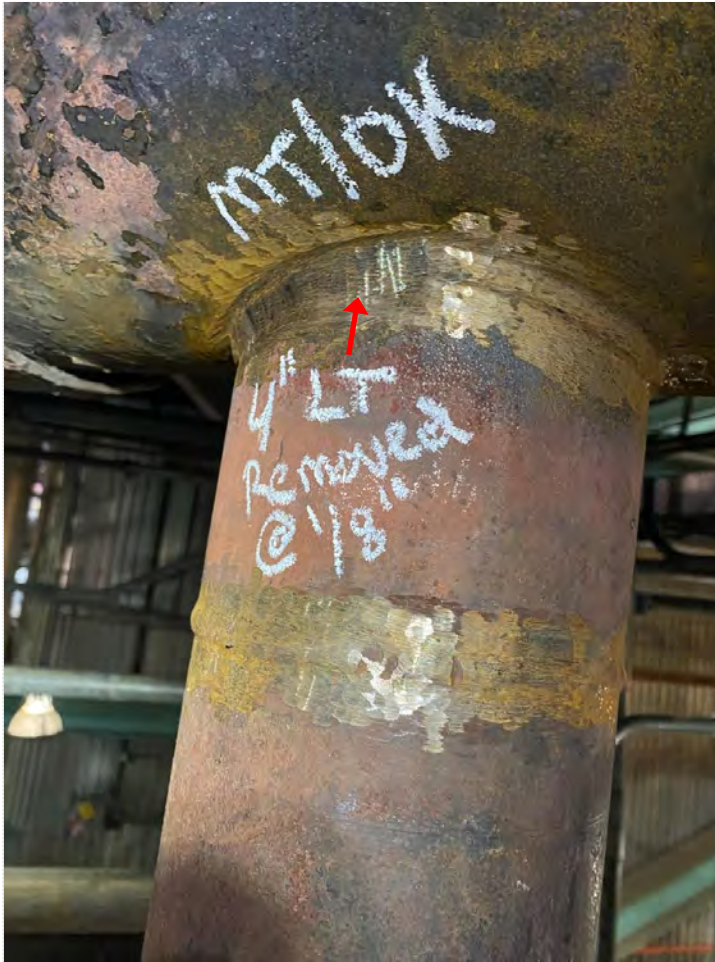
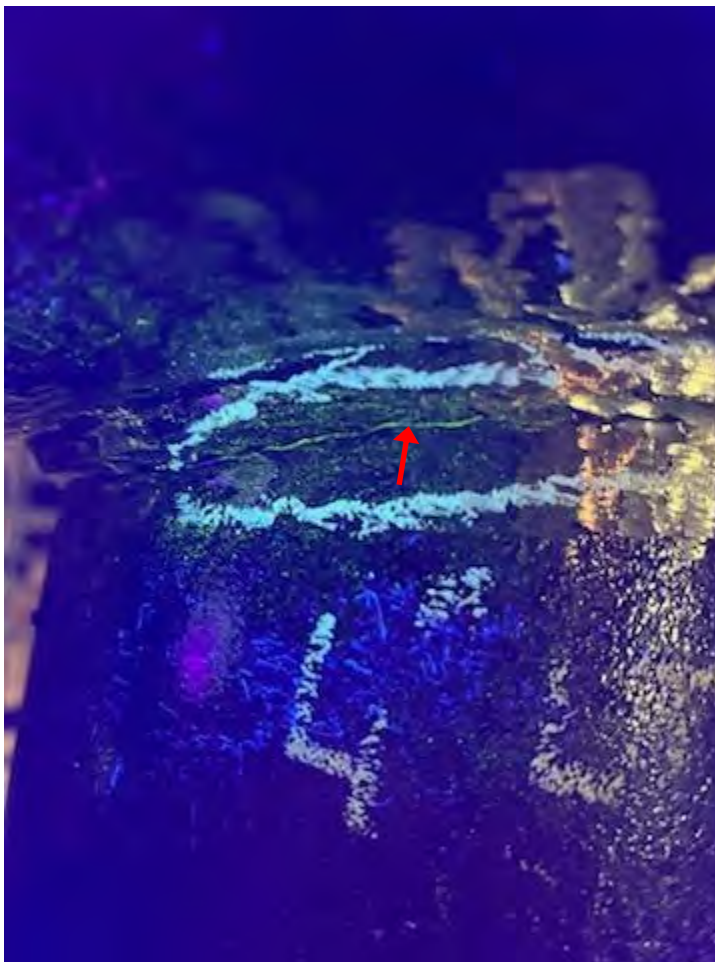
Fig. 7.

Photographs of the indication at hanger attachment No. MSH-5 on the Main Steam piping system.

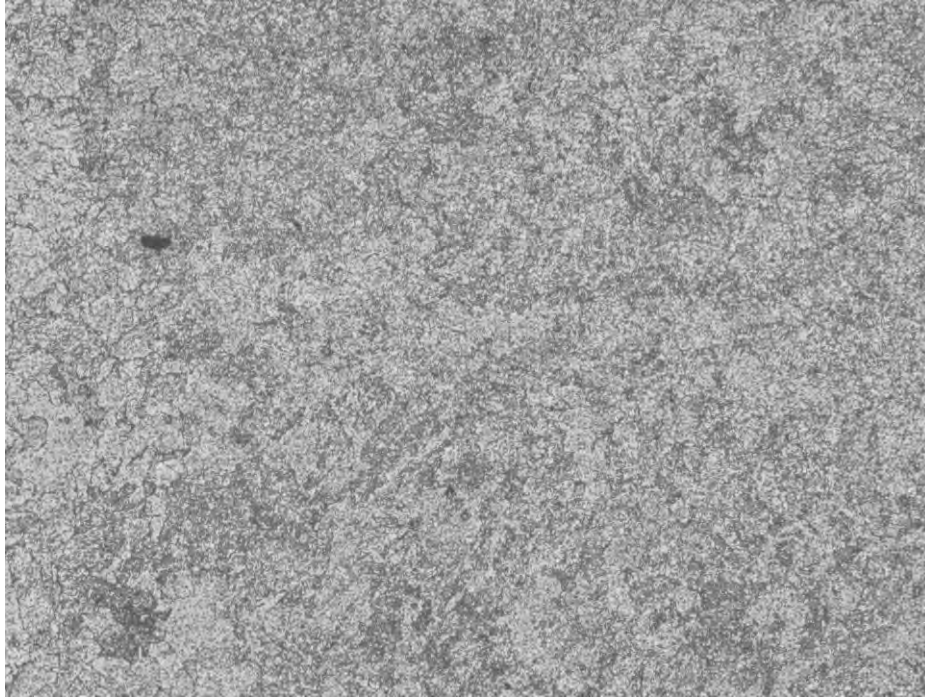
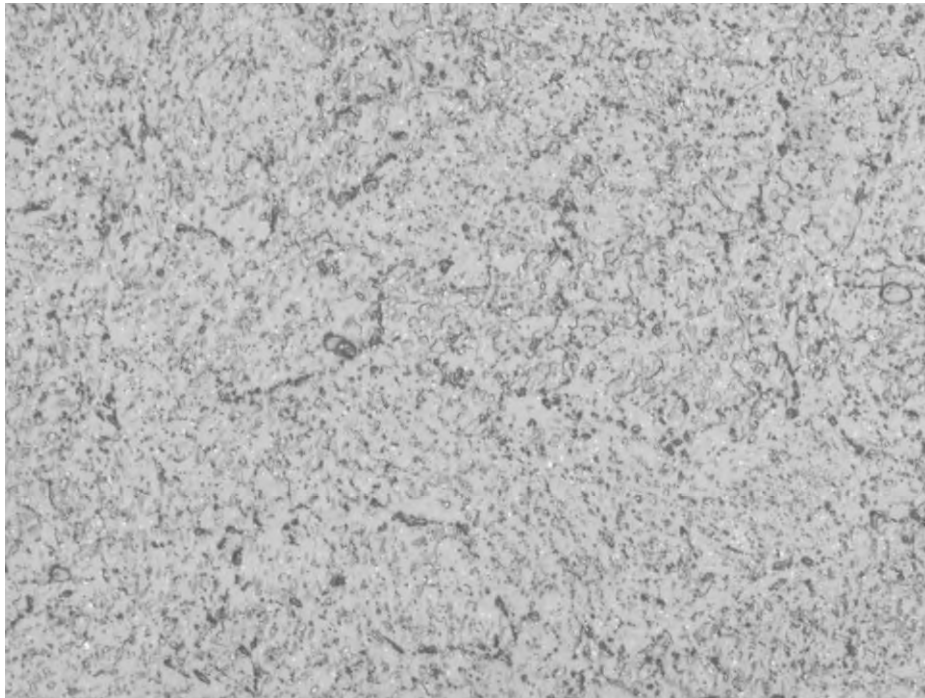
Fig. 8. Replica No. MS-R1.

Bainite and ferrite
microstructure

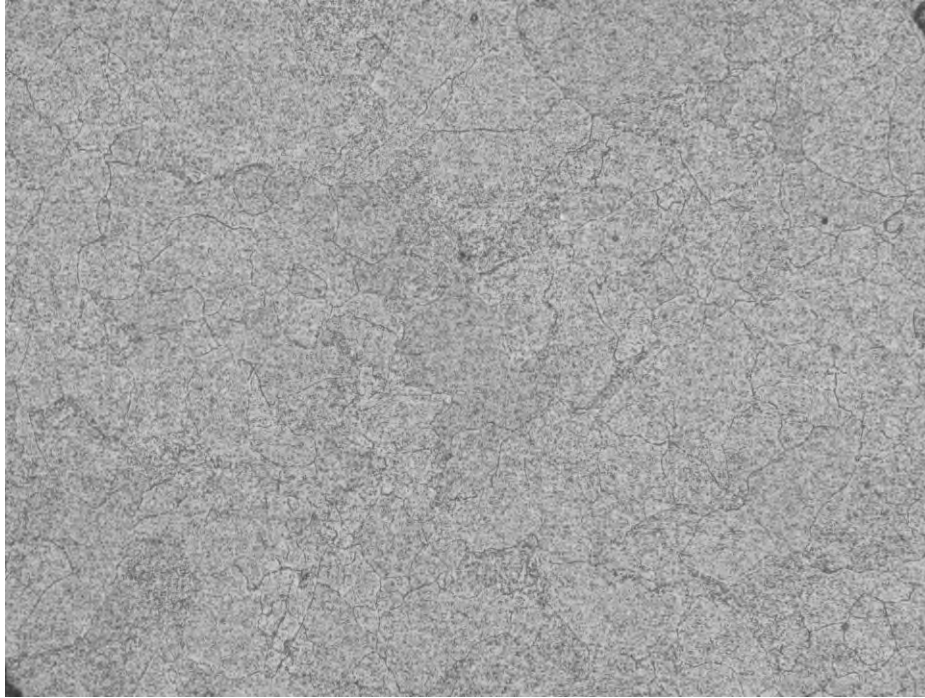
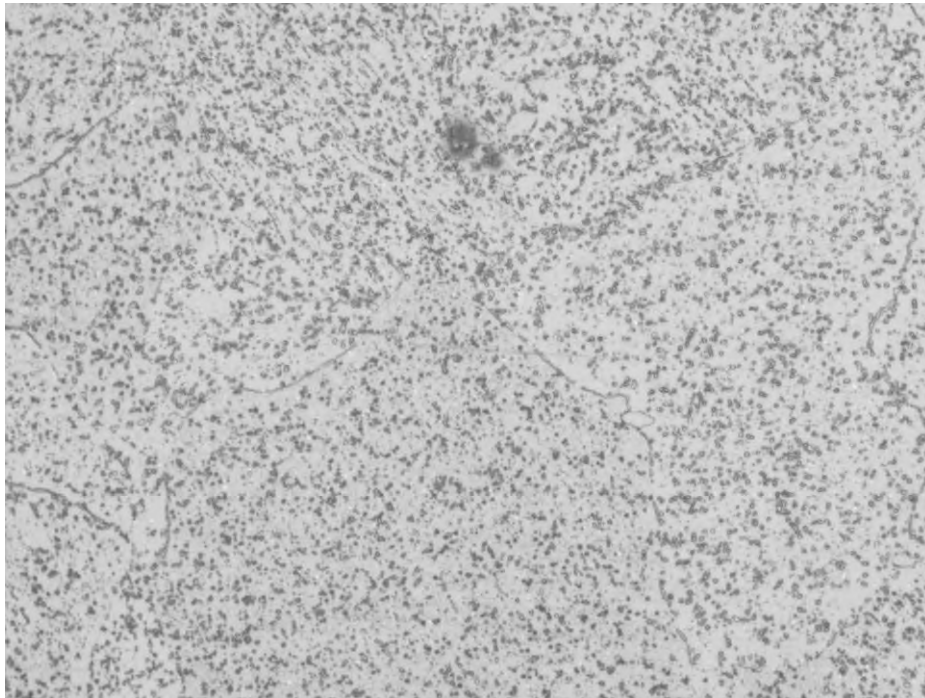
Fig. 9. Replica No. MS-R2.

Bainite and ferrite
microstructure

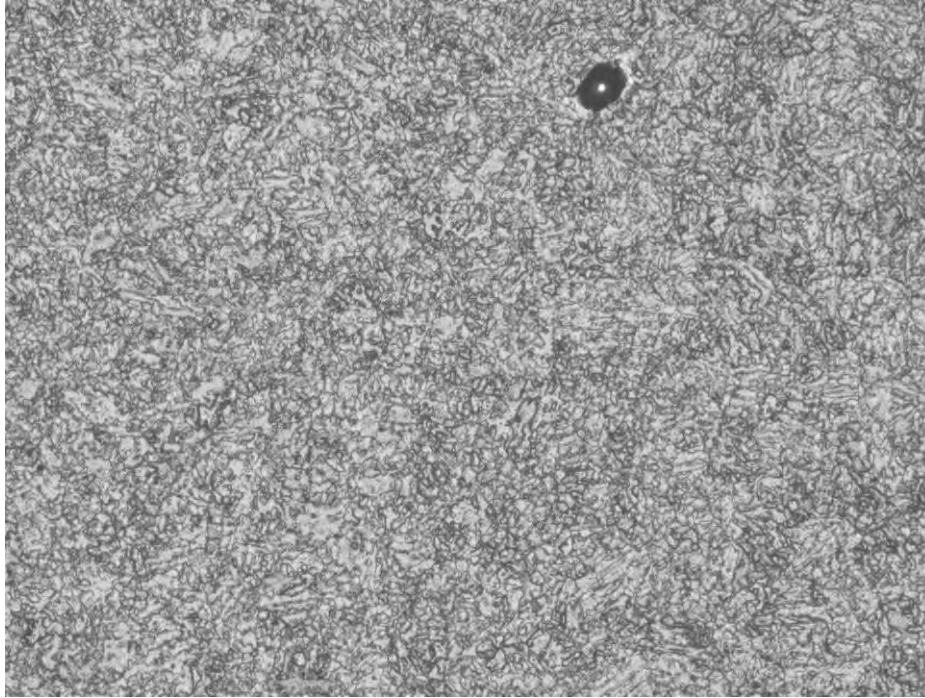
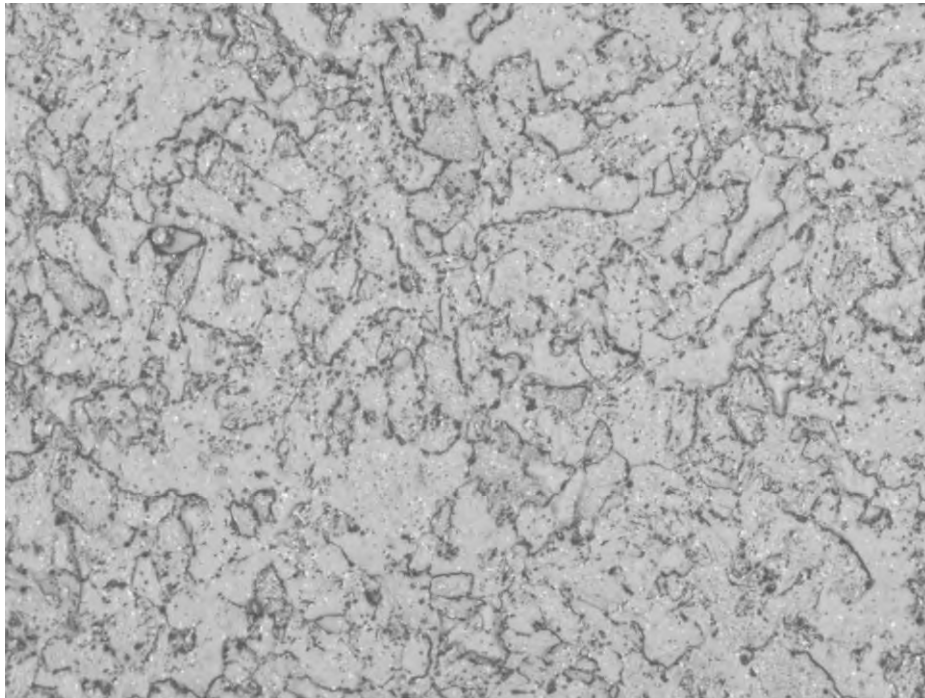
Fig. 10. Replica No. MS-R3.

Bainite and ferrite
microstructure

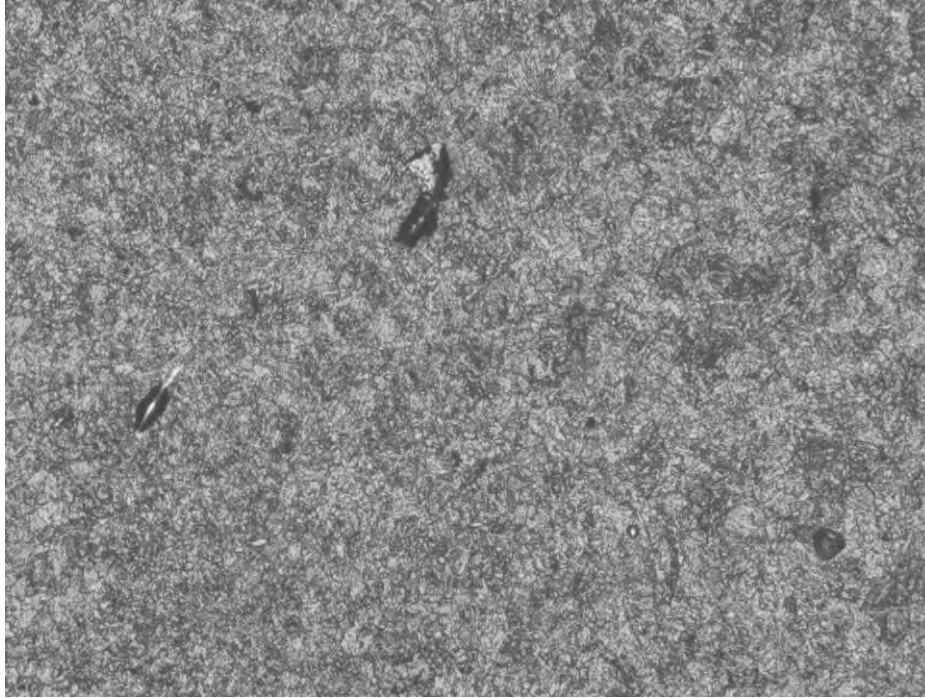
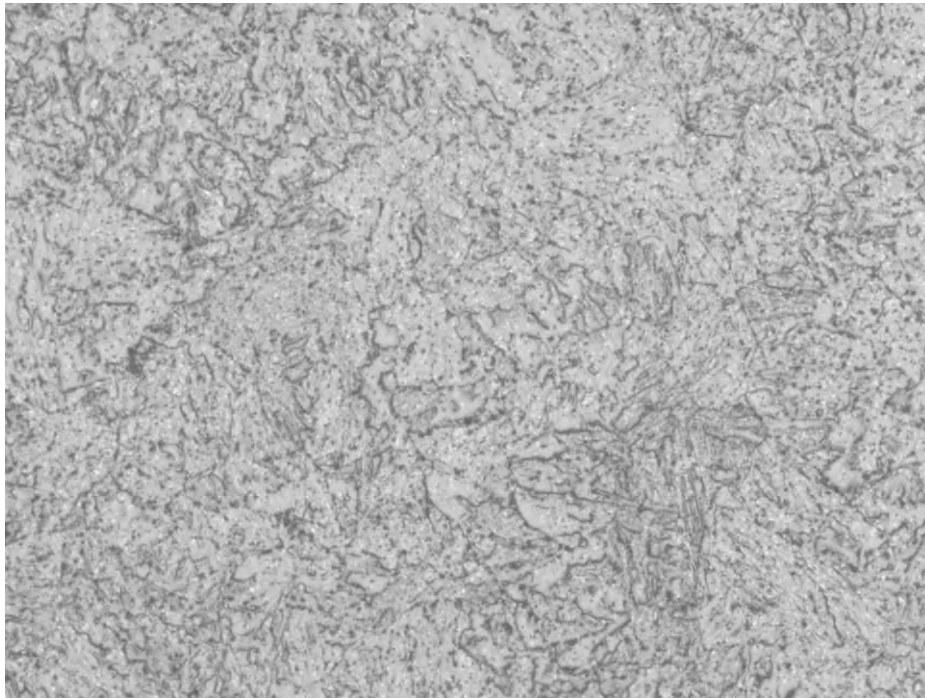
Fig. 11. Replica No. MS-R4.

Bainite and ferrite
microstructure

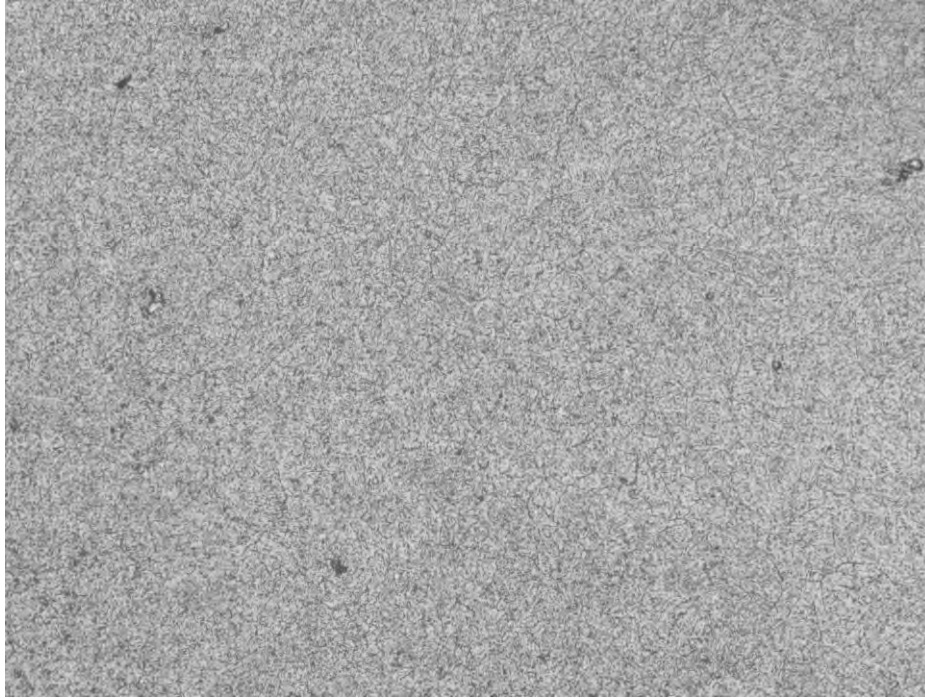
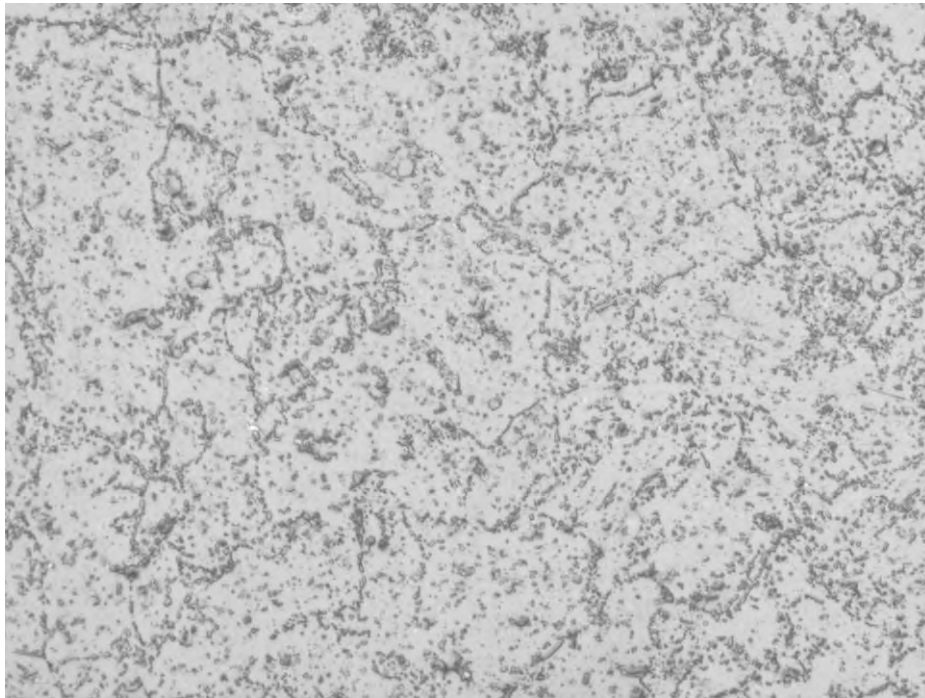
Fig. 12. Replica No. MS-R5.

Bainite and ferrite
microstructure

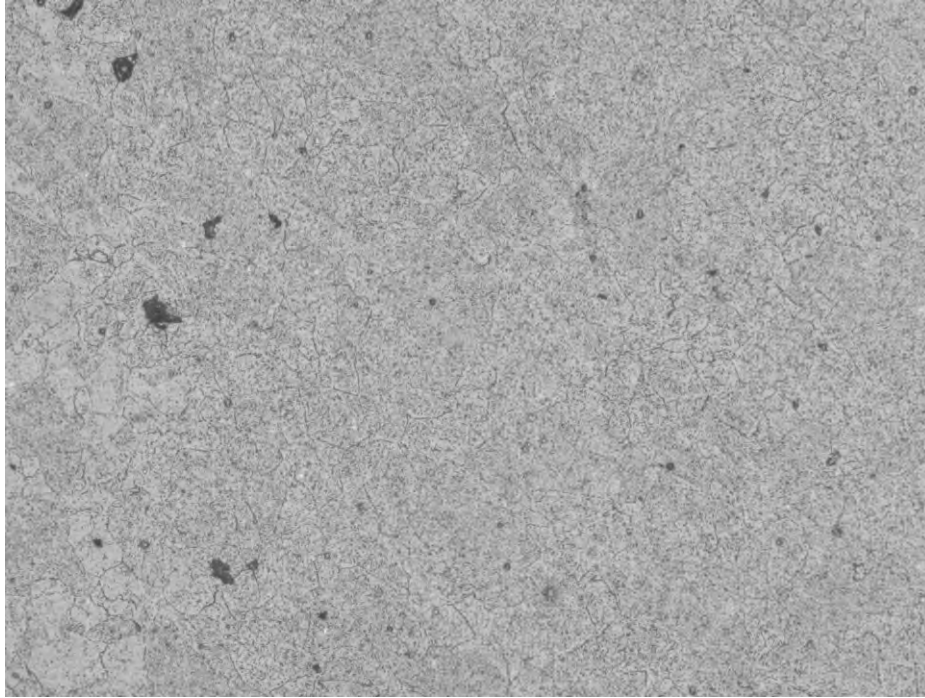
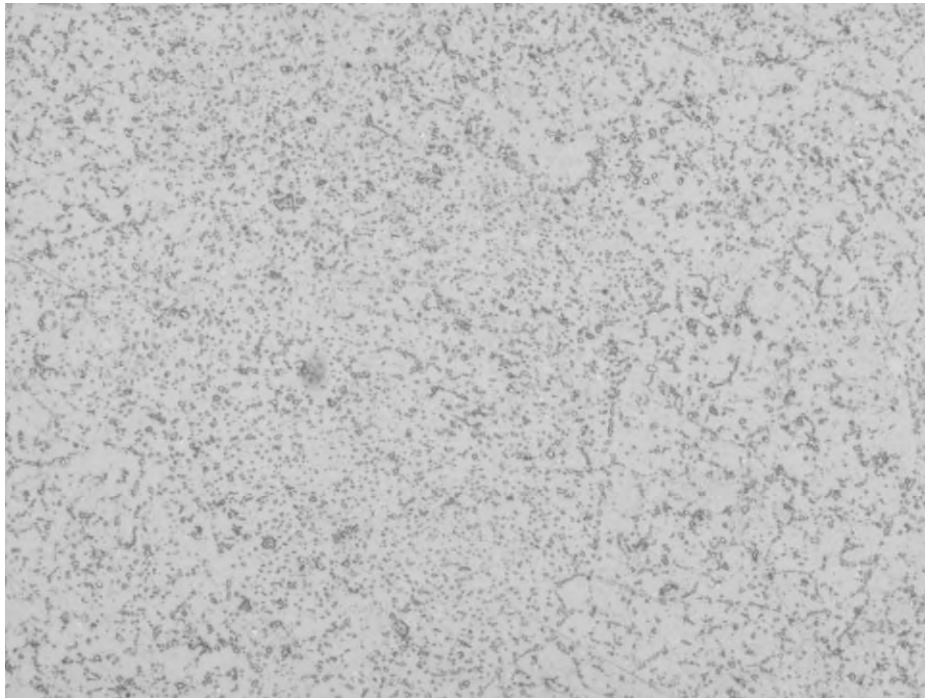
Fig. 13. Replica No. MS-R6.

Bainite and ferrite
microstructure

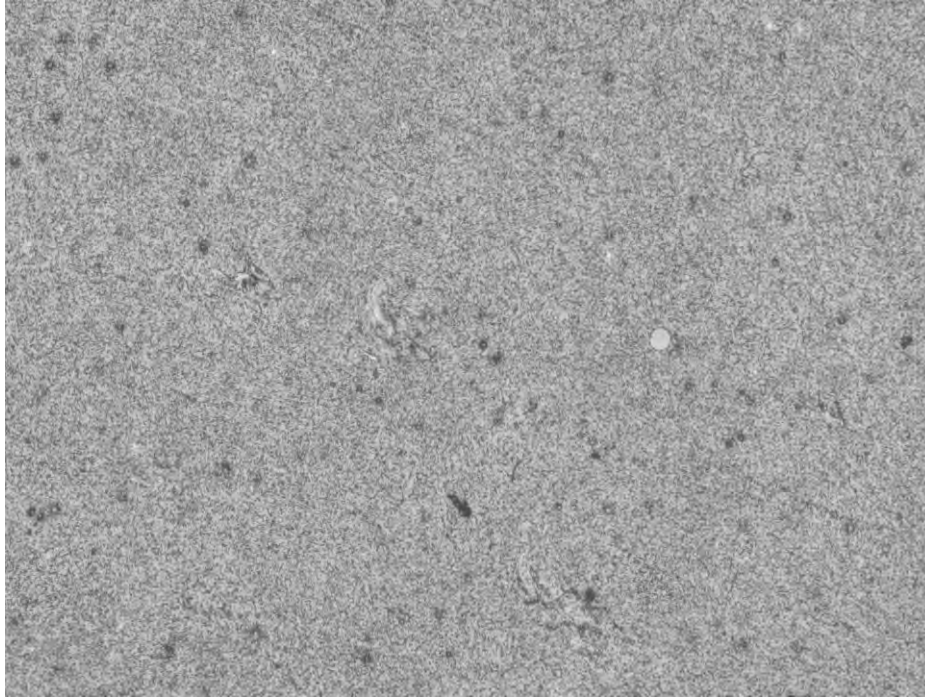
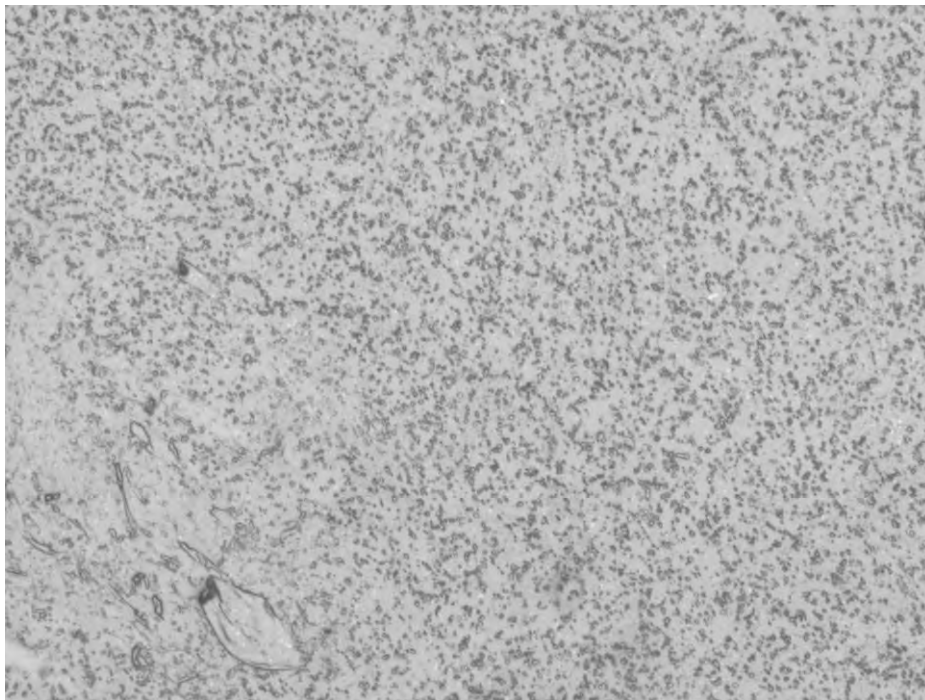
Fig. 14. Replica No. MS-R7.

Bainite and ferrite
microstructure

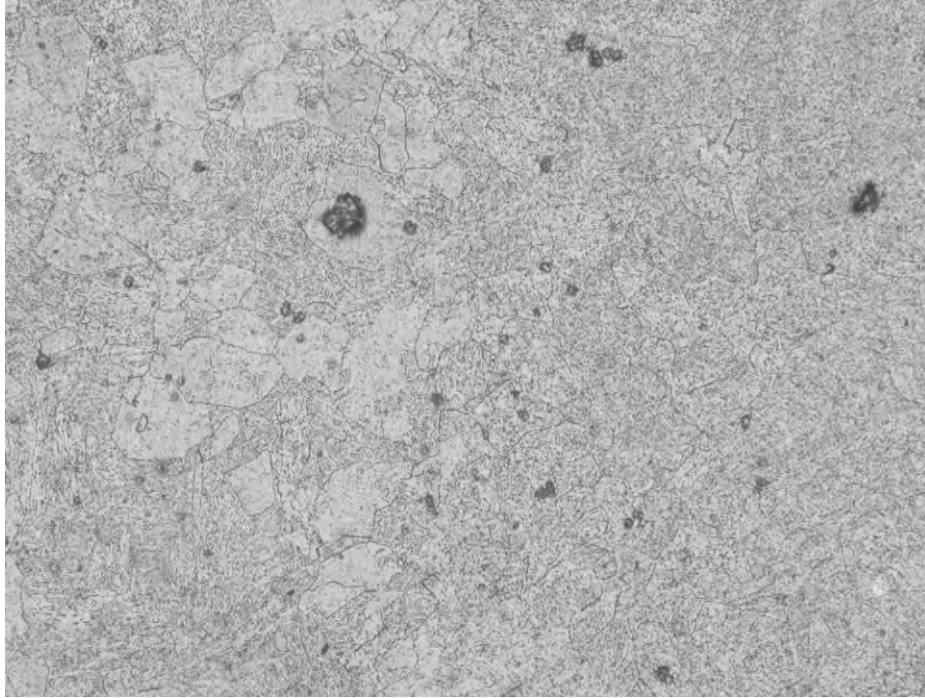
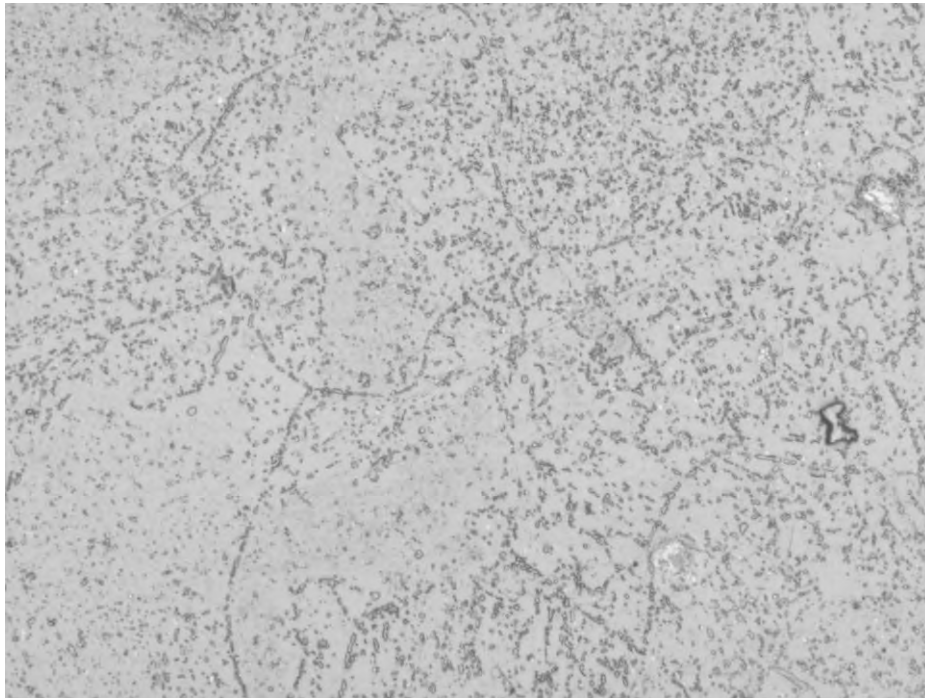
Fig. 15. Replica No. MS-R8.

Bainite and ferrite
microstructure

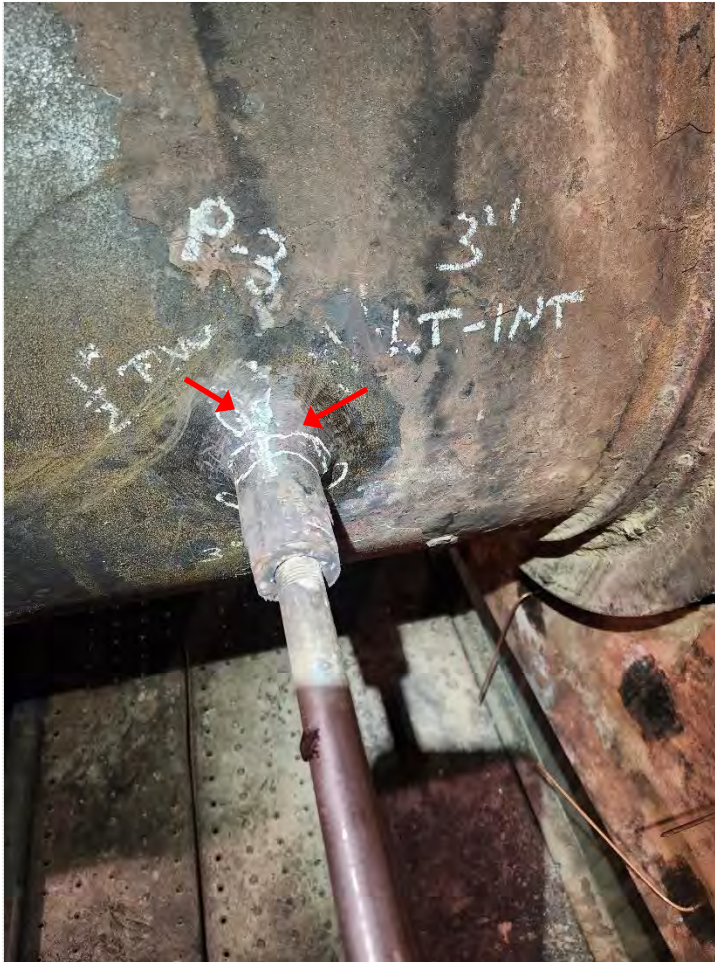
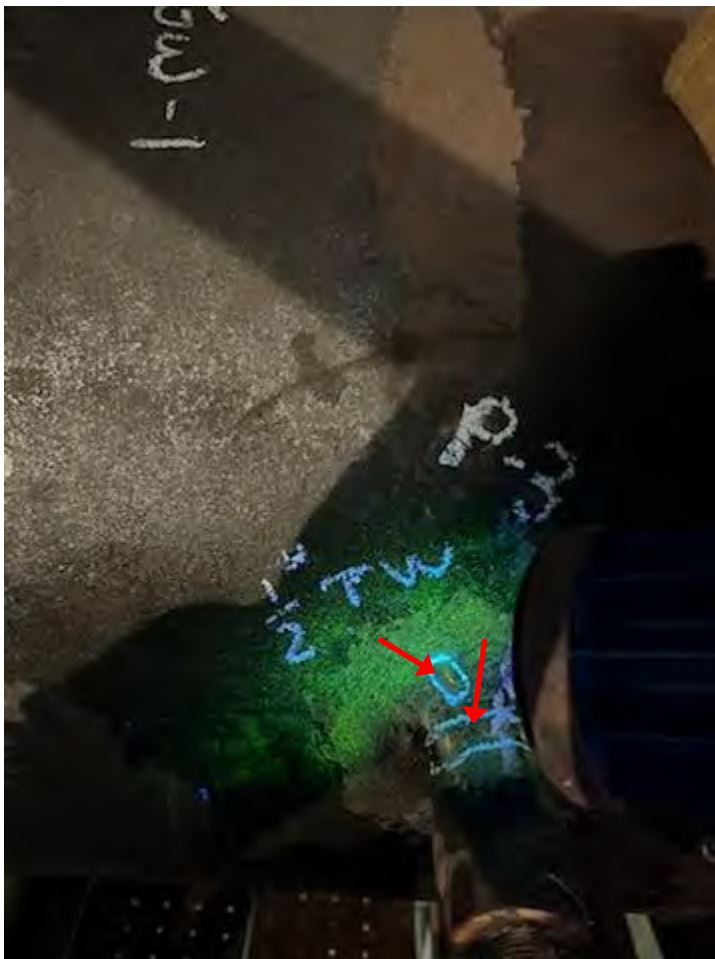
Fig. 22.

Photographs of the indications at penetration No. P-3 on the Hot Reheat piping system.

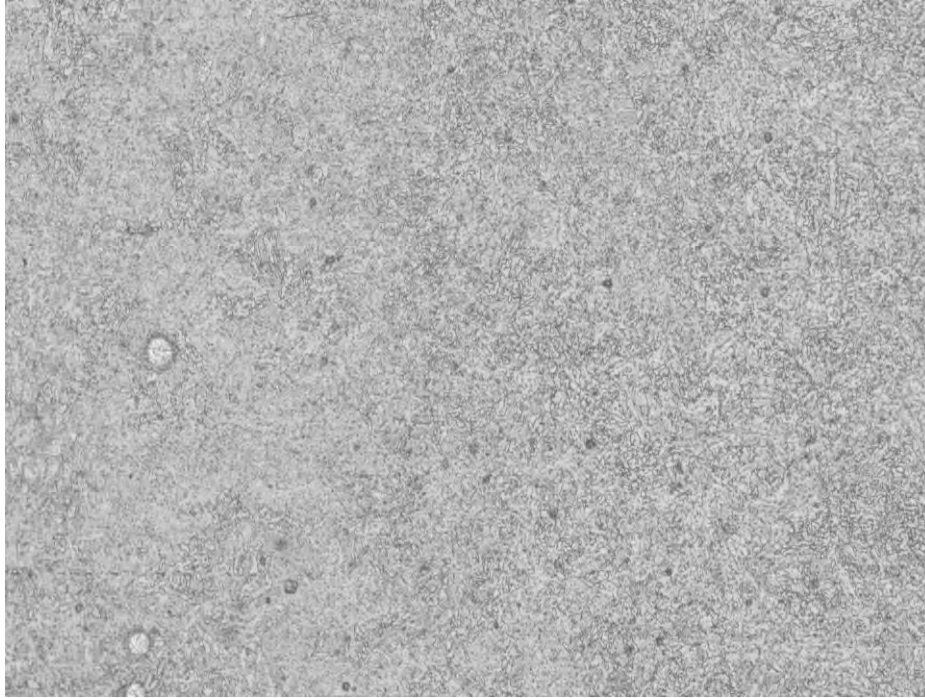
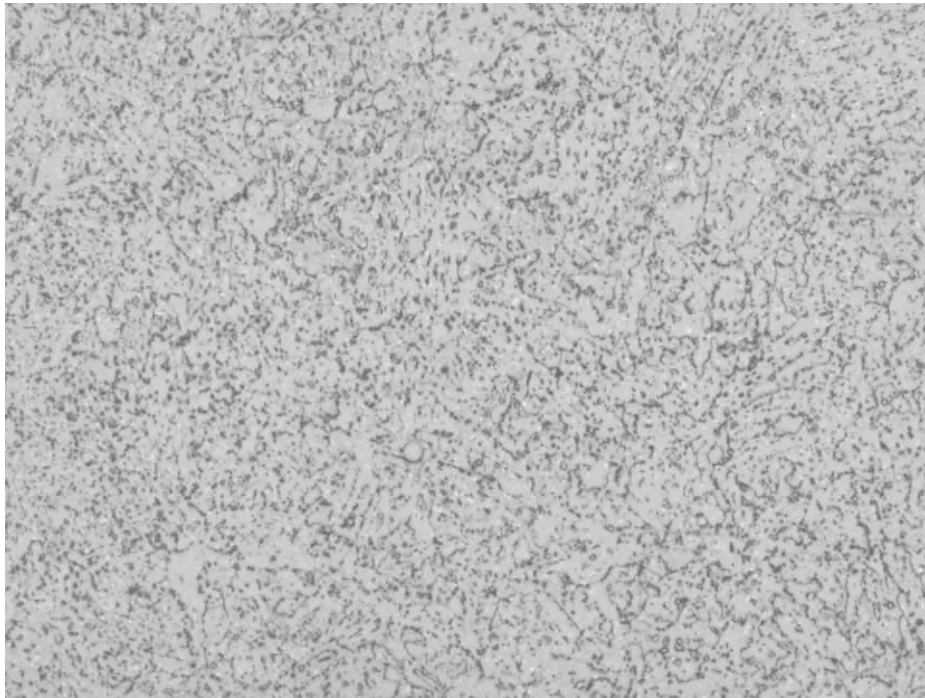
Fig. 23. Replica No. HRH-R1.

Bainite and ferrite
microstructure

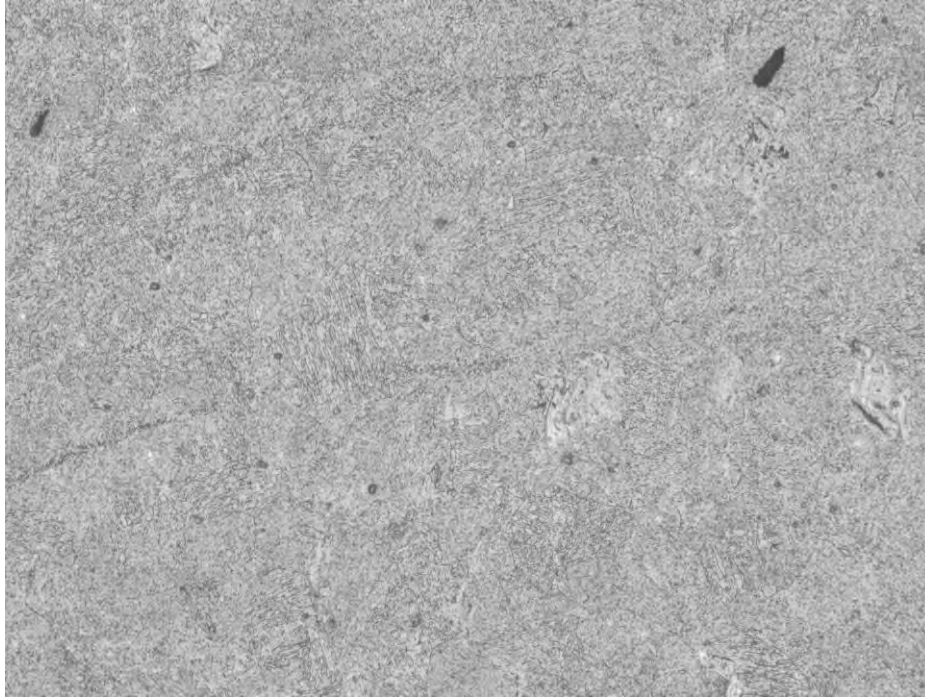
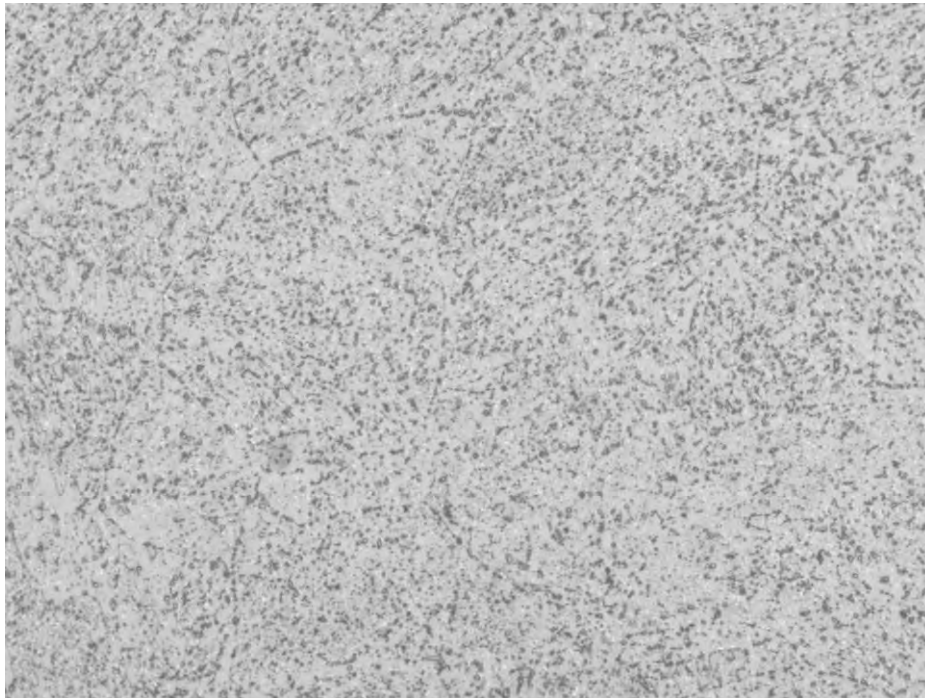
Fig. 24. Replica No. HRH-R2.

Bainite and ferrite
microstructure

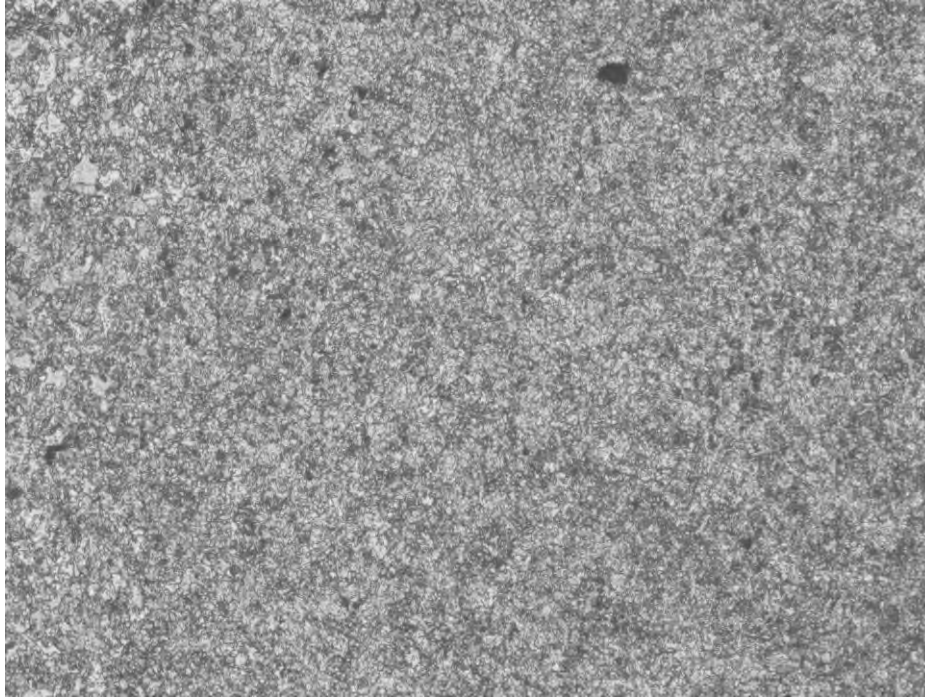
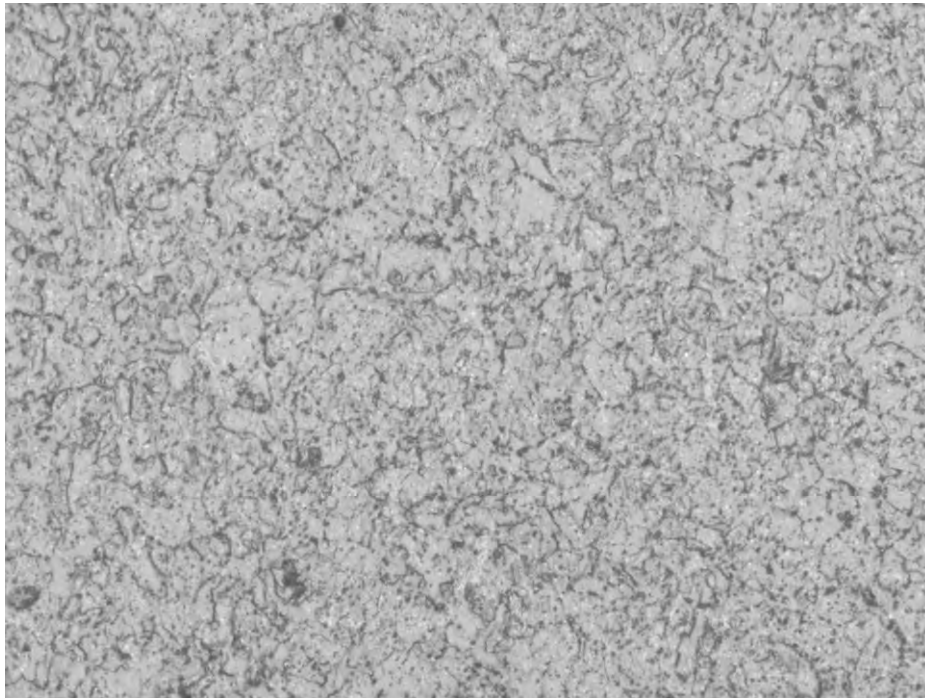
Fig. 25. Replica No. HRH-R3.

Bainite and ferrite
microstructure

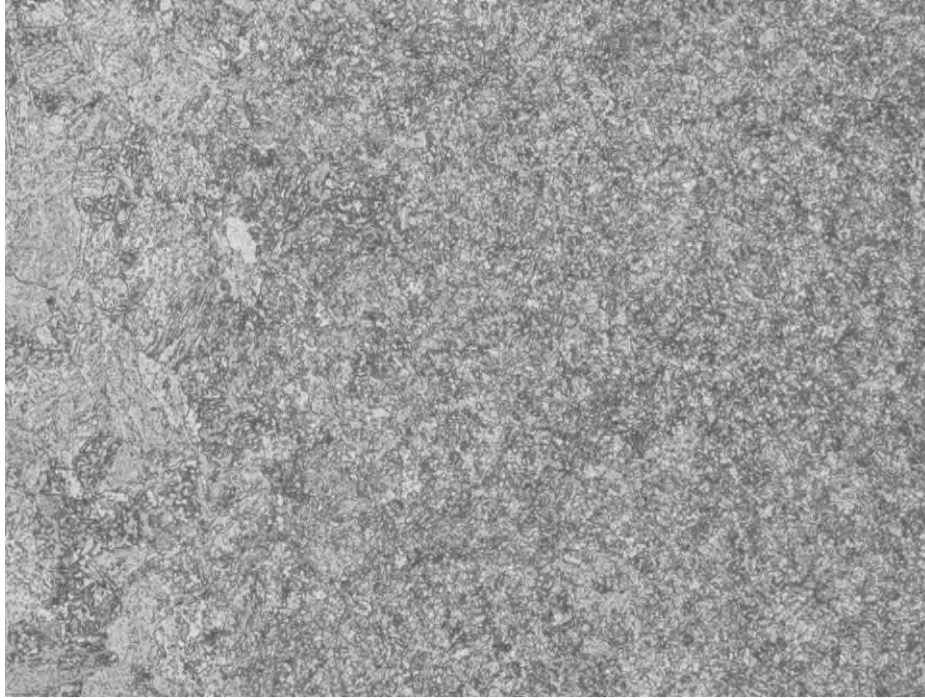
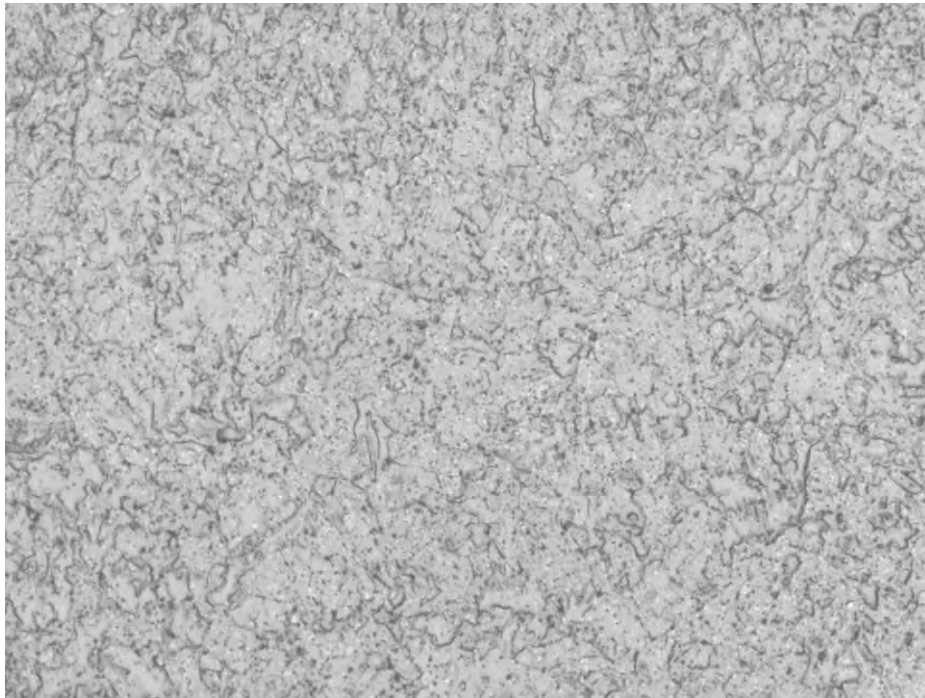
Fig. 26. Replica No. HRH-R4.

Bainite and ferrite
microstructure

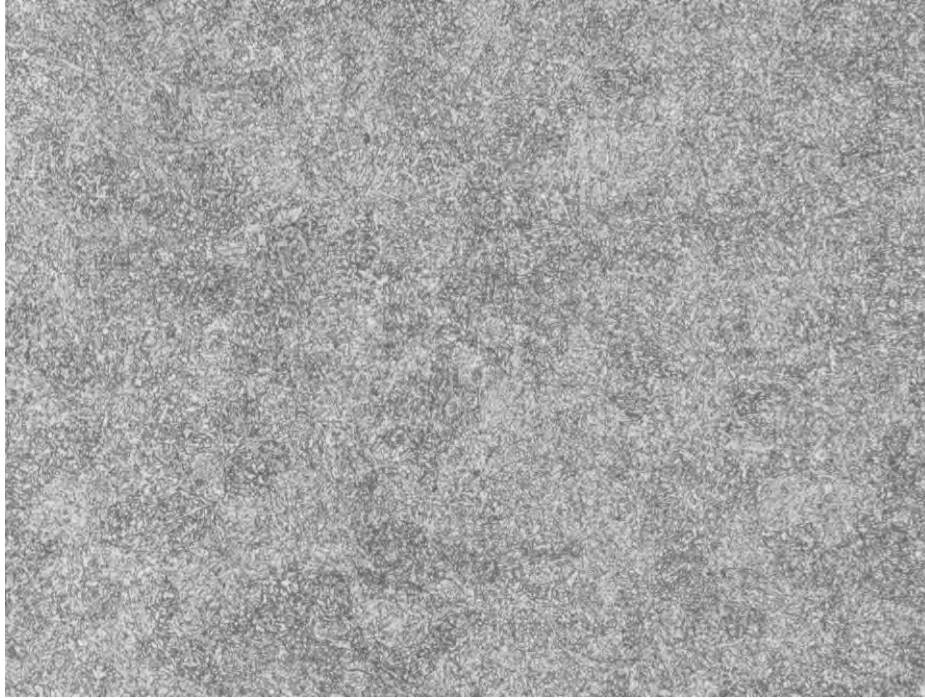
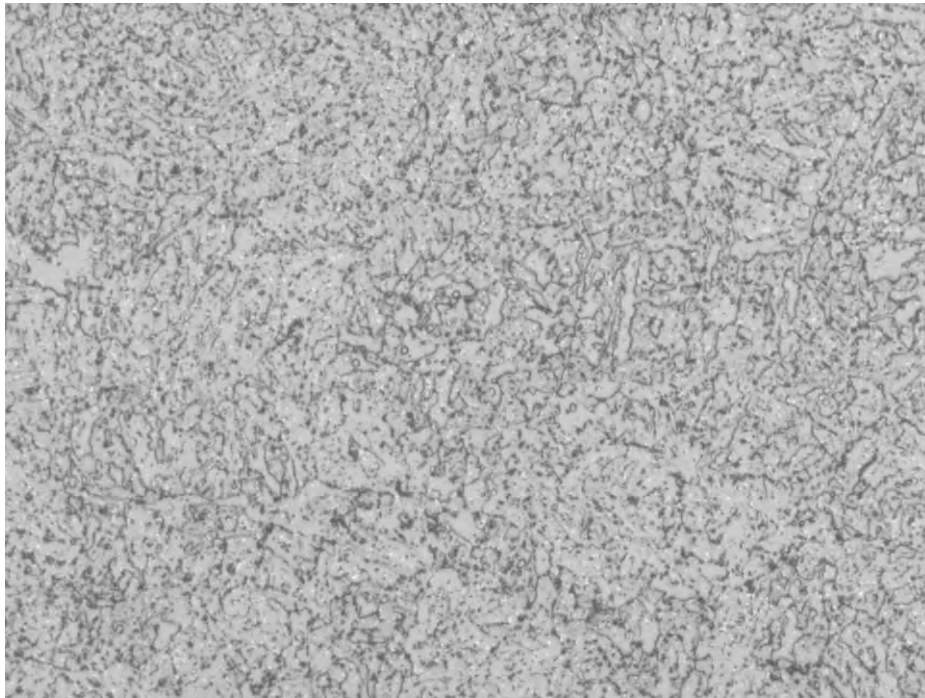
Fig. 27. Replica No. HRH-R5.

Bainite and ferrite
microstructure

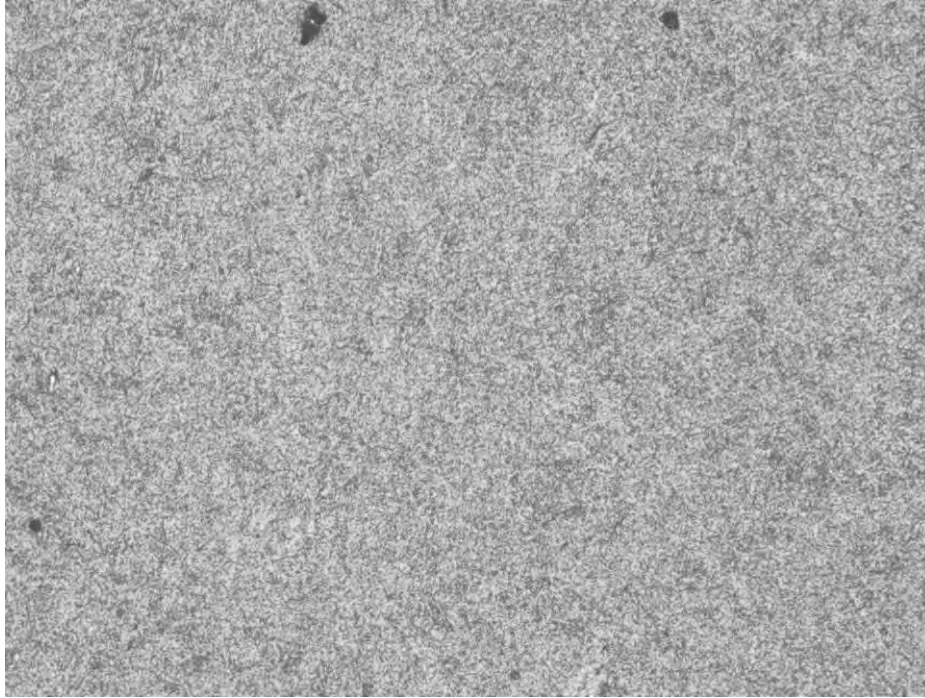
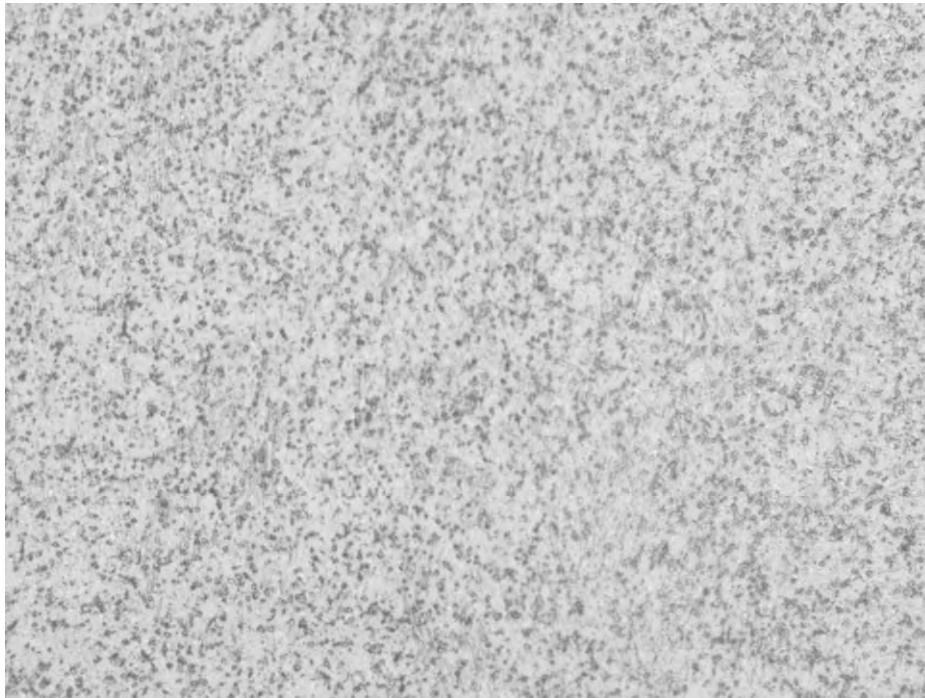
Fig. 28. Replica No. HRH-R6.

Bainite and ferrite
microstructure

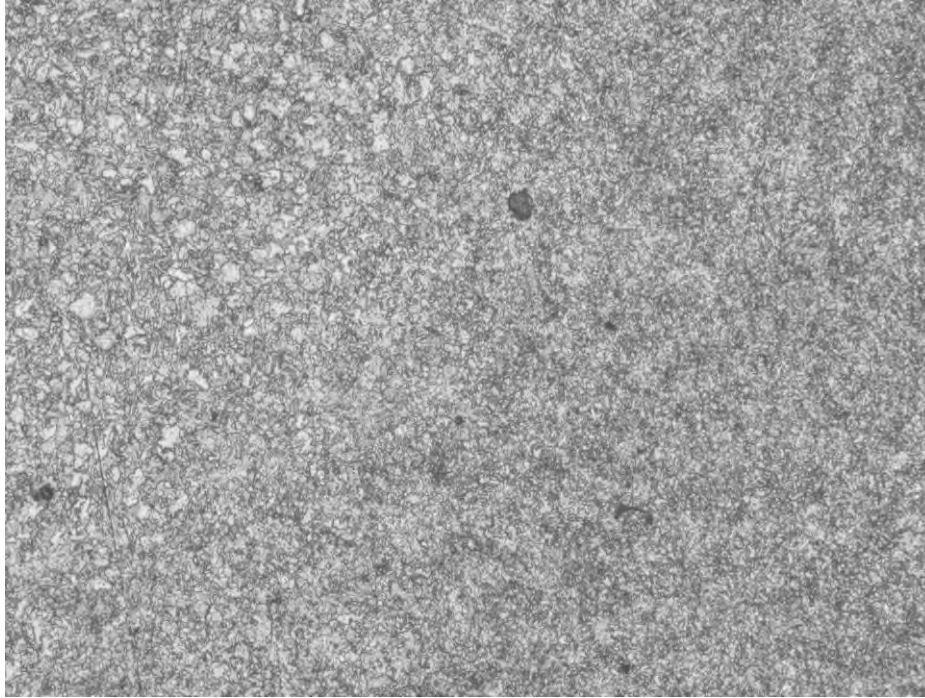
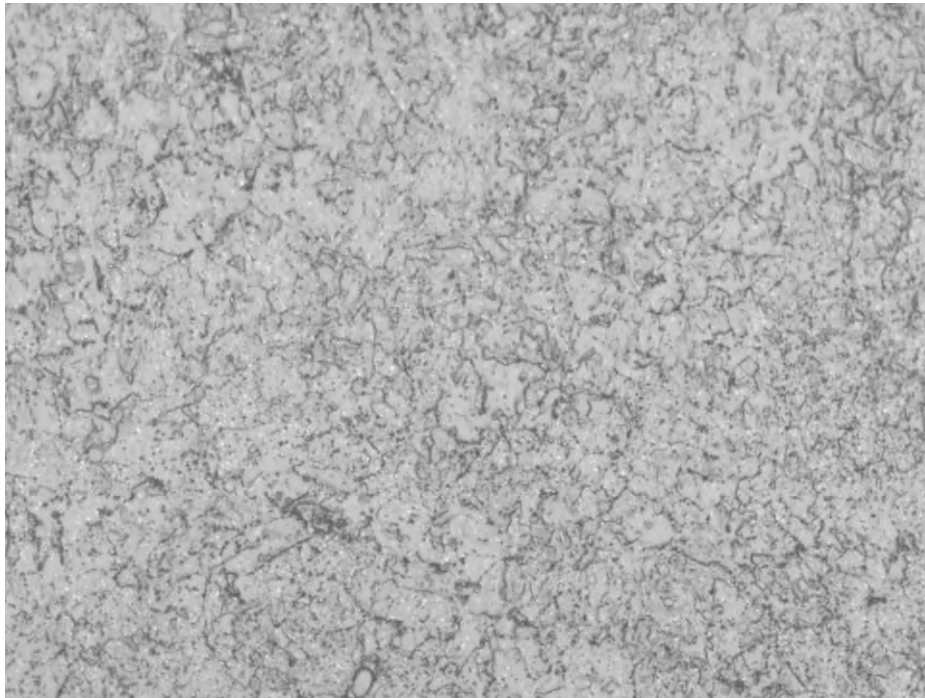
Fig. 29. Replica No. HRH-R7.

Bainite and ferrite
microstructure
