FINAL INSPECTION REPORT

UNIT 1
#3 FEEDWATER HEATER

SPURLOCK STATION

TESTEX, INC.

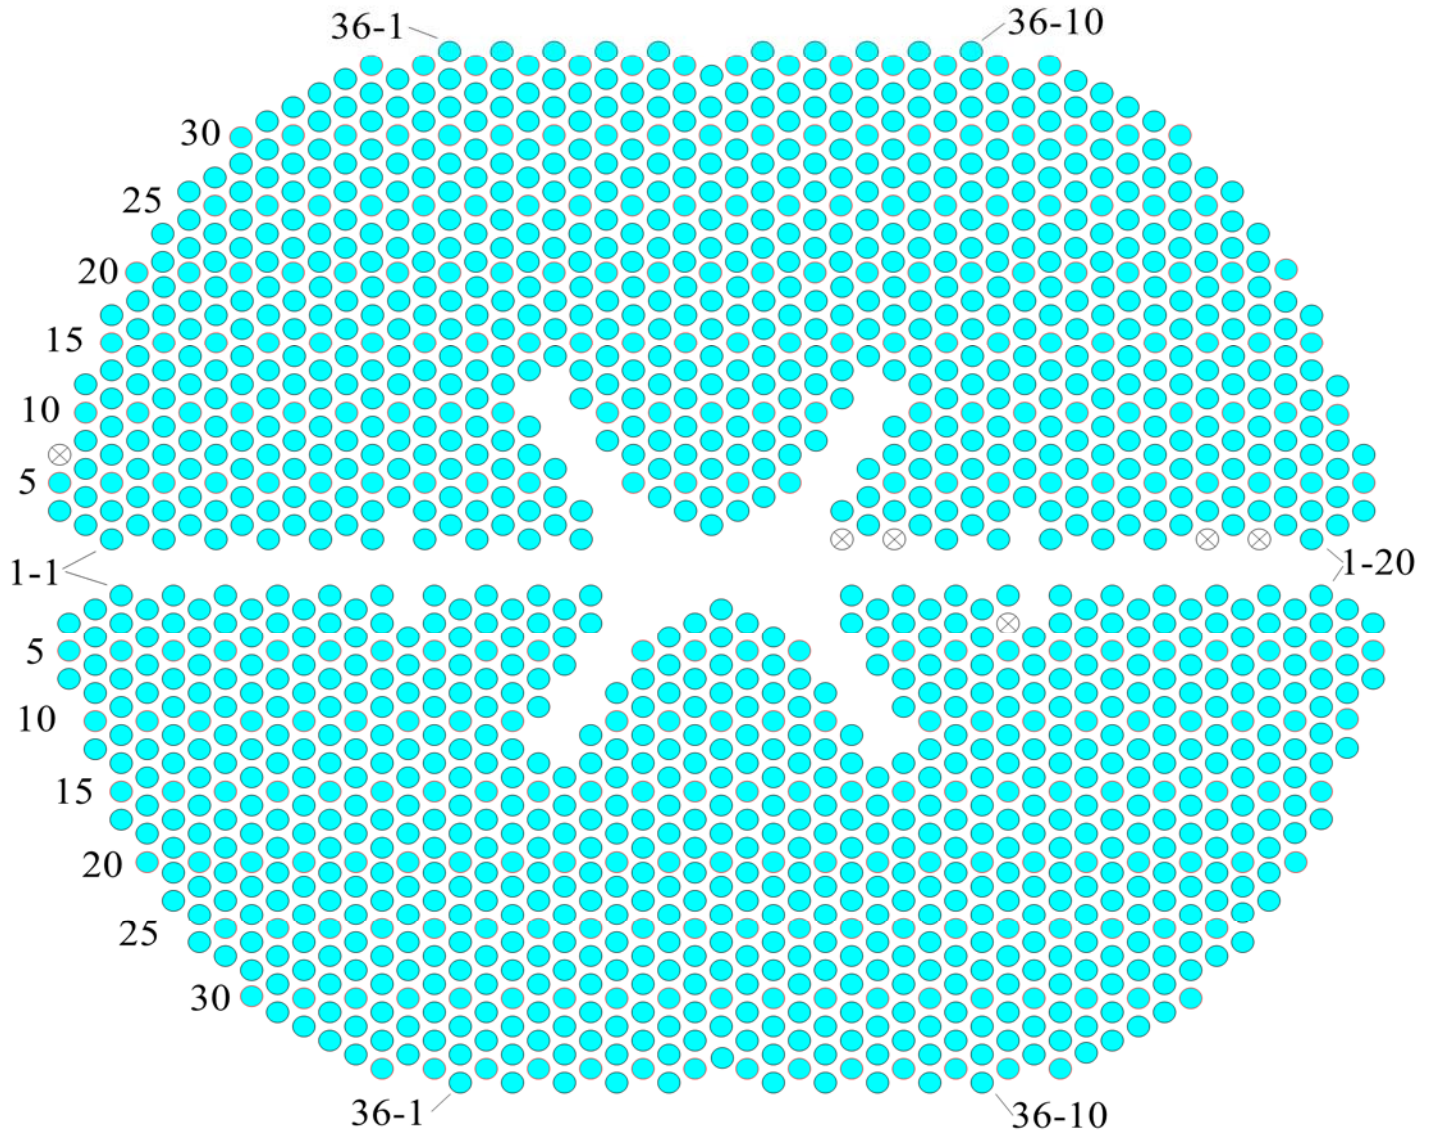
#3 Feedwater Heater

Note: (6) tubes are marked as Blocked on the Tube Sheet Map were as the inspection probe was not able to pass through the tube.

The blockage is within 18 inches of the tube sheet

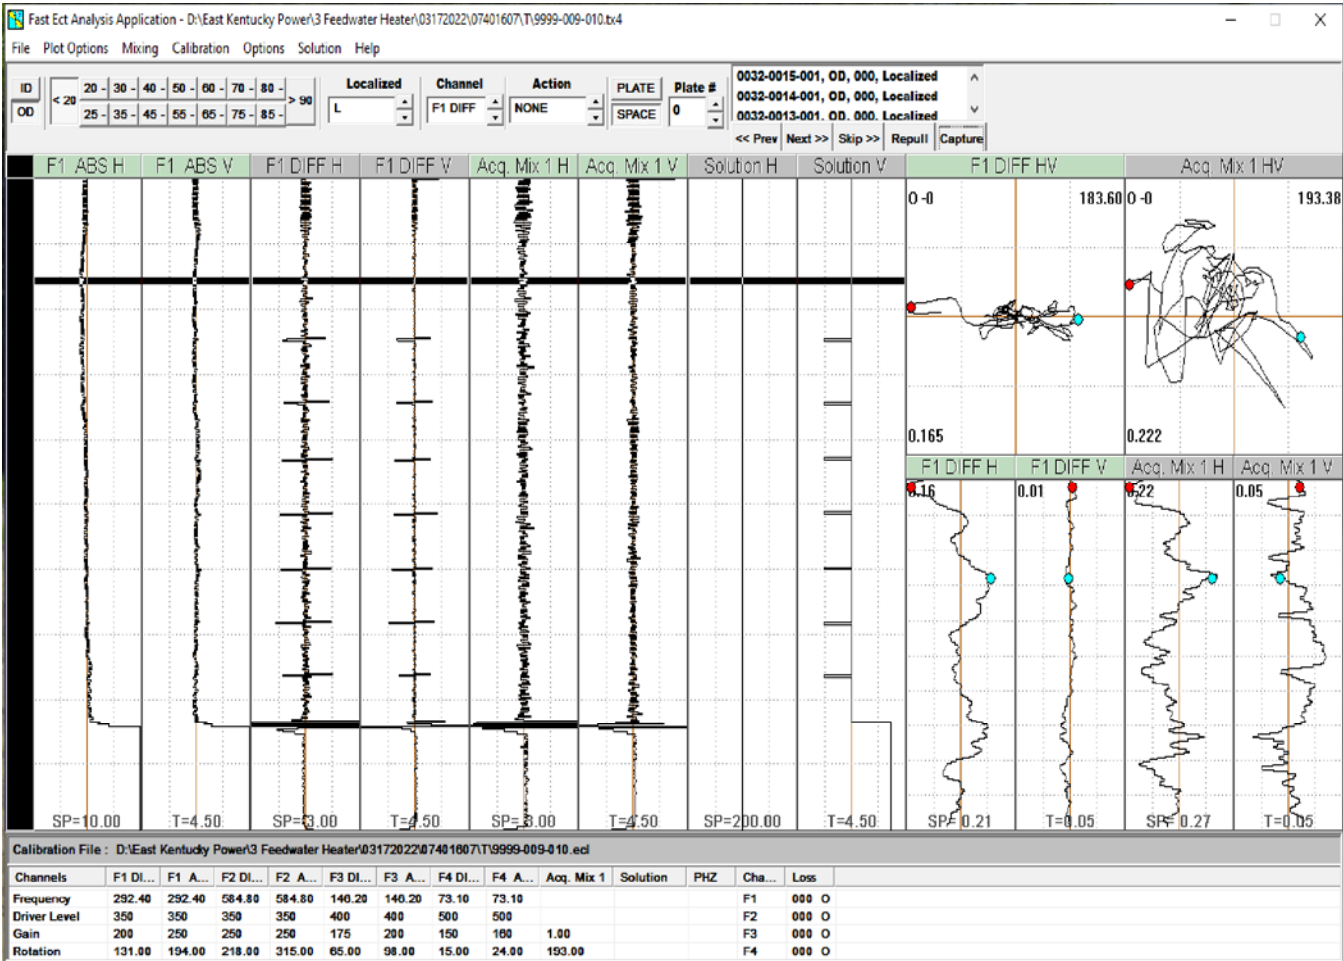
This is an example of <20% wall loss in Tube 32-16 of the Top Section.

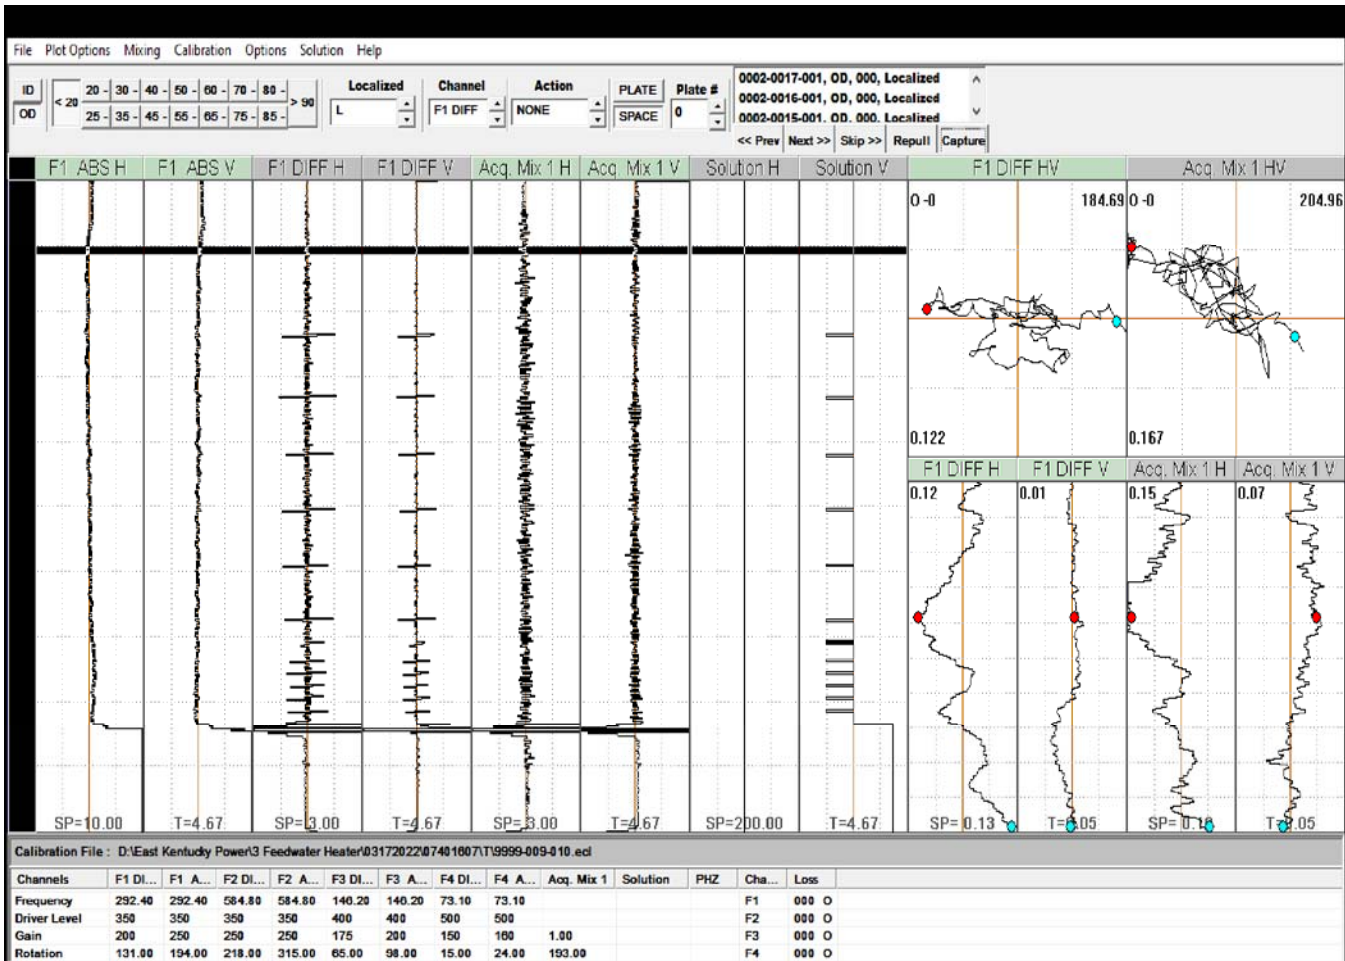
This is an example of <20% wall loss in Tube 2-18 of the Bottom Section.
