The Babcock & Wilcox Company

**Eastern Kentucky Power Cooperative
Spurlock Station, Unit #2**

U2 SPRING 2023 OUTAGE BOILER INSPECTION REPORT

B&W Project No.: BA9312817

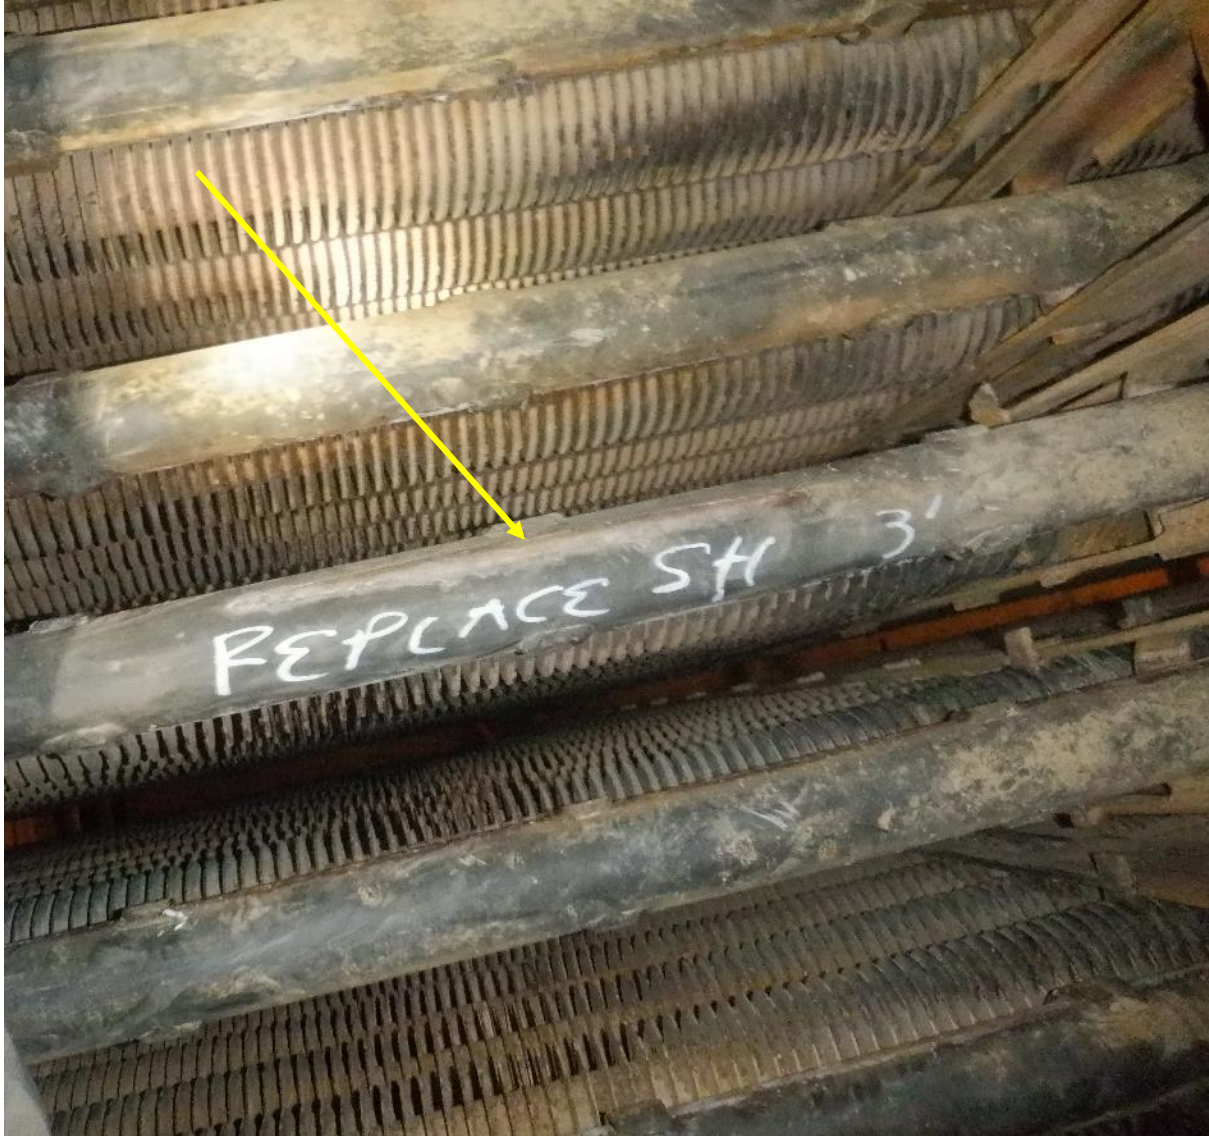
Date: 5/12/2023	Inspected by: B&W - CSH	Unit: 2	Item: BLTSHTOEC 9
Component Inspected: Top of the economizer.			
Condition Assessment: IK 30 Lane: There was minor erosion to the rear economizer intermediate header at the end of a damaged shield.			
Recommendations: Replace the economizer header shield or extend the existing by about 12". Economizer intermediate headers are 8.625" OD.			
Criticality: P3			
Risk if NOT Performed: Erosion to the unprotected header.			
EKPC Comments:

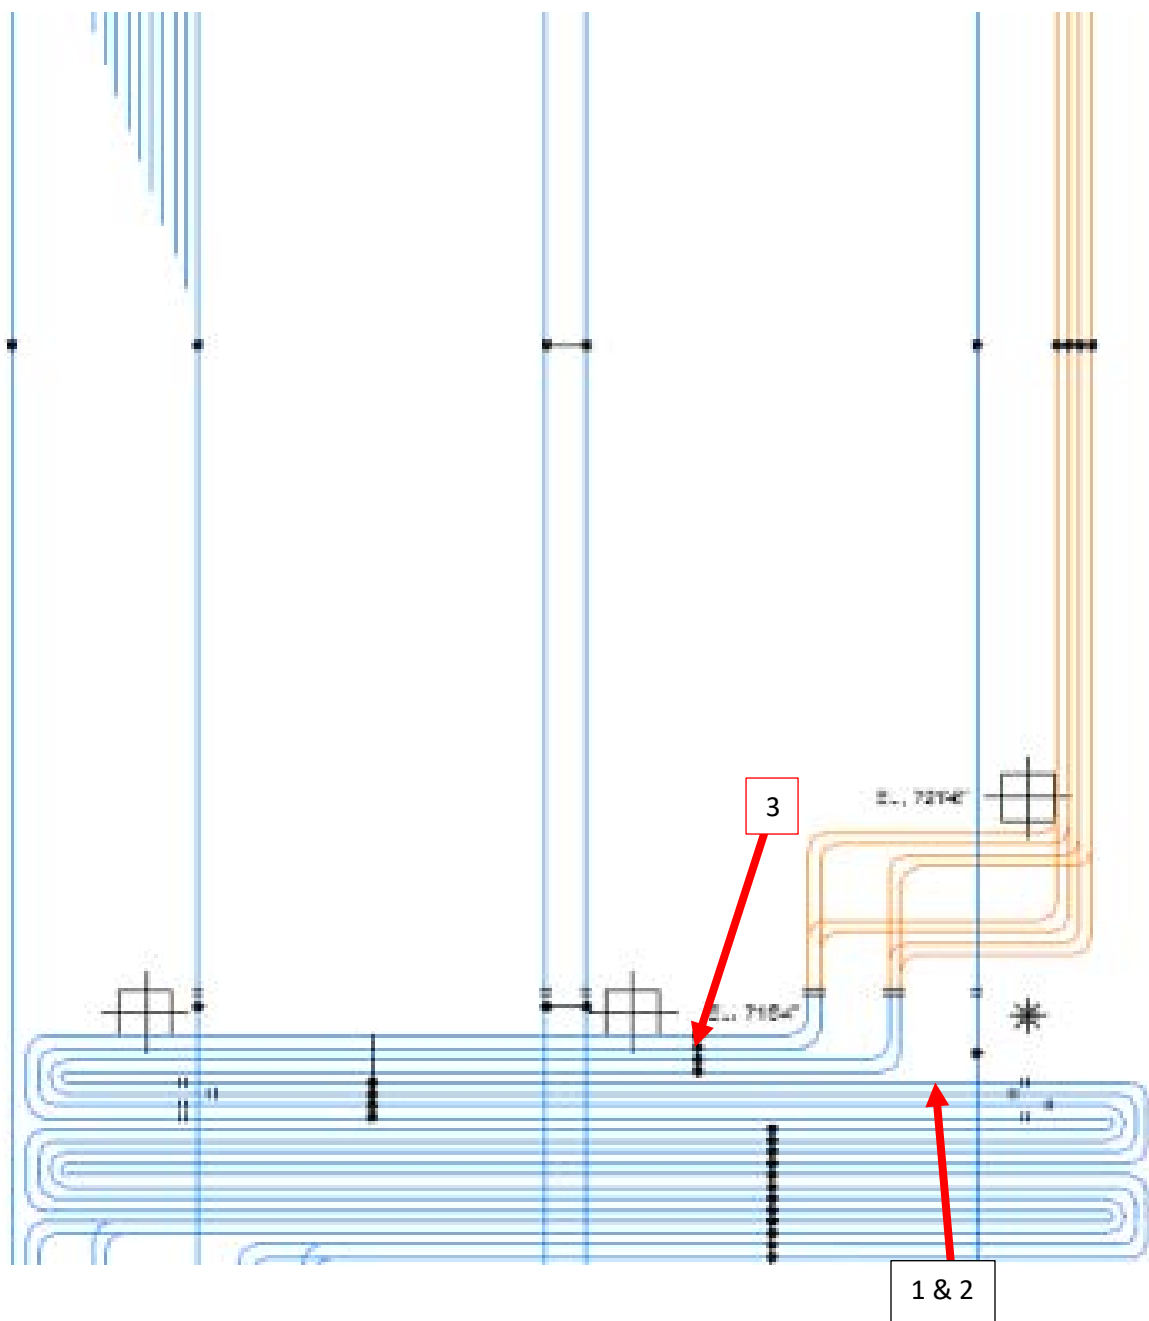
Date: 5/12/2023	Inspected by: B&W -CSH	Unit: 2	Item: TOPLTSH 1
Component Inspected: Top of LTSH Front Crawl			
Condition Assessment: There was minor-erosion on the front economizer stringer tubes at the alignment bar U straps at rows: 45 & 67			
Recommendations: Continue to monitor. If time allows - Cut off U strap, install a 4" long shield on aforementioned tubes and install a new U strap. Tube Material: SA210-A1, 2.00" OD, .220" MW			
Criticality: P3			
Risk if NOT Performed: Erosion could worsen causing a tube leak.			
EKP Comments:

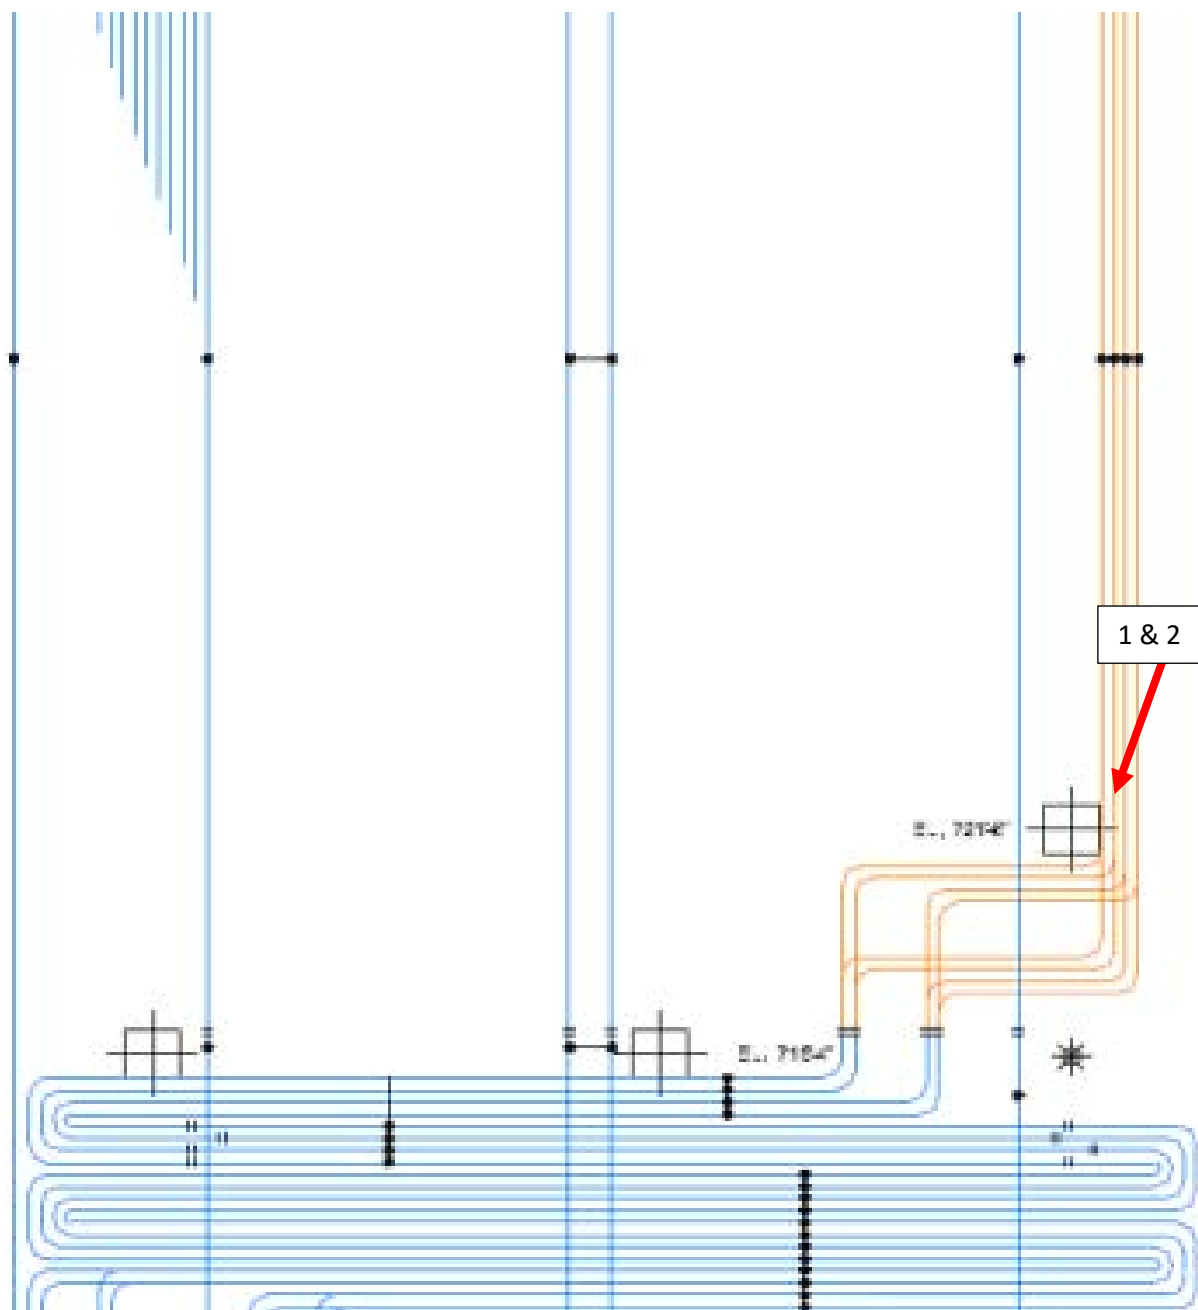
Date: 5/12/2023	Inspected by: B&W - CSH	Unit: 2	Item: RPENDSH 1
Component Inspected: Rear Pendant Superheater (LTSH)			
Condition Assessment: The front to rear alignment bars at the front of the LTSH, from the boiler center line to the RHSW were damaged throughout but were holding the tubes in place.			
Recommendations: Continue to monitor and prepare to have failed bars to replace in future outages.			
Criticality: P3			
Risk if NOT Performed: Tube alignment issues.			
EKP Comments:

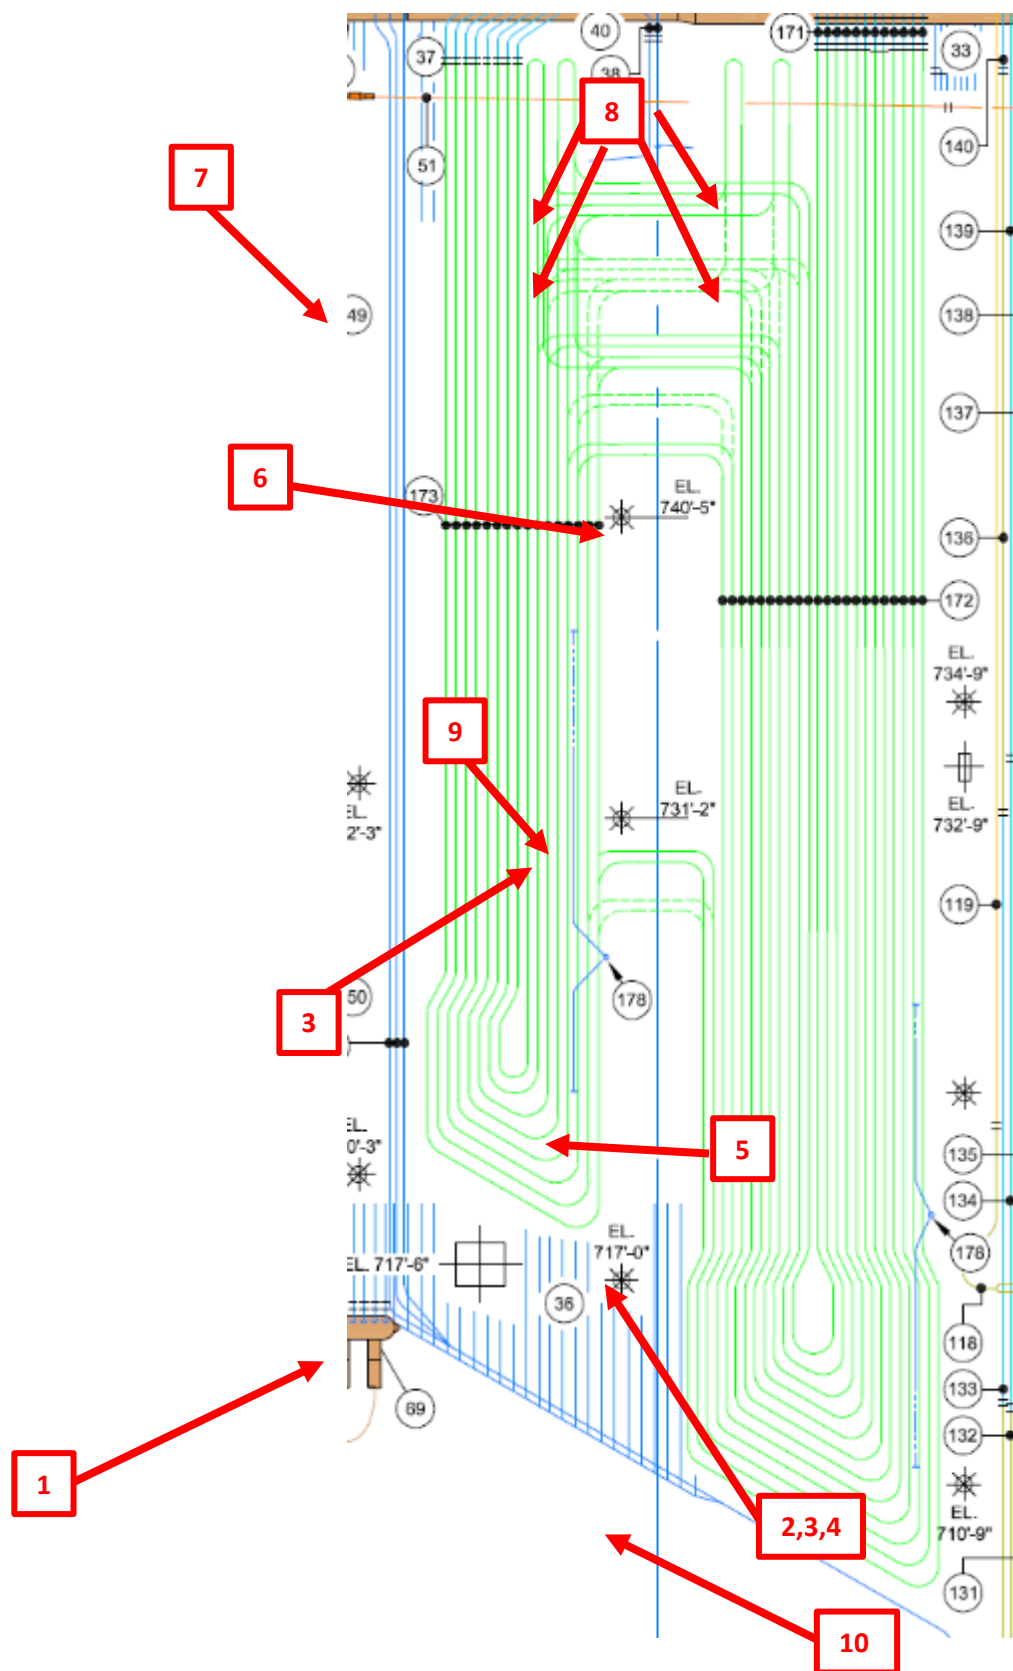
Date: 5/17/23	Inspected by: B&W ECC	Unit: 2	Item: RRHCORSCR 8
Component Inspected: WW Screen tubes			
Large sections of the refractory dam are missing at tube 60 and from tube 41 to 44.			
Recommendations: Replace the refractory. Install additional refractory ties to maintain the refractory.			
Criticality: P2			
Risk if NOT Performed: Tubes are subject to erosion and corrosion. Flue gas or tramp air can enter the space between the tubes and dead air space casing through the gaps between the tubes.			
EKP Comments:			
Photos:

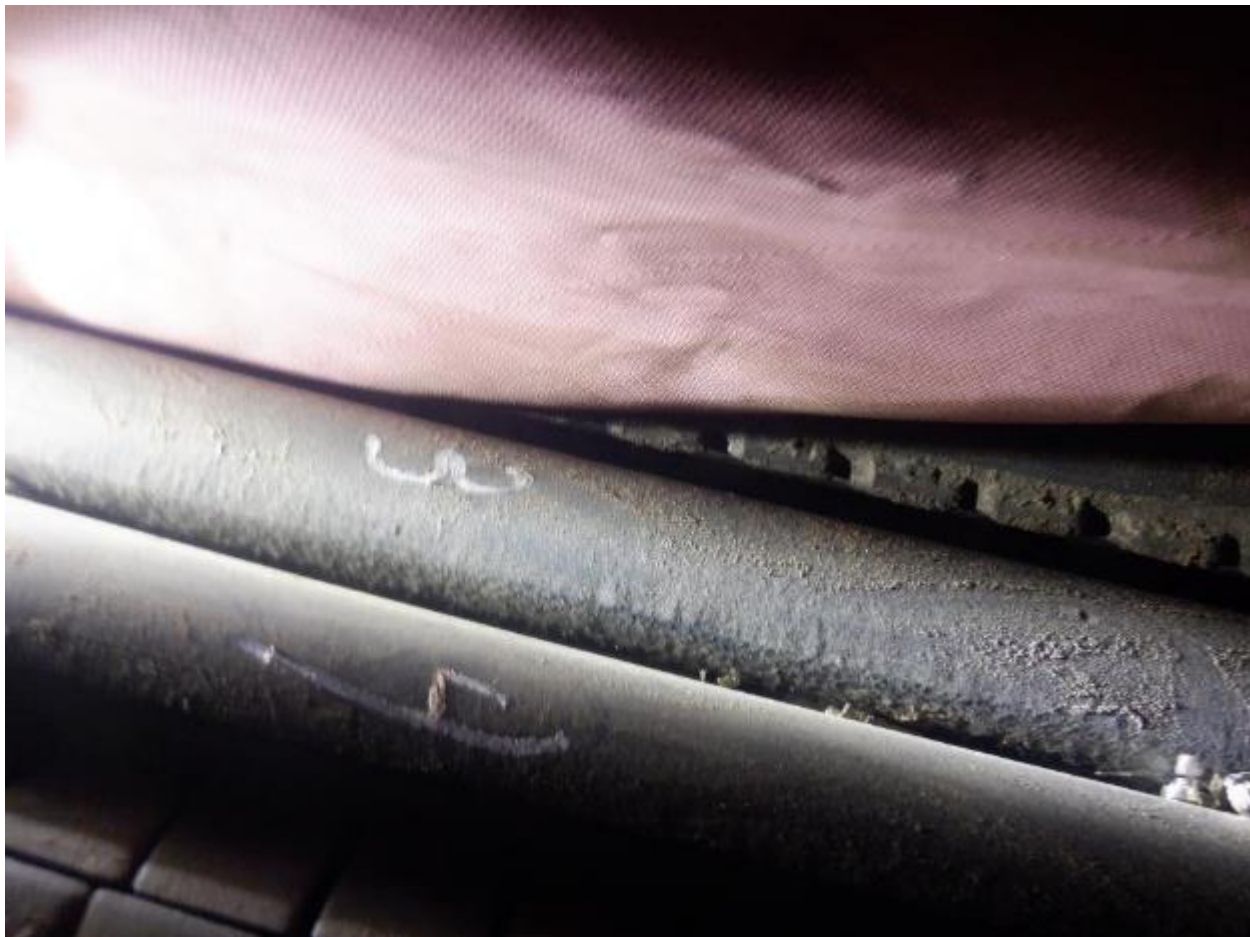
Date: 5/27/23	Inspected by: B&W	Unit: 2	Item: RRHCORSCR 2
Component Inspected: Upper Arch Beneath RHO			
Condition Assessment: Minor sootblower erosion was found on the WCS tube, above the arch penetration on the LHS.			
Recommendations: Install a 24" long shield. WCS tubes are 2.00"OD.			
Criticality: P3			
Risk if NOT Performed: Tubes are subject to continued erosion and wall loss which could lead to tube failures.			
EKP Comments:			
Photos:

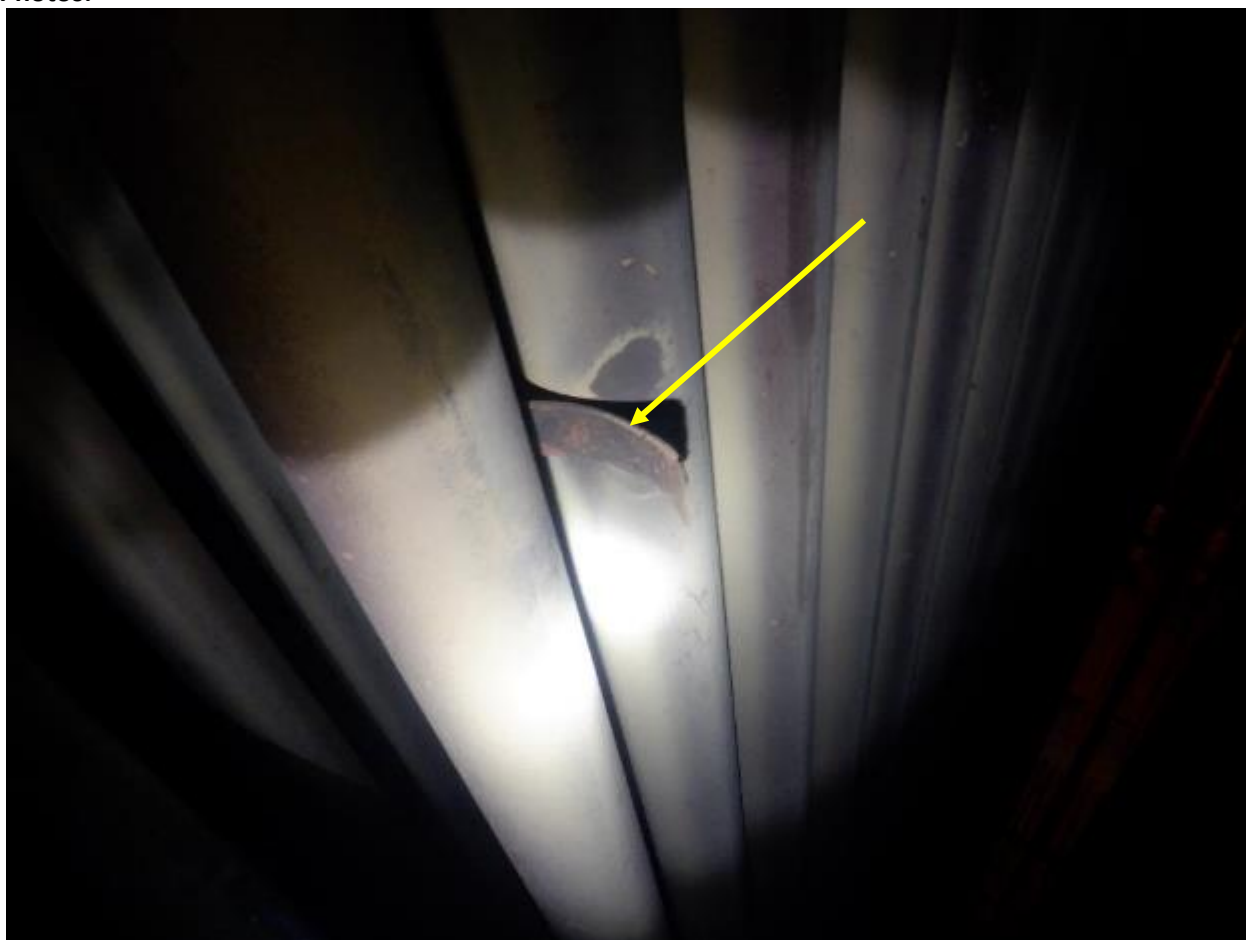
Date: 5/15/2023	Inspected by: B&W - CSH	Unit: 2	Item: RHFPEND 2
Component Inspected: RH Front Pendant & Between SH Pendant Platens			
Condition Assessment: Slip spacers were disengaged at multiple elevations. See locations below.			
Level 3: 23, 42, 43			
Level 1: 25, 30, 43, 45			
Recommendations: Replace the disengaged slip spacers. B&W Part Numbers: 3099889 & 7004750			
Criticality: P3			
Risk if NOT Performed: Disengaged slip spacers can lead to misalignment.			
EKP Comments:			
Photos:

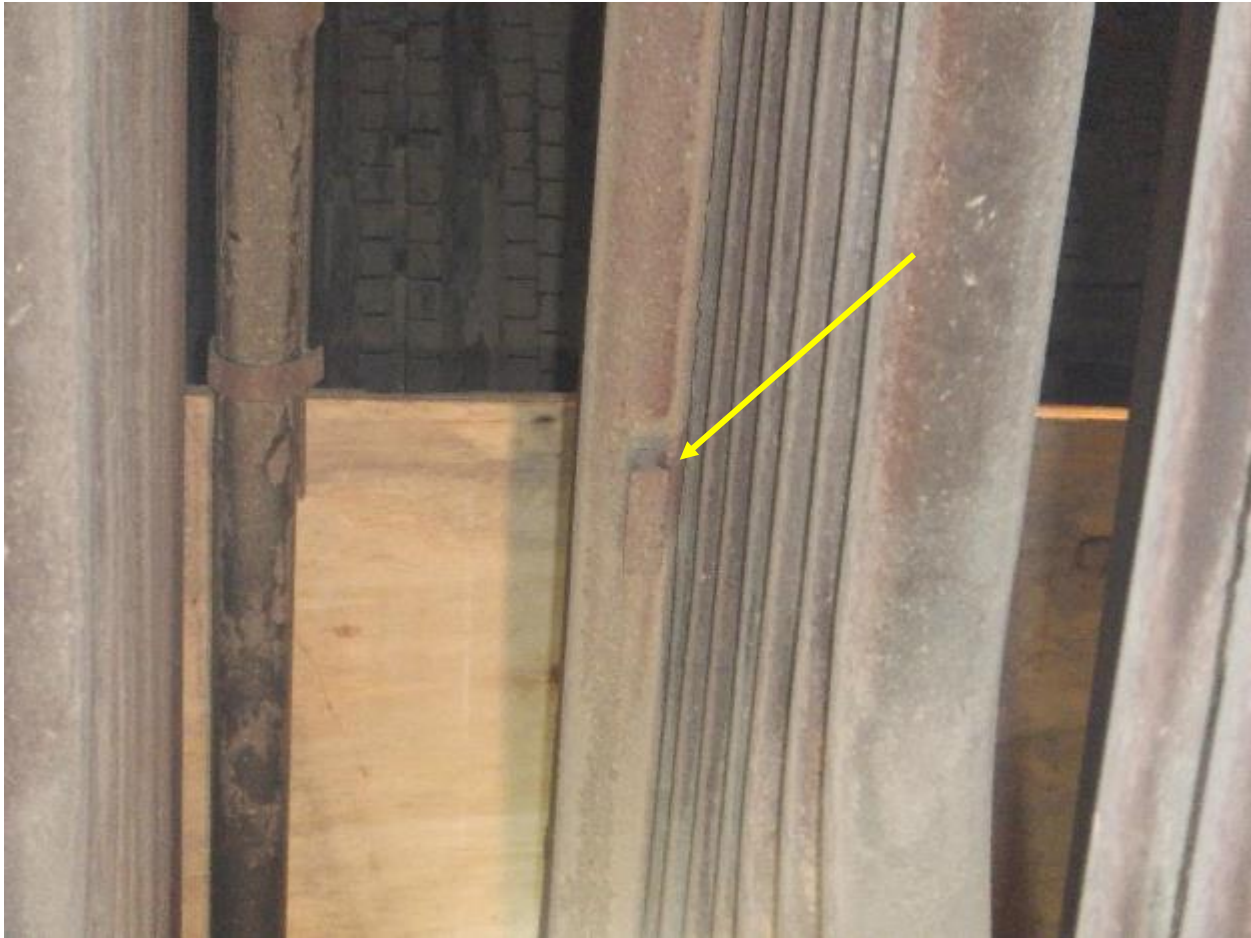
Date: 5/15/2023	Inspected by: B&W - CSH	Unit: 2	Item: RHFEND 3
Component Inspected: RH Front Pendant & Between SH Pendant Platens			
Condition Assessment: Scaffold Level 2: The WCS bilateral casting was overheated at the front of assembly 24.			
Recommendations: Continue to monitor, replacing the casting would result in a similar result to a new casting due to the two open (uncooled) spaces in the casting.			
Criticality: Information only.			
Risk if NOT Performed: None.			
EKP Comments:

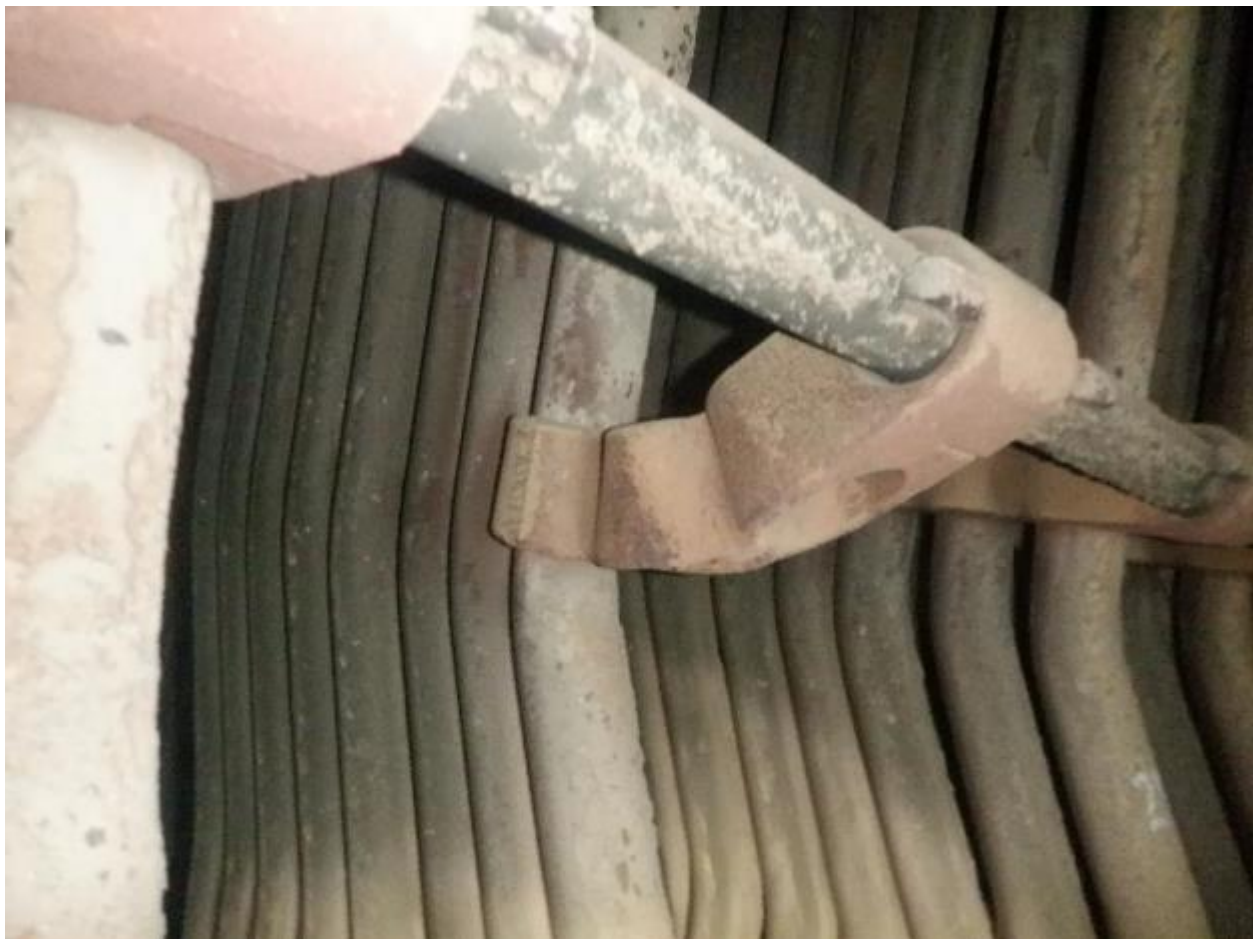
Date: 5/15/2023	Inspected by: B&W - CSH	Unit: 2	Item: RHFPEND 4
Component Inspected: RH Front Pendant & Between SH Pendant Platens			
Condition Assessment: Scaffold Level 7: The WCS U strap was overheated and cracked at the LHSW.			
Recommendations: Replace the U-strap.			
Criticality: P3			
Risk if NOT Performed: The strap could fail and allow the WCS tube to swing loose.			
EKP Comments:

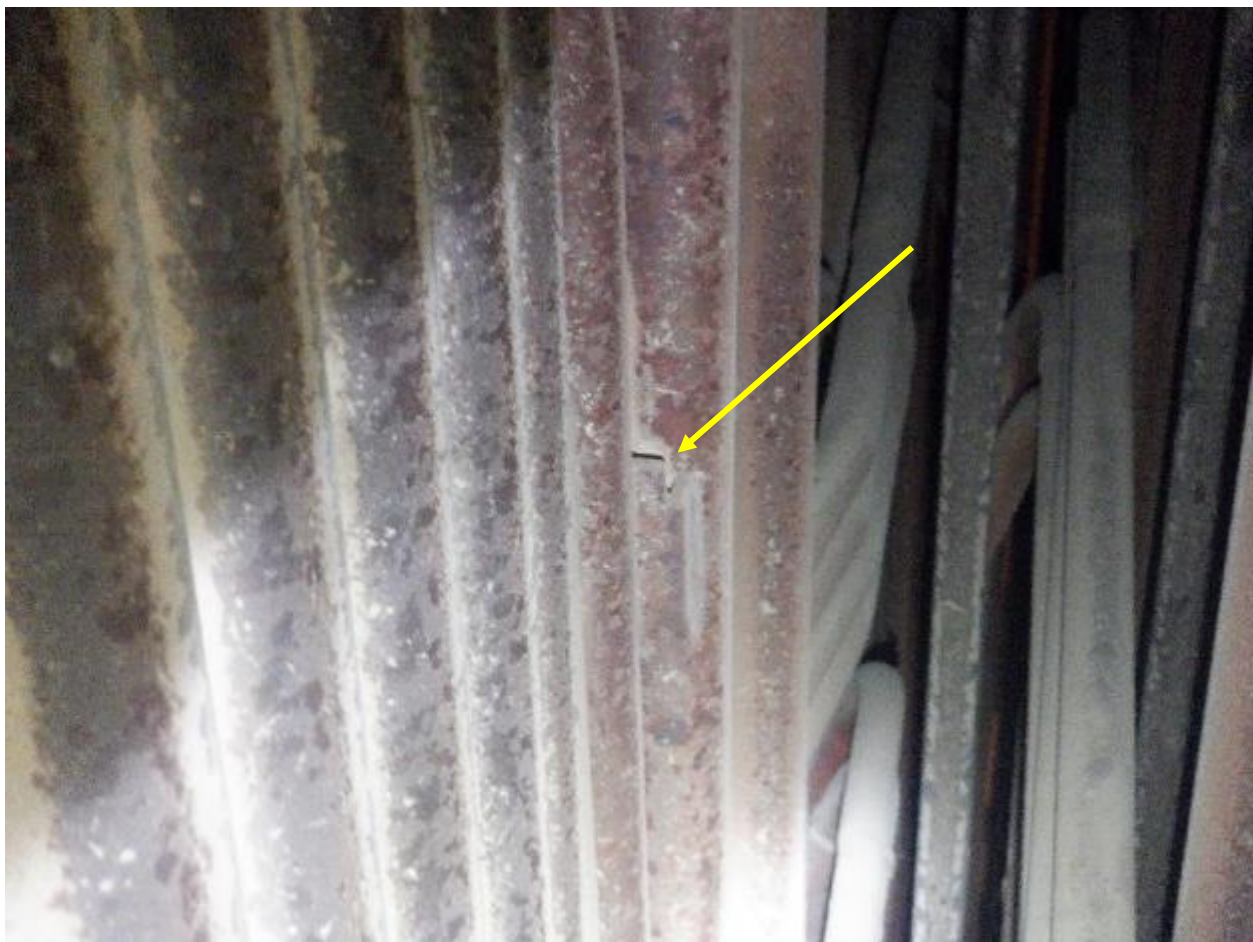
Date: 5/15/2023	Inspected by: B&W - CSH	Unit: 2	Item: RHPEND 6
Component Inspected: RH Front Pendant & Between SH Pendant Platens			
Condition Assessment: Scaffold Level 2: The WCS bilateral castings had cracked welds at the leading edge of assemblies: 3, 10, 16, 17, 20, 21, 22, 32 The incorrect bilateral model number SRC was used on assembly 3.			
Recommendations: Replace the bi-lateral castings.			
Criticality: P3			
Risk if NOT Performed: Casting failures which will lead to WCS deformation and the assemblies will be able to swing loose.			
EKP Comments:

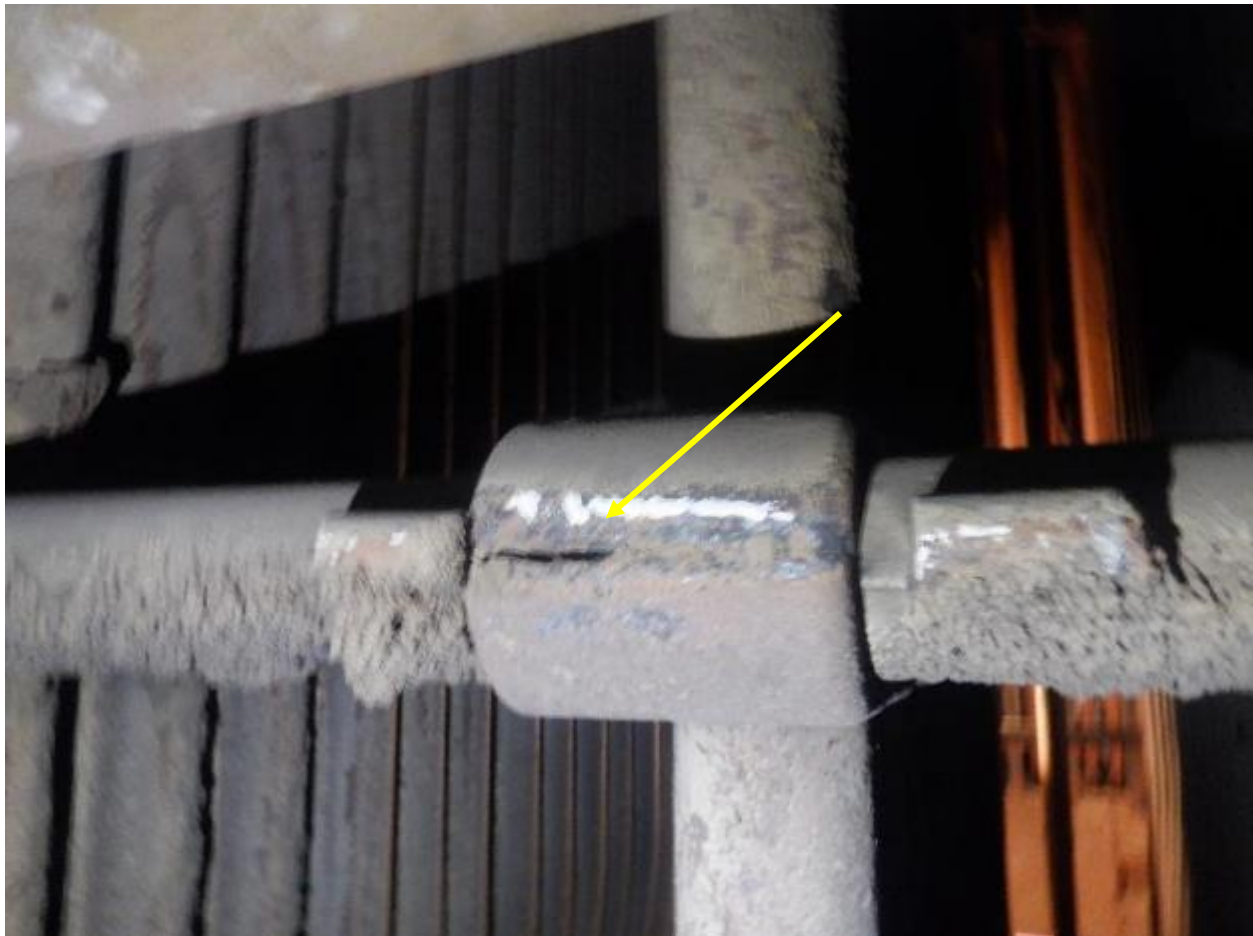
Date: 5/15/2023	Inspected by: B&W - CSH	Unit: 2	Item: RHFPEND 7
Component Inspected: RH Front Pendant & Between SH Pendant Platens			
Condition Assessment: Scaffold Level 3: Where the old shields were removed, there are wafer wheel cuts in the leading-edge tubes of assemblies: 10, 28, 31, 33-37.			
Recommendations: Remove the remaining portion of the shield and install a padweld over the cuts. RH Inlet Tubes are 2.50" OD x .165" MW, SA213TP304H.			
Criticality: P3			
Risk if NOT Performed: Tube failure if wear occurs at the thinned locations.			
EKP Comments:

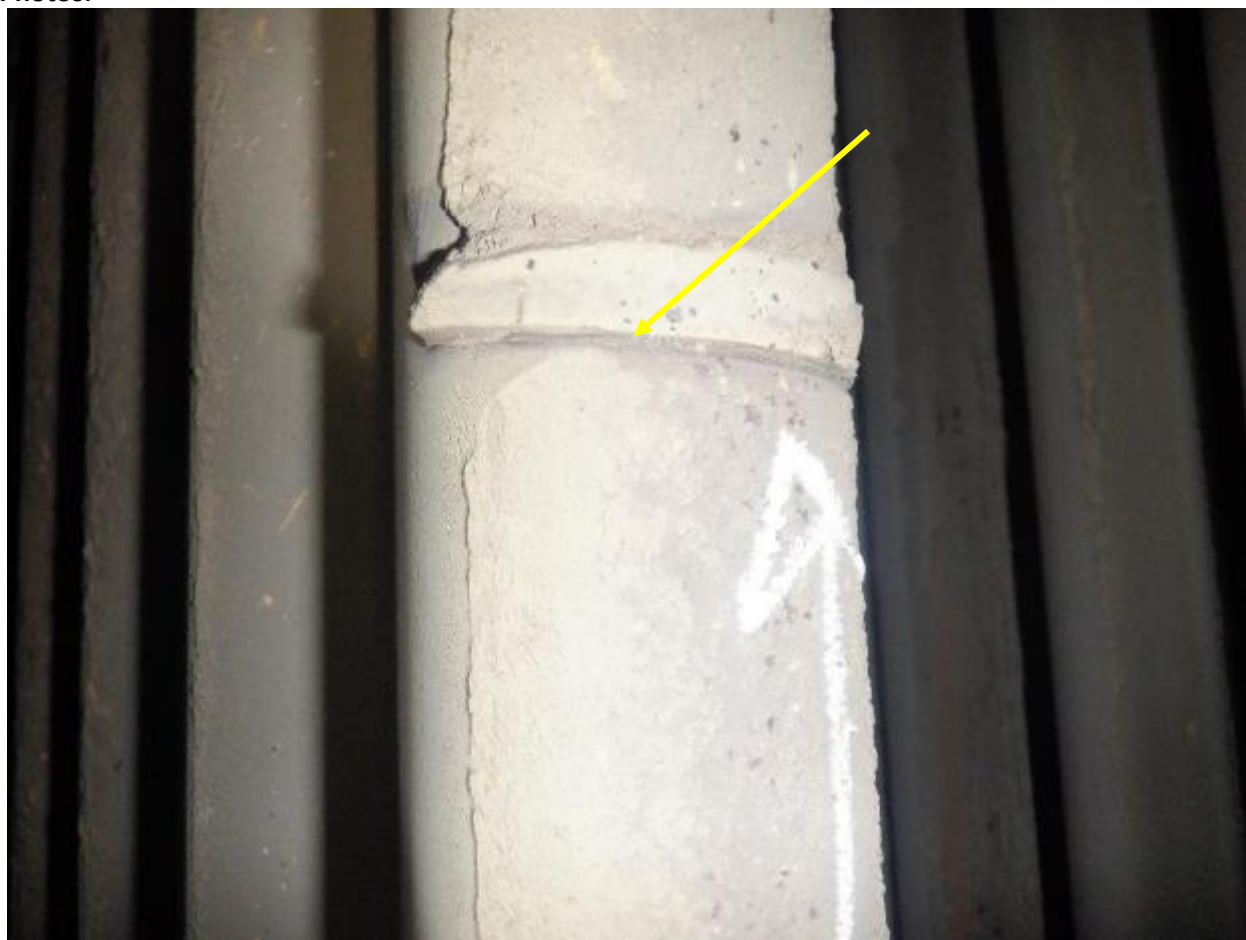
Date: 5/15/2023	Inspected by: B&W - CSH	Unit: 2	Item: RHPEND 8
Component Inspected: RH Front Pendant & Between SH Pendant Platens			
Condition Assessment: Scaffold Level 1: There was minor corrosion damage, likely carburization, on the leading edge of assemblies(UT): 24(.148), 26(.140), 28(.143) UT readings were performed at the worst appearing tubes. The damage appeared to be localized to the center of the boiler from the bottom bend up about three feet.			
Recommendations: Schedule at UT survey and monitor status during future outages.			
Criticality: P3			
Risk if NOT Performed: Tube failure if damage worsens.			
EKP Comments:			
Photos:

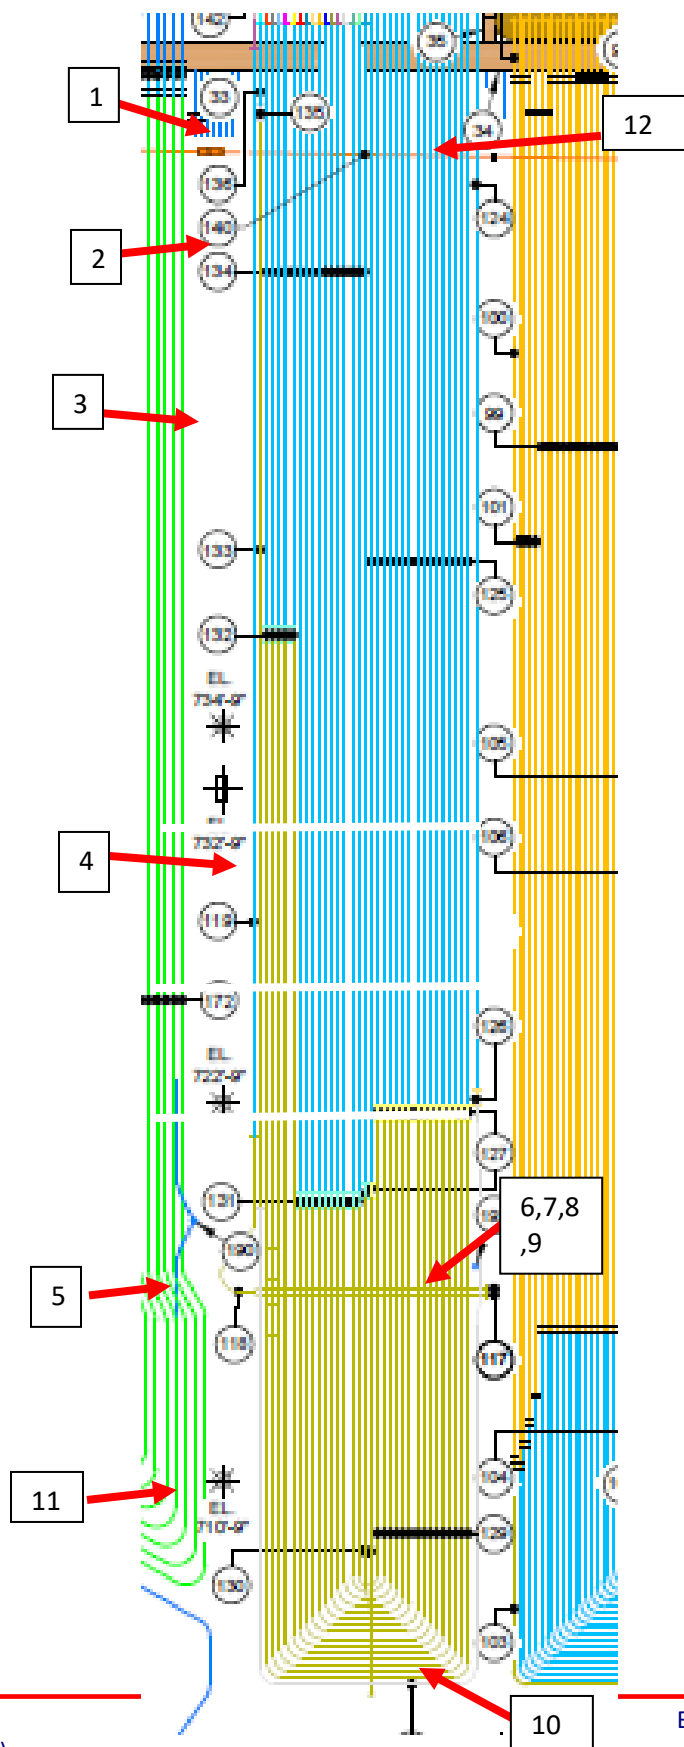
Date: 05/15/23	Inspected by: B&W ECC	Unit: 2	Item: SHPENDPL 1
Component Inspected: SH Pendant Platens & Between SH Division Panels			
Condition Assessment: Scaffold elevation 5 element 1 & 2: Mechanical damage to the training edge tube. The tube was likely bent during installation. Some tool marking are present in element 2 trailing edge tube. The tube is still in plan with the element.			
Recommendations: When installing sections make sure the elements are properly rigged to prevent damage.			
Criticality: Noted for future inspections			
Risk if NOT Performed:			
EKP Comments:			
Photos:

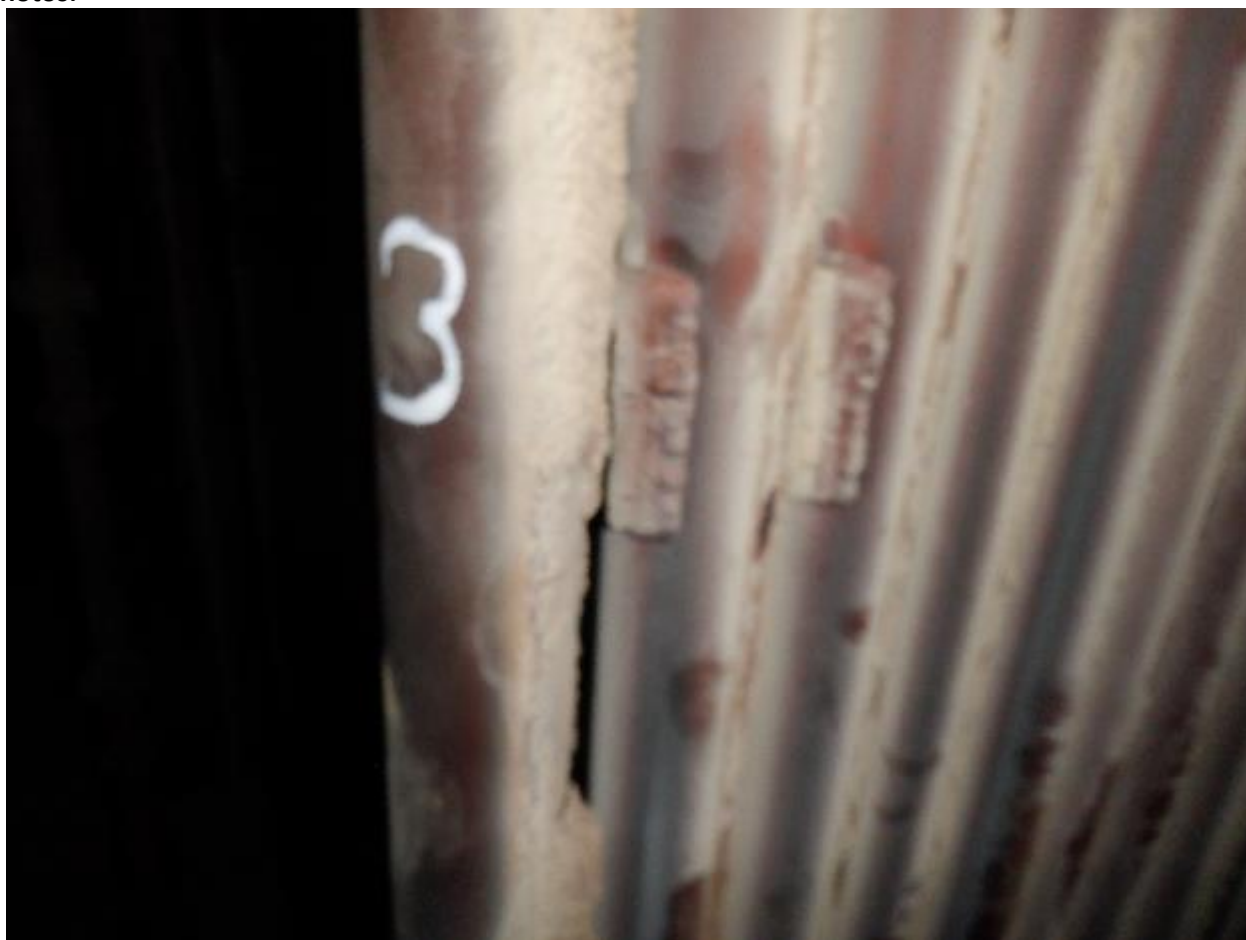
Date: 05/15/23	Inspected by: B&W ECC	Unit: 2	Item: SHPENDPL 5
Component Inspected: SH Pendant Platens & Between SH Division Panels			
Condition Assessment Scaffold Elevation 3: Ties on the wrap-around tube of the element have indications in the welds or missing welds on elements 7 and 21.			
Recommendations: Grind out the indication and weld. Weld areas where the welds are missing.			
Criticality: P3			
Risk if NOT Performed: Tie could fall off. Alignment would be maintained from the slip spacers.			
EKP Comments:

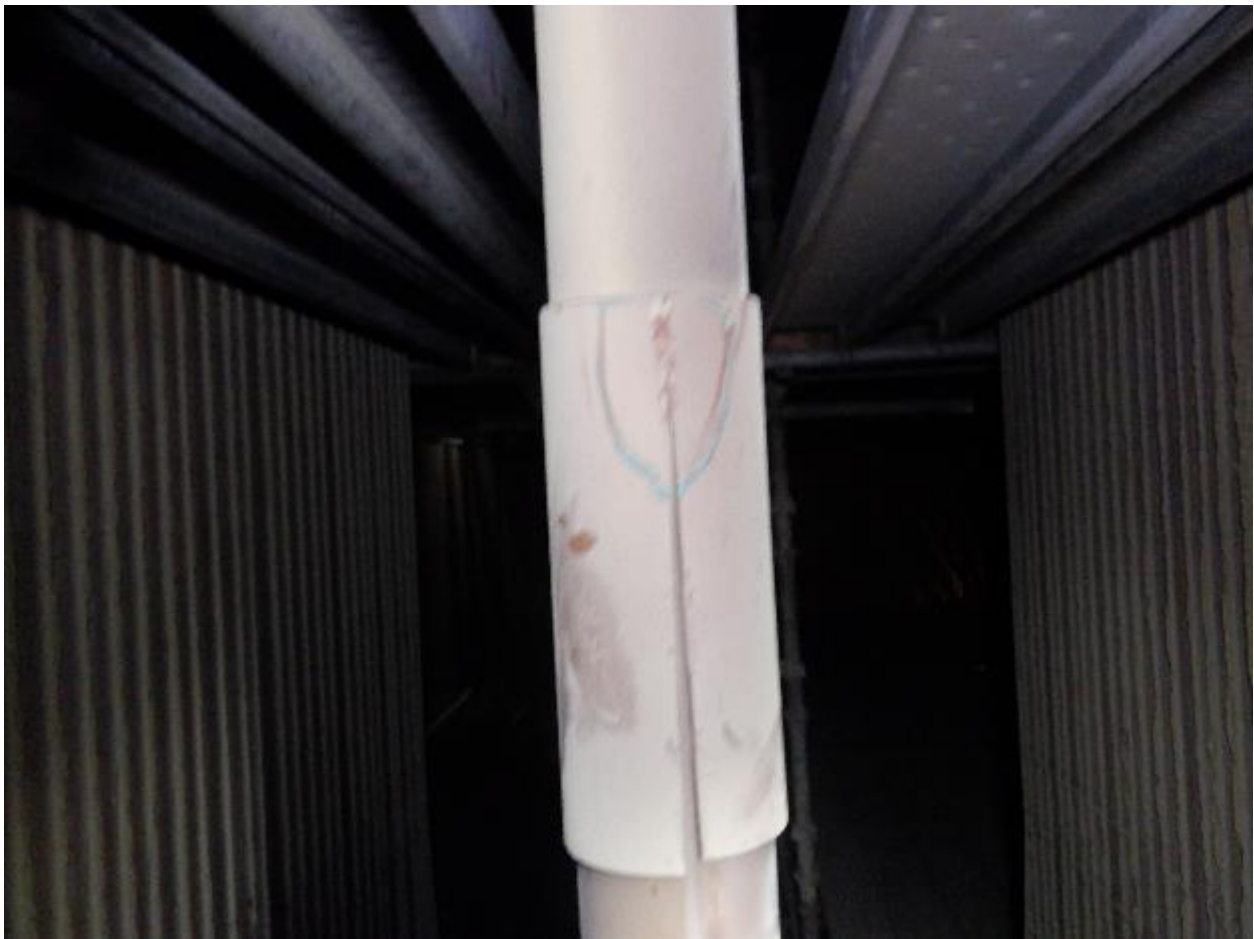
Date: 05/15/23	Inspected by: B&W ECC	Unit: 2	Item: SHPENDPL 6
Component Inspected: SH Pendant Platens & Between SH Division Panels			
Condition Assessment: Water cooled spacer tube: The spacer is very worn from contact with the element tube on tubes: 3, 6

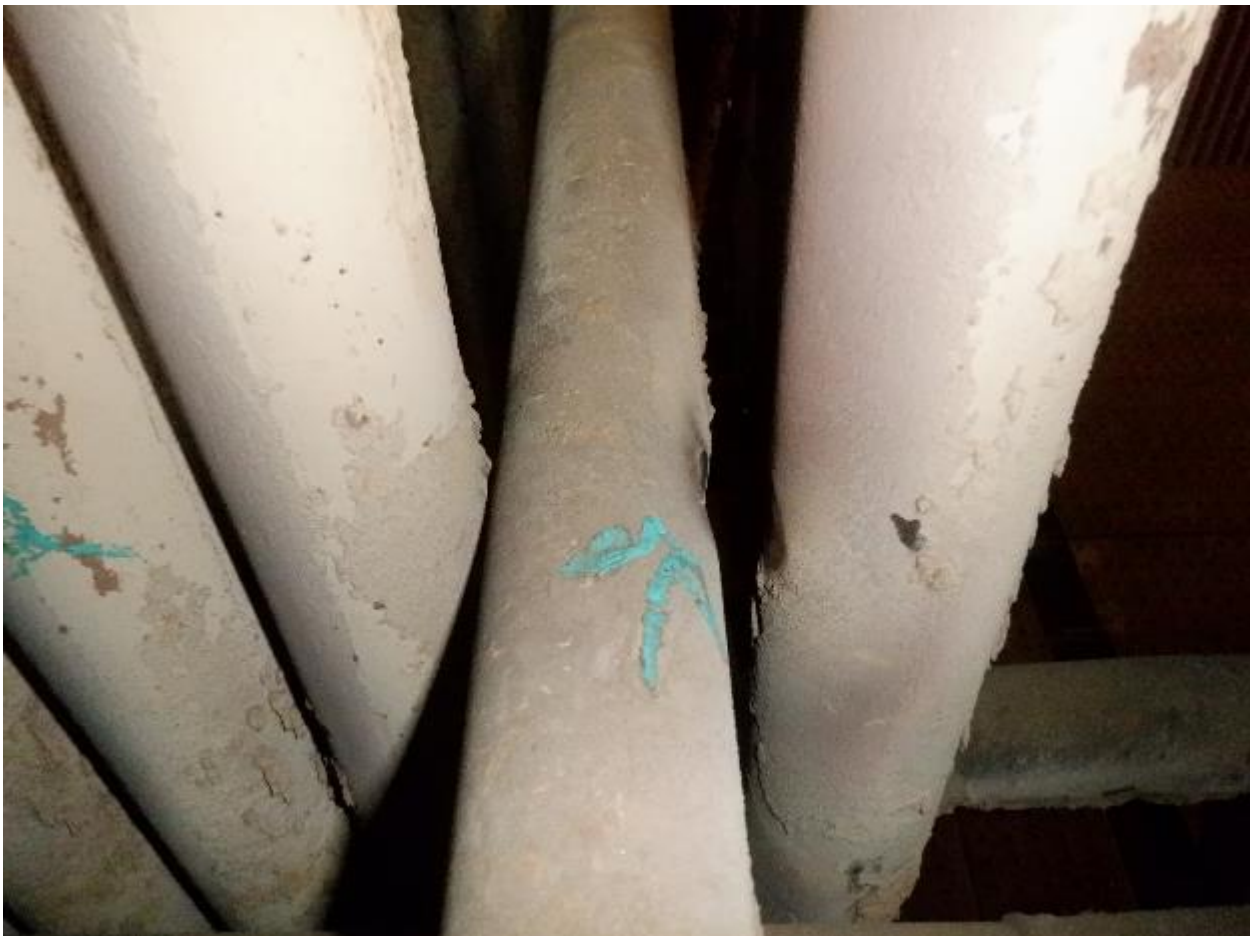
Date: 05/15/23	Inspected by: B&W ECC	Unit: 2	Item: SHPENDPL 7
Component Inspected: SH Pendant Platens & Between SH Division Panels			
Condition Assessment water cooled spacer tube: The spacer is worn from contact with the element tube on tubes: 17

Recommendations: Install a tube shield on the water cooled spacer.			
Criticality: P3			
Risk if NOT Performed: The water cooled spacer tube could fail as wear continues.			
EKP Comments:			
Photos:

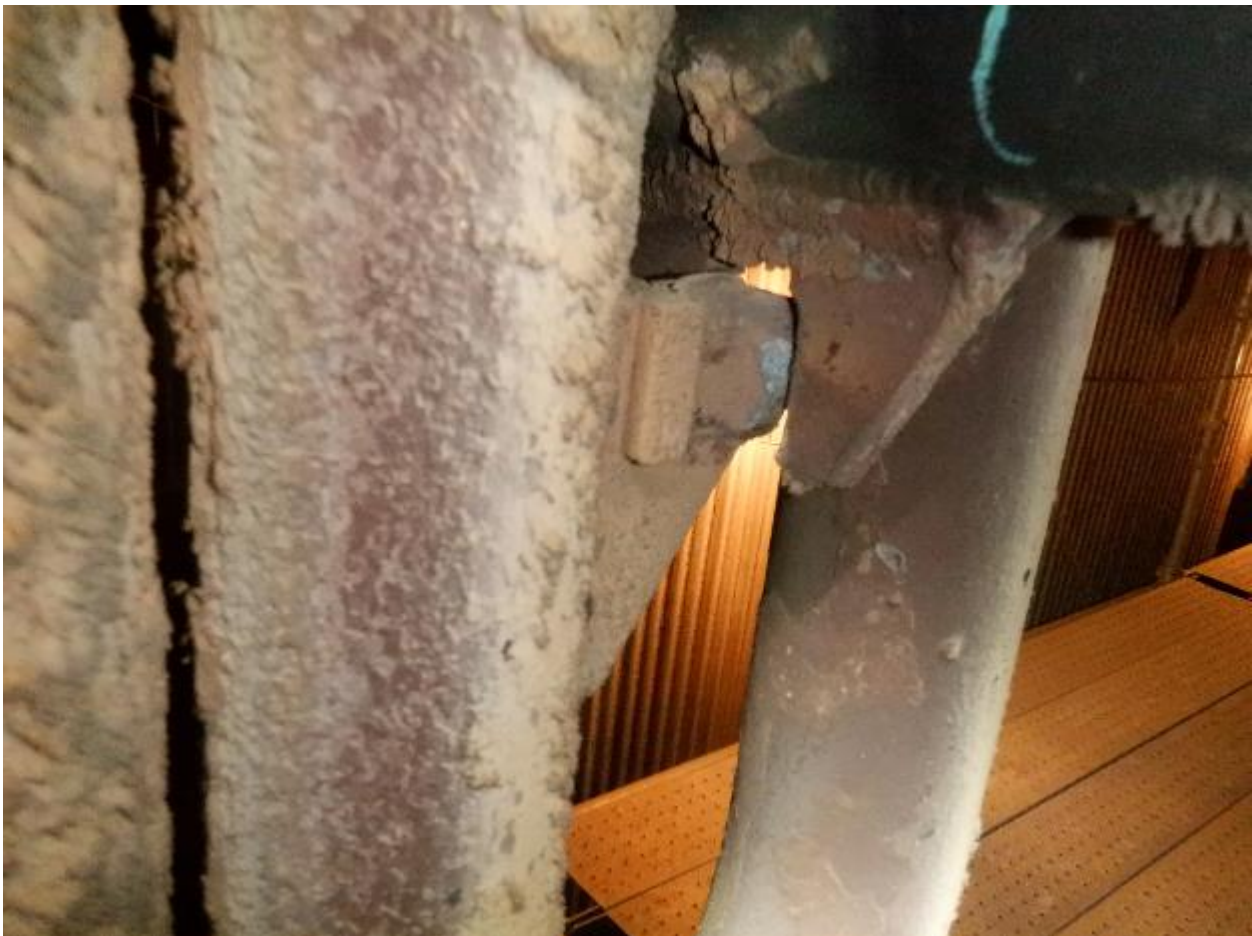
Date: 05/15/23	Inspected by: B&W ECC	Unit: 2	Item: SHPENDPL 9
Component Inspected: SH Pendant Platens & Between SH Division Panels			
Condition Assessment: The top wrap around tube on element 21 has a gouge at the cross between the pendent superheater and division panel.			
Recommendations: Pad weld the gouge.			
Criticality: P3			
Risk if NOT Performed: Damage could continue to failure.			
EKP Comments:			
Photos:
