The Babcock & Wilcox Company

**Eastern Kentucky Power Cooperative
Spurlock Station, Unit #2**

U2 SPRING 2023 OUTAGE BOILER INSPECTION REPORT

B&W Project No.: BA9312817

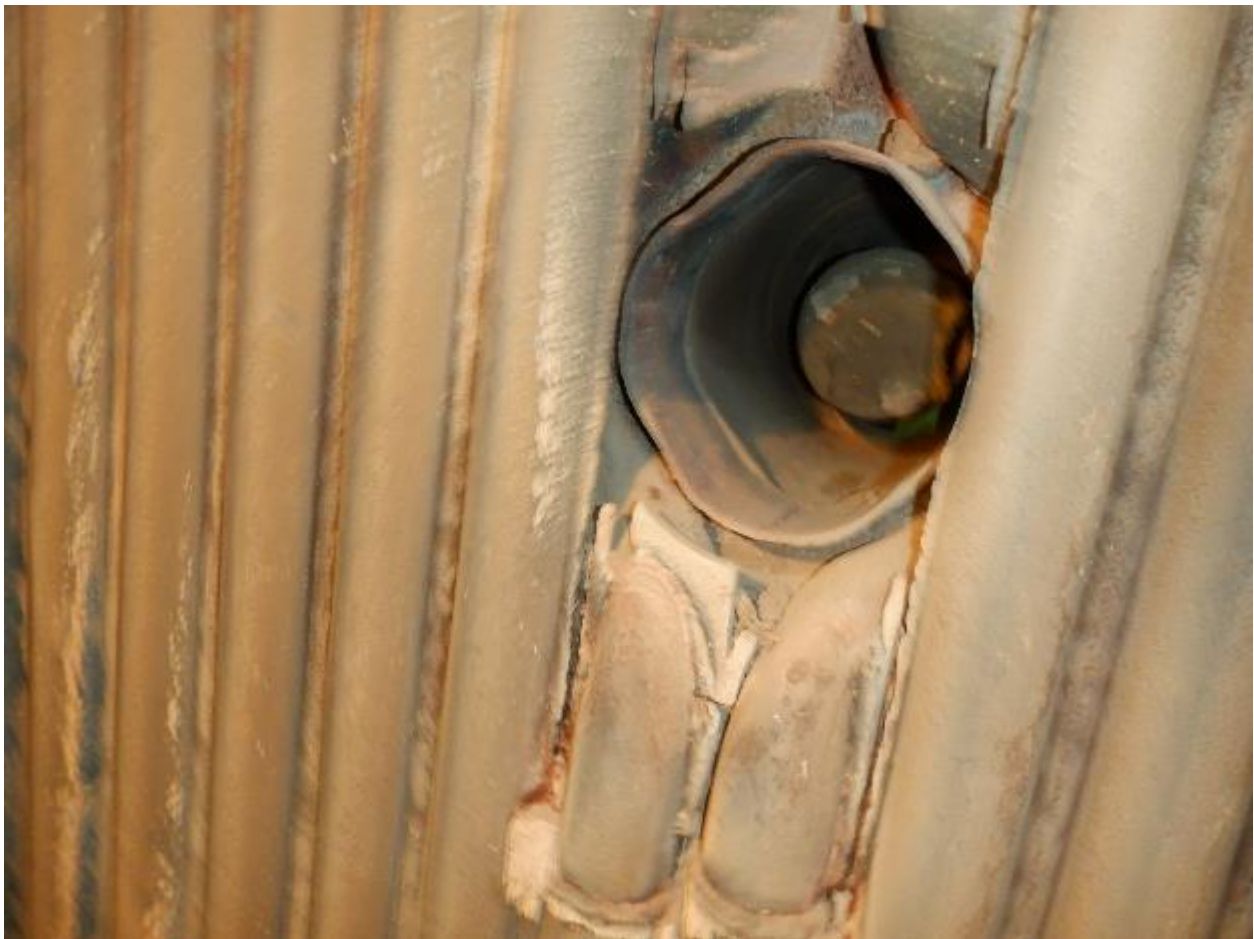
Date: 05/15/23	Inspected by: B&W ECC	Unit: 2	Item: SHPENDPL 12
Component Inspected: SH Pendant Platens & Between SH Division Panels			
Condition Assessment: The right side furnace pressure tap on scaffold elevation 6 between the division panel and pendent superheat is missing refractory box plate at 4 o'clock.			
Recommendations: Replace the refractory box plate.			
Criticality: P3			
Risk if NOT Performed: Damage to refractory.			
EKP Comments:

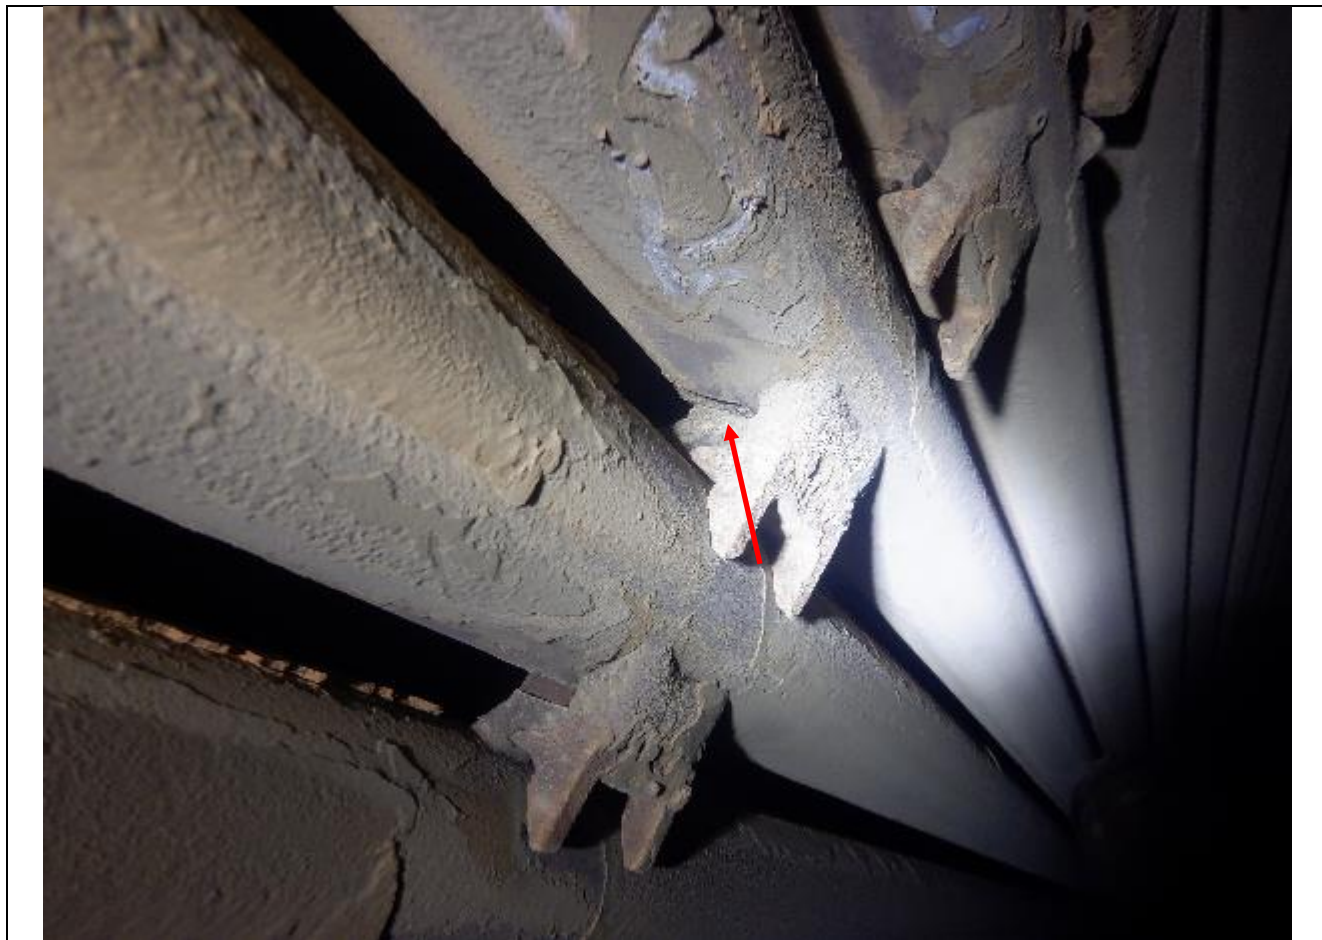
Date: 05/15/2023	Inspected by: B&W RJP	Unit: 2	Item: SHDIVPAN 5
Component Inspected: SH Division Panels, Landing #3, Rear Panel #6			
Condition Assessment: There was moderate bowing at pendants 60-65.			
Recommendations: Monitor condition for future outages.			
Criticality: P3			
Risk if NOT Performed: Pendants may continue bow.			
EKP Comments:

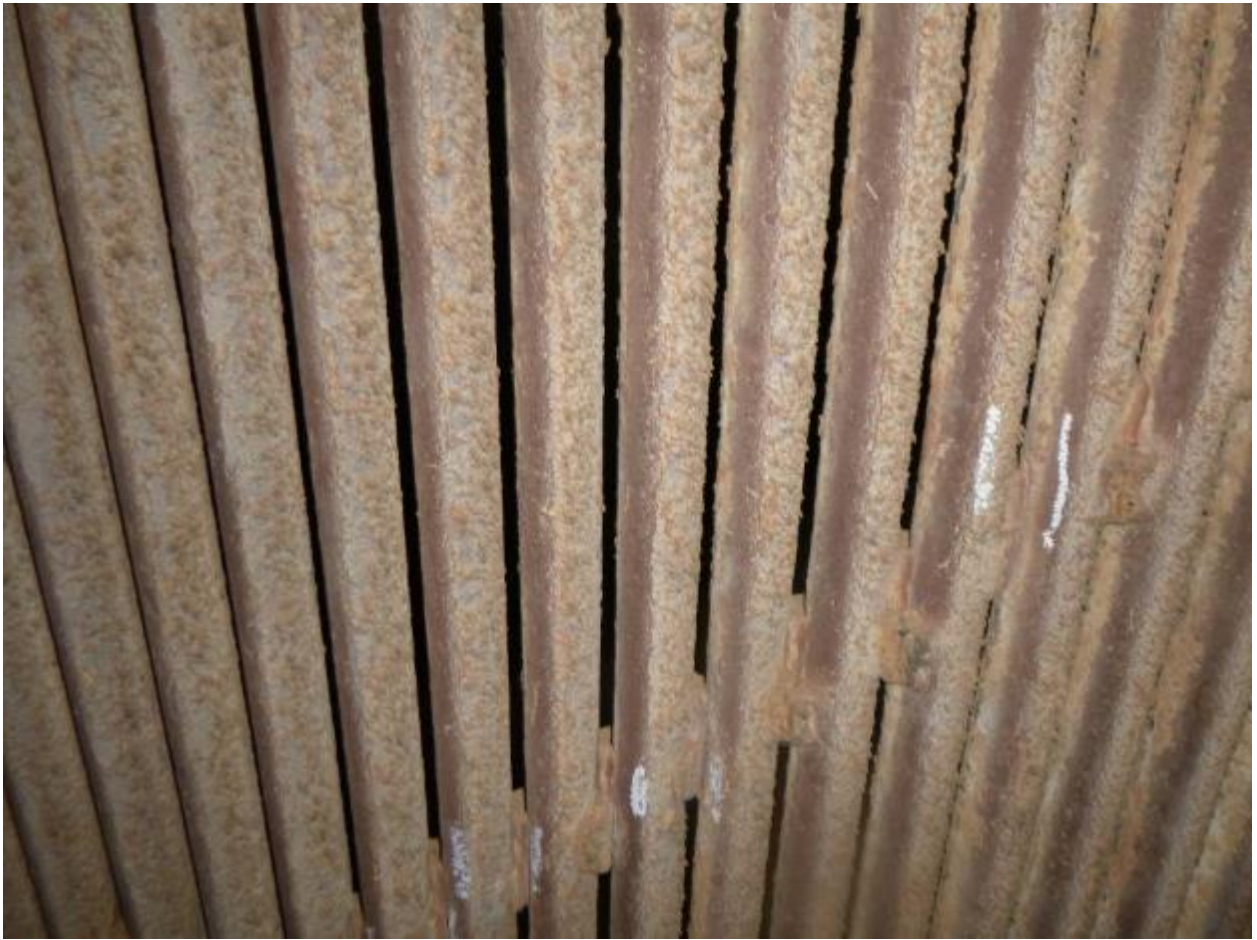
Date: 05/15/2023	Inspected by: B&W RJP	Unit: 2	Item: SHDIVPAN 7
Component Inspected: SH Division Panels, Landing #1, Rear Panel #4			
Condition Assessment: There was a broken alignment lug at the center of the panel.			
Recommendations: Repair weld the broken lug.			
Criticality: P3			
Risk if NOT Performed: Tube misalignment.			
EKP Comments:

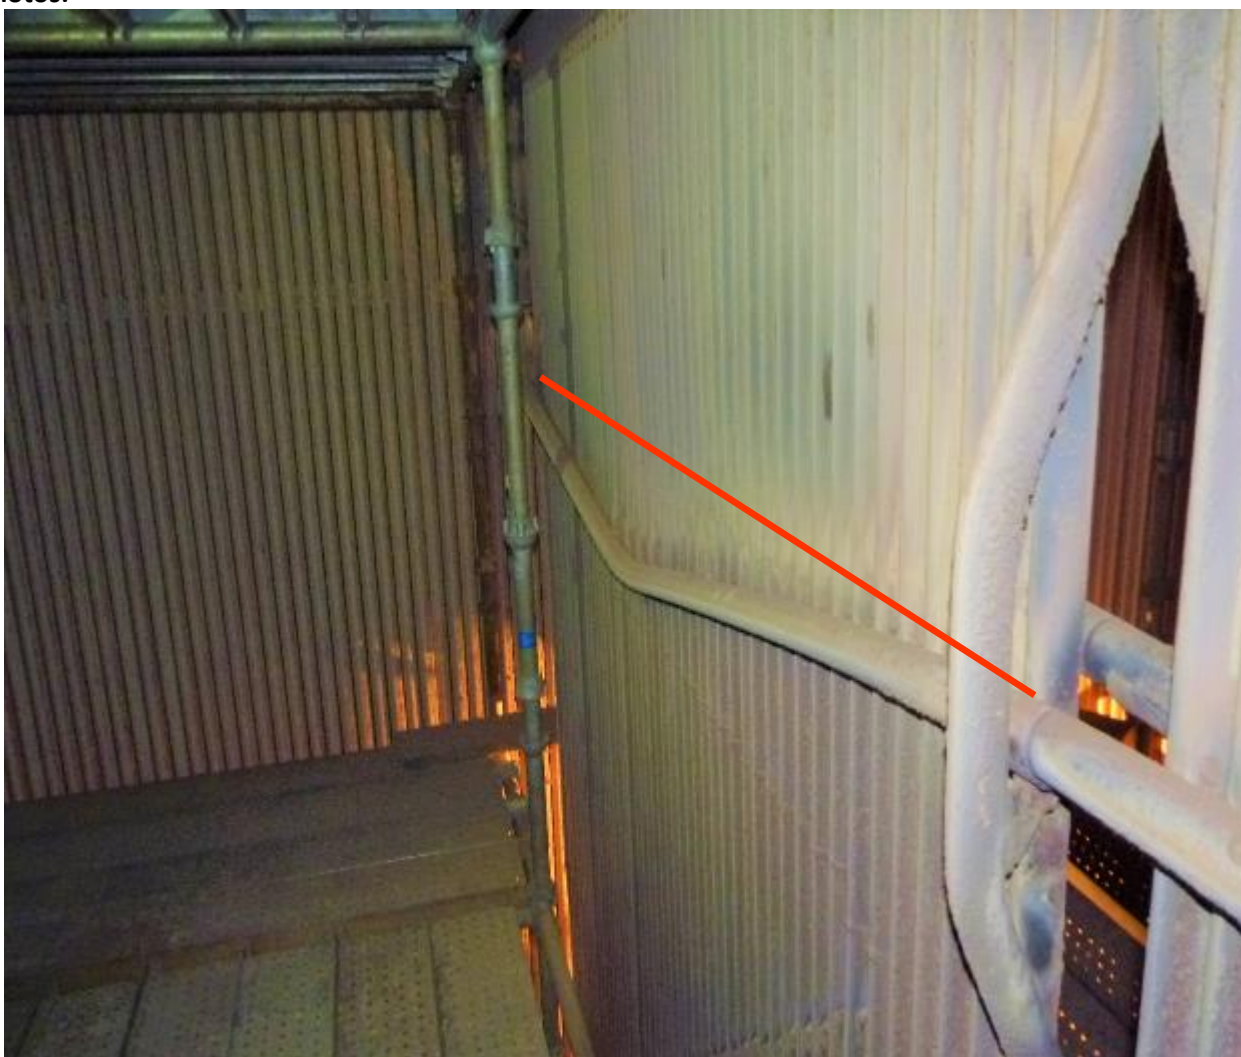
Date: 05/15/2023	Inspected by: B&W BC	Unit: 2	Item: SHDIVPAN 9
Component Inspected: SH Division Panels			
Condition Assessment: Scaffold Level 2: The lower bumper wear sleeves have cracked in multiple locations			
Recommendations: V out the crack with a burr bit, weld the crack and grind the sleeve face flush.			
NOTE: Material of sleeve is unknown. Prior to welding determine material so a proper weld procedure can be used to prevent damage/cracking of the sleeve.			
Criticality: P3			
Risk if NOT Performed: Crack could grow, the sleeve could fail, and the tube could be left unprotected/susceptible to mechanical erosion.			
EKP Comments:

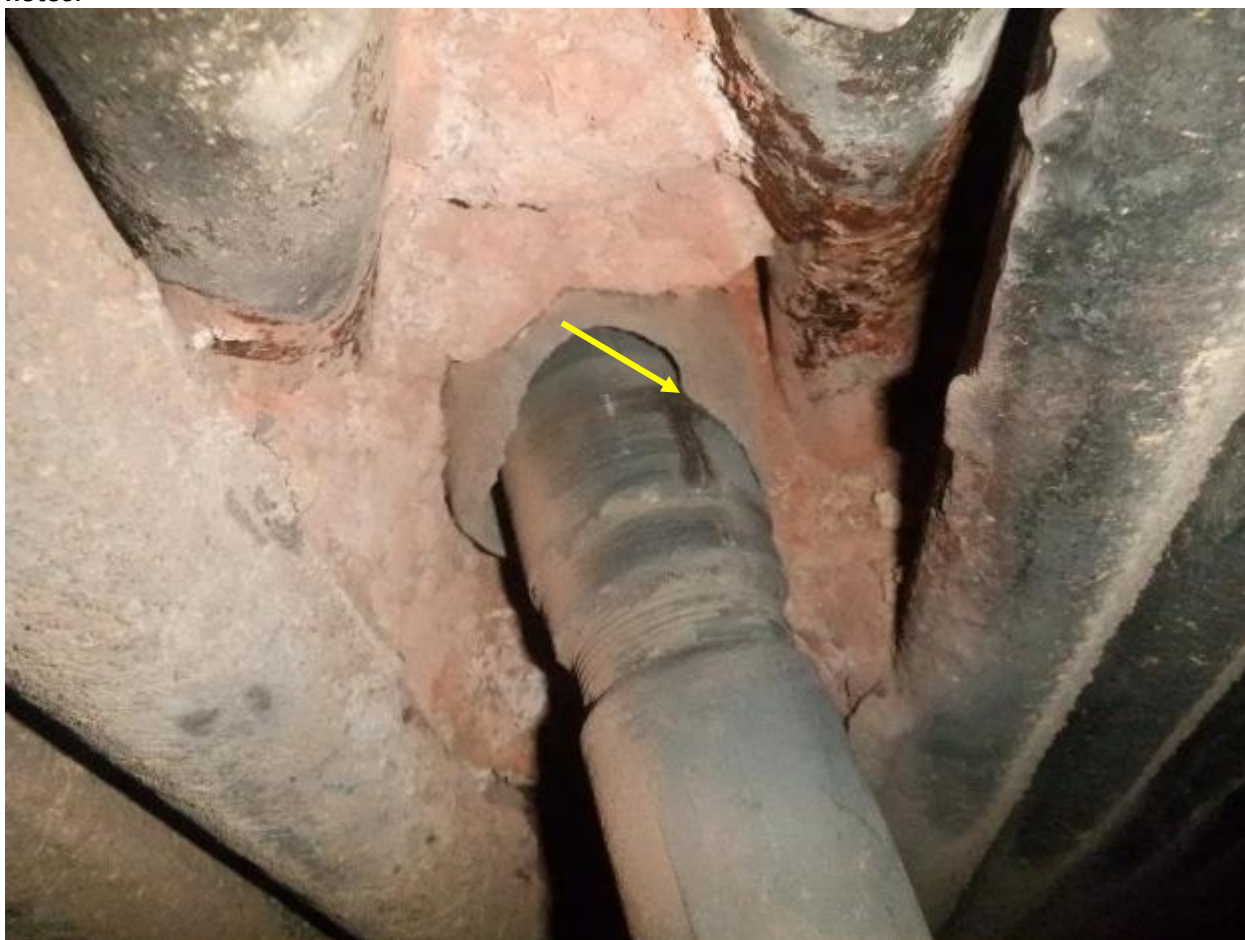
Date: 5/16/2023	Inspected by: B&W	Unit: 2	Item: WW 3
Component Inspected: Water Walls			
Condition Assessment: LHSW Scaffold Level 6: There was a hole in the nozzle at IR 46.			
Recommendations: Replace the IR nozzle.			
Criticality: P3			
Risk if NOT Performed: IF the nozzle tip fails, slag will build up because the IR cannot effectively clean the wall because it is blowing straight into the furnace.			
EKP Comments:

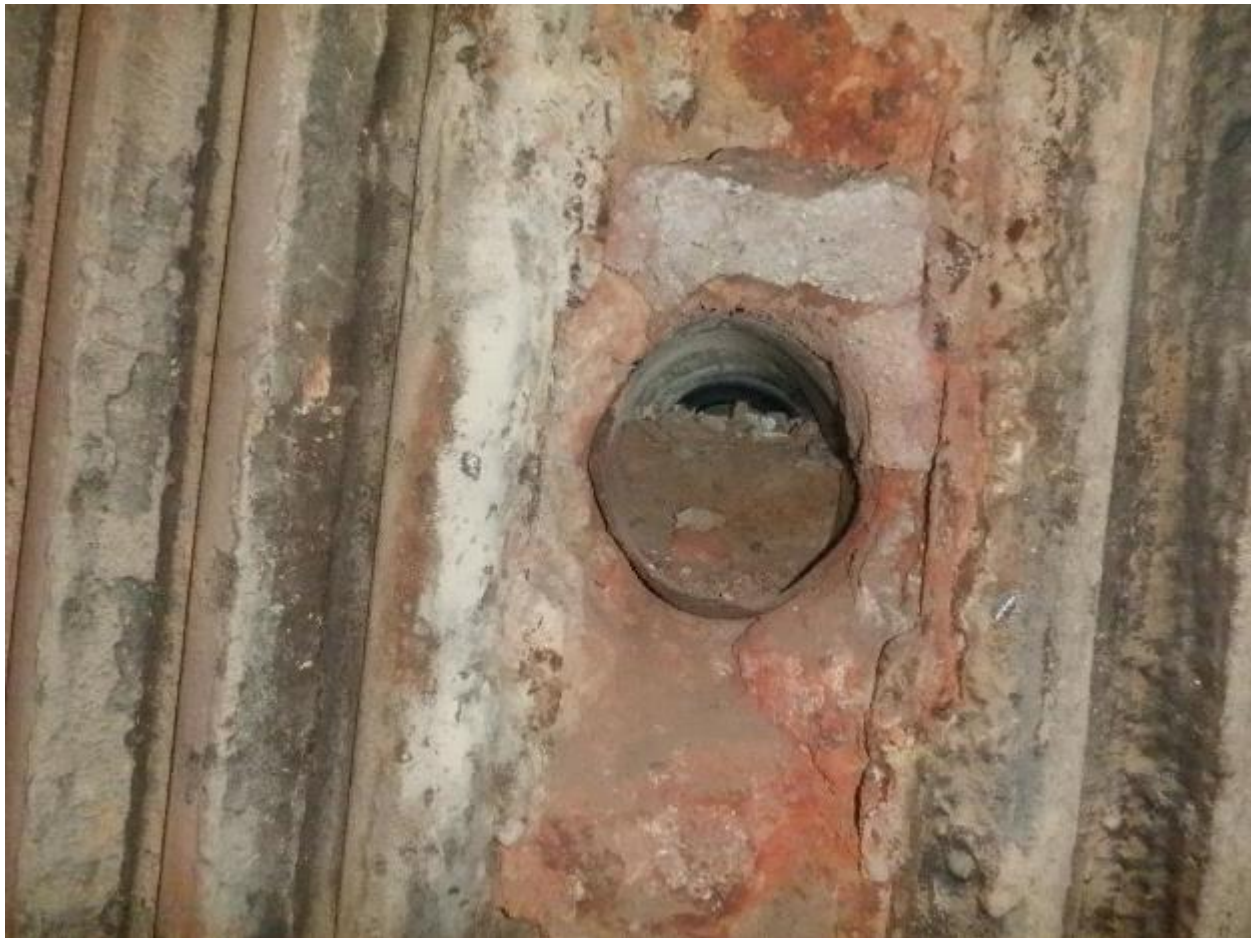
Date: 5/16/2023	Inspected by: B&W	Unit: 2	Item: WW 5
Component Inspected: Water Walls			
Condition Assessment: RW and RHSW Scaffold Level 7: The slag buster points were cracked at IR 30 (RW) and IR 36 (RHSW).			
Recommendations: Replace the IR nozzle.			
Criticality: P3			
Risk if NOT Performed: If the cracked protrudes and the nozzle tip fails, slag will build up because the IR cannot effectively clean the wall because it is blowing straight into the furnace.			
EKP Comments:

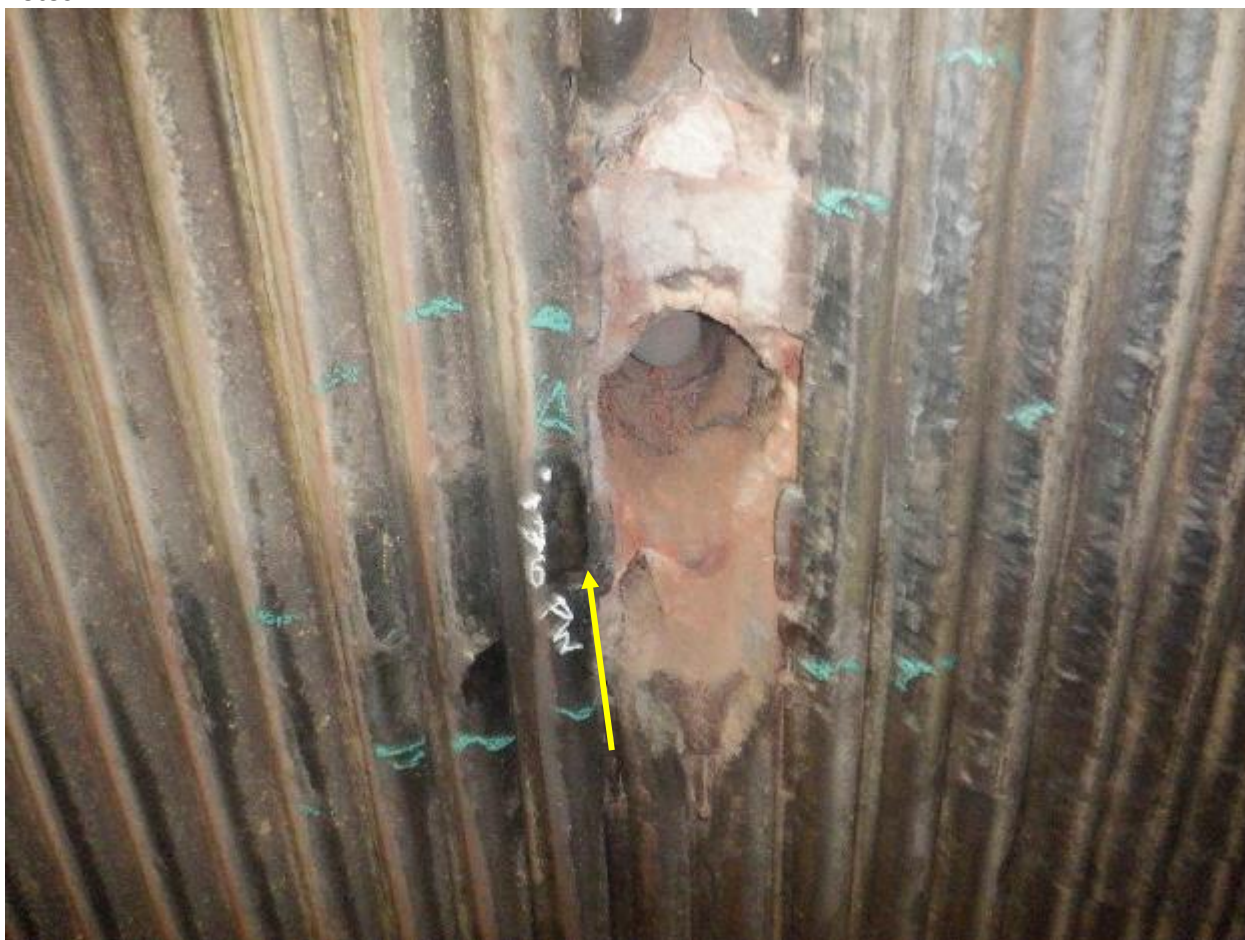
Date: 5/16/2023	Inspected by: B&W	Unit: 2	Item: WW 7
Component Inspected: Water Walls			
Condition Assessment: There was minor refractory damage at the following observation door locations.			
Wall	Location	Scaffold Elevation	
LHSW	At FW and RW corners	7	
FW	At RHSW corner	10	
RW	At RHSW and LHSW corners	10	
RW	At RHSW corner	13	
Recommendations: Replace the refractory.			
Criticality: P3			
Risk if NOT Performed: Refractory will continue to deteriorate and could overheat the wallbox.			
EKP Comments:

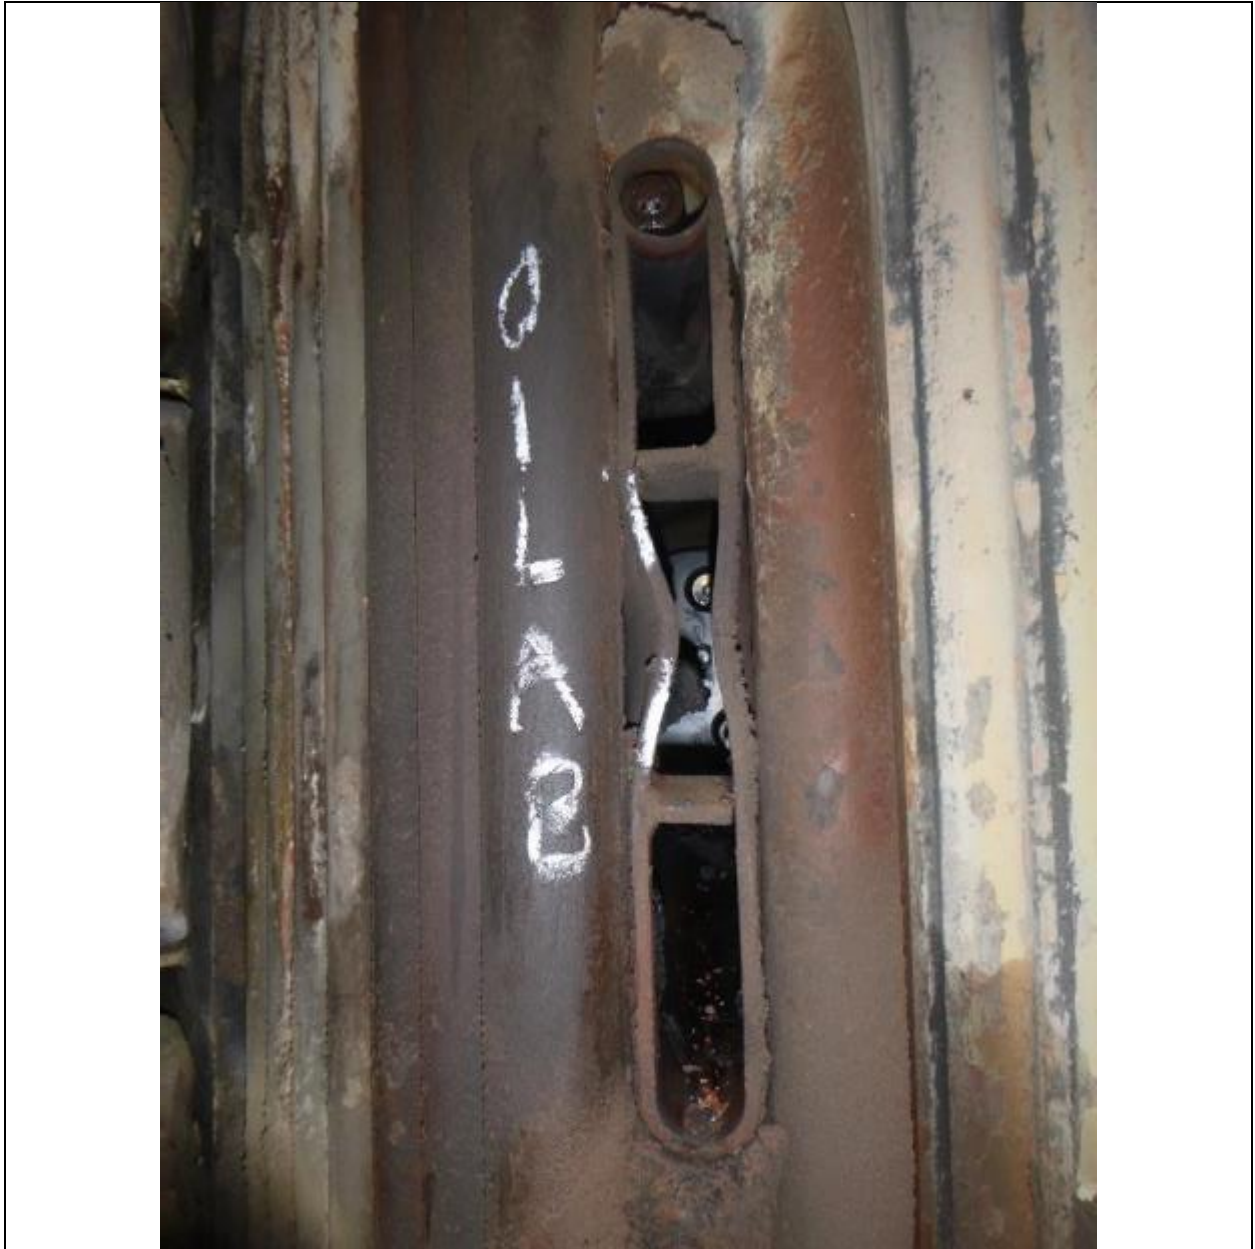
Date: 5/15/2023	Inspected by: BC	Unit: 2	Item: Burner 8
Component Inspected: B3			
Condition Assessment: Splitter plates were found missing and debris has collected in the burner opening			
Recommendations: Replace the burner tip. If not replacing, replace splitter plates and straighten the bottom of the tip and weld to the stiffeners on the bottom of the plate.			
Criticality: P2			
Risk if NOT Performed: Burner fires.			
EKP Comments:

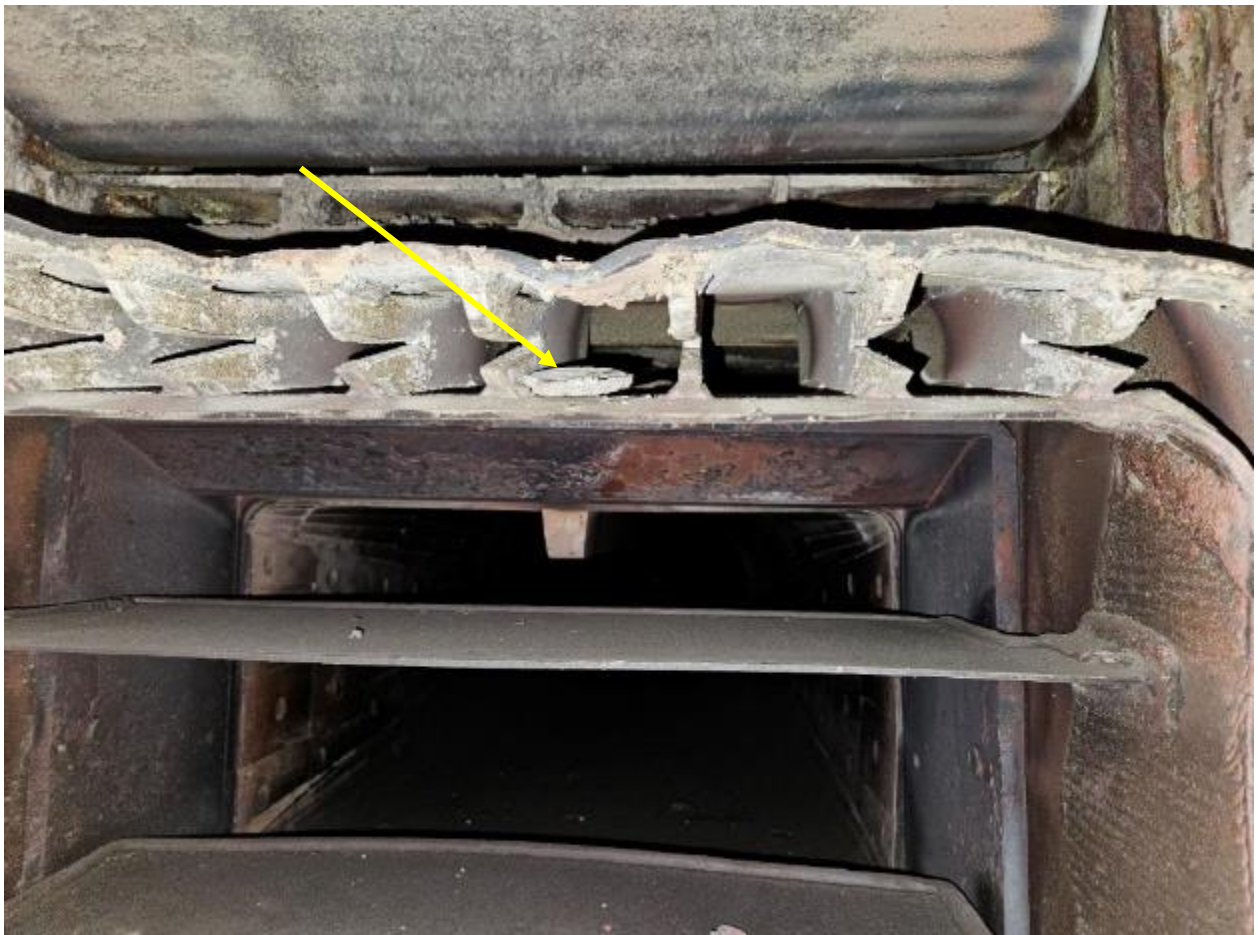
Date: 5/19/2023	Inspected by: B&W -CSH	Unit: 2	Item: BURNERS 13
Component Inspected: Burners – All Corners			
Condition Assessment: There were cracks in most of the CFS, SOFA, existing burner parts. See the following sheet for locations and sizes of weld repairs.			
Recommendations: Weld the cracks. New plates may be required to straighten the tips.			
Criticality: P2			
Risk if NOT Performed: Burner parts will fail prematurely.			
EKP Comments:

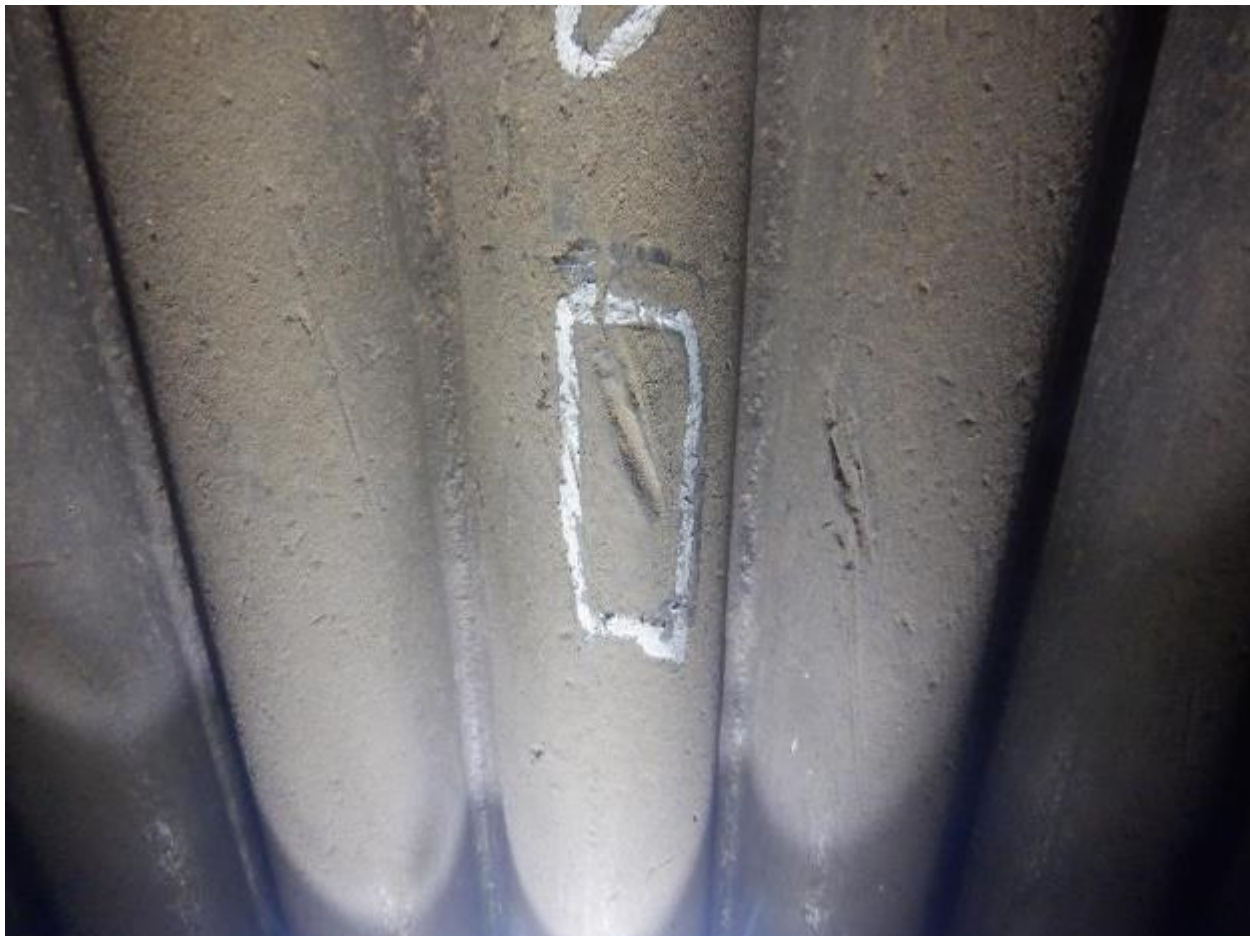
Date: 5/16/23	Inspected by: B&W ECC	Unit: 2	Item: CSLOPES 2																							
Component Inspected: Coutant Slopes																										
Condition Assessment: Rear Slope – Minor Gouges were discovered throughout and the worst are listed below:

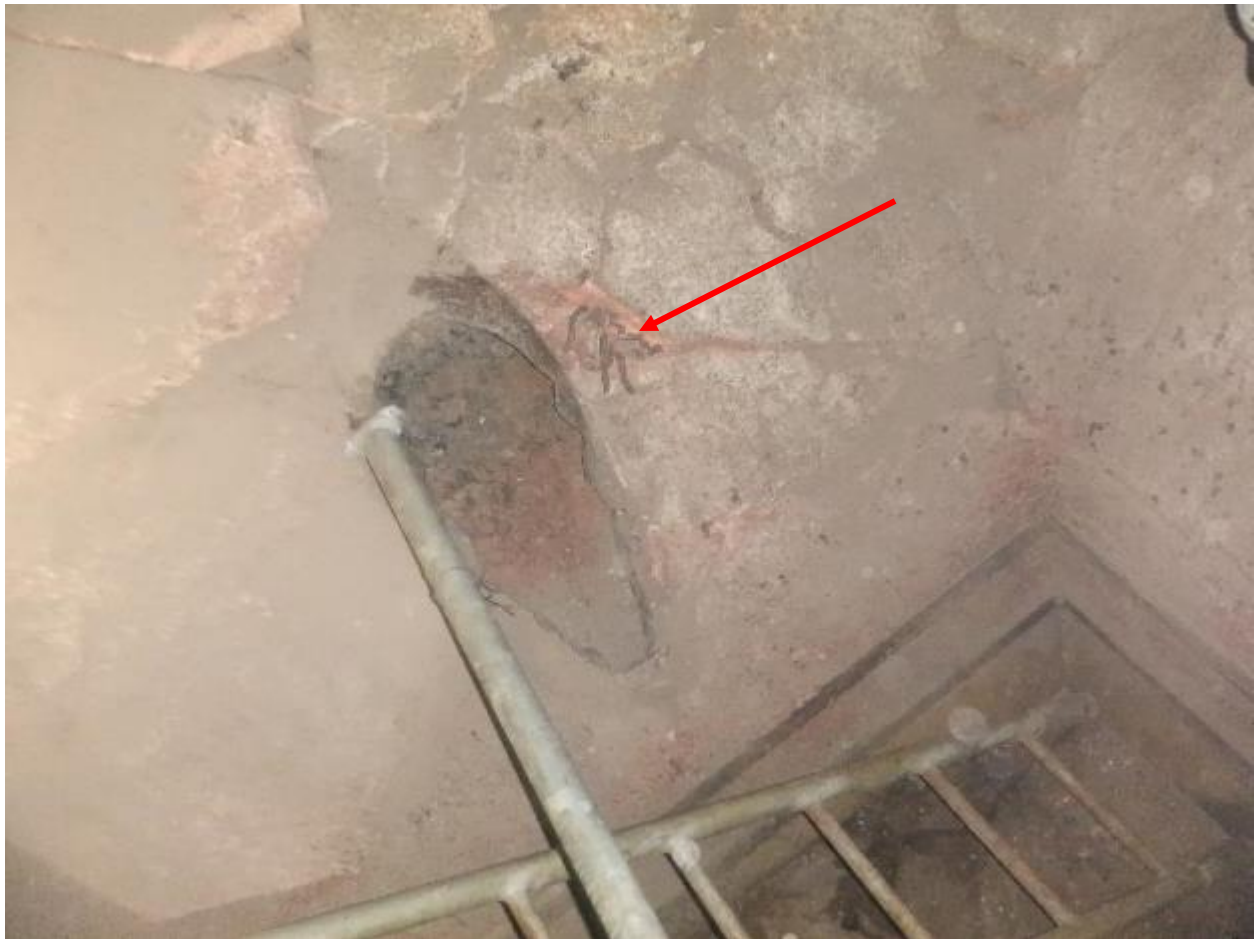
Date: 5/16/2023	Inspected by: B&W	Unit: 2	Item: ASHHOP 3
Component Inspected: Ash Hopper and Throat Tubes from Dance Floor			
Condition Assessment: The knife gates at hoppers A and D weren't fully closed.			
Recommendations: Stroke dampers and rebuild the seal above the gates on D hopper.			
Criticality: P3			
Risk if NOT Performed: If the knife gate is open while the unit is online, ash can go through the opening.			
EKP Comments:

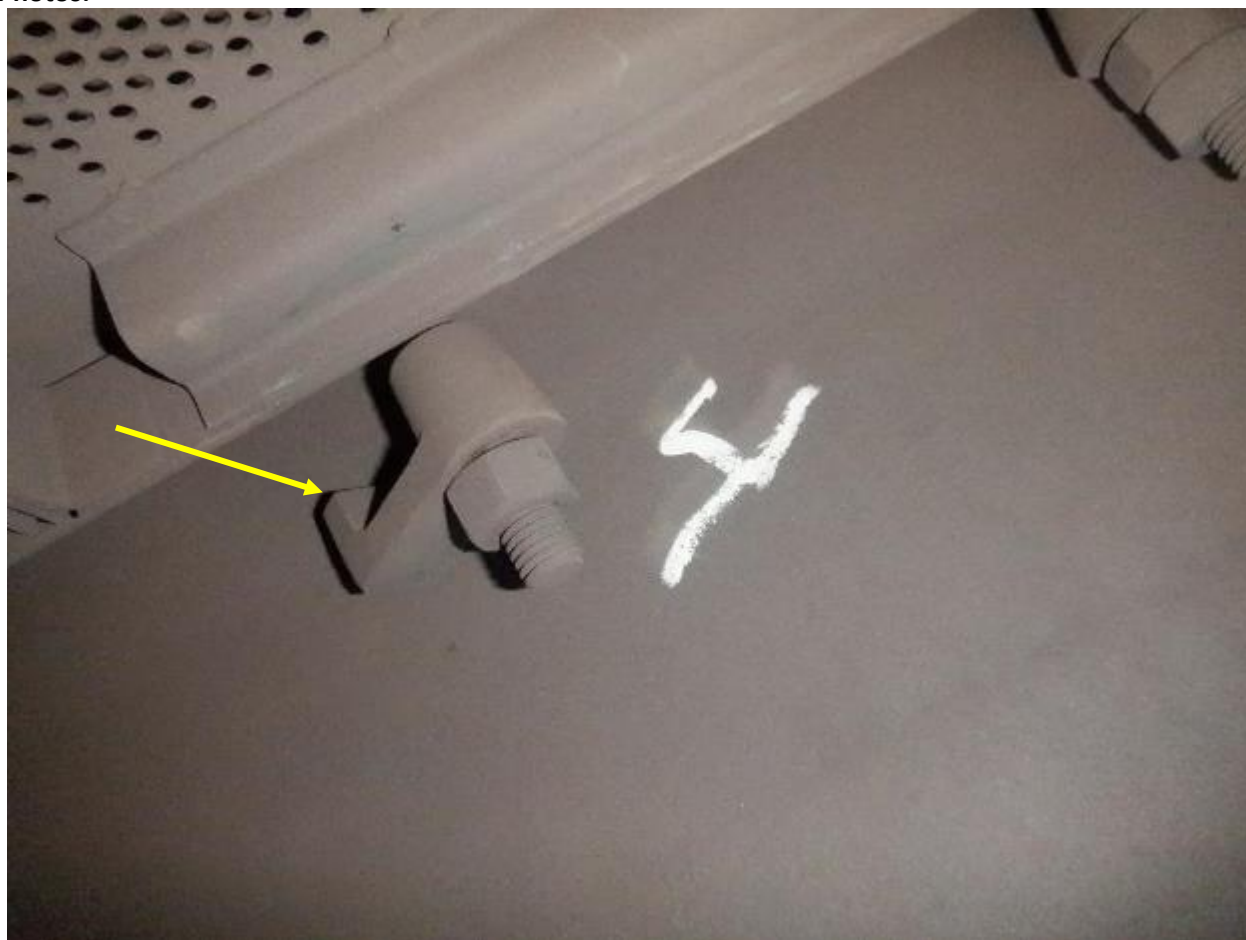
Date: 10/8/2021	Inspected by: B&W	Unit: 2	Item: FWWINHDR 2
Component Inspected: Front Waterwall Inlet Header (Mud Drum)			
Condition Assessment: There were pieces of door gasket in the header on each end.			
Recommendations: Remove the gasket material.			
Criticality: P2			
Risk if NOT Performed: The gasket material will plate out inside a furnace tube.			
EKP Comments:

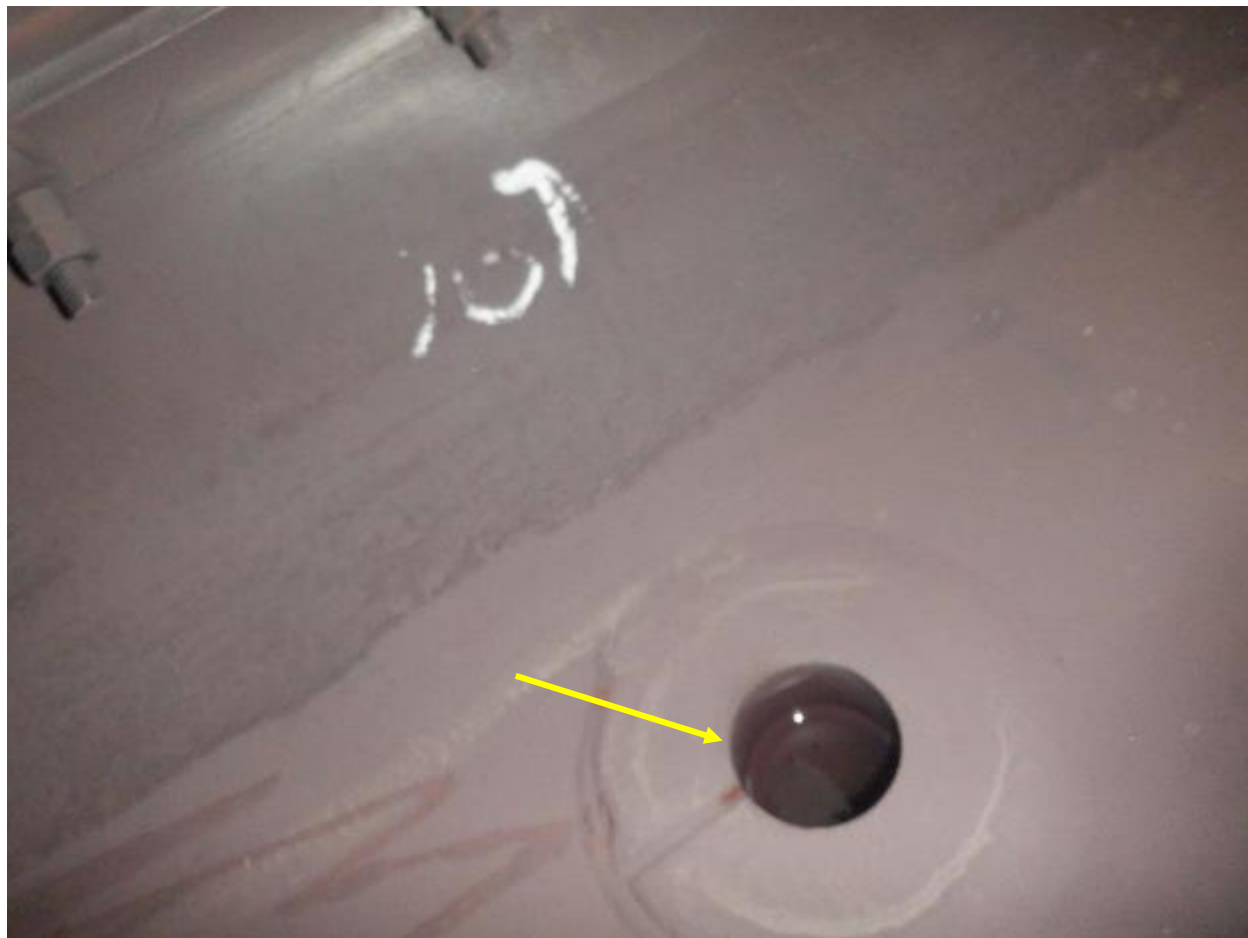
Date: 5/25/2023	Inspected by: B&W	Unit: 2	Item: FWWINHDR 3
Component Inspected: Front Waterwall Inlet Header (Mud Drum)			
Condition Assessment: There was a loose cap screw in the drum. No missing hardware was identified in either waterwall inlet headers.			
Recommendations: Information only, the cap screw was removed.			
Criticality: INFO			
Risk if NOT Performed: None at this time.			
EKP Comments:

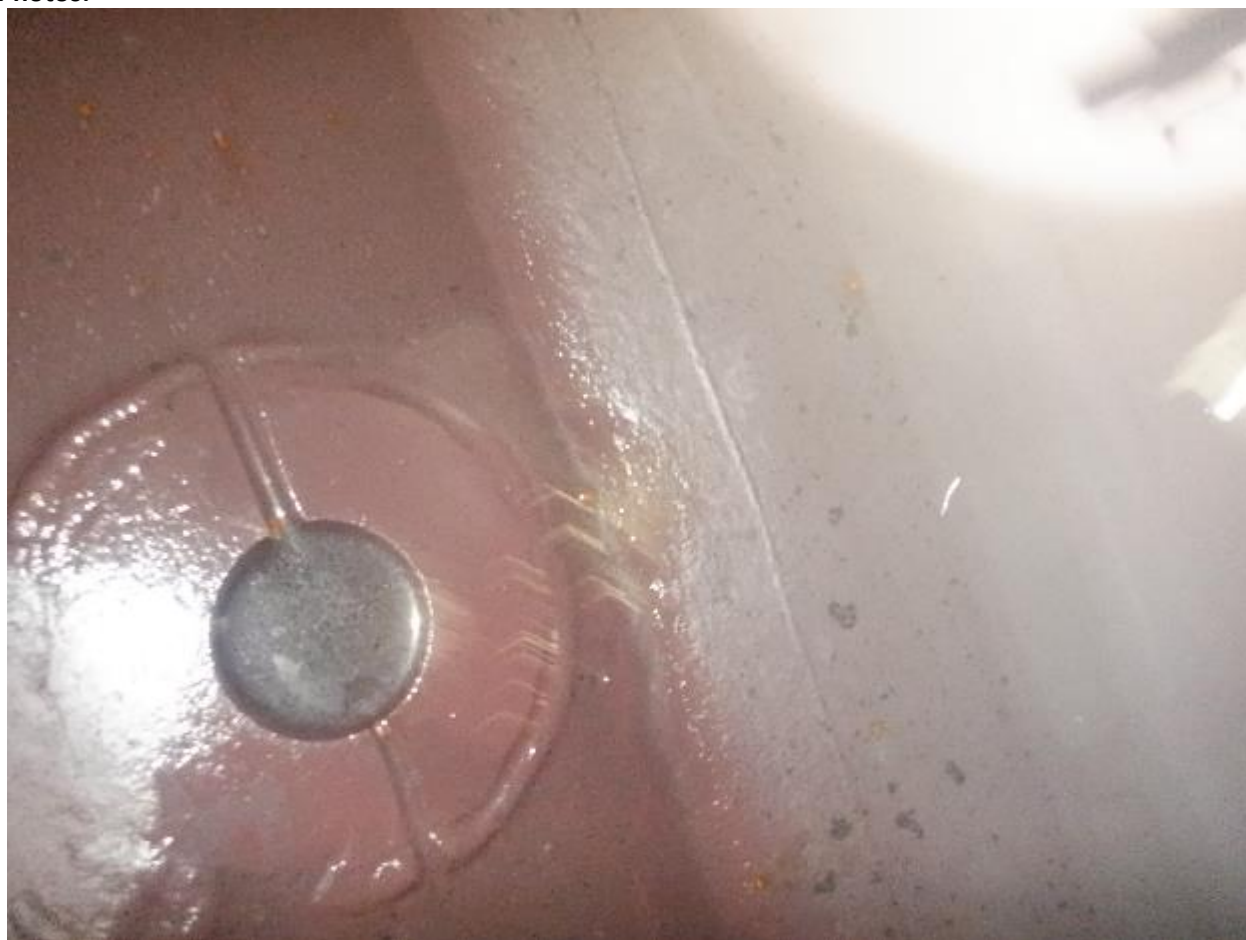
Date: 5/25/2023	Inspected by: B&W	Unit: 2	Item: RWWINHDR 3
Component Inspected: Rear Waterwall Inlet Header (Mud Drum)			
Condition Assessment: There were pieces of door gasket in the header on each end.			
Recommendations: Remove the gasket material.			
Criticality: P2			
Risk if NOT Performed: The gasket material will plate out inside a furnace tube.			
EKP Comments:

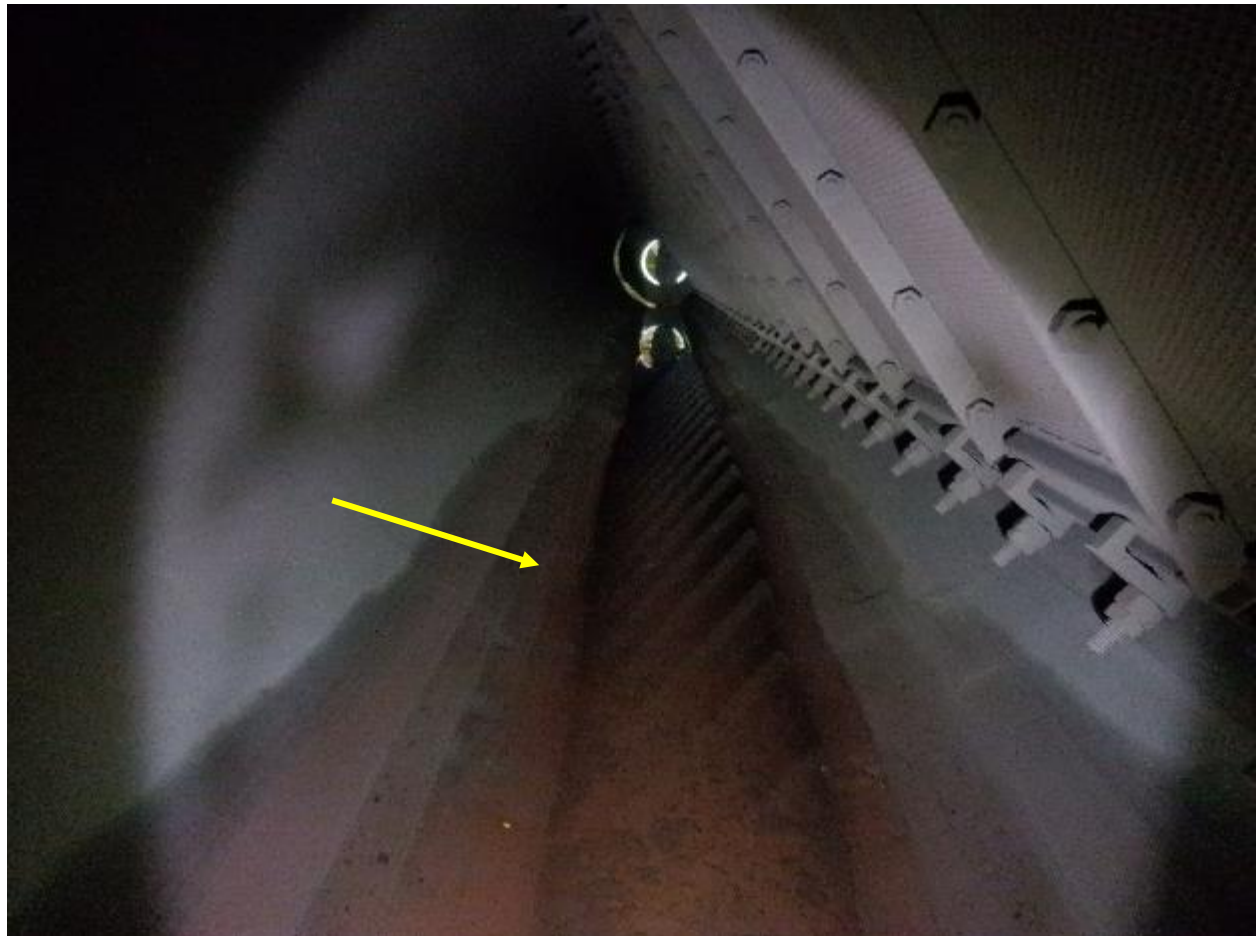
Date: 5/25/2023	Inspected by: B&W	Unit: 2	Item: RWWINHDR 5
Component Inspected: Rear Water-wall Inlet Header (Mud Drum)			
Condition Assessment: There was a missing claw at the top of screen 2.			
Recommendations: Replace the claw, the claw nut, and the lock nut. The stud may also need to be replaced.			
Criticality: P3			
Risk if NOT Performed: Screen could work loose.			
EKP Comments:

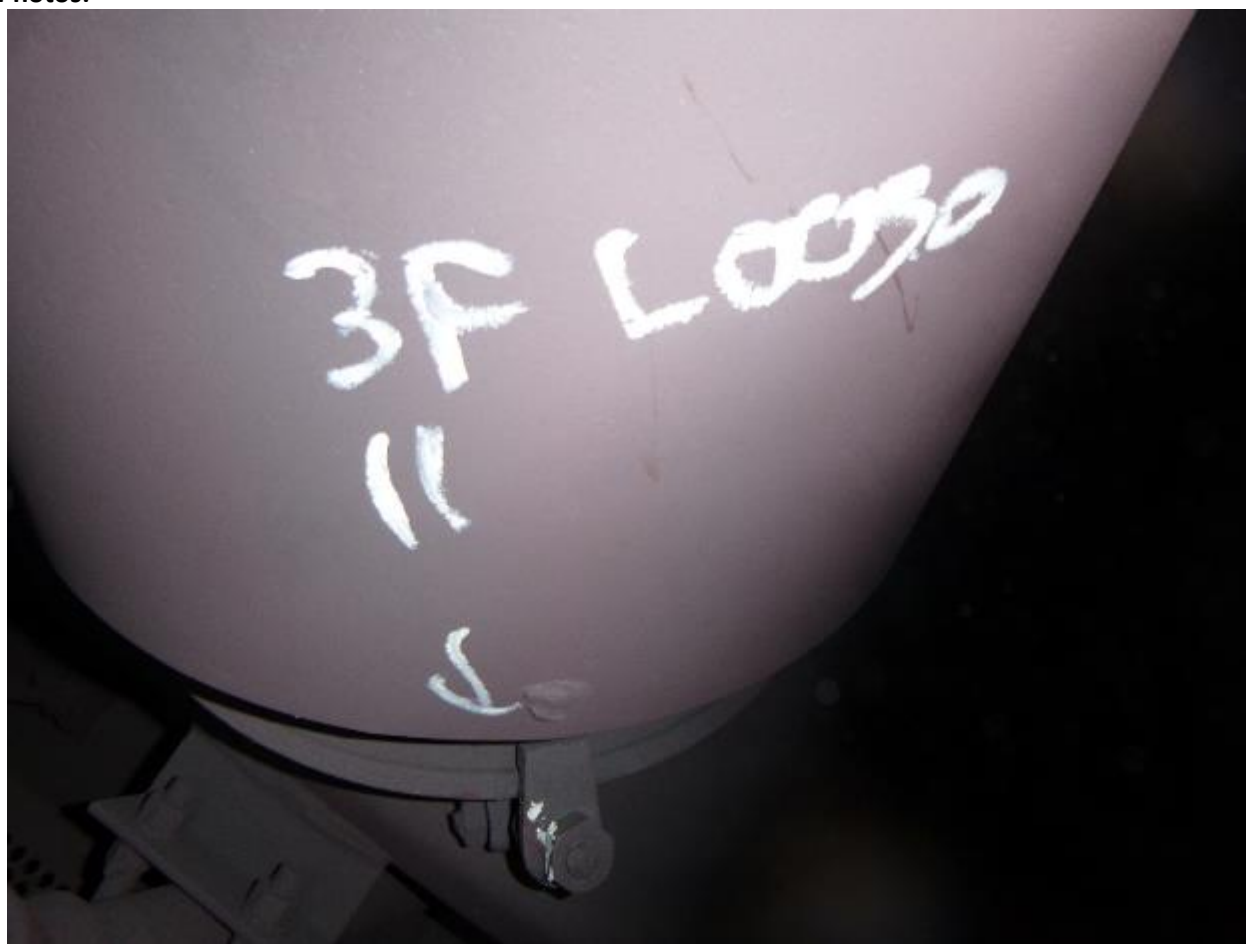
Date: 5/16/2023	Inspected by: B&W	Unit: 2	Item: STMDRUM 2
Component Inspected: Steam Drum			
Condition Assessment: The J-hook holding the secondary scrubbers to the separator was loose on the front side or back side on the following: Backside of rear turbo separator: 4, 9 Backside of front turbo separator: 8, Front side of rear turbo separator: 10, 11, 12 Front side of front separator: 10			
Recommendations: Tighten nut on J-hook.			
Criticality: P3			
Risk if NOT Performed: Eventually the secondary scrubber may come loose and not have a proper seal.			
EKP Comments:			
Photos:

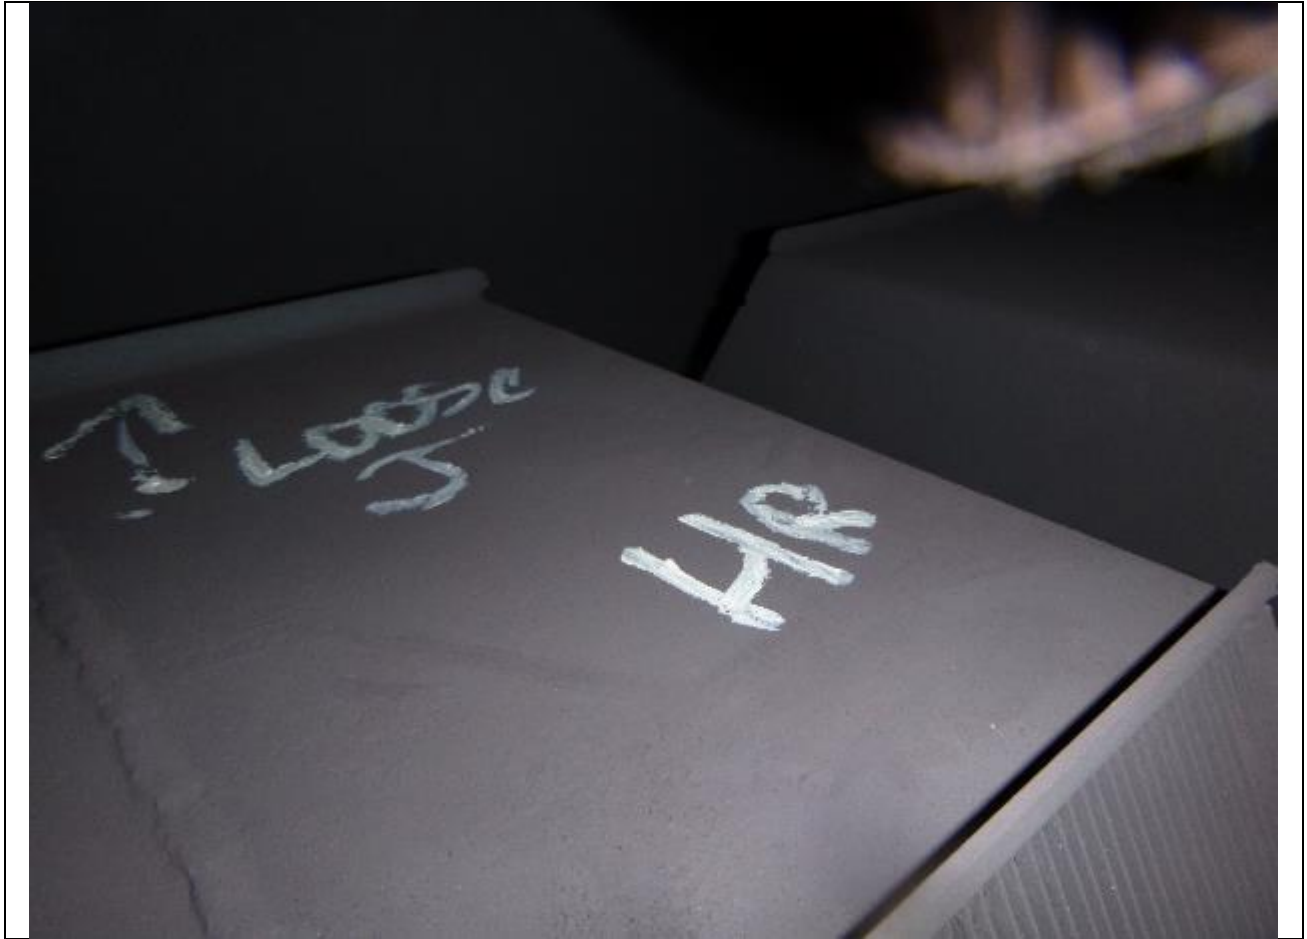
Date: 5/16/2023	Inspected by: B&W RJP	Unit: 2	Item: STMDRUM 3
Component Inspected: Steam Drum			
Condition Assessment: The downcomer screen hold-down clamps are loose on every downcomers screen.			
Recommendations: Tighten the nuts.			
Criticality: P3			
Risk if NOT Performed: Eventually the screens may become loose.			
EKP Comments:
