The Babcock & Wilcox Company

**Eastern Kentucky Power Cooperative
Spurlock Station, Unit #2**

U2 SPRING 2023 OUTAGE BOILER INSPECTION REPORT

B&W Project No.: BA9312817

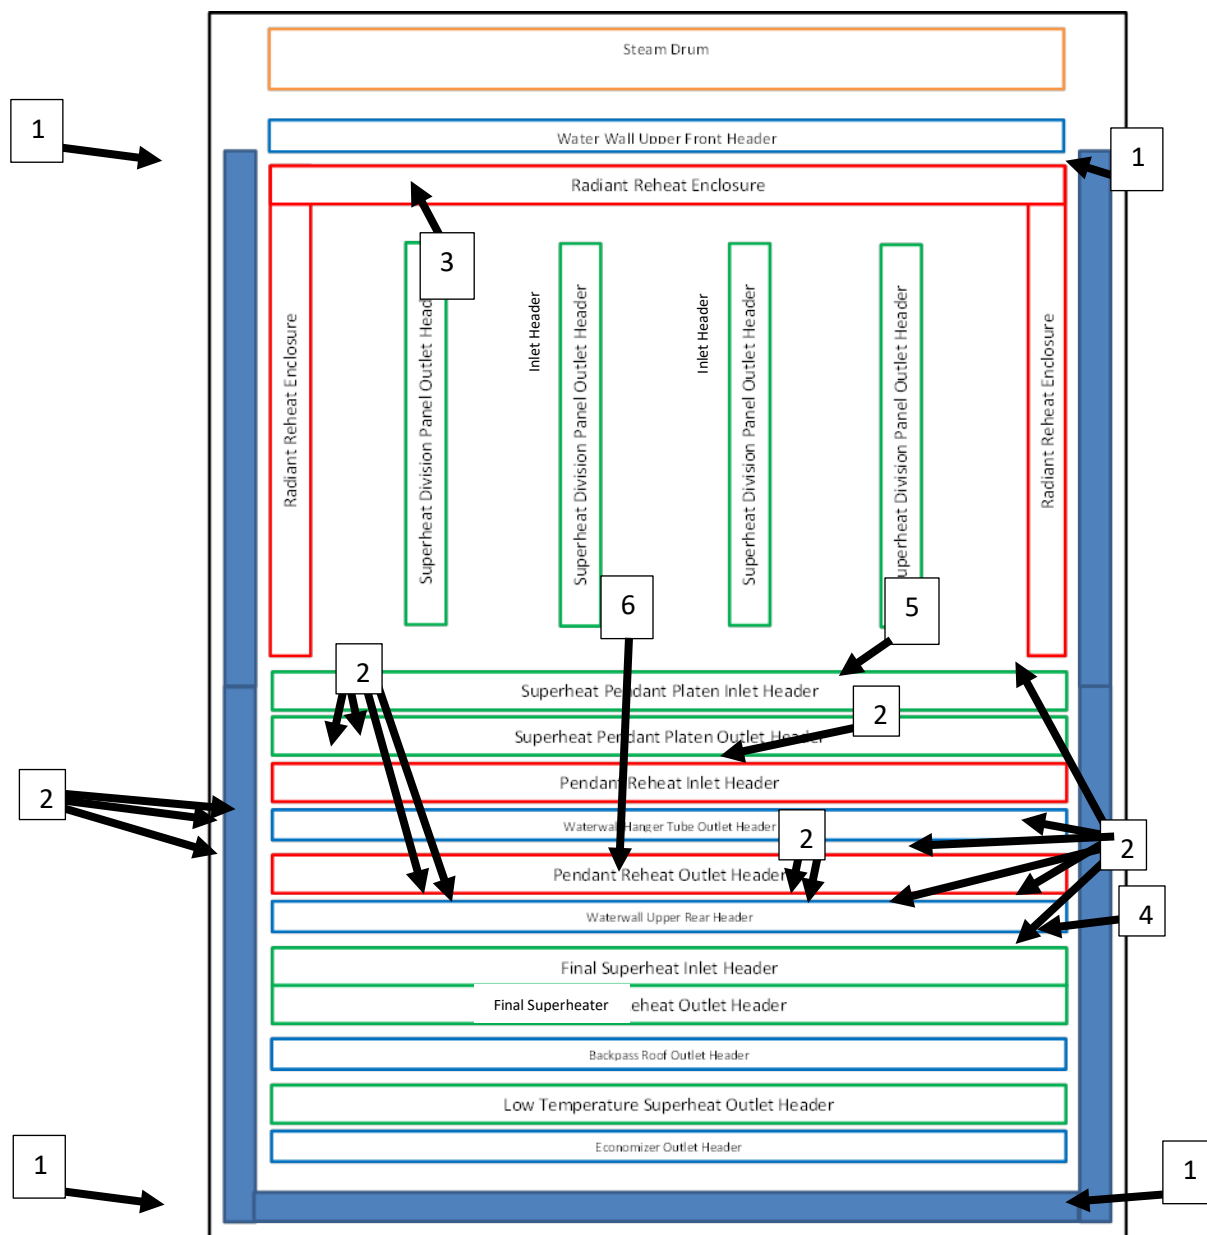
Date: 5/17/2023	Inspected by: B&W - CSH	Unit: 2	Item: PENT 1
Component Inspected: Penthouse			
Condition Assessment: The refractory around the perimeter of the unit was cracked and damaged. The most damage can be found at the corners of the unit.			
Recommendations: Continue to monitor and patch when necessary during future outages.			
Criticality: INFO			
Risk if NOT Performed: NA			
EKP Comments:			
Photos:

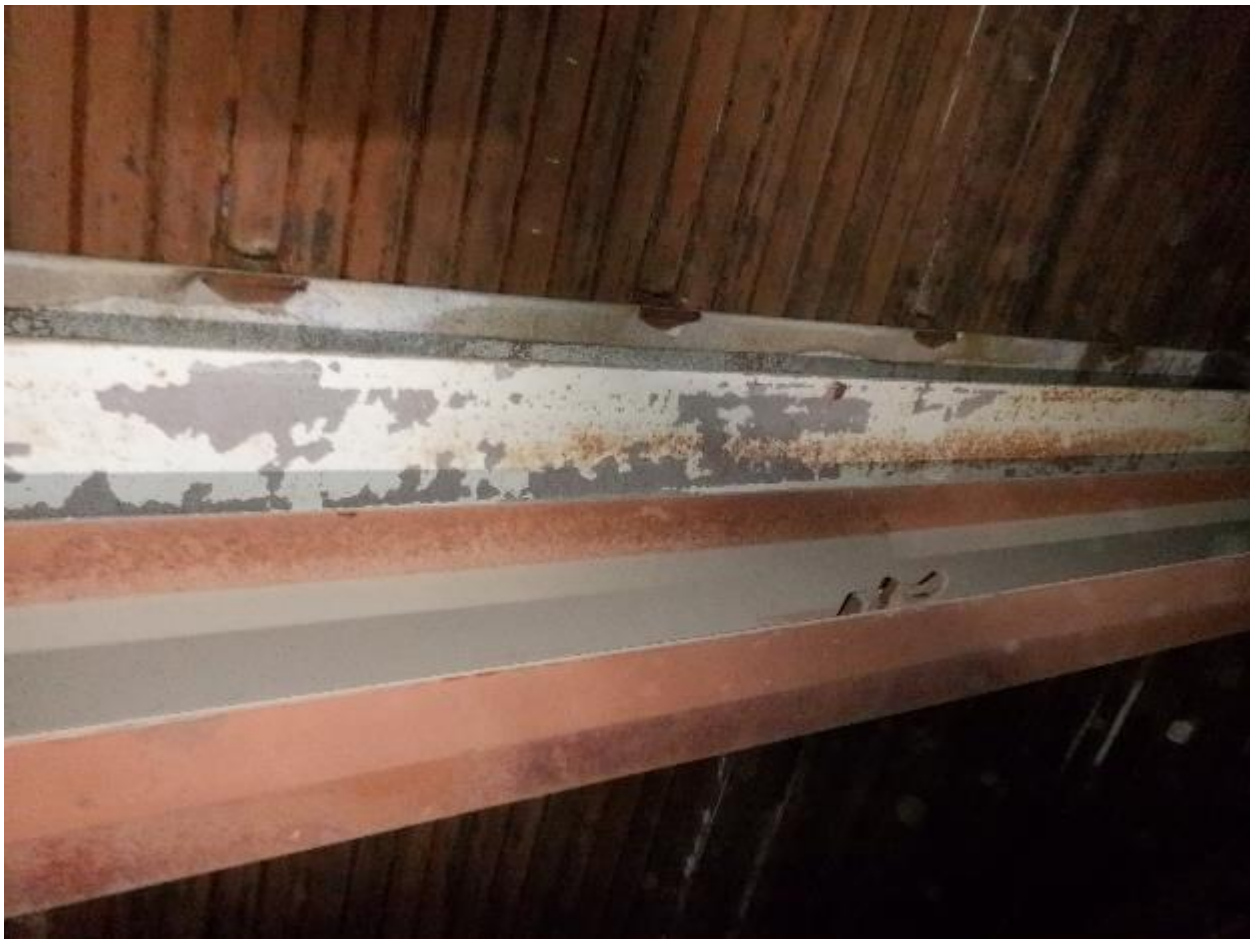
Date: 5/11/23	Inspected by: B&W CSH BC	Unit: 2	Item: LOWERDAIR 3
Component Inspected: Lower Dead Air Spaces			
Condition Assessment: Front and Rear Lower Dead Air Spaces: The refractory along the floor in each lower dead air space is beginning to break up.			
Recommendations: Patch the refractory and continue to monitor.			
Criticality: P3			
Risk if NOT Performed: Refractory seals the vestibule floor.			
EKP Comments:

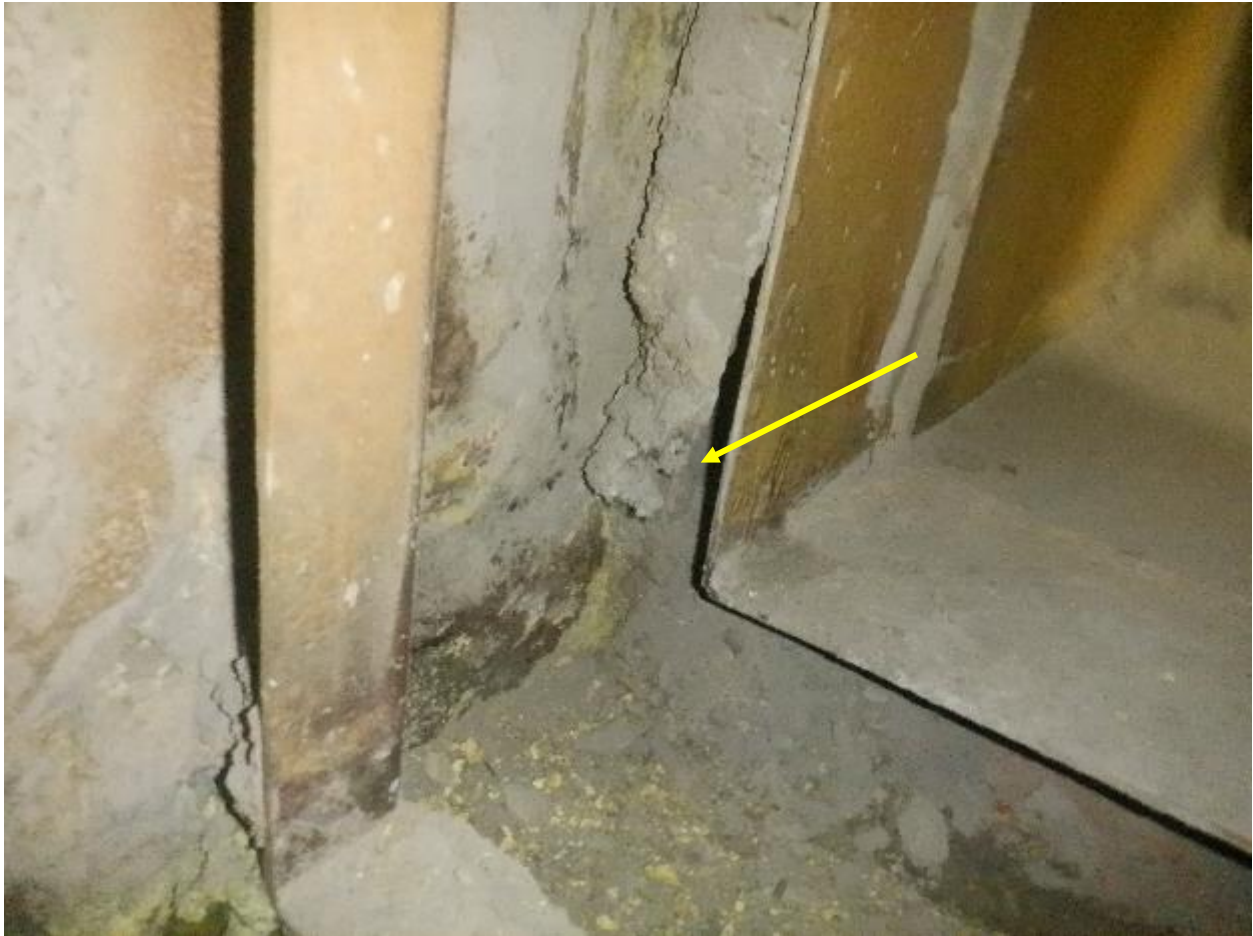
Date: 5/23/2023	Inspected by: B&W	Unit: 2	Item: ESPDUCTS 9
Component Inspected: 2AA ESP Outlet Duct			
Condition Assessment: There appeared to be multiple casing leaks in the expansion joint frame at the following locations – multiple holes in the RHSW near the roof, (1) in the roof near the LHSW, (1) in the roof at the $\frac{3}{4}$ point, and (1) in the roof at the $\frac{1}{4}$ point in the expansion joint frame.			
Recommendations: Seal weld patches over the frame and plan to replace the frame when the expansion joint requires replacement.			
Criticality: P3			
Risk if NOT Performed: Air in-leakage and the leaks will worsen.			
EKP Comments:

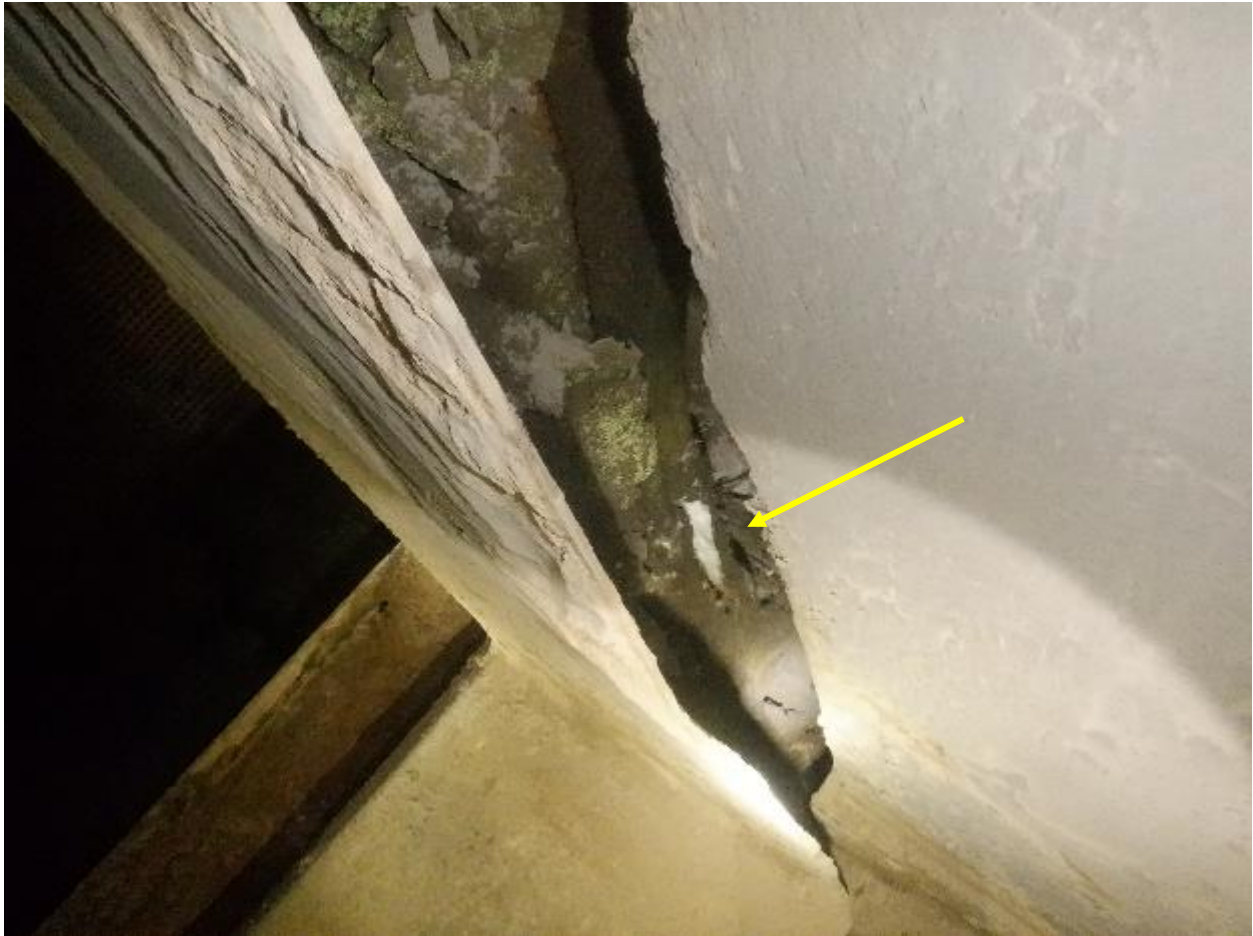
Date: 5/23/2023	Inspected by: B&W	Unit: 2	Item: ESPDUCTS 13
Component Inspected: 2AB ESP Outlet Duct			
Condition Assessment: There was a casing leak in the roof at the LHSW of the outlet flue.			
Recommendations: Remove the lagging and insulation from the exterior and repair the casing with seal welded 3/16" carbon steel patches. Rework the lagging and insulation at the top of the ESP to flue transition to prevent water from going underneath the lagging.			
Criticality: P3			
Risk if NOT Performed: Allows in-leakage and the hole will worsen.			
EKP Comments:
