## ENGINEERED PUMP SERVICES, INC.

# INSPECTION REPORT

<b>CUSTOMER</b>	: East Kentucky Power Cooperative	<b>REPORT DATE</b>	: 01/17/22
<b>PLANT NAME</b>	: Spurlock Station	<b>REPORT NO.</b>	: 56731-IR1
<b>CITY/STATE</b>	: Maysville, KY	<b>CUST. ORDER</b>	: TBD
<b>EQUIPMENT</b>	: 12x12x14 HDB-6	<b>COPY</b>	: Tony Ring
<b>SERVICE</b>	: Boiler Feed		
<b>MANF.</b>	: Byron-Jackson	<b>FILE</b>	: 56731
<b>SERIAL NO.</b>	: Unit 2A	<b>PAGE</b>	: 1 of 4

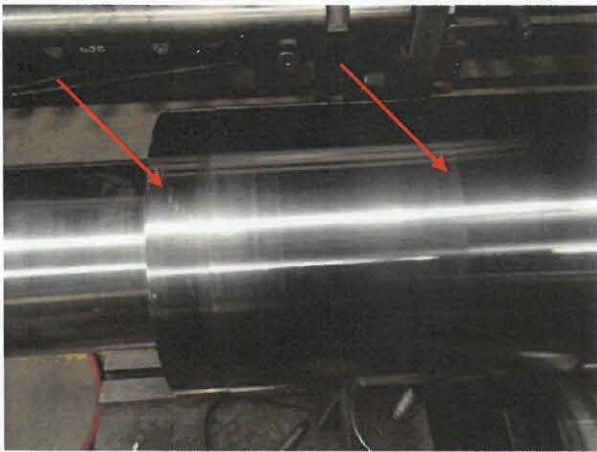
**Shaft (167)** – Overall, the shaft is in very good condition with only minor (under .0015" TIR) runout. During disassembly, several of the fit turns were lightly galled during removal of the impellers. The major impeller and sleeve turns all measured to the expected diameters and provided ideal fit interferences and running clearances to the corresponding mating parts. Both bearing journals are lightly grooved, and there is minor visible wear on the spiral breakdown grooves on the coupling end. Based on the service report from removing this pump element, it is assumed that this was the area that made hard contact with the bearing cover and caused the noise heard at the plant during operation. Magnetic particle and ultrasonic NDE analysis did not reveal any linear indications of damage to the shaft.

Photo 1: Typical Shaft Bearing Journal Wear

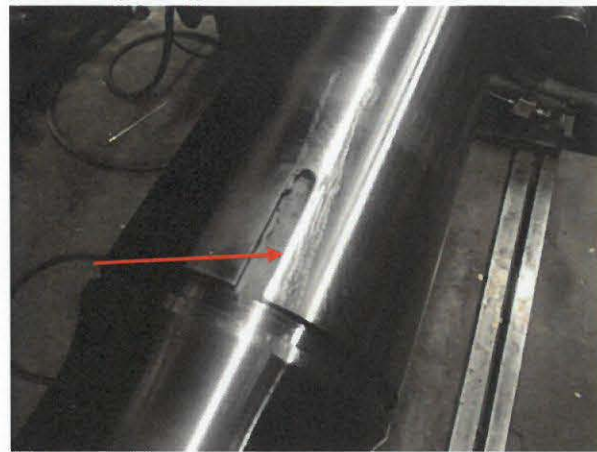
Photo 2: Shaft Gall At 4<sup>th</sup> Stage Impeller

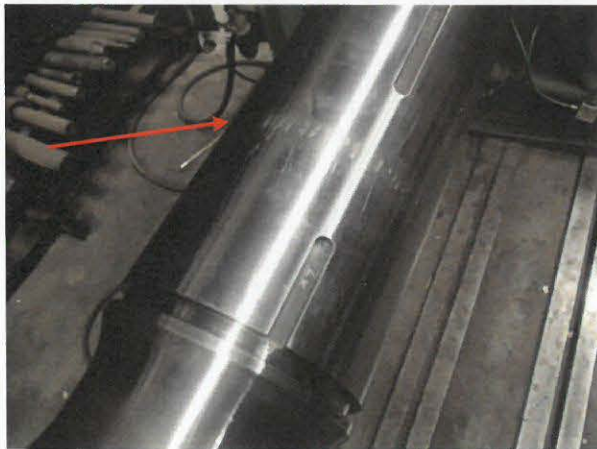
Photo 3: Shaft Gall On Center Impeller Fit

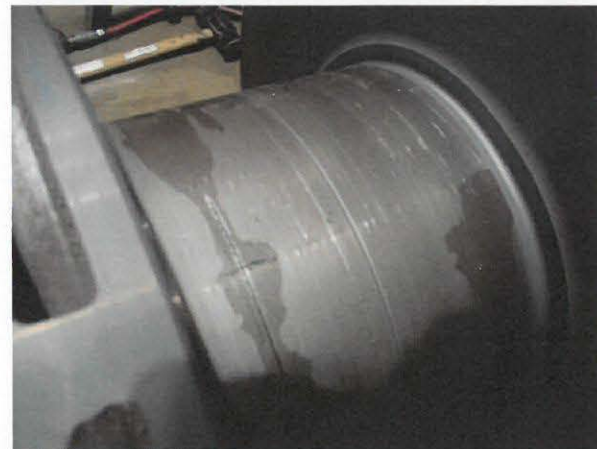
**Impellers (176)** - Most of the impeller bores are in good condition with the exception of the 3rd stage which was lightly out of round; the resulting fit interferences to the shaft are all very close to design specification. All series seal turns (hub and eye) appear to be laser weld (40-45 Rc) surface hardened, and the process seems to have performed well during pump operation. Each turn is only lightly worn resulting in marginally excessive running clearances to the corresponding case rings and stage pieces. NDT examination of the impellers found few or no linear indications on all seven impellers.

Photo 4: Typical Wear On Impeller Turns

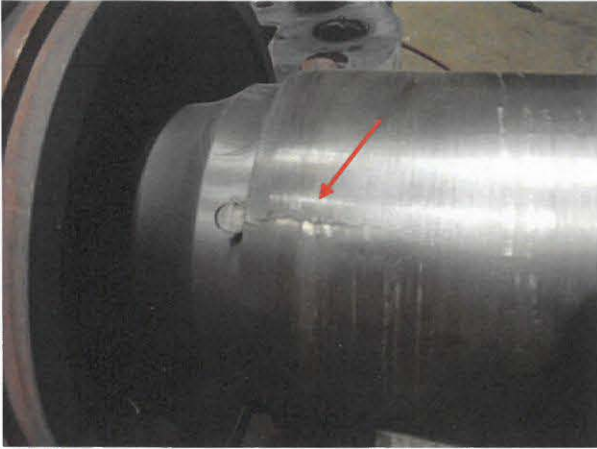
**Balance Sleeve (218)** – As mentioned in the introduction, the balance sleeve was cracked as received. The crack location is close to the split ring face. Dimensionally, the sleeve measures close to expected dimensions, and the material (420 SS) seems to be the correct hardness for this application. There does not seem to be any obvious reason for the crack, and there was no ancillary damage caused to the pump element.

Photo 5: Cracked Balance Sleeve (As Received)

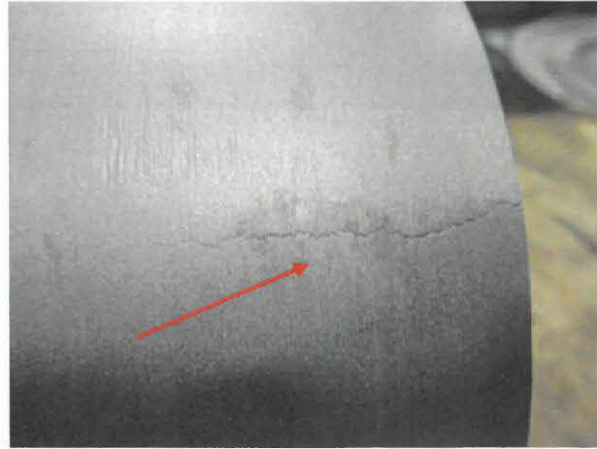
Photo 6: Cracked Balance Sleeve (When Clean)

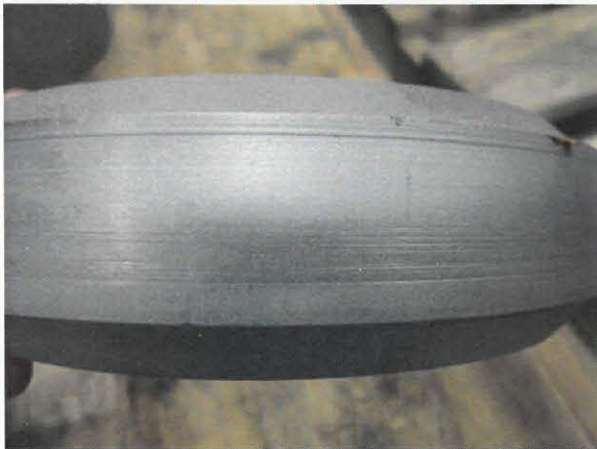
**1<sup>st</sup> Stage Shaft Sleeve (217)** - The shaft sleeve is in good visual condition with only light wear on the outer turn; dimensionally, the fit bore to the shaft is lightly out of round and appears to have collapsed during the assembly or disassembly process.

Photo 7: Light Wear On 1-2 Sleeve Turn

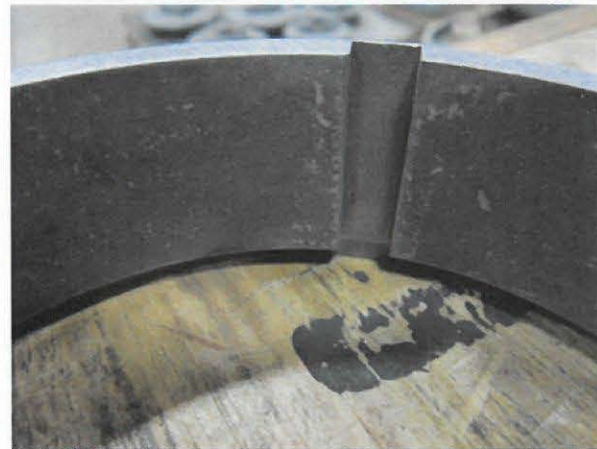
Photo 8: Fretting In 1-2 Sleeve Fit Bore

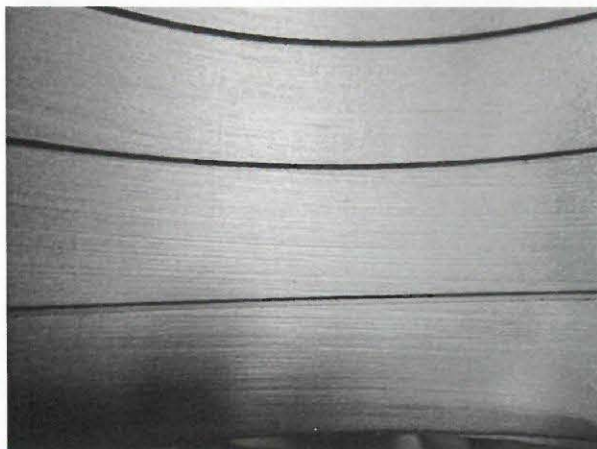
**Stage Pieces (009)** – Typically speaking, all stage pieces are in very similar condition to the case wear rings with marginally excessive running clearances to the impellers and very good fit clearances to the volute casing. There is only very light visible wear in some of the sealing bores and no evidence of water erosion on the sealing faces.

Photo 9: Light Wear On Center Stage Piece

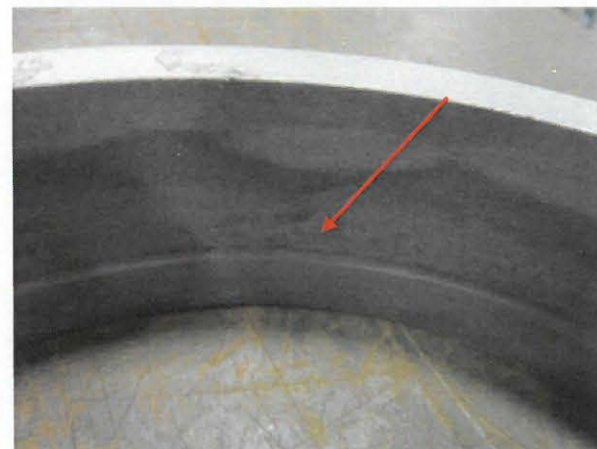
**Volute Bushing (26)** - The volute bushing is in good condition. Visually, there is light fretting in the aligning fit bore to the end head, but the bore measures to the correct diameter. The fit turn to the volute has a marginally oversize fit clearance to the volute case receiving bore.

Photo 10: Fretting In Volute Bushing Bore
