INSPECTION REPORT

CUSTOMER	: East Kentucky Power Cooperative	REPORT DATE	: 12/17/21
PLANT NAME	: Spurlock Generating Station	REPORT NO.	: 56743-IR1
CITY/STATE	: Maysville, Kentucky	CUST. ORDER	: TBD
EQUIPMENT	: 29" APKD - 4	COPY	: Anthony Ring
SERVICE	: Condensate Water	FILE	: 56743
MANF.	: Ingersoll-Rand	PAGE	: 1 of 4 Pages
SERIAL NO.	: Unit #2

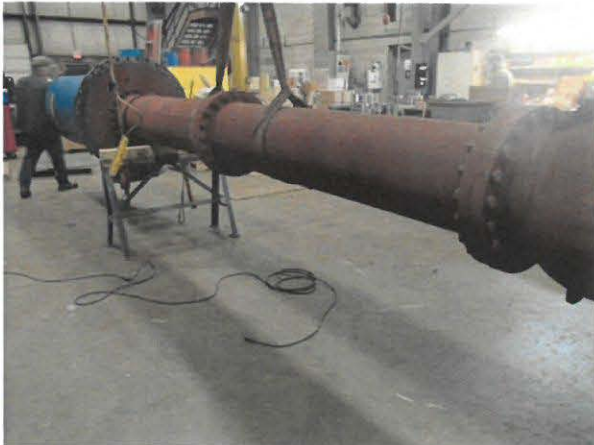
Photo 1: Pump As Received

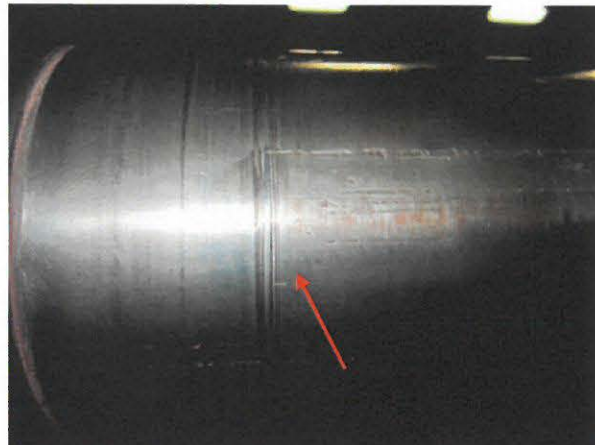
Upper Shaft – The upper shaft body measures consistently to a uniform diameter across all coupling and journal sleeve fits. The total indicated runout (TIR) of the shaft is .005” which is marginal for this application. There is a small area of deep wear at the top of the shaft caused by contact with the floating seal ring of the mechanical seal assembly. Ultrasonic and magnetic particle testing did not reveal any linear indications of damage.

Photo 2: Seal Ring Wear On Upper Shaft

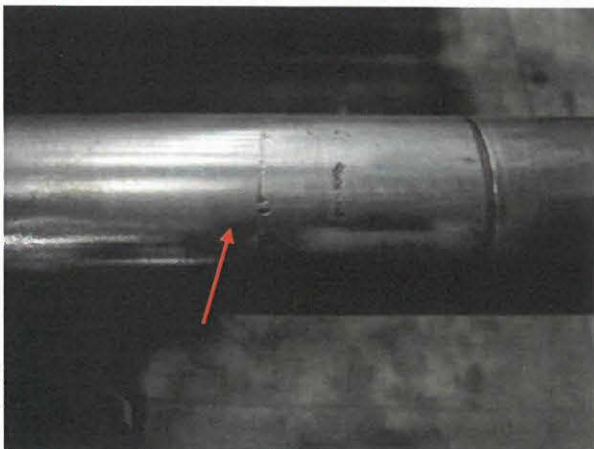
Photo 3: Shaft Galls At 1st Stage Impeller Nut

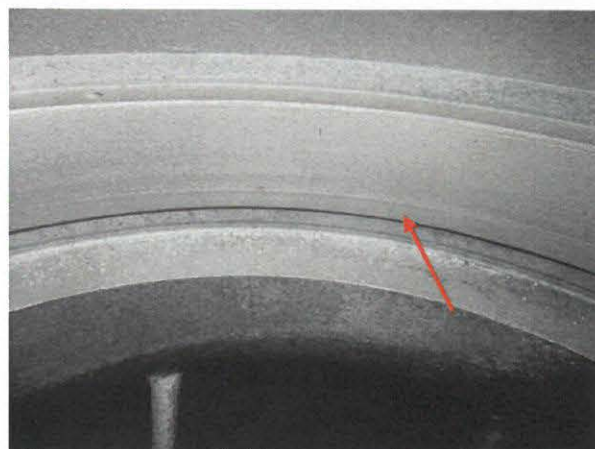
Series Casing – The (2) series stage casings are in fair visual condition. Both stages have little or no vane damage and negligible corrosion. The fit clearances between all stages are marginally out of tolerance. Both bearing bores have moderate wear resulting in excessive fit clearance to the journal sleeves. Both case rings are lightly worn with excessive running clearances to the impellers.

Photo 4: Typical Case Ring Wear

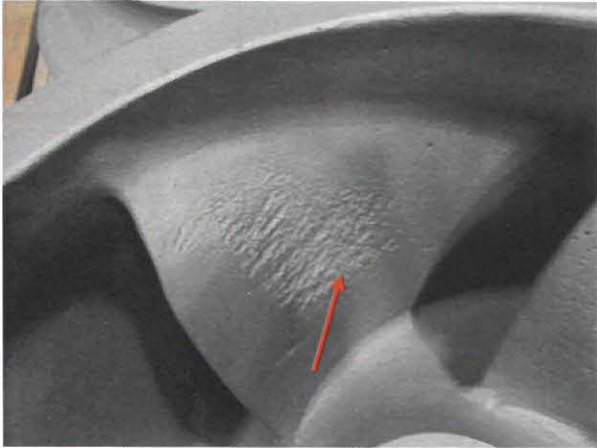
Photo 5: Typical Cavitation On 1st Stage Impeller

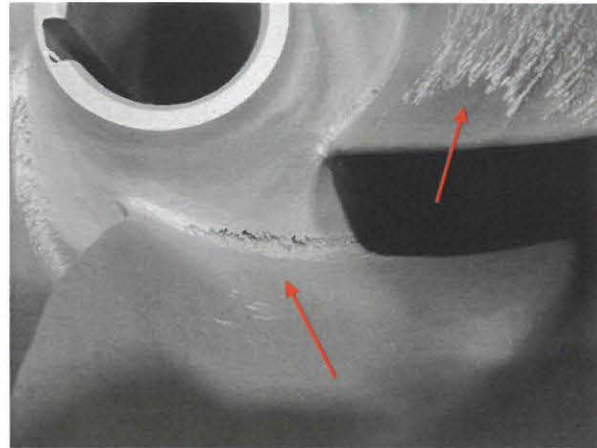
Photo 6: Typical Cavitation On 1st Stage Impeller

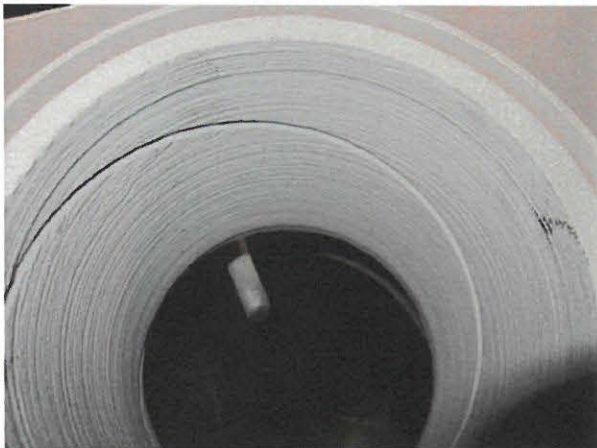
Photo 7: Typical Wear On Series Bearing

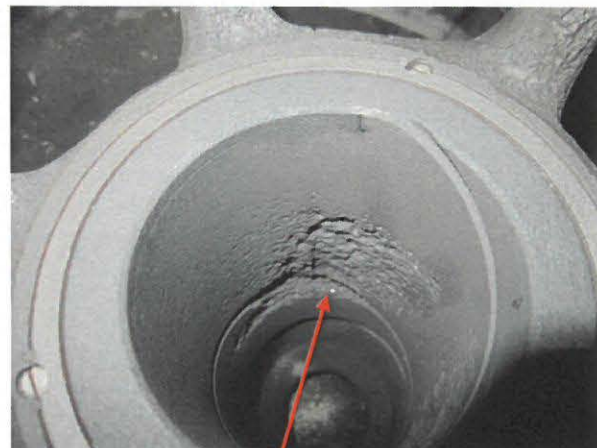
Suction Bell – Overall, the suction bell is in fair condition. The wear ring and tail bearing show light visible wear, and the resulting running clearances are moderately oversized. There is minor cavitation damage on the inlet suction faces and some unusual cavitation in the lower bearing. The male fit turn to the 1st casing section measures over the existing diameter with the resulting fit actually measuring as interference instead of light clearance. There does not to be any galling or lack of sealing resulting from this tight fit.

Photo 8: Cavitation Damage On Suction Bearing

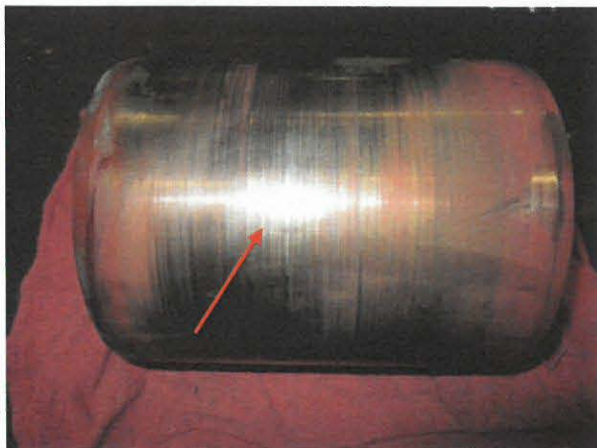
Journal Sleeves – The (8) shaft sleeves are in fair condition with light to moderate eccentric radial wear on the outer diameters; as mentioned previously, the resulting running clearances to the graphite bearings are all moderately excessive. The fit bores to the shaft all measure to expected design diameters with appropriate fit clearances to the shaft.

Photo 9: Typical Wear On Series Shaft Sleeves

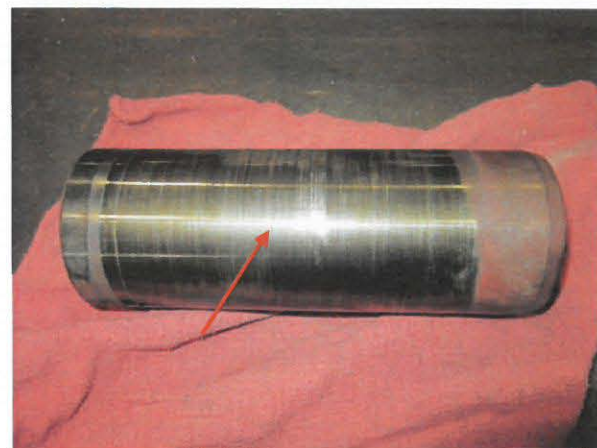
Photo 10: Wear On Suction Shaft Sleeve

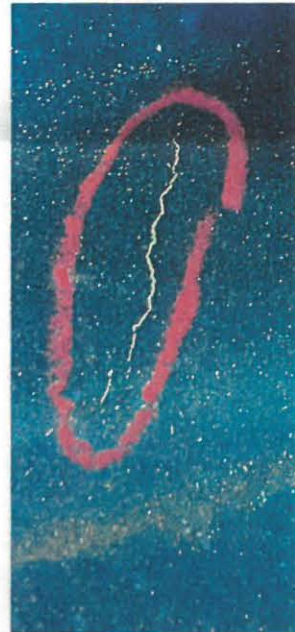
Photo 1

Serial # 1 rejected for 1/4" crack. (Picture Zoomed)

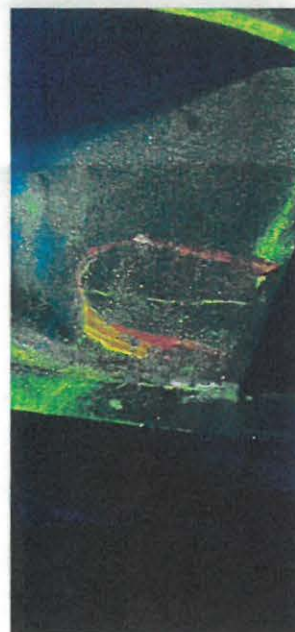
Photo 2

Serial # 2 rejected for 1" through-wall crack.

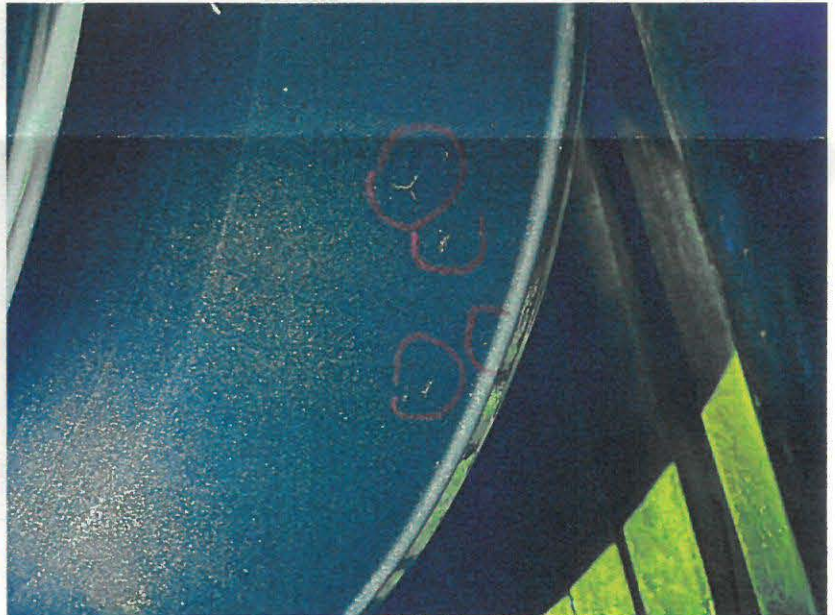
Photo 3

Serial # 3 rejected for multiple 1/16"-1/8" cracks.

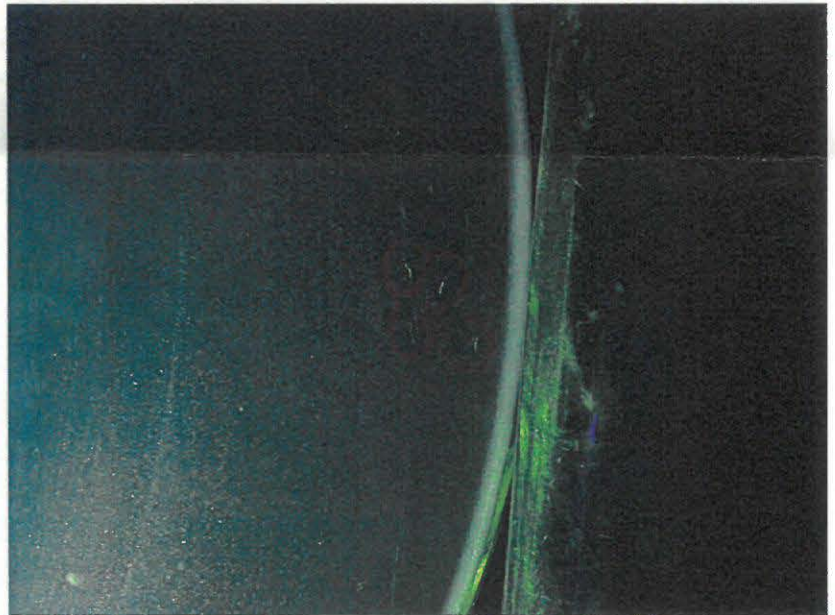
Photo 4

Serial # 3 rejected for multiple 1/16"-1/8" cracks.

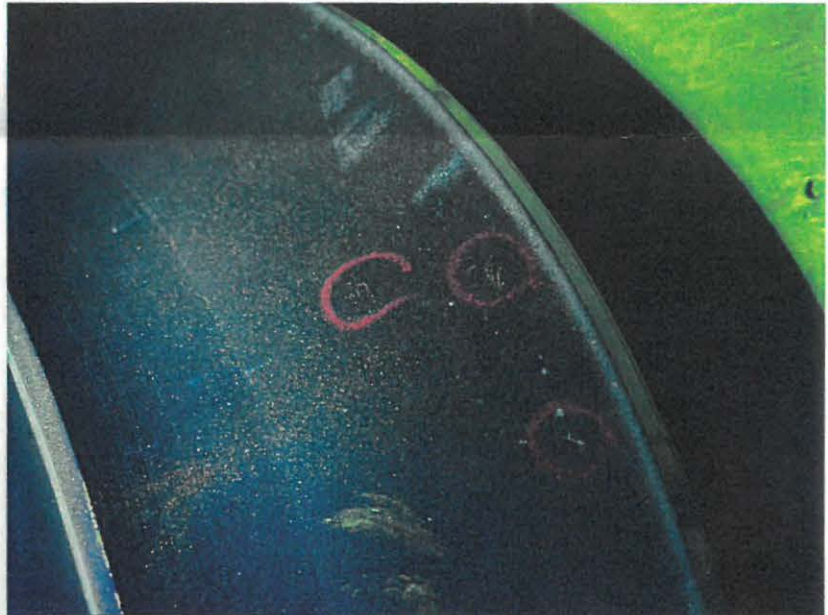
Photo 5

Serial # 3 rejected for multiple 1/16"-1/8" cracks.

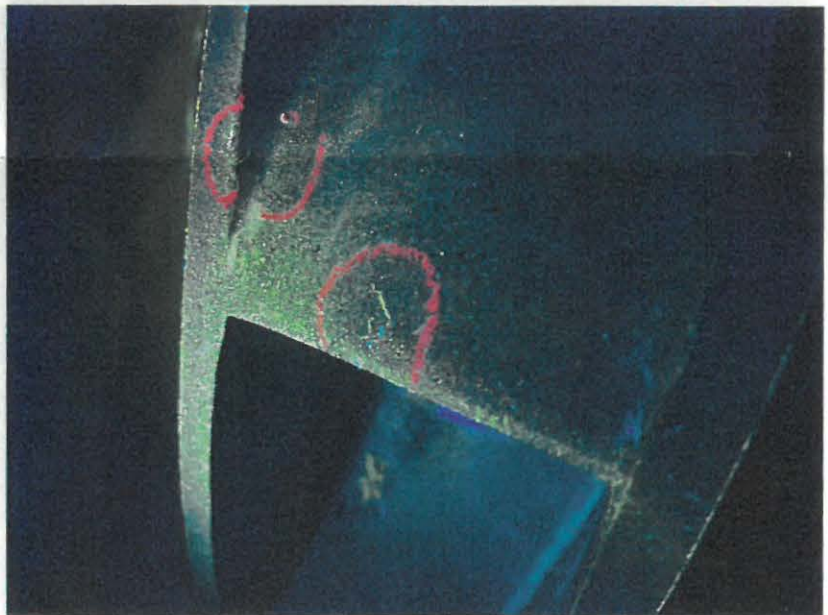
Photo 6

Serial # 3 rejected for multiple 1/16"-1/8" cracks.
