| <b>Date:</b> 3/22/2024 | <b>Inspected by:</b> EKPC (J.Schaeffer) | <b>Unit:</b> 2 | <b>Item:</b> 1 |
| <b>Component Inspected:</b> DA | | | |

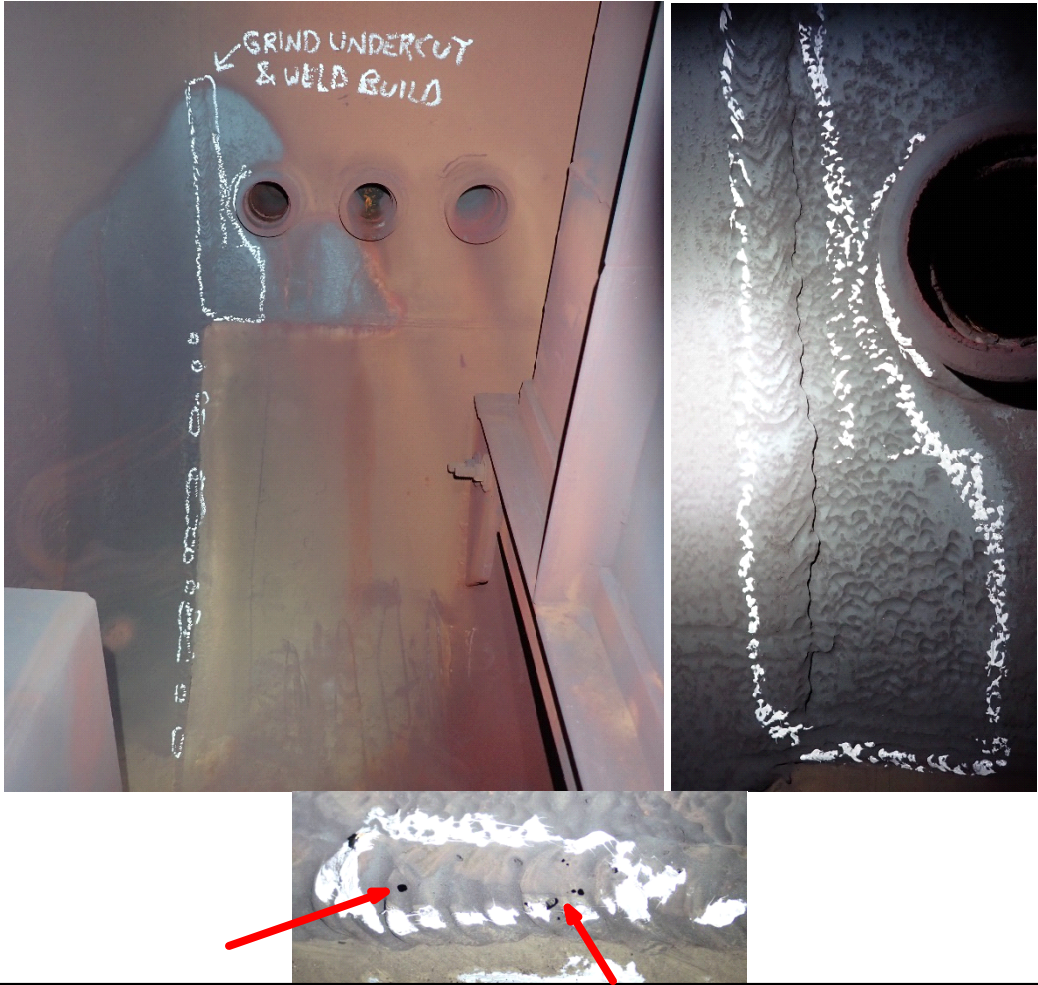
| <b>Condition Assessment:</b> The RHS/East end shell to head weld had issues with a past patch and flashing.<br><ol style="list-style-type: none"><li>1. The South side of the shell had flashing damage between the head weld and the inlet lines from the FWH vents. This also started causing undercut on the head weld. No UT data could be taken because of irregular surface from flashing damage but area was &lt;25% wall loss.<ol style="list-style-type: none"><li>a. Area is ~24.375in<sup>2</sup>.</li></ol></li><li>2. The shell to head weld also had porosity in the weld, found in several spots totaling ~13" from the 8:00-9:00 position (looking at the head from East-to-West).</li></ol> | | | |
| <b>Criticality:</b> P2 | | | |

| <b>Recommendations:</b><br><ol style="list-style-type: none"><li>1. Grind out the started undercut on the weld from flashing damage, and grind down imperfections in the shell from flashing damage. Tie into the existing weld that had undercut started, and then perform base metal restoration (pad welding) in the marked area.</li><li>2. Grind out any porosity in the previous weld, and tie into existing weld with new weld.</li></ol><br>**Shell (3/8" THK) and heads (7/16" THK) are both the following material: ASTM A-515 Gr.70. | | | |

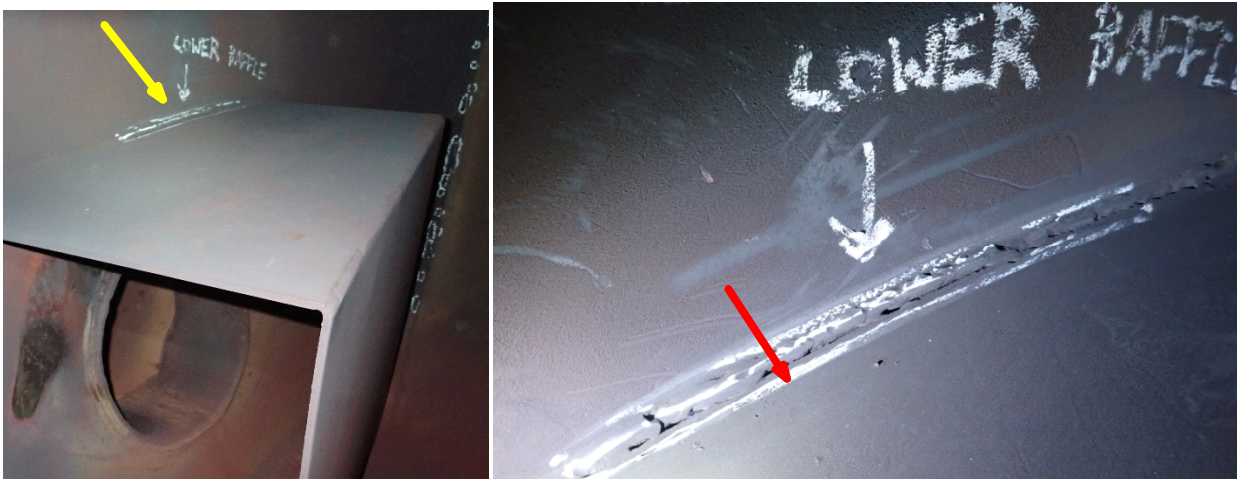
| <b>Condition Assessment:</b> The lower FWH drains inlet baffle, located on the RHS/East end of the DA, had 11" of weld on the top weld to the head where there was lack of fusion and visible gaps on the baffle side. | | | |
| <b>Criticality:</b> P3 | | | |

| <b>Recommendations:</b> Use grinder to clean area. Weld over affected area to join baffle with head. Most likely, 2 or more passes will be needed to weld the affected area.<br>**Shell (3/8" THK) and heads (7/16" THK) are both the following material: ASTM A-515 Gr.70. | | | |

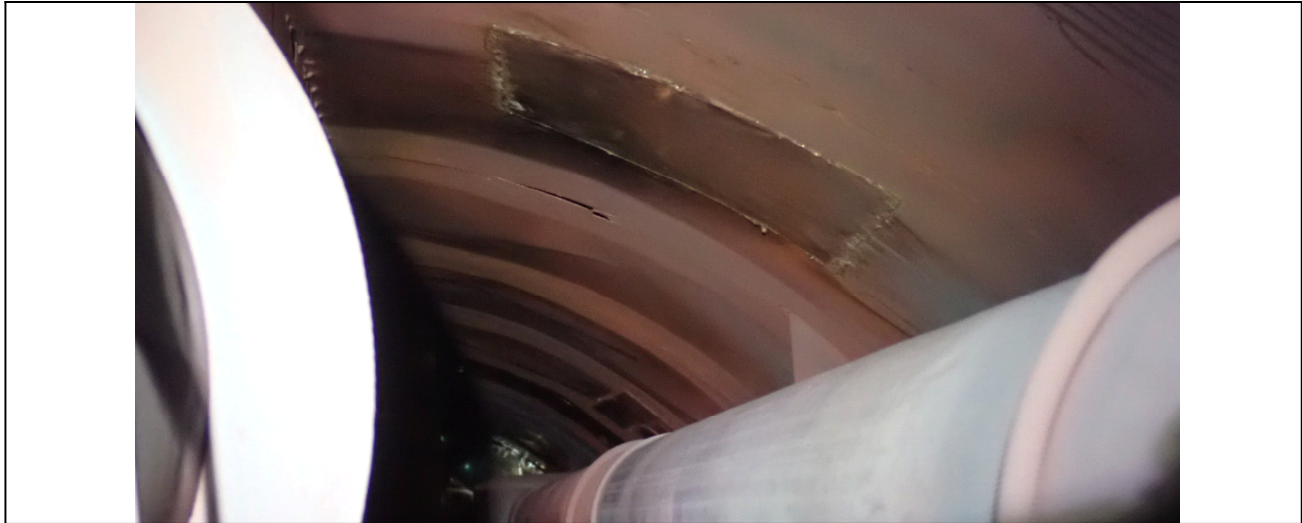
| <b>Condition Assessment:</b> The tray enclosure had an ~6" LG rip on the upper North side of the enclosure, located ~10-12' in from the RHS/East access door. | | | |
| <b>Criticality:</b> INFO | | | |

| <b>Recommendations:</b> Wait for a future year when all trays are removed, to allow access to the repair. | | | |

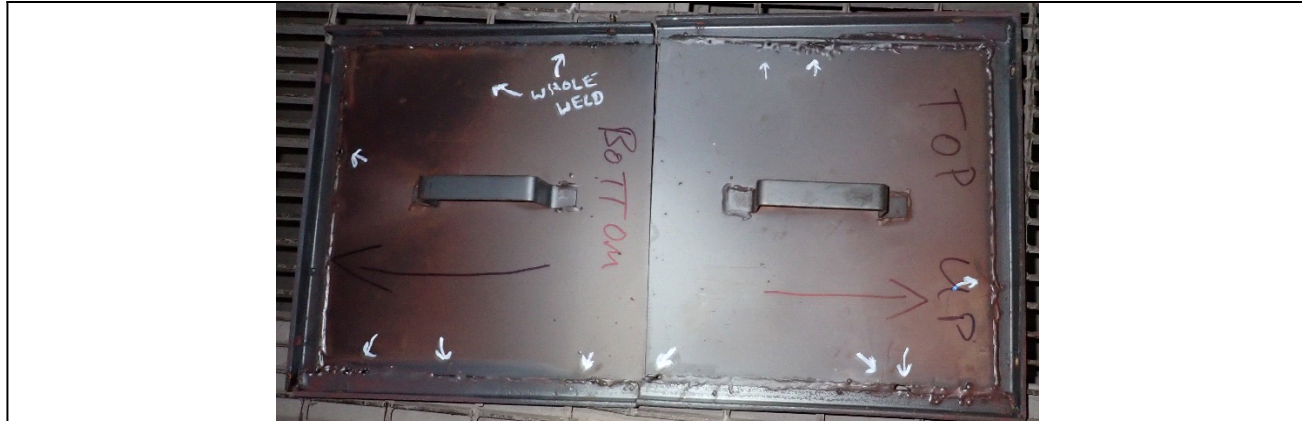
| <b>Condition Assessment:</b> The LHS/West tray enclosure doors (top and bottom) needed numerous weld repairs from holes in the weld or any cracks. | | | |
| <b>Criticality:</b> P3 | | | |

| <b>Recommendations:</b> Perform weld repairs to all areas of the door, to ensure a full seal weld.<br>**Tray compartment material is 304 SS. | | | |

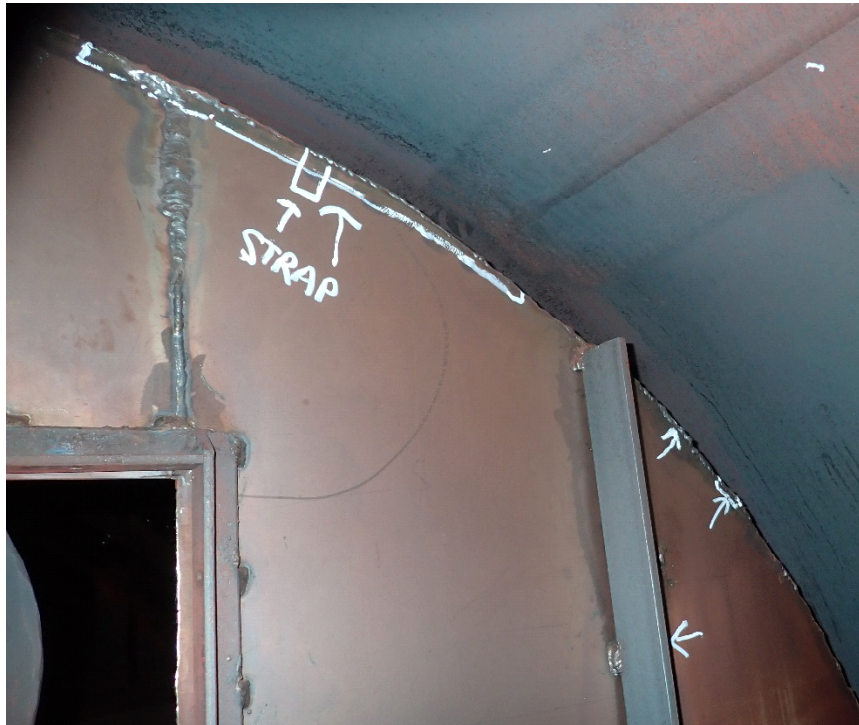
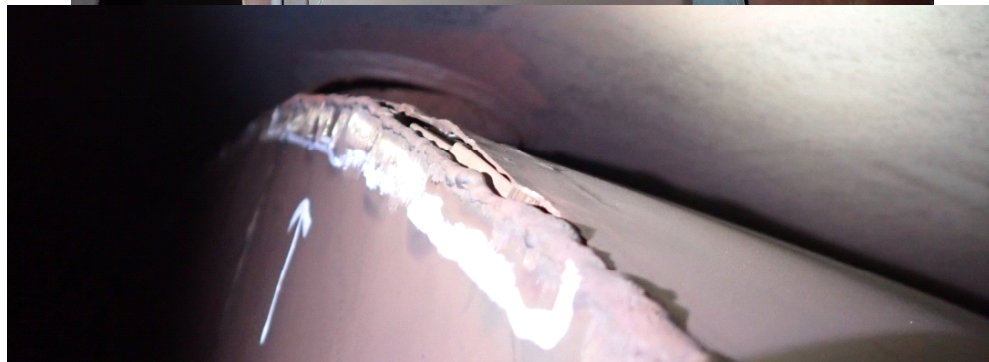
| <b>Condition Assessment:</b> The LHS/West end of the tray enclosure had several cracks in stiffener welds, and holes in the weld along the top corner/weld seam of the South half of the tray enclosure. This also consisted of a 13 ½" LG rip in the top corner. | | | |

**Criticality:** P2

| <b>Recommendations:</b> <ol style="list-style-type: none"><li>Grind out any cracks, and re-weld all areas to ensure a fully sealed tray enclosure.</li><li>On the long seam failure, use a screw-dog as necessary and get the tray enclosure pulled back</li></ol> | | | |

together and seal weld.

3. After welding the long seam, install a 2"x2"x1/4" (1" wide) strap across the top and side of the enclosure, and stitch weld this in place to provide additional stability, similar to previous repairs.

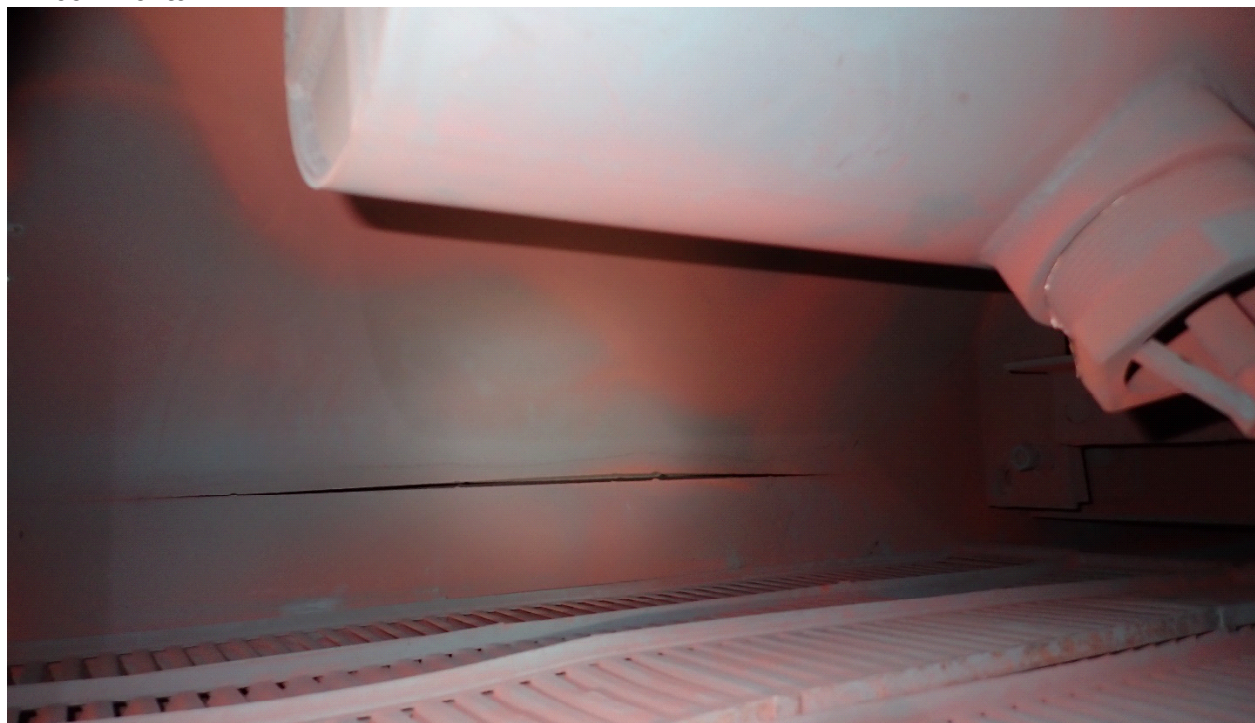
| <b>Condition Assessment:</b> The North side of the tray enclosure had a 2 ½' LG horizontal rip in the enclosure, ~6" above the trays. | | | |

**Criticality:** P3

| <b>Recommendations:</b> <ol style="list-style-type: none"><li>1. Remove 6-8 trays for access into the tray enclosure.</li><li>2. Install a duck-bill porta-power or similar tooling on the outside of the tray enclosure, to push</li></ol> | | | |

against the shell and push the tray enclosure back together.

3. Stitch weld the tray enclosure rip initially, then follow-up with full seal weld.

4. Add 3 pieces of 1 ½" x 3/16" (2" LG) SS flat bar across the inside of the seam to provide additional strength, and stitch weld it to the top and bottom sides of the seam.

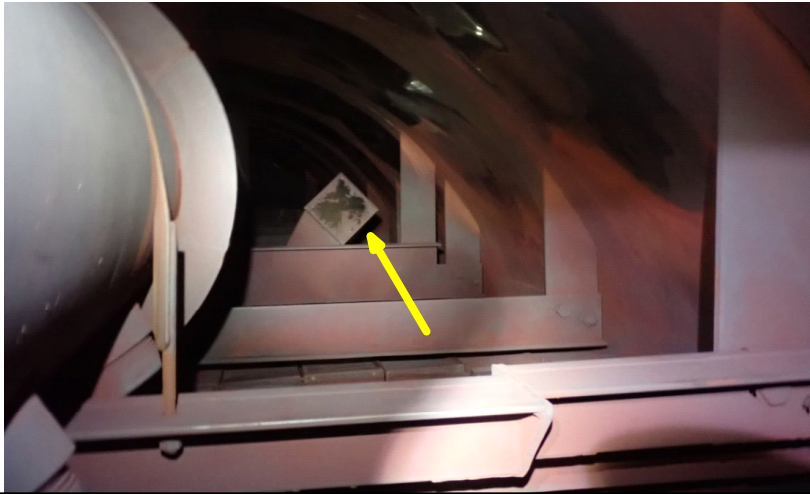
| <b>Condition Assessment:</b> One tray was found up on top of the support. Otherwise, all other trays were in place, including along the entire bottom of the tray enclosure. | | | |

| <b>Recommendations:</b> Continue to monitor in 2025. Plan to remove all trays to access this area if several other trays are found up out of place in 2025. | | | |

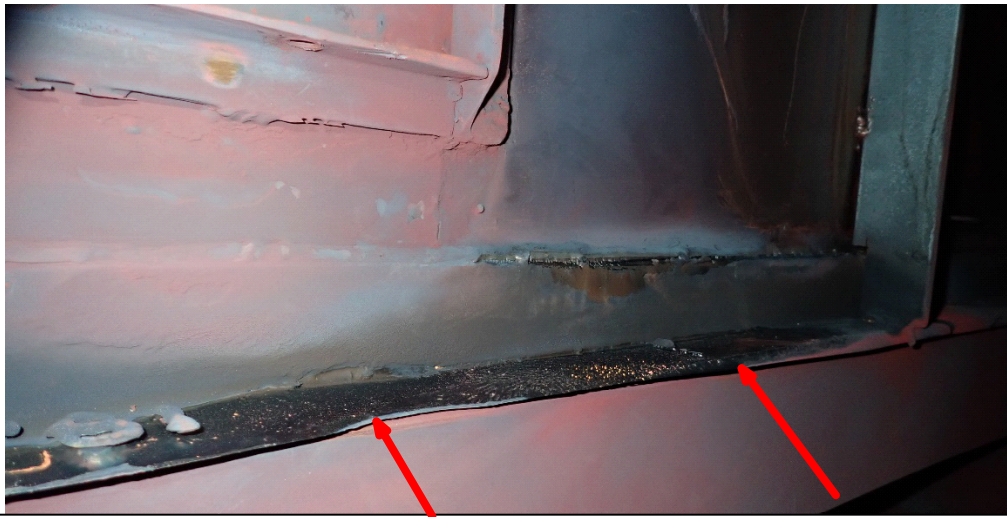
**Date:** 3/22/2024**Inspected by:** EKPC (J.Schaeffer)**Unit:** 2**Item:** 9**Component Inspected:** DA**Condition Assessment:** The West end of the tray enclosure had the bottom angle eroded from steam erosion on the steam inlet.**Recommendations:** Plan to replace the 2"x2"x3/8" (49" LG) SS frame in 2025.**Criticality:** INFO**Risk if NOT Performed:****EKP Comments:**
