SP193805: U3 BFP 3A volute replacement (EPS rep onsite 3/22/23)

CLOSING REPORT

CUSTOMER : East Kentucky Power Cooperative **REPORT DATE** : 12/22/23
PLANT NAME : Spurlock Generating Station **REPORT NO.** : 57180-CR1
CITY/STATE : Maysville, Kentucky **CUST. ORDER** : EKPC-
0000162081

EQUIPMENT : 8 X 10 X 14 HDB-11 Stage **COPY** : Jody McCord
SERVICE : Boiler Feed
MANF. : Byron-Jackson **FILE** : 57180
SERIAL NO. : Spare Element from Unit 3A **PAGE** : 1 of 2

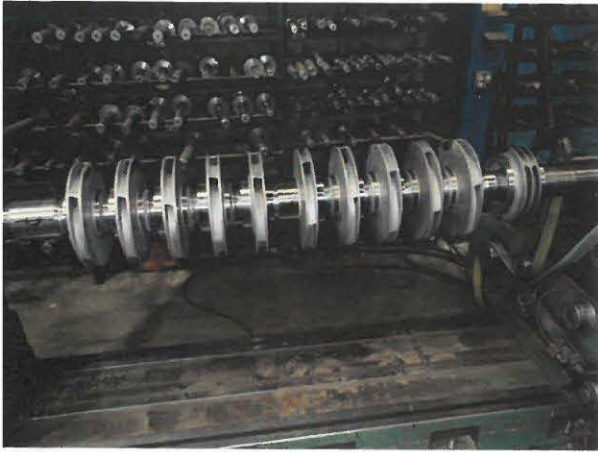
Photo 1: Rotor Dynamic Balance

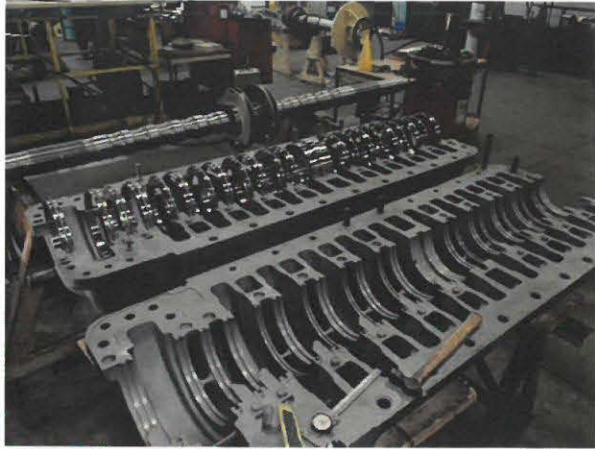
Photo 2: Trial Fit Of Stationary Rings

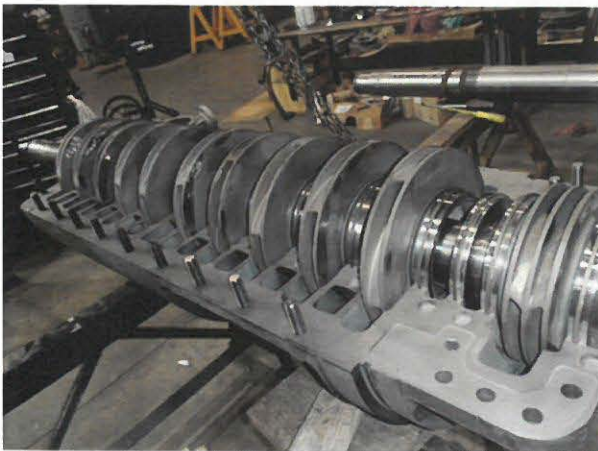
Photo 3: Rotor Cradle Check In Casing

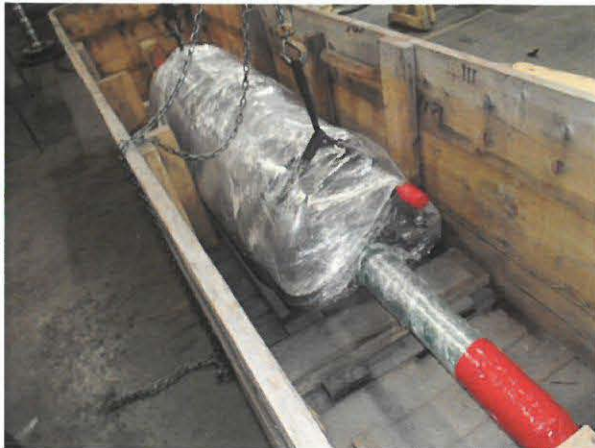
Photo 4: Completed Element In Shipping Crate
