SP226334: UNIT 3 DA #4 FWH ANNUAL OUTAGE INSPECTION

Asset: SP5302 Unit 03 Condensate System Deaerator Storage Tank
Location: SP03.WA.CD.D. Unit 03 Condensate System Deaerator Storage Tank

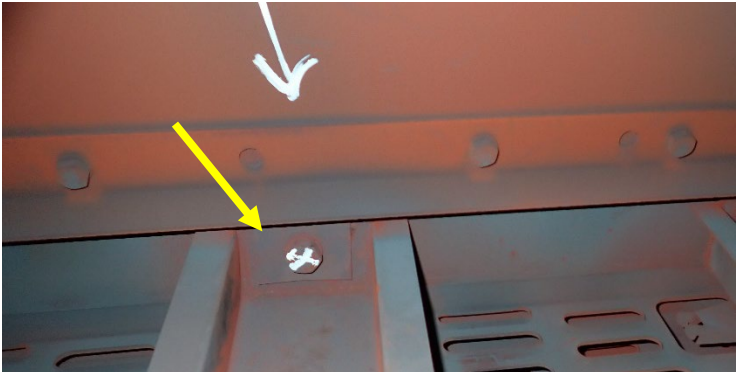
Date: 4/16/2024	Inspected by: EKPC (J.Schaeffer)	Unit: 3	Item: 1
Component Inspected: U3 Deaerator			
Condition Assessment: Inside the tray enclosure, the 3 rd distributing trough from the RHS/East end had a loose shim on the North side. Note that the bolt was not loose by hand but the shim was loose.			
Recommendations: Try to see if bolt will tighten, which could tighten up the shim between the bolt head and the distributing trough. (15/16" head)			
Priority: P2			
Risk if NOT Performed:			
Cost Estimates:			
Action Taken:			
Photos:

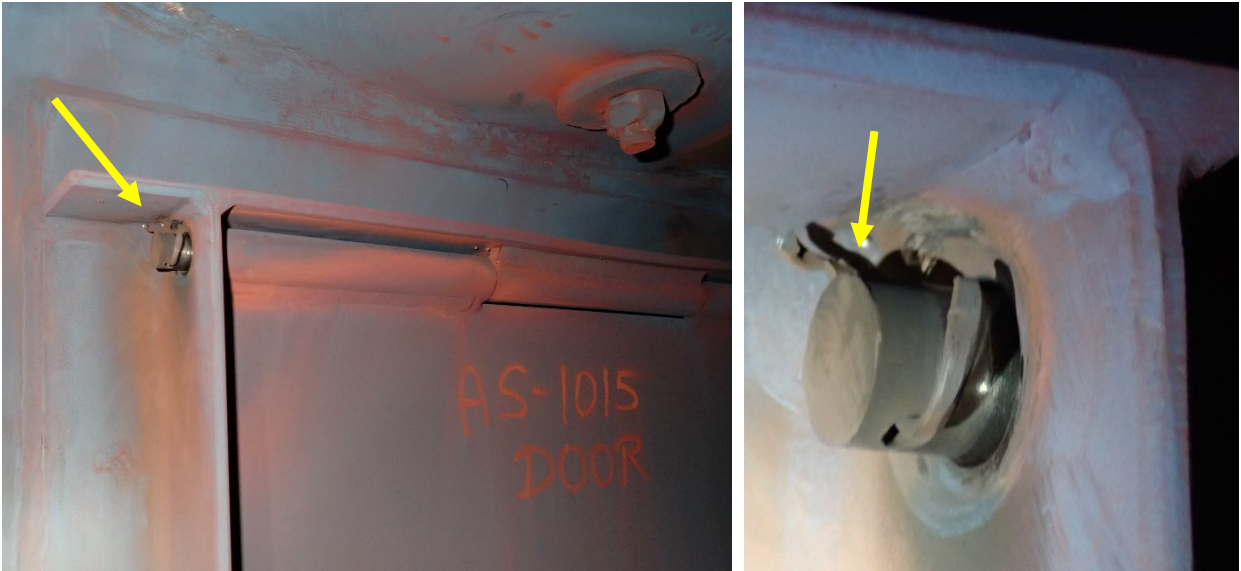
Date: 4/16/2024	Inspected by: EKPC (J.Schaeffer)	Unit: 3	Item: 2
Component Inspected: U3 Deaerator			
Condition Assessment: The RHS/East door to the tray enclosure had the North cotter pin damaged.			
Recommendations: Replace cotter pin. Appears to be ~1 1/4"-1 1/2" LG and maybe <1/8" DIA.			
Priority: P2			
Risk if NOT Performed:			
Cost Estimates:			
Action Taken:			
Photos:

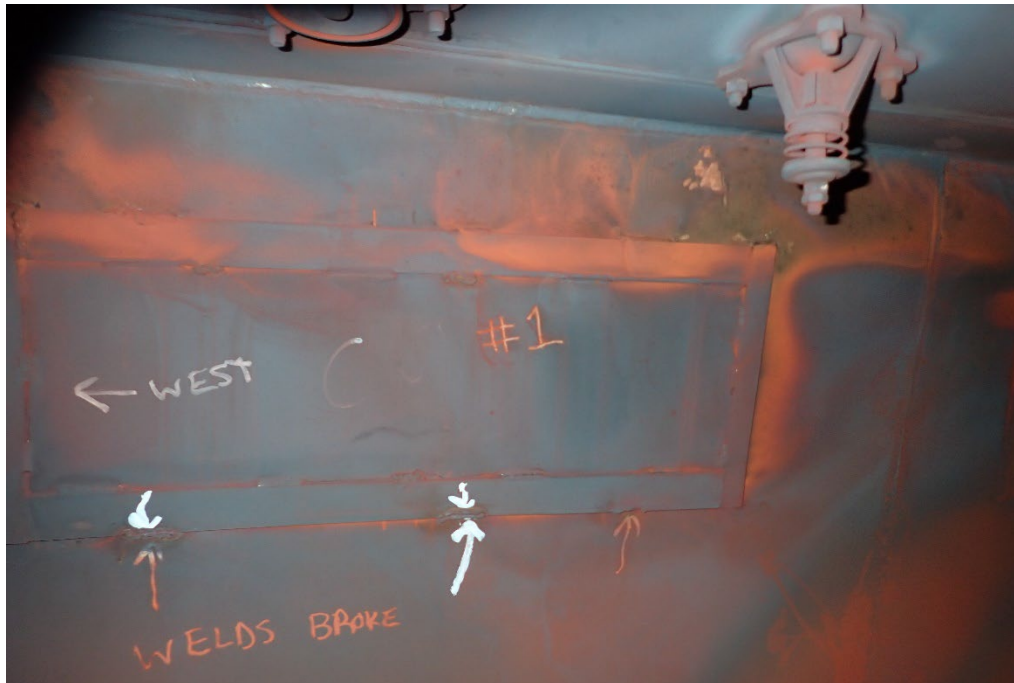
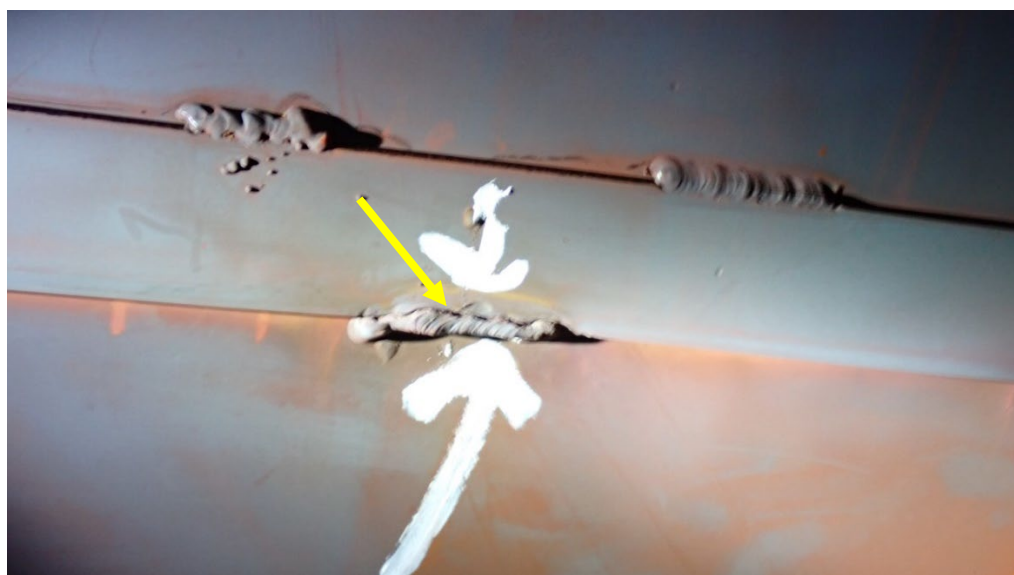
Date: 4/16/2024	Inspected by: EKPC (J.Schaeffer)	Unit: 3	Item: 3
Component Inspected: U3 Deaerator			
Condition Assessment: The North half of the tray enclosure had an old cutout with two cracked welds on the bottom part of the cutout. This was on the cutout closest to the LHS/West end of the enclosure.			
Recommendations: Time permitting this outage only, grind out entire failed welds and re-weld. Otherwise, this can wait until Spring 2025. Tray enclosure is Stainless Steel.			
Priority: P3			
Risk if NOT Performed:			
Cost Estimates:			
Action Taken:

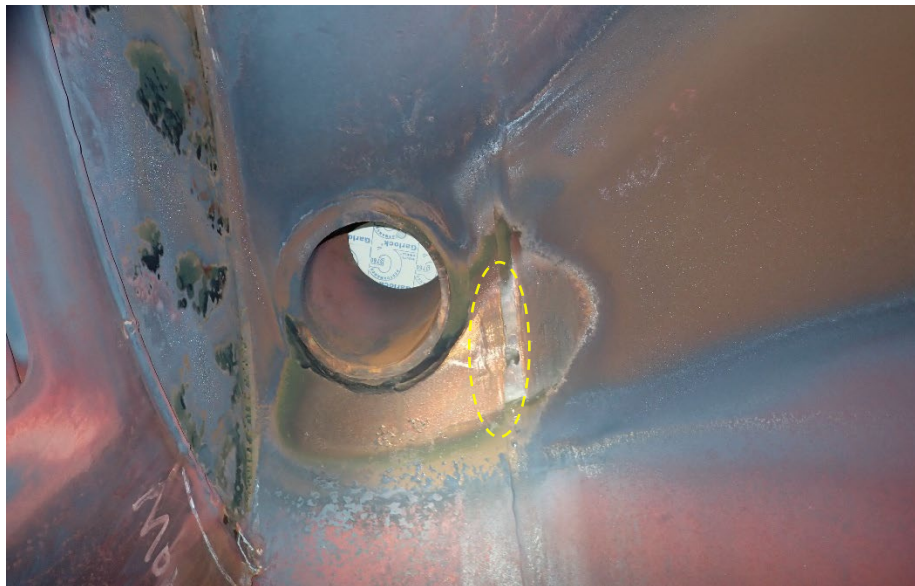
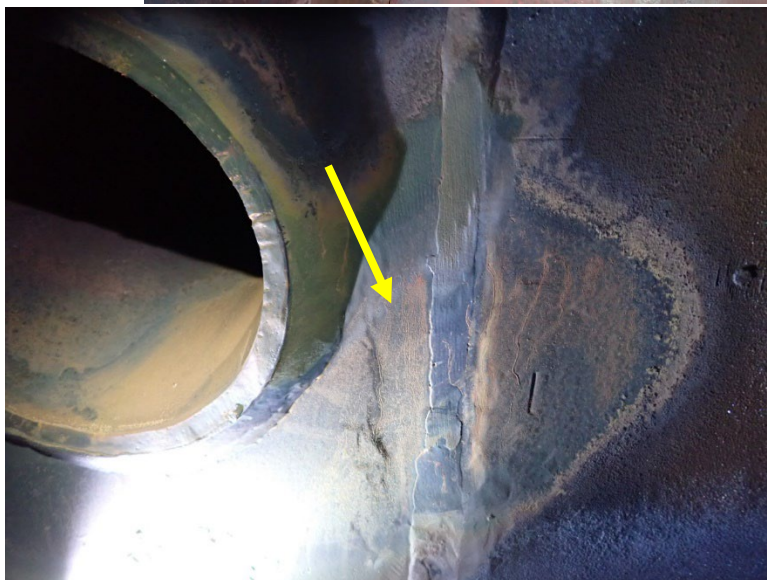
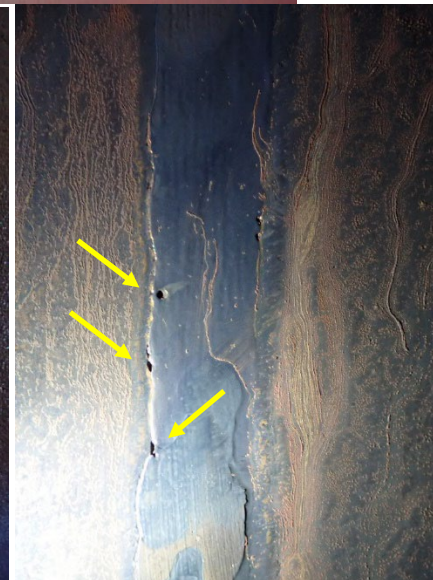
Date: 4/16/2024	Inspected by: EKPC (J.Schaeffer)	Unit: 3	Item: 4
Component Inspected: U3 Deaerator			
Condition Assessment: The LHS/West end of the shell had steam erosion near the South-most safety relief valve nozzle. The erosion was on the weld itself, and extended into the shell side of the weld. Note that the weld line also had 3 indications of porosity. The lowest UT reading on the shell side of the weld was 0.440", and the lowest UT reading in the weld was 0.507". Note that this eroded area pertained to ~1 1/2"x6" area. (Heater Shell and Head = 0.500" NWT, SA516-70)			
Recommendations: Plan for 2025: 1. Grind out indications in the weld, to ensure no further indications are discovered. 2. Pad weld over entire affected area, including original shell/head weld line.			
Priority: P3			
Risk if NOT Performed:			
Cost Estimates:			
Action Taken:

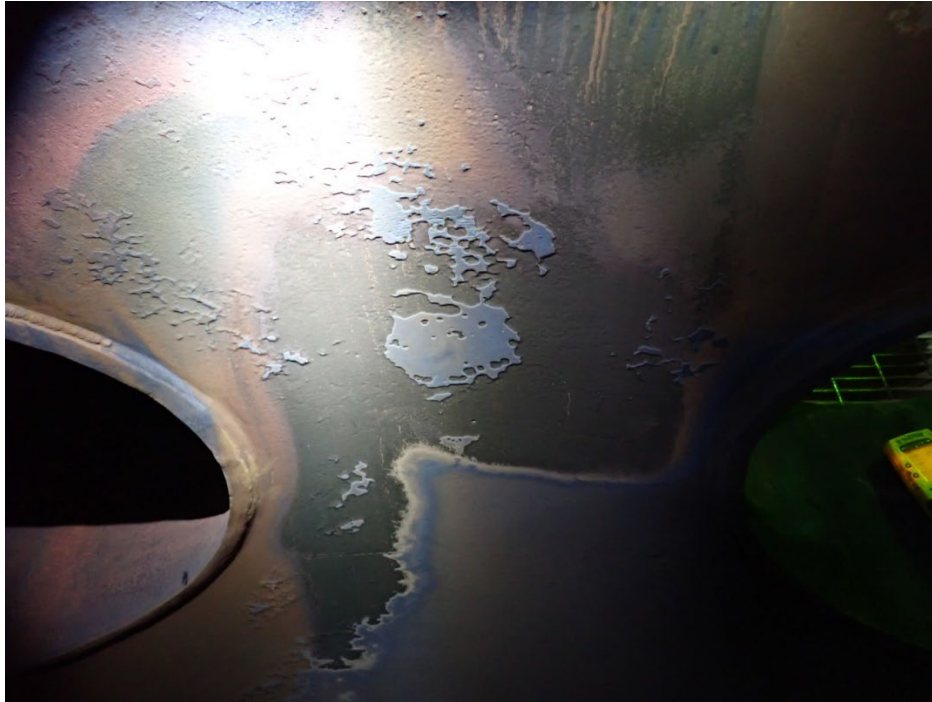
Date: 4/16/2024	Inspected by: EKPC (J.Schaeffer)	Unit: 3	Item: 5
Component Inspected: U3 Deaerator			
Condition Assessment: The LHS/West end of the DA head still had signs of steam erosion. The area between the extraction steam inlet nozzle and the manway was 0.459" low. (0.500" NWT = 92% remain)			
Recommendations: Continue to monitor every year.			
Priority: INFO			
Risk if NOT Performed:			
Cost Estimates:			
Action Taken:

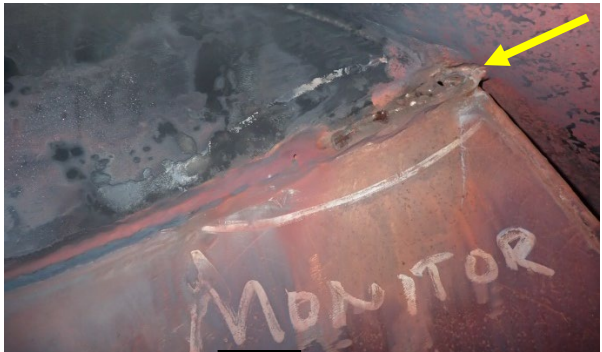
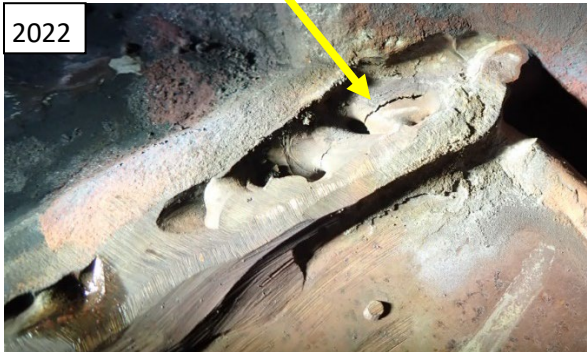
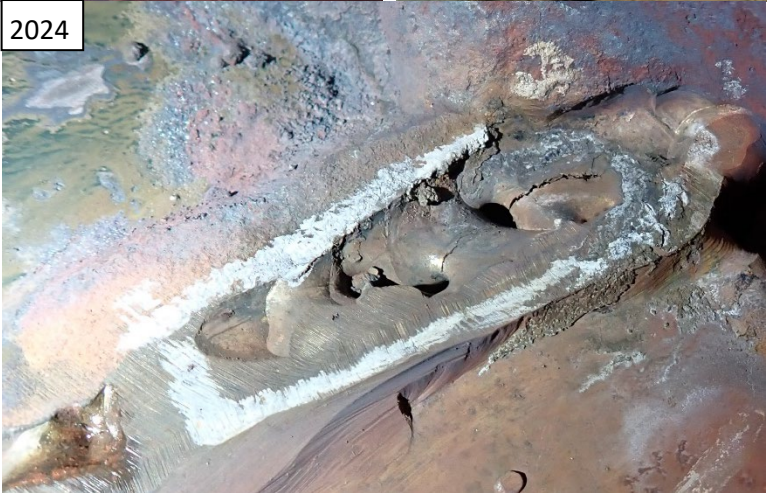
Date: 4/16/2024	Inspected by: EKPC (J.Schaeffer)	Unit: 2	Item: 6
Component Inspected: U3 Deaerator			
Condition Assessment: The top South corner of the tray enclosure, located on LHS/West end, still had indications from expansion at the corner of this tray enclosure attachment to the heater shell. Still a 1/2" long crack (1/32" open) at the corner. Note that these pictures are from 2022 and 2024, as nothing appears to have worsened from 2022.			
Recommendations: Monitor in 2025, and repair as necessary.			
Priority: INFO			
Risk if NOT Performed:			
Cost Estimates:			
Action Taken: NONE. Monitor.

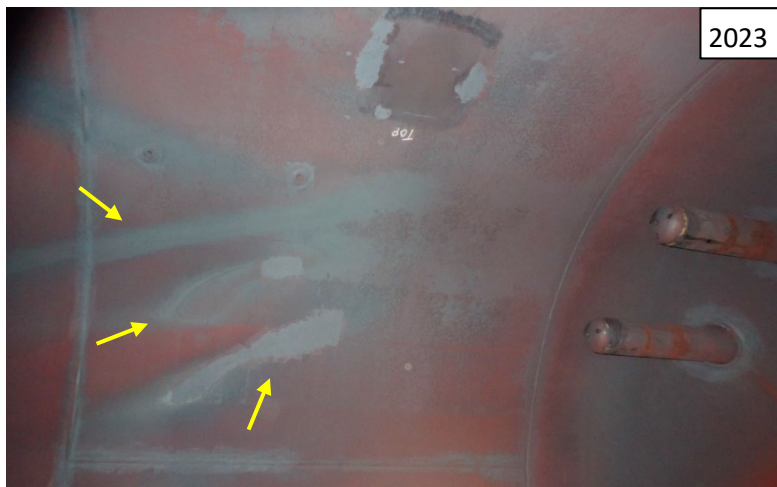
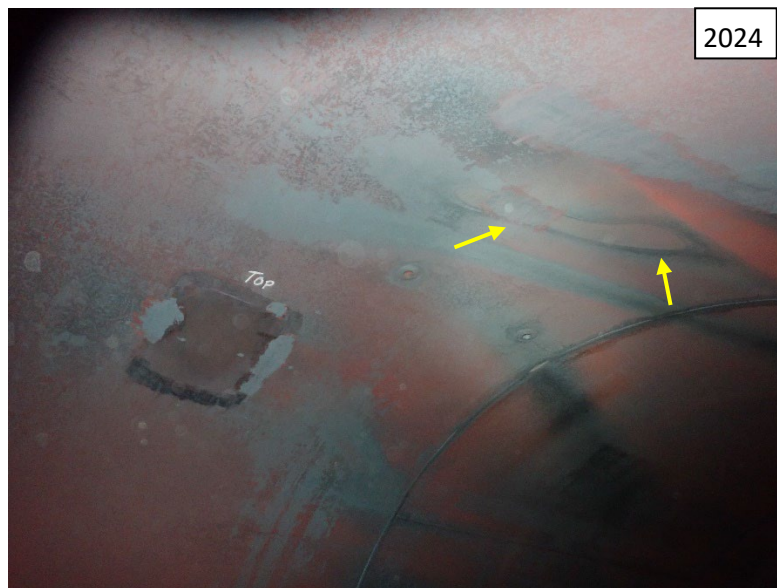
Date: 4/16/2024	Inspected by: EKPC (J.Schaeffer)	Unit: 2	Item: 7
Component Inspected: U3 Deaerator Storage Tank			
Condition Assessment: No major issues were found in the DA Storage Tank. It appears that the South-most BFP recirc. Nozzle has increased flow over the other. The washing on the inside of the tank, closest to the nozzles, was increased from this nozzle. Note that it also had a slightly larger impact on the opposite side of the tank head (East end) as well. It appears the center-most area appears to be getting the most wear, as indicated in the 2024 picture.			
Recommendations: 2025 – Plan to put a ladder in the DA storage tank for UT reading on this area.			
Priority: INFO			
Risk if NOT Performed:			
Cost Estimates:			
Action Taken: N/A

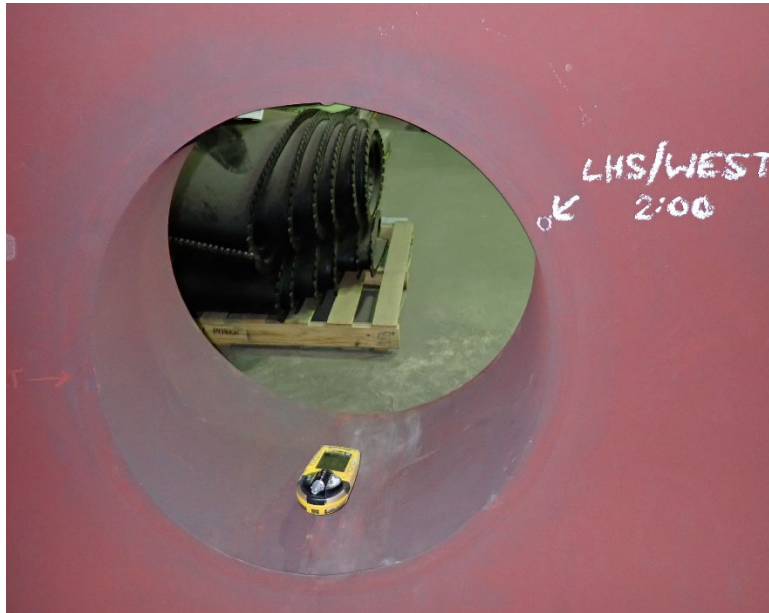
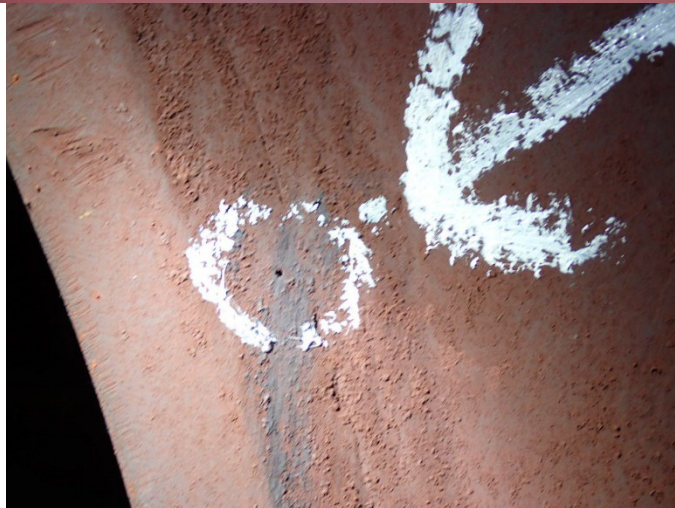
Date: 4/16/2024	Inspected by: EKPC (J.Schaeffer)	Unit: 3	Item: 8
Component Inspected: U3 Deaerator			
Condition Assessment: The LHS/West manway nozzle had a small porosity spot at the 2:00 position (looking outside).			
Recommendations: Continue to monitor.			
Priority: INFO			
Risk if NOT Performed:			
Cost Estimates:			
Action Taken:
