## SP233529: UNIT 4 DA (#4 FWH) ANNUAL OUTAGE INSPECTION

**Asset:** SP5724 Unit 04 Condensate System Deaerator Storage Tank  
**Location:** SP04.WA.CD.D. Unit 04 Condensate System Deaerator Storage Tank

<b>Date:</b> 9/18/2024	<b>Inspected by:</b> EKPC (J.Schaeffer)	<b>Unit:</b> 4	<b>Item:</b> 1
<b>Component Inspected:</b> U4 Deaerator			
<b>Condition Assessment:</b> The extraction steam inlet nozzle, internal weld, had a distinct line visible between the toe of the weld and the nozzle. It appears as if the original internal weld did not have fusion with the nozzle from ~3:00-6:00.			
<b>Recommendations:</b> In 2024, plan to <ol style="list-style-type: none"><li>1. Incorp - remove insulation and flashing on the West end of the heater head.</li><li>2. M3/4 – Wire wheel around the extraction steam inlet nozzle to repad to head welds.</li><li>3. M3/4 – At the 7:00 position, lightly grind a smooth contour into the existing weld. Add a weld pass over this area to build back to the original internal weld profile.</li><li>4. M3/4 – From the 3:00-6:00 position, grind out the internal weld to expose the original extraction steam inlet nozzle to shell head interface.<ol style="list-style-ty

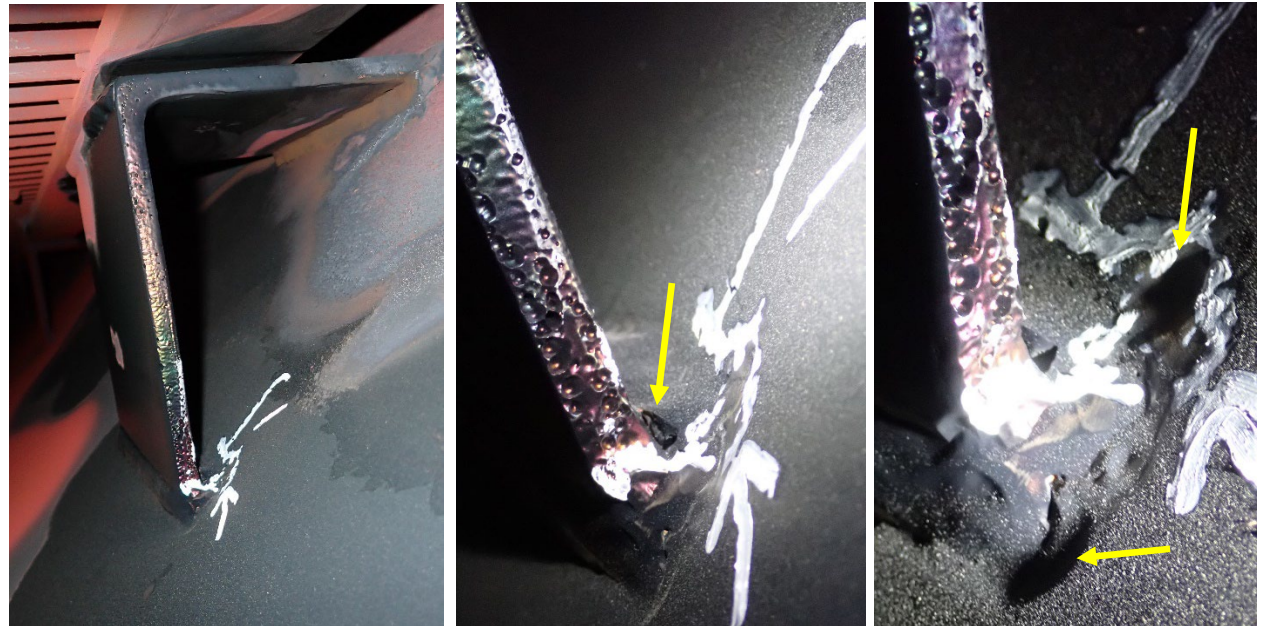
<b>Date:</b> 9/18/2024	<b>Inspected by:</b> EKPC (J.Schaeffer)	<b>Unit:</b> 4	<b>Item:</b> 2
<b>Component Inspected:</b> U4 Deaerator			
<b>Condition Assessment:</b> The Southwest tray enclosure support foot had flashing damage on the leading edge of it, and appears to have created a pit in the weld. It has also eroded into original undercut on the foot to shell weld.			
<b>Recommendations:</b> Burr bit out the pit. Do not dig straight in; open the pit up large enough to prevent any cracking to propagate from the edges of the pit. Re-weld over shell side of weld and burred out area on support foot side of the weld.			
*Heater shell is ½" THK, SA516-70 material and the tray enclosure support foot was verified carbon steel with a materials analyzer.*			
<b>Priority:</b> P2 - 2024			
<b>Risk if NOT Performed:</b>			
<b>Cost Estimates:</b>			
<b>Action Taken:</b>

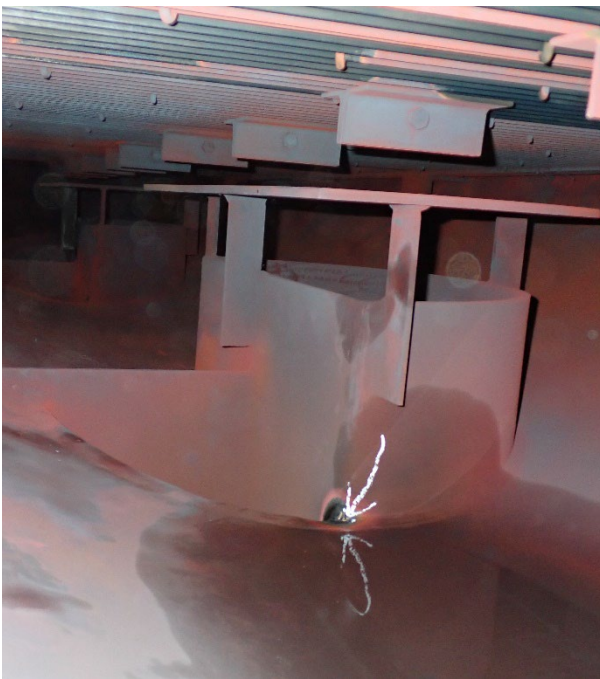
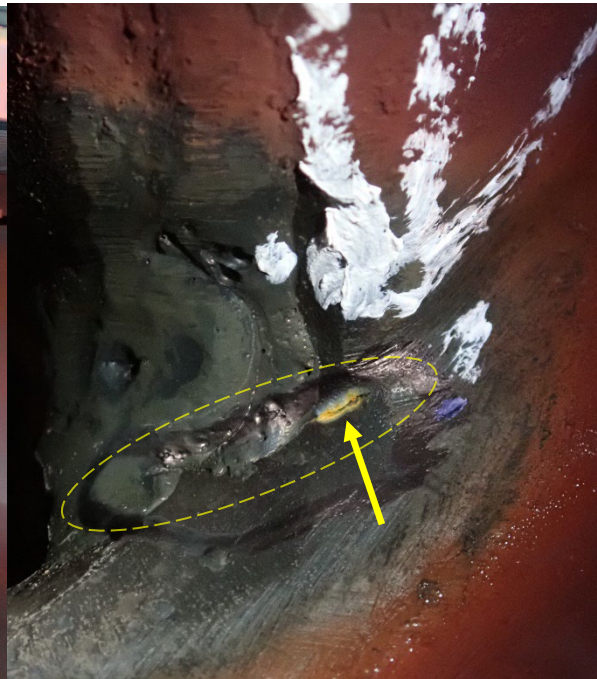
<b>Date:</b> 9/18/2024	<b>Inspected by:</b> EKPC (J.Schaeffer)	<b>Unit:</b> 4	<b>Item:</b> 3
<b>Component Inspected:</b> U4 Deaerator			
<b>Condition Assessment:</b> The East side of the East downcomer/equalizer nozzle had a small crack identified on the weld at the corner of where the nozzle welds to the shell.			
<b>Recommendations:</b> Grind out the crack, which extends through a prior weld repair. Use a burr bit to grind this out along a 1" length but don't dig deep into it, as you need to feather out the edges to create a smooth, wide valley. Then, re-weld over this area. *Downcomer/equalizer nozzle is SA516-70 material.*			
<b>Priority:</b> P2			
<b>Risk if NOT Performed:</b>			
<b>Cost Estimates:</b>			
<b>Action Taken:</b>

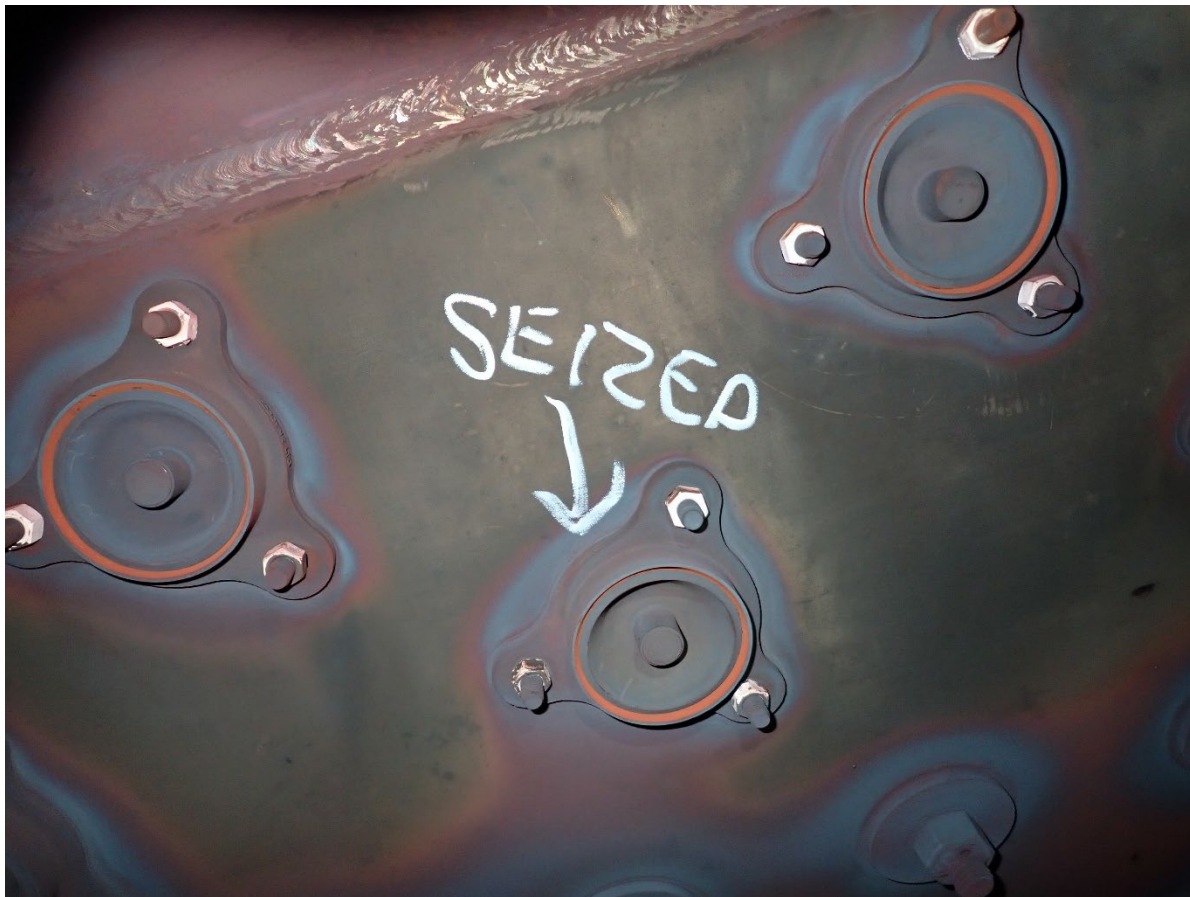
<b>Date:</b> 9/18/2024	<b>Inspected by:</b> EKPC (J.Schaeffer)	<b>Unit:</b> 4	<b>Item:</b> 4
<b>Component Inspected:</b> U4 Deaerator			
<b>Condition Assessment:</b> A couple of the tray spray nozzles were tight, and I could not get one to move with just my hands.			
<b>Recommendations:</b> Use channel locks or something to grip the spray nozzle and see if it will pull down and spin around as it's originally designed.			
<b>Priority:</b> P2			
<b>Risk if NOT Performed:</b>			
<b>Cost Estimates:</b>			
<b>Action Taken:</b>

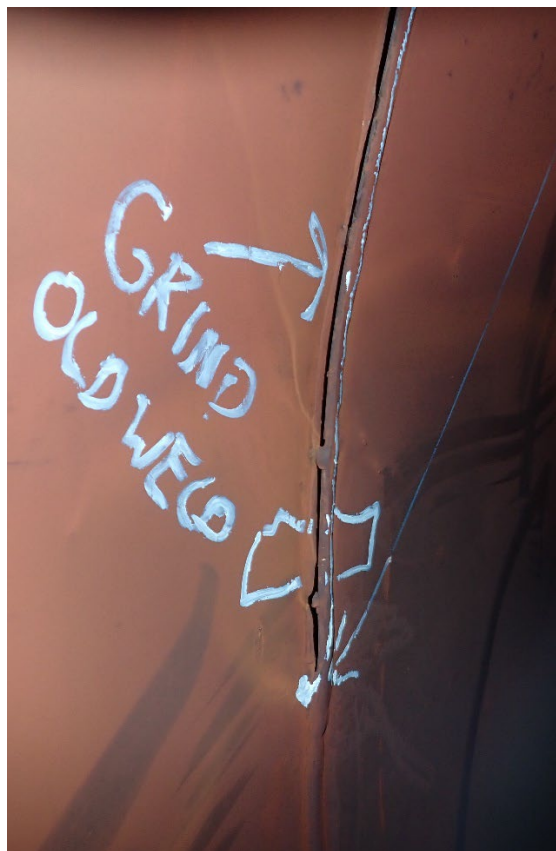
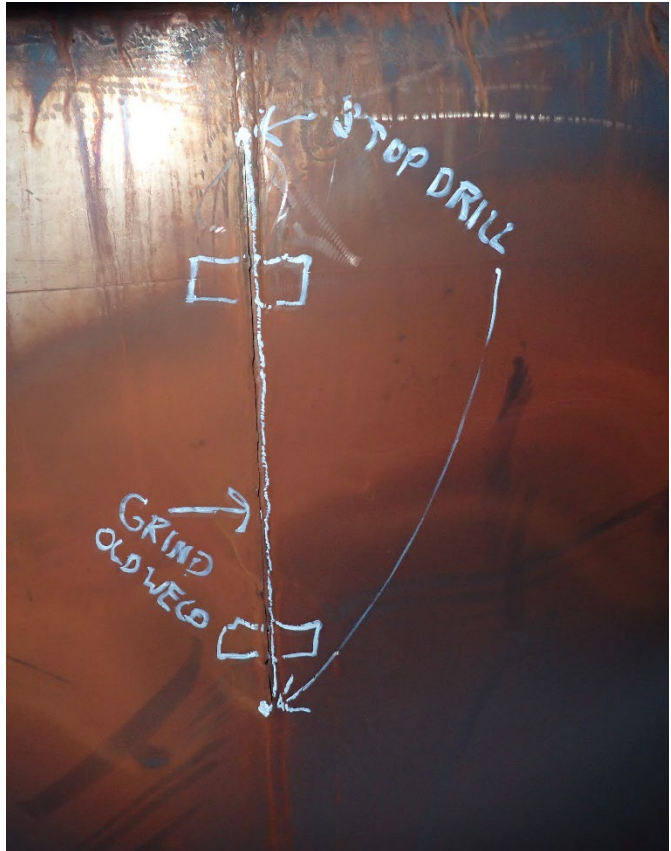
<b>Date:</b> 9/18/2024	<b>Inspected by:</b> EKPC (J.Schaeffer)	<b>Unit:</b> 4	<b>Item:</b> 5
<b>Component Inspected:</b> U4 Deaerator			
<b>Condition Assessment:</b> The South end of the tray enclosure had a 14" long crack, and one side was folded in.			
<b>Recommendations:</b> <ol style="list-style-type: none"><li>1. Stop-drill the ends of the cracks with a 1/8" drill bit.</li><li>2. Grind out the original weld. The two split lines will not push together easily if it's not ground, as the one side has two weld stubs sticking out.</li><li>3. Use a screw-dog to force the two halves back flush with each other, and re-weld at split line.</li><li>4. Install 1"x3"x3/16" or 1/4" S.S. THK bands across the weld line.<ol style="list-style-type: none"><li>a. Planner may have to see if we have some SS onsite to cut these bands out, or else may be some over in WHS6.</li></ol></li></ol>			
*Tray enclosure is 304L SS*

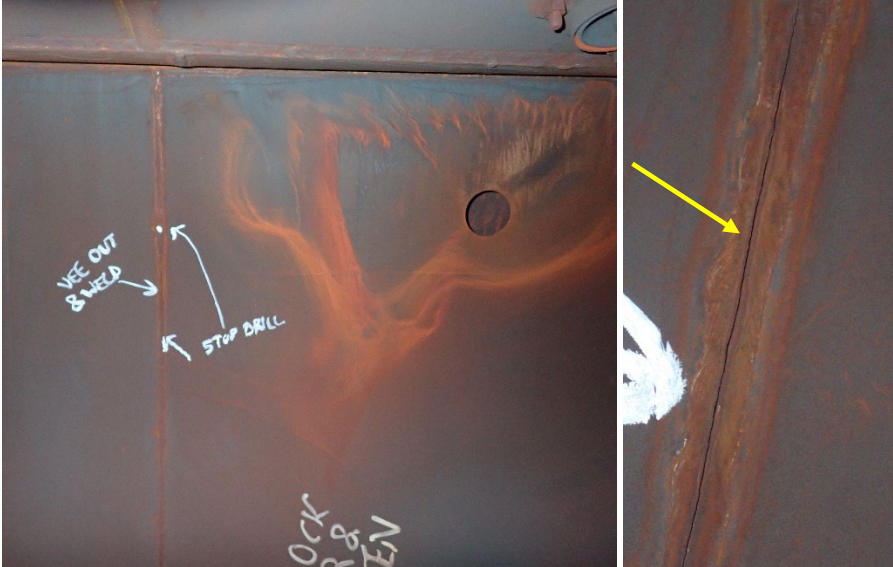
<b>Date:</b> 9/18/2024	<b>Inspected by:</b> EKPC (J.Schaeffer)	<b>Unit:</b> 4	<b>Item:</b> 6
<b>Component Inspected:</b> U4 Deaerator			
<b>Condition Assessment:</b> The North end of the tray enclosure had a 4" long crack at the weld line.			
<b>Recommendations:</b> Stop drill the ends of the cracks, VEE out the original weld, and re-weld. *Tray enclosure is 304L SS*			
<b>Priority:</b> P2			
<b>Risk if NOT Performed:</b>			
<b>Cost Estimates:</b>			
<b>Action Taken:</b>			
<b>Photos:</b>

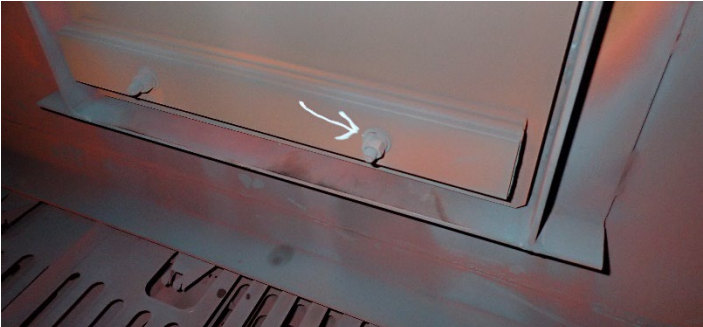
<b>Date:</b> 9/18/2024	<b>Inspected by:</b> EKPC (J.Schaeffer)	<b>Unit:</b> 4	<b>Item:</b> 7
<b>Component Inspected:</b> U4 Deaerator			
<b>Condition Assessment:</b> The East tray enclosure door had a loose nut on the door weights.			
<b>Recommendations:</b>			
<b>Priority:</b> P2			
<b>Risk if NOT Performed:</b>			
<b>Cost Estimates:</b>			
<b>Action Taken:</b>			
<b>Photos:</b>

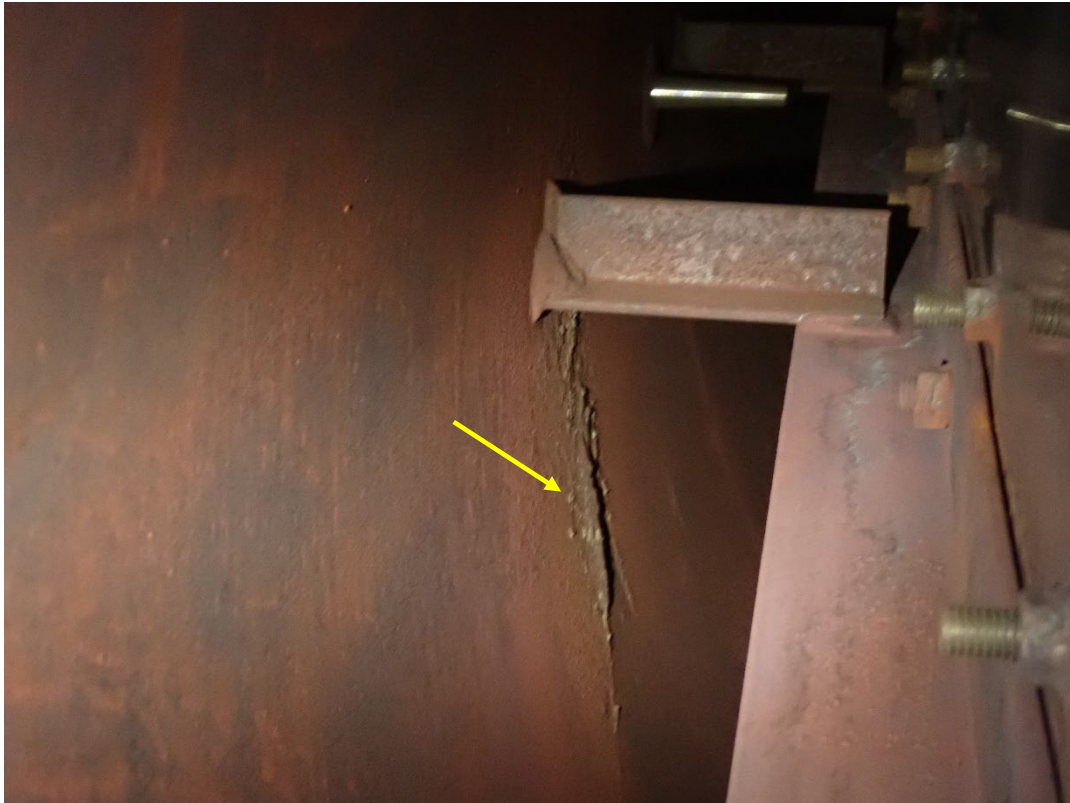
<b>Date:</b> 9/18/2024	<b>Inspected by:</b> EKPC (J.Schaeffer)	<b>Unit:</b> 4	<b>Item:</b> 7
<b>Component Inspected:</b> U4 Deaerator			
<b>Condition Assessment:</b> The South side of the DA shell still had deposits at the 2 <sup>nd</sup> tray enclosure stiffener in from the East side.			
<b>Recommendations:</b> Use a putty knife duct-taped to a broom stick, and scrape off all deposits in 2025. Save deposits for Engineering to get a deposit analysis, and notify Engineering once complete so an inspection can be performed to ensure no under-deposit corrosion has taken place.			
<b>Priority:</b> 2025			
<b>Risk if NOT Performed:</b>			
<b>Cost Estimates:</b>			
<b>Action Taken:</b>
