INSPECTION REPORT

CUSTOMER	: East Kentucky Power Cooperative	REPORT DATE	: 07/15/22
PLANT NAME	: Spurlock Station	REPORT NO.	: 56870-IR1
CITY/STATE	: Maysville, Kentucky	CUST. ORDER	: EKPC- 0000153973
EQUIPMENT	: 06x08x13 HDB-6	COPY	: Eddy Meek
SERVICE	: Boiler Feed	FILE	: 56870
MANF.	: Byron-Jackson	PAGE	: 1 of 4
SERIAL NO.	: Unit #1A

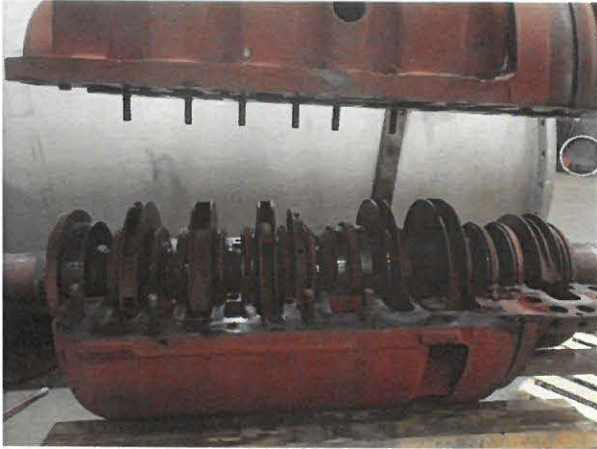
Photo 1: Rotor Assembly As Received

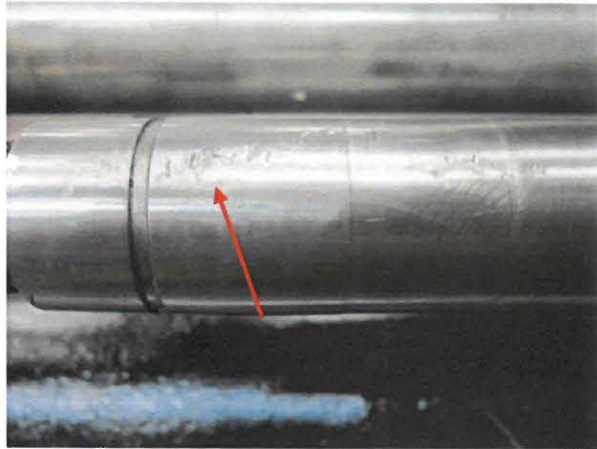
Shaft – Overall, the shaft is in good condition with only minor visible damage. There are light rubs on both ends from contact with the bearing covers, and it looks like the thrust collar nut lightly galled on the shaft. There is also light galling on the balance sleeve fit. Apart from this, there is no real damage to the shaft, and the breakdown grooves and impeller fits are in good condition. The total indicated runout of the shaft is .002" TIR or better which is very good for a shaft in this application. All critical fit turns measured to the expected design diameters.

Photo 2: Shaft Gall At Thrust Collar Nut Fit

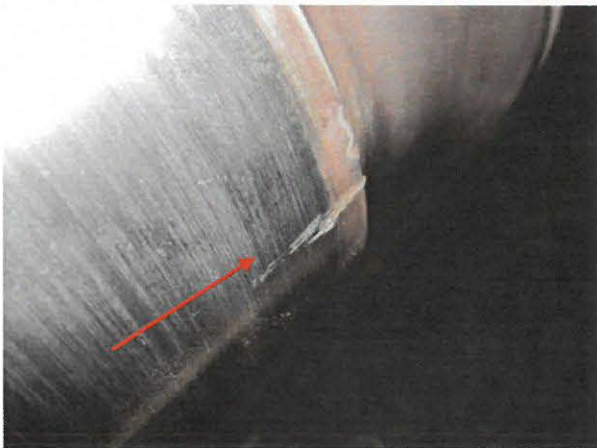
Balance Sleeve – As mentioned above, the balance sleeve had galled to the shaft and had to be cut for removal. There is light wear and washing on the outer turn of this part

Photo 3: Shaft Gall At Balance Sleeve Fit

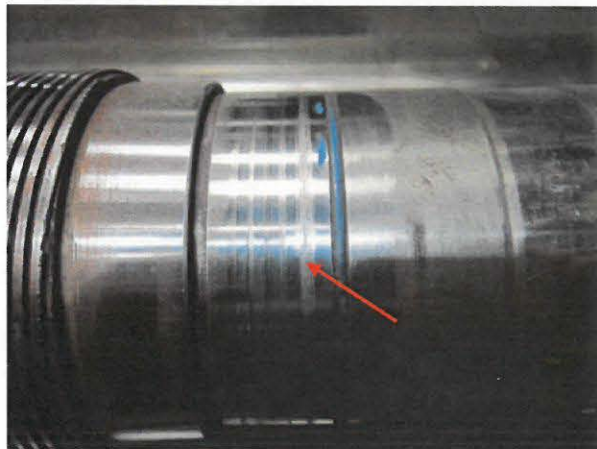
Photo 4: Shaft Wear From Bearing Covers

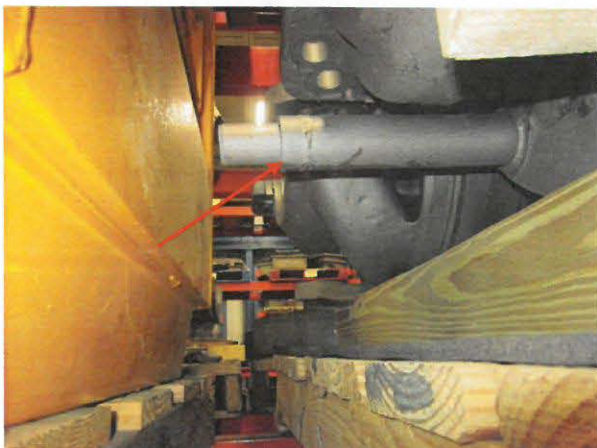
Takeoff Tube – The takeoff tube on this pump had a special field modification that was required to address a length issue in the field. Essentially, it was a tube extension that was welded onto the existing tube. The modification worked well, and there is no evidence of damage at the weld joint.

Photo 5: Field Modification Of Takeoff Tube

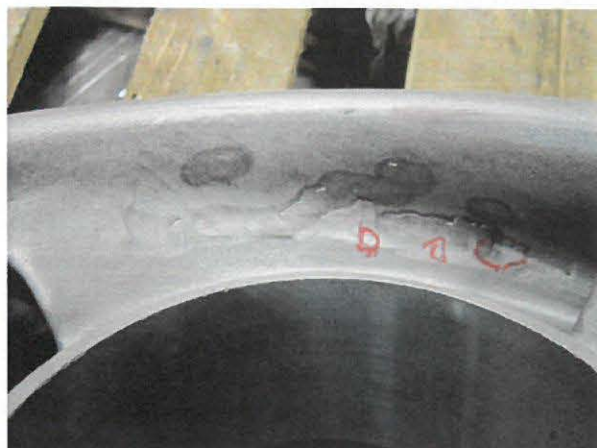
Photo 6: Previous weld repair on 1st Stage Impeller

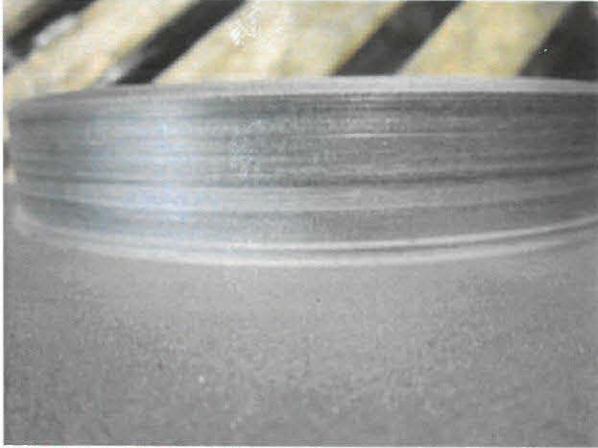
Impellers – As mentioned in the introduction of this report, most of the impellers have light to moderate grooving on the eye side and hub side seal turns. The as measured running clearances are all only marginally oversized and out of round. The seven impeller fit bores are all in good visual condition and have been previously chrome plated. Generally speaking, all interference fits to the shaft measure to design specifications. Magnetic particle analysis only picked up a few minor indications that were mostly cosmetic

Photo 7: Typical Wear On Impeller Eye Turns

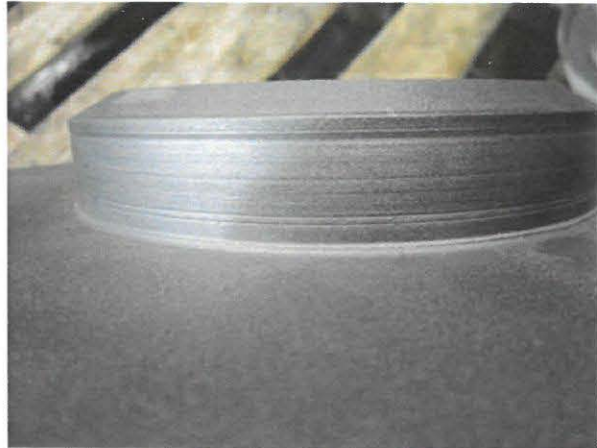
Photo 8: Typical Wear On Impeller Hub Turns

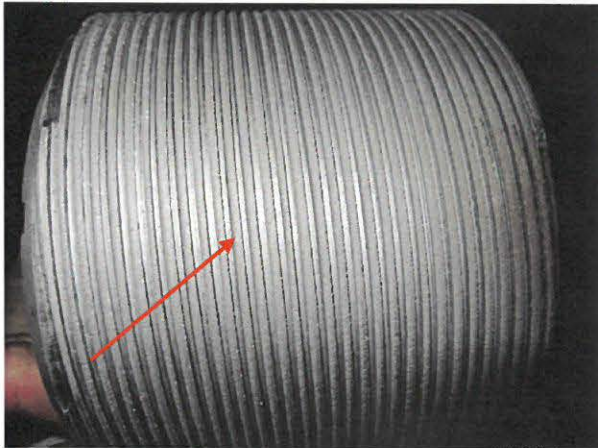
Photo 9: Light Wear On Balance Sleeve

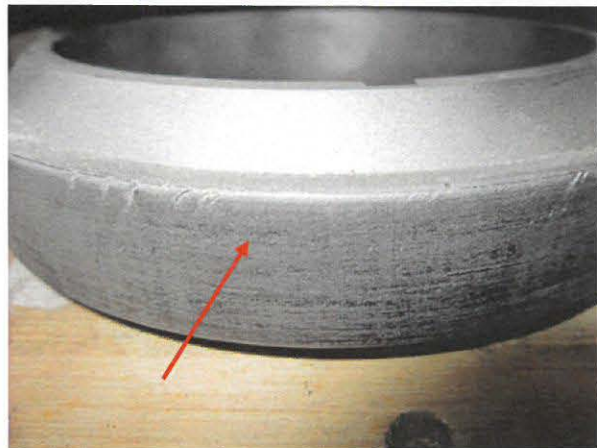
1st Stage Shaft Sleeve - The shaft sleeve is in fair condition with light wear and washing on the sealing turn. The fit bore to the shaft measures close to design diameter but is lightly out of round and has some visual fretting.

Photo 10: Light Wear On 1-2 Sleeve

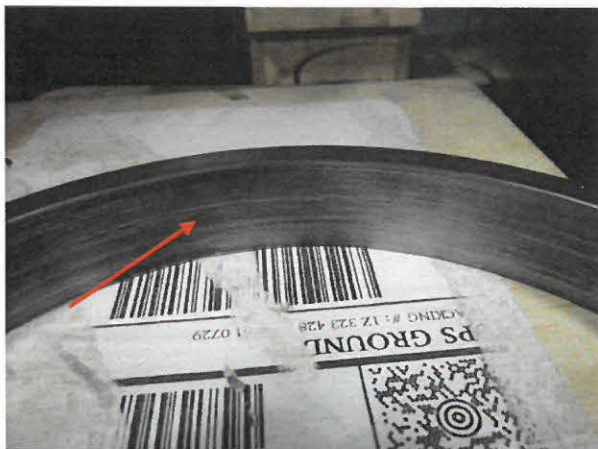
Wear Rings - Case – The case rings are in fair visual and dimensional condition. All running clearances to the impeller are moderately oversized and out of round with some visible grooving wear. Several of the rings have also lightly “sprung” out of round at the outer fit to the volute casing.

Photo 11: Typical Wear On Case Rings

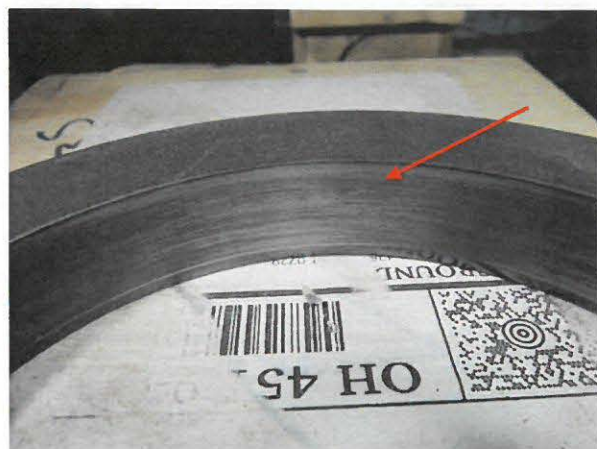
Stage Pieces - Split – The split stage pieces are in very good condition with light visible wear and all critical dimensions measuring to the expected design values. Similar to the case rings, all running clearances are moderately oversized and out of round.

Photo 12: Typical Wear On Stage Pieces

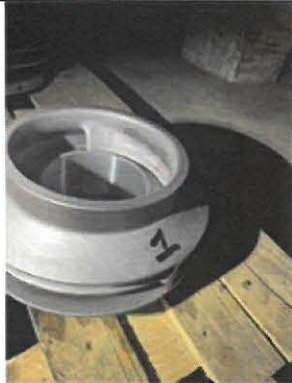
Linears found on vane inlets and outlets

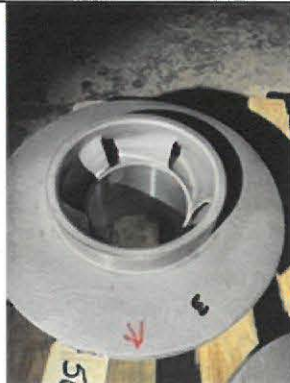
Linears found on vanes and keyway.

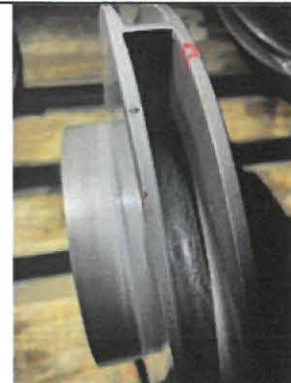
Linear found on vane outlet.
