ENGINEERED PUMP SERVICES, INC.

CLOSING REPORT

CUSTOMER	: East Kentucky Power Cooperative	REPORT DATE	: 01/08/21
PLANT NAME	: Spurlock Generating Station	REPORT NO.	: 56261-CR1
CITY/STATE	: Maysville, Kentucky	CUST. ORDER	: EKPC- 0000138153
EQUIPMENT	: 17" MQX1H5-6	COPY	: Eddy Meek
SERVICE	: Condensate Water	FILE	: 56261
MANF.	: Byron Jackson	PAGE	: 1 of 2
SERIAL NO.	: Unit # 1

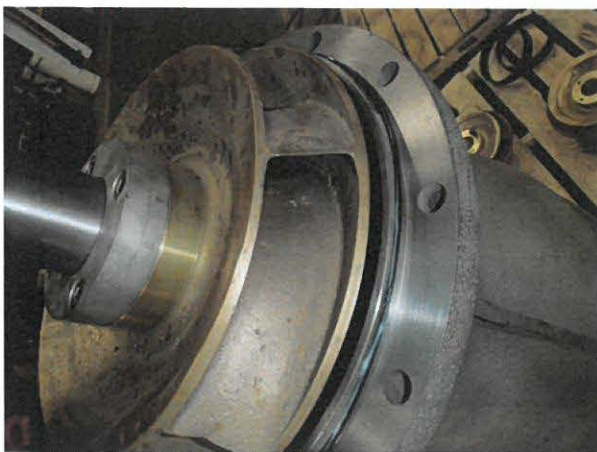
Photo 1: Closeup Of Typical Impeller Stage

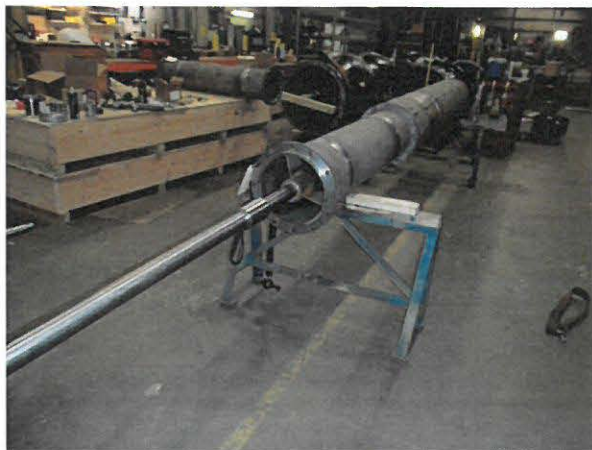
Photo 2: Pump Assembly Progress
