CLOSING REPORT

CUSTOMER	: East Kentucky Power Cooperative	REPORT DATE	: 12/30/24
PLANT NAME	: Spurlock Generating Station	REPORT NO.	: 57093-CR1
CITY/STATE	: Maysville, Kentucky	CUST. ORDER	: EKPC- 0000162701
EQUIPMENT	: 17" MQX1H5-6	COPY	: Eddy Meek
SERVICE	: Condensate Water	FILE	: 57093
MANF.	: Byron Jackson	PAGE	: 1 of 2
SERIAL NO.	: Unit # 1B

East Kentucky Power Cooperative
Spurlock Generating Station
Byron-Jackson 17" MQX1H5 – 6 Stage Condensate Pump

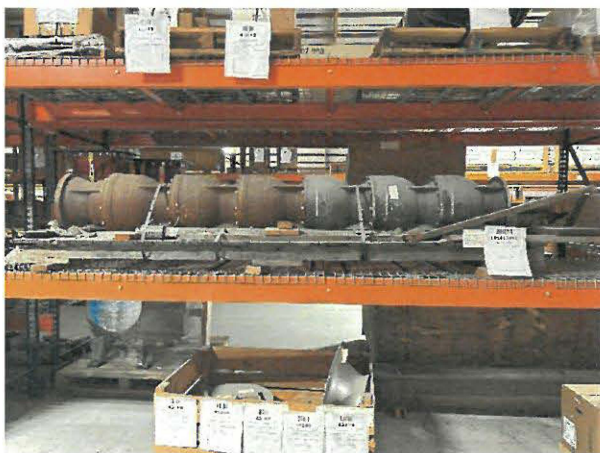
This repair made use of the spare lower element and parts repaired under EPS order 52557 (EKPC-0000023948) during the fall of 2004. This was discovered to be the best course of action after initial inspection revealed the existing element would require a new 1st stage impeller and one new series casing. This element will be repaired under a separate order after the critical outage timeline is over. Overall, there was only one setback during the project. The repaired mechanical seal was not completed as quickly as requested by our aftermarket repair shop. This did not, however, negatively impact the installation schedule at Spurlock.

Photo 1: Spare Element from Spurlock Stores

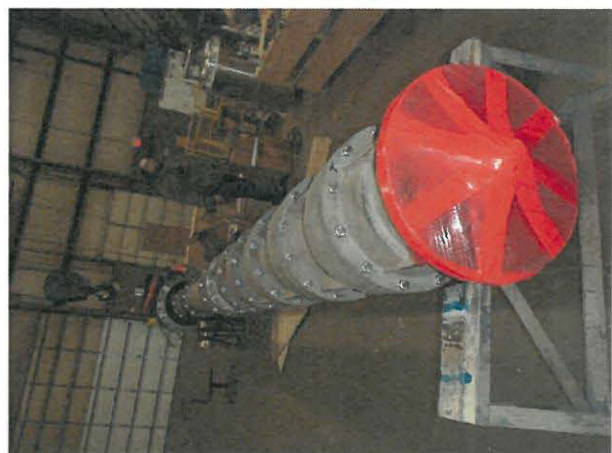
The pump was completely repaired and rebuilt in accordance with EPS specification 57093-RS2; the total indicated runouts of the new shafts were all under .0015", and each impeller turn runout was under .0015". The final float of the completed assembly was .974", and the pump spun freely when lifted. Apart from the delay previously mentioned, there were no issues with the pump repair or assembly. The completed pump assembly was returned to Spurlock on 11/08/23.

Photo 2: Completed Pump Assembly
