DEAERATOR INSPECTION REPORT

PREPARED FOR
**EAST KENTUCKY POWER
ELECTRIC COOPERATIVE**

**SPURLOCK STATION, MAYSVILLE, KY
UNIT 1 DEAERATOR**

Inspection Date: 3/22/2022

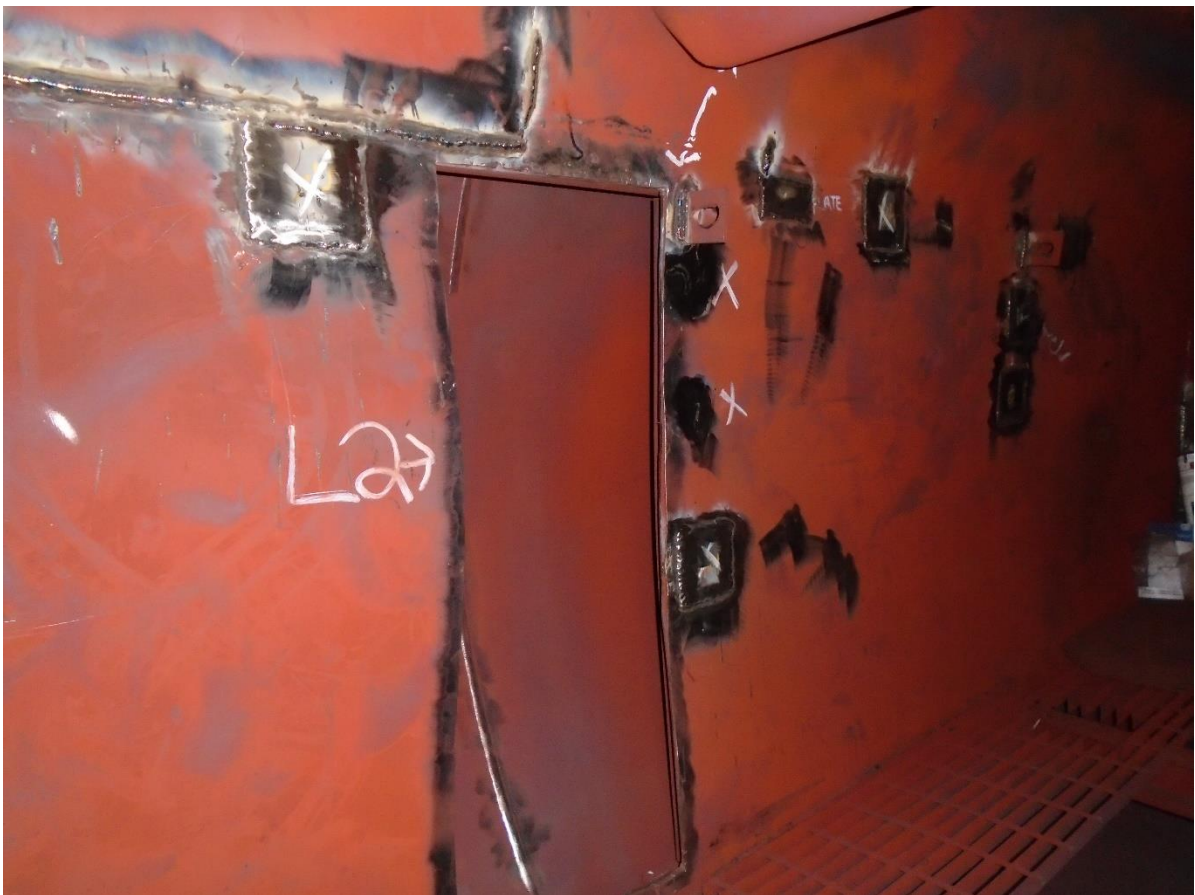
Upon entering the deaerator, the trays had been removed, which allowed for easy access throughout the tray enclosure. It was first noted that several openings had been cut out from the tray enclosure, most likely so the circumferential welds of the vessel could be tested. It has been noted in past inspections that small holes have developed in certain areas of the tray enclosure—most notably in areas where previous repairs have been done, and in the corners of the tray enclosure. These small holes, often referred to as “pin holes”, can allow non-condensable gases to escape the tray enclosure, which can contribute to further oxygen problems. Be sure these openings and “pin holes” are properly sealed to minimize these problems and increase performance.

Tray enclosure opening.

It is important that the tray enclosure remains completely sealed to prevent non-condensable gases from escaping the enclosure and entering areas where they can do damage to the carbon steel pressure boundary of the vessel. Be sure that tray enclosure repairs are sealed with no openings to also maximize deaerator performance.

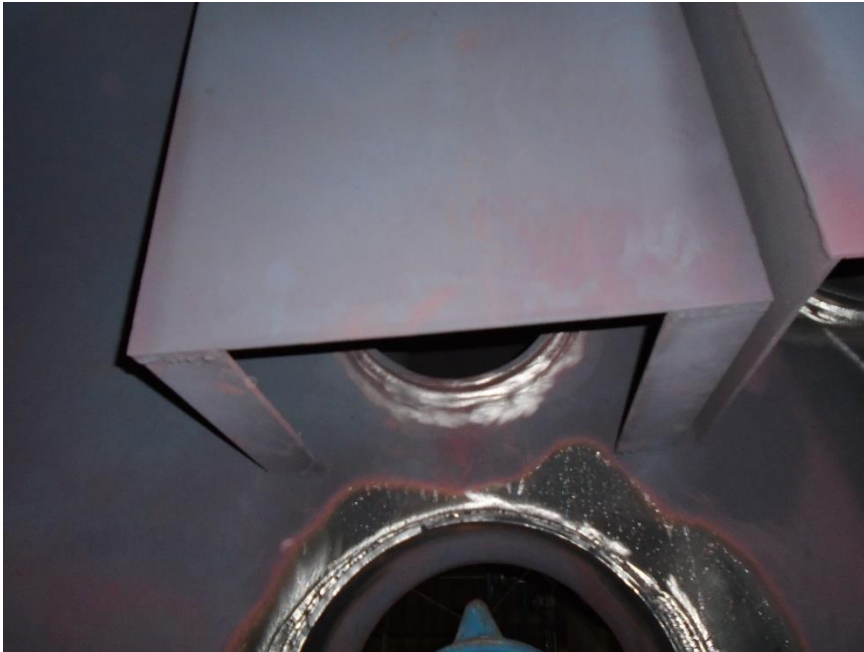
It has been noted in previous inspections that flow accelerated corrosion (FAC) has been a problem on both heads. Flow accelerated corrosion (FAC) is defined as metal loss that occurs in carbon steel equipment when the normally protective oxide layer is dissolved into a flowing stream (liquid, vapor or 2-phase flow). The carbon steel goes through a continuous cycling of oxide layer production followed by loosening and dissolution into the flowing stream. The oxide layer is not able to protect the metal surface and the continuous loss of the layer results in steady loss of metal thickness. In this vessel, the location of the steam inlets above the manways could possibly be causing stream impingement, subsequently resulting in FAC on the heads.

Erosion on West head near steam inlet and manway. Note the appearance of black magnetite around the nozzle.

All spots susceptible to erosion should be monitored and tested by means of VT examination every outage to ensure no major loss of material is occurring. If material loss appears to be evident, these areas should be UT tested. All internal welds should be

inspected by MT per NACE RP0590 and the frequency per NBIC. If UT determines that any point on the head is less than the minimum thickness required by code, the area should be repaired by means of weld overlay. Multiple passes should be made to ensure full coverage of the thinned area. It is recommended that the heads and areas surrounding the steam inlet nozzles be the focus of the NDE being performed during the next outage.

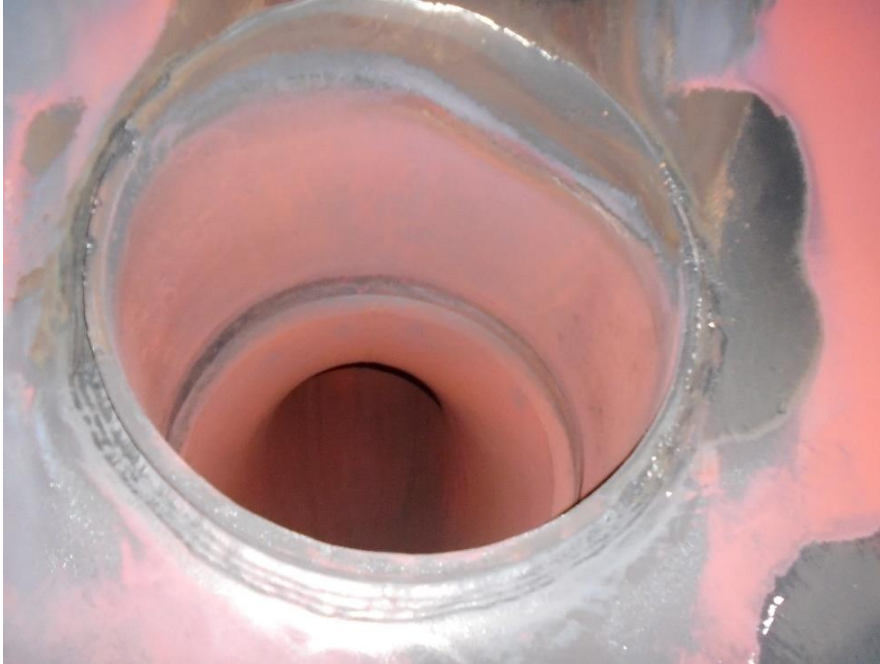
The steam inlet nozzle itself also showed some signs of FAC. If left unchecked, this could contribute to further material loss in the deaerator head.

Steam inlet erosion.

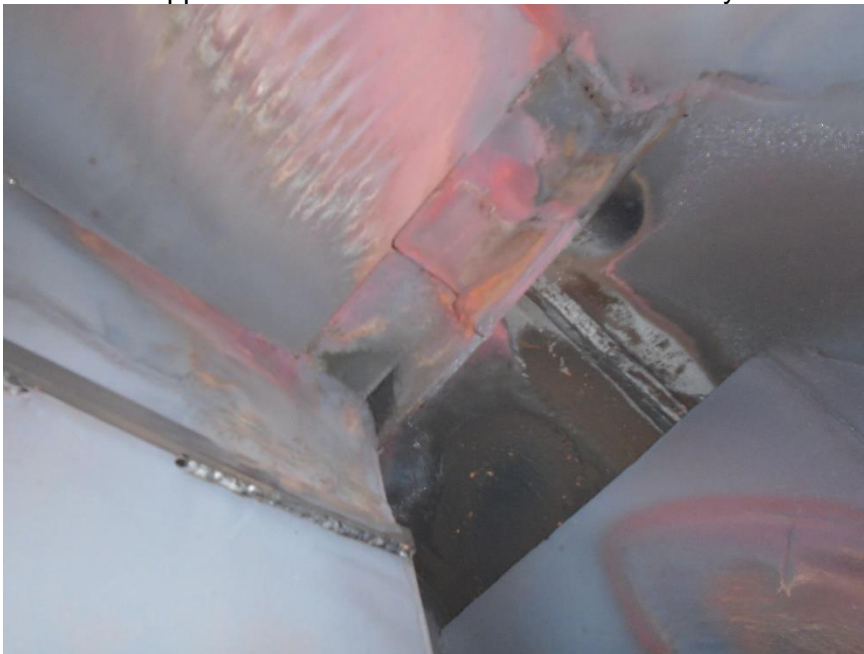
There also appeared to be some material loss in the tray enclosure support angles.

Tray enclosure support angle material loss.

The cause of the material loss is unclear, however, as there are no inlets in the immediate area. One possible cause could be water escaping through holes in the tray enclosure. In past reports, numerous holes were found in the tray enclosure, which would easily allow

water to bypass the trays. The constant flow of steam against the water could then erode the outside of the box.

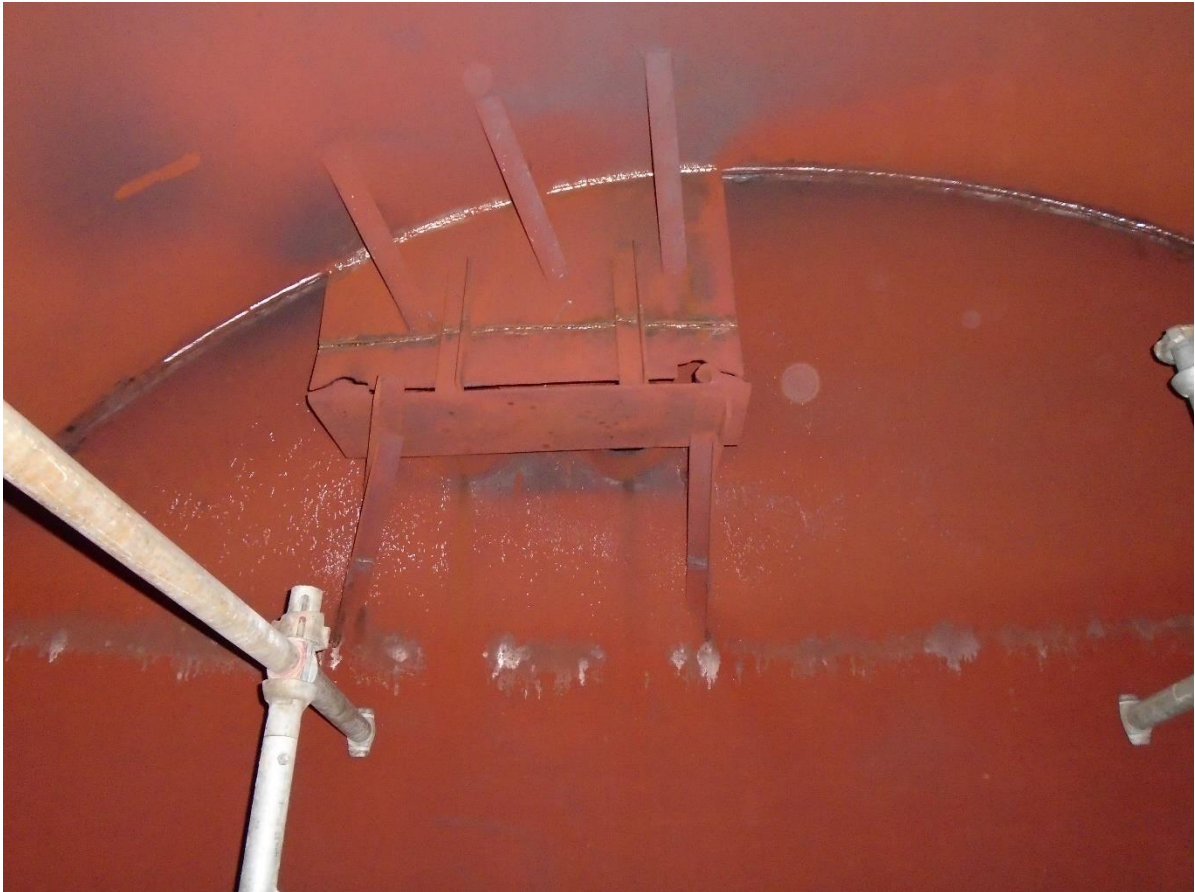
The storage tank did appear to be in good condition. All nozzles and welds looked good, and there appeared to be a uniform oxide layer throughout the tank. It was noticed that the North end head baffle had suffered a major crack at the angle where the plates meet. Also, there did appear to be some debris laying in the bottom of the storage tank.

Cracked baffle plate in storage tank.

There was a small amount of debris in the bottom of the storage tank. This should be removed to avoid damage to pumps and anything else downstream of the deaerator. Also, the cracked baffle plate support in the storage tank should be replaced or reinforced to prolong usage of the baffle plate.
