1.1 The Accident .....	1
1.1.1 Area Layout.....	2
1.1.2 Service Line and Tee Replacement at Palmer Building 2 .....	5
1.1.3 Natural Gas Leak and Explosion .....	8

Pipeline Investigation Report

Report Number PIR-25-01

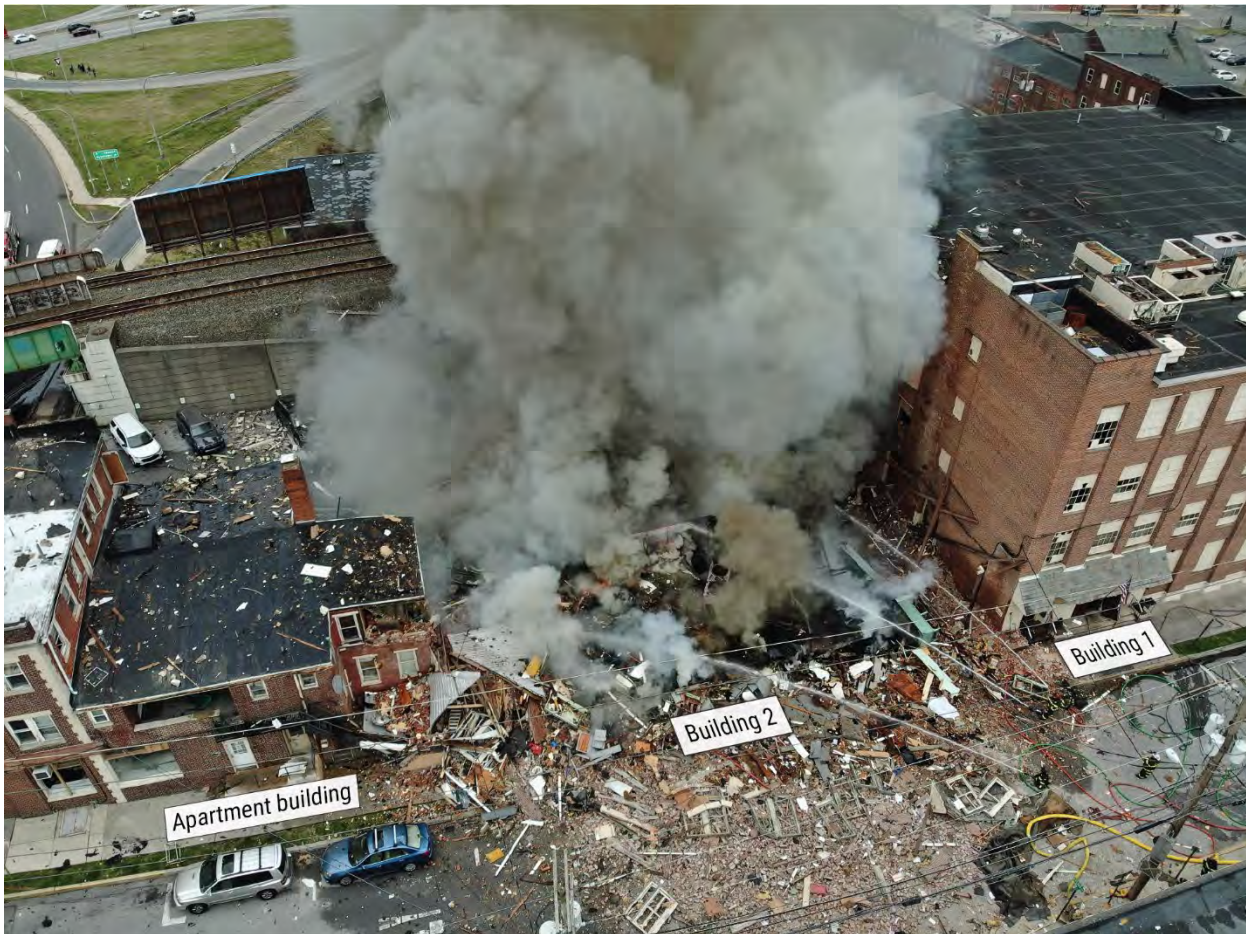
**Figure 1.** Overhead image of the accident. (Source: Western Berks Fire Department.)

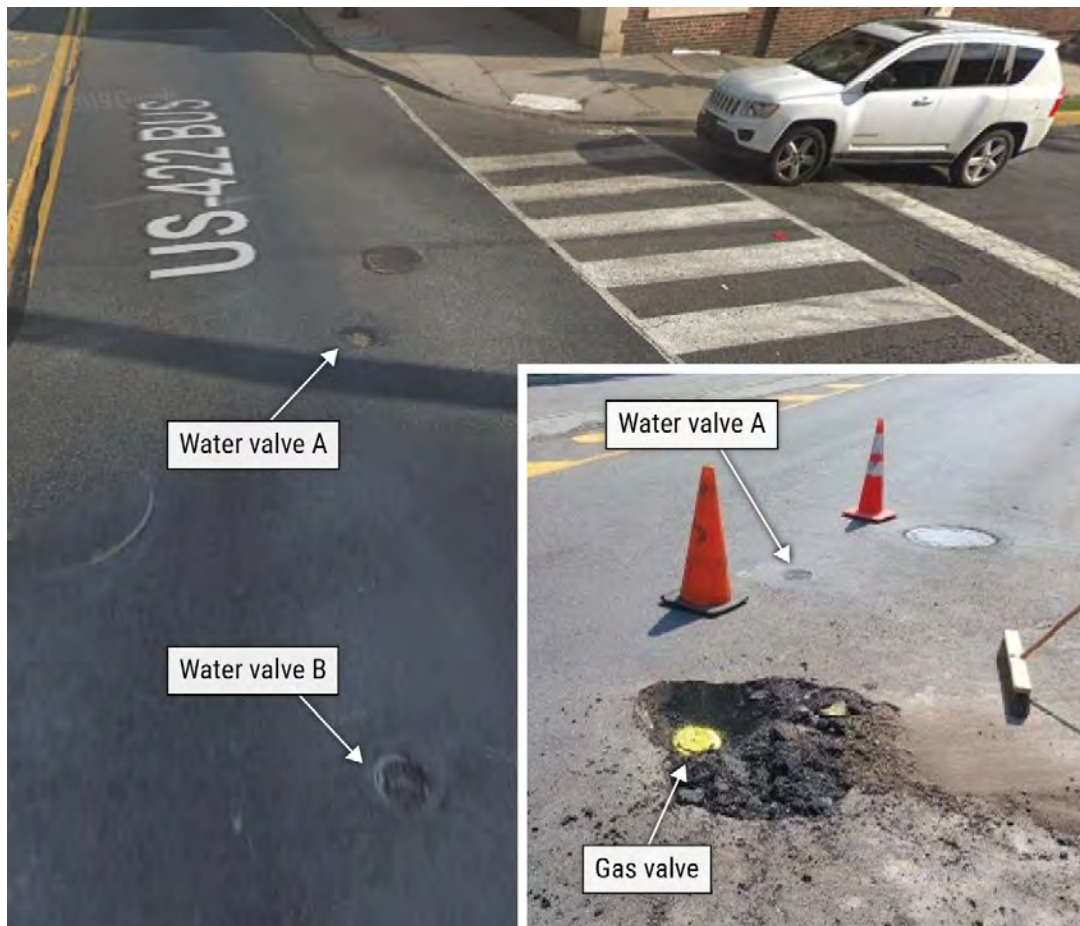
**Figure 8.** South 2nd Avenue and Penn Avenue intersection in 2018 (*main image*) and during an excavation in 2024 (*inset*); water valve A had a gas cover. (Source: Google Street view via UGI.)

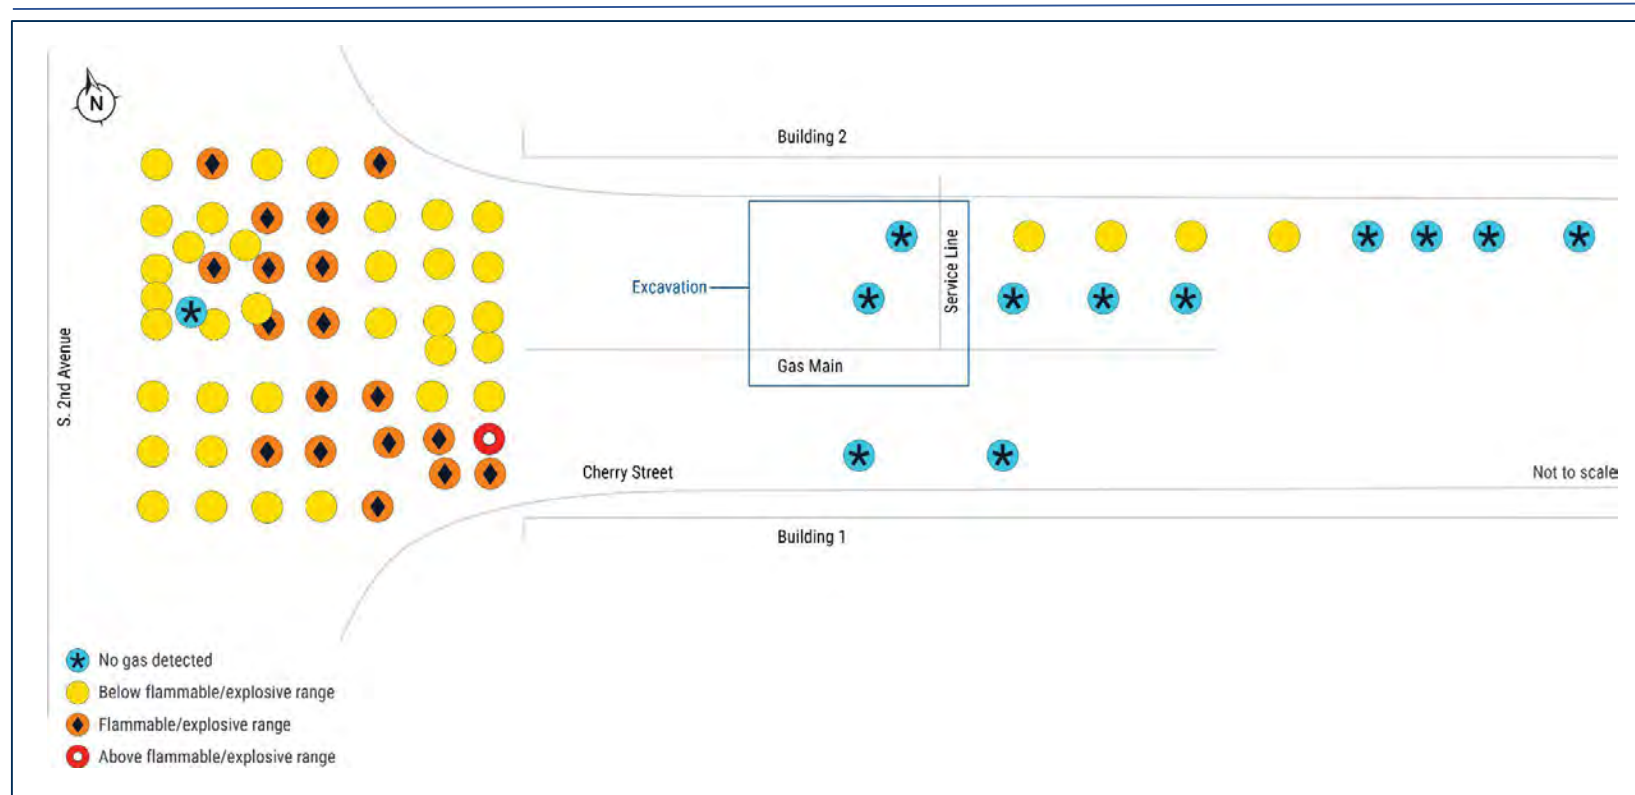
**Figure 9.** Bar hole test readings conducted in March 2023 (*left side of image*) and April 2023 (*right side of image*).

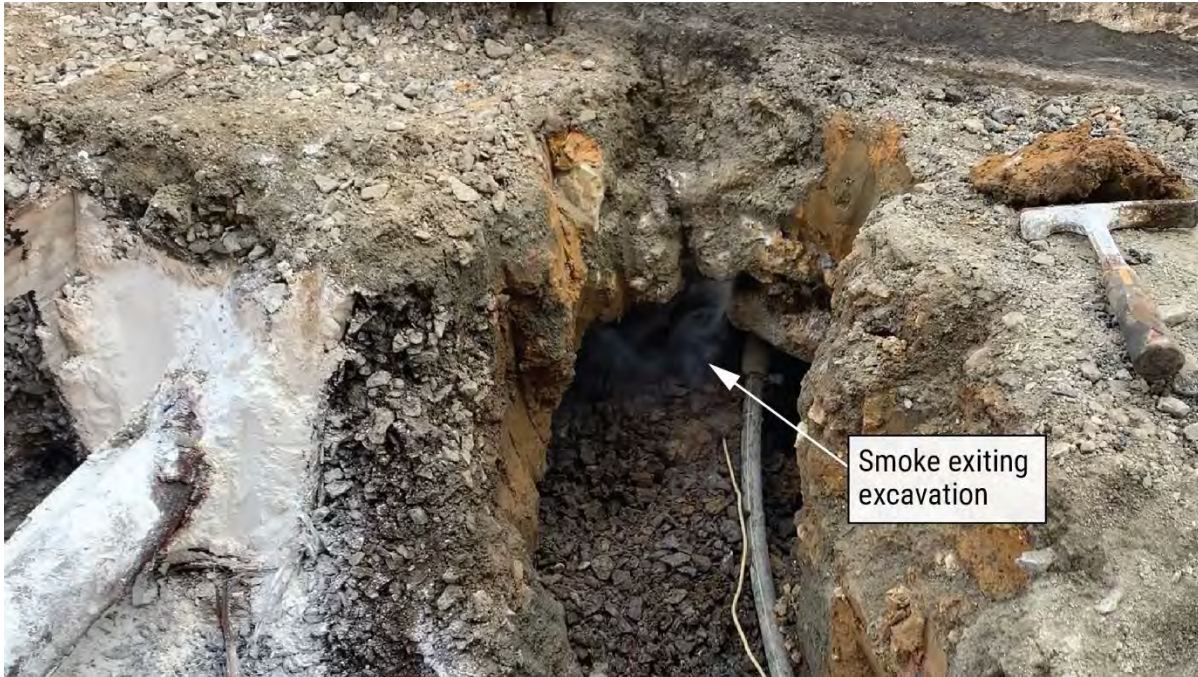
To further test the interaction between the chocolate pipe conduits and the ground around the gas pipelines, the NTSB used rags to block the spaces in the conduit opening around the chocolate pipes in the Building 1 basement. When the smoke generator was restarted in the Building 2 basement, smoke emanated from the ground near the Building 2 foundation and the gas service line. (See figure 10.)

**Figure 10.** Smoke from conduit visible near gas service line to Building 2.

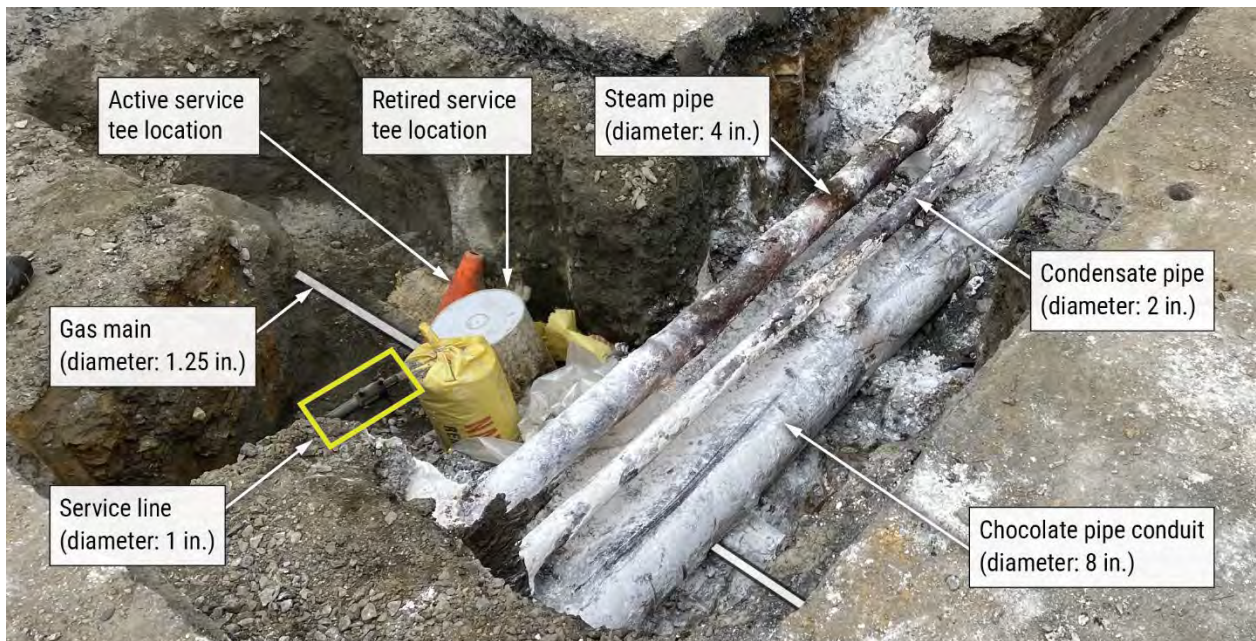
**Figure 11.** Excavation of pipes at the accident location.

As the retired service line to Building 2, which was under pressure, was being unearthed, the NTSB observed that air was coming from the top of the retired 1982 service tee. The service tee's cap and a portion of its insert were missing.<sup>43</sup> The NTSB oversaw as UGI sifted the soil from the excavation but did not recover the cap or the upper portion of the insert; the lower portion of the insert remained with the service tee. The NTSB removed the remaining portions of the retired service tee, along with the section of 1.25-inch-diameter Aldyl A gas main to which the tee had been attached, and sent them to the NTSB Materials Laboratory for evaluation (see section 1.6.2).

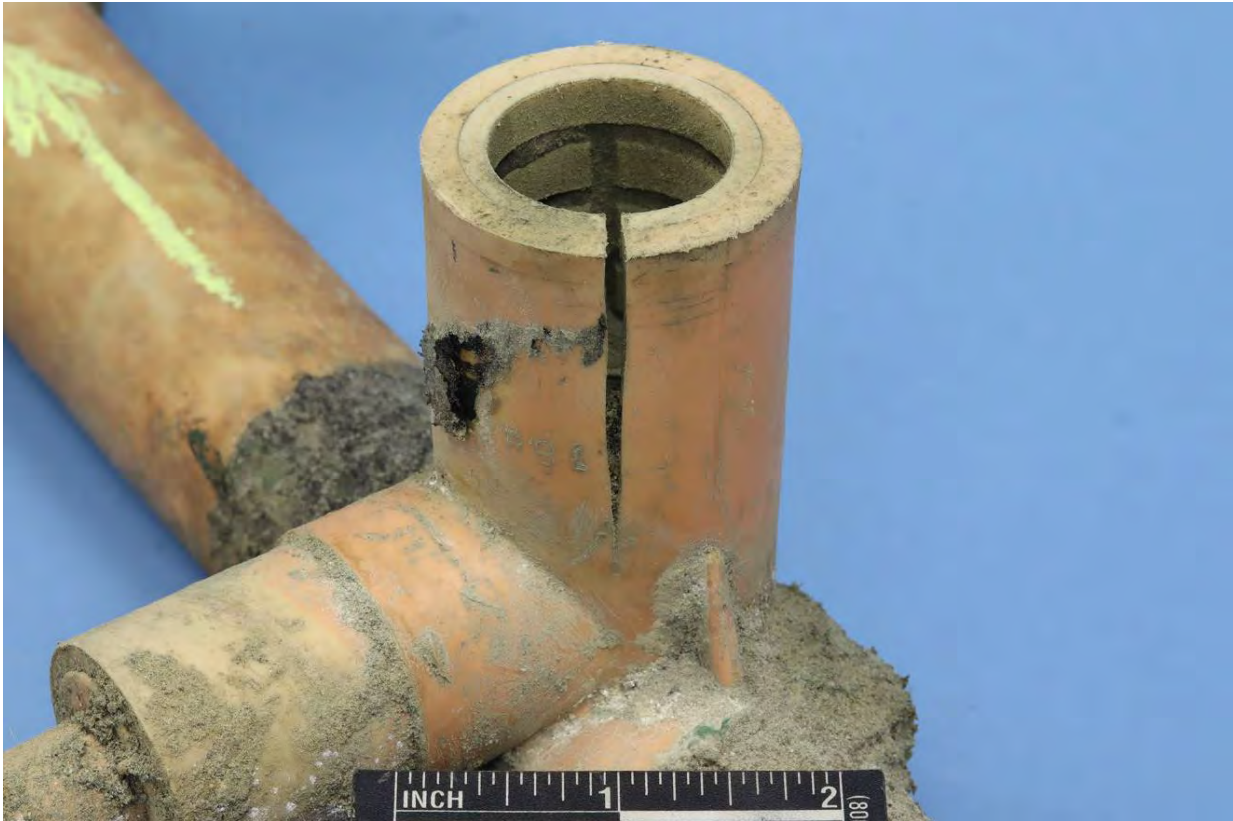
**Figure 13.** Longitudinal fracture in retired service tee.

One of the fracture surfaces was cleaned and examined. It exhibited features consistent with fracture initiation from slow crack growth.<sup>48</sup> The slow crack growth region originated on the interior surface of the shell, between 0.325 inches and 0.430 inches from the top of the tower. From there it progressed through the wall, to the top of the tower and toward its base. Toward the top of the tower, the fracture surfaces were flat, comparatively featureless, and exhibited fibrils.<sup>49</sup> Near the base, the flat, featureless regions of the fracture surface transitioned to hackle consistent with a fast fracture following slow crack growth.<sup>50</sup> (See figure 15.)

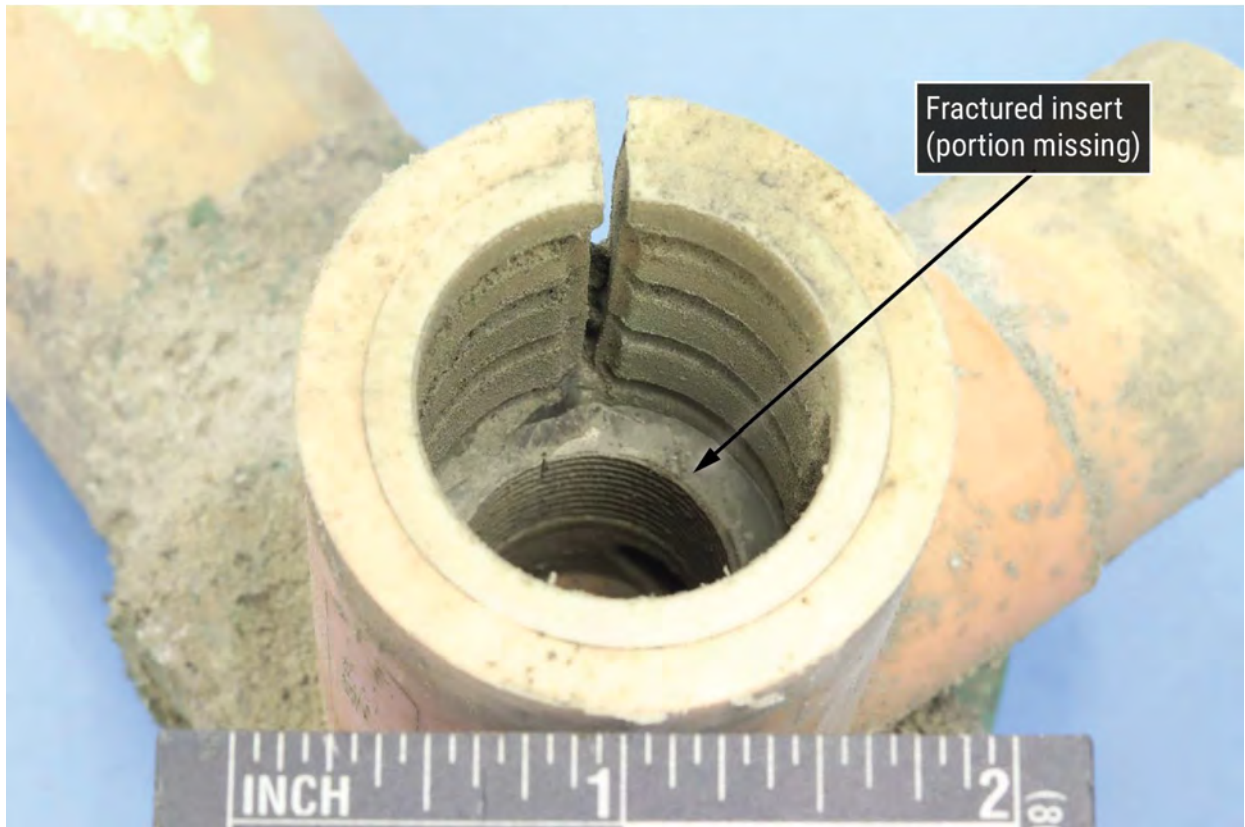
**Figure 14.** Interior of retired service tee tower with top portion of Delrin insert missing.

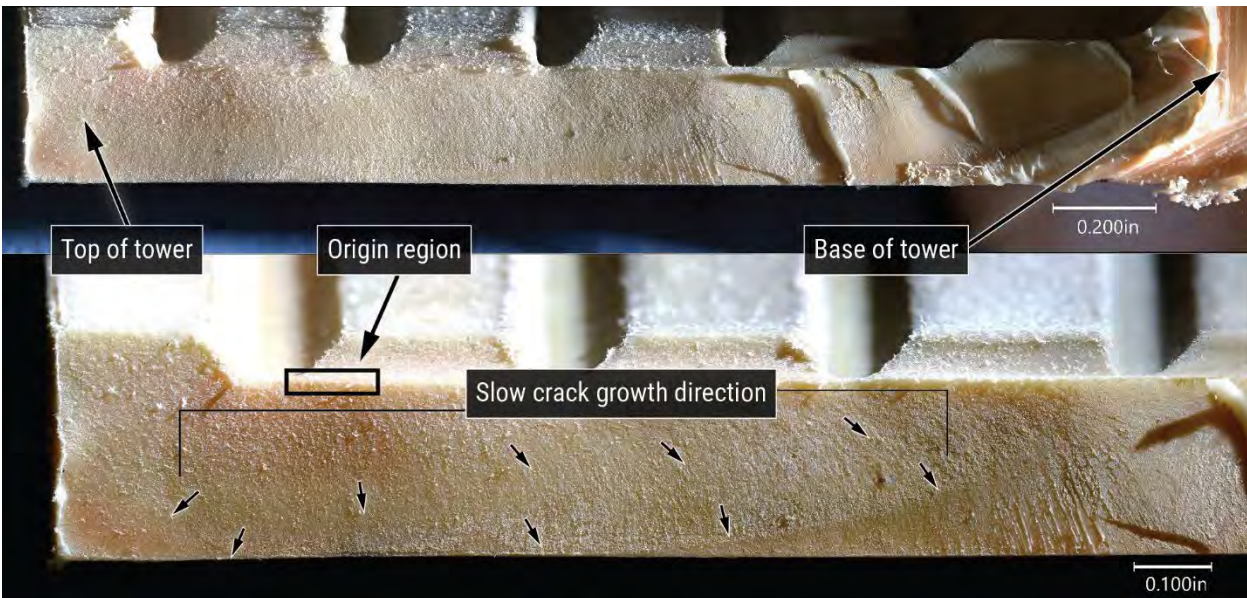
**Figure 15.** (Top image) Longitudinal fracture from top to base of tower. (Lower image) Detailed image of slow crack growth region.

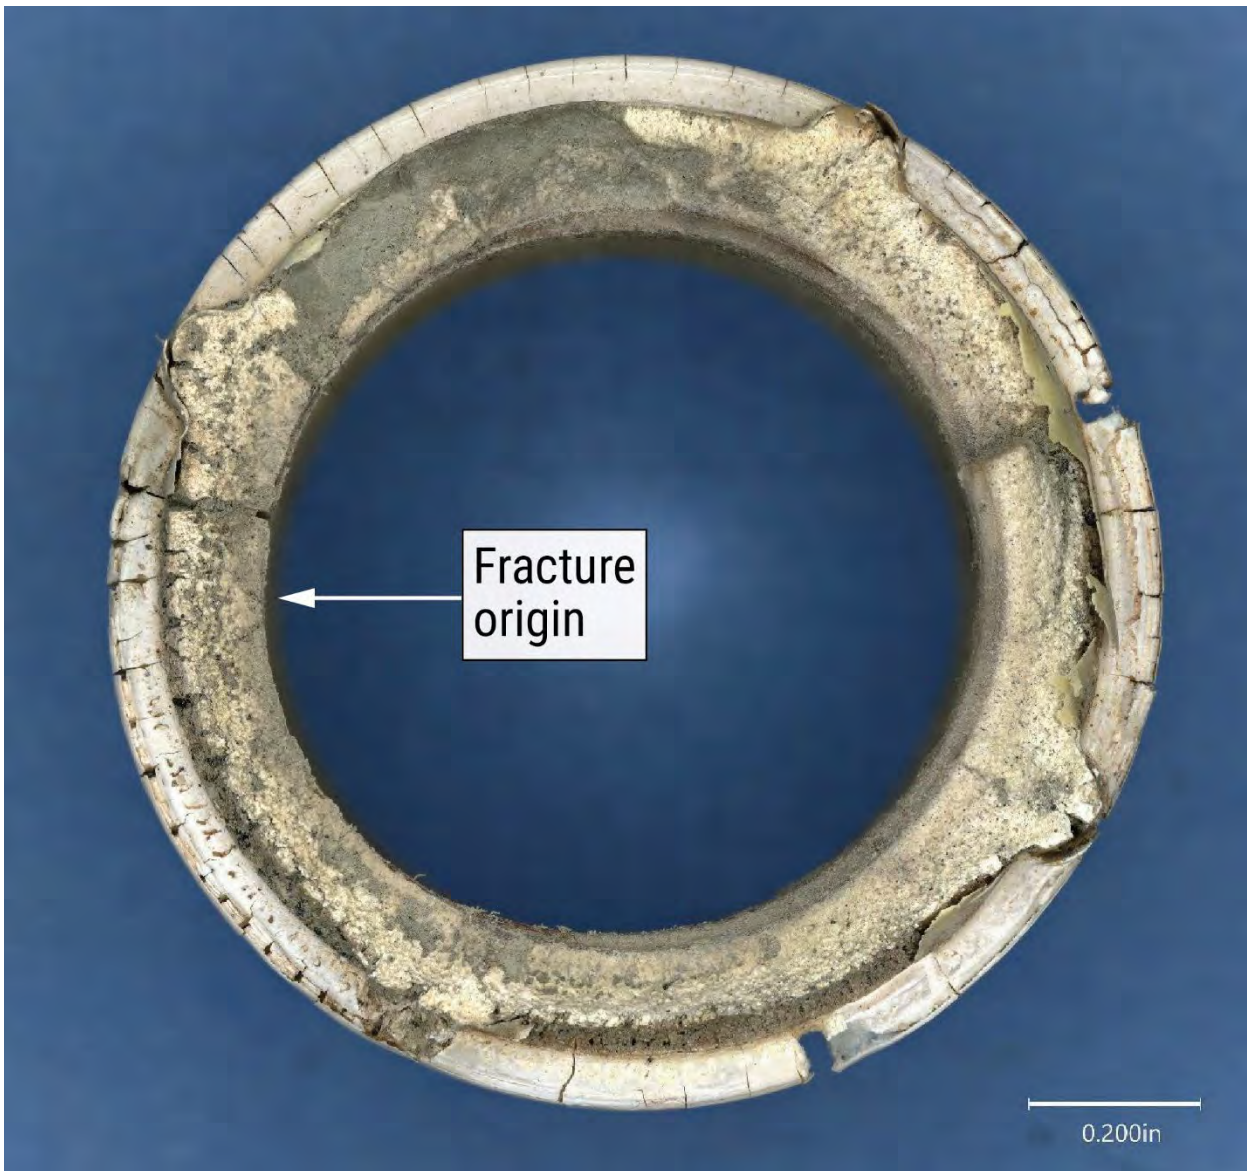
A visual assessment of the retired service tee's Delrin insert showed that it too was fractured, with a transverse fracture located near the bottom of the insert. A region of the fracture, which was closest to the steam pipe before the accident, had a crazed and fibrous appearance.<sup>51</sup> Elsewhere, the fracture had a granular and porous appearance. The outer surface of the insert showed surface cracking and volume loss, which is visible in figure 16 along with the fracture origin. This was the first accident NTSB has investigated involving a longitudinal fracture from thermal degradation of an Aldyl A service tee with Delrin insert.

**Figure 16.** Image of fracture surface on Delrin insert for retired service tee.

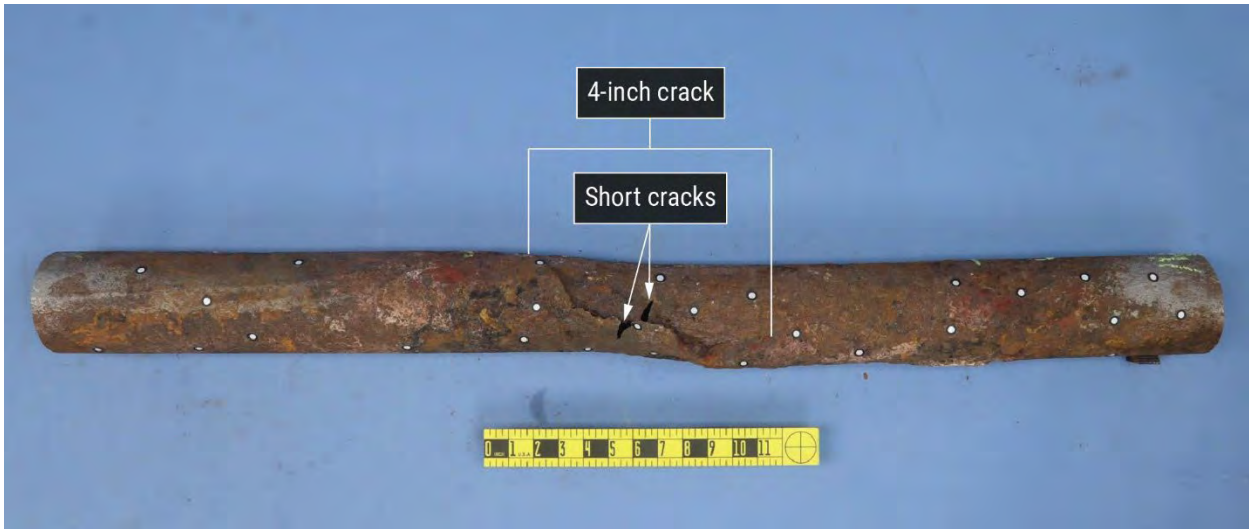
Investigators also observed corrosion and a through-wall crack of approximately 4 inches on the underground steam pipe that had been exposed in the NTSB's postaccident excavation. This pipe was located about 15.5 inches above and 23 inches to the west of the retired service tee.<sup>45</sup> Visual observation of the length of the exposed pipe showed external corrosion, which can also be seen in figure 11. The NTSB oversaw as UGI removed surface rust from the steam pipe (outside of the section containing the through-wall crack) to take wall thickness measurements. The thickest measurement was 0.216 inches and the thinnest was 0.148 inches. The

inches long and had formed along a compressive buckle within the sheared region.<sup>55</sup> Two shorter cracks branched off the 4-inch crack. (See figure 17.)

**Figure 17.** Through-wall cracks in steam pipe.
