Kentucky Power Company
KPSC Case No. 2025-00346
Commission Staff's Second Set of Data Requests
Dated February 13, 2026

- a. Provide more detail regarding the current physical deterioration and damage that exists on the Prestonsburg-Thelma 46kV circuit.
- b. Provide photographic evidence that demonstrates the current physical deterioration and damage that exists on the Prestonsburg-Thelma 46kV circuit.

Prestonsburg – Thelma 46 kV Circuit FCAT Pictures

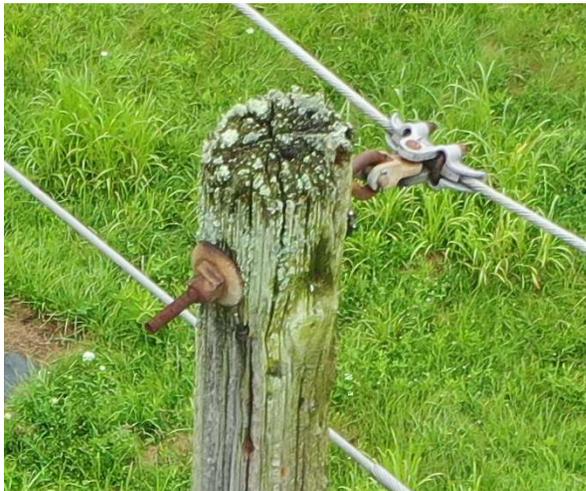
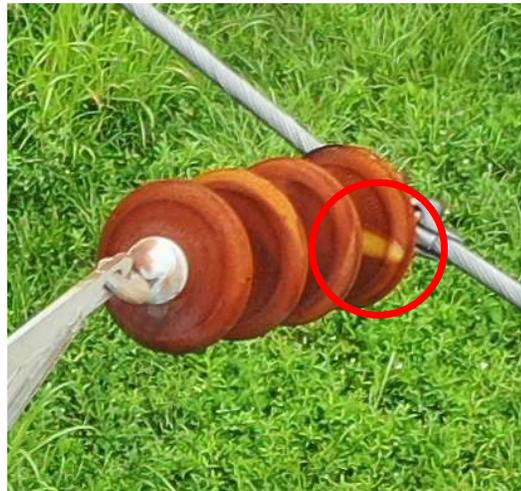
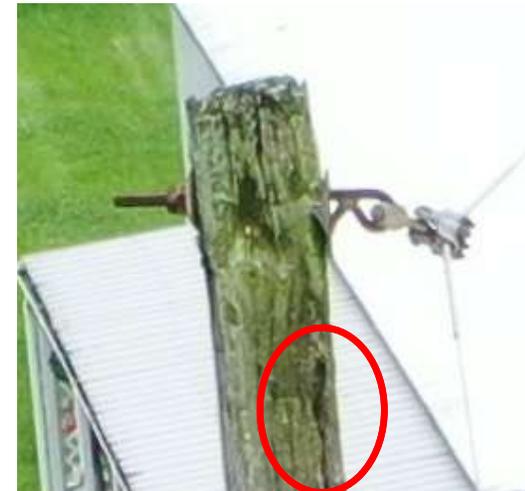
- **K346-28:** upper pole decay
- **K346-30:** pole-top rot
- **K346-37:** vertical splitting and decay
- **K346-63:** splitting at guy attachment
- **K346-66:** rot and woodpecker holes

- **K346-37: broken insulator bell**
- **K346-28, 30, 37, 63, 66: repeated flashover markings**

- Structure K346-28
 - Rot Top
 - Flashover-Arcing Damage to Insulator
 - Rot Heart

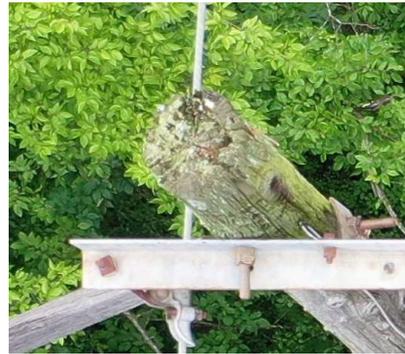
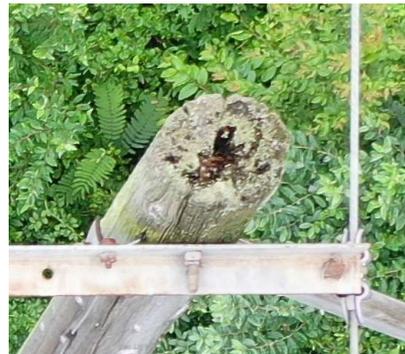
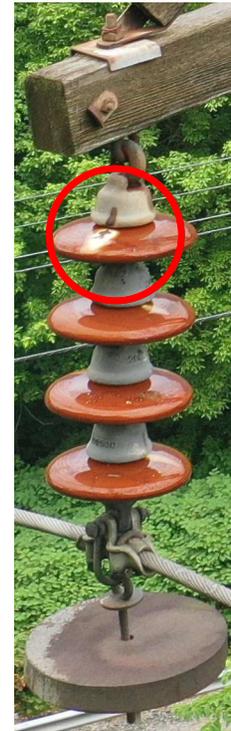
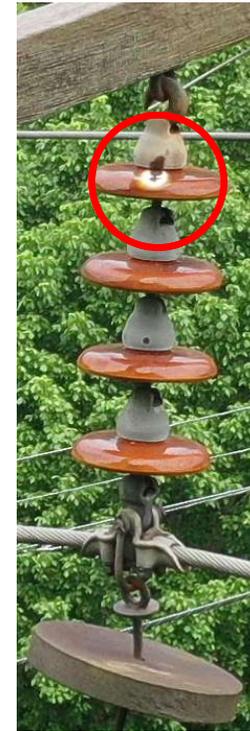
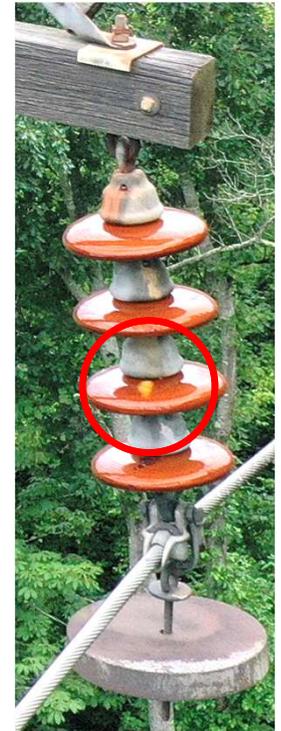
- Structure K346-30
 - Rot Top
 - Flashover-Arcing Damage to Insulators (see circled areas)
 - Rusted Hardware

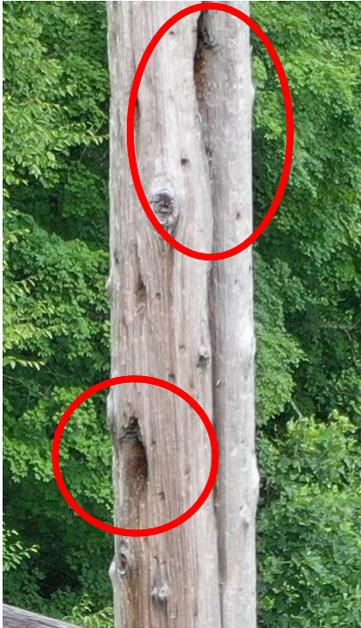
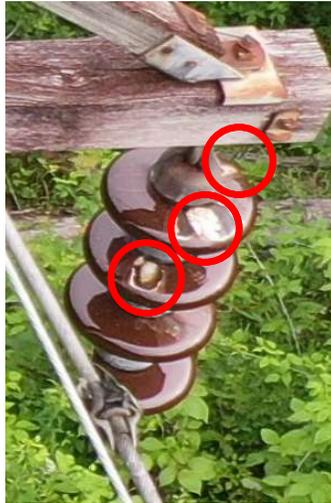
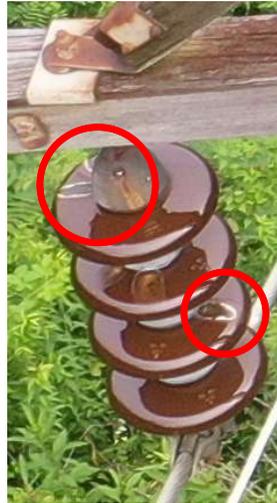
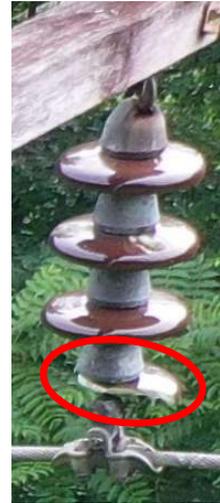
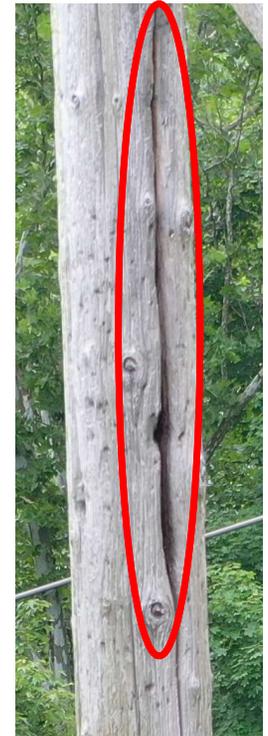
- Structure K346-37
 - Vertical Pole Splitting & Decay (left and right images)
 - Pole Cavities
 - Flashover-Arcing Damage to both Insulators
 - One Broken Insulator Bell (third insulator image shows it best)
 - Rusted Hardware

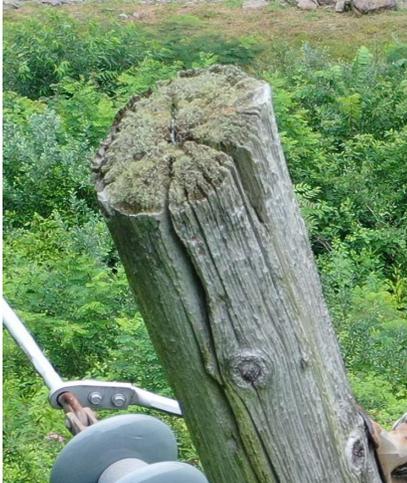
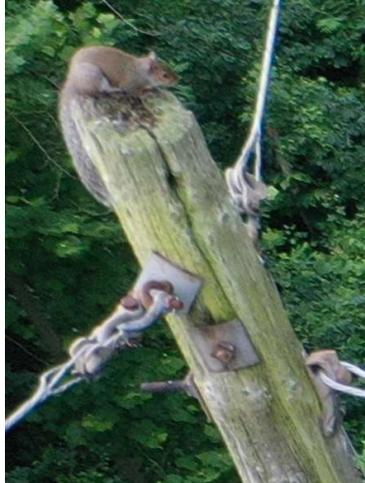
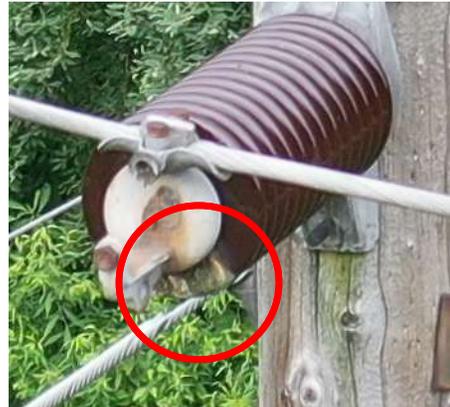
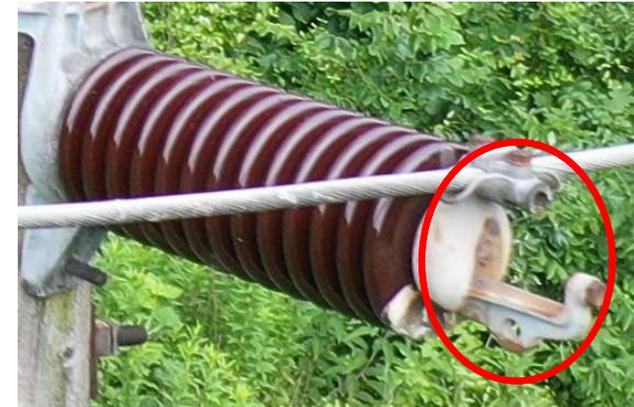
- Structure K346-38
 - Rot Top
 - Jumper Attachment Disconnected from Post Insulator (see it is hanging in an open position in far-right image)
 - Flashover Arcing Damage on Insulator (third image)

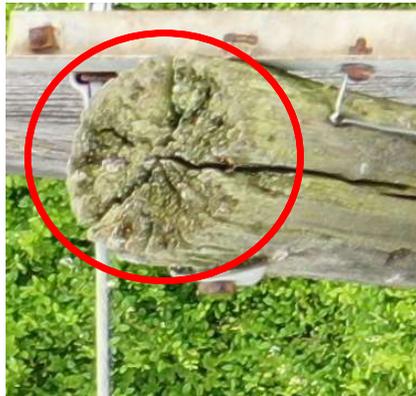
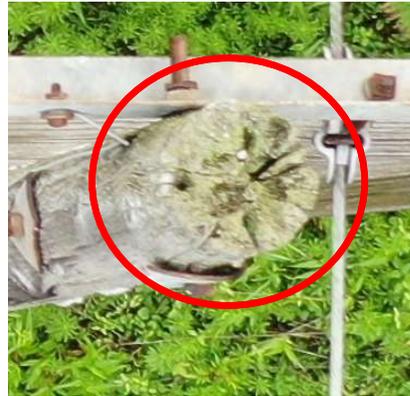
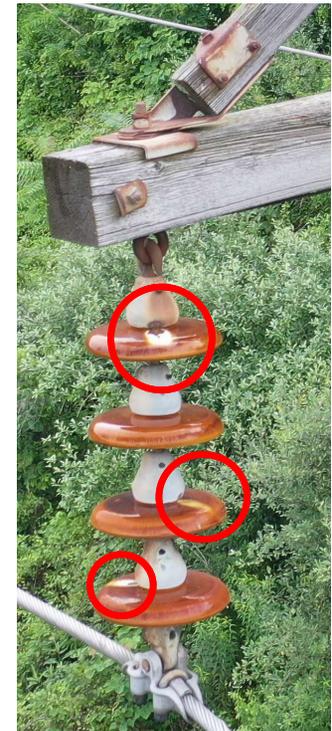
- Structure K346-39
 - Rot Top
 - Vertical Pole Splitting
 - Pole Cavities
 - Rusted Hardware
 - Flashover Arcing Damage on Insulator
