April 24, 2025 MP1960835

> Geo-Hazard Risk Assessment Supplemental Desktop Study and Site Visit Prestonsburg – Thelma 46kV Rebuild Prestonsburg, Kentucky

October 17, 2025 MP1960835

> Geo-Hazard Risk Assessment Memo Supplemental Desktop Study and Site Visits Prestonsburg – Thelma 46kV Rebuild: Kenwood Station Exit Prestonsburg, Kentucky

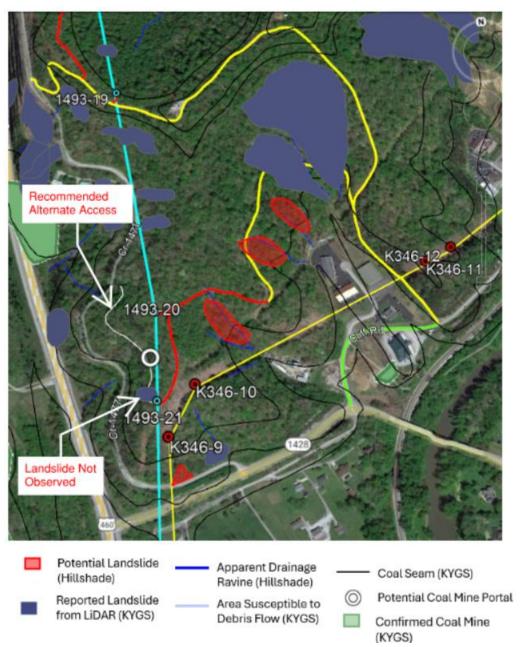
The reasons for visiting Structure 1493-21 were to look at the reported landslides along the proposed access from the east and to verify the reported landslide at the structure.

Figure 1. Access to Str 1493-21.

CGE does not recommend using the proposed access from the east due to prevalence of several large landslides. An alternative access from the west as shown in Figure 1 with the white line is recommended for construction. In addition, there did not appear to be a landslide at the 1493-21 structure location. However, an apparent abandoned coal mine portal was observed along the alternate access road. Coal fragments were observed in the area downslope of the portal. CGE's opinion is the imagery for the reported landslide is offset and was intended to be mapped at the mine portal. However, there is not a mapped coal seam in this area. CGE recommends a geotechnical boring at Structure 1493-21 to further evaluate potential mining activity.

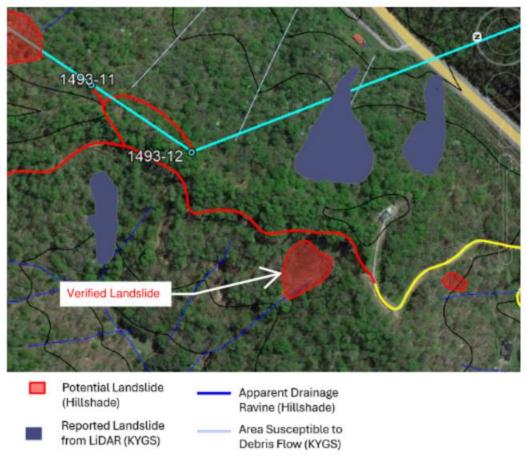
The access road to Structures 1493-11 and -12 was visited to evaluate the landslide that CGE observed in aerial imagery (Figure 2). The presence of the landslide was verified. CGE recommends proactive landslide mitigation and considerable drainage improvement at this location to use the access road for construction. A geotechnical boring will be obtained to further evaluate.

Figure 2. Verified Landslide Along Access to Structures 1493-11 and -12.

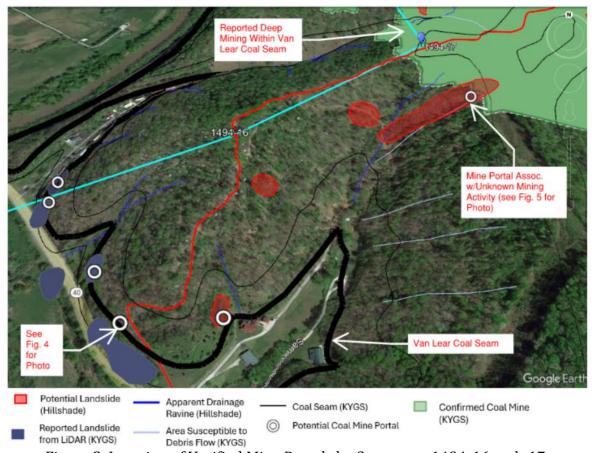
The reported coal mining in Figure 3 beneath Structure 1494-17 appears to have occurred within the Van Lear coal seam. In addition, the coal mine portals noted in Figure 3 were verified during the site visit. One of the mine portals that is aligned with the Van Lear coal seam outcrop is shown in Figure 4. As such, it is probable that additional historical coal mining also occurred within the Van Lear coal seam and likely beneath Structure 1494-16 in addition to Structure 1494-17. There is about 300 ft of overburden between the Van Lear coal seam and the structures. If coal mining was only potentially performed in the Van Lear coal seam, the risk of subsidence is lower. However, the subsidence risk increases when there is more than one deep mine and/or coal mining within 100 ft of depth.

Figure 3. Location of Verified Mine Portals by Structures 1494-16 and -17.

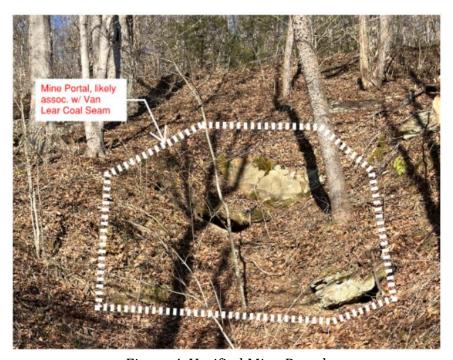
Figure 4. Verified Mine Portal.

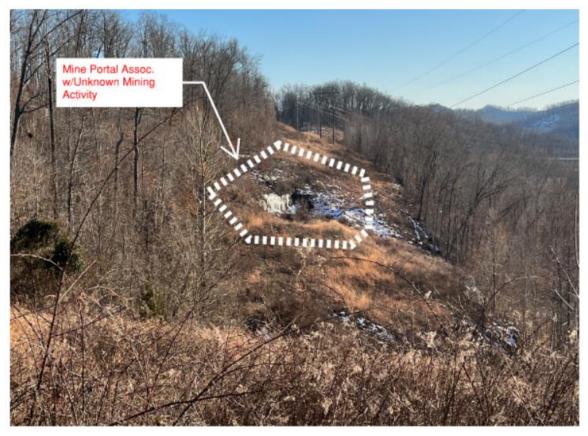
Figure 5 shows a mine portal associated with unknown mining activity at a similar elevation as Structure 1494-17. The mine portal is at a similar elevation as the mapped Upper Peach Orchard coal seam. Given the similar elevation, a geotechnical boring should be performed at Structure 1494-17 to verify potential historical coal mining activity.

Figure 5. Mine Portal Visible from Structure 1494-17.

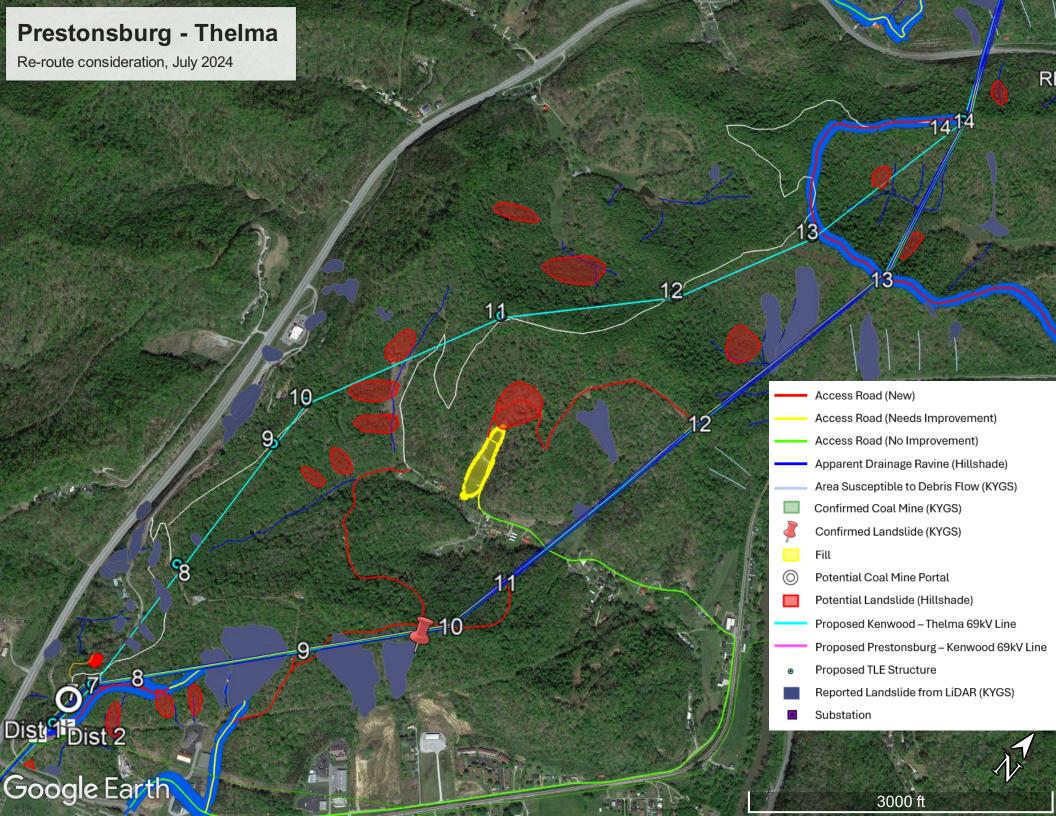
Appendix A

The western alignment appears to present less geo-hazard risk from a desktop study based on more developed access and less landslide activity. The landslide activity between the Structures 8-10 on the eastern alignment was particularly concerning. The access to get to structures along the eastern alignment required crossing more and larger reported landslides. Please note, the site visit described later in this addendum confirms the presence of the significant landslide activity in this area, which supports that the western route is preferred from a geo-hazard perspective.

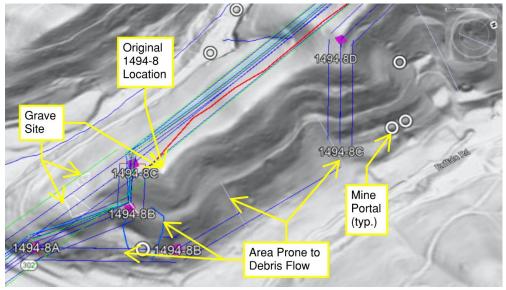
While scouting access for geotechnical borings, a grave site was discovered at the original proposed location of Str 1494-8. Multiple re-routes were considered to divert around the grave site. However, more grave sites were discovered when field verifying offset structure locations. Efforts to thread the needle between grave sites and residences without impact were not successful despite multiple site visits, including a site visit on May 15, 2025. Figure 1 shows the various challenges identified around Str 1494-8 and potential offset locations.

Figure 1. Challenging Conditions around 1494-8.

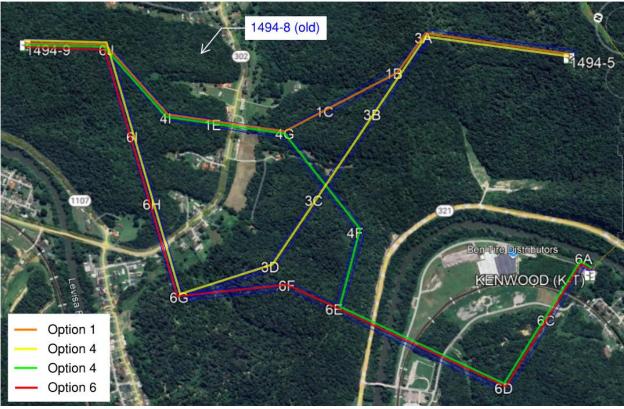
In consideration of the field data collected at 1494-8, AEP decided to bypass the area altogether. CGE was asked to compare 4 potential alignments (Option 1, 3, 4, and 6) to bypass the area of concern at 1494-8 (Figure 2).

Figure 2. Alternative Alignments to Bypass 1494-8 Area.

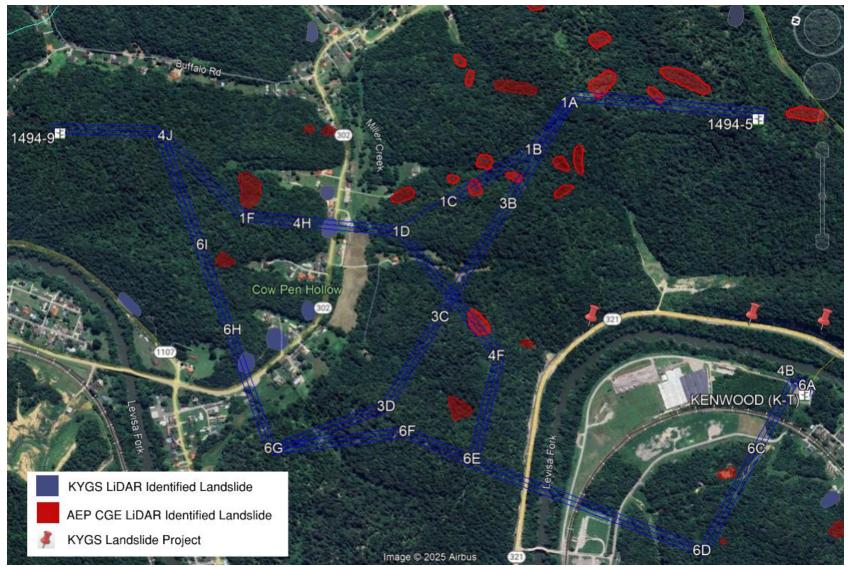
CGE performed a desktop geo-hazard study of the potential new alignments. Figure 3 shows identified landslides within the study area (Reference 1). Option 6 appears to avoid the most landslides. Figure 4 shows apparent coal mining activity. More detailed desktop geo-hazard mapping is provided in Appendices A and B. Although coal seams are present throughout, the State of Kentucky does not report mining activity along the alignments (Reference 2). Based on the appearance of potential mine portals along coal seams, indicating possible historical mining activity, the geo-hazard risk related to mining activity appears roughly equivalent across the four options.

Figure 3. Landslide Risk.

Based on the geo-hazard desktop study and GFT's site visit, CGE's opinion is that Option 6 has the least geo-hazard risk and is recommended for the final line route.

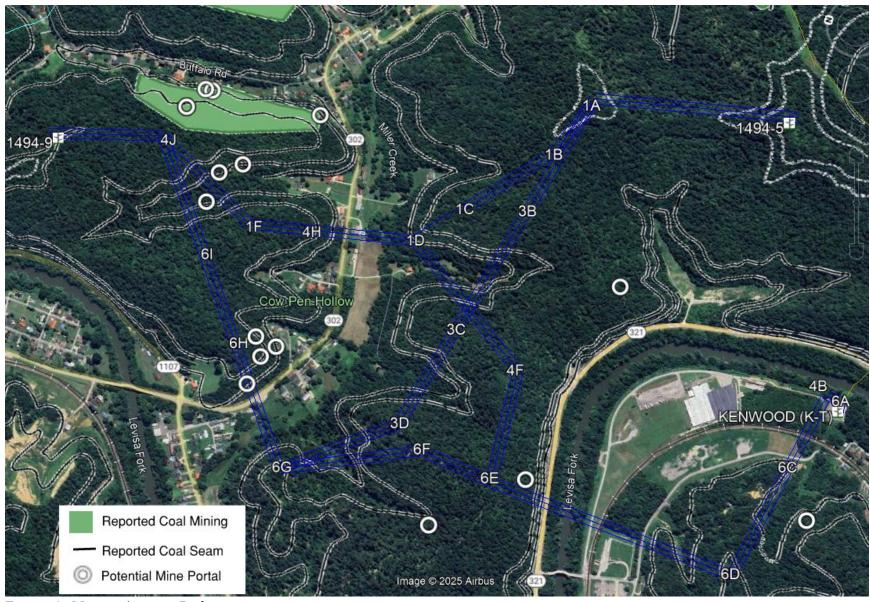
Figure 4. Mining Activity Risk
