Kentucky Power Company
KPSC Case No. 2026-00001
Commission Staff's First Set of Data Requests
Dated March 19, 2026

**AMERICAN ELECTRIC POWER SERVICE CORPORATION
OHIO POWER COMPANY
MITCHELL PLANT, UNIT NO. 1
MOUNDSVILLE, WEST VIRGINIA**

**Report
for
Inspection of 370'-0" High
Reinforced Concrete Cooling Tower**

American Electric Power Service Corporation
Ohio Power Company
Service Order B-6858
March 12, 1990

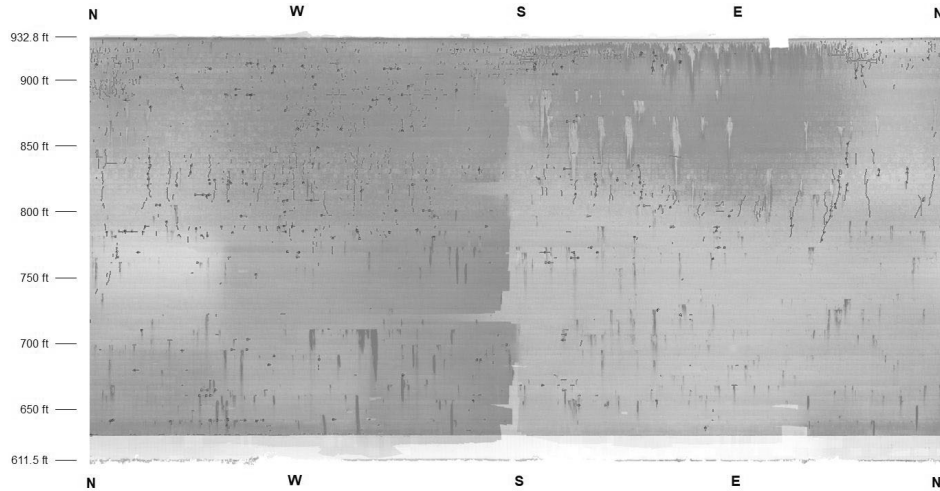
There is a small number of cracks and a third of them are with efflorescence. They are almost all located on the upper part of the structure. The cracks under 0.03in opening were not drawn. The following capture shows the distribution of the cracks on the entire shell:

Distribution of cracks

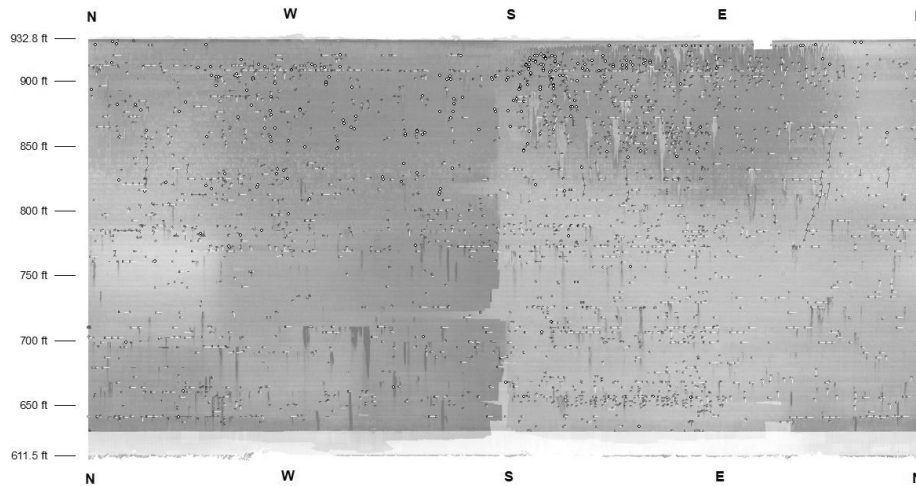
The following capture shows the distribution of the seepage and efflorescence:

Distribution of seepage and efflorescence

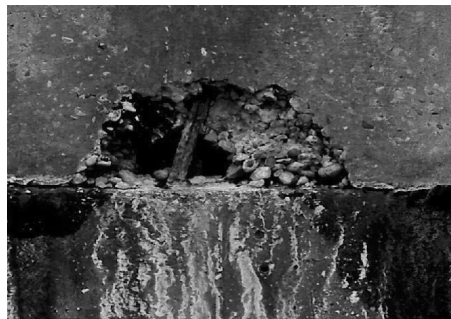
- The first one (Defect ID n°3462) is located at 95ft from the bottom of the shell, on the SE side. We can see the vapor inside and the steel bars. The width of the hole is 1.74ft and the height is 0.69ft You can locate it precisely using any GIS software recommended above and opening the 2D data.

Hole (1.74ft width x 0.69ft height)

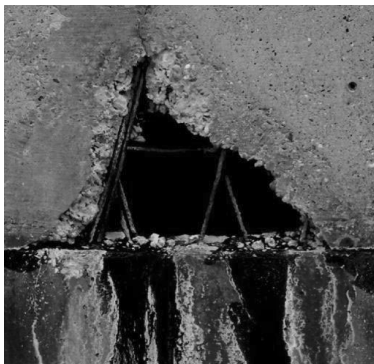
- The second one (Defect ID n°2340) is located 49ft from the bottom of the shell, on the South side. The width is 2.4ft and the height is 1.8ft.

Hole (2.4ft width x 1.8ft height)

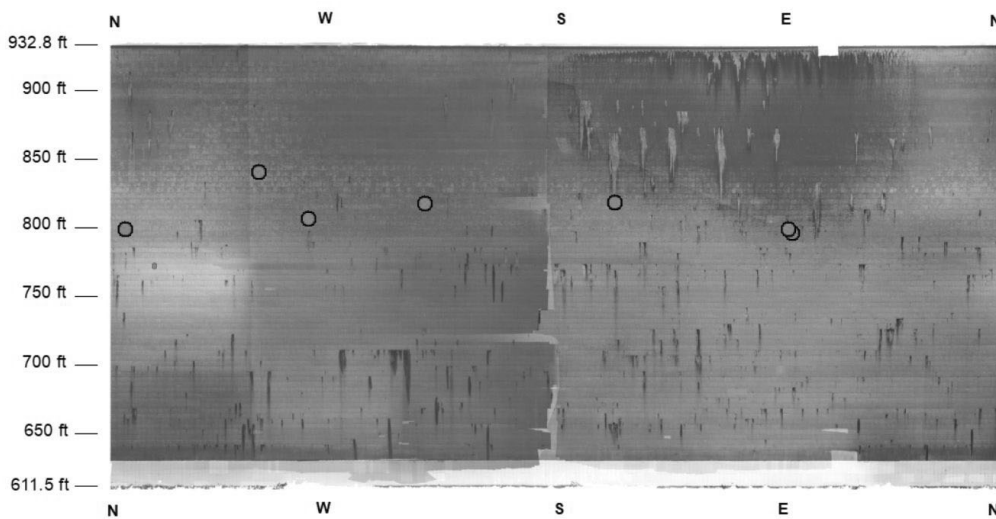
The following map found in Appendix 3 gives the location of all of these falling risks. A major part of these defects are above 200 ft from the bottom of the shell.

Defects with falling risk

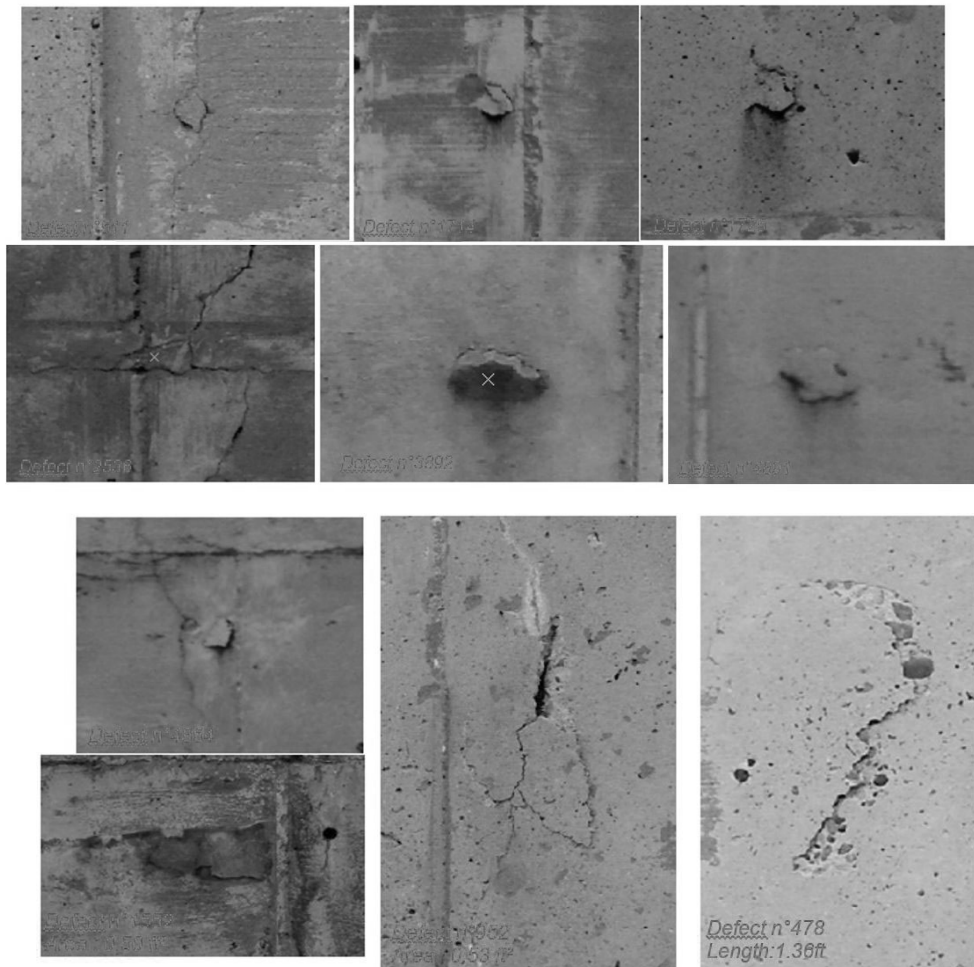
The following captures show examples of these defects with falling risks, you can use QGIS with the delivered 2D data to locate each of those defects on the shell and see high resolution pictures.

Defects with falling risk

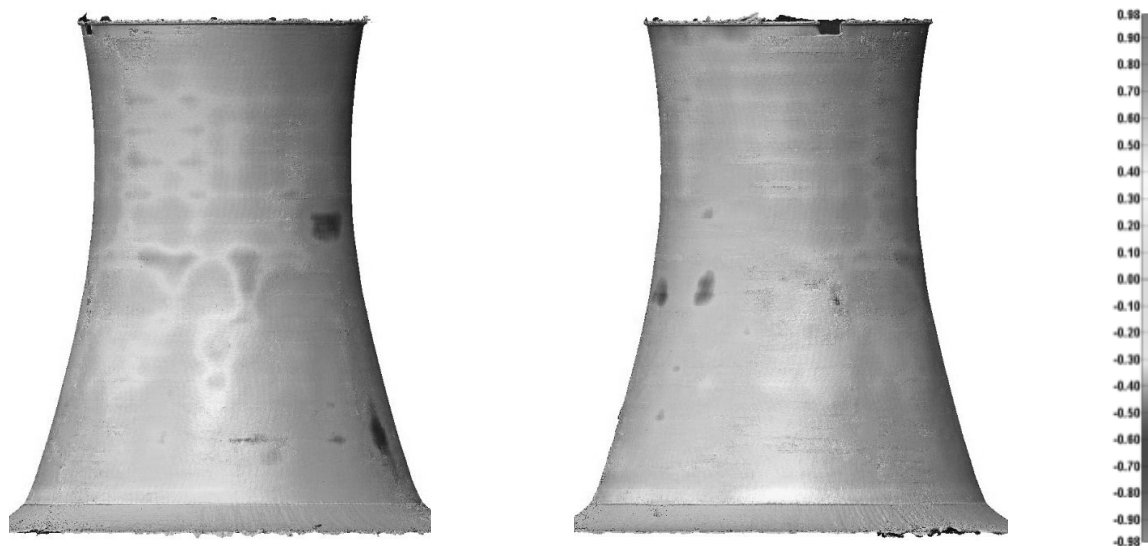
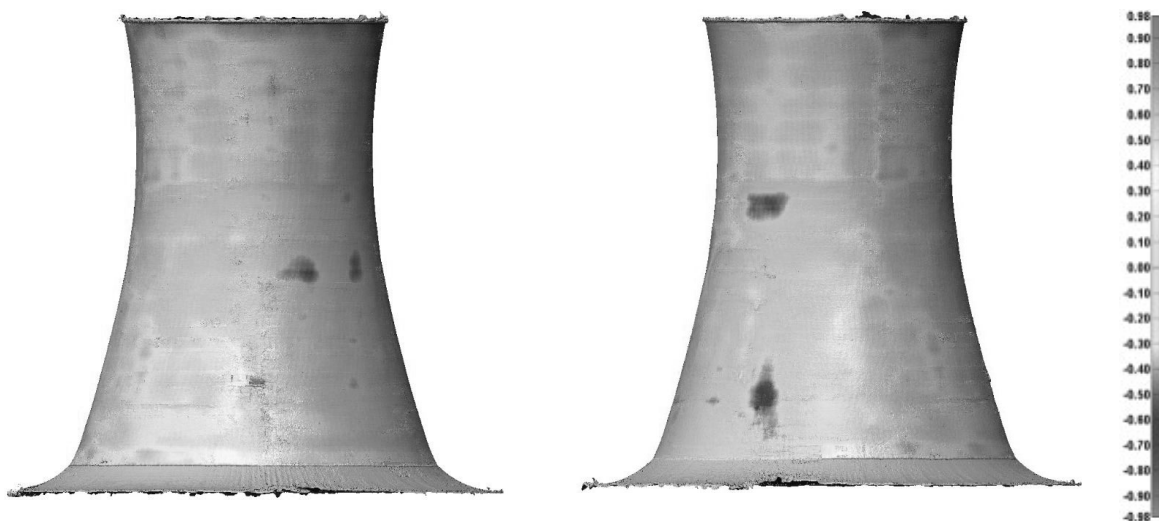
The maximum inside measured distortion is -0.59 ft and the maximum outside distortion is +0.65 ft.

Views from North and East - scale in foot (right)

Views from South and West - scale in foot (right)

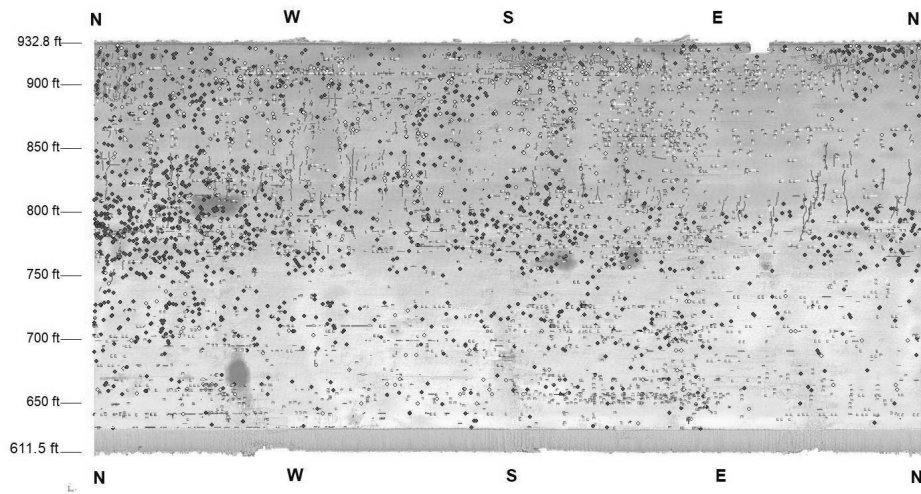
The superposition of the disorder mapping with the deformations measured in relation to the theoretical drawings show that there does not seem to be a correlation between deformations and defects. The deformations remain low.
