**TAYLOR MILL TREATMENT PLANT**  
**UPGRADES AND IMPROVEMENTS**

**Preliminary Engineering Report**

**Northern Kentucky Water District  
2835 Crescent Springs Road  
Erlanger, KY 41018**

**November 2020**

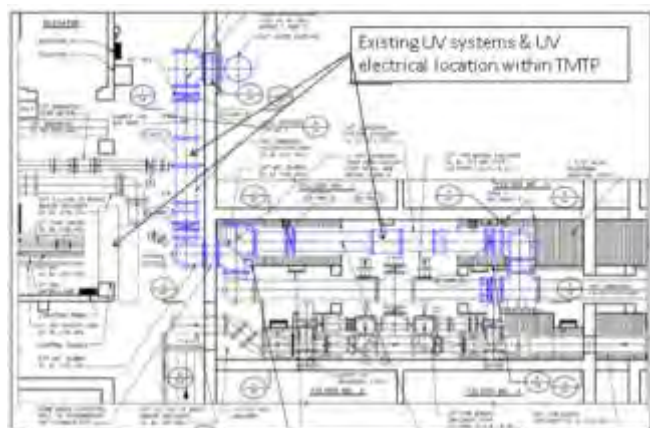
The Ultraviolet Disinfection System (UV DS) at the Taylor Mill Treatment Plant was installed in 2007 and includes two TrojanUVSwift 24 reactors (24" diameter). Each reactor is connected to the combined filter effluent header so they can treat flow independently or simultaneously to the finished water clearwell. UV Train 2 (UV-UVE2 in the sketch) is currently not functional; UV Train 1 has experienced intermittent failures. An uninterruptible

power supply (UPS) was installed along with the UV units about 250 ft away in the tunnel connecting the Chemical Building and the Filter Building and it is currently not functional.

Reported failures, typically of the ballasts that drive the UV lamps, have been attributed to the humid and dusty conditions in the filter pipe gallery area. The ballasts require replacement 3 to 4 times annually. Since 2012, the lamps are warranted for 9,000 hours of operation, which is just over a year of continuous operation. Ballasts are warranted for up to 10 years, with full replacement in the first year. It is reported that since the UPS system ceased operating, the UV

Replacement of both UV treatments units with available mercury vapor-based UV units is recommended, with the reactors replaced at their current locations. The controls can be placed either at the current location, subject to verification during design, or in the area of the current UPS location (i.e., inside the tunnel). A replacement UPS is an optional decision based on timing of the upcoming generator project and of the accreditation process. The budgetary construction cost to replace both UV treatment systems is \$1,117,000, which includes a new UPS system. This cost could potentially be reduced through refinement during the detailed design and competitively bidding the work. Competitively pre-purchasing the equipment and materials ahead of construction may also result in lower costs.

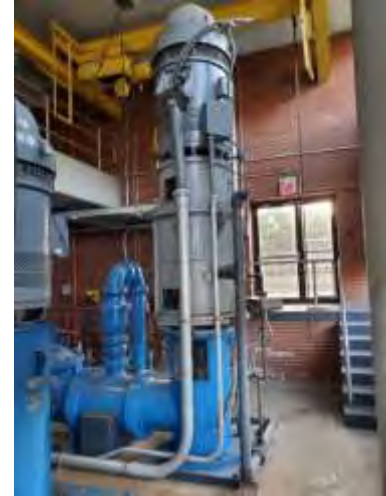
According to NKWD staff, there had been operating issues since the installation, but finally the system failed in 2012 reportedly because of high heat generated within the MagnaDrive, and HSP No. 3 has not been operated since. The machinery has not been exercised during the outage, and is currently abandoned in place and disconnected from power and controls.

A new replacement constant speed pump, motor and soft-start system rated for 4,167 gpm (6 mgd) at 375 ft TDH is recommended, at a conceptual cost of \$450,000, installed. A comparable refurbishment is estimated at \$555,000 because of the added costs for variable frequency drive or MagnaDrive equipment to achieve the target flow rate.

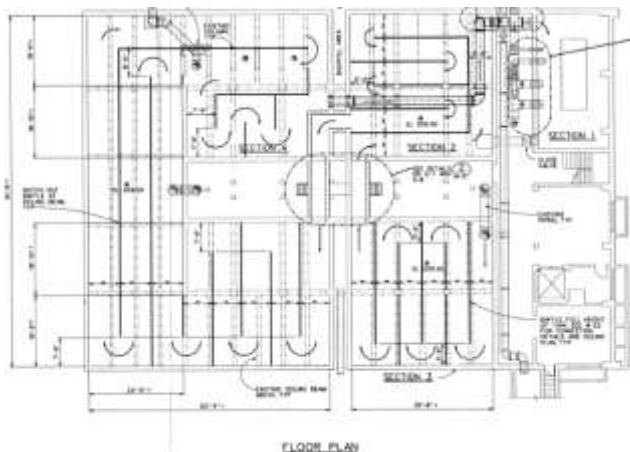
conditions. Note in the sketch that there is an existing pipe turned upward at the left end of the FTTP main. This pipe measured 14” in the field, but will require verification.

In reviewing the options, it was observed that the existing plug valve and connections could be left in place as an emergency system under all of the proposed new conditions. Leaving this functionality is recommended.

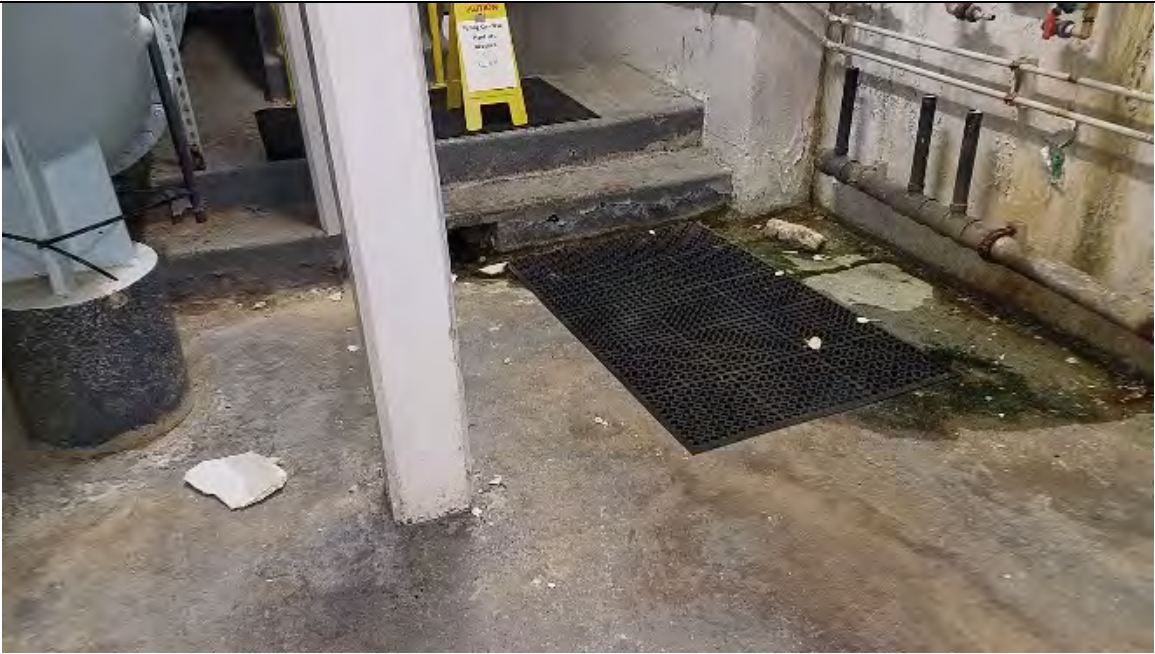
T2

1. Upon entering the tunnel, it was observed that concrete has fallen from a deteriorating corbel and debris was on the floor below refer to photograph T2. The reinforced concrete corbel is at the location indicated by T1 on the attached photo location sketch. The cracks and spalling concrete at the corbel correspond to the termination of the expansion joint running along the South Flocculator Basin. See the termination of the expansion joint in the photograph below.

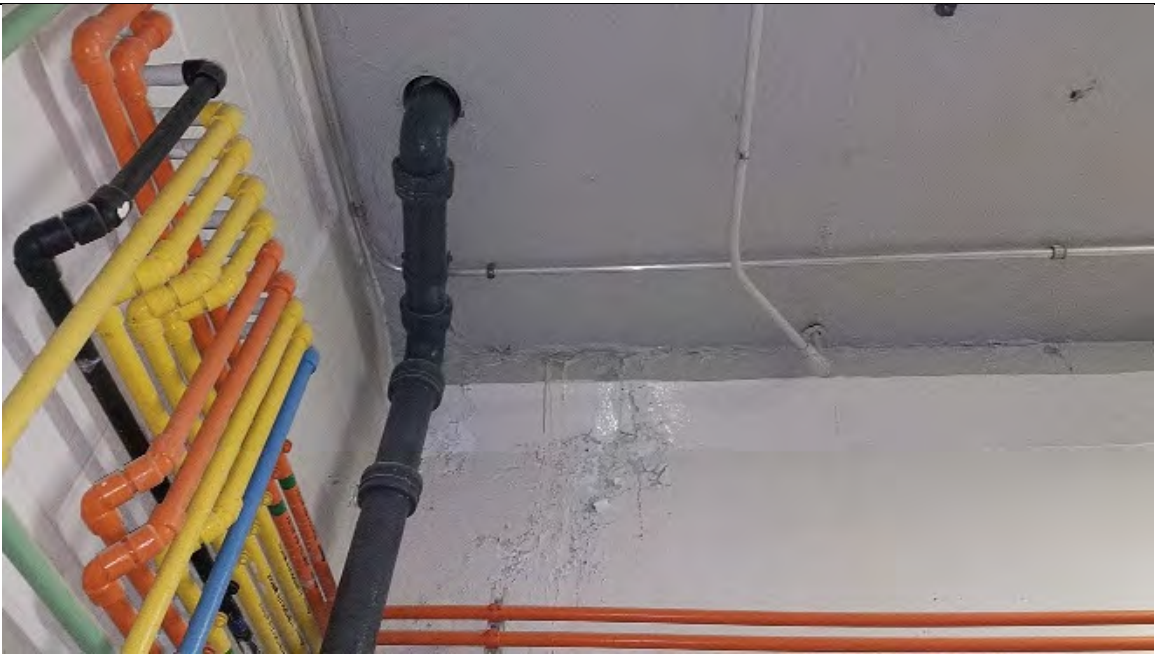
T11

2. The paint on the tunnel walls is peeling from the basin walls in numerous locations throughout the length of the tunnel. Refer to photographs T3, T4, T5, T7, T8, T9, T10 and T16.
3. Minor cracks were observed in the basin wall of the tunnel. No water was observed to be running through the cracks. Refer to photographs T11, T12-T16 and T18.
