COMMONWEALTH OF KENTUCKY
BEFORE THE PUBLIC SERVICE COMMISSION

SOUTH KENTUCKY RURAL ELECTRIC)	
COOPERATIVE CORPORATION)	CASE NO.
_____)	2009-00015
)	
ALLEGED FAILURE TO COMPLY WITH)	
KRS 278.042)

INCIDENT INVESTIGATION ~ Staff Report

Electric Utility Personal Injury Incident Report

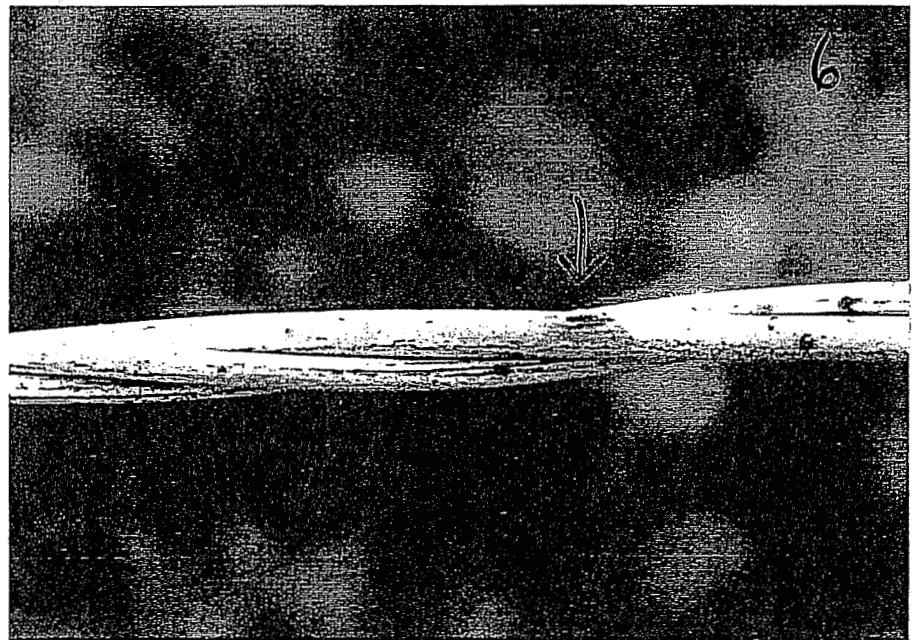
6 6 A CWC conductor where # 2 ACSR made contact in span between pole # 128161 and pole # 128162 approximately 120 feet out from pole # 128161.

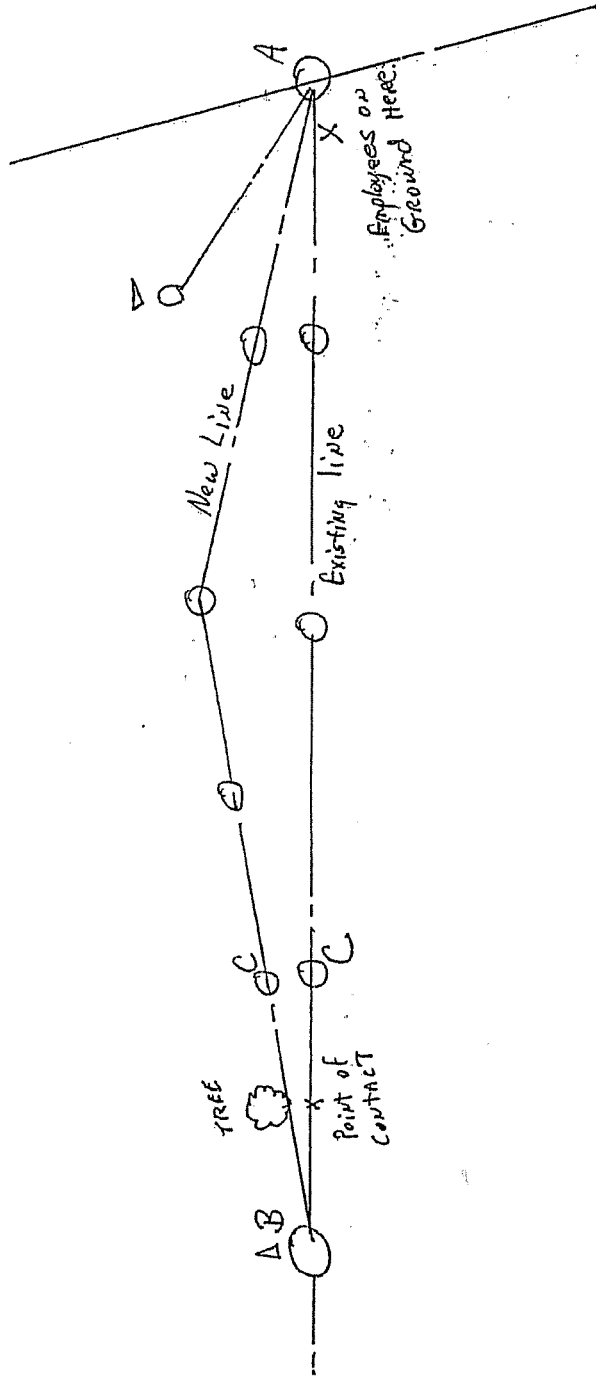
See drawing on back of incident form for reference to points A,B and C

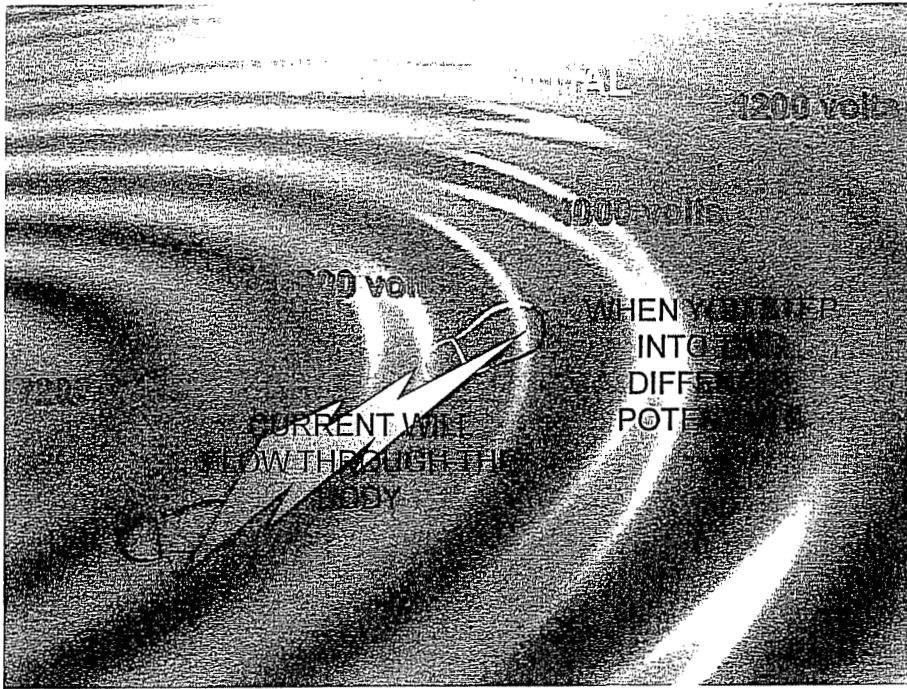
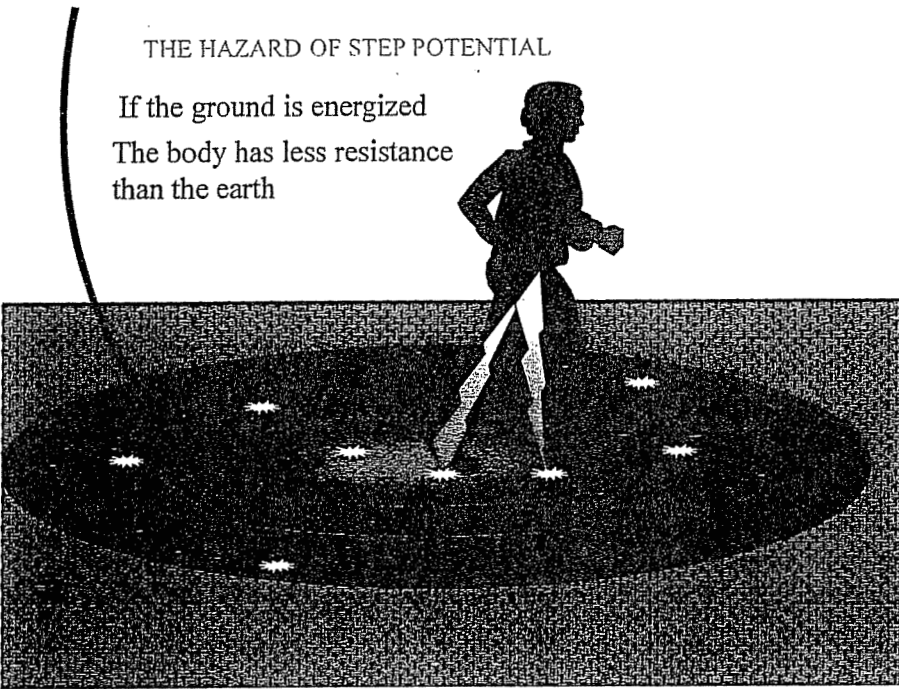
THE HAZARD OF STEP POTENTIAL

As Scotty and Donnie were pulling the wire up, it became snagged in a tree limb. Due to the amount of wire they were pulling, they were not concerned that it was a hard pull. They could not see the area where the wire was snagged in the tree. As they pulled harder the wire dislodged from the tree limb. The resulting jerk caused the new wire to contact the energized old wire. When this contact occurred, both Scotty and Donnie experienced an electrical shock. Both employees had exit wounds on one foot. Due to the nature and extent of the injuries, we have determined that the electrical shock was a result of a Step Potential condition caused when excess wire laying on the ground, near the employees became energized.

If the ground is energized
The body has less resistance
than the earth
