COMMONWEALTH OF KENTUCKY
BEFORE THE PUBLIC SERVICE COMMISSION

KENERGY CORPORATION)	
_____)	
ALLEGED FAILURE TO COMPLY WITH)	CASE NO. 2009-00431
KRS 278.042)	
)

INCIDENT INVESTIGATION ~ Staff Report

Electric Utility Personal Injury Incident Report

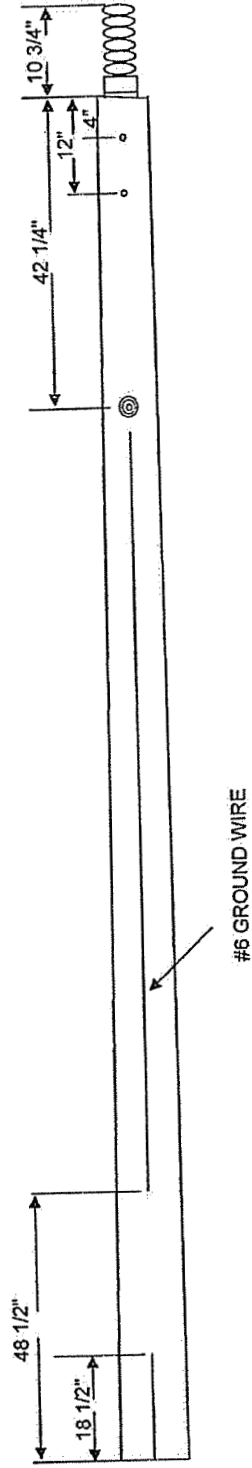
LYON COUNTY
KNIGHT ROAD

Bobcat operator (Justin Peripone) picked up a 40' pole with machine, put clamps around bottom 42" butt end of pole. He then picked the pole up approximately 2-3' and put the chain around the pole and the frame of the lifting bar. There was approximately 71/2' of chain not being used and the

40 FOOT POLE
not to scale
