COMMONWEALTH OF KENTUCKY
BEFORE THE PUBLIC SERVICE COMMISSION

DUKE ENERGY KENTUCKY, INC.)	
_____)	CASE NO.
)	2010-00248
ALLEGED FAILURE TO COMPLY WITH)	
KRS 278.042)

O R D E R

Incident Location ~ Showplace Landscaping, Crittenden, Kentucky
Report Date: March 24, 2010
Incident Date: July 27, 2009
PSC Investigator: Jeff Moore
Utility: Duke Energy Kentucky
Injured: Kenneth Tyler Cummins

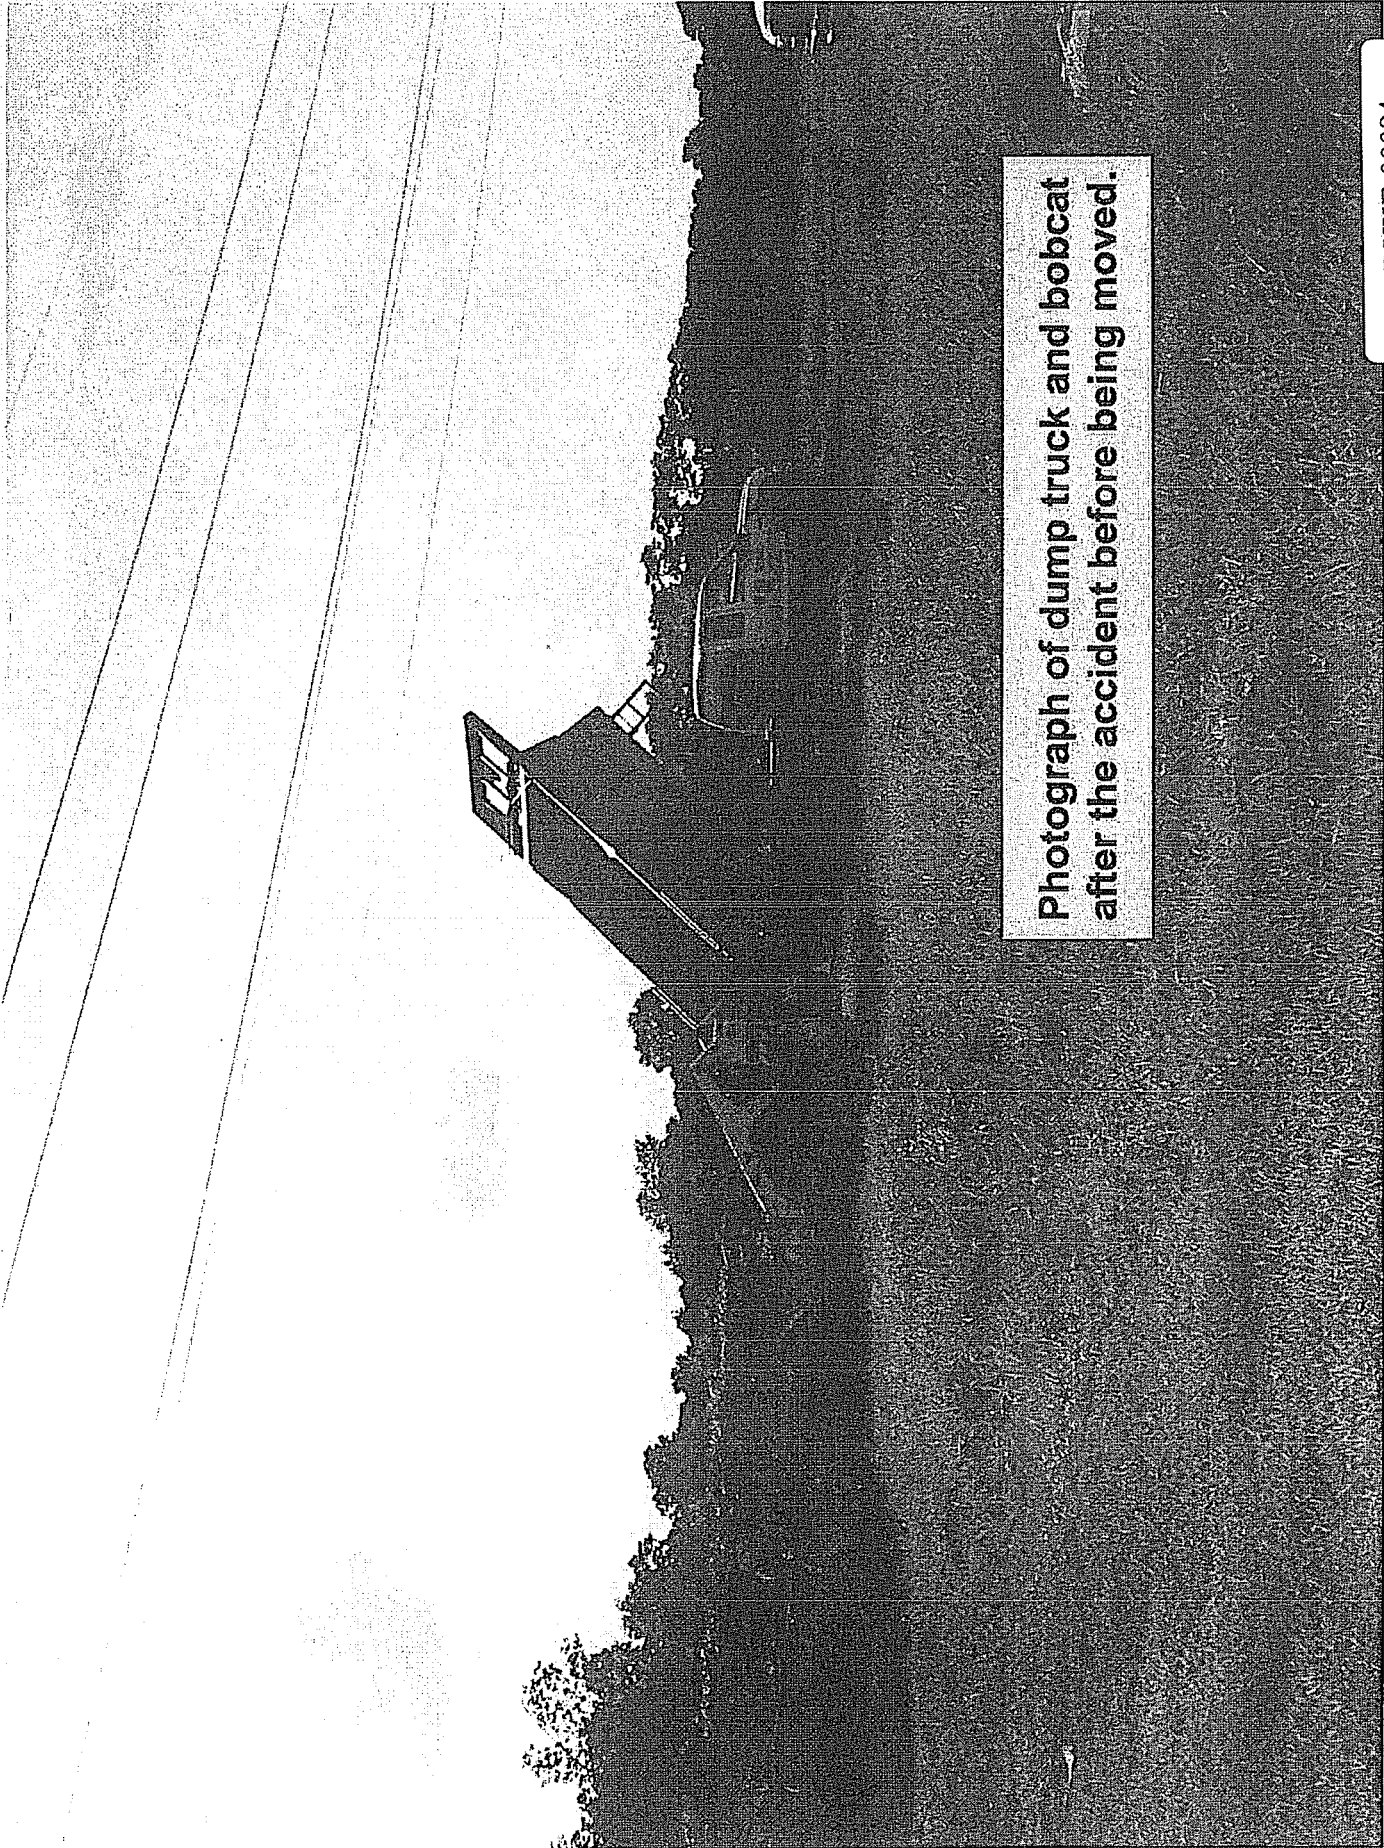
DUKE-00094
CONFIDENTIAL

Photograph of dump truck and bobcat after the accident before being moved.

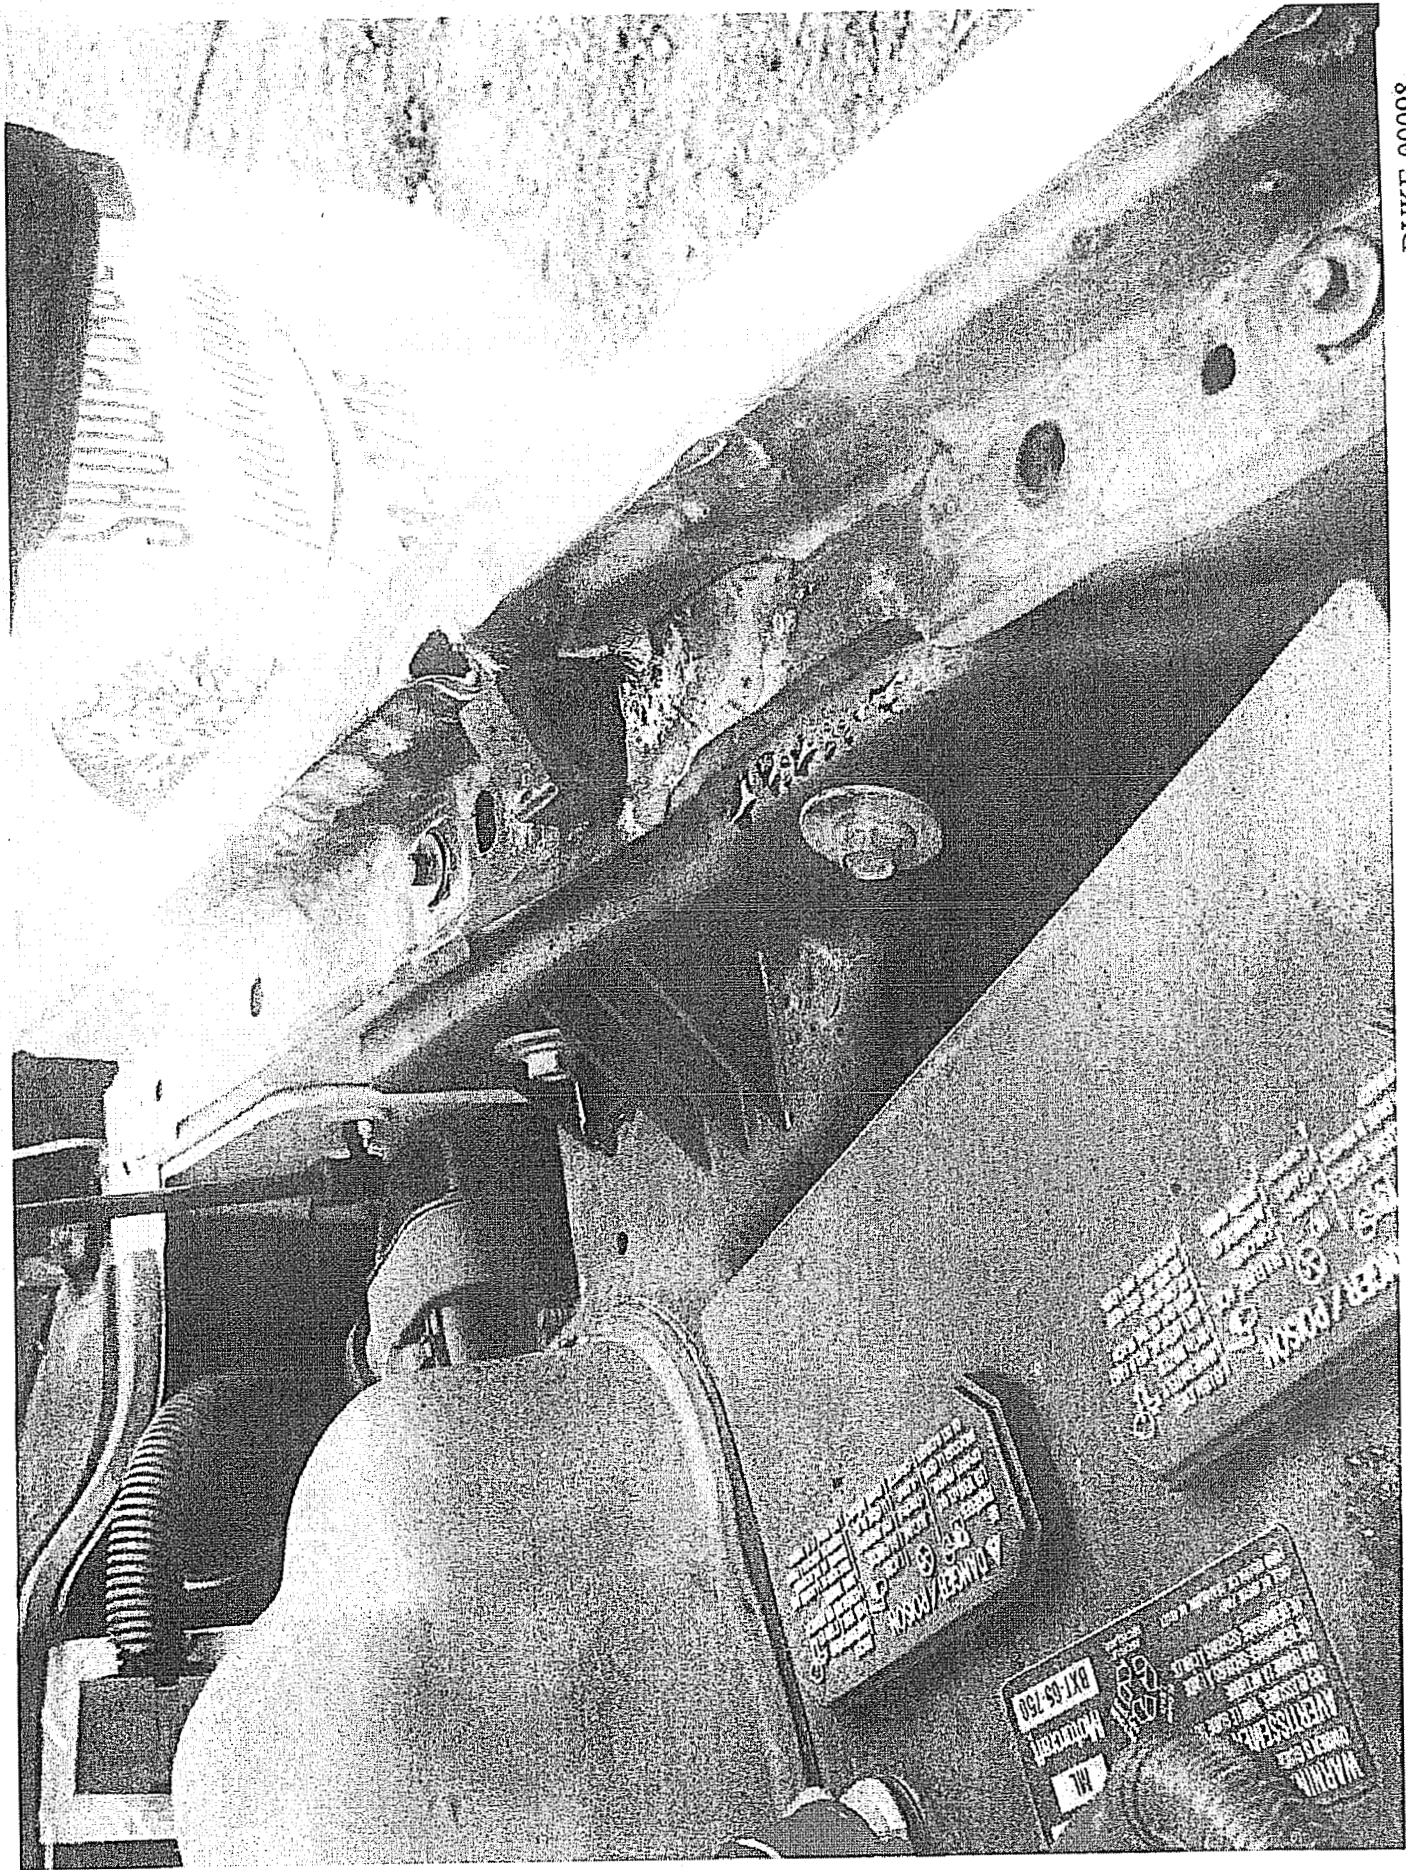
DUKE-00098
CONFIDENTIAL

With the dump truck bed measuring sixteen feet, six inches, and both the top of the bed and conductors showing contact points, the supply conductor must have been less than sixteen feet, six inches when the bed of the dump truck made contact. This is a probable violation of the National Electric Safety Code (NESC).

**16'-6" measurement of dump
bed fully extended**

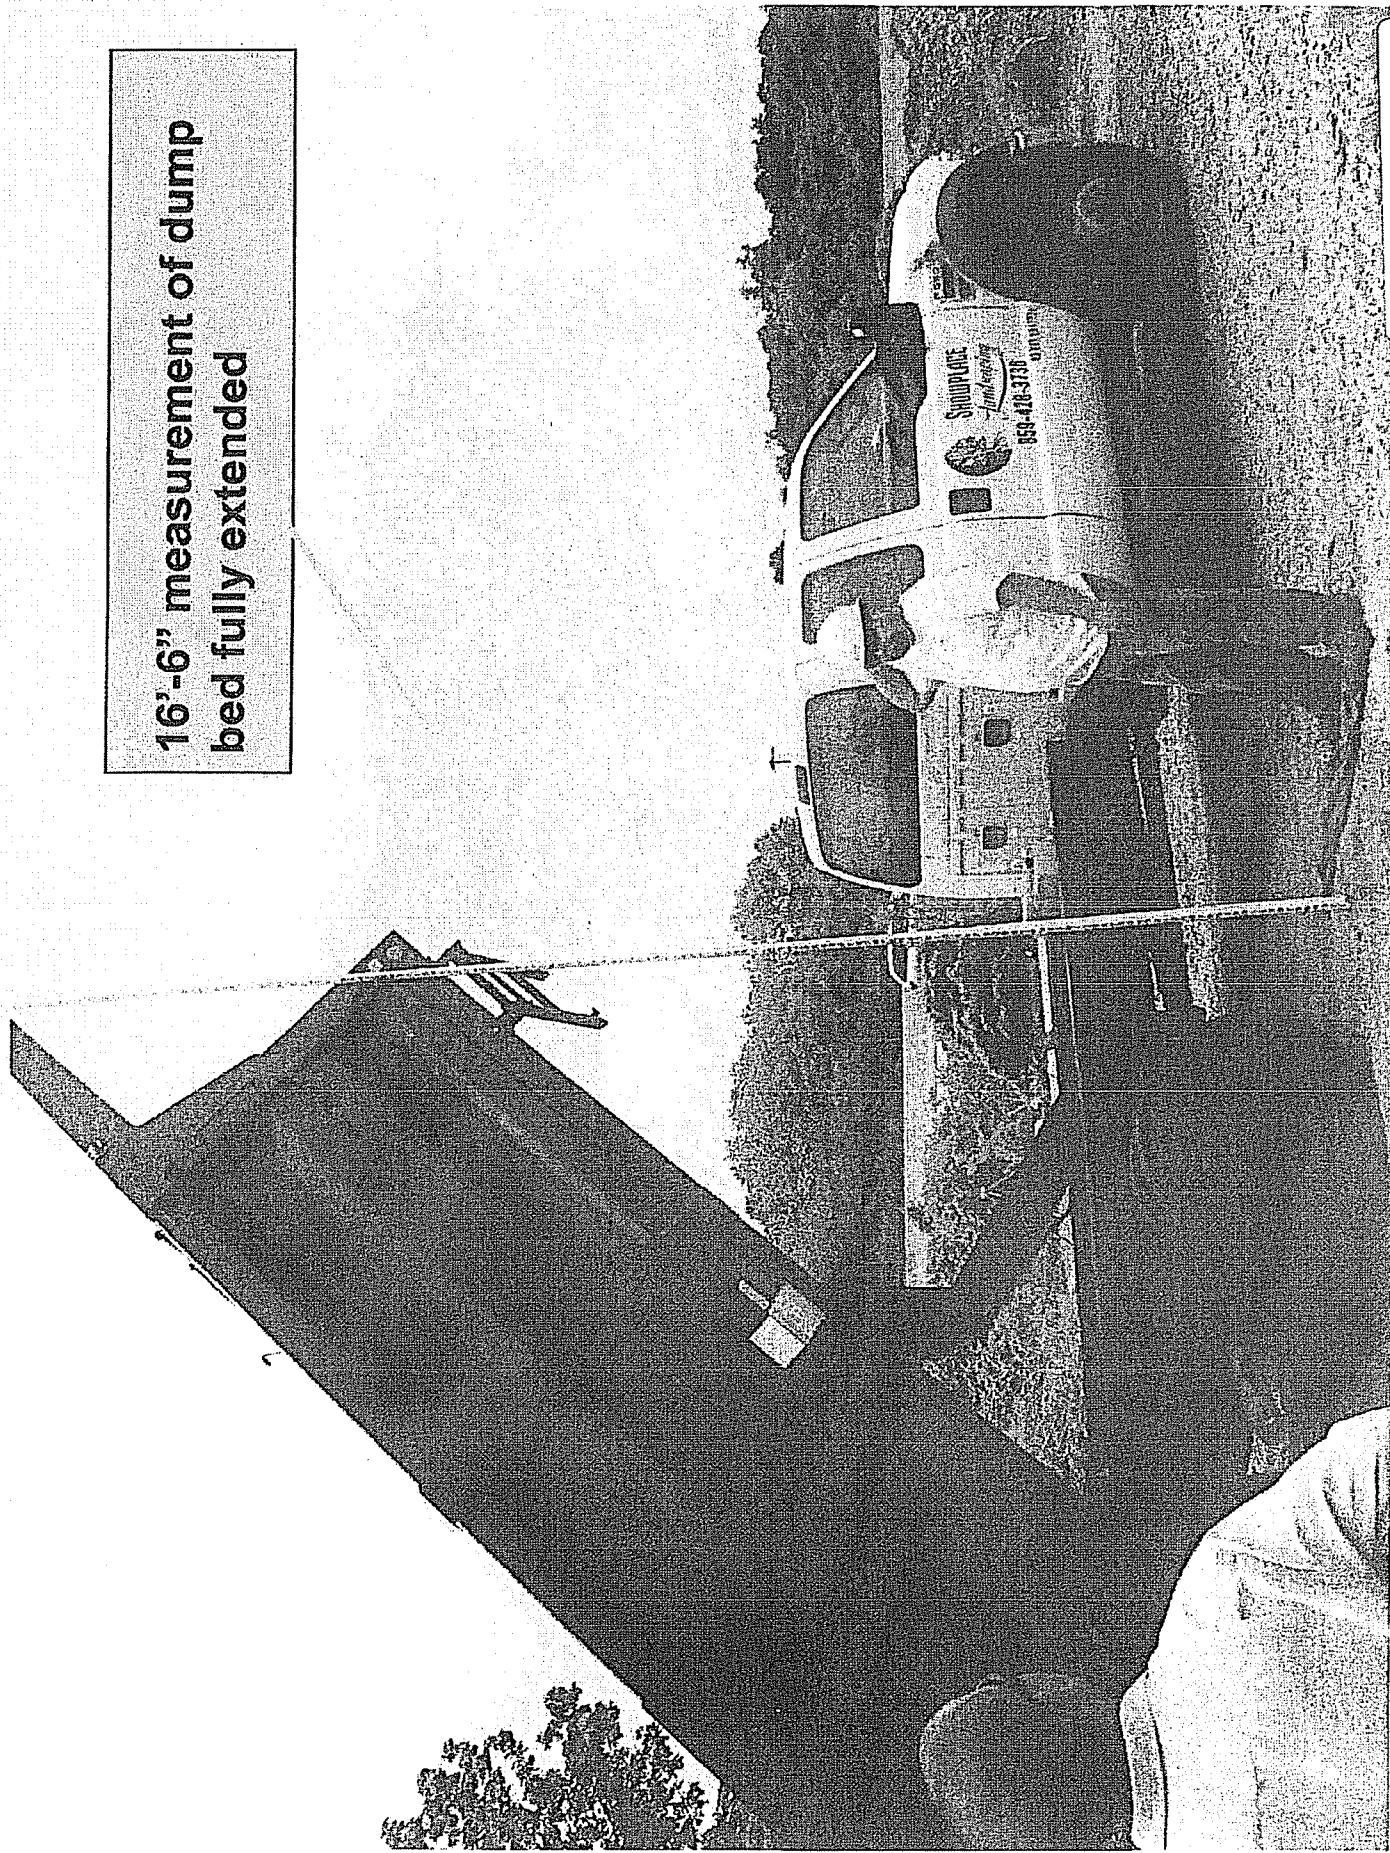
DUKE-00099
CONFIDENTIAL

**18'-1" measurement of Neutral
between poles 10G-85E and
10G-86E after repair on
July 27, 2009**

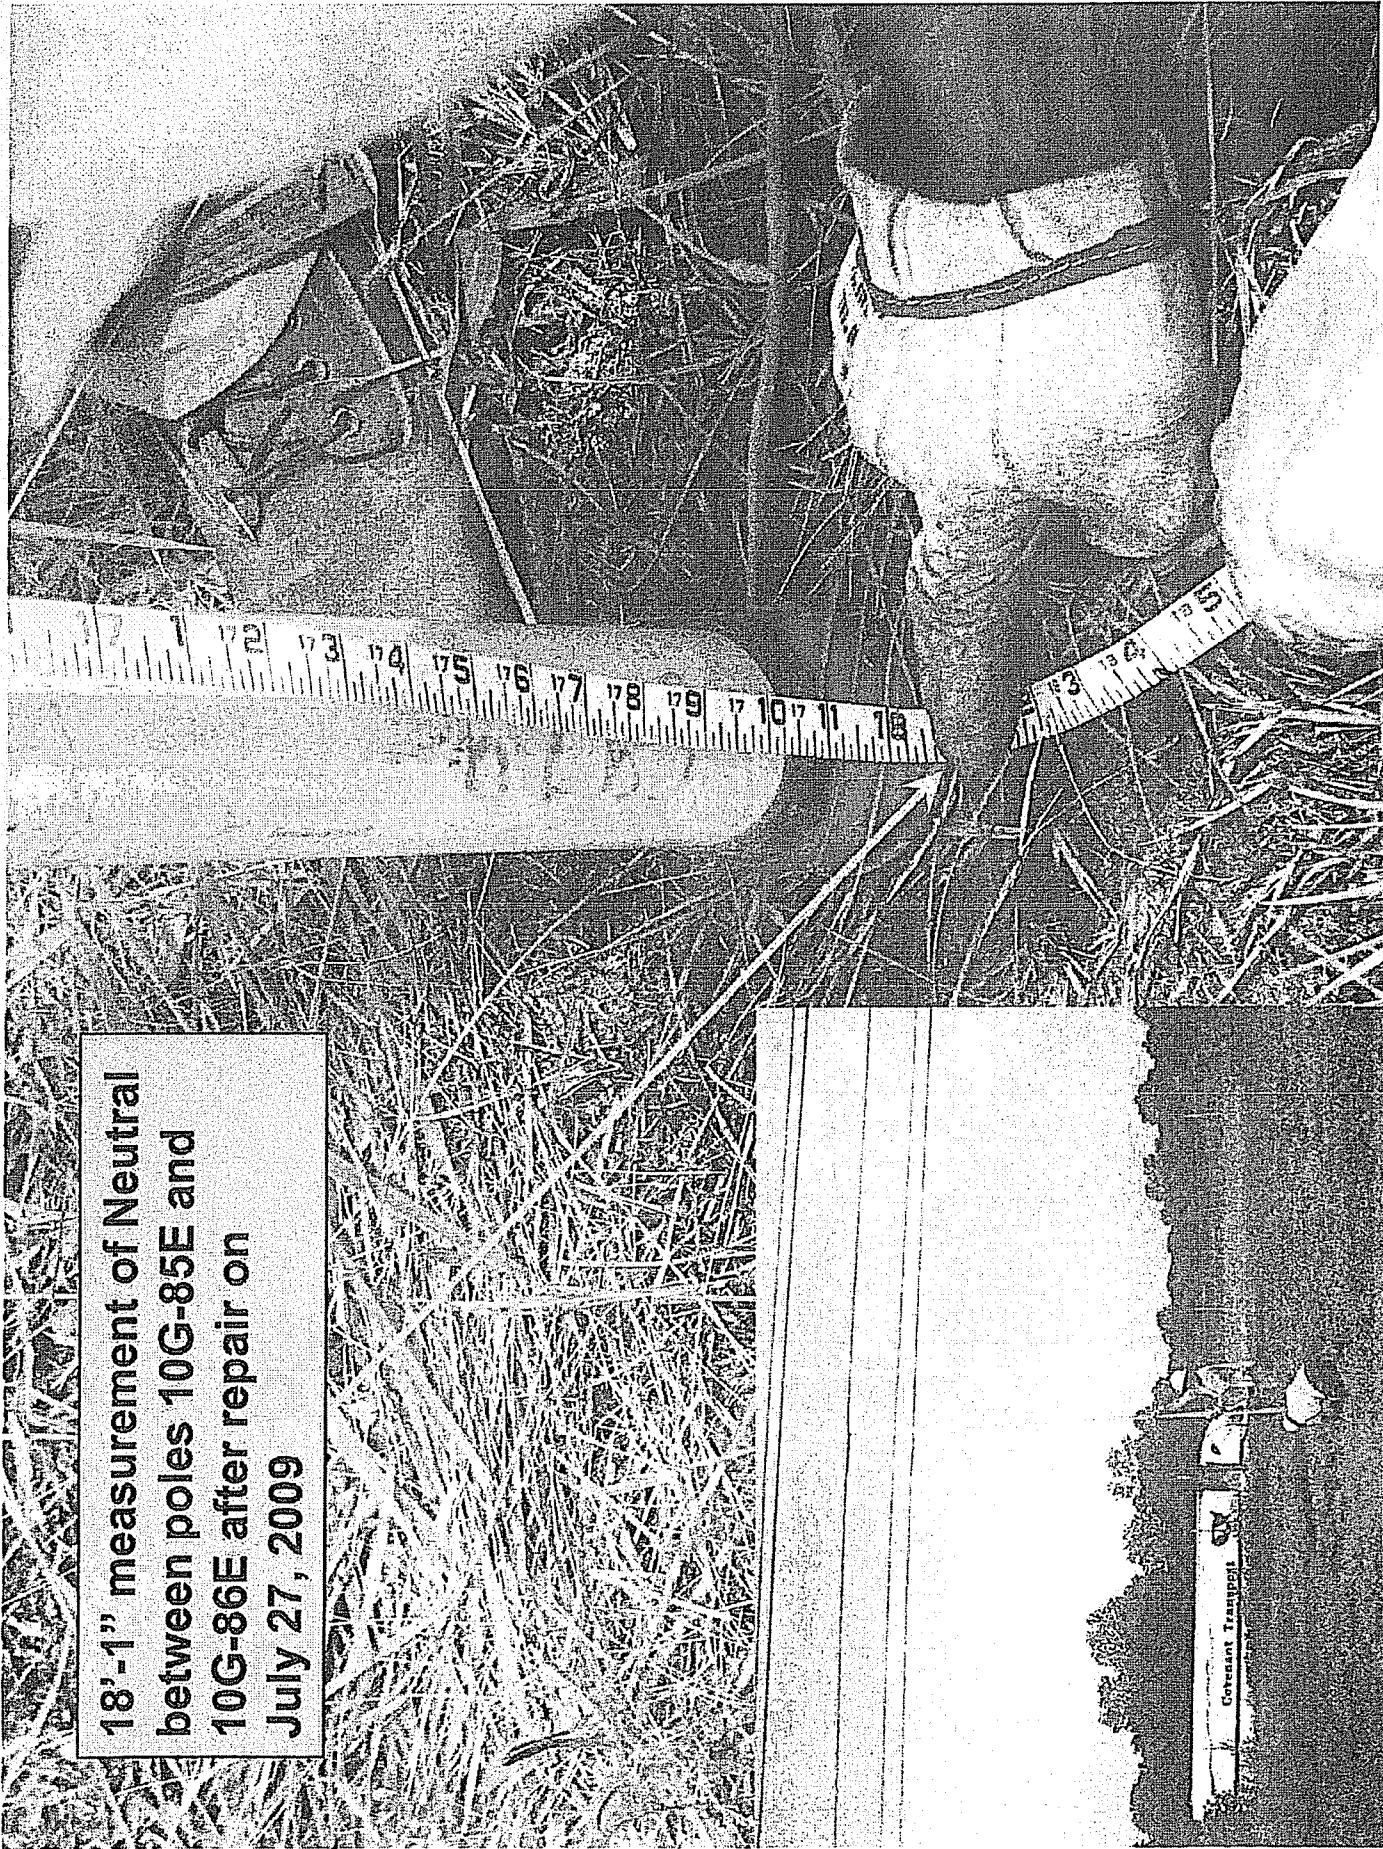
Attachment A shows the ground clearance of the west supply conductor at seventeen feet, six inches after repairs. This is still a probable violation of the NESC, section 20, table 232-1.

After receiving the documents in Attachment A (date stamped November 20, 2009) showing the conductors height at seventeen feet, six inches after the repairs had been made, it was discovered that Duke Energy Kentucky facilities at the incident site had been changed, new structures installed, and the conductor height changed. I contacted Duke Energy Kentucky and asked if they would like to amend the seven-day report showing the height of the conductors after the changes mentioned above. They sent an amended document for Duke Energy Kentucky's seven-day report on January 14, 2010 documenting changes made to the facilities at the incident site. The photograph in Attachment A, DUKE-00112 shows the supply conductor at thirty two feet, six inches, compared to photograph DUKE-00101 which shows the supply conductor at seventeen feet, six inches.

**17'-6" measurement of West
conductor between poles
10G-85E and 10G-86E after
repair on July 27, 2009**

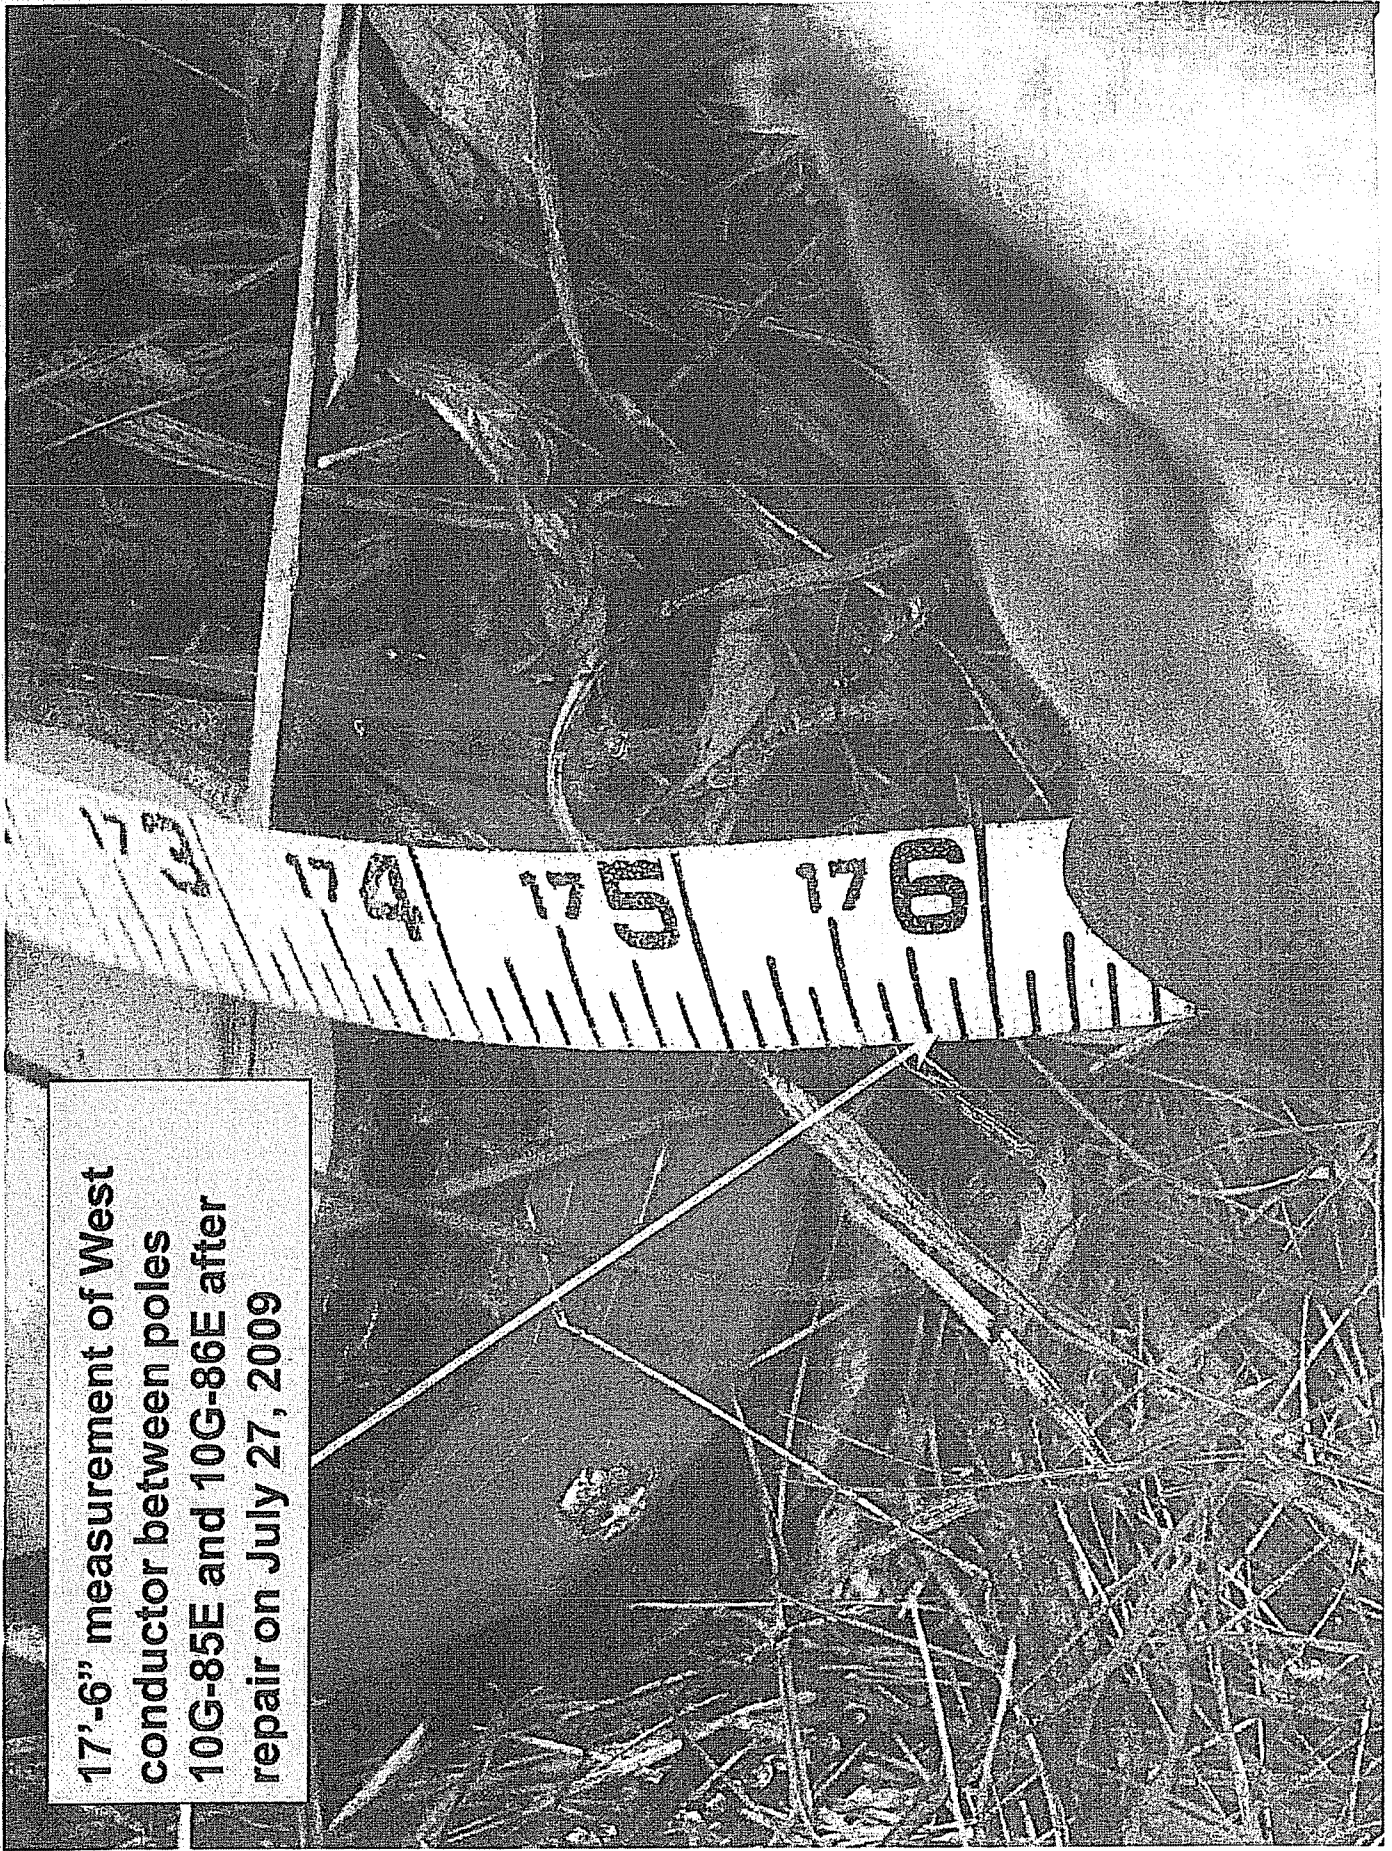
15'-3" measurement of Neutral
between poles 5G-345E and
5G-346E prior to raising on
July 31, 2009

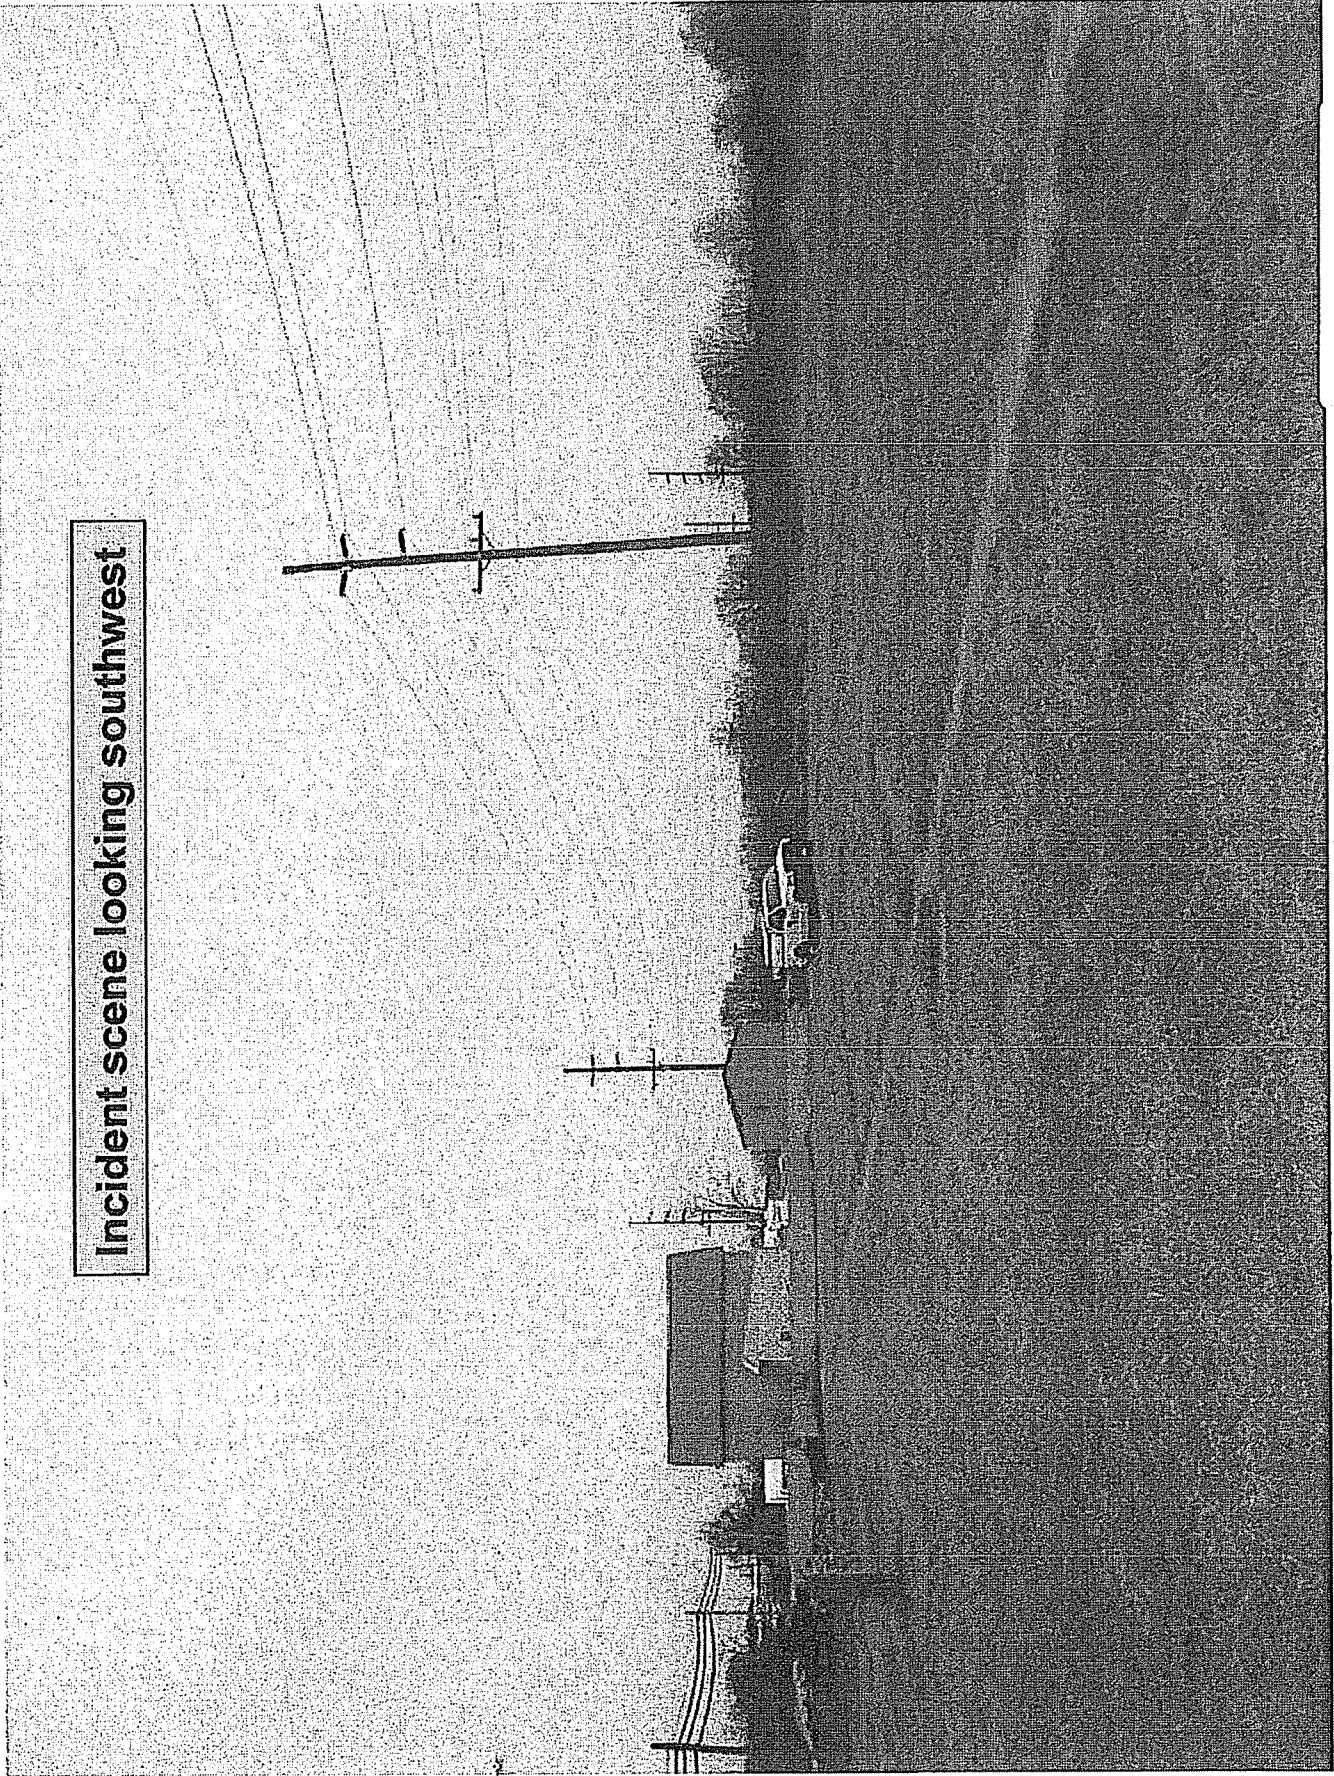
DUKE -00107
CONFIDENTIAL

Incident scene looking southwest

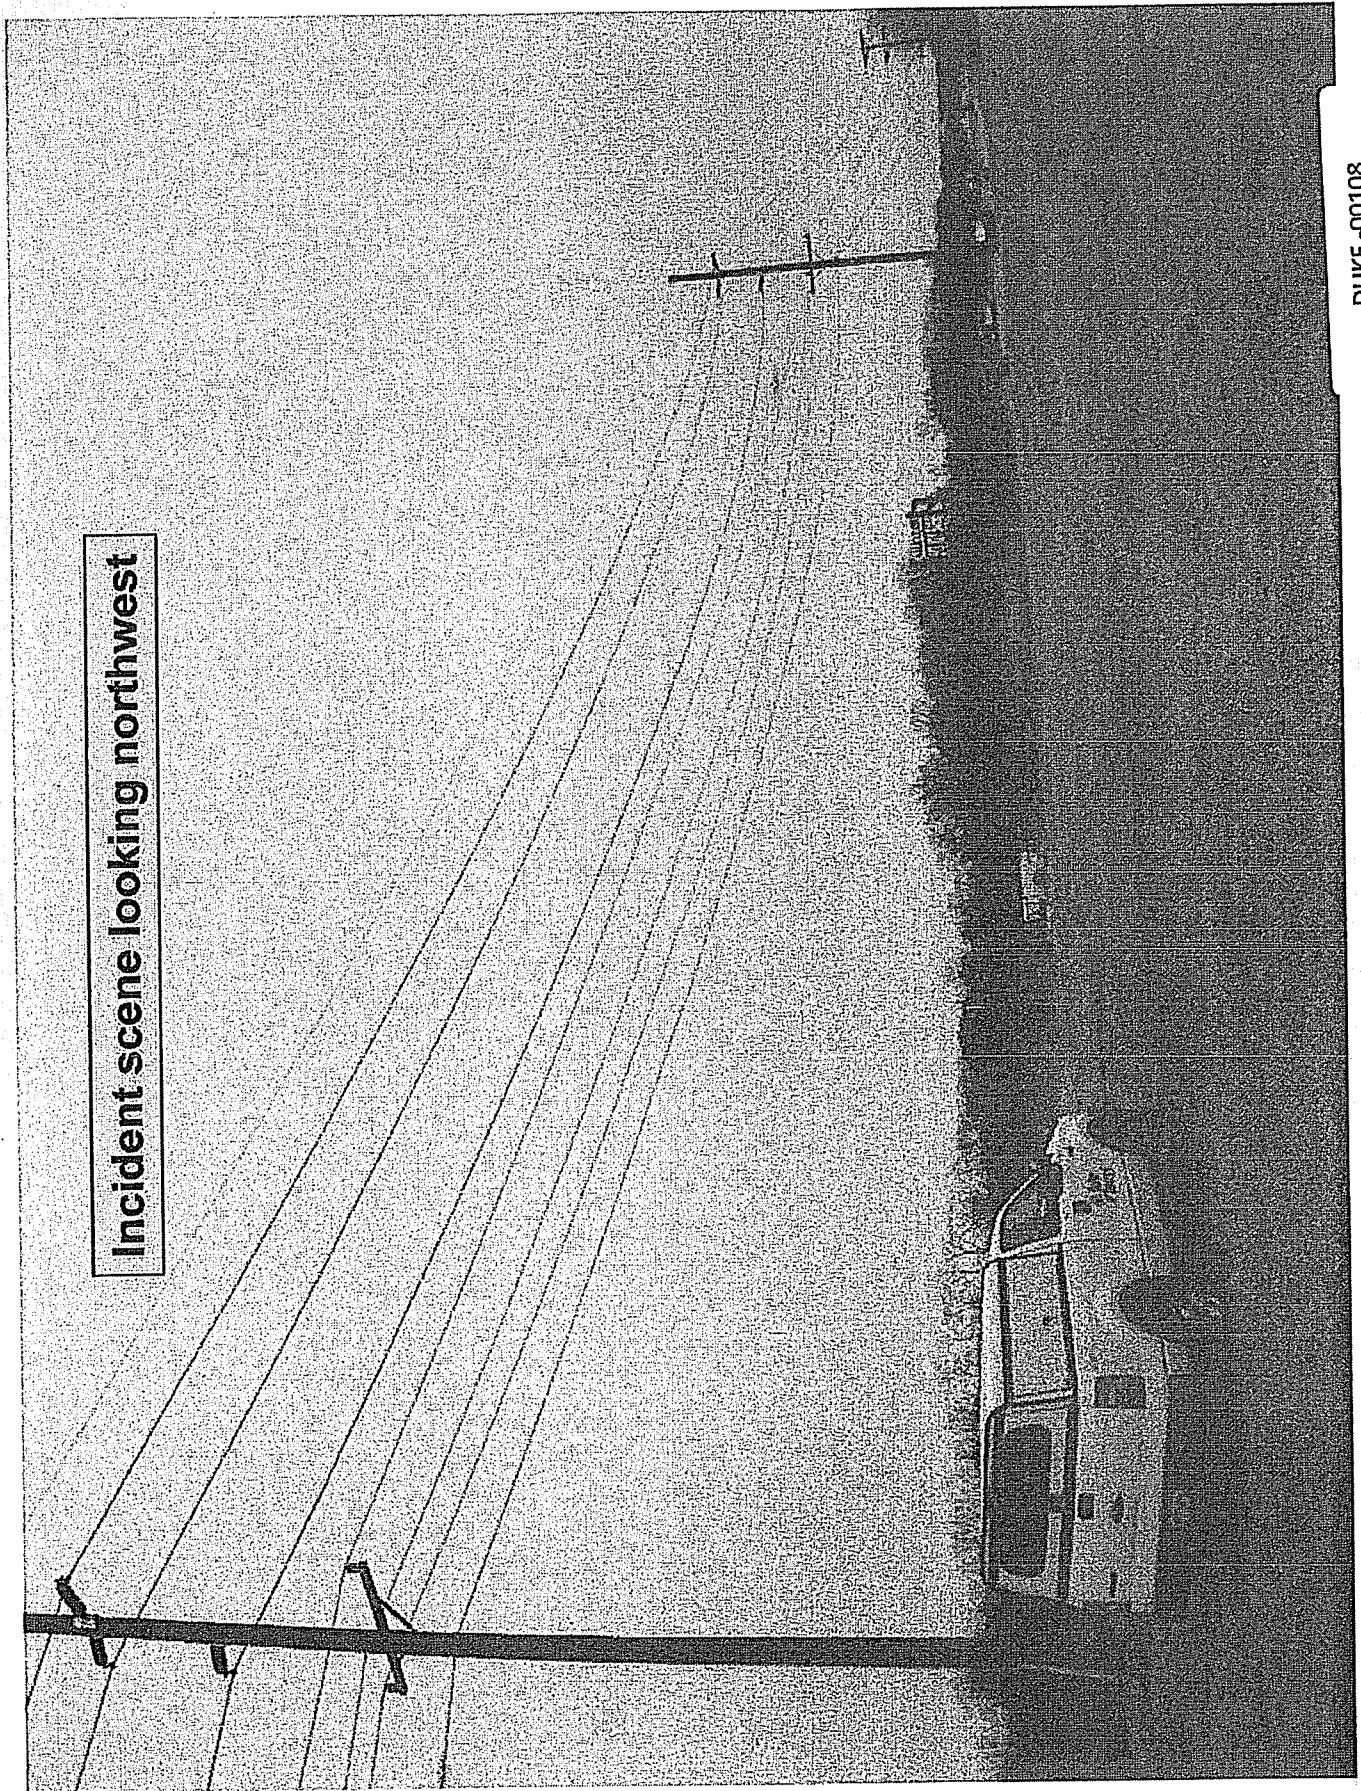
DUKE -00108
CONFIDENTIAL

Incident scene looking northwest

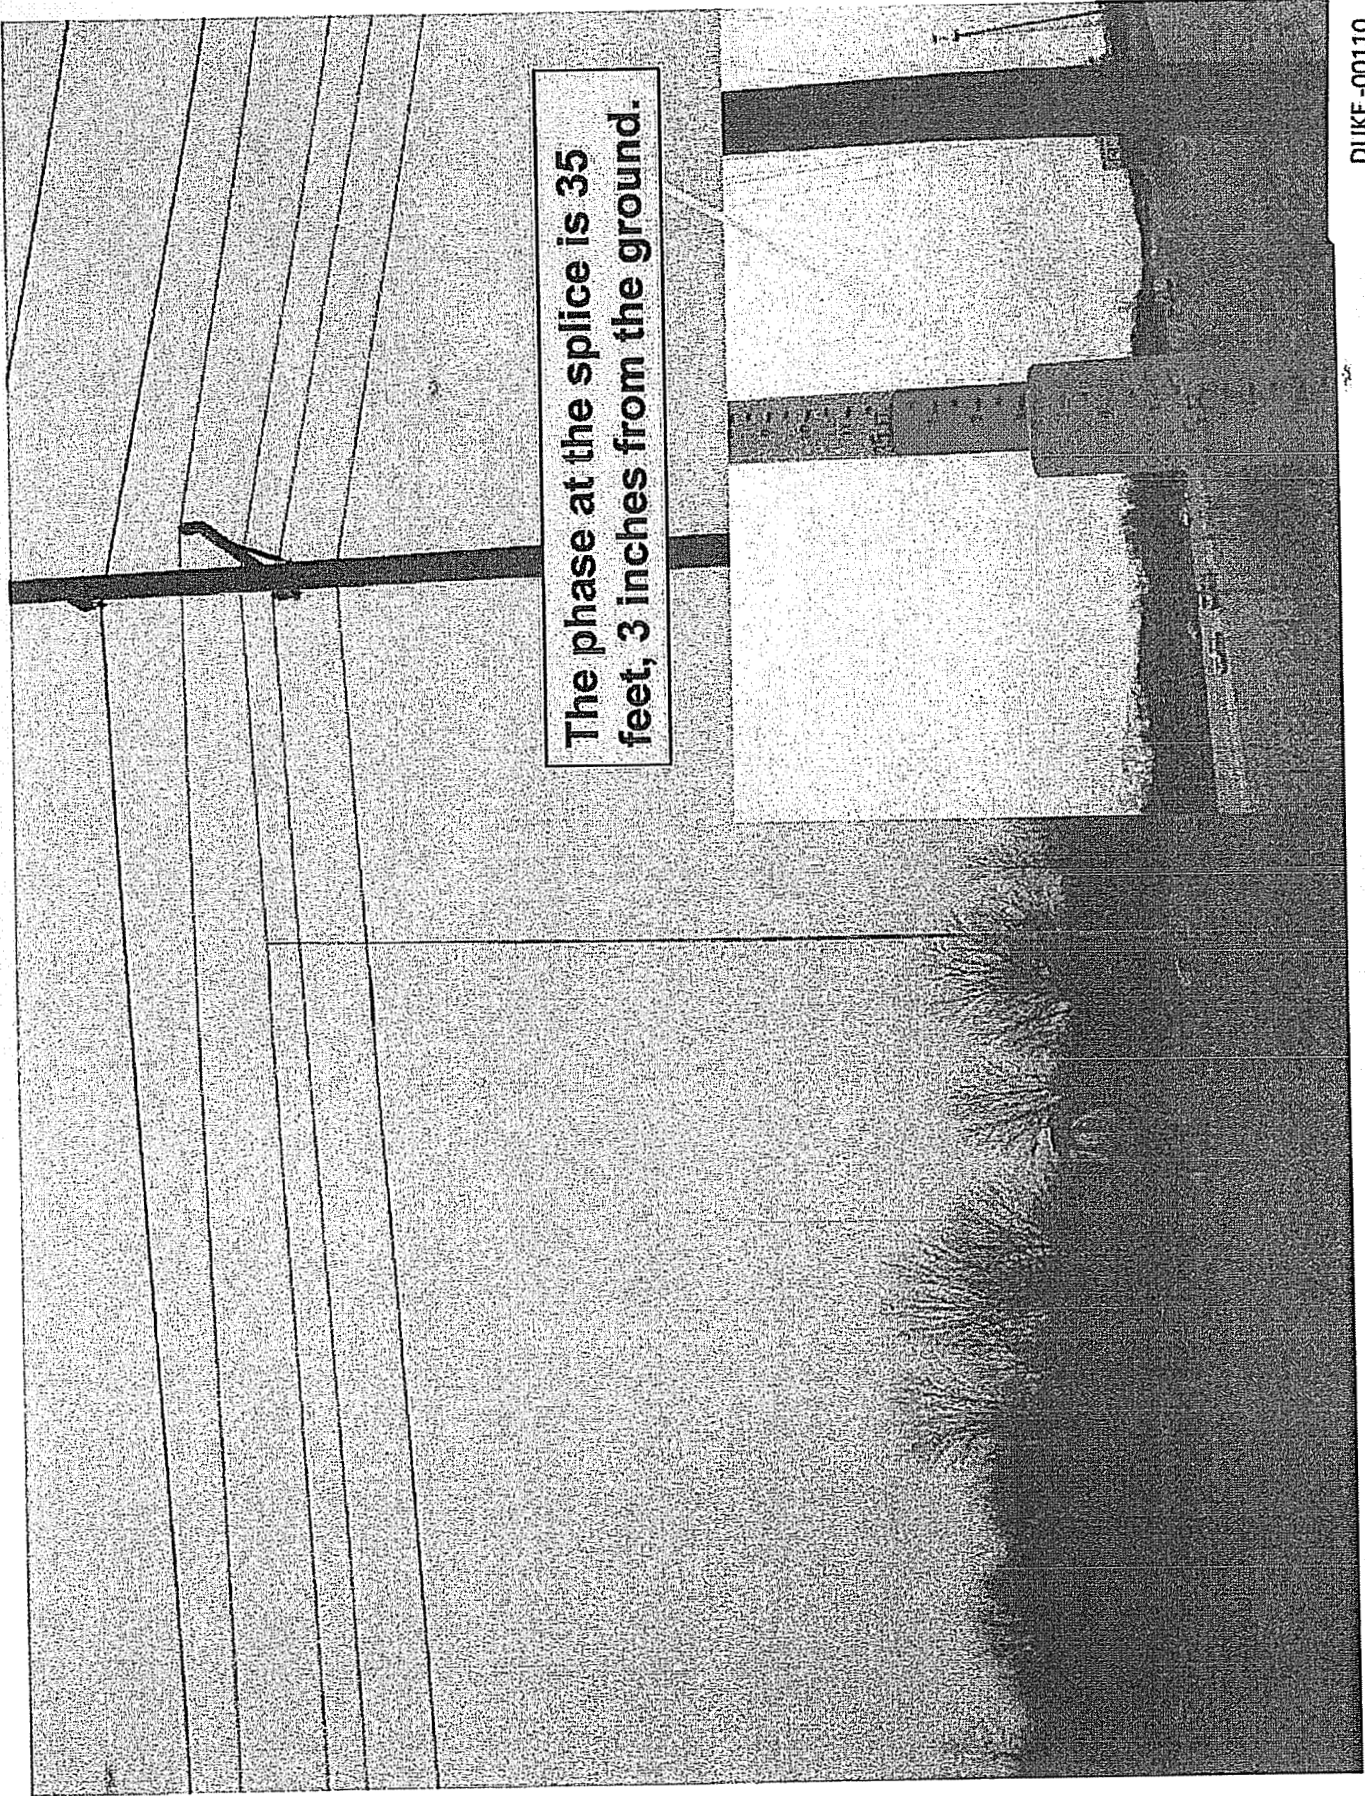
**Neutral at the splice is
30 feet from the ground.**

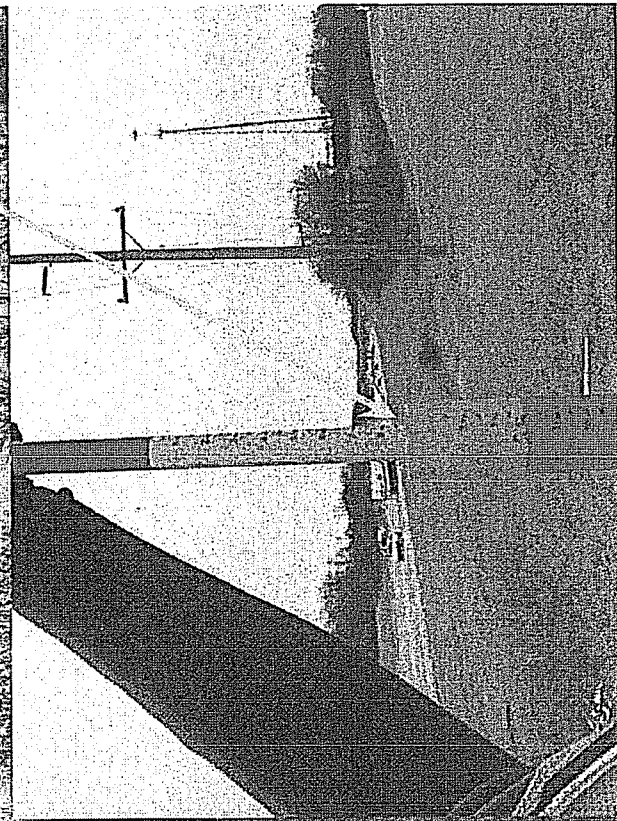
The phase at the splice is 35 feet, 3 inches from the ground.

The neutral at the lowest point in the span is 22 feet, 9 inches from the ground.
