COMMONWEALTH OF KENTUCKY
BEFORE THE PUBLIC SERVICE COMMISSION

DUKE ENERGY KENTUCKY, INC.)	
_____)	CASE NO.
)	2010-00248
ALLEGED FAILURE TO COMPLY WITH)	
KRS 278.042)

O R D E R

Incident Location ~ Showplace Landscaping, Crittenden, Kentucky
Report Date: March 24, 2010
Incident Date: July 27, 2009
PSC Investigator: Jeff Moore
Utility: Duke Energy Kentucky
Injured: Kenneth Tyler Cummins

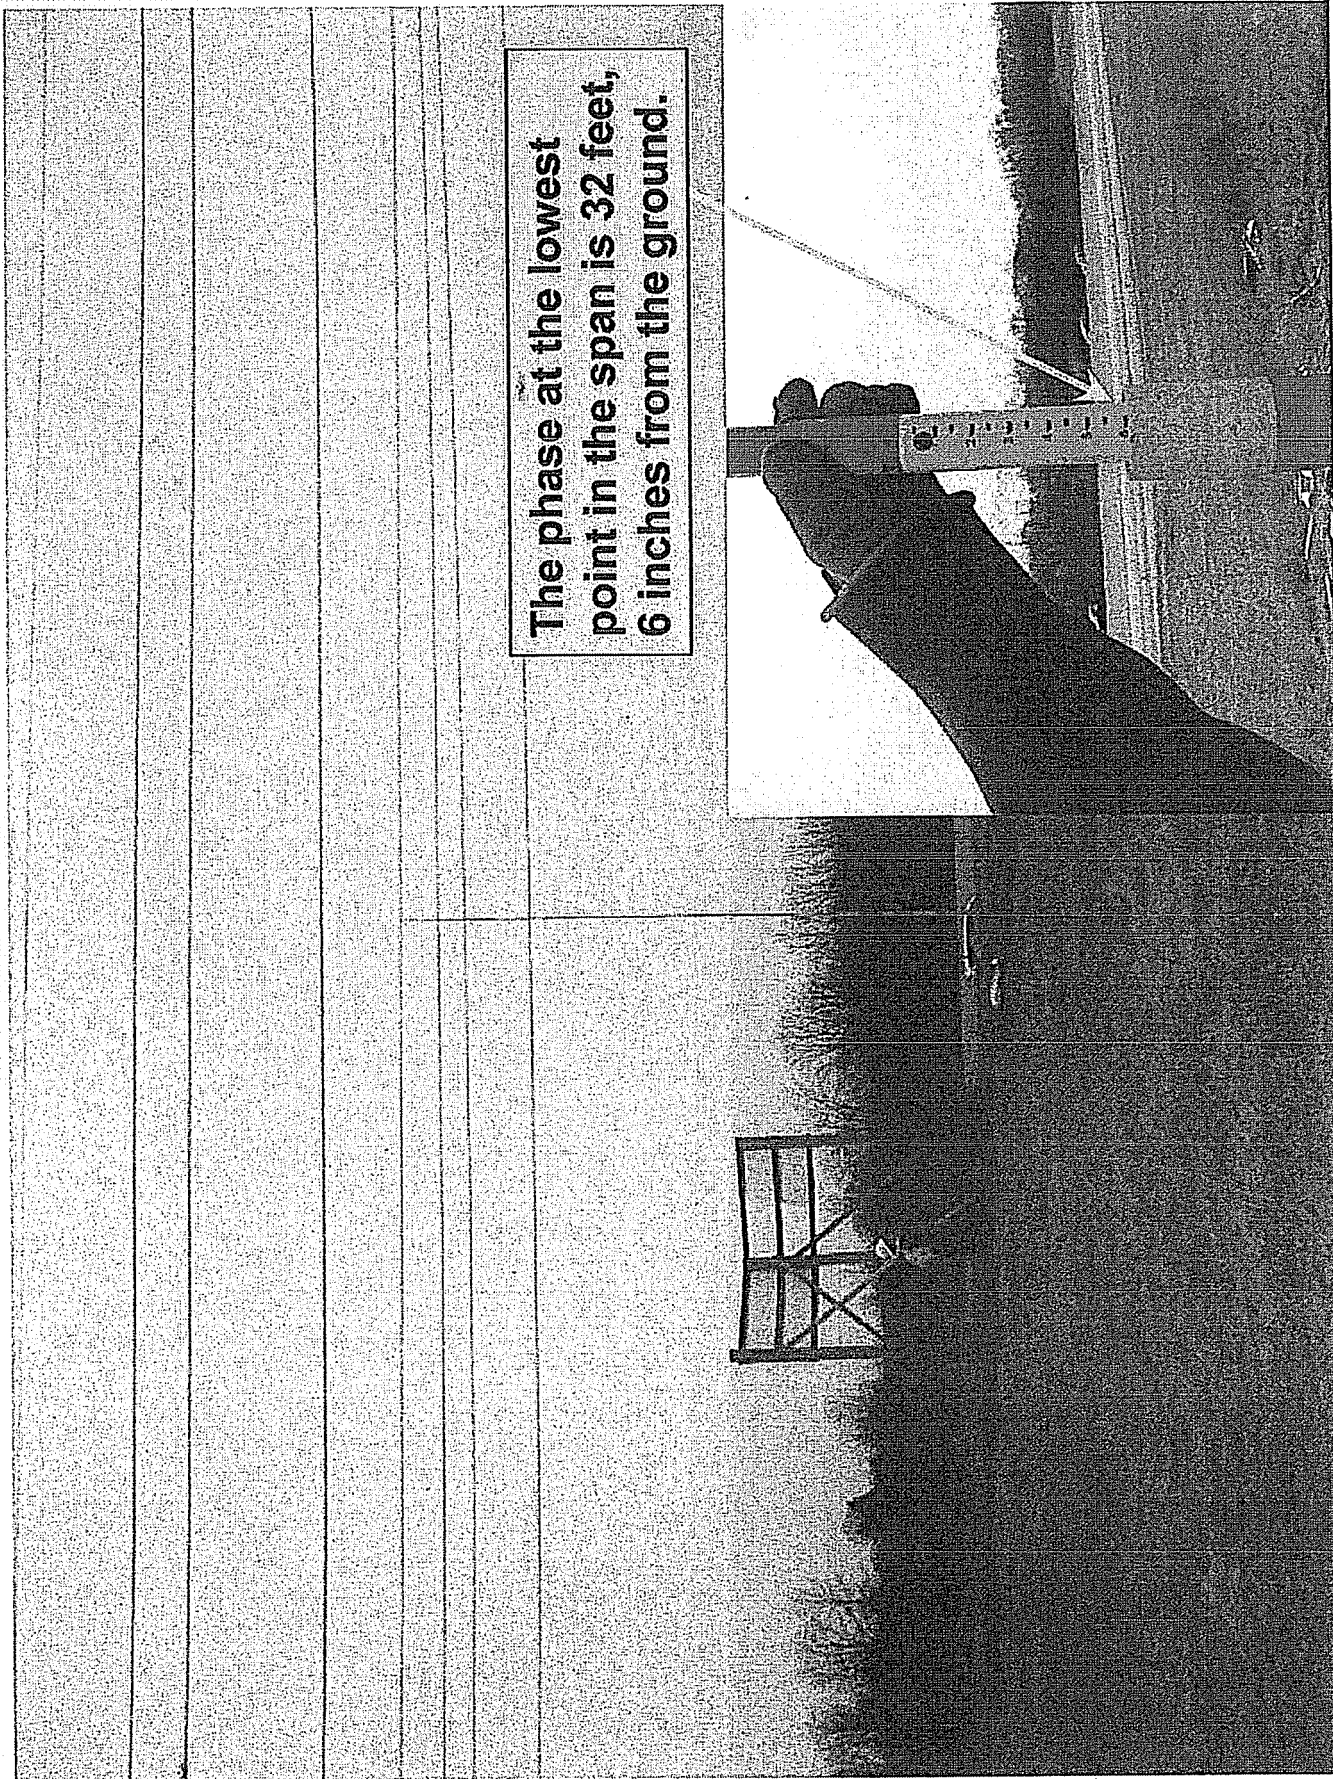
The phase at the lowest point in the span is 32 feet, 6 inches from the ground.
