City of Liberty

Re: Case No. 2017-00053

Attached is the first repair report from the leakage survey for the Liberty Gas System which was completed by Heath Consultants in August 2018. During the survey, three (3) grade 2 leaks and five (5) grade 3 leaks were discovered in Liberty's gas system.

LEAK REPORT

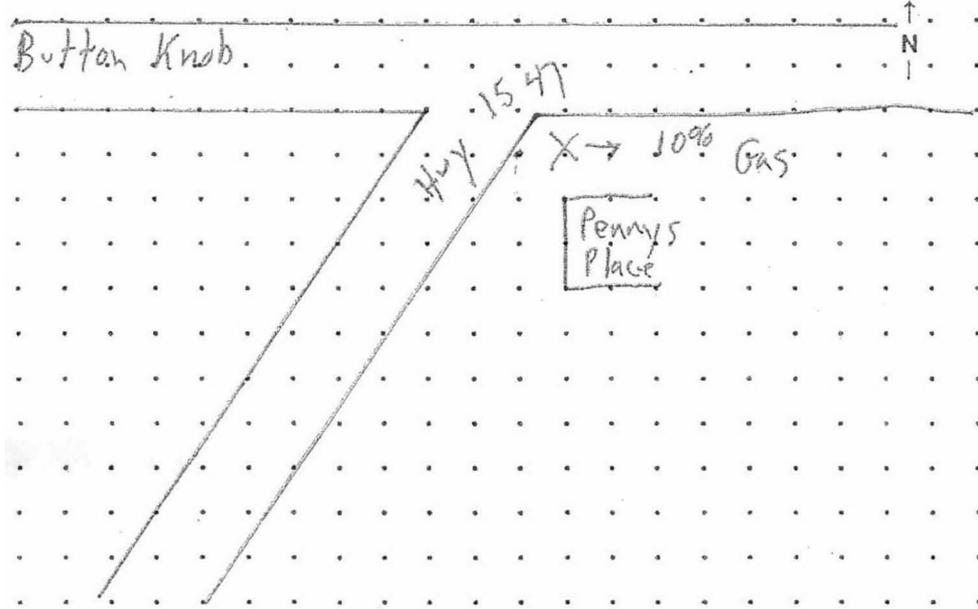
Pennys Pl, Hwy, 1547

Remarks Leak appear to be on main
