**RE: Louisville Gas and Electric Company Alleged Failure to Comply with
KRS 278.495, 807 KAR 5:022, and 49 C.F.R. Part 192
Case No. 2017-00119**

Report No. 202100071**Metallurgical Evaluation of an 16" Coupling and Associated Hardware****Location: River Rd. & E. Witherspoon Rd.****DESCRIPTION AND PURPOSE**

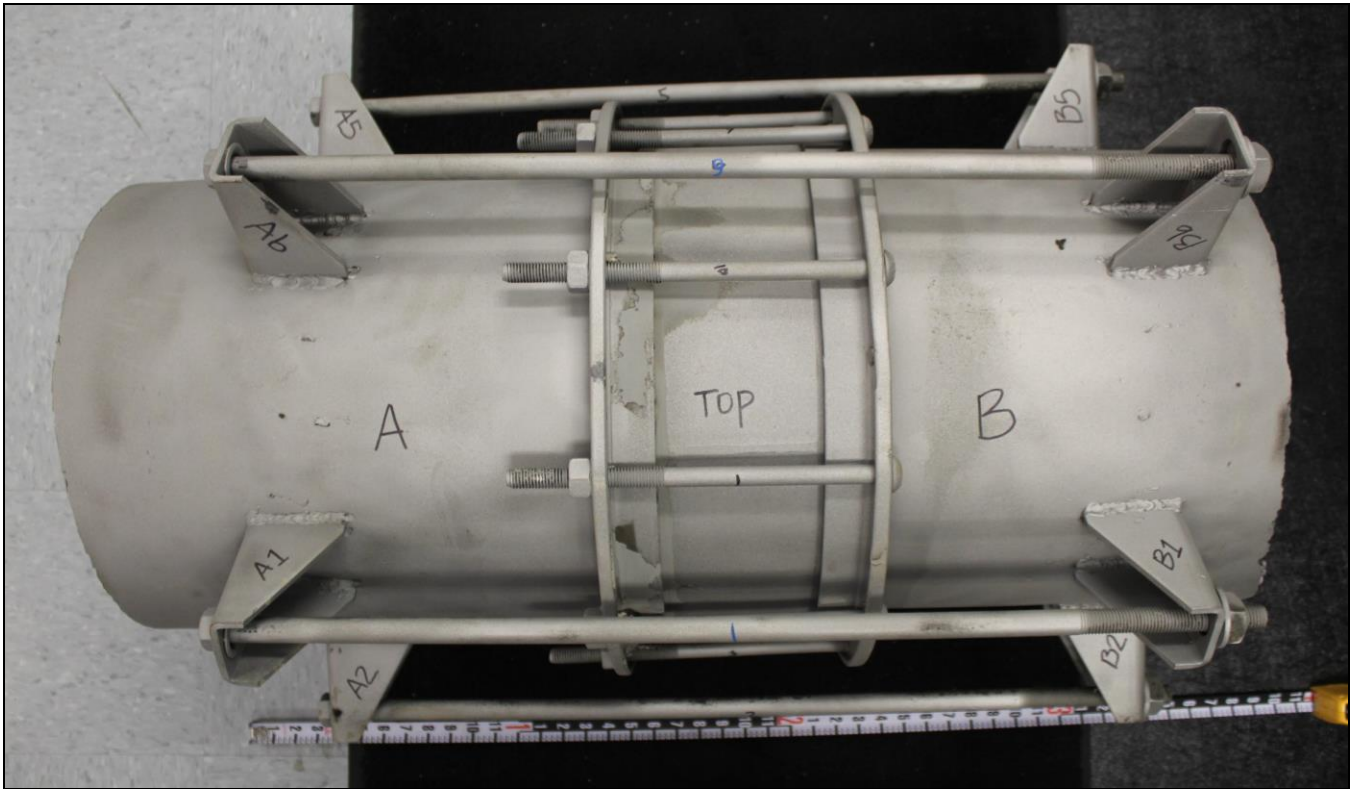
Figure 1. Photograph of the top of the submitted coupling sample.

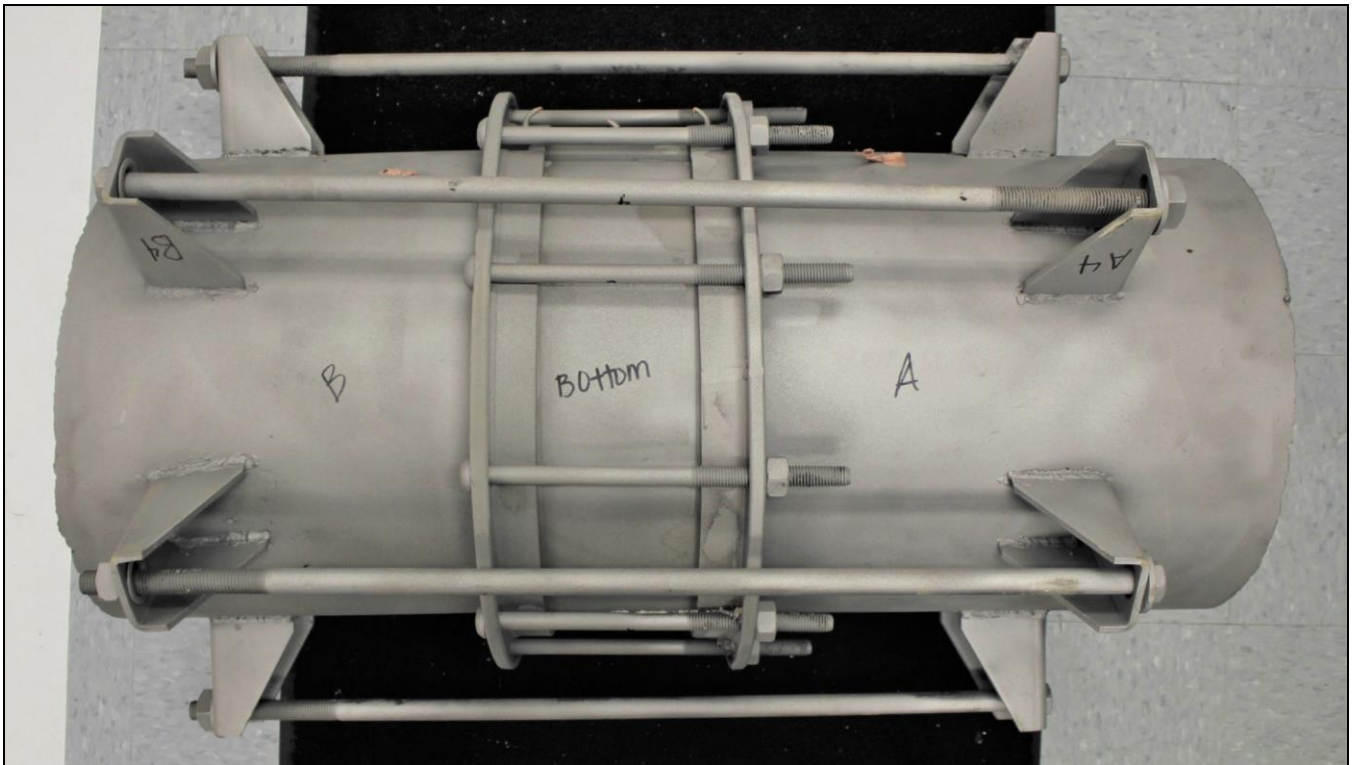
Figure 2. Photograph of the bottom of the submitted sample.

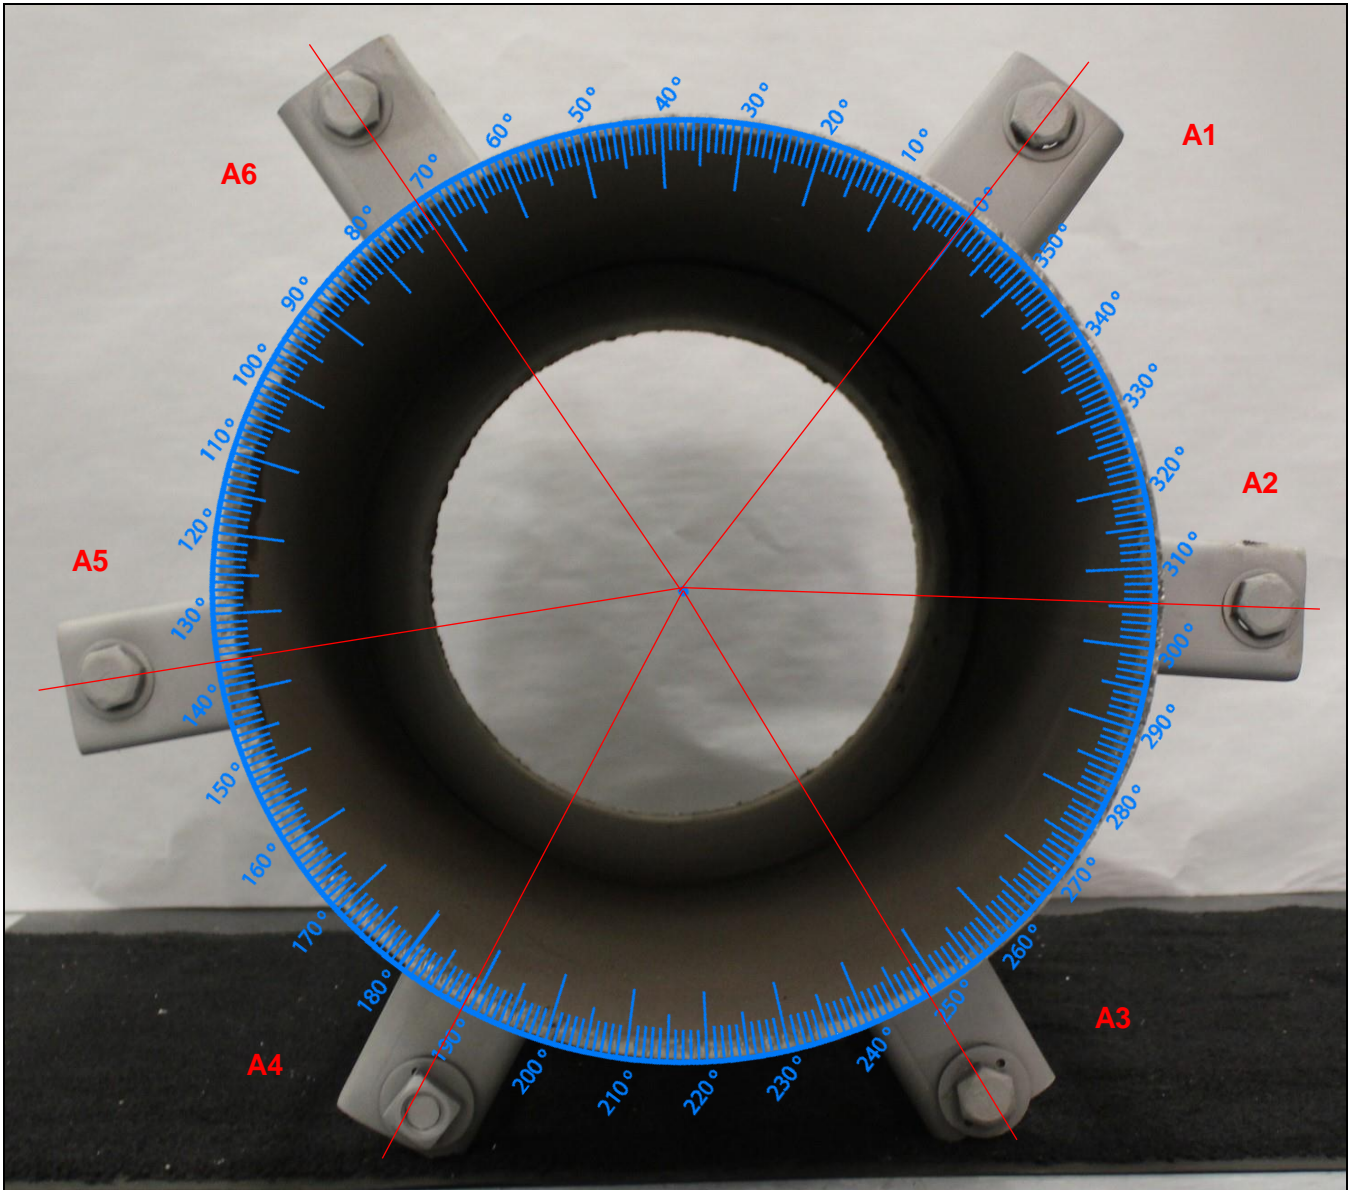
Compound	Angle	Deviation from 60°	Image
Rod A1 / Rod A2	55	5	Figure 3
Rod A2 / Rod A3	57	3	Figure 3
Rod A3 / Rod A4	59	1	Figure 3
Rod A4 / Rod A5	53	7	Figure 3
Rod A5 / Rod A6	64	4	Figure 3
Rod A6 / Rod A1	72	12	Figure 3
Rod B1 / Rod B2	65	5	Figure 4
Rod B2 / Rod B3	53	7	Figure 4
Rod B3 / Rod B4	60	0	Figure 4
Rod B4 / Rod B5	61	1	Figure 4
Rod B5 / Rod B6	50	10	Figure 4
Rod B6 / Rod B1	71	11	Figure 4

Figure 3. End facing image of the sample at End A with a superimposed protractor.

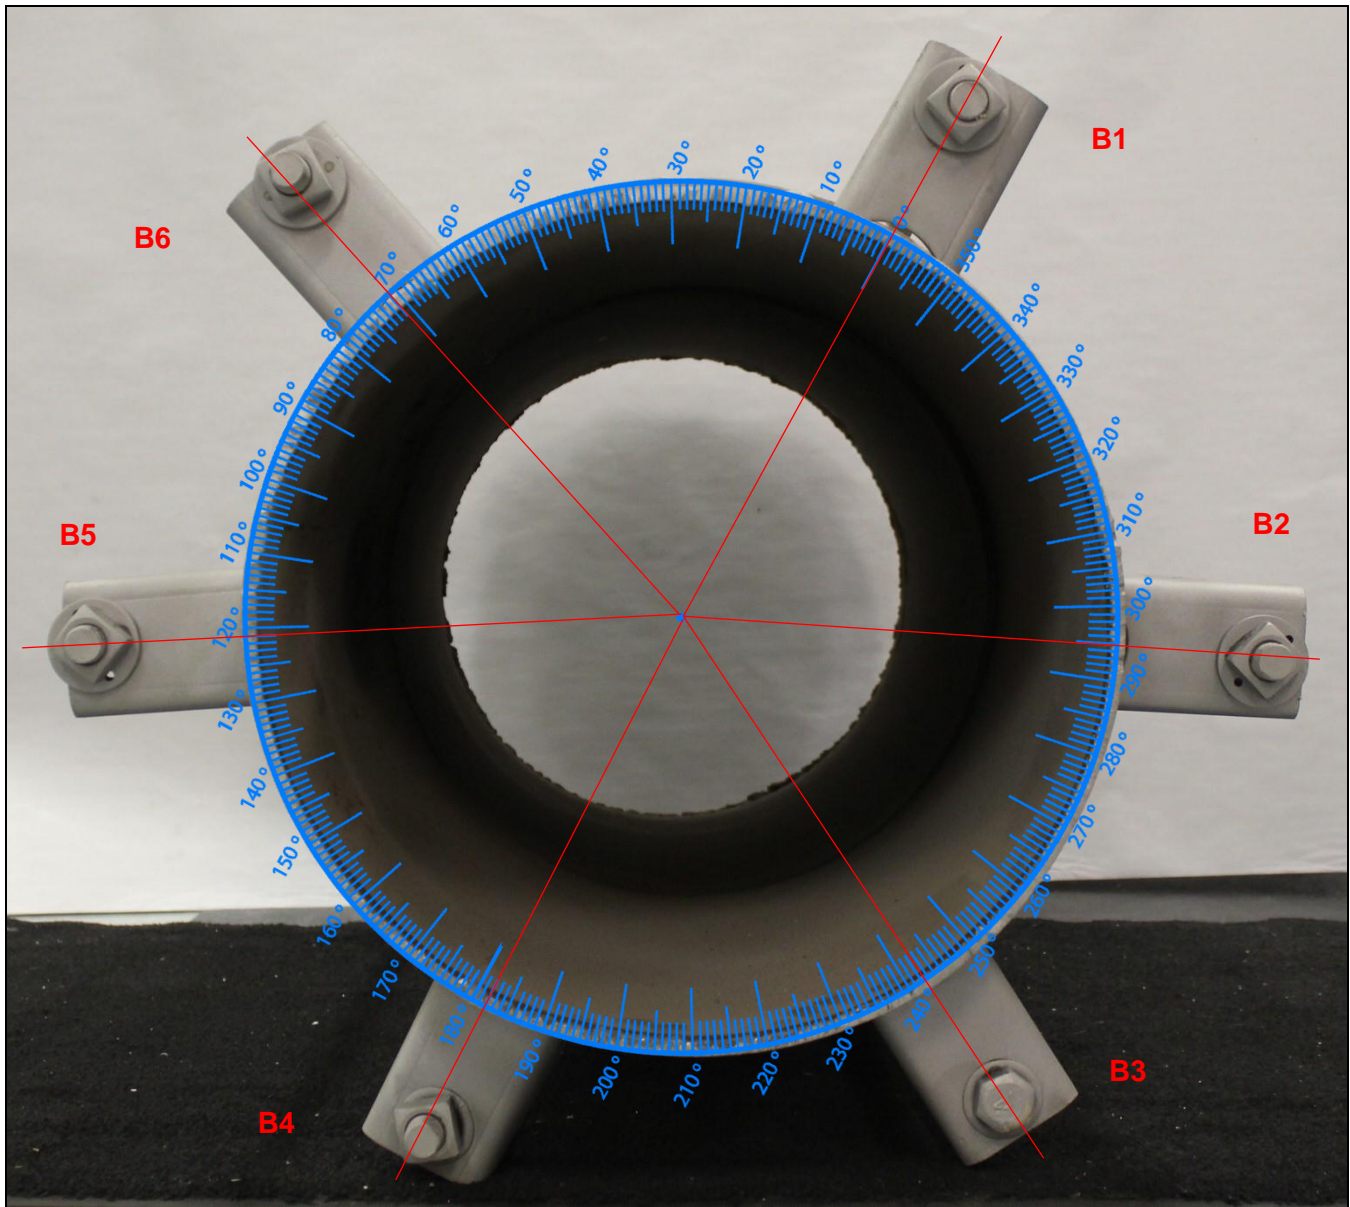
Figure 4. End facing image of the sample at End B with a superimposed protractor.

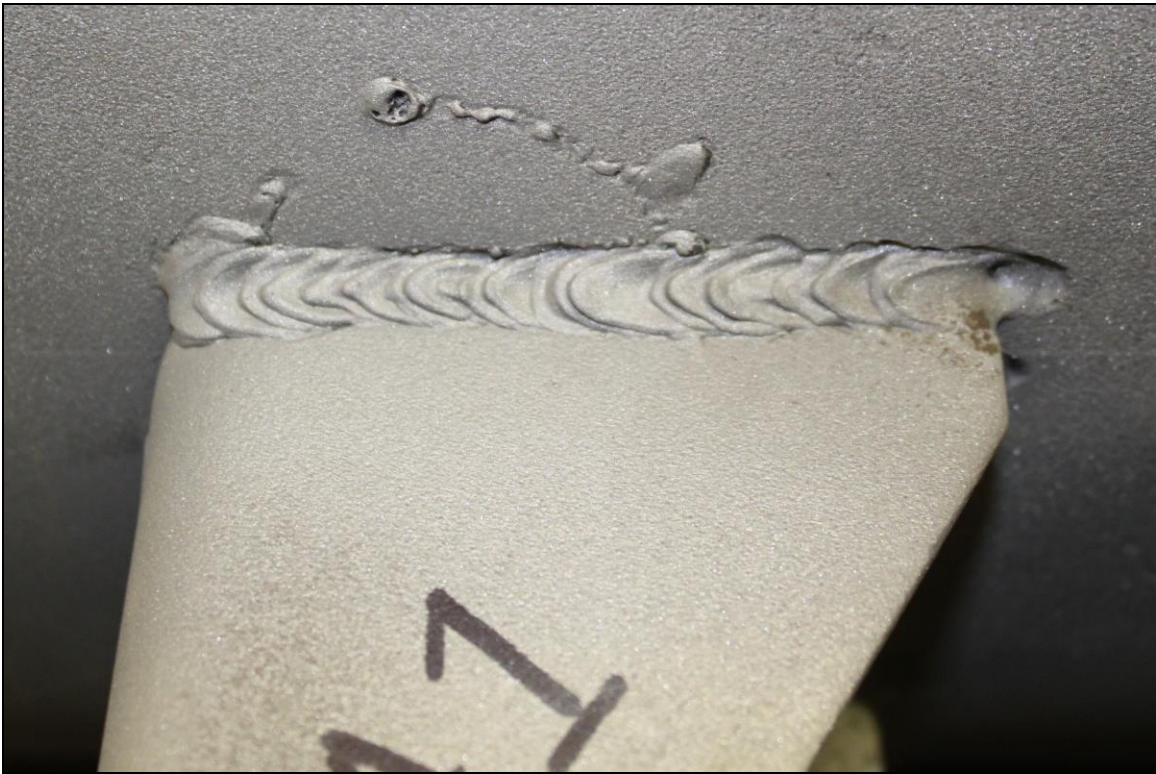
Figure 5. Image of the Lug A1 exterior top weld which exhibited substantial fusion except for some undercut and arc strikes.

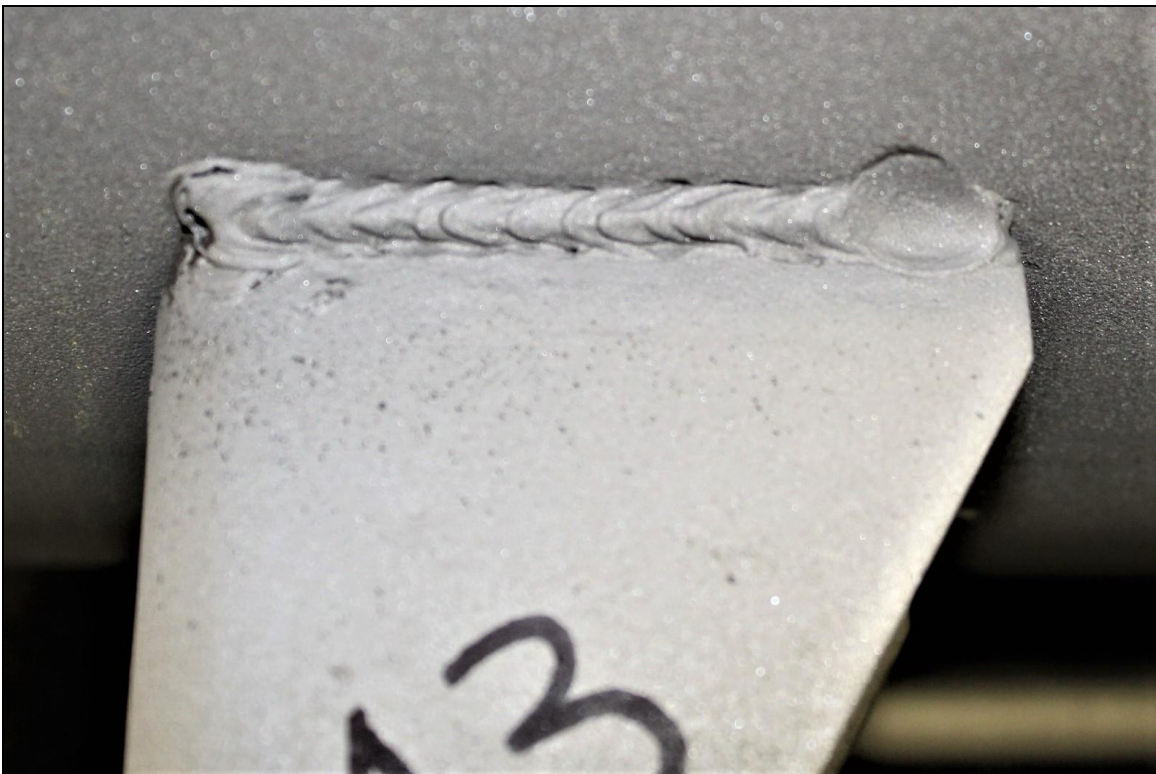
Figure 6. Image of the Lug A3 exterior top weld which exhibited substantial fusion except for some undercut and porosity.

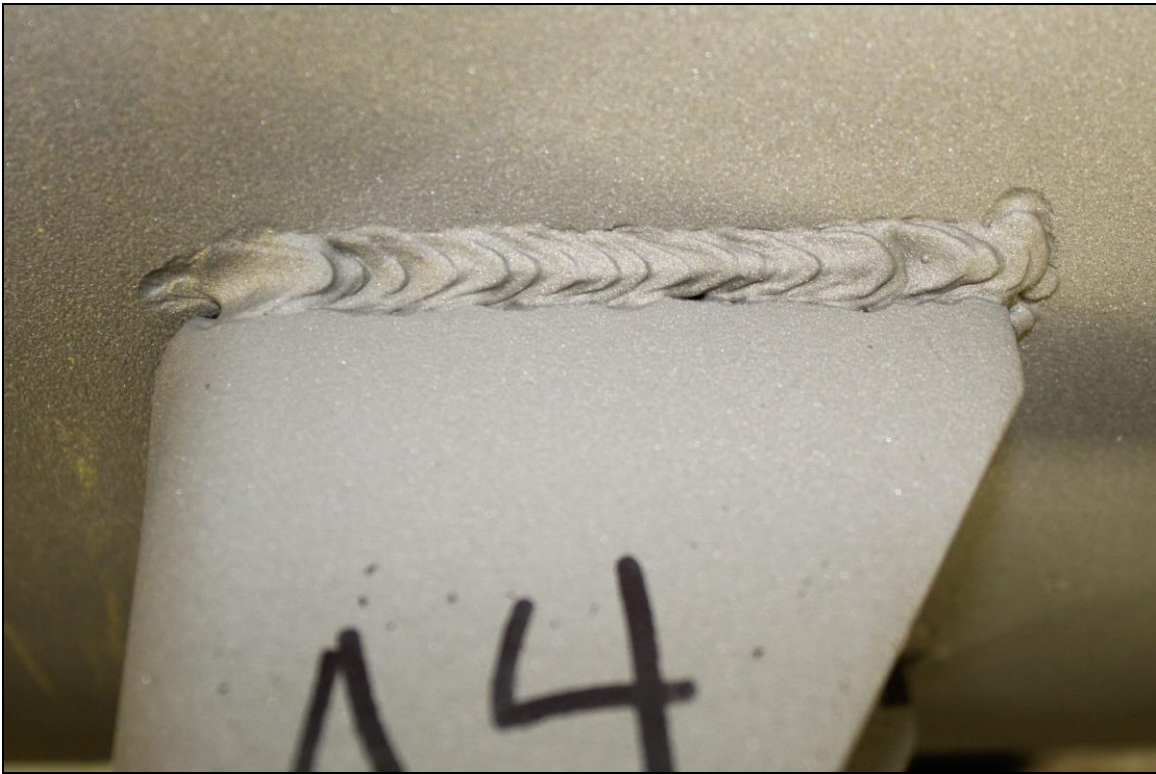
Figure 7. Image of the Lug A4 exterior bottom weld which exhibited substantial fusion.

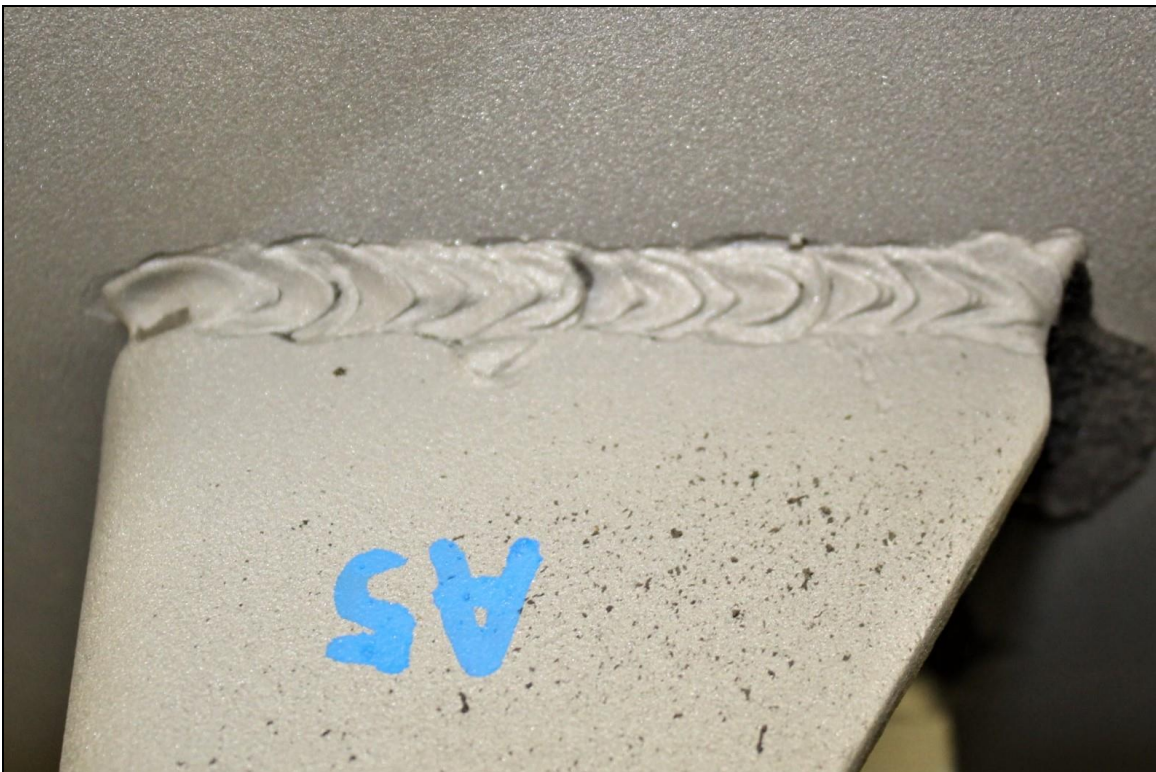
Figure 8. Image of the Lug A5 exterior bottom weld which exhibited substantial fusion except for some undercut and porosity.

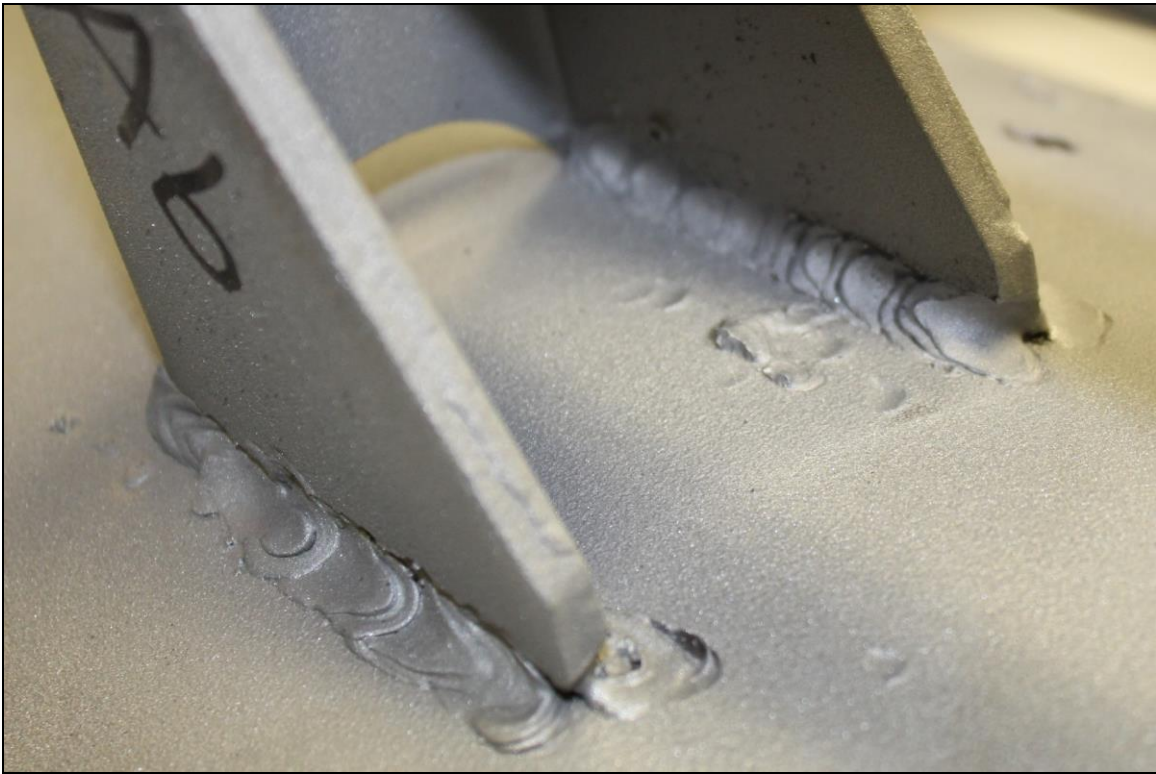
Figure 9. Image of the Lug A6 exterior top and interior bottom welds which exhibited substantial fusion except for some undercut, arc strikes, and porosity.

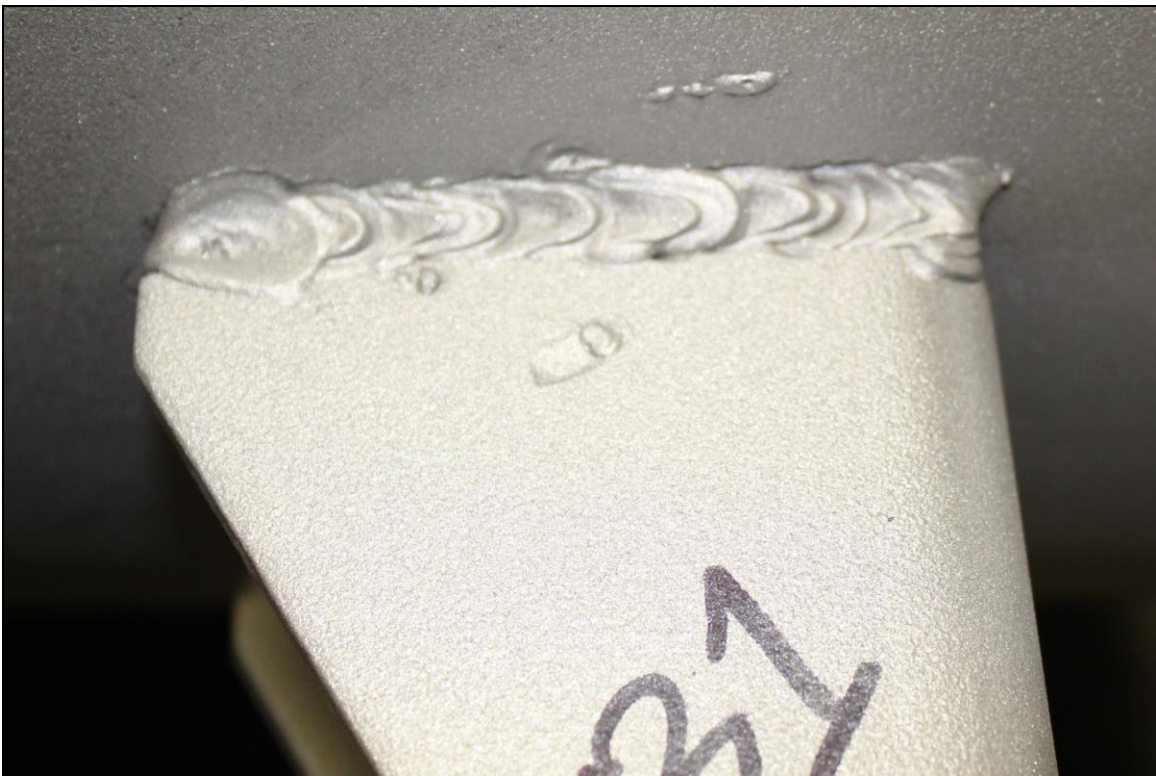
Figure 10. Image of the Lug B1 exterior top weld which exhibited substantial fusion except for arc strikes, undercut, and spatter.

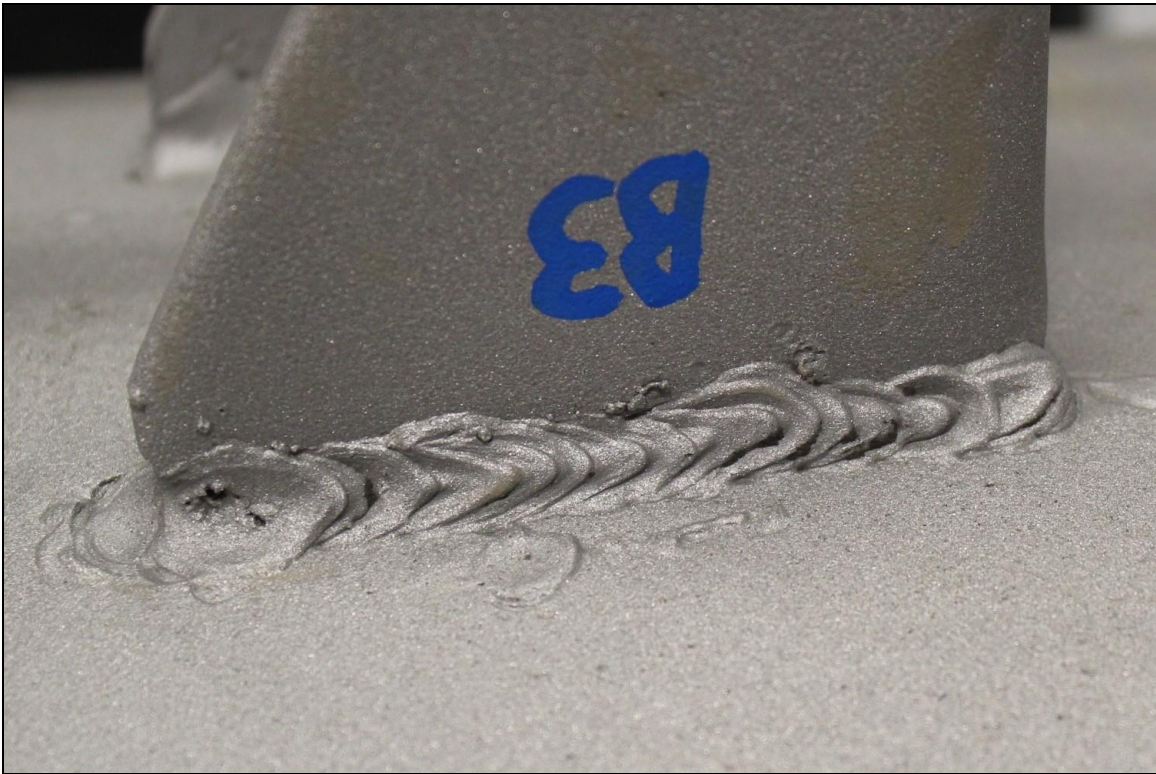
Figure 11. Image of the Lug B3 exterior bottom weld which exhibited substantial fusion except for arc strikes, porosity, and spatter.

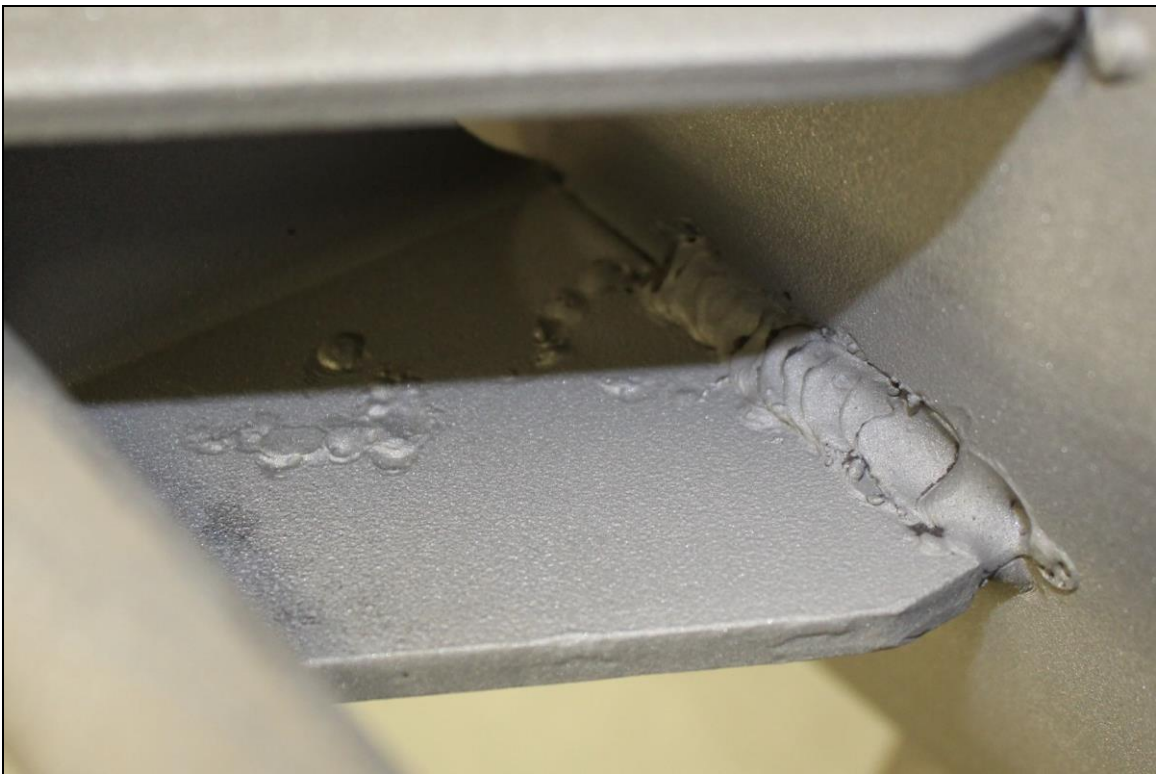
Figure 12. Image of the Lug B5 interior bottom weld which exhibited substantial fusion except for arc strikes, porosity, and spatter.

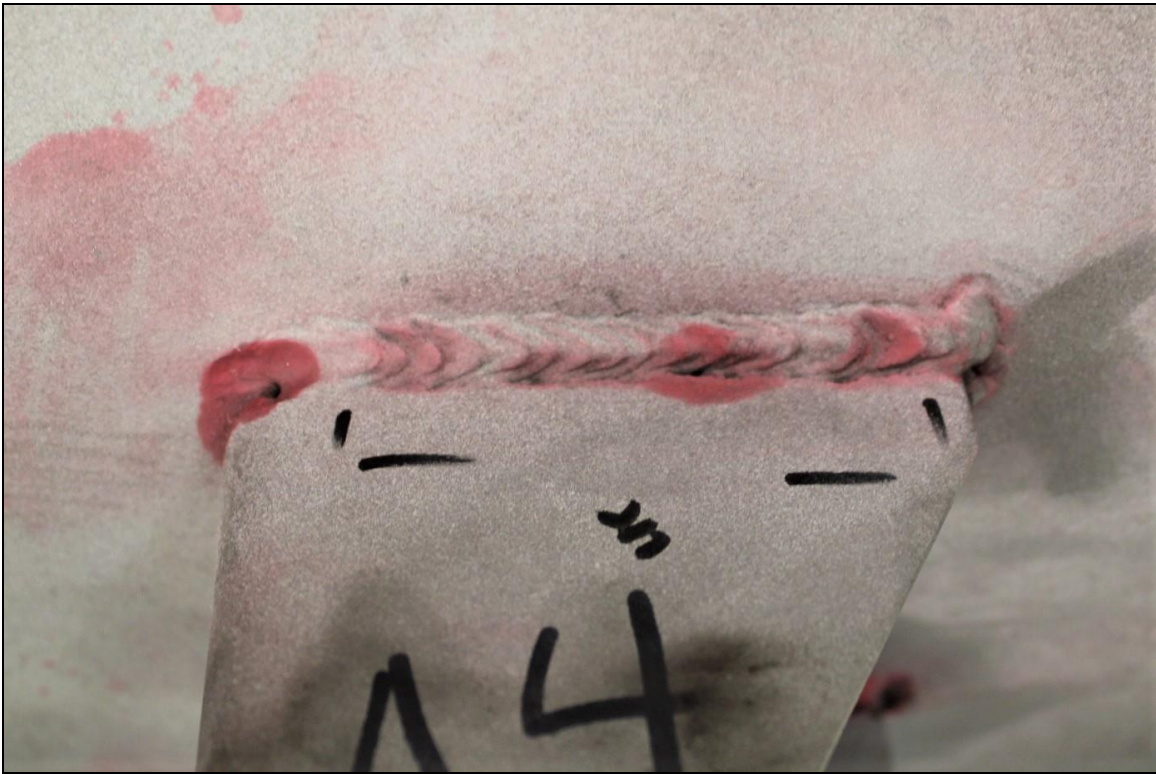
Figure 13. Image of the Lug A4 exterior top weld after dye penetrant media had been used during inspection.

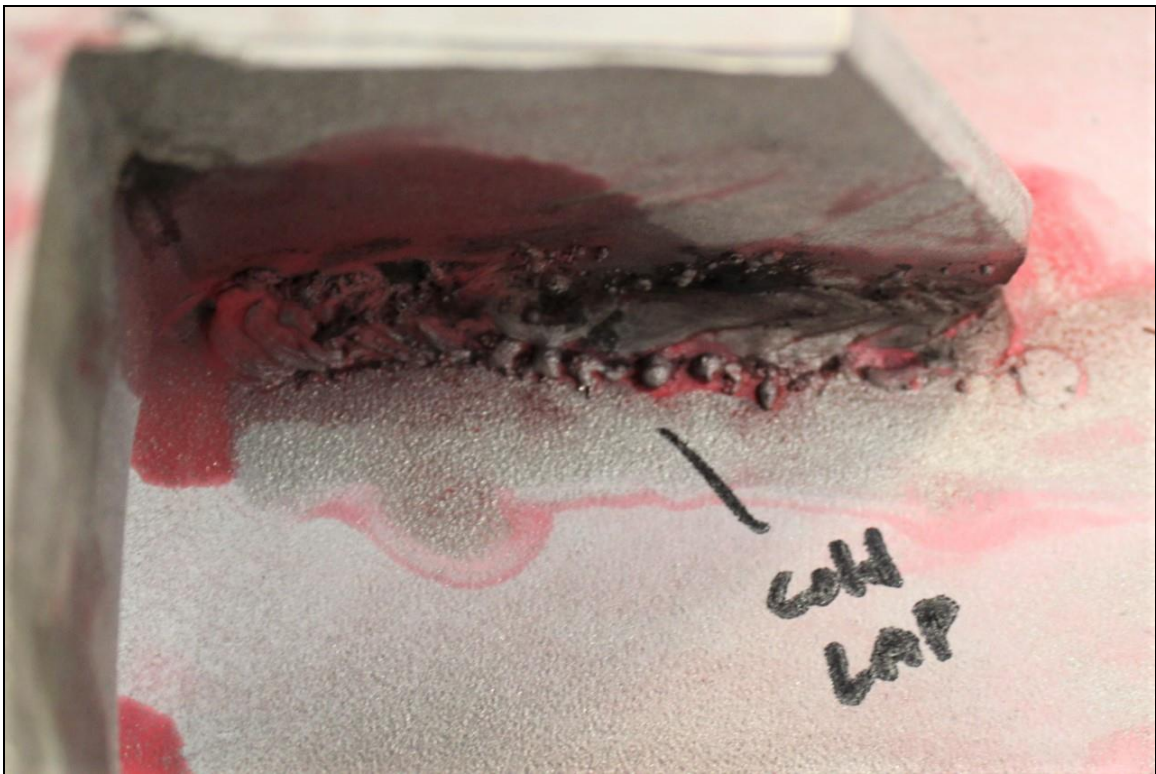
Figure 14. Image of the Lug B6 interior top weld after dye penetrant media had been used during inspection. A cold lap was identified.
