COMMONWEALTH OF KENTUCKY
BEFORE THE PUBLIC SERVICE COMMISSION

LARRY MORTON CONSTRUCTION)	
)	
_____)	CASE NO.
)	2023-00171
ALLEGED VIOLATION OF UNDERGROUND)	
FACILITY DAMAGE PREVENTION ACT)

INITIATING ORDER FOR ALLEGED 811 VIOLATION OF THE KENTUCKY
UNDERGROUND FACILITY DAMAGE PREVENTION ACT

PIPELINE DAMAGE INVESTIGATION REPORT

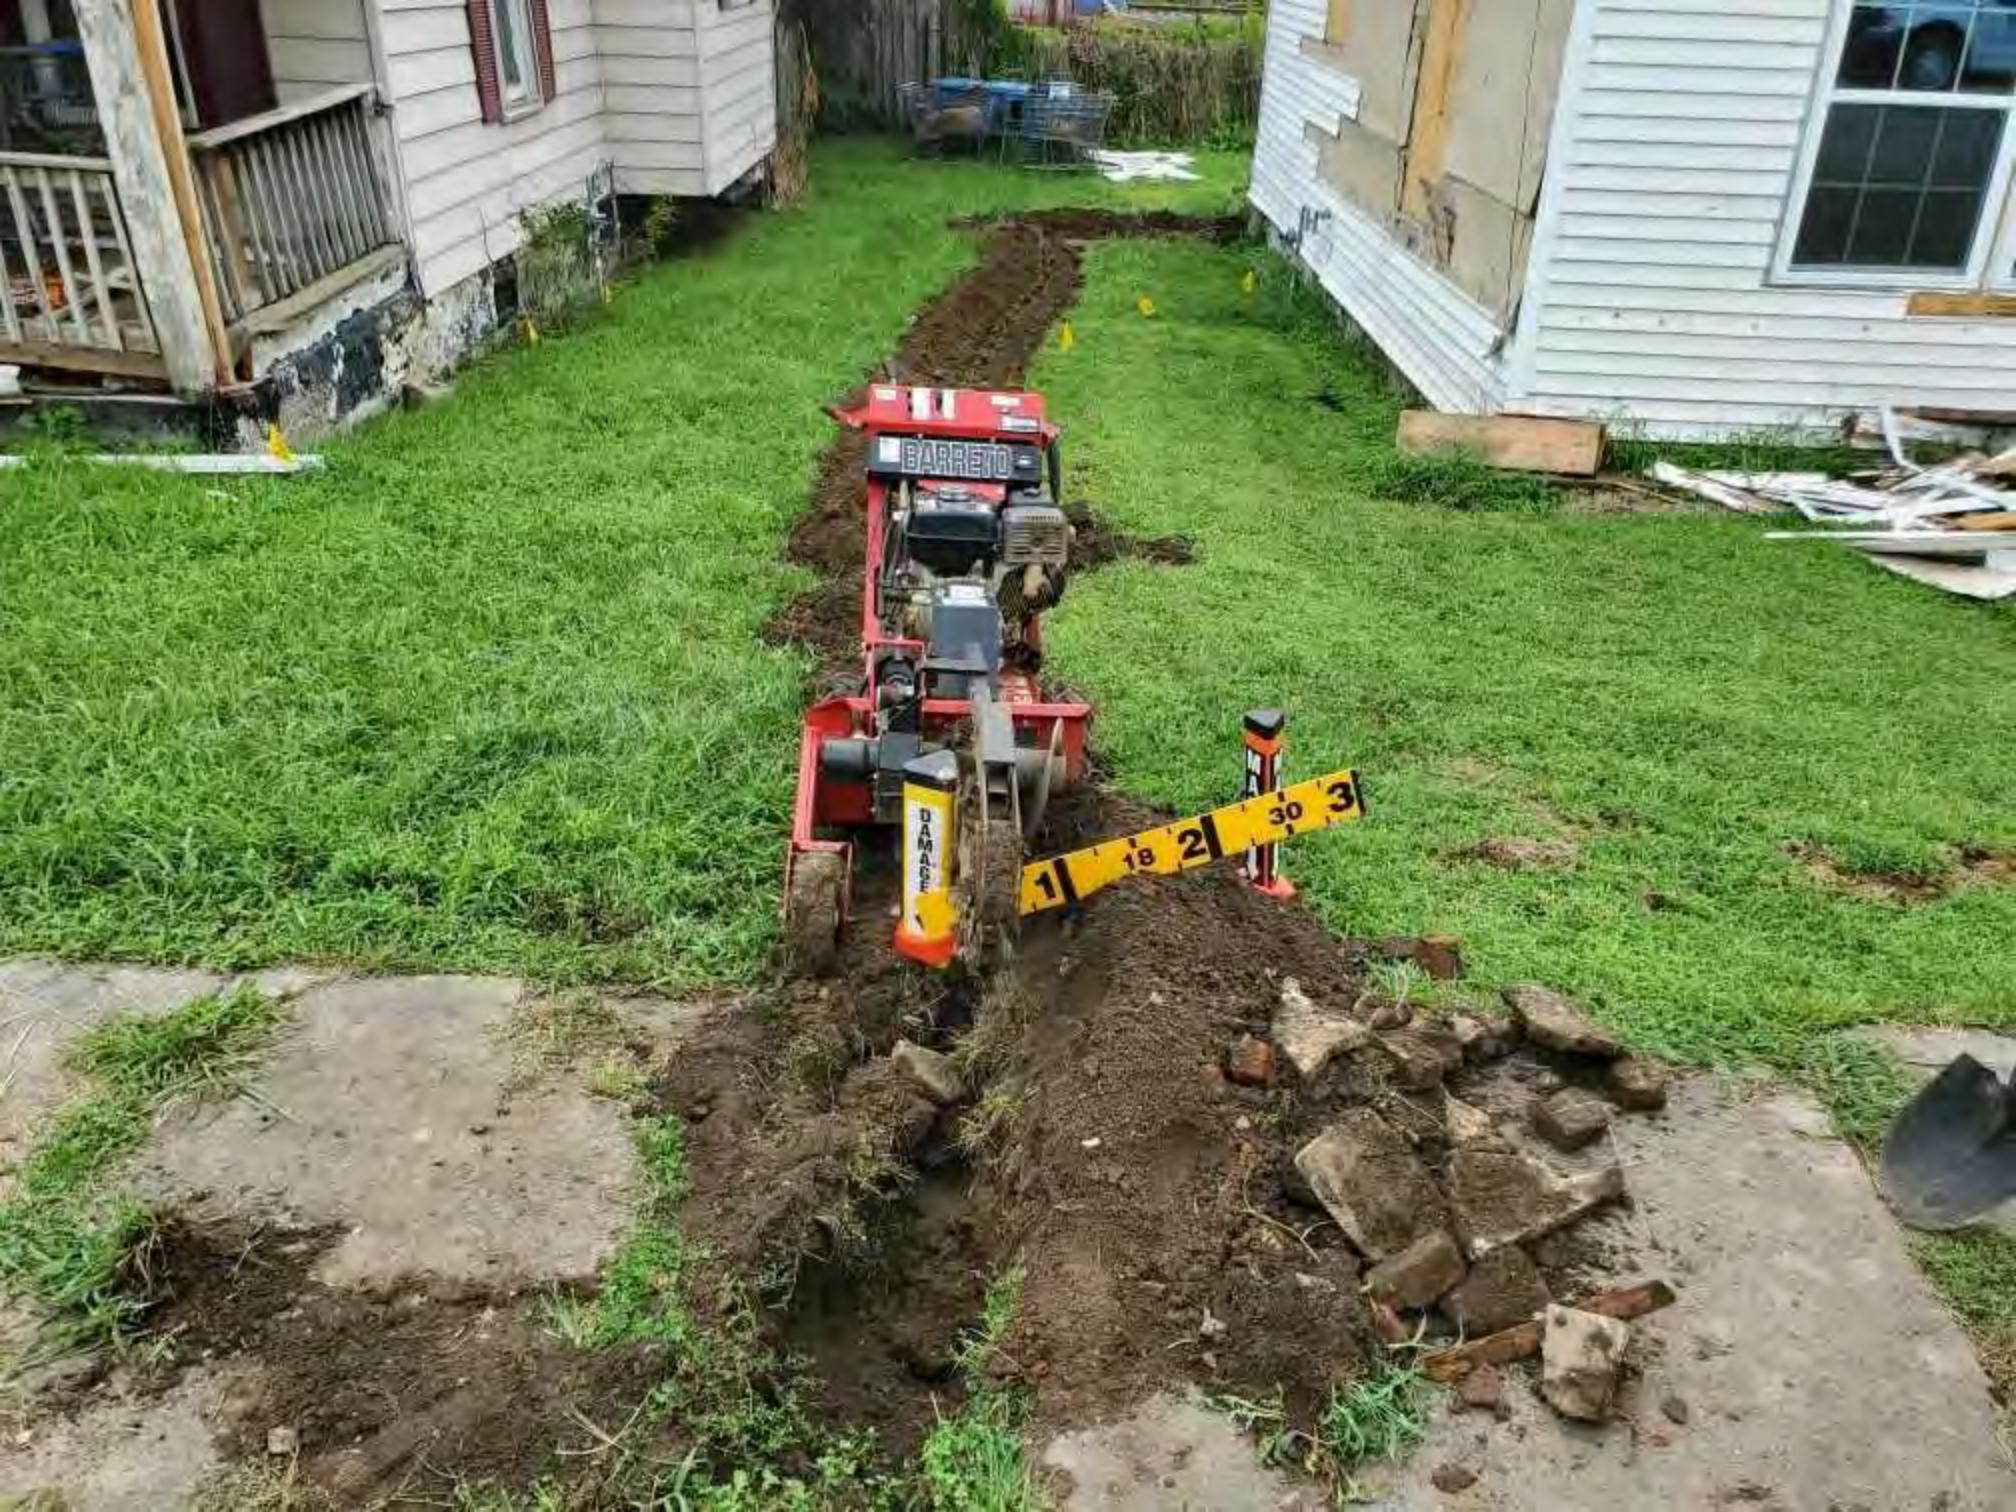
The Operator reports that the Excavator damaged a correctly marked ¾-inch gas service with a trencher installing a water service.

DAMAGE
