Case No. 2012-00362

The following documentation is being submitted by RussMar Logistics, LLC. on behalf of Tompkinsville Natural Gas System.

MARTIN CONTRACTING, INC.
LEAK SURVEY

Leak Survey Pt 1

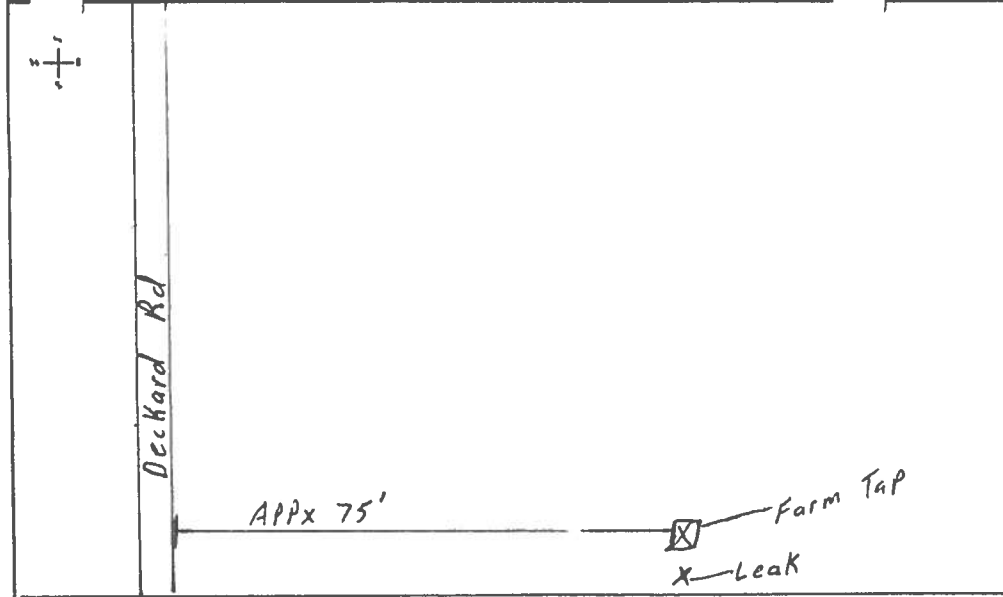
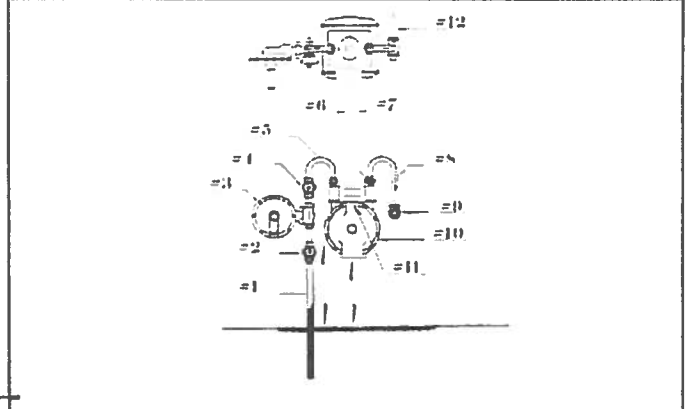
Address: Intersection of DeCard Rd + Hwy 63 | City/County: Tompkinsville / Monroe | State: KY

Leak detected in ground between tap + Hwy 63. Also leak on Compression fitting on inlet side.

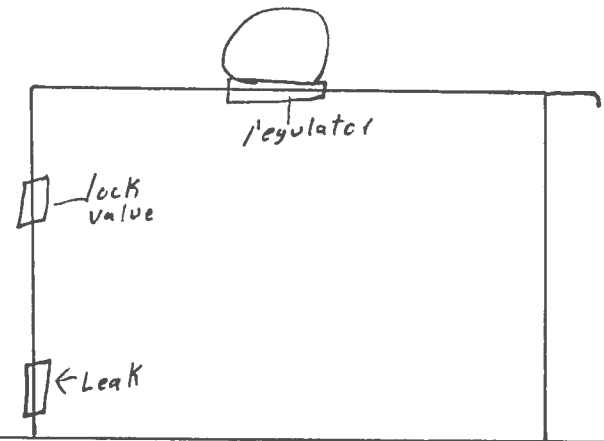
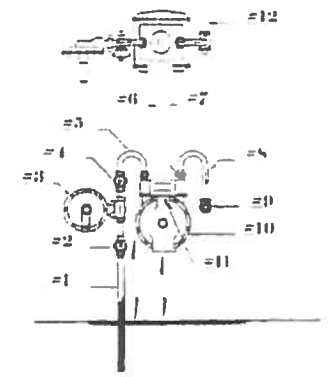
Address 913 Hwy 63 City/County Tompkinsville / Monroe State Ky

Outlet side of farm tap on repair clamp.

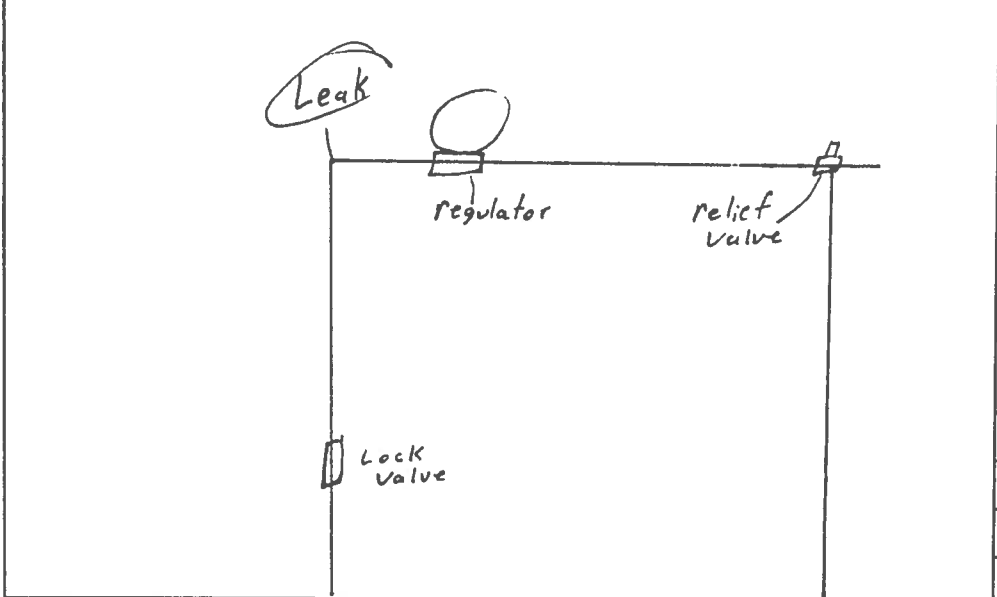
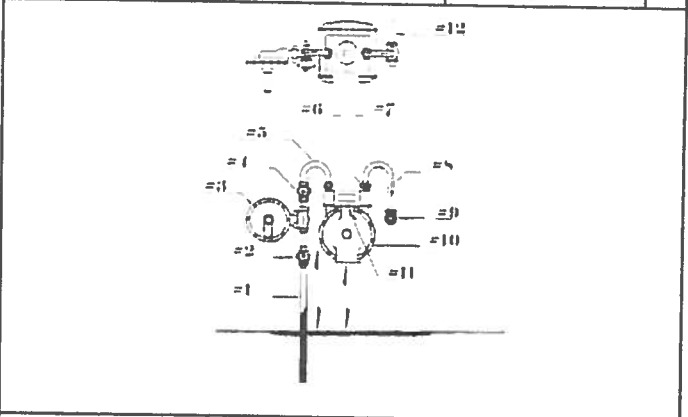
Leak on inlet side 1st 90°

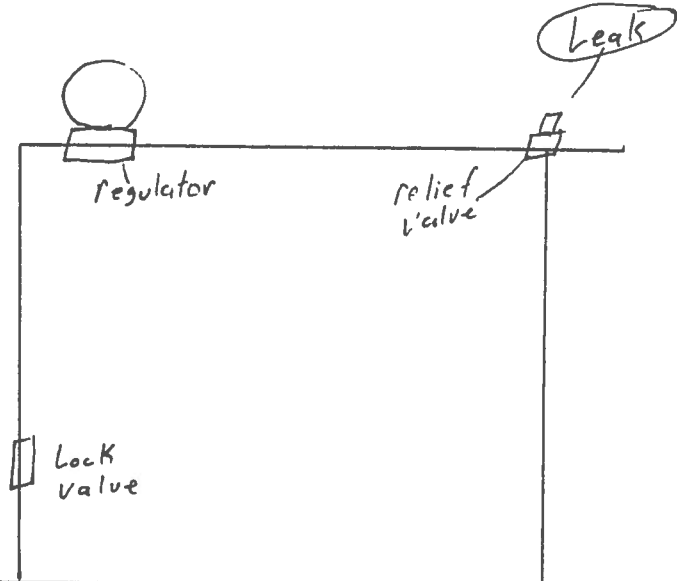
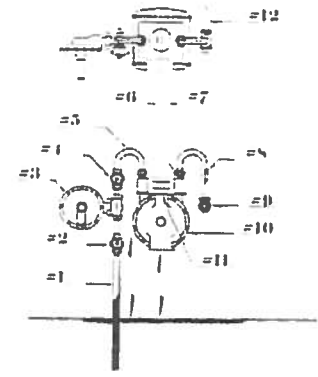
Leak on relief valve nut.

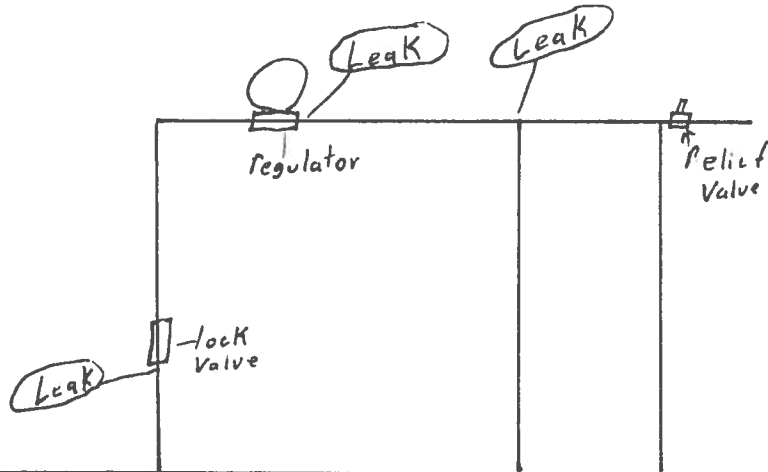
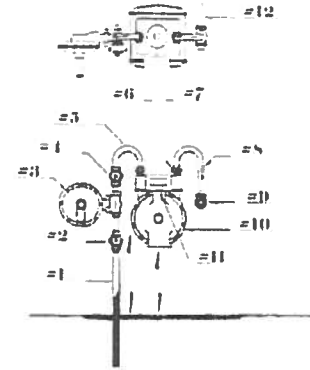
Leak on lock valve, outlet side of regulator, & on 1st tee.

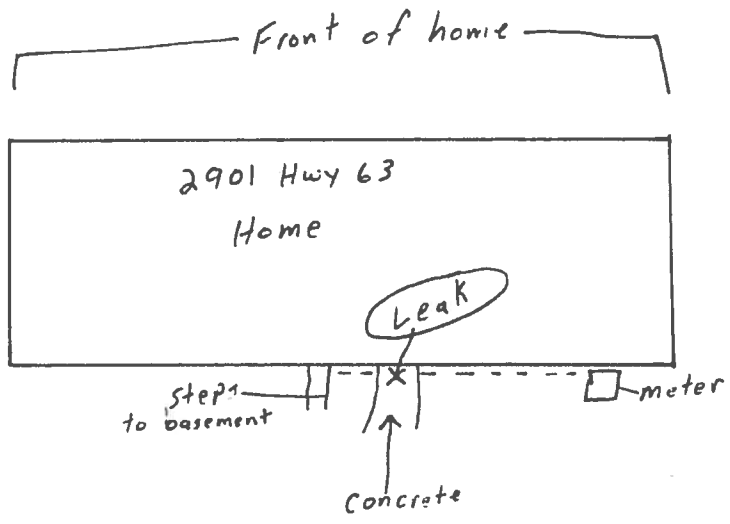
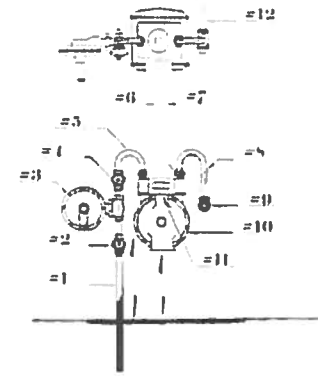
Leak detected in sleeve under concrete. Customer notified.

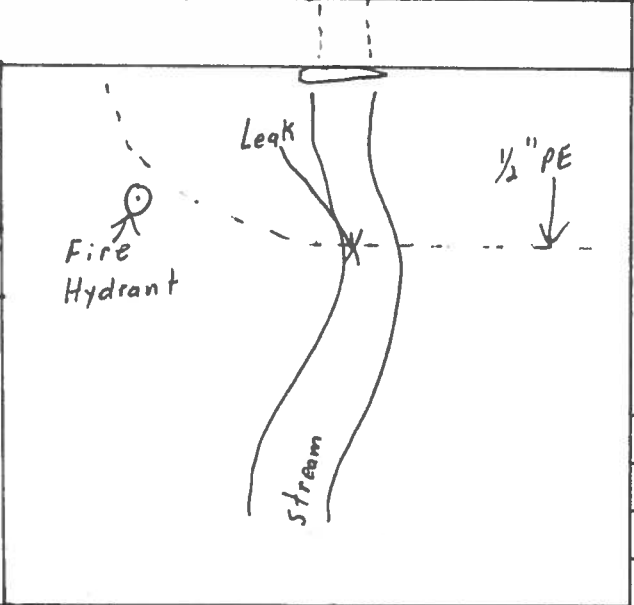
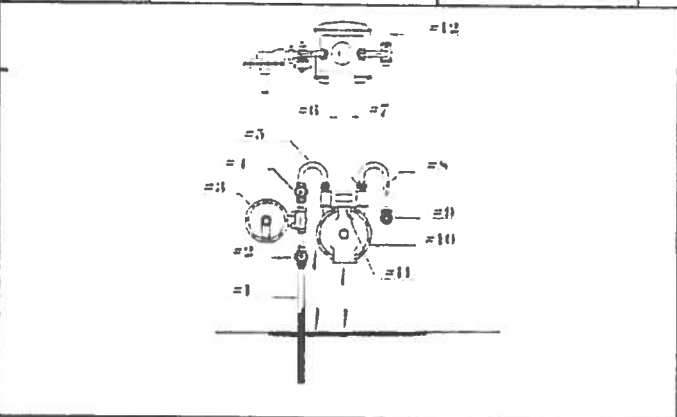
Address Intersection of Hwy 63 & Hwy 2452 City/County Monroe / Tompkinsville State KY

Compression leaking.

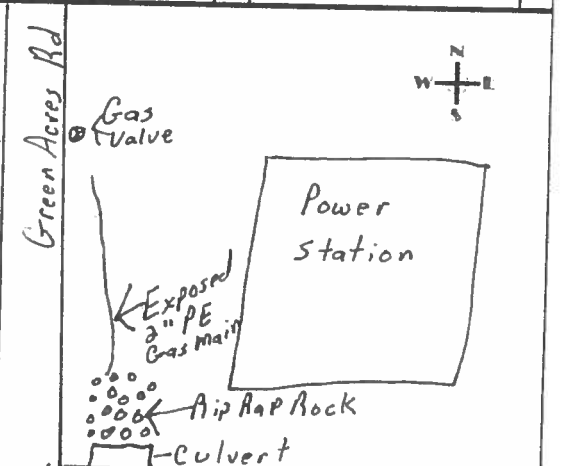
Description/Comments:
 Exposed 2" P.E. Gas Main on the right side of the road when you turn in off of Hwy 100 to Green Acres Road. Pipe is still in very good condition, just need to lower the line.

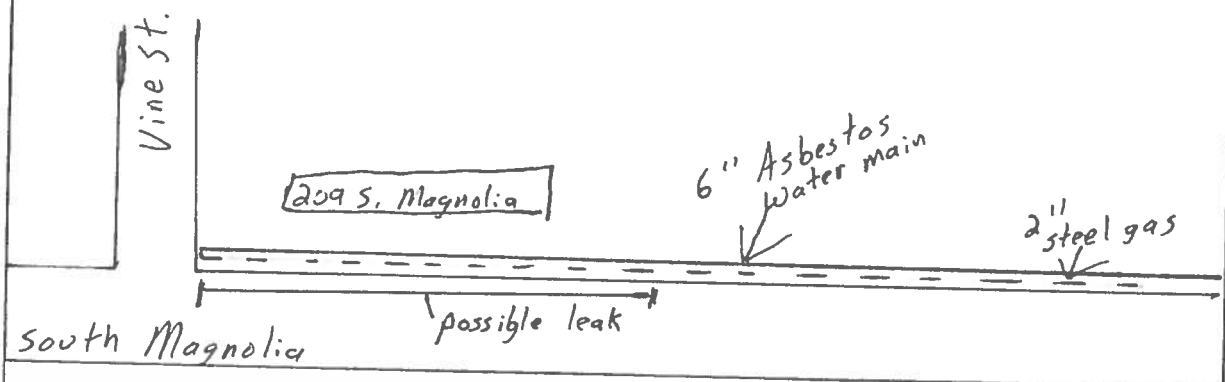
Description/Comments: We intended to complete a leak repair. When we dug it out, we discovered it was laying on solid rock & there were big rocks in their backfill material. We decided to replace this entire section of line in the very near future to stop all leaks present. Line replacement plan is for first thing next week, when we get all supplies in.

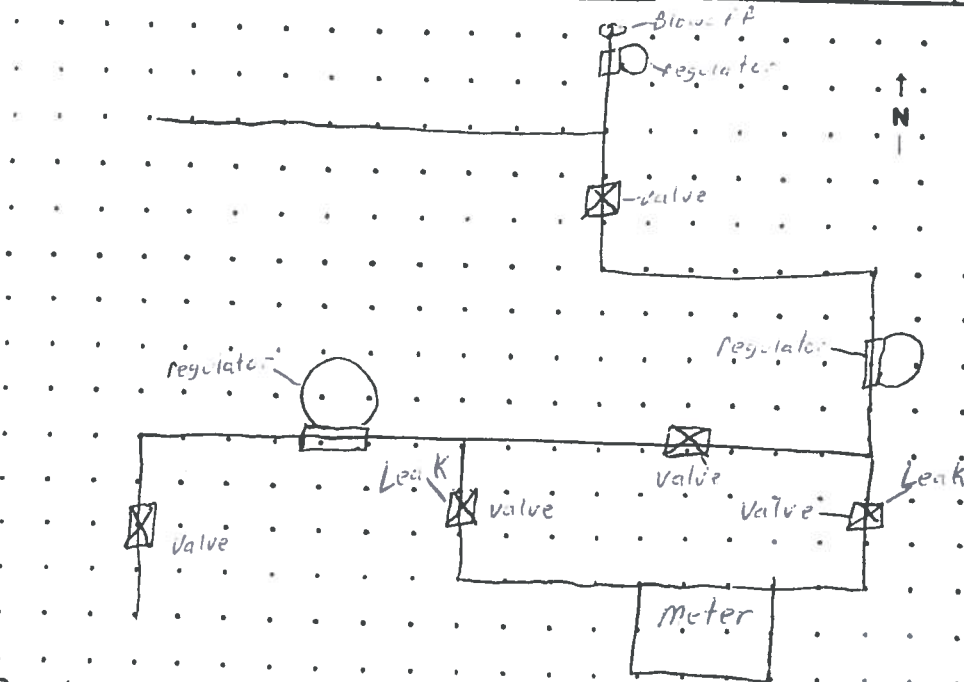
Remarks The leak here was on the inlet side of the meter on the 2" flange valve, as well as on the out let side of the meter on the 2" flange valve. We tightened the flange bolts & stopped the leak.

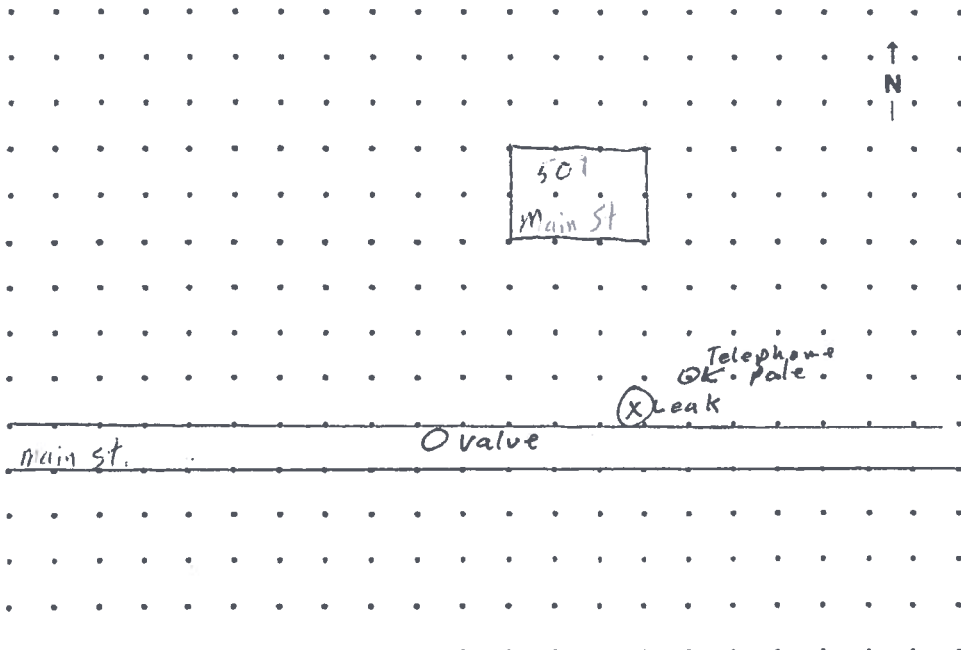
Remarks We repaired a valve that was leaking near the leak detected at this address. We have continued to monitor the area & have had no traces of gas since the valve repair. The gas had migrated down the line & surfaced in this area. We will continue to monitor the area.
 repaired-2-20-13

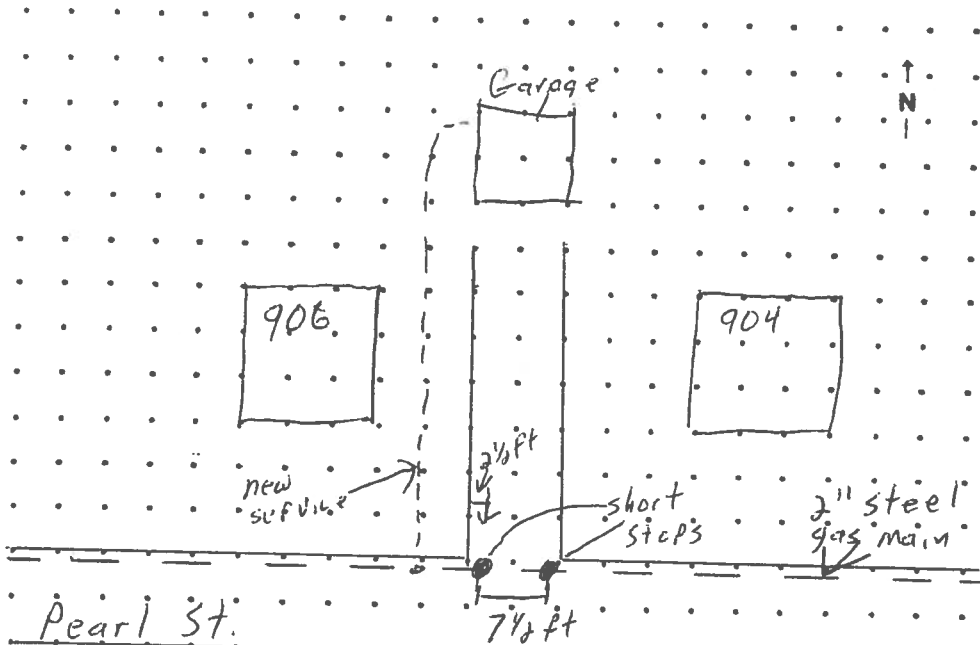
Remarks We detected a leak in the middle of the driveway of the home. We put on a new service above the old one. We then put on short steps to stop the gas flow & removed the bad section of line with the leaking tap. We then put in a new piece of 2" steel & restored the service.

Completed on - 6-6-13
