COMMONWEALTH OF KENTUCKY
BEFORE THE PUBLIC SERVICE COMMISSION

APPLICATION OF KENTUCKY UTILITIES)	CASE NO.
COMPANY FOR AN ADJUSTMENT OF)	2014-00371
ITS BASE RATES)

SUPPLEMENTAL RESPONSE OF
KENTUCKY UTILITIES COMPANY
TO
THE FIRST SET OF DATA REQUESTS OF
KENTUCKY INDUSTRIAL UTILITY CUSTOMERS, INC.
DATED JANUARY 8, 2015

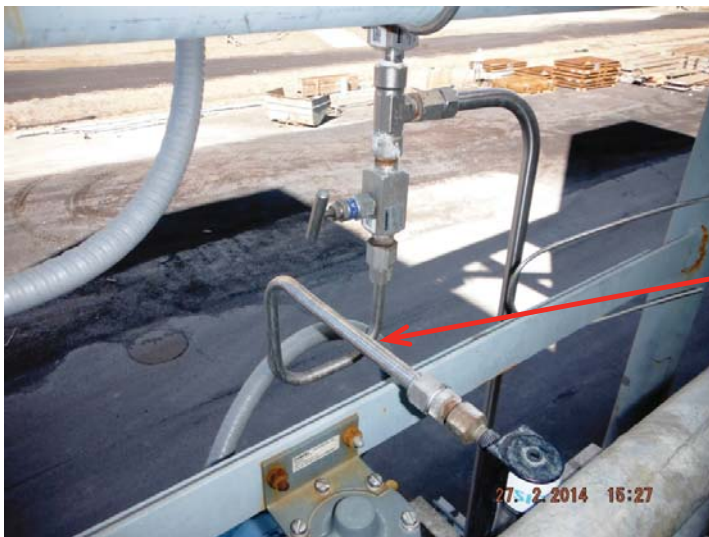
The purge air inlet pipe to the flow control unit runs between a lower header and the metal body of the flow control unit and by inspection is sufficiently flexible

Replace a 5" section of the flow control unit outlet pipe with flexible hose to remove thermal expansion

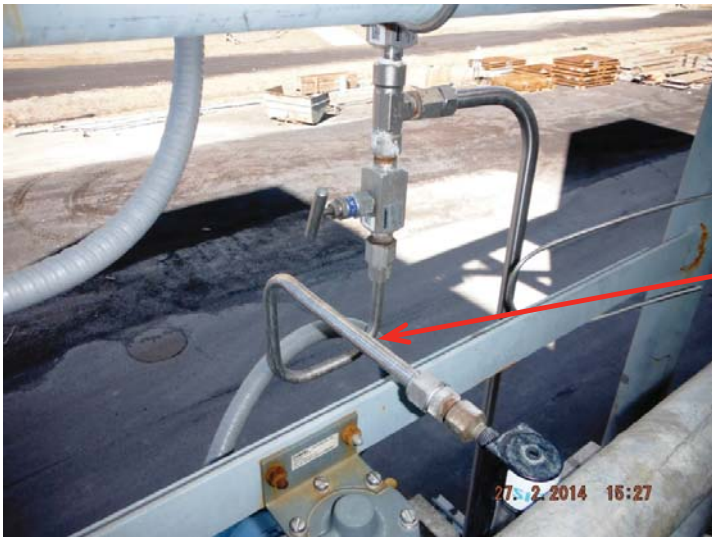
The purge air inlet pipe to the flow control unit runs between a lower header and the metal body of the flow control unit and by inspection is sufficiently flexible

Replace a 5" section of the flow control unit outlet pipe with flexible hose to remove thermal expansion

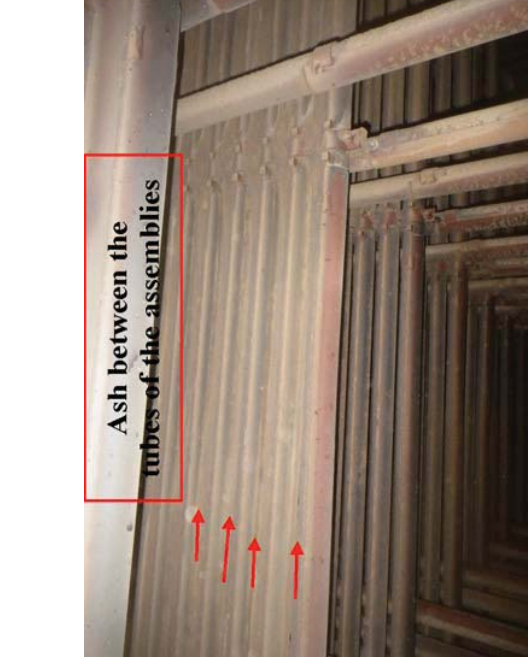
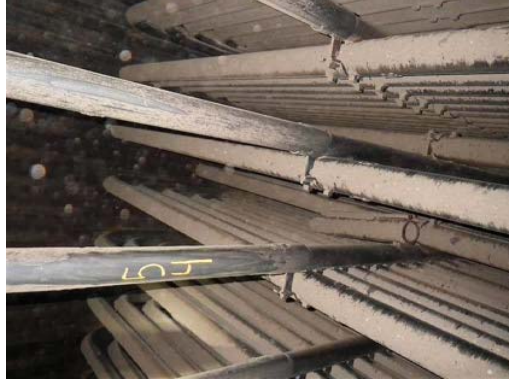
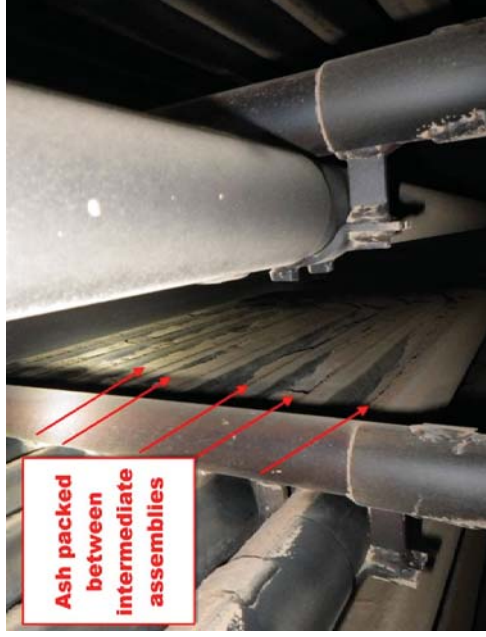
- Completed mid-way through outage to facilitate repairs.
- Most of backpass was not reinspected after waterwash.

Lack of initial wash limited access for a thorough inspection

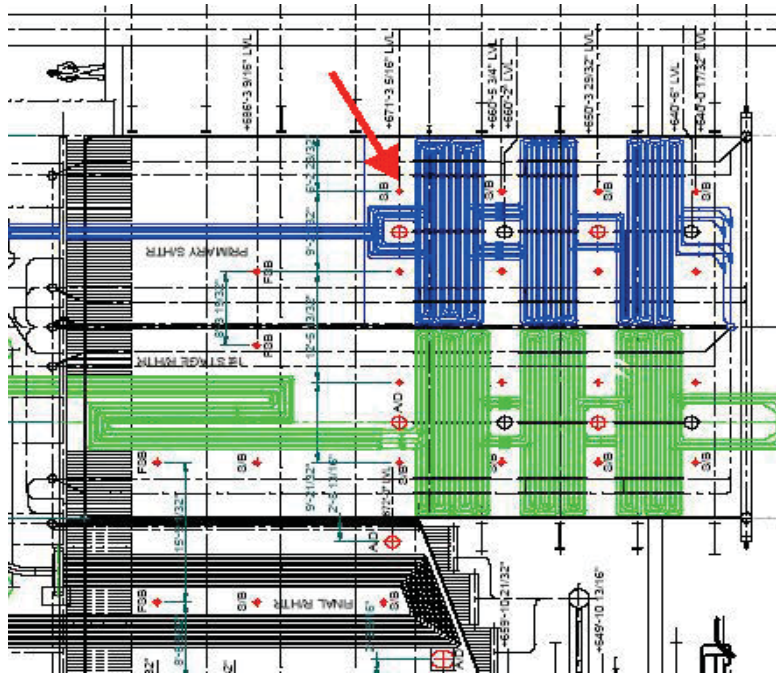
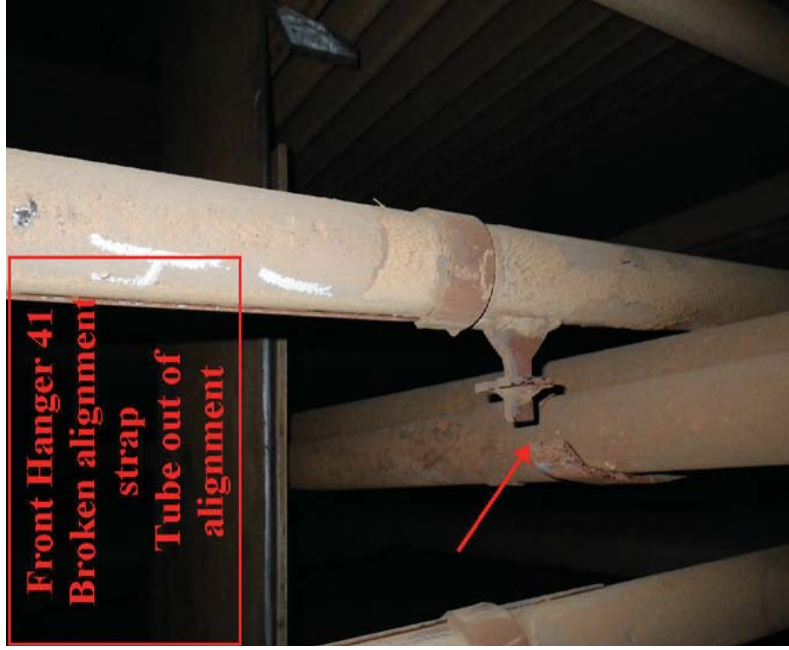
Top of Top Bank

34 out of 202 alignment straps were weld repaired

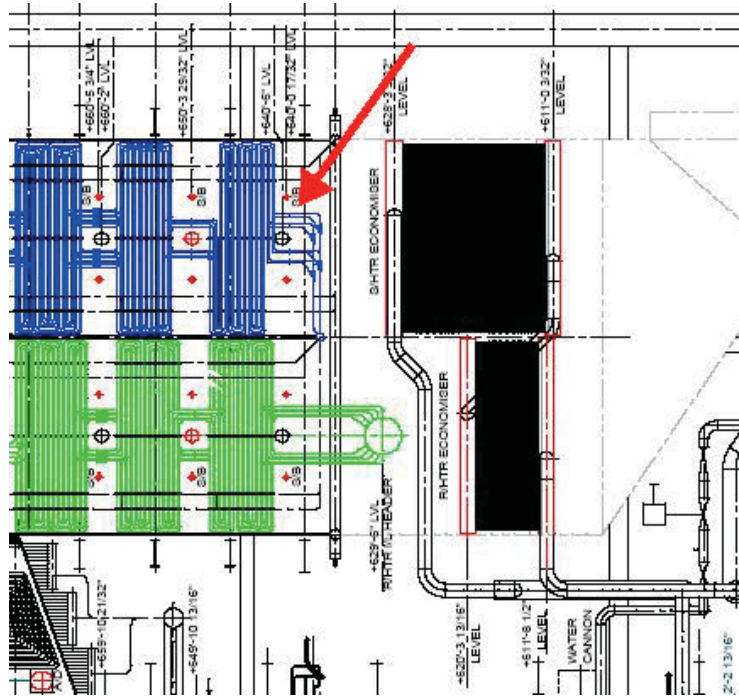
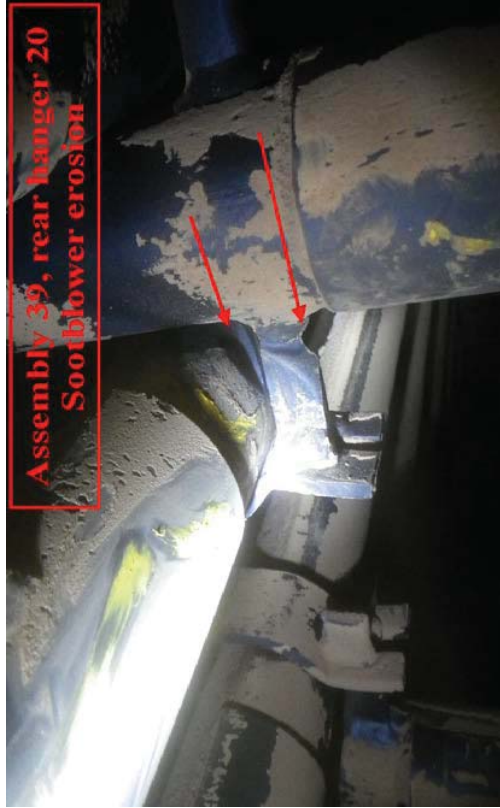
Bottom of Bottom Bank

- 64 of 101 sling (hanger) tubes noted for moderate erosion at the support brackets.
- 53 tubes were shielded and the brackets were weld repaired.

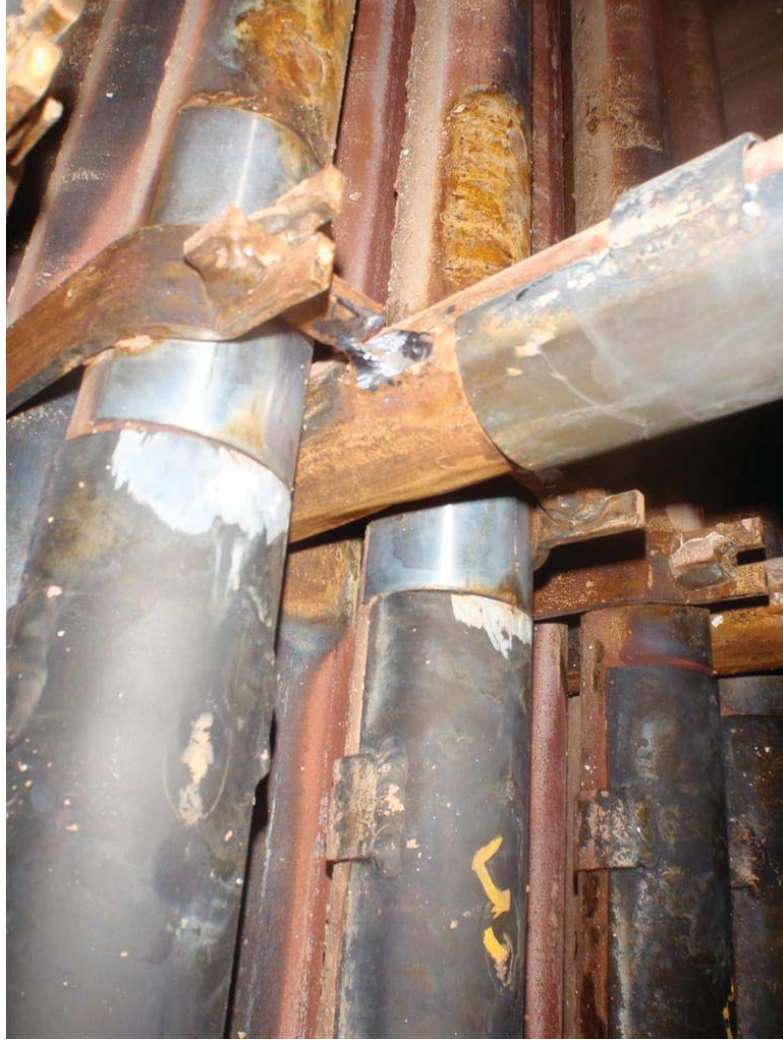
Bottom of Bottom Bank

Typical Repair with 6" additional tube shield. Plan to do balance in 2016

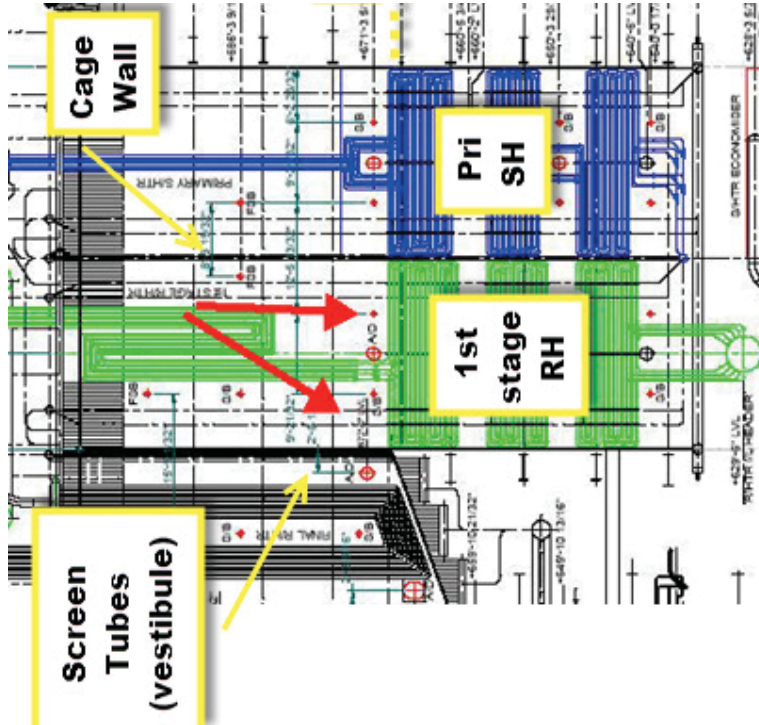
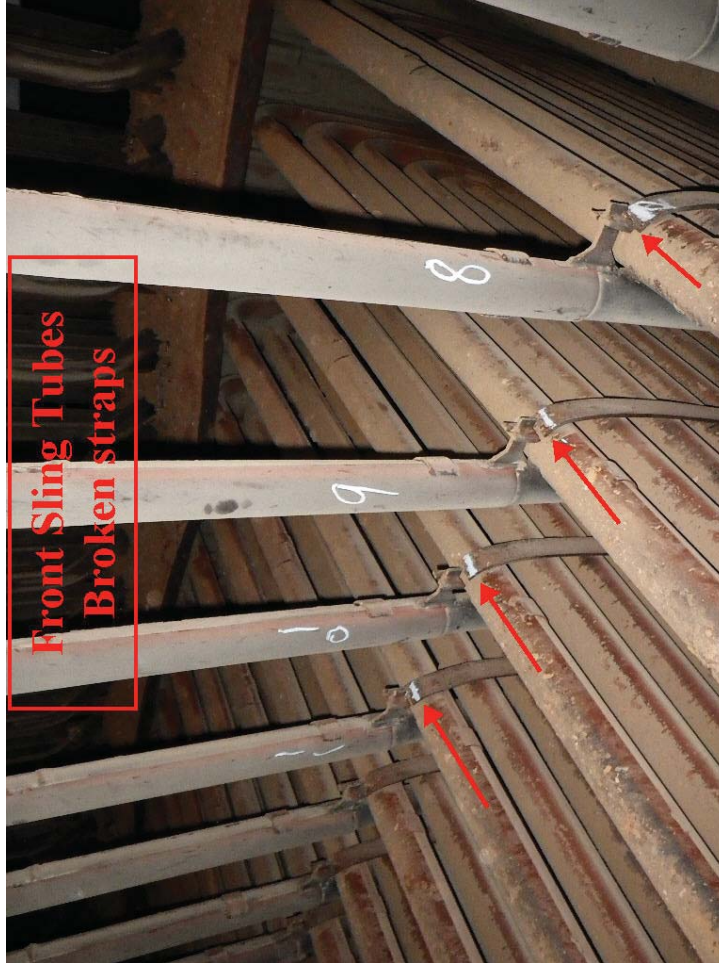
Top of Top Bank

141 out of 202 alignment straps were weld repaired

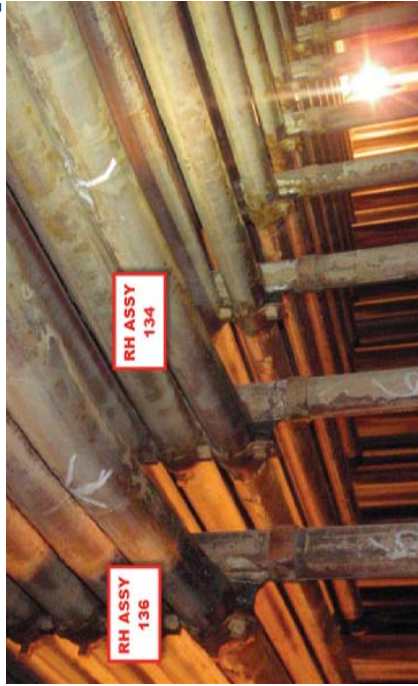
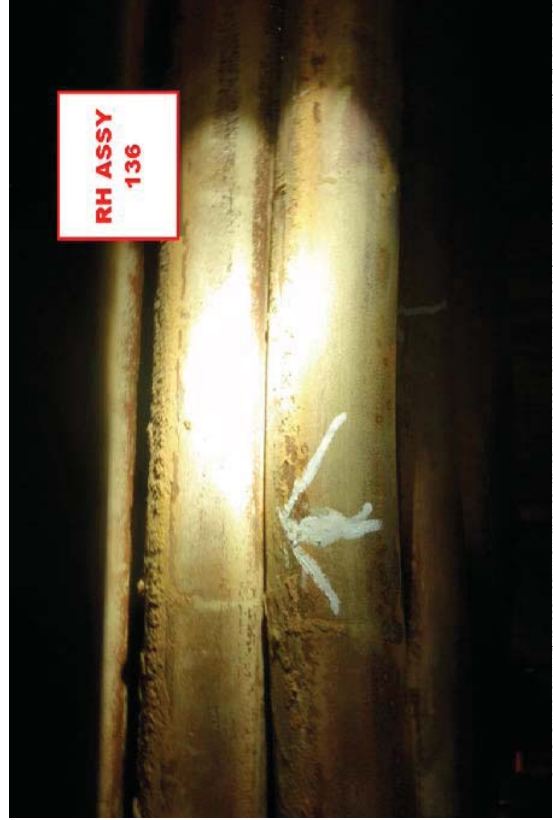
- Seven 3' dutchmen installed at the bottom of the top bank assembly due to disfigured circuits possibly caused during original erection

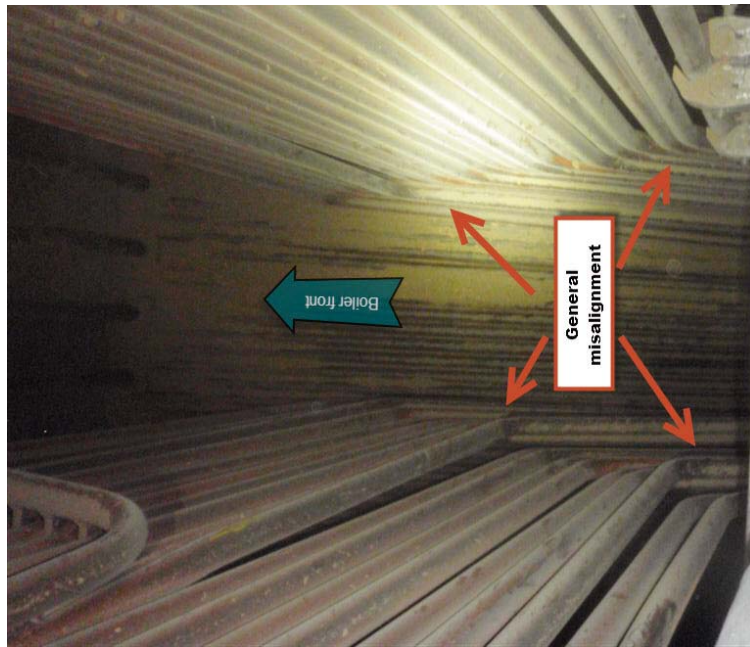
- Worsening general misalignment as noted in 2012

Consider installing additional alignment devices

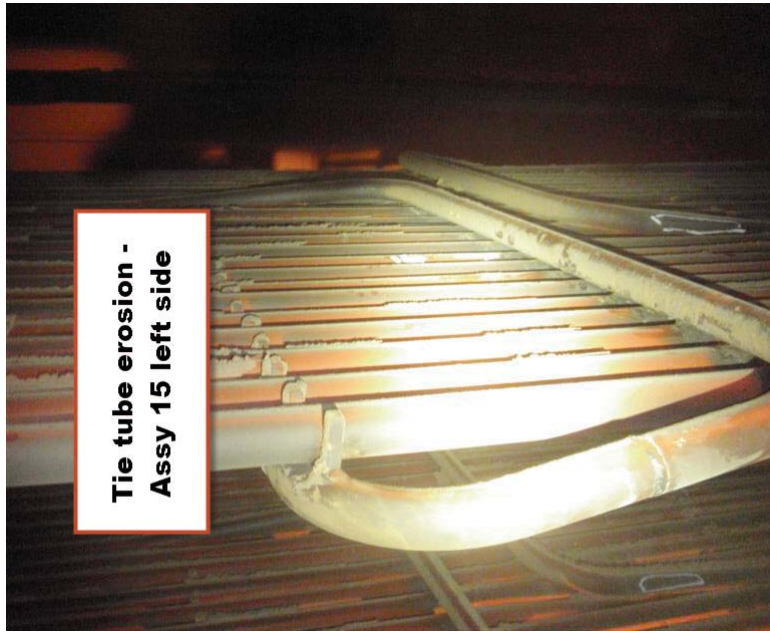
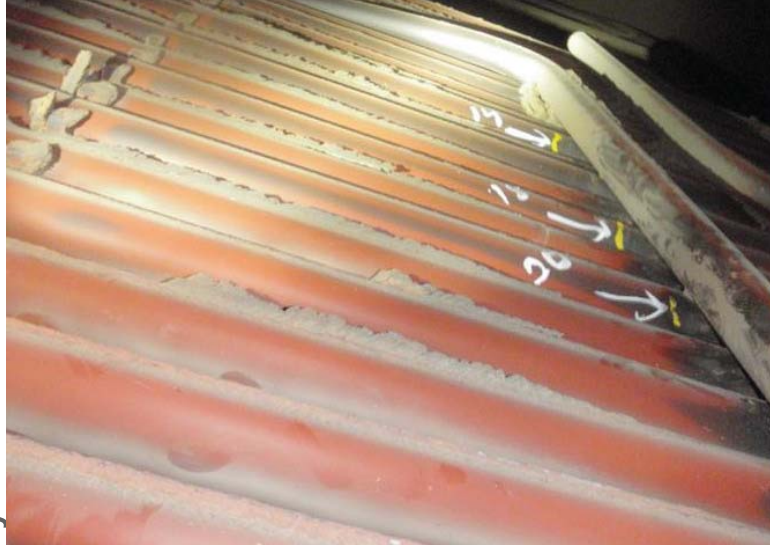
- Found at lower wrap-around tube (paperclip) IK -37/38 lane
- Limited access to front of assembly

Build scaffold for more thorough inspection 2015 outage

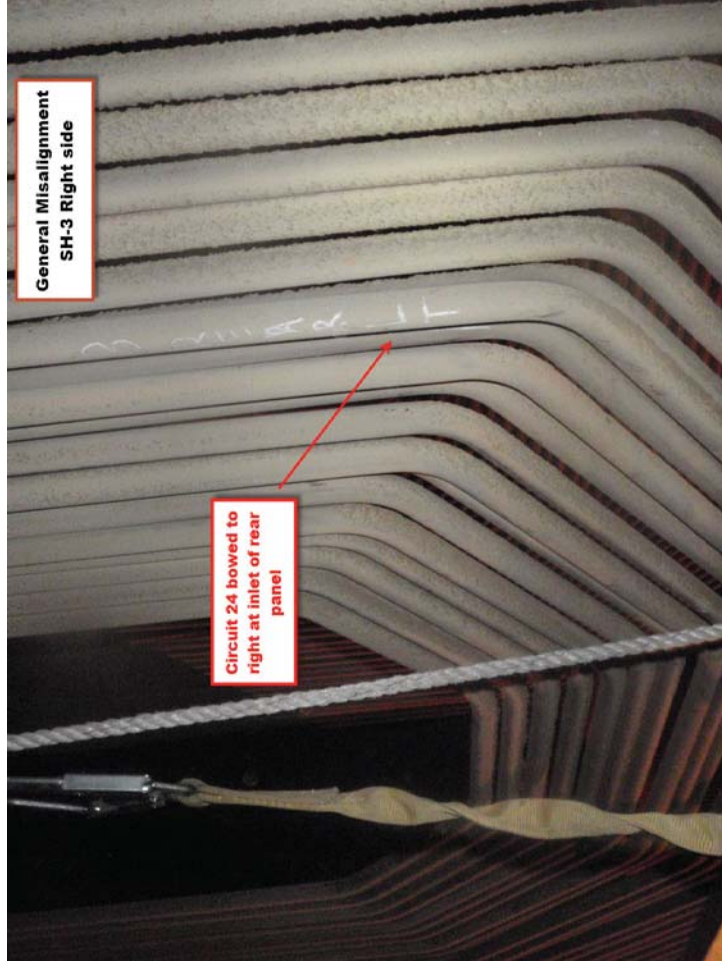
General Misalignment within Assemblies

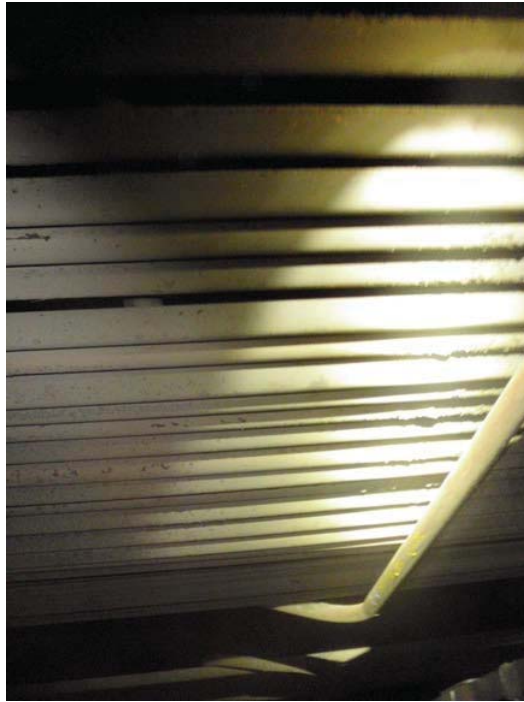
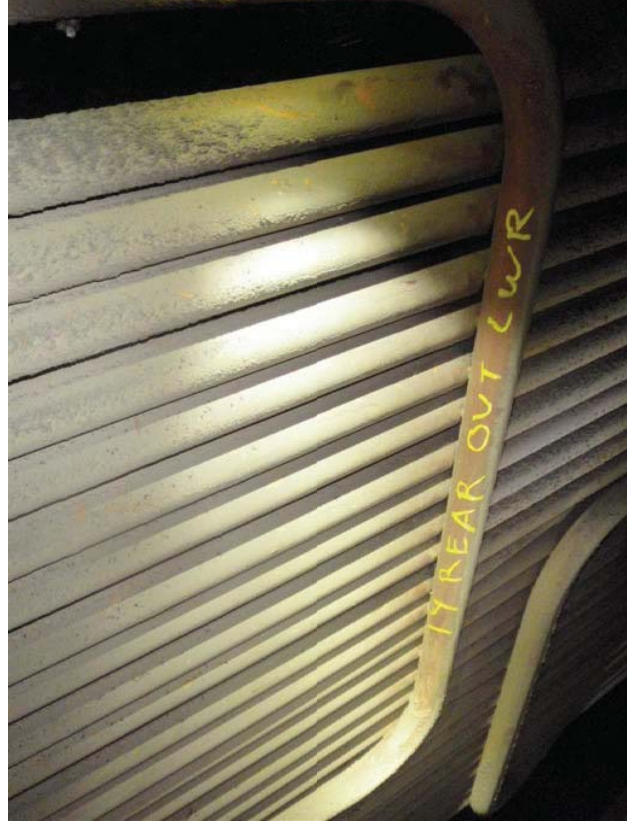
- Rear Inlet – loose circuits up to 2.5” away from tie tube
- Rear Outlet - Circuits in plane and snug to tie tube

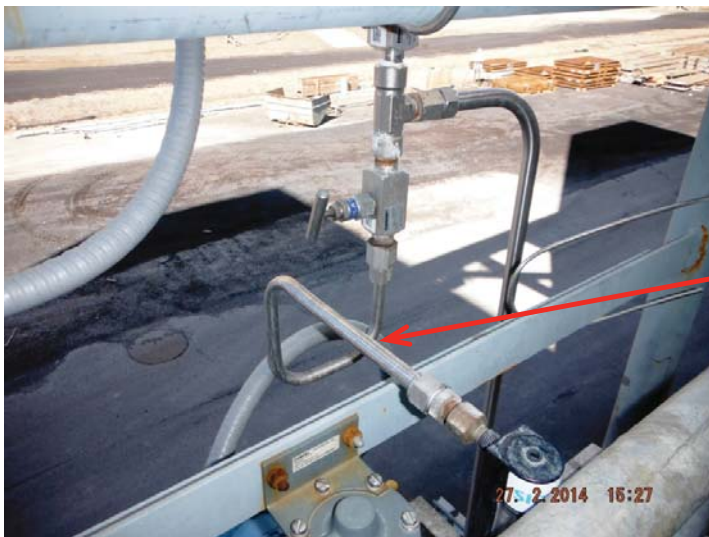
The purge air inlet pipe to the flow control unit runs between a lower header and the metal body of the flow control unit and by inspection is sufficiently flexible

Replace a 5" section of the flow control unit outlet pipe with flexible hose to remove thermal expansion

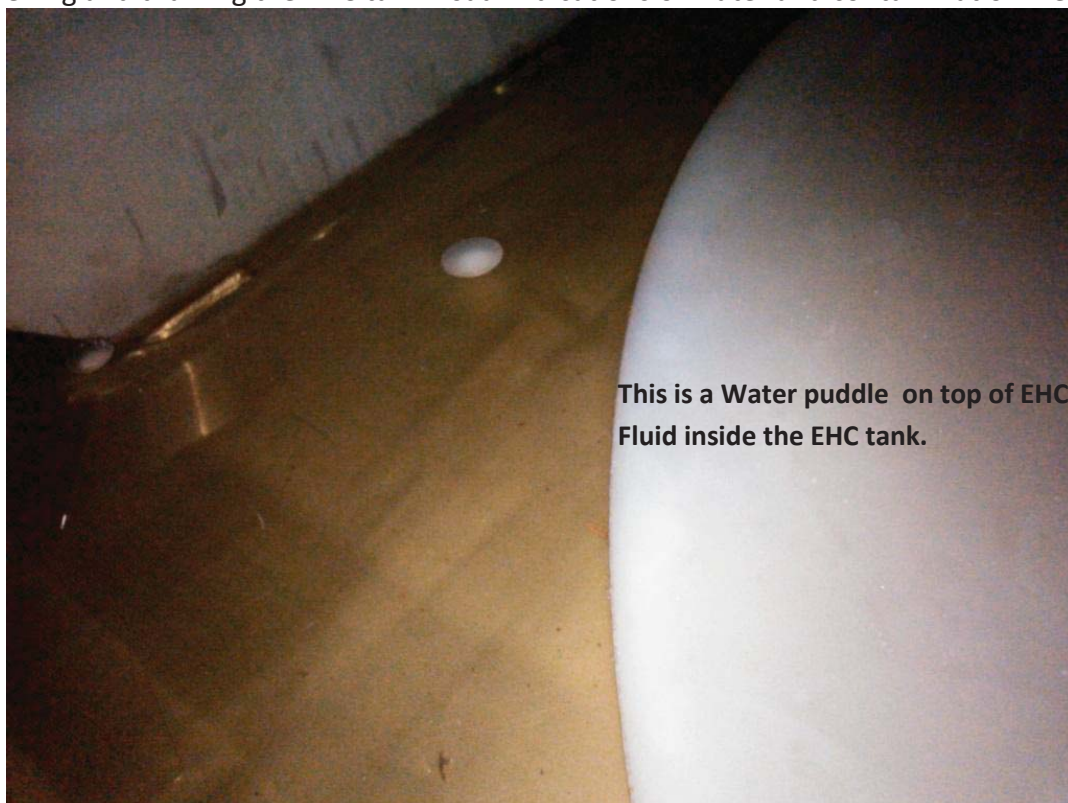
Upon opening and draining the EHC tank visual indications of water and contamination were found.

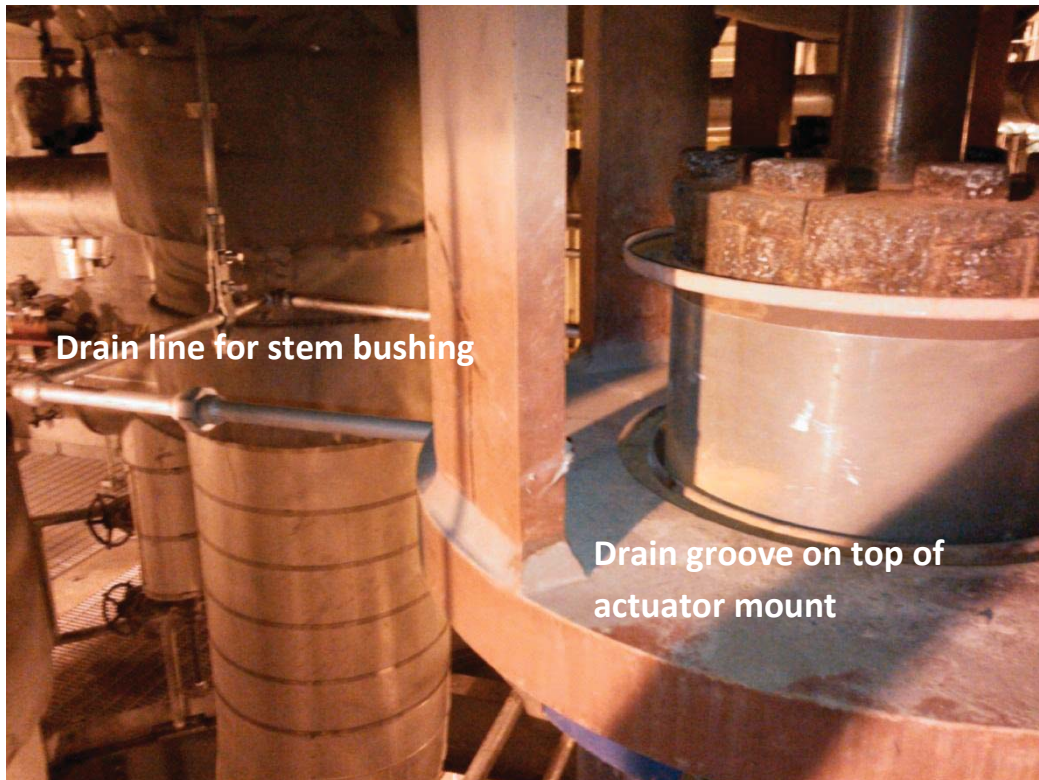
A source of water into the EHC system could be during start up when the Main Stop and Re-Heat Stop Valve stems are not back seated. These drain line from the stem bushings below the valves should be ensured free of obstructions to prevent water from backing up on top of the actuators. Observe this and ensure lines are clear and no stand water is on top of these actuators during the next start up.
