STREAM AND WETLAND DELINEATION

Mantle Rock Solar LLC

Livingston County, Kentucky

Wetland and Stream Delineation Report for the Proposed Mantle Rock Solar Project in Livingston County, Kentucky

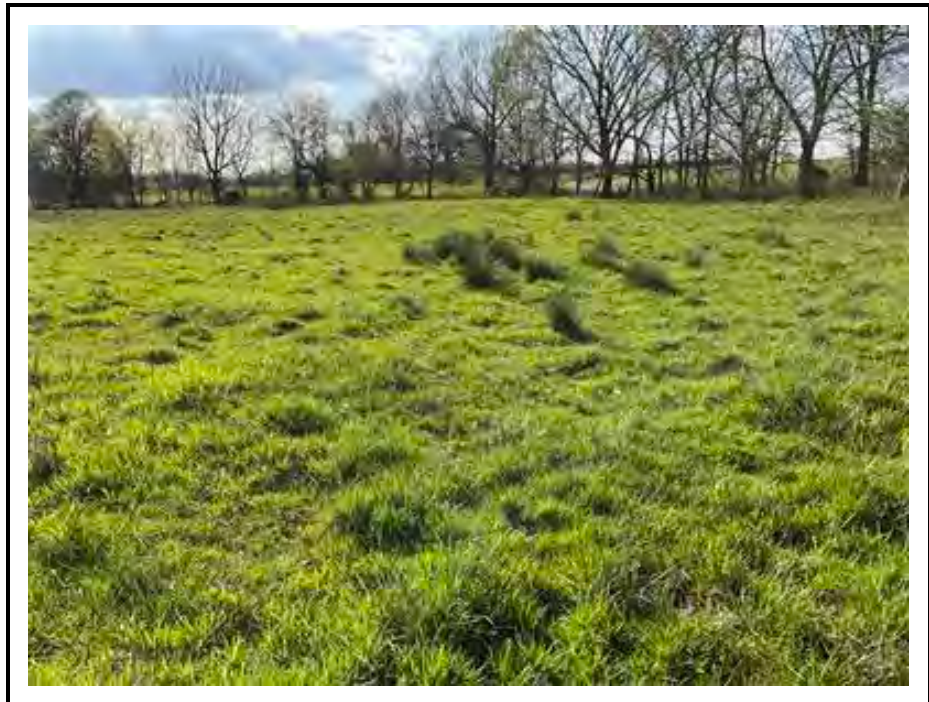
3.

View of PEM wetland
WAB.

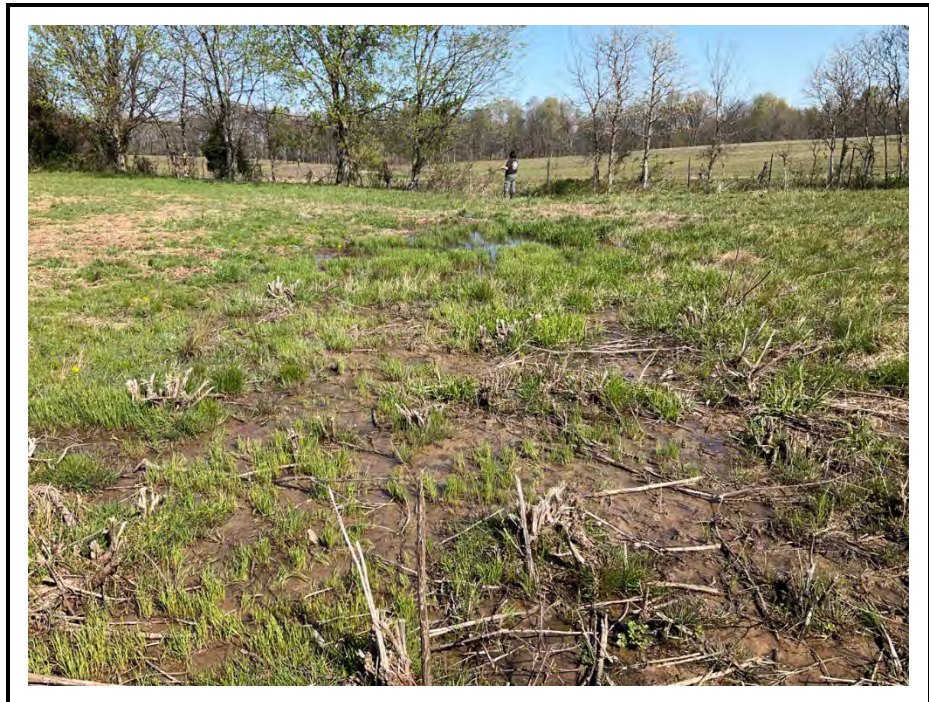
5.

View of PEM wetland
WAD.

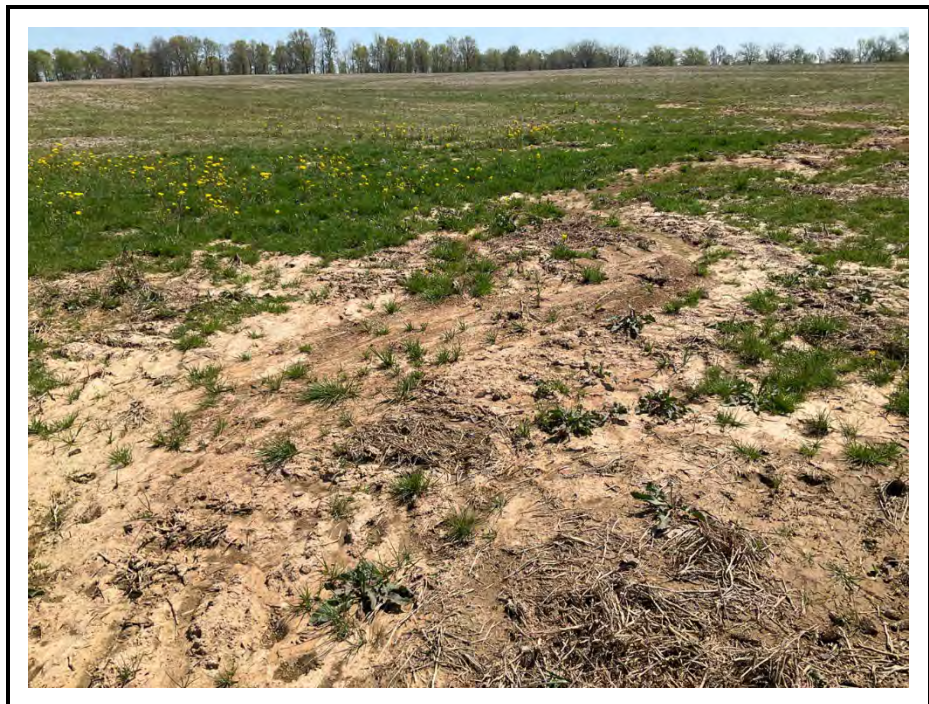
7.

View of PEM wetland
WAF.

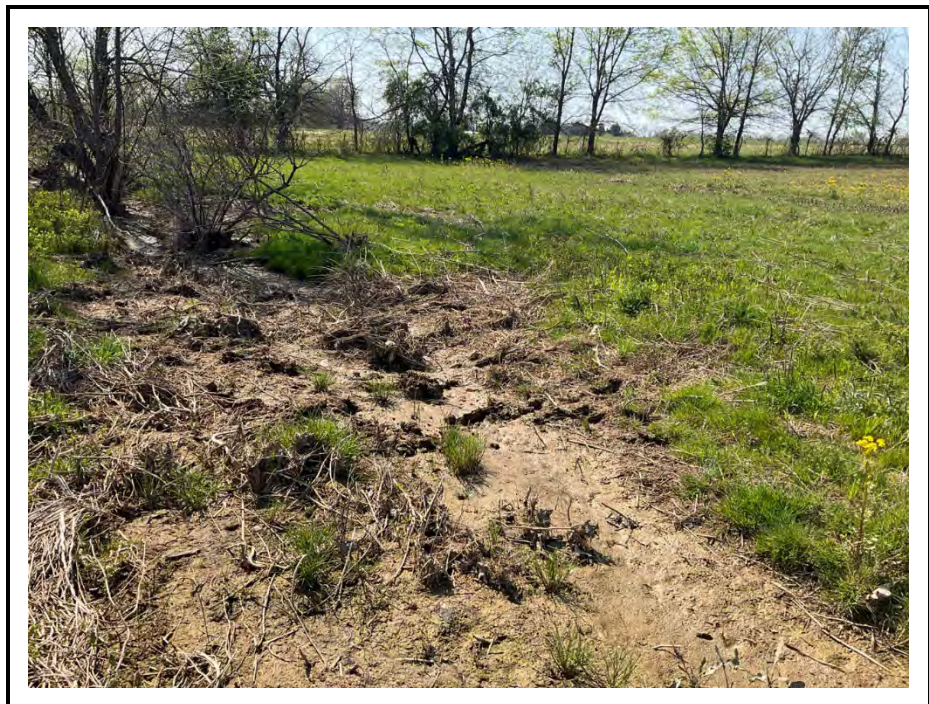
9.

View of wetland WAG.

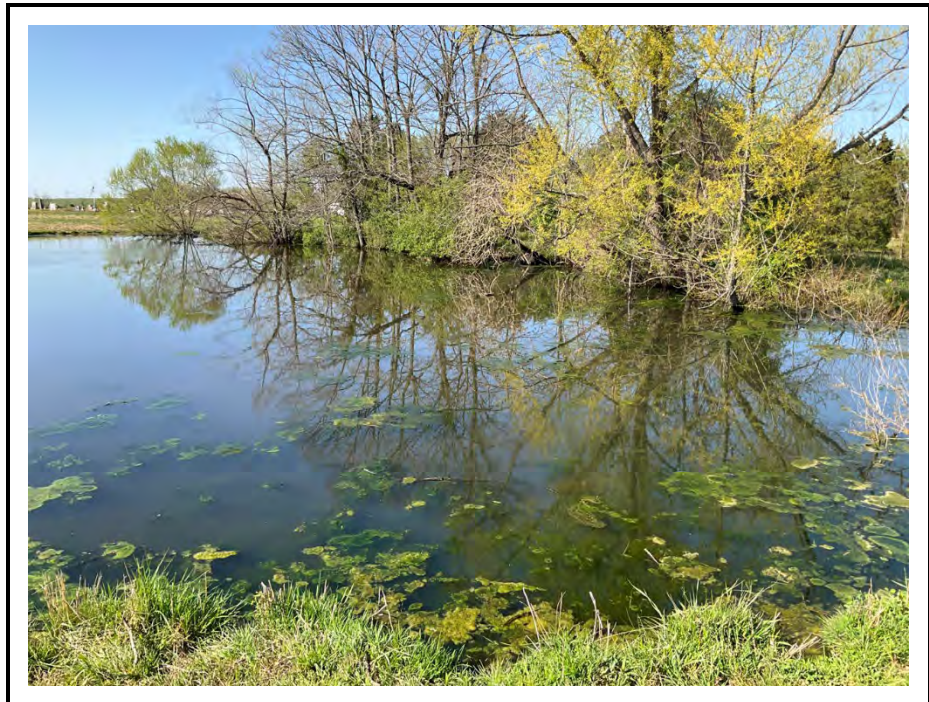
19.

View of PUB wetland
WBE.

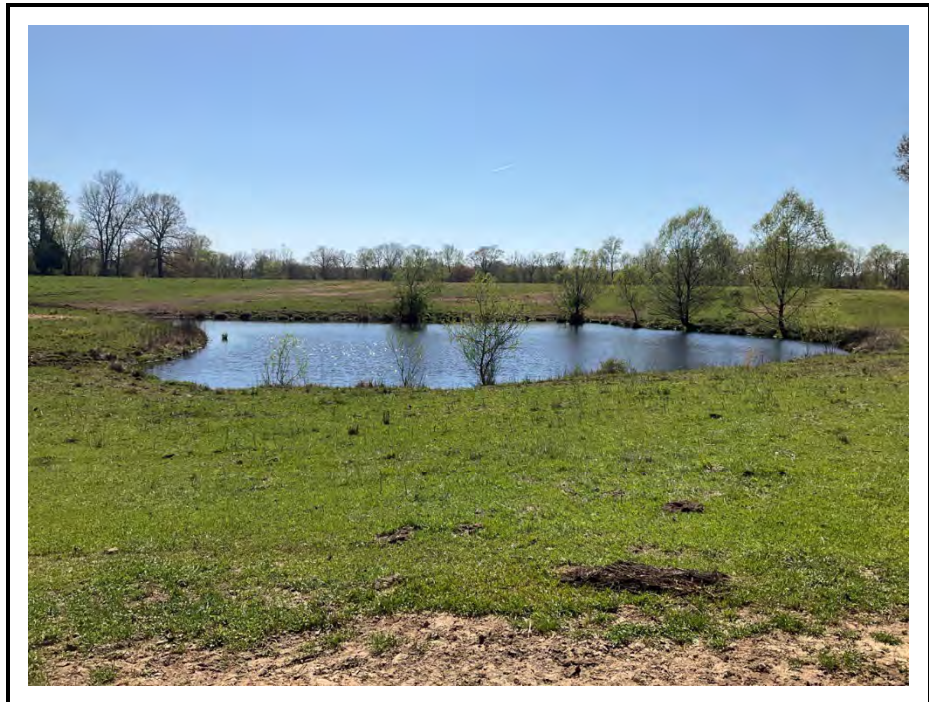
33.

View of PUB wetland
WCG.

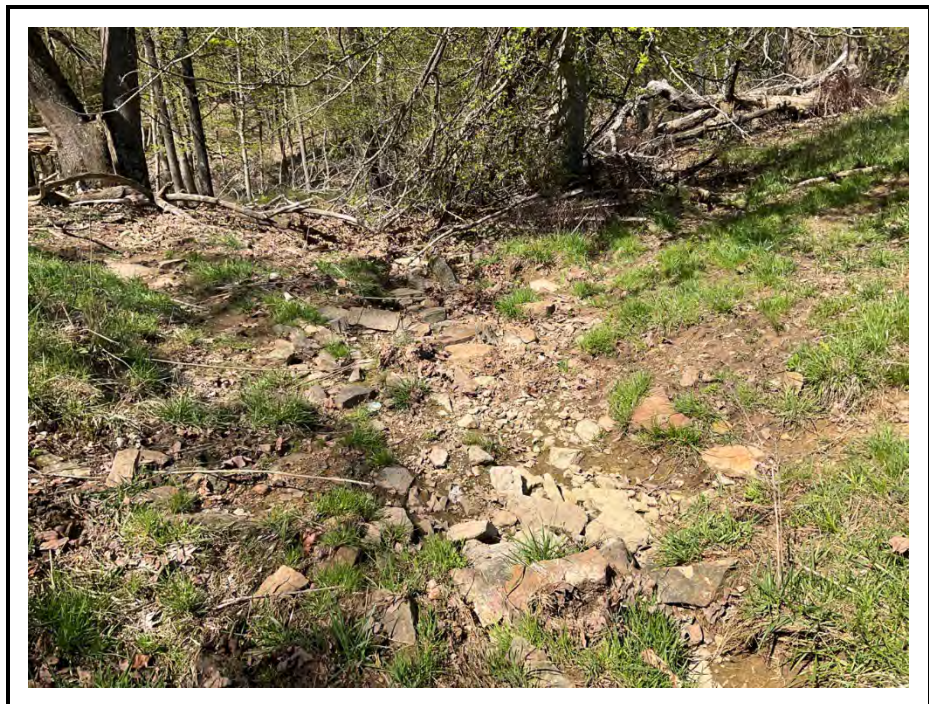
Description:
View of the ephemeral
section of stream SBF
facing downstream.

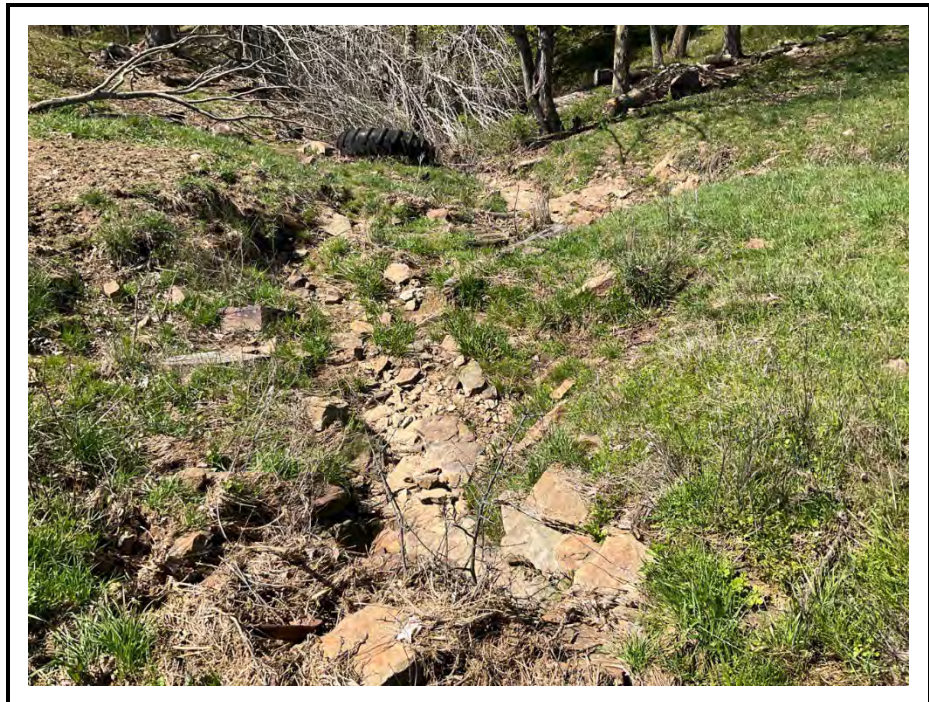
Description:
View of the intermittent
section of stream SBF
facing downstream.

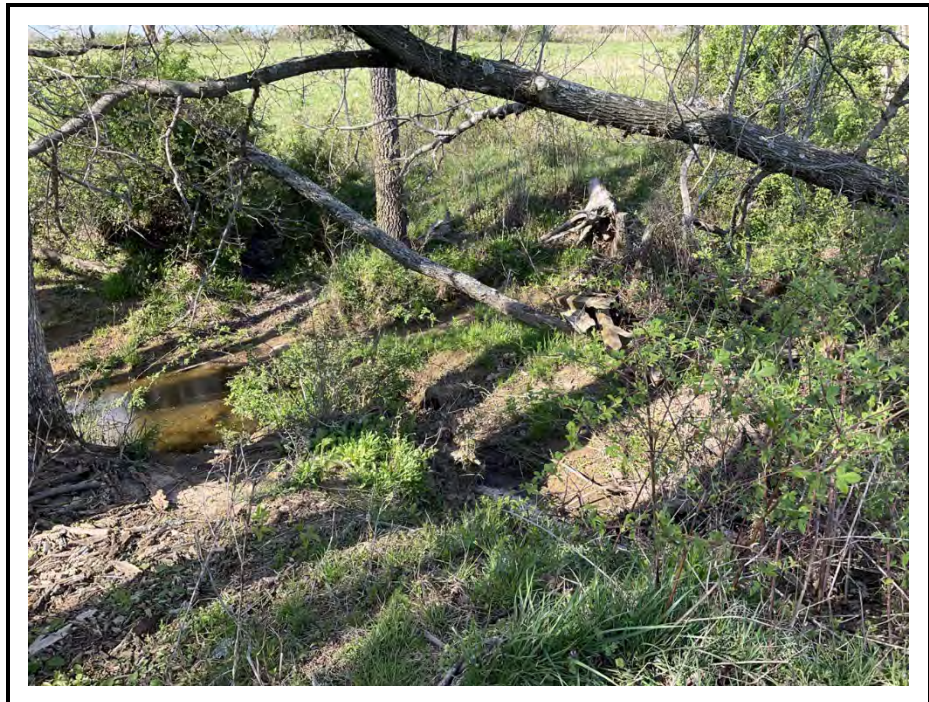
Description:
View of ephemeral section
of stream SCD facing
downstream.

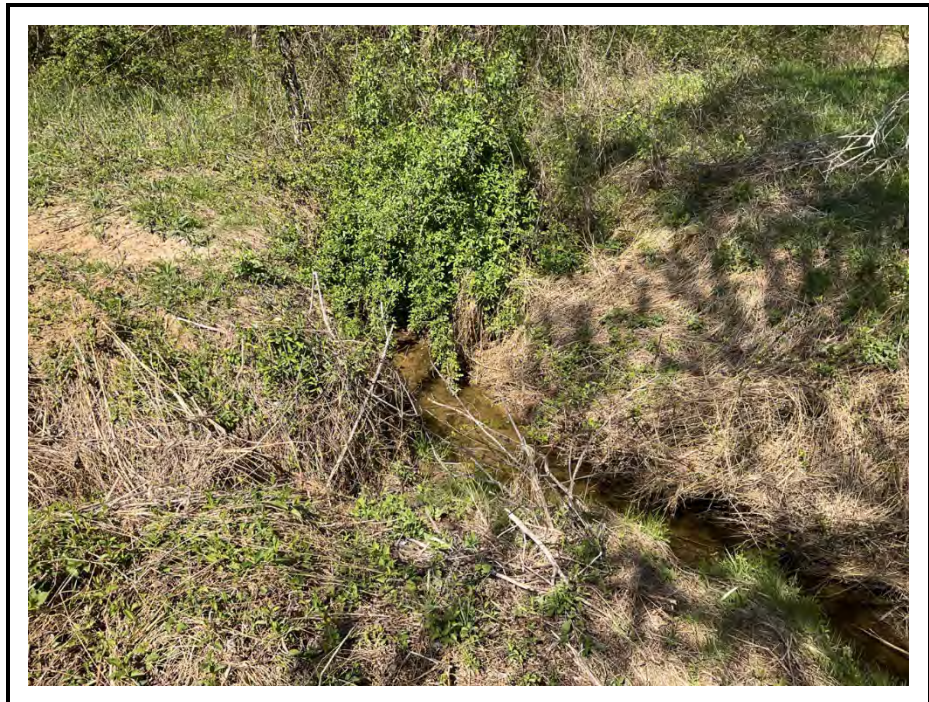
Description:
View of intermittent
section of stream SCD
facing downstream.
