Clover Creek Solar Project LLC d/b/a New Frontiers Solar Park Second Set of Supplemental Responses to Siting Board Staff's First Request for Information Case No. 2024-00253

Geophysical Investigation

New Frontiers Solar Park

February 3, 2025

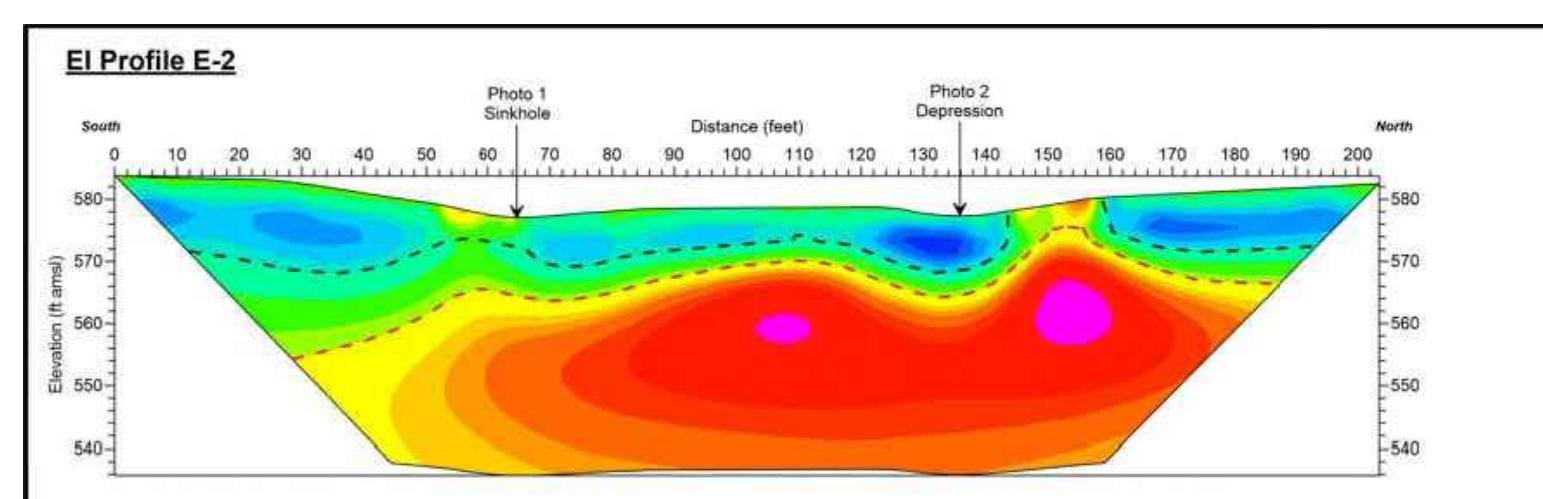
Below the sinkhole, elevated apparent resistivities are interpreted as poorly consolidated sediments overlying shallow, fractured sandstone, permitting the downward movement of materials into deeper karst units. Near the depression, a pocket of low apparent resistivities is interpreted as saturated sediments overlying a dipping interpreted bedrock surface that is likely related to deeper collapse within limestone or differential weathering of the limestone, leading to the formation of pinnacles. Also near the depression is a section of near-surface elevated apparent resistivities interpreted as very shallow rock overlying a shallow limestone pinnacle. Pockets of very high apparent resistivities within the two (2) most prominent pinnacles are interpreted as competent limestone separated by sections of lower competency limestone. No voids are interpreted within this profile.

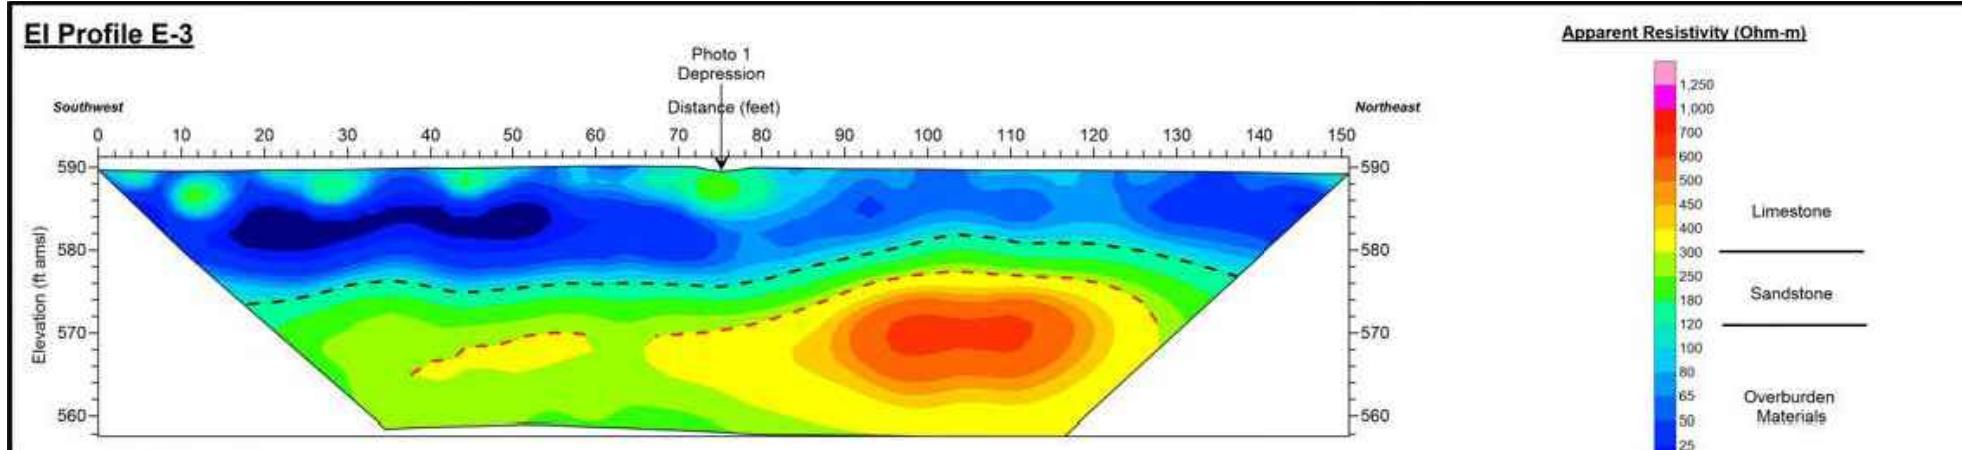
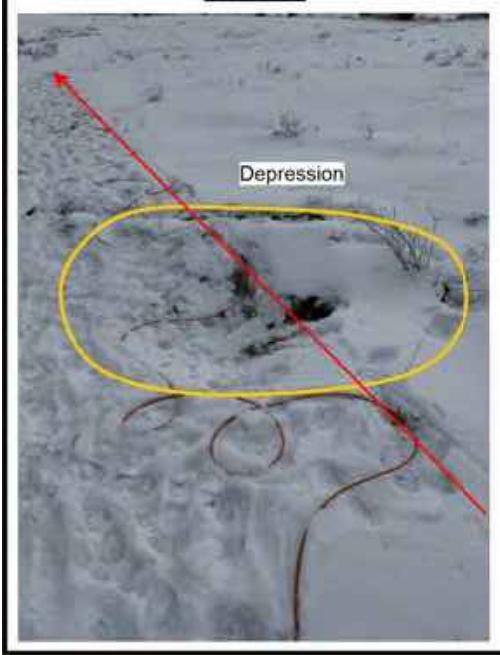
Below the depression is a small pocket of elevated apparent resistivities interpreted as poorly consolidated overburden materials related to differential settlement over deeper carbonate formations. The interpreted sandstone top of rock is somewhat hummocky, suggesting differential weathering of the underlying limestone. The interpreted limestone top of rock is highly irregular and contains gaps interpreted as highly fractured and vuggy intervals of limestone that are also present in deeper sections of the unit. No voids are interpreted from this profile; however, the limestone appears to severely weathered and likely has very low competency.

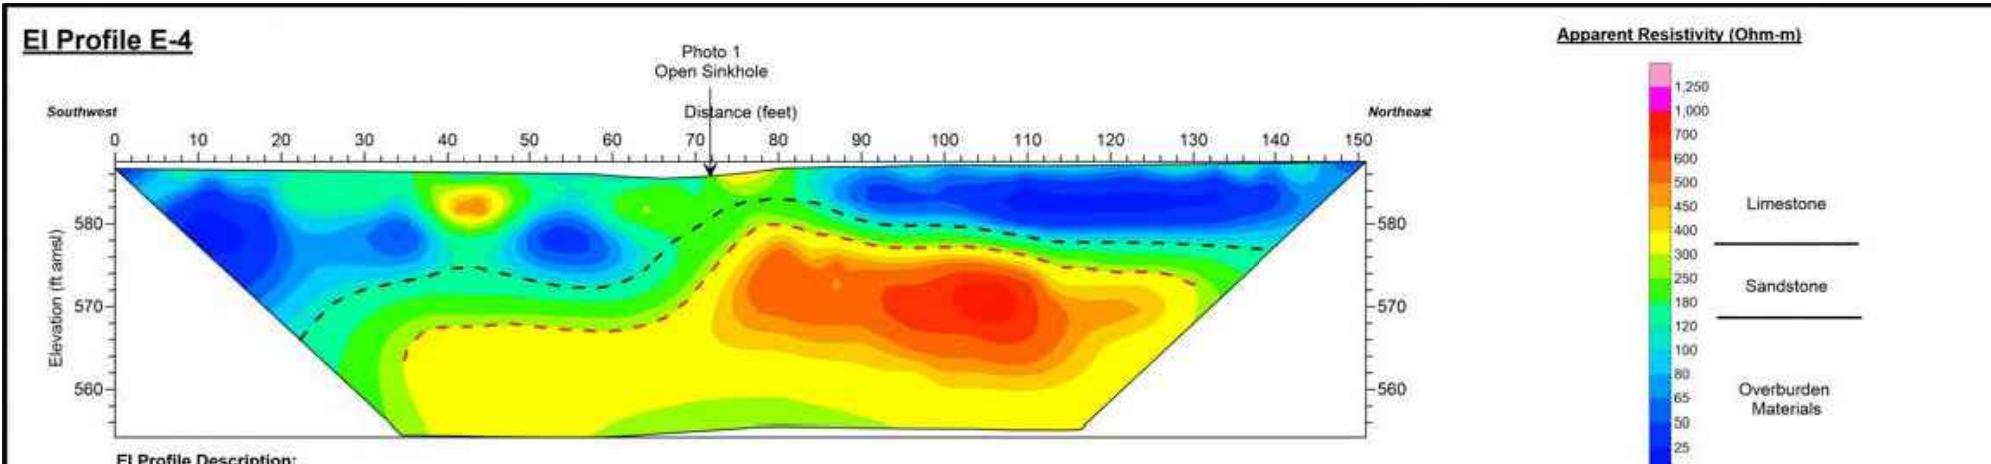
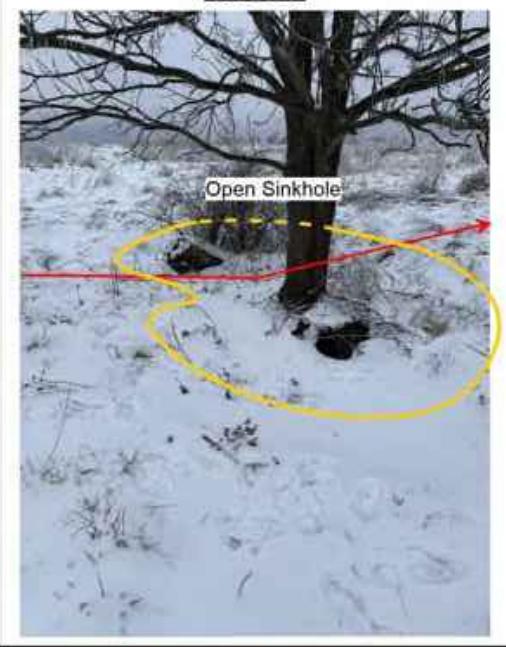
This profile images highly irregular interpreted top of sandstone and limestone surfaces that are indicative of differential weathering and erosion of the limestone unit. Beneath the open sinkhole feature, this profile images a section of elevated apparent resistivities interpreted as poorly consolidated sediments related to the downward movement of materials into deeper karst voids. The shallow limestone beneath the open sinkhole likely contains numerous fractures or small voids that lead to the development of the sinkhole. Additionally, variable apparent resistivities within the interpreted limestone indicate a range of competency within the unit, where lower apparent resistivities are interpreted as sections of increased weathering and may be more porous and vuggier than adjacent sections displaying higher apparent resistivities. No voids are readily apparent within this profile but may be present at deeper depths.

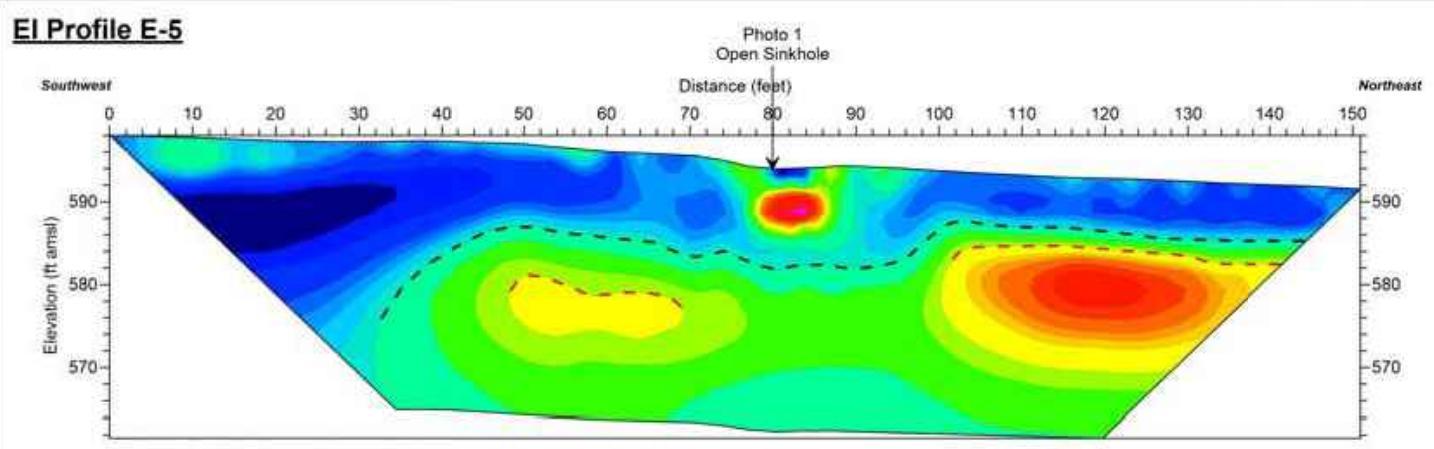
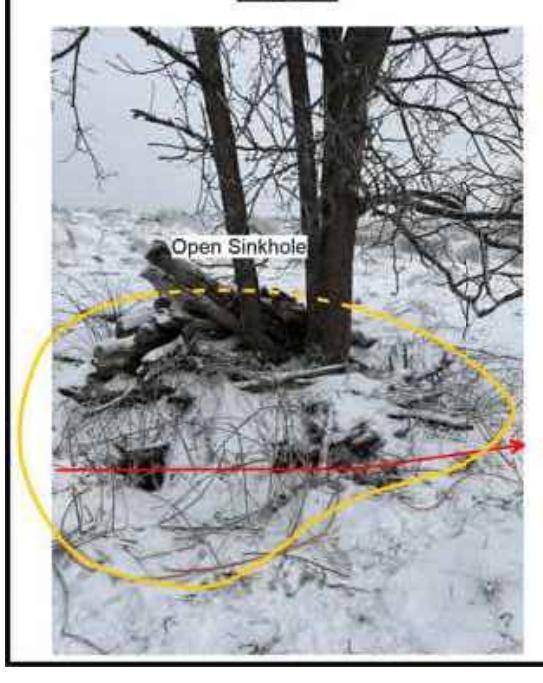
Below the open sinkhole is a small pocket of very high apparent resistivities interpreted as an air-filled void or fracture zone. The interpreted sandstone top of rock is irregular and hummocky, suggesting differential weathering of the underlying limestone. The interpreted limestone top of rock is highly irregular and contains gaps interpreted as highly fractured and vuggy intervals of limestone that are also present in deeper sections of the unit. The limestone appears to severely weathered and likely has very low competency.

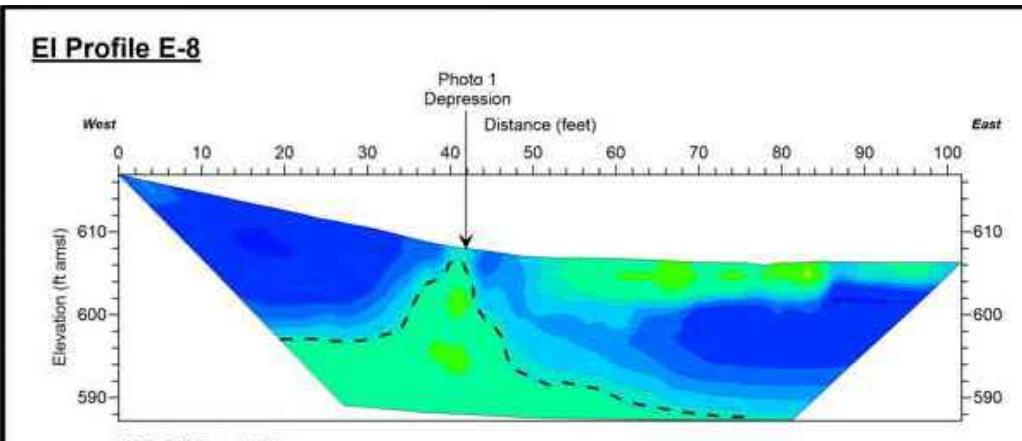
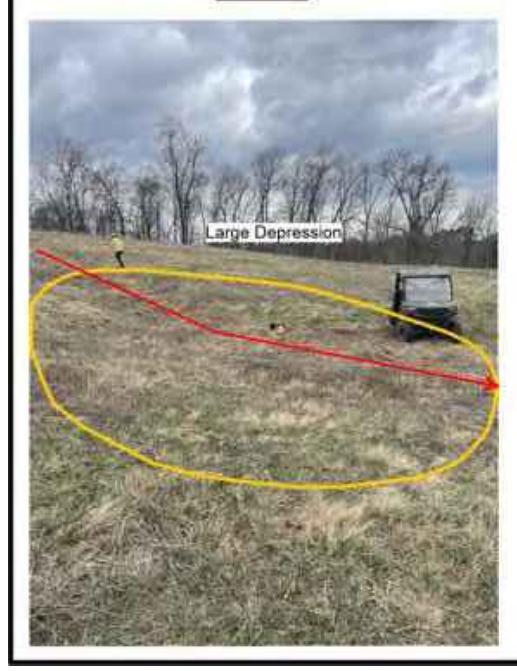
This profile exhibits a highly variable interpreted sandstone top of rock surface suggesting severe differential settlement from the dissolution or collapse of deeper limestone. Additionally, the shallow portion of elevate apparent resistivities beneath the depression may indicate poorly consolidated or dryer soils related to differential settlement of materials moving downward into sandstone fractures and deeper limestone karst features. No air filled voids or fractures are identified in this profile.

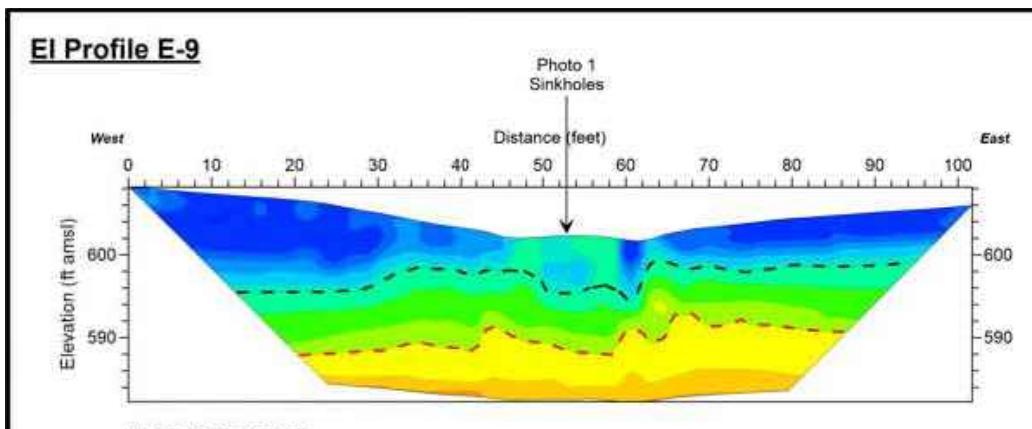
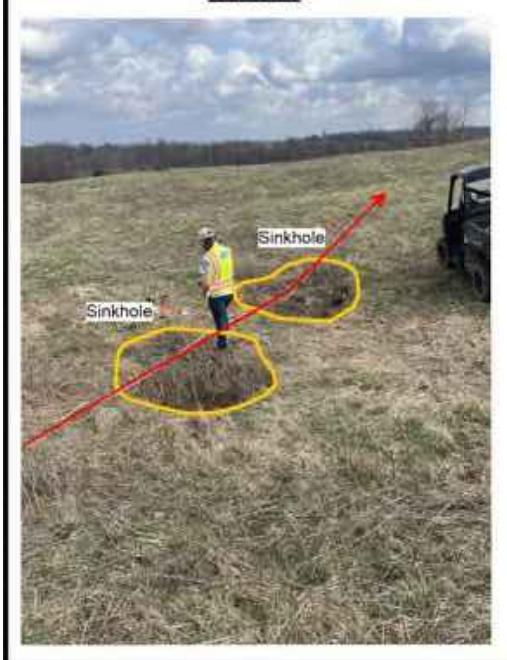
Both the interpreted top of sandstone and top of limestone are well-defined in this EI profile. The variable limestone top of rock is likely due to differential weathering and dissolution of limestone along the contact between the two units. Two vertical extensions of resistive materials extend to the surface directly below the two sinkholes. These two resistive columns are interpreted to indicate poorly consolidated or dryer soils related to the downward movement of materials into fractures or vuggs within the deeper limestone. Additionally, small pockets of elevatd apparent resistivities within the interpreted sandstone may indicate partially air-filled pathways fractures within the rock.

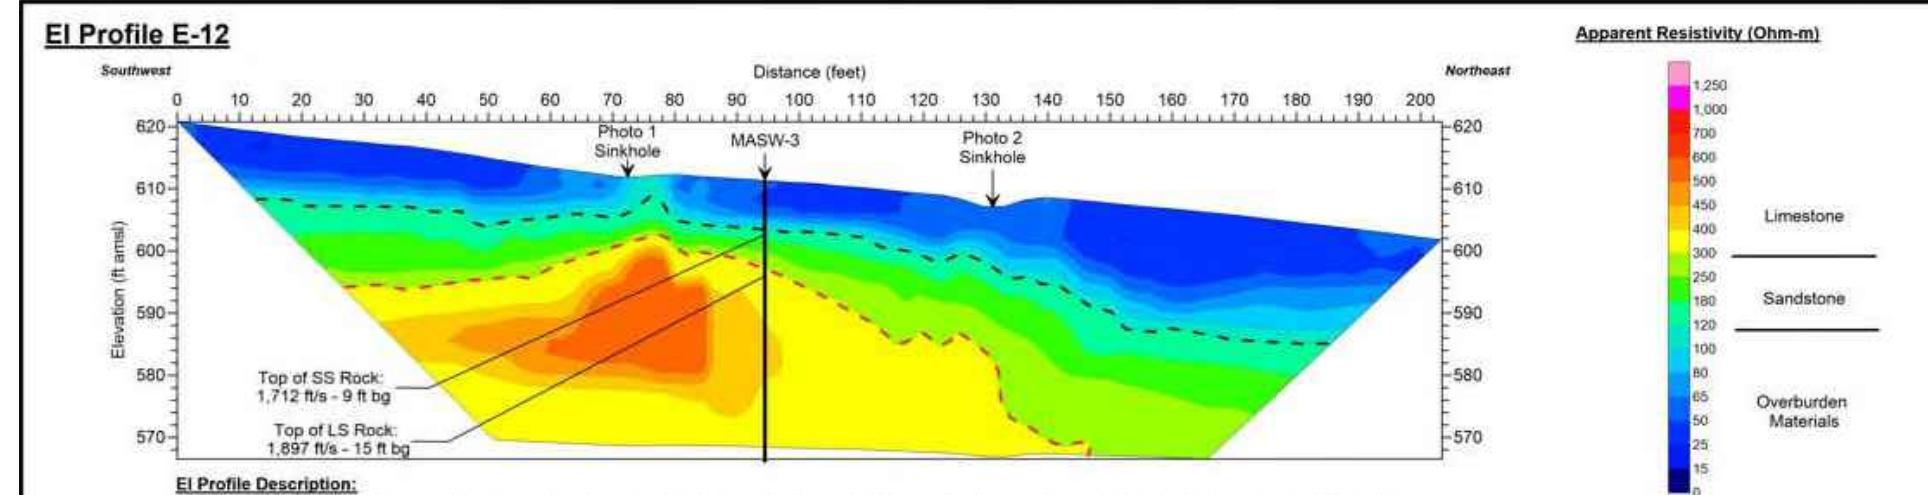
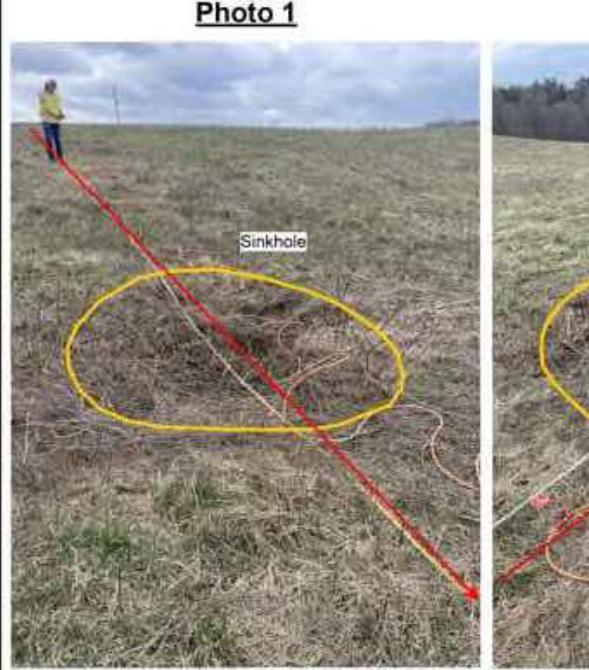
Both the Hardinsburg Sandstone and the Haney Limestone are well-displayed in this profile. The bedrock surface for each unit is variable indicating differential weathering and dissolution of the limestone. A section of elevated apparent resistivity within the interpreted limestone from approximately 60 to 88 feet along the profile and approximately 12 to 30 feet bg may be indicative of severe limestone weathering resulting in the formation of an air-filled fracture zone.

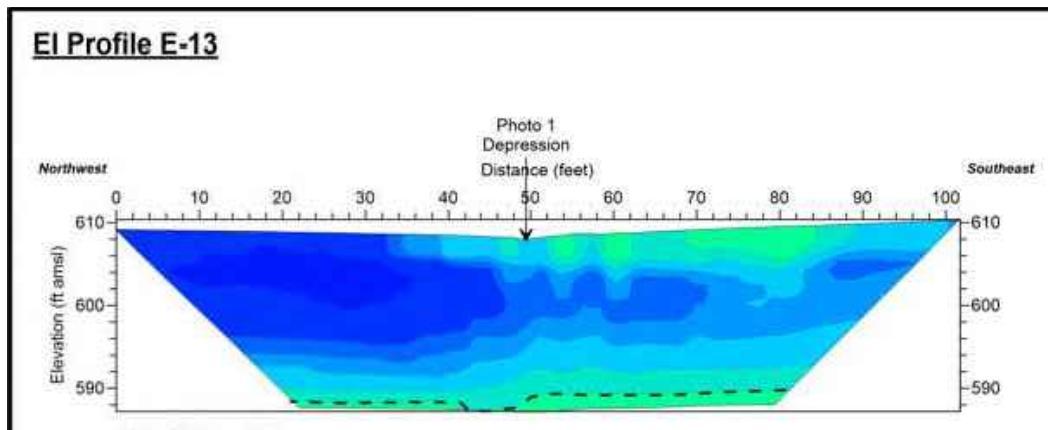
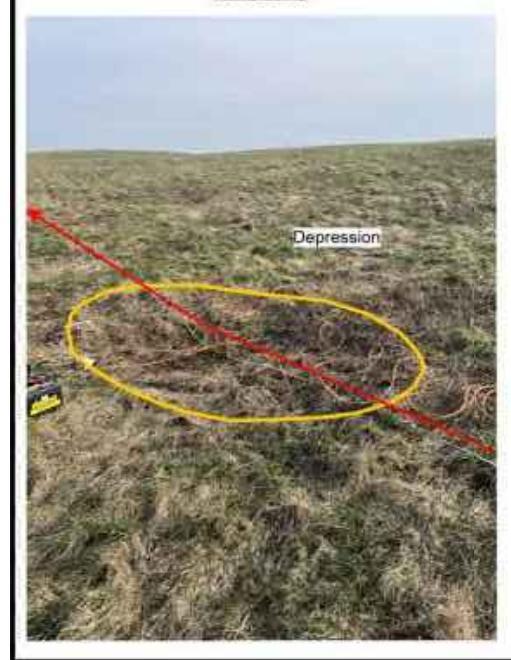
The apparent resistivity values within the profile are very low, suggesting deep soils that are likely saturated. The interpreted top of sandstone is mapped near the base of the profile. Based on the mapped sandstone profile, the source of the surface depression is interpreted to be caused by differential settlement of soils related to karst features within deeper limestone. No voids are interpreted in this El profile.

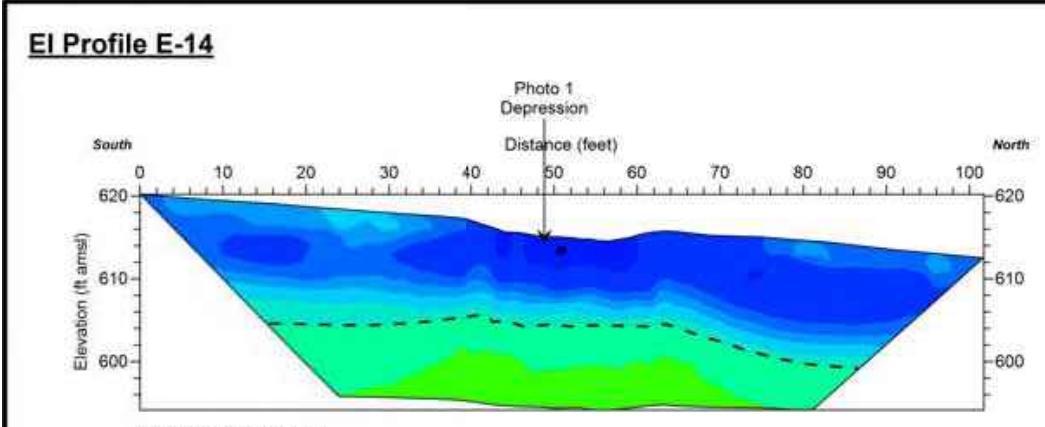
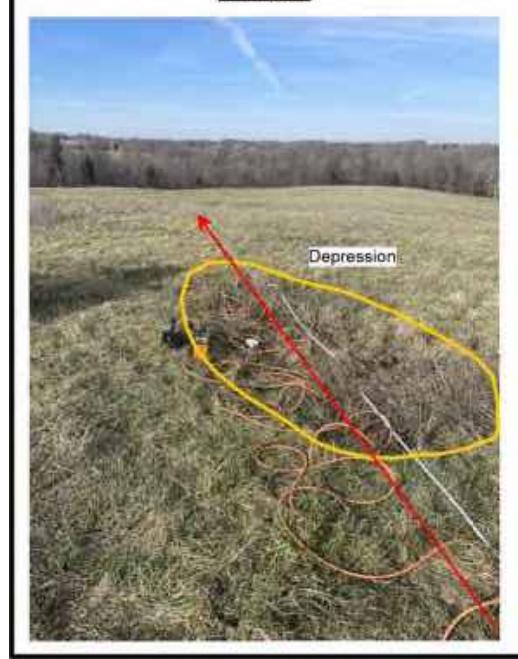
The interpreted top of sandstone is well-displayed within this profile and is mapped at relatively consistent elevations. No air-filled voids or other karst conditions are identified in the resistivity data. The source of the surface depression is likely related to similar processes interpreted from other profiles in this area, where sediment is moving through sandstone fractures into voids, vuggs, and fractures within deeper limestone.

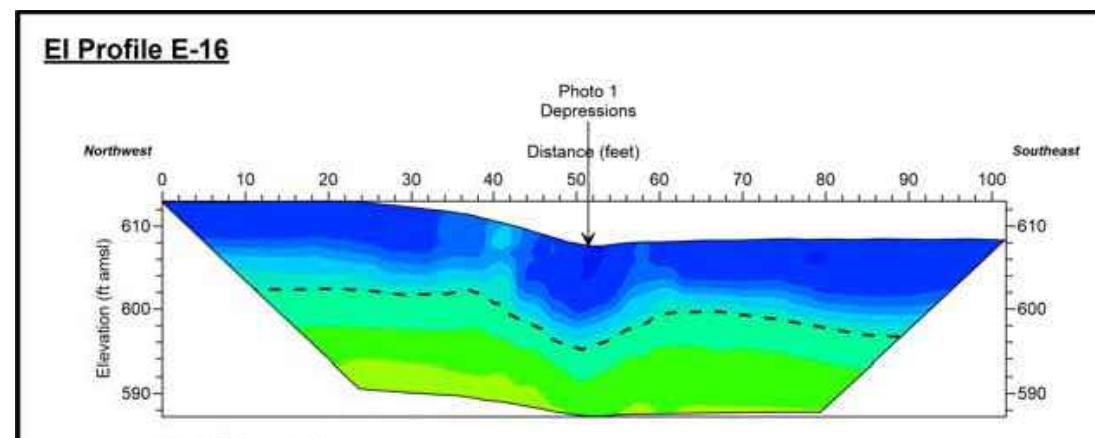
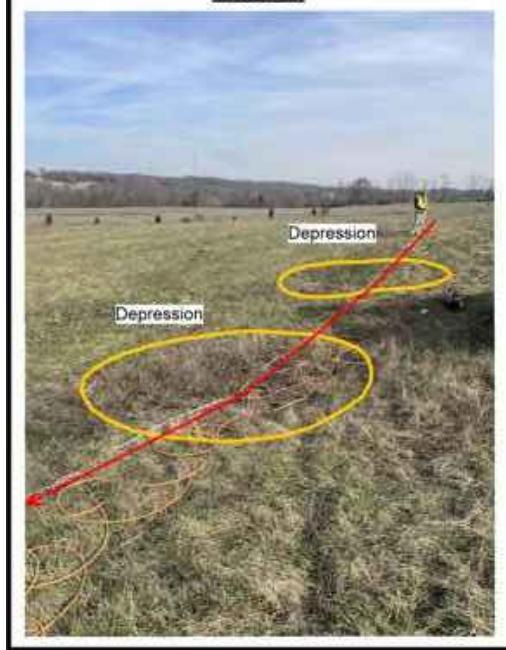
The top of sandstone rock is well-imaged in this profile and displays significant sagging from approximately 42 to 60 feet along the profile. This sag is likely the source of the depressions and is interpreted to be caused by differential settlement from dissolution of deeper limestone. No air- or clay-filled voids are identified in this El profile.

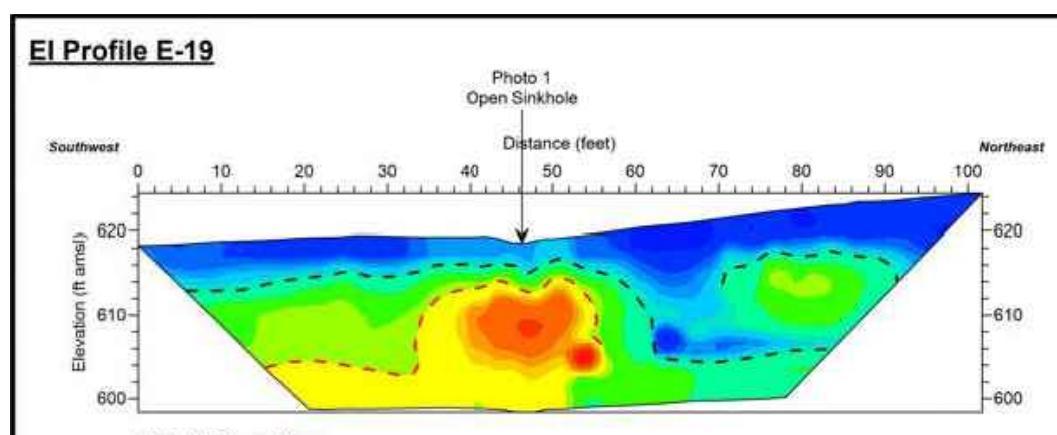
The apparent resistivity values measured along this profile indicate a highly variable bedrock surface, both in the sandstone and limestone. A very resistive pocket located within the interpreted limestone, from approximately 40 to 54 feet along the profile and 8 to 12 feet bg, is interpreted as a section of partially air-filled fractures or small voids and is located directly below the open sinkhole. Additionally, from approximately 60 to 94 feet along the profile, no limestone is present and the interpreted top of sandstone becomes highly irregular suggesting severe differential settlement from karst within the limestone below.

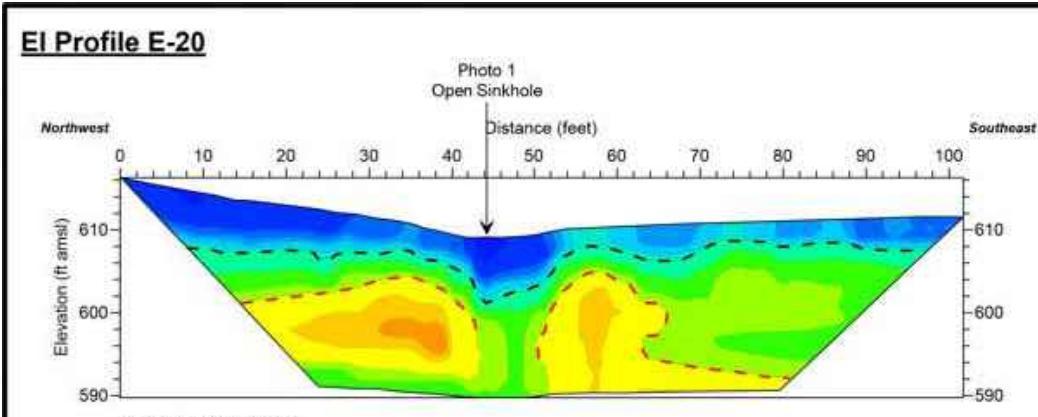
The interpreted top of sandstone mapped along this profile is irregular and hummocky. The underlying interpreted top of limestone is also highly variable. Near the center of the profile directly beneath the open sinkhole, a vertical discontinuity within the El data is interpreted as a throat feature related to the open sinkhole above. This feature is interpreted as a pathway to a deep void through which sediment is moving vertically downward, causing the formation of the open sinkhole and likely contains clay-filled or saturated voids or fracture zones. The limestone imaged in this El profile appears to be severely differentially weathered and is likely prone to further karst development.

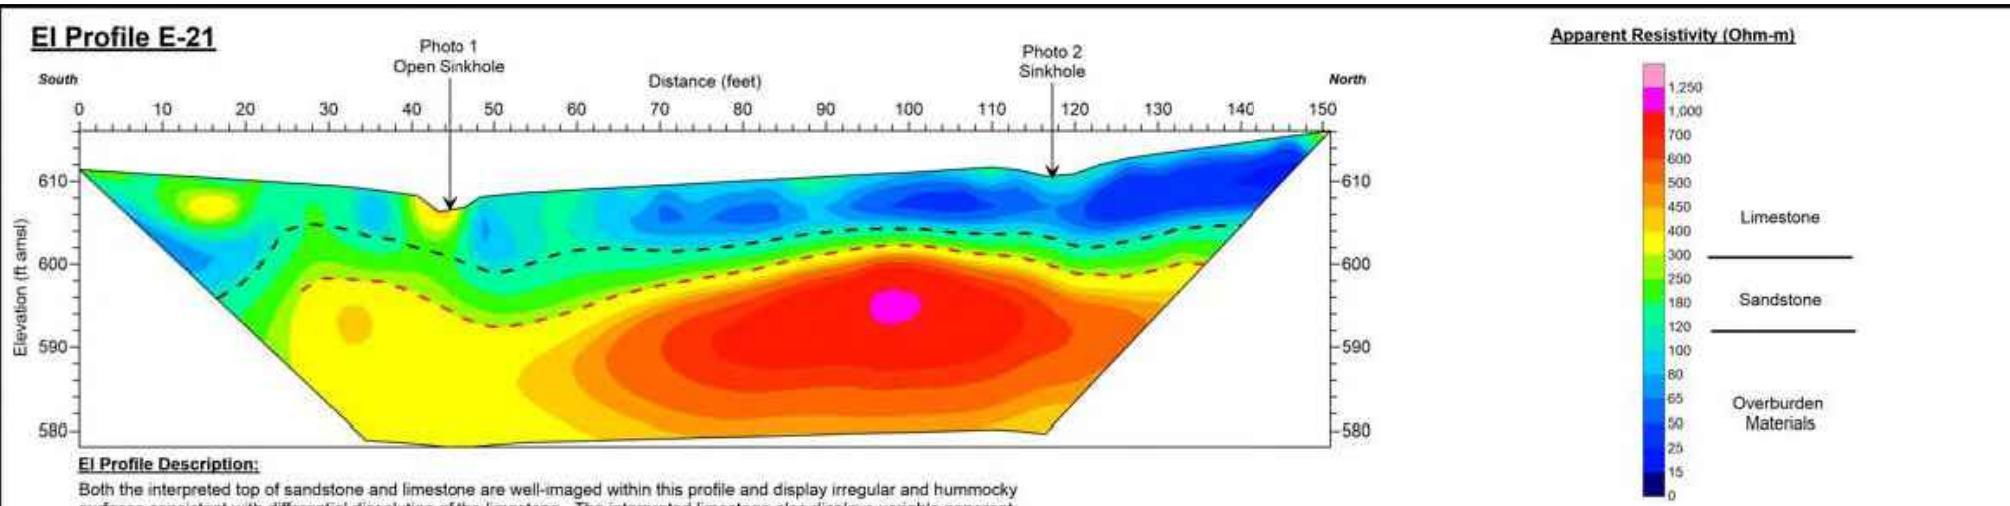
surfaces consistent with differential dissolution of the limestone. The interpreted limestone also displays variable apparent resistivities indicating a range of competency within the rock. Beneath both surficial karst features, the interpreted limestone dips suggesting that these intervals of limestone may contain clay-filled fractures and vuggs. The limestone appears to be most compromised beneath the open sinkhole feature where a vertical column of elevated apparent resistivities may represent a throat permitting the downward movement of sediments and increasing the potential for continued karst development.

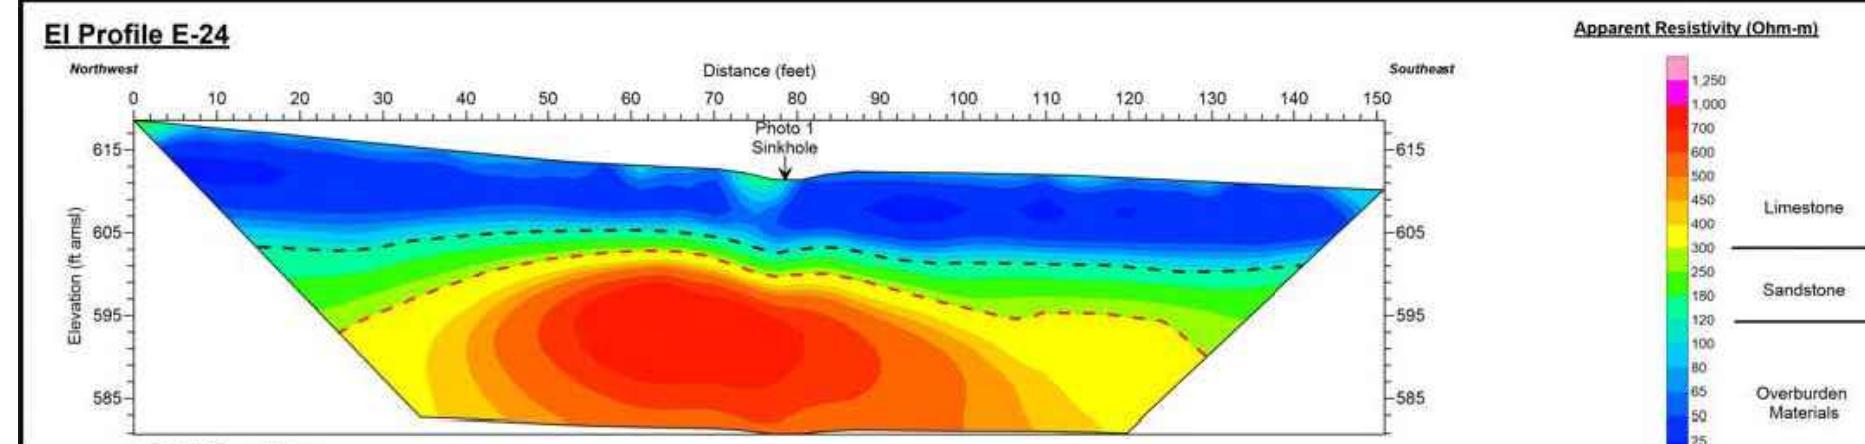
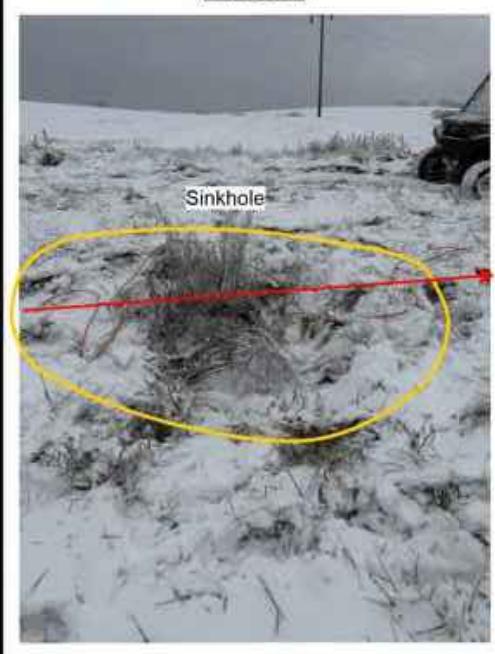
The interpreted top of sandstone and limestone are both well-imaged in this profile and are mapped along relatively uniform elevations. A pocket of slightly elevated apparent resistivities directly beneath the sinkhole is interpreted as poorly consolidated sediments due to differential settlement into fractures within deeper limestone. The limestone imaged within this profile displays somewhat variable apparent resistivities indicating a range of rock competency. No voids are interpreted within this profile.

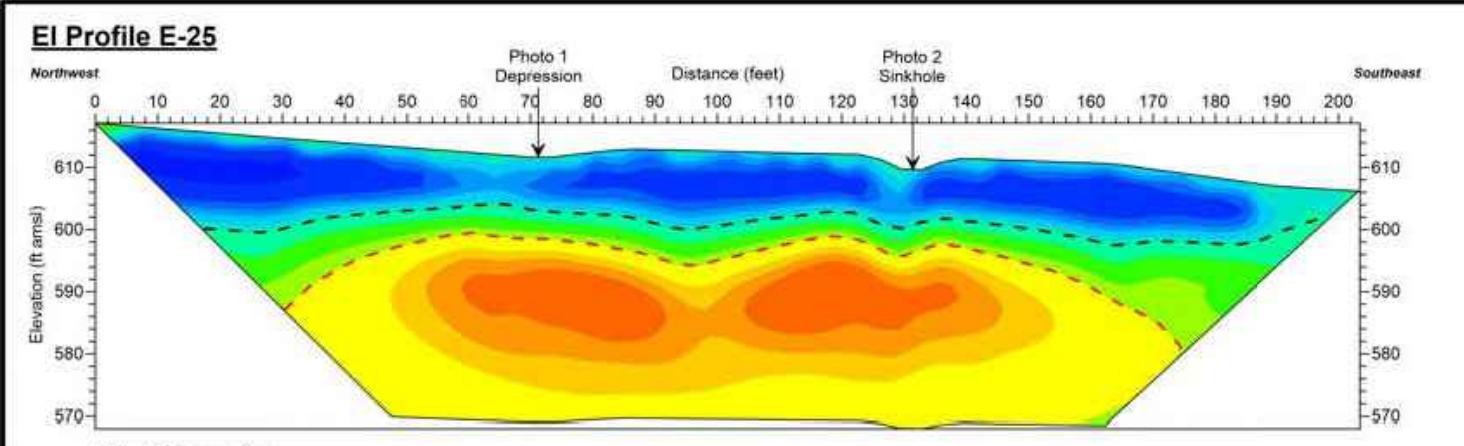
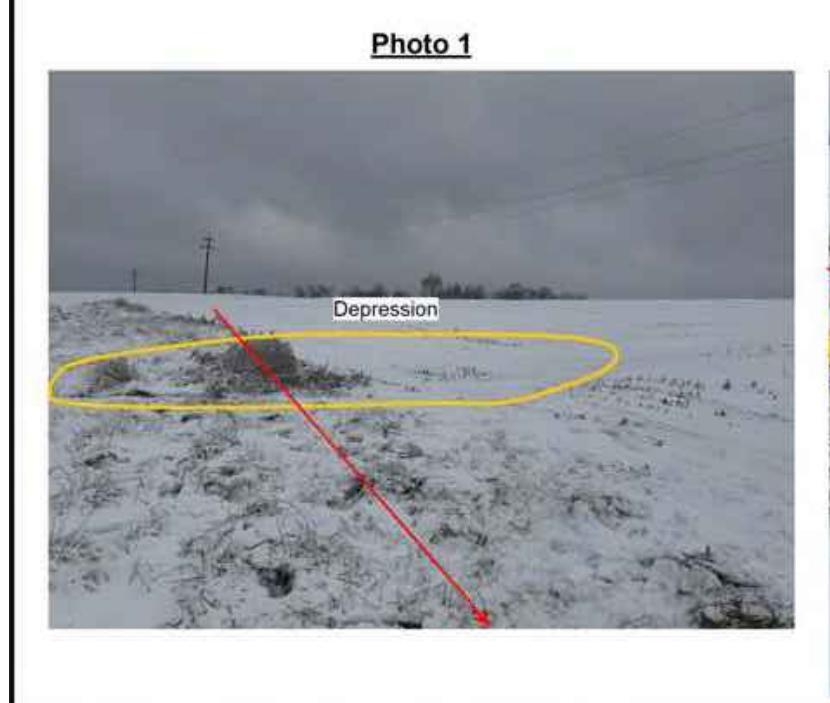
The interpreted top of sandstone and limestone are both well-imaged in this profile and display some irregularity most noticeable beneath the sinkhole feature and near the edges of the profile. Slightly elevated apparent resistivities are imaged beneath both surficial karst features indicating poorly consolidated soils due to differential settlement into deeper karst voids and fractures. The limestone imaged within this profile displays variable apparent resistivities indicating a range of competency. Additionally, deeper portions of the interpreted limestone display lower apparent resistivities than imaged above indicating that deeper sections of the rock are less competent. No voids are interpreted within this profile.

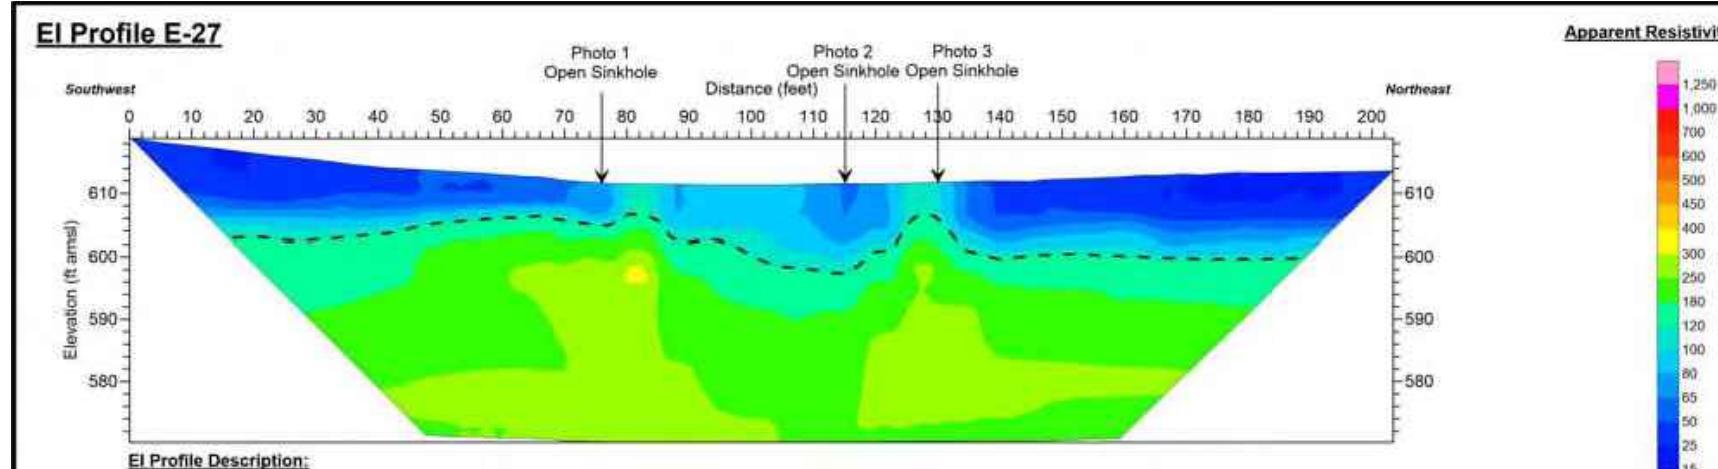
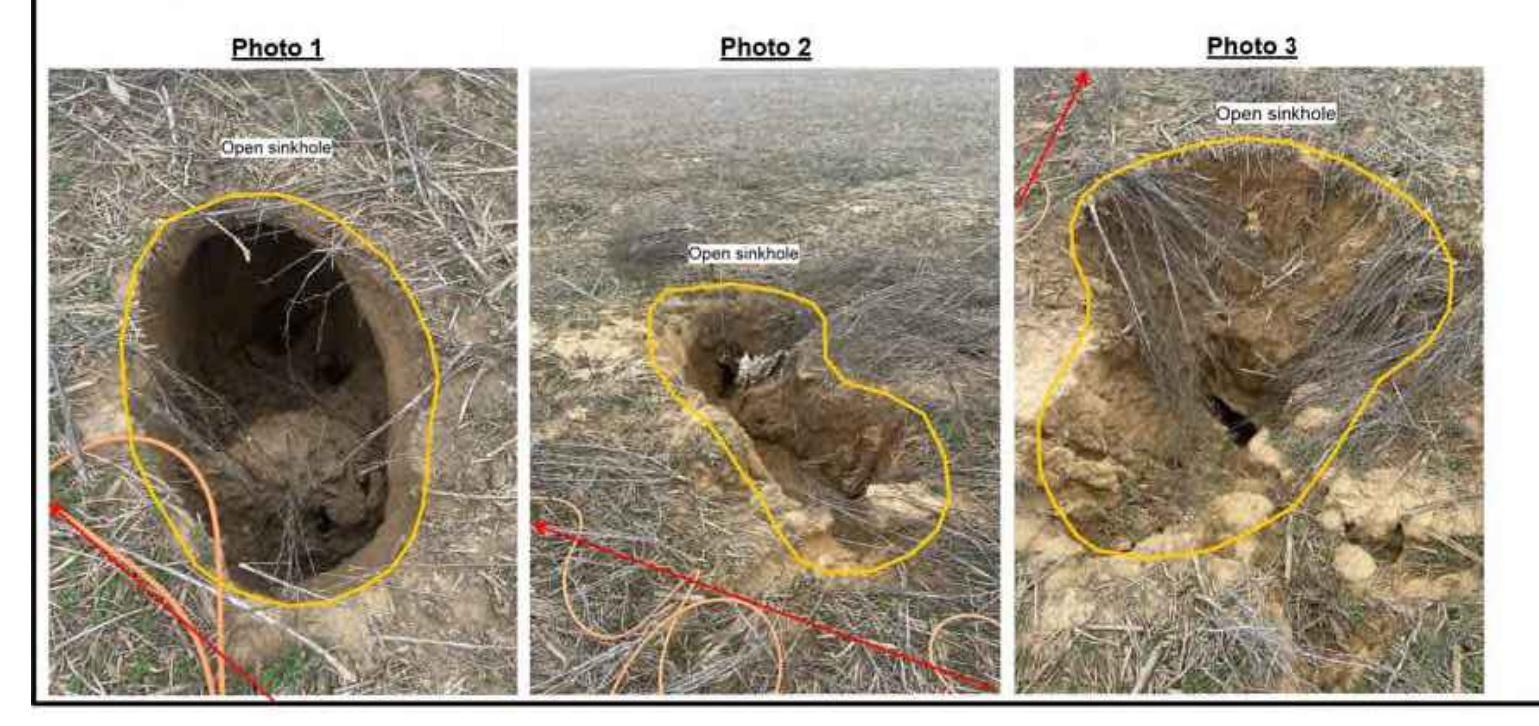
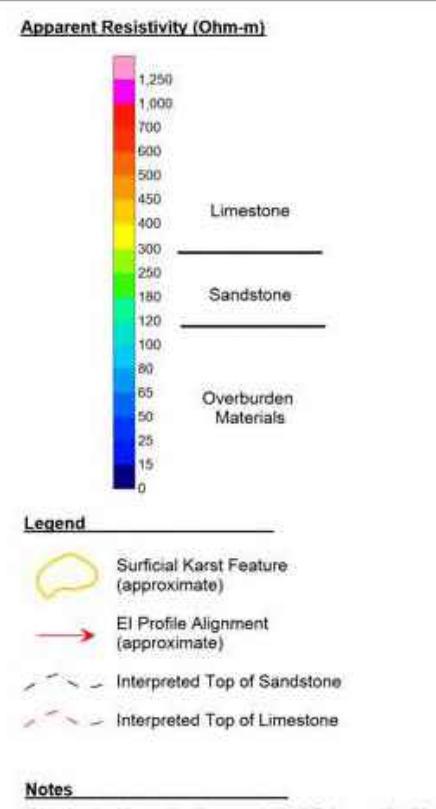
The interpreted top of sandstone is well-imaged in this profile and the underlying sandstone displays highly variable apparent resistivities indicative of fractures. The mapped top of rock surface displays variable elevations suggesting differential weathering and dissolution settlement within deeper limestone. Two elevated resistivity pockets within the interpreted sandstone bedrock are positioned just below open sinkhole features at approximately 80 feet and 126 feet along the profile. Both features are interpreted as sandstone fracture zones. These likely extend down into deeper limestone providing a pathway for sediment movement, thus forming the open sinkholes observed at the surface. No air-filled voids are interpreted in this El profile.

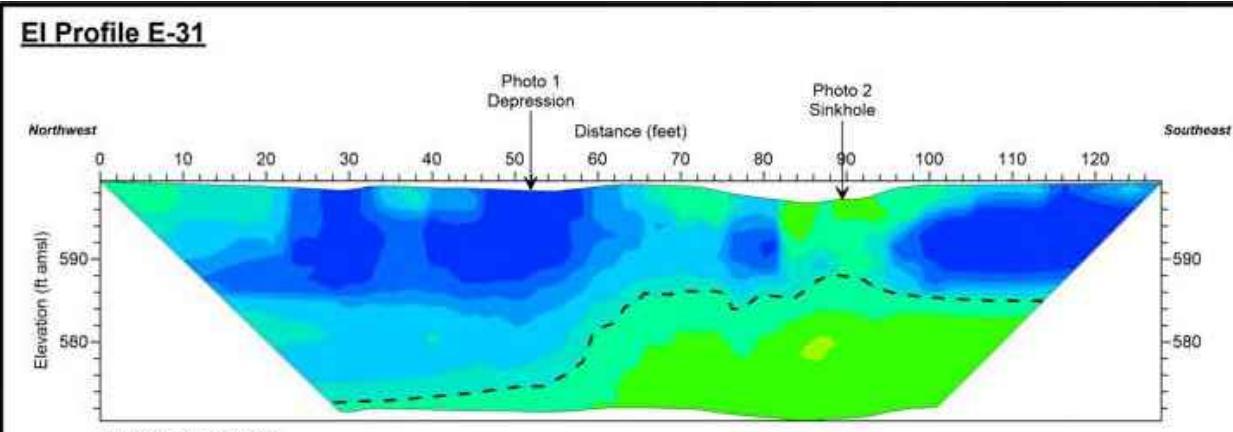
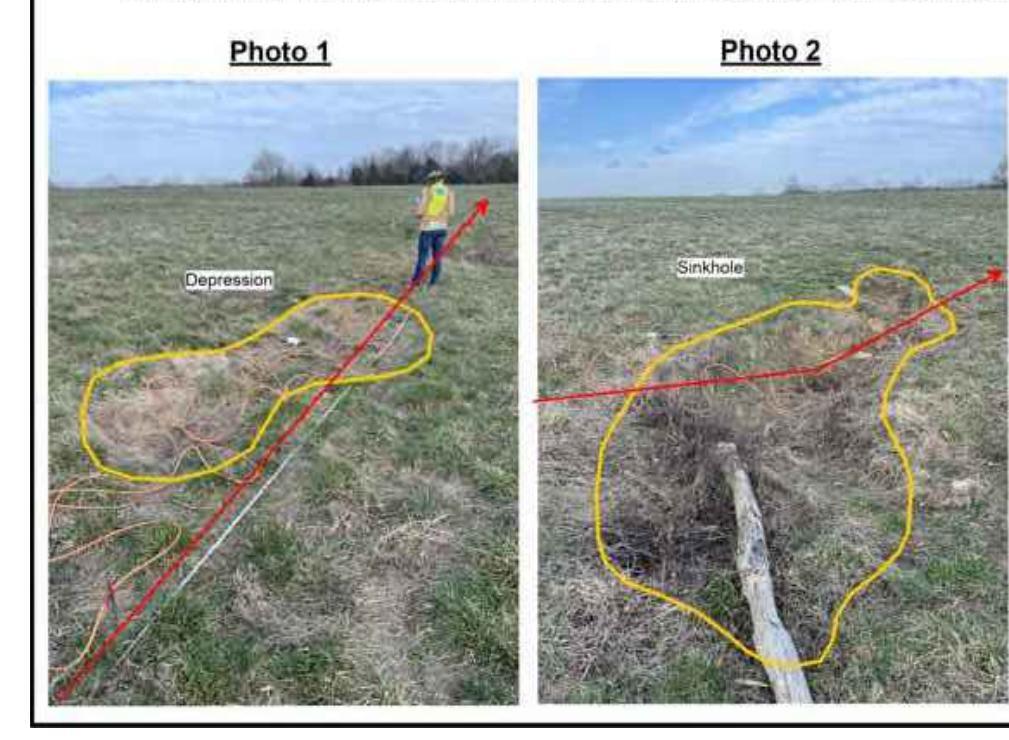
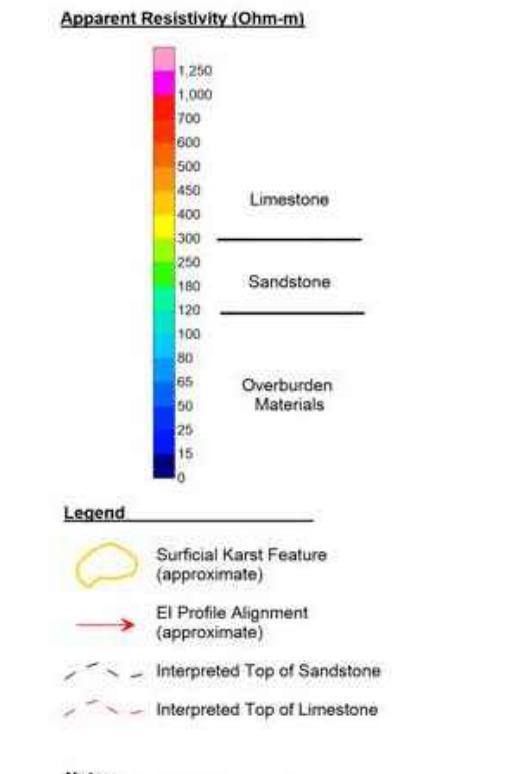
The interpreted top of sandstone mapped in this profile is uneven, indicative of karst features, such as pinnacles, within deeper limestone. This is especially notable where the sandstone surface is at a significantly different elevation than the second half of the profile and suggests potential collapse of karst features below. A pockets of very low resistivities is observed beneath the depression from 78 to 82 feet along the profile and is confined to the upper 10 feet of the profile. This low-resistive pocket suggests an increased degree of saturation related to the downward movement of moisture and sediment. Beneath the sinkhole is a shallow pocket of slightly elevated apparent resistivities interpreted as poorly consolidated soils related to differential settlement within deeper karst features as sediments and moisture move down into open spaces.

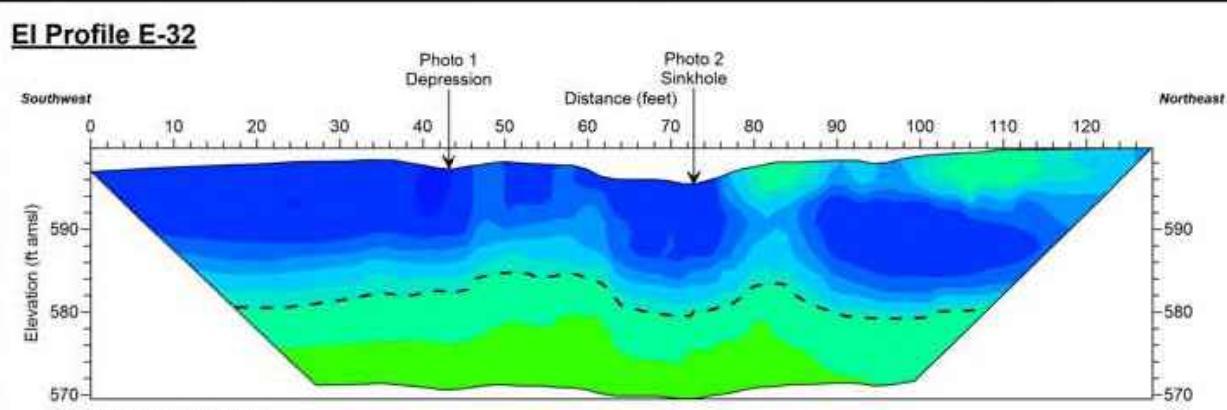
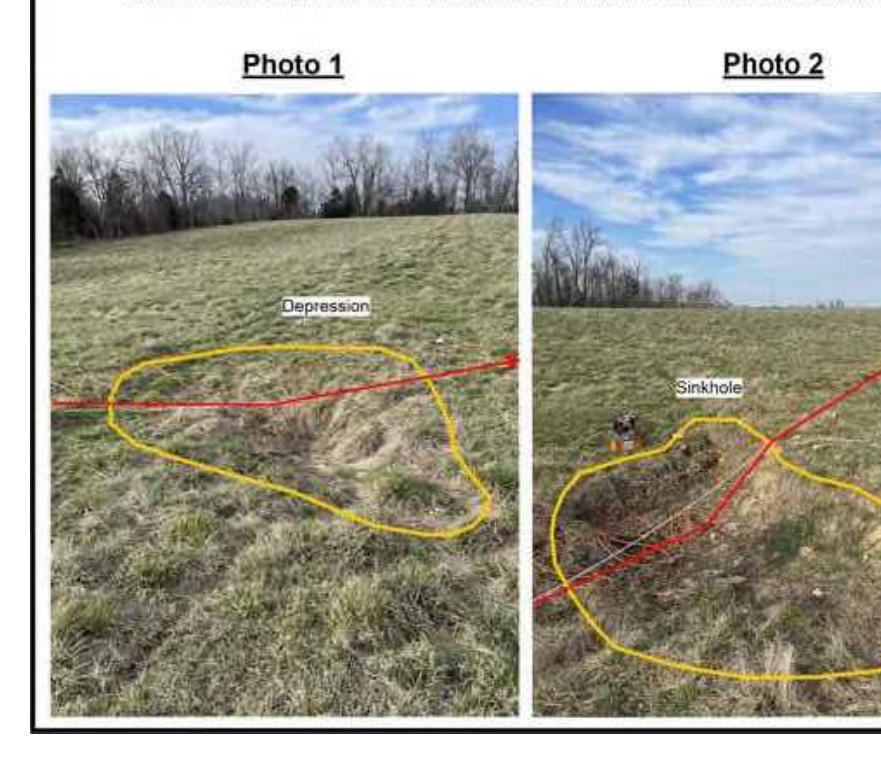
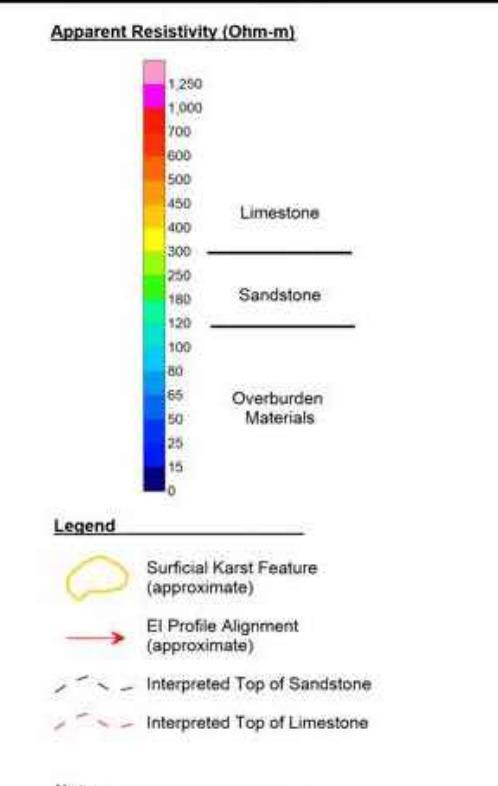
This profile is located very close to E-31 and maps similar subsurface conditions. The interpreted sandstone top of rock is well-imaged across the profile and undulates indicating that the limestone below contains karst conditions such as pinnacles or collapsed voids. Beneath the depression is a thick section of very low apparent resistivities interpreted as saturated sediments. The source of the depression is assumed to be related to differential settlement of deeper limestone karst features beneath the sandstone. The sagging observed in the interpreted sandstone profile is likely the source of the sinkhole observed on the surface. Additionally, a vertical column of slightly elevated apparent resistivities extends from the interpreted sandstone to the surface near the sinkhole and is interpreted to represent poorly consolidated soils related to differential settlement within deeper karst voids and fractures. No air-filled voids or fractures are interpreted from this profile.
