Clover Creek Solar Project LLC d/b/a New Frontiers Solar Park Second Set of Supplemental Responses to Siting Board Staff's First Request for Information Case No. 2024-00253

Geophysical Investigation

New Frontiers Solar Park

February 3, 2025

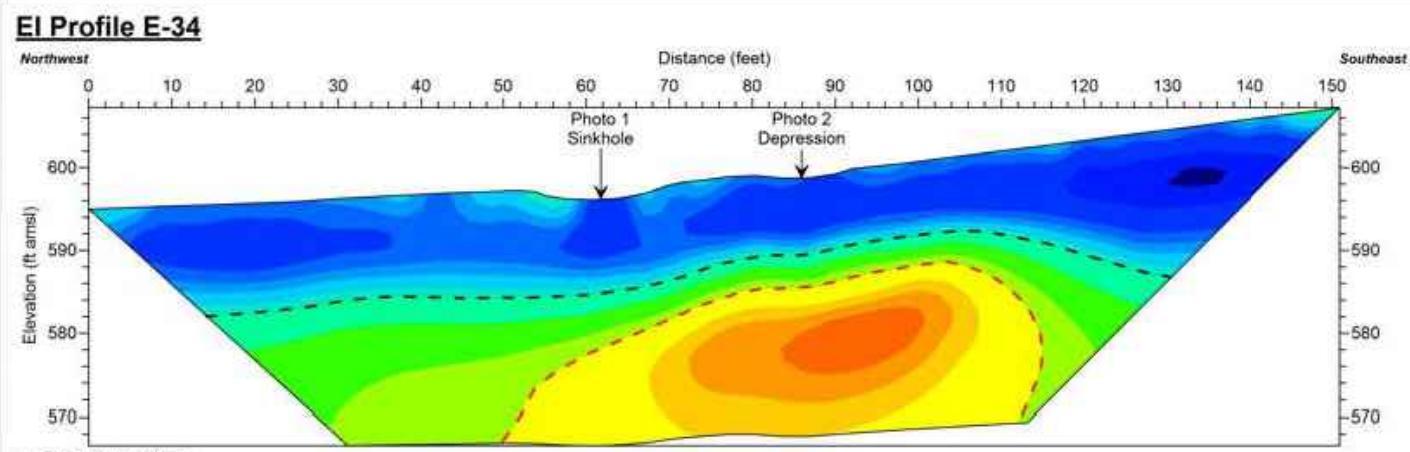
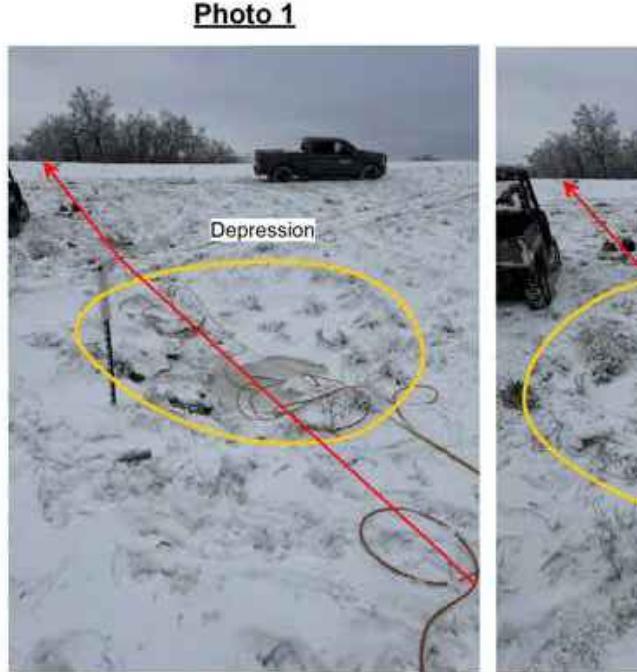
The interpreted top of sandstone and limestone are both well-displayed within this profile. The interpreted sandstone surface undulates much less than the deeper limestone, suggesting that the limestone may extend further than interpreted; however, that implies that the limestone is displaying anomalously low apparent resistivities and contains numerous saturated and clay-filled fractures or vugs. Beneath both surficial karst features are somewhat thick pockets of low apparent resistivities interpreted to be saturated sediments related to water carrying sediments draining into deeper karst features such as voids or fractures. No air-filled voids are interpreted within this profile.

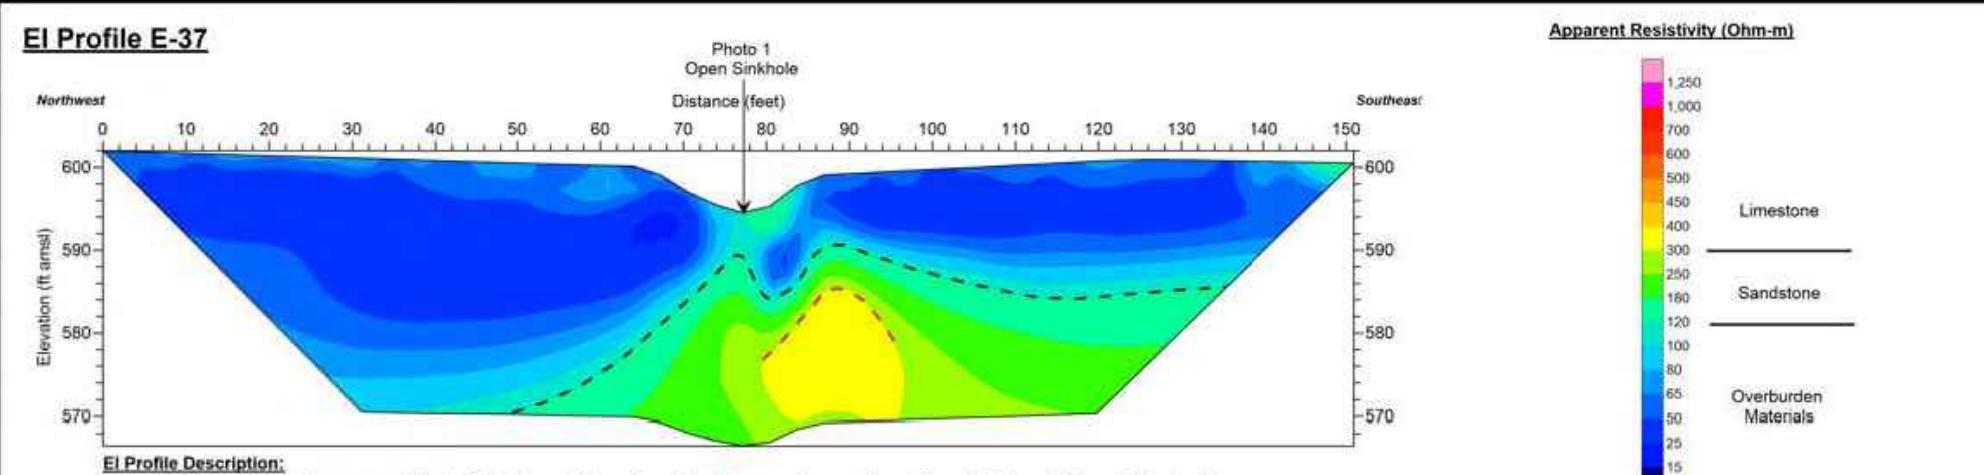
This profile imaged a very deep open sinkhole. The interpreted top of sandstone is mapped across the profile and displays highly variable elevations suggesting severe karst within the deeper limestone. Beneath the open sinkhole, the interpreted sandstone appears to dip sharply which is interpreted as severely weathered and fractured rock. Below this zone of fractured sandstone is a small pocket of apparent resistivities consistent with limestone; however, this interpreted limestone does not appear to continue laterally and displays lower apparent resistivities beneath it. It is likely that this portion of limestone is a severely weathered limestone pinnacle situated within a section of very low competency limestone. Additionally, a vertical column of elevated apparent resistivities extends to the surface near the base of the open sinkhole indicating that sediments are poorly consolidated and continuing to move downard into deeper karst volds and fractures. No air-filled voids or fractures are interpreted from this profile.

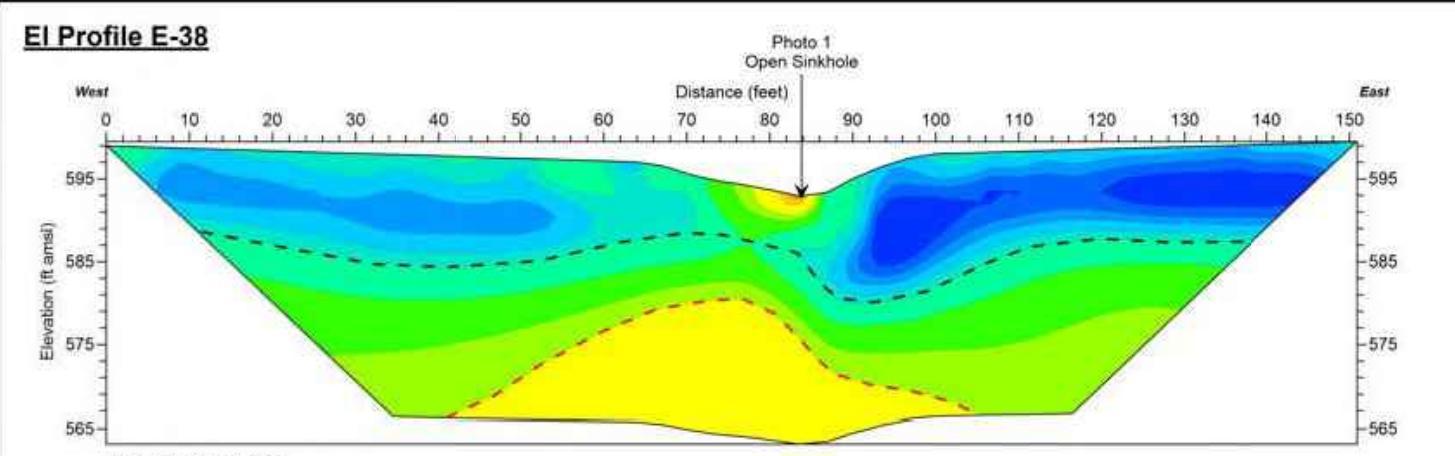
This profile imaged a very deep open sinkhole. The interpreted top of sandstone and limestone are mapped across the profile and display variable elevations suggesting severe differential dissolution of the limestone, consistent with deeper collapse or pinnacle formation. Directly beneath the open sinkhole is a pocket of elevated apparent resistivities that are interpreted as poorly consolidated sediments related to the sinkhole throat that are continuously moving downward into deeper karst voids or fractures. The abrupt dip in both interpreted top of rock surfaces is likely the source of the sinkhole formation and both rock types are interpreted to contain clay-filled and saturated fractures. No air-filled voids or fractures are imaged in this profile.

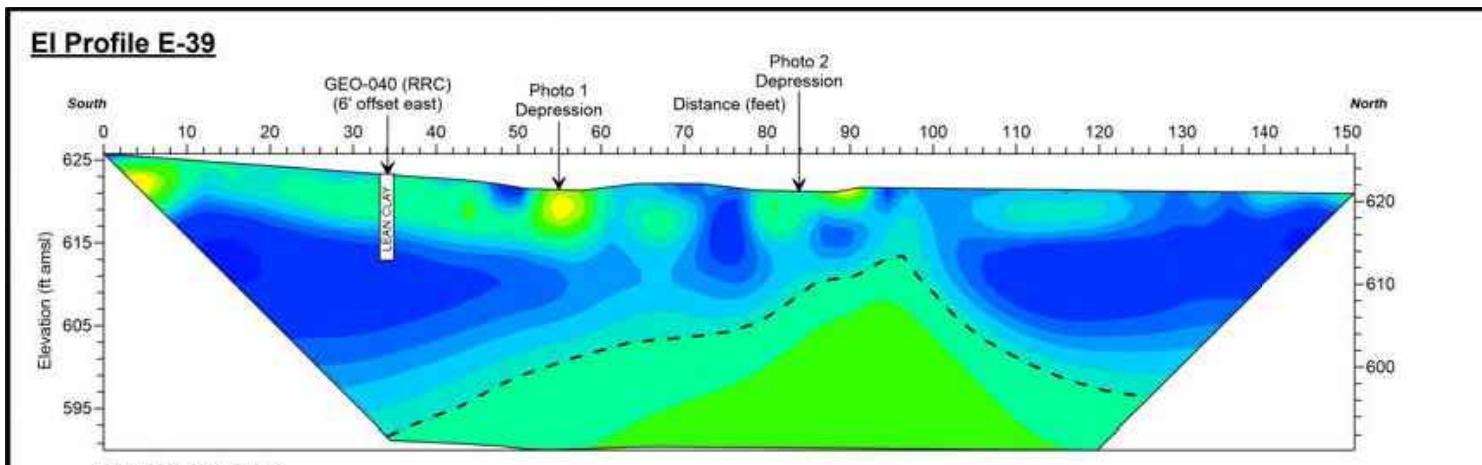
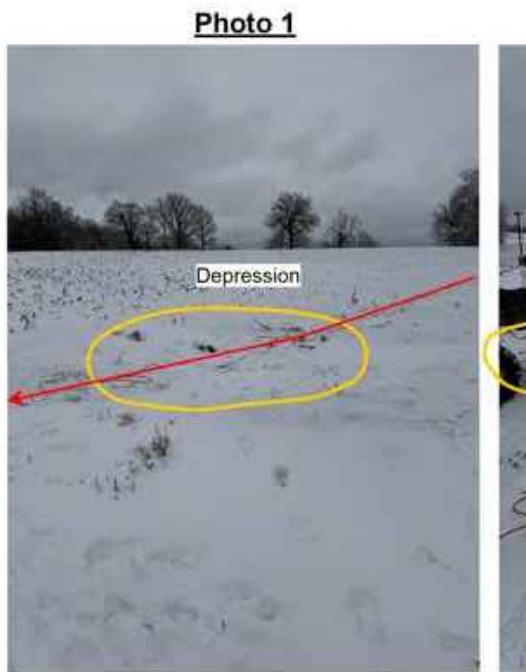
The interpreted top of sandstone is well-imaged in this profile and displays highly variable elevations indicating differential weathering and dissolution of deeper limestone units. No limestone is imaged within this profile. Beneath both depressions are small pockets of elevated apparent resistivities that somewhat extend downwards. These features are interpreted as poorly consolidated sediments related to differential settling of materials into deeper karst voids and fractures. No air- or clay-filled voids or fractures are interpreted from this profile.

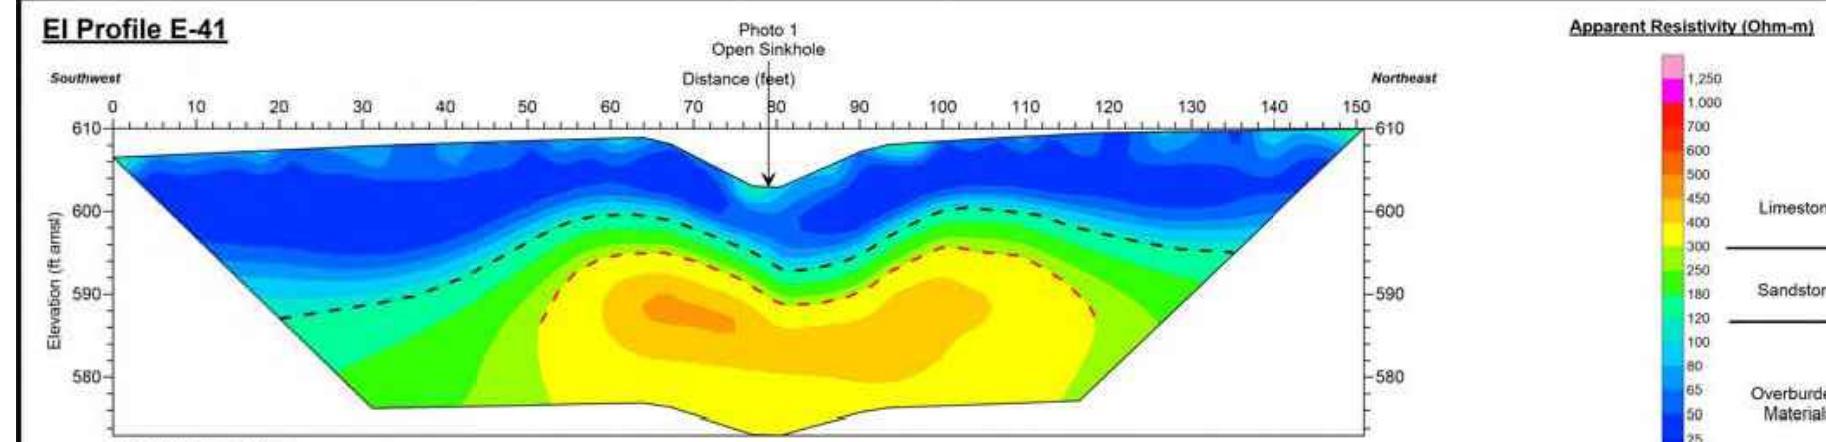
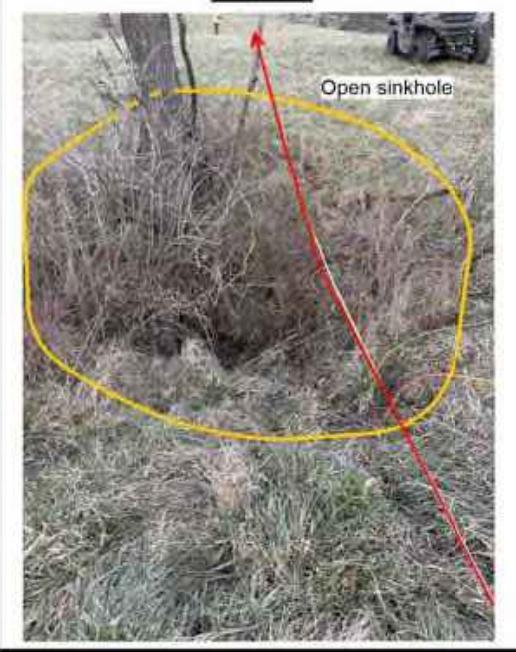
Both the interpreted top of sandstone and limestone are well-imaged in this profile and both display highly variable elevations consistent with differential dissolution of limestone and pinnacle formation. Directly beneath the open sinkhole is a section of slightly elevated apparent resistivities that are interpreted to represent poorly consolidated sediments or dryer sediments due to the downward movement of water and materials as they differentially settle into karst features such as fractures and voids within the limestone. Both interpreted top of rock surfaces display a dip below the sinkhole suggesting that either a deeper portion of limestone has collapsed here or the rock is severely weathered and fractured. Additionally, limestone is not imaged near the beginning or end of the profile suggesting that significant karst development is present in the subsurface along those intervals. No air-filed voids or fractures are interpreted from this profile.

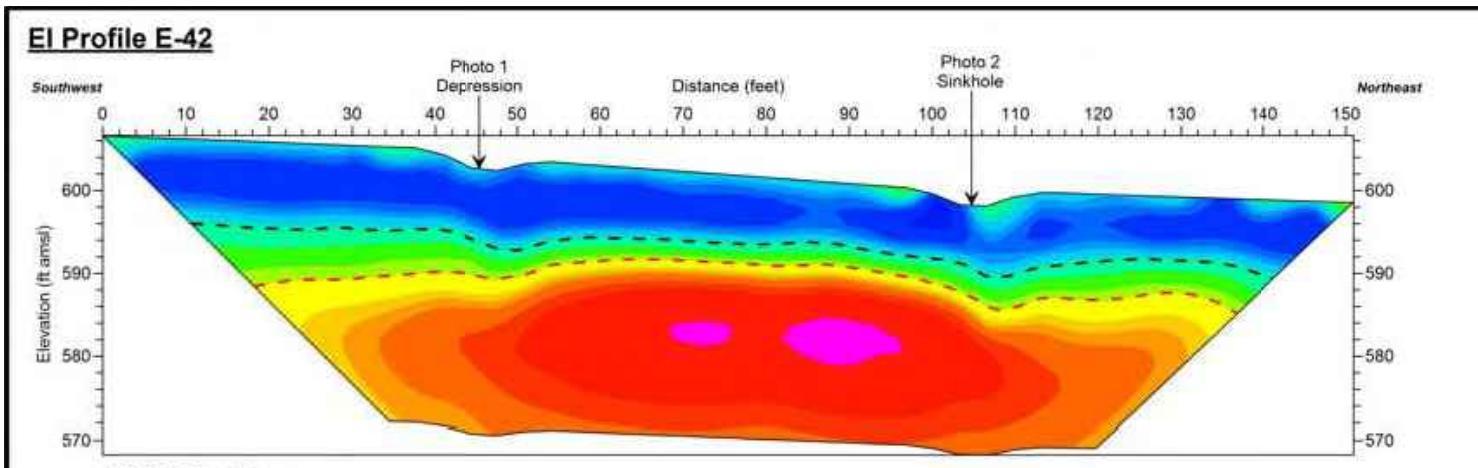
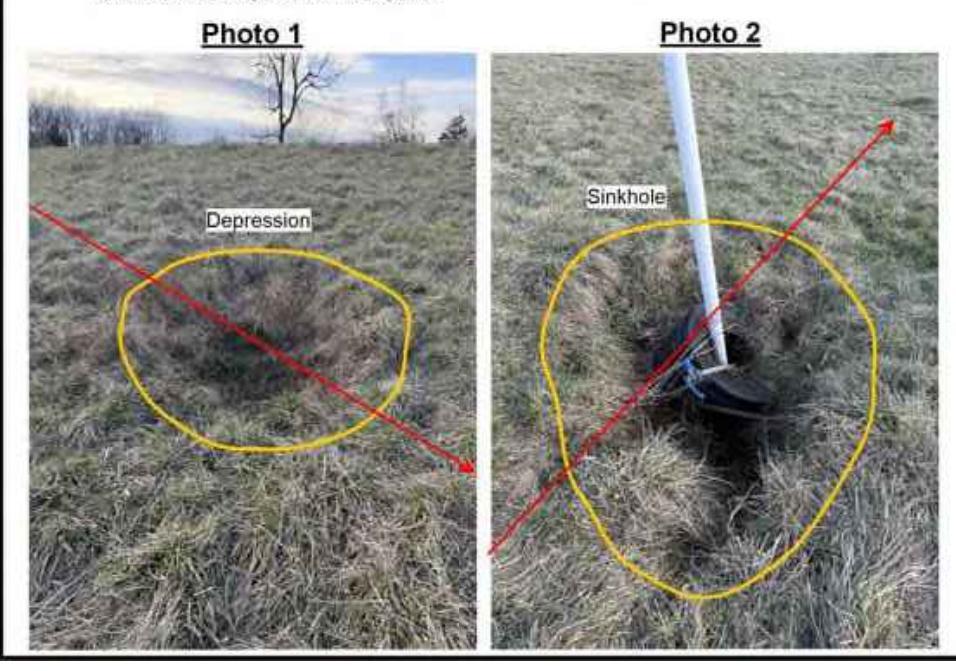
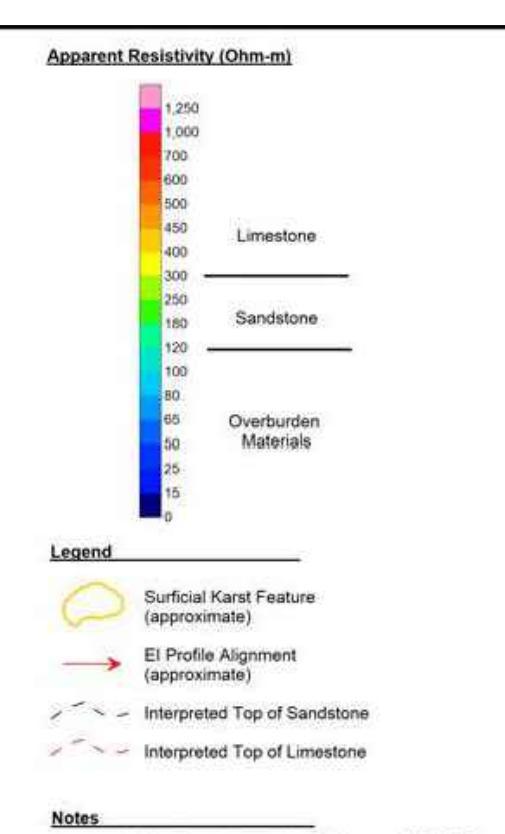
Both the interpreted top of sandstone and limestone are well-imaged in this profile and both appear to be relatively flay-lying. Beneath the depression, the El profile images a section of saturated soils overlying a slight dip in both interpreted rock surfaces. The dip in the rock surfaces is interpreted to be related to differential dissolution of the limestone along this interval and may contain clay-filled fractures or vugs. Beneath the sinkhole is a shallow pocket of slightly elevated apparent resistivities that is interpreted as poorly consolidated sediments or slightly dryer sediments related to the downward movement of water and materials into deeper limestone fractures or vugs. A dip in both rock surfaces is also imaged directly beneath the sinkhole and is interpreted to be related to differential dissolution of the limestone along this interval and may contain clay-filled fractures or vugs. The interpreted limestone imaged along this profile appears to be predominantly competent, but shows some variability near the begging and end of the profile suggesting that rock competency varies somewhat within the unit. No air-filled voids or fractures are interpreted within this profile.

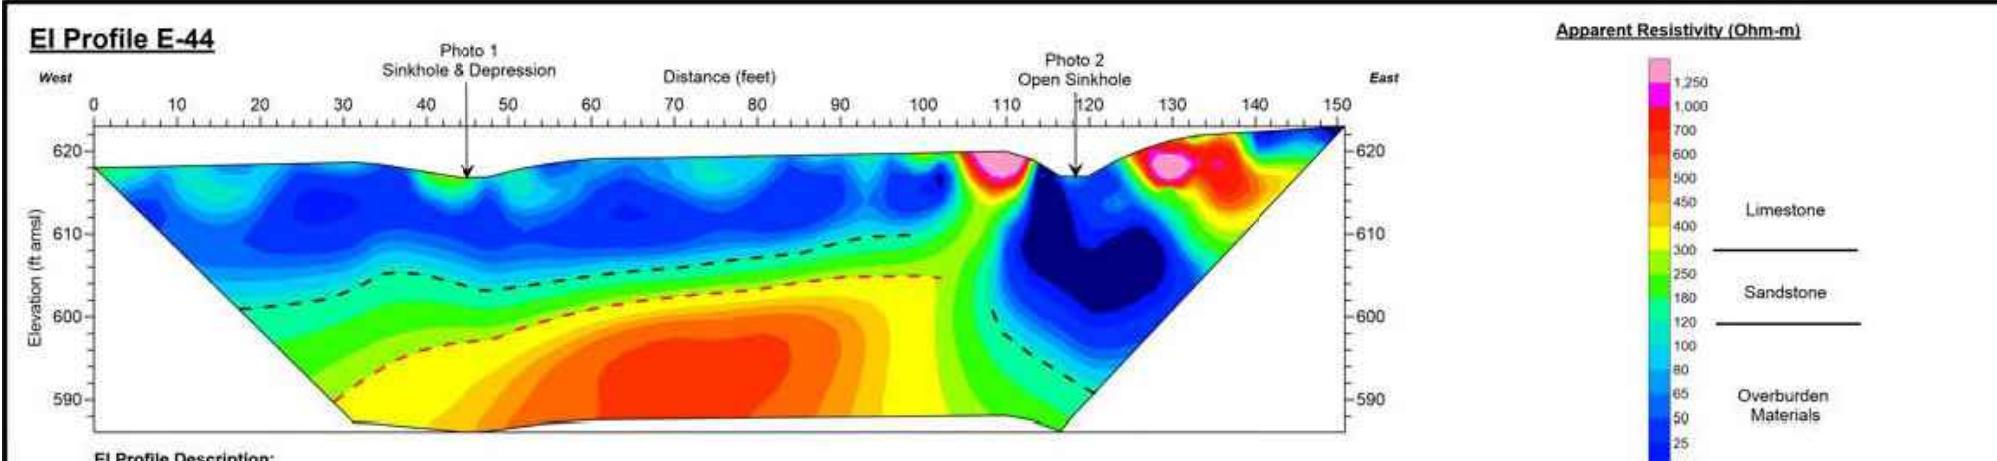
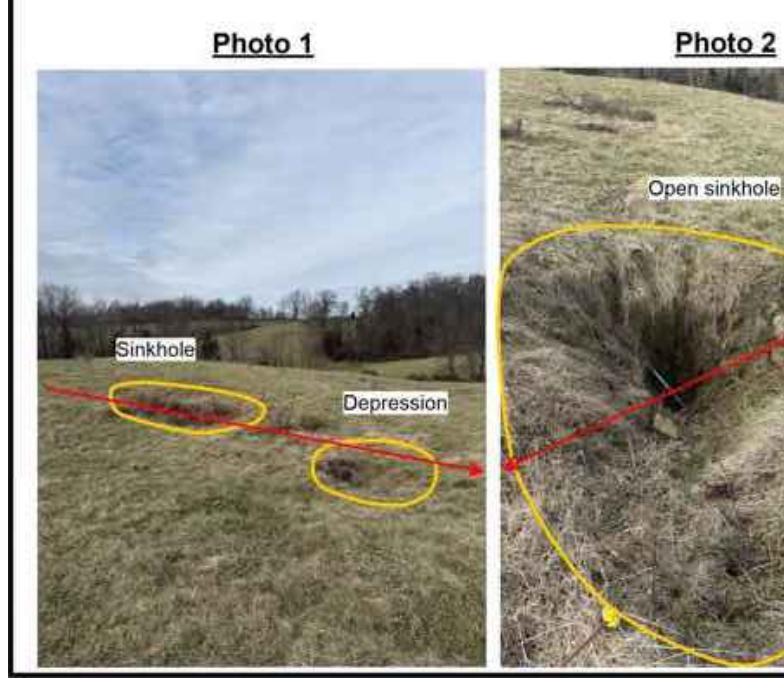
Both the interpreted top of sandstone and limestone are well-imaged by this profile and appear to be relatively flat-lying for the majority of the profiles length. Beneath the sinkhole and depression at 45 feet along the profile, the interpreted rock surfaces slightly dip and the underlying limestone displays slightly decreased apparent resistivities suggesting a fracture zone or interval of vuggy rock. Beneath the open sinkhole, the EI data maps several very resistive pockets interpreted as air-filled cavities within the soils, one of which appears to extend downward towards the interpreted limestone and may be a partially air-filed sinkhole throat. Additionally, from 110 to 130 feet along the profile, no limestone is imaged and the interpreted sandstone abruptly dips suggesting that deeper limestone collapse may be present

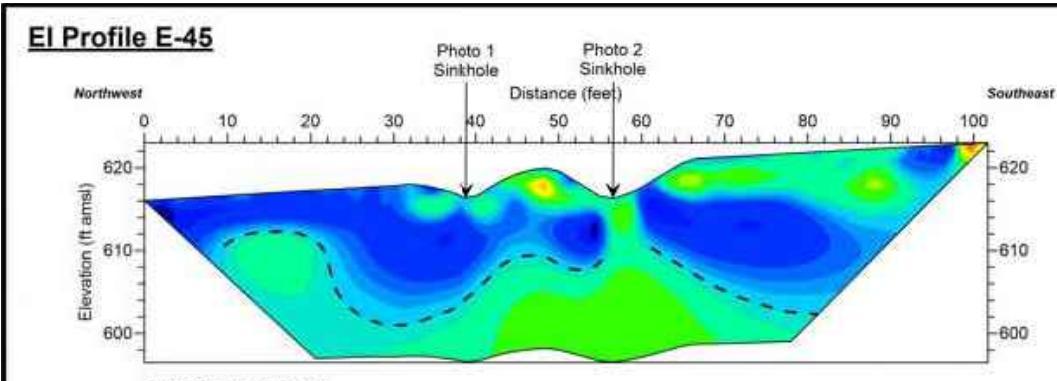
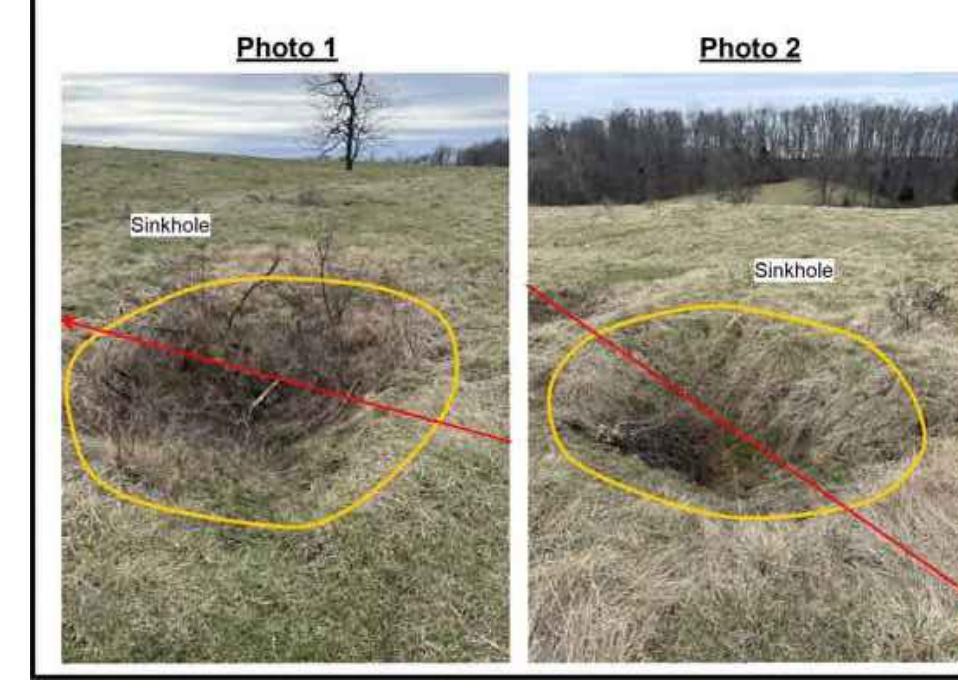
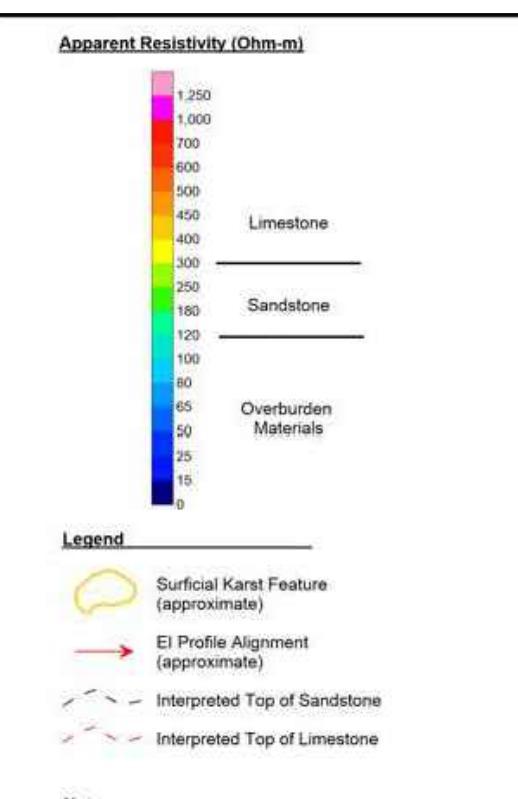
This profile images a highly variable interpreted top of sandstone surface across the profile. The variability in the top of rock elevations are attributed to differential dissolution and potential collapse of deeper limestone units. Limestone is not imaged in this profile. Beneath both sinkholes are shallow pockets of slightly elevated apparent resistivity that are interpreted as poorly consolidated or dry soils related to the downward movement of water and materials into deeper karst features such as voids, vuggs, or fractures. Additionally, a vertical column of elevated apparent resistivities is imaged beneath the sinkhole at 56 feet along the profile indicating that a partially air-filled sinkhole throat may be present into fractures within the interpreted sandstone.

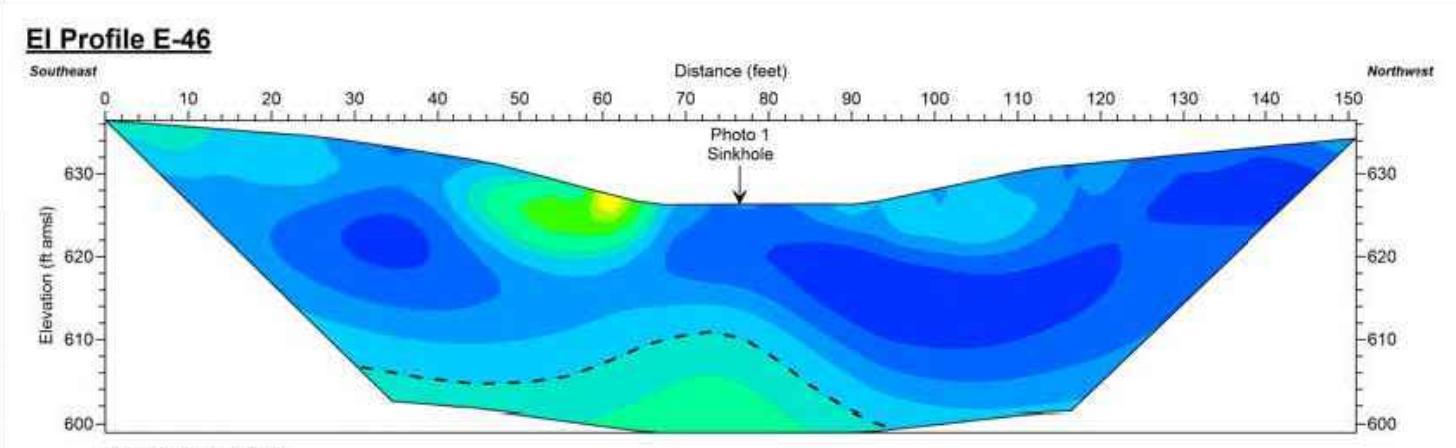
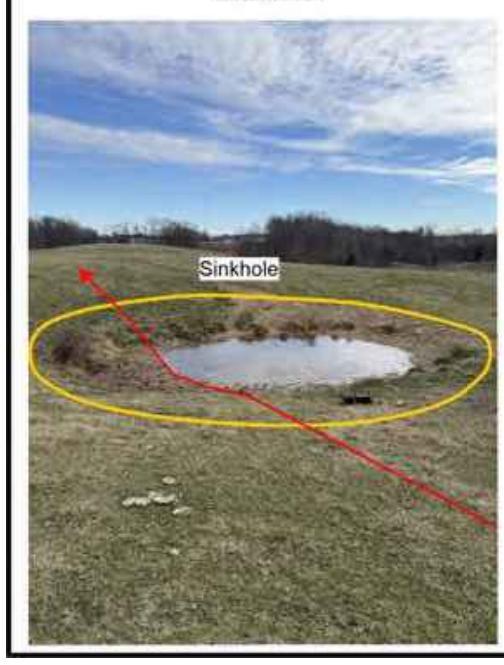
The interpreted top of sandstone is partially imaged near the base of the profile and is absent by 100 feet along the profile. The interpreted rock surface is undulating indicating differential dissolution and potential collapse of deeper limestone units and is likely the source of the sinkhole. No limestone is imaged in this profile. No air- or clay-filled voids or fractures are interpreted from this profile.

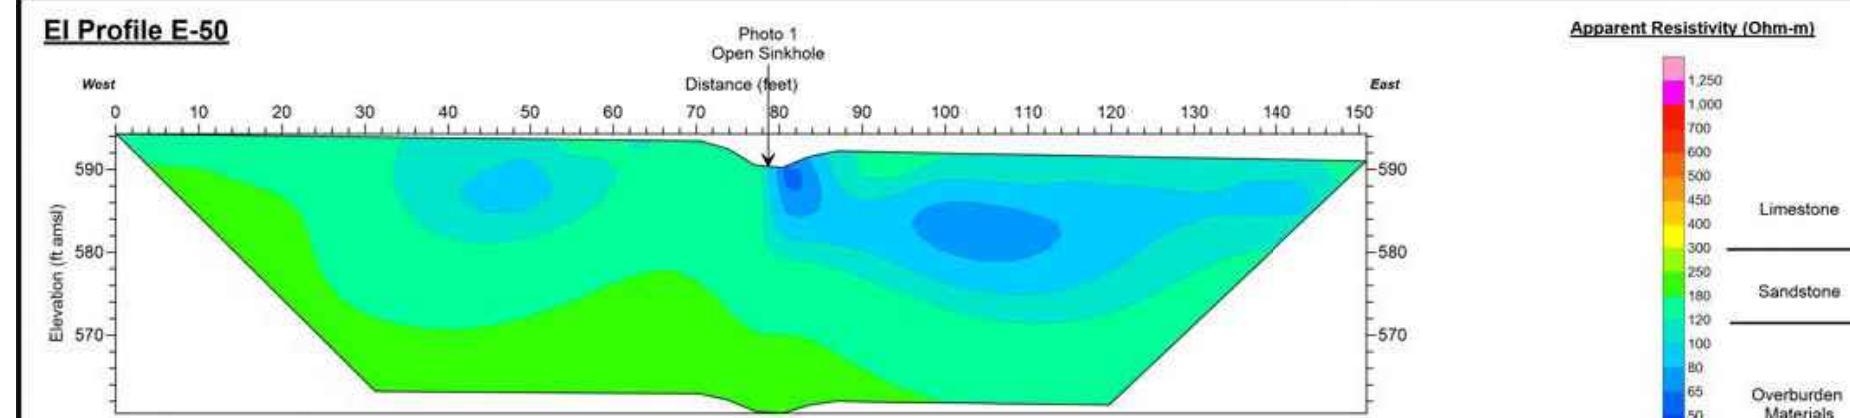
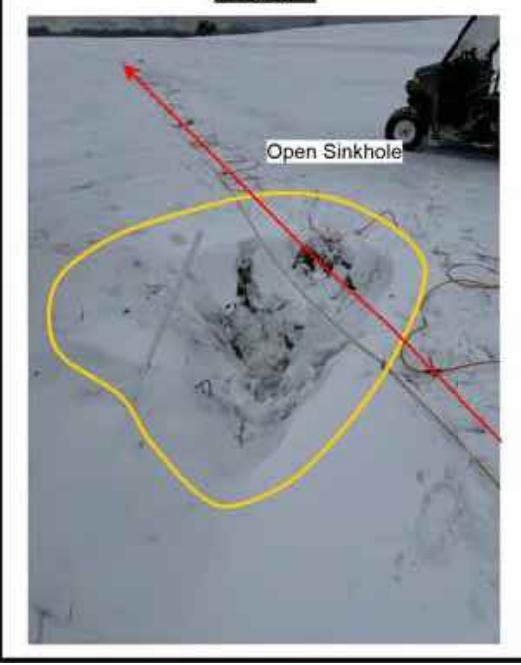
The apparent resistivities measured in this profile are consistent with interpreted sandstone indicating that sandstone is present at or near the surface. No limestone is imaged in this profile. Directly beneath the open sinkhole, a pocket of very low apparent resistivities is interpreted as a saturated, clay-filled through feature and appears to connect to a larger feature that extends towards the end of the profile. This extended low-resistivity feature is interpreted as a section of sandstone containing clay-filled/saturated fractures. Although limestone is not imaged, this sandstone fracture zone is likely related to deeper karst within underlying limestone. No air-filled voids or fractures are interpreted from this profile.

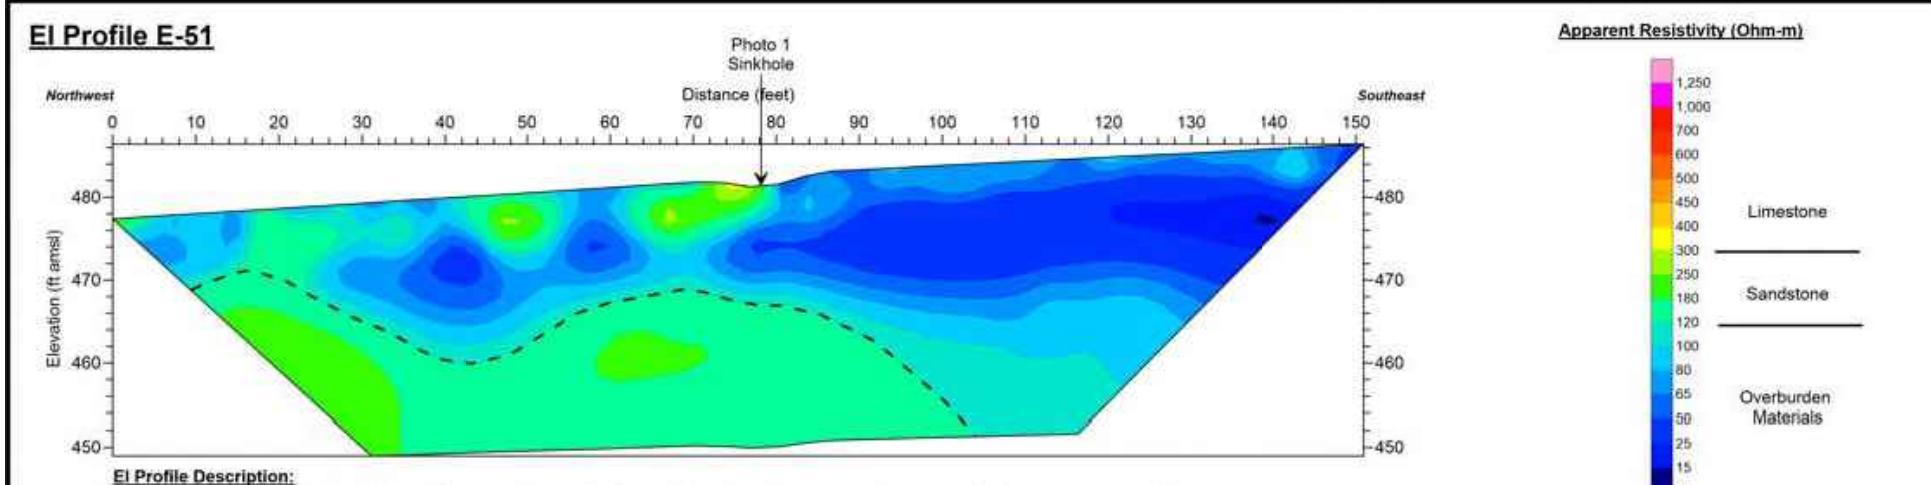
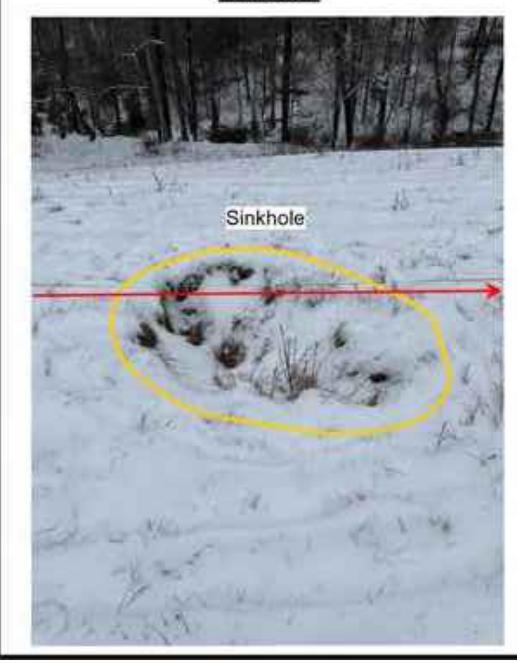
The interpreted top of sandstone is imaged by this profile and displays highly variable elevations and appears to dip deeper than the profile imaging depth by 110 feet along the profile. Limestone is not imaged in this profile. The variability of the sandstone elevation is indicative of deeper limestone collapse or differential dissolution. Beneath the sinkhole is a pocket of slightly elevated apparent resistivities interpreted as poorly consolidated or dryer sediments related to differential settlement into sandstone fractures. No air-filled voids or fractures are interpreted from this profile.

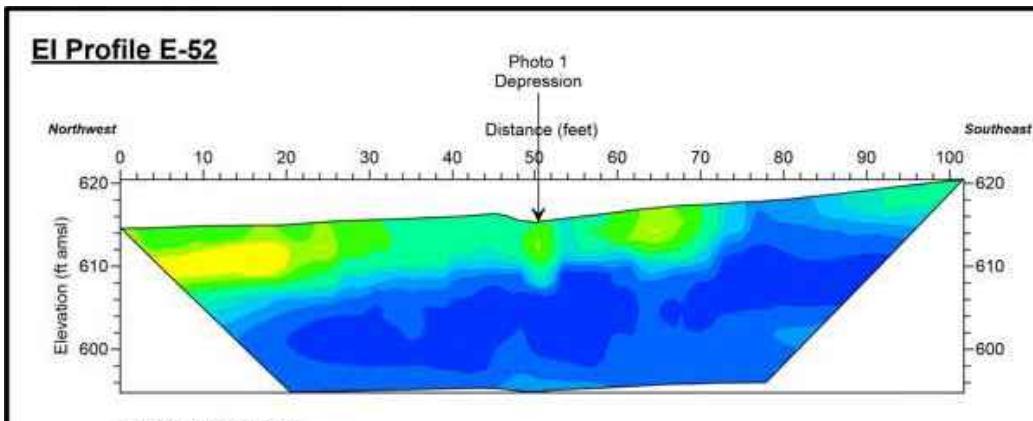
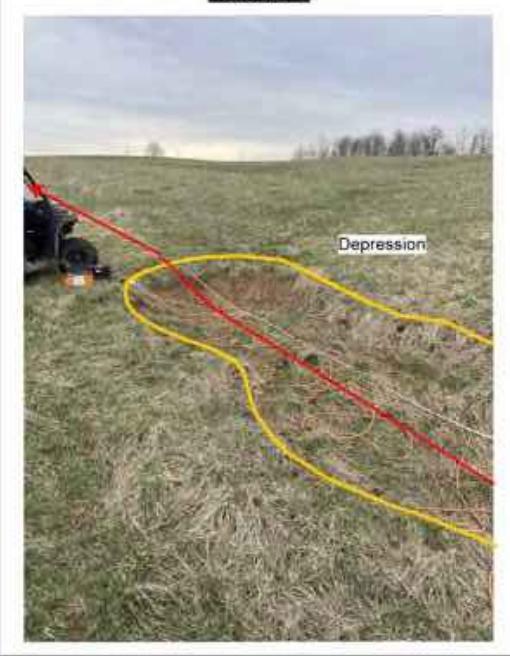
No rock is imaged in this EI profile and the profile is interpreted to map saturated soils to depth. No air- or clay-filled voids or fractures are interpreted in this EI profile and the source of the depression is likely related to karst within deeper limestone units.

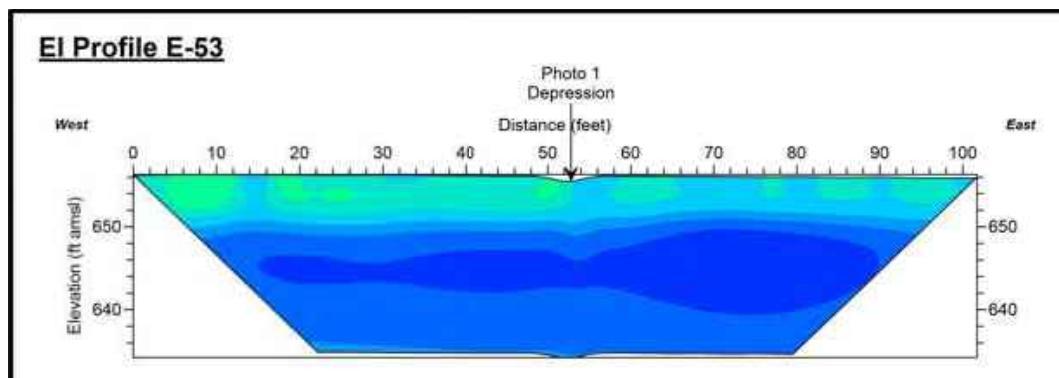
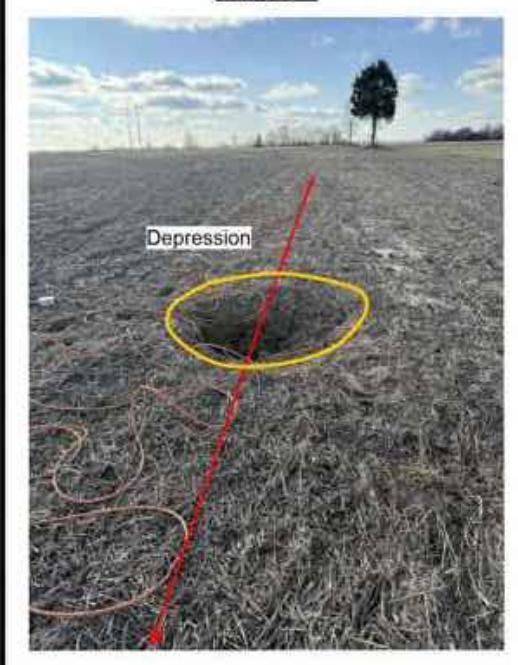
This profile measured very low apparent resistivities to depth interpreted as saturated soils. No rock is imaged in this profile. If rock is present, it is interpreted to be highly saturated. The source of the depression is unclear as rock is not imaged; however, it is possible that this feature is related to sediment piping along potential drainage tile that may be within this agricultural field. No air- or clay-filled voids or fractures are interpreted from this profile.

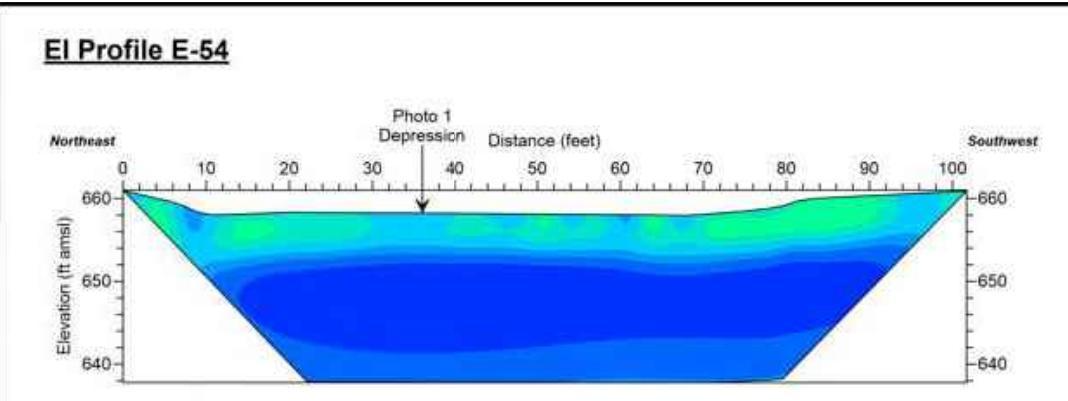
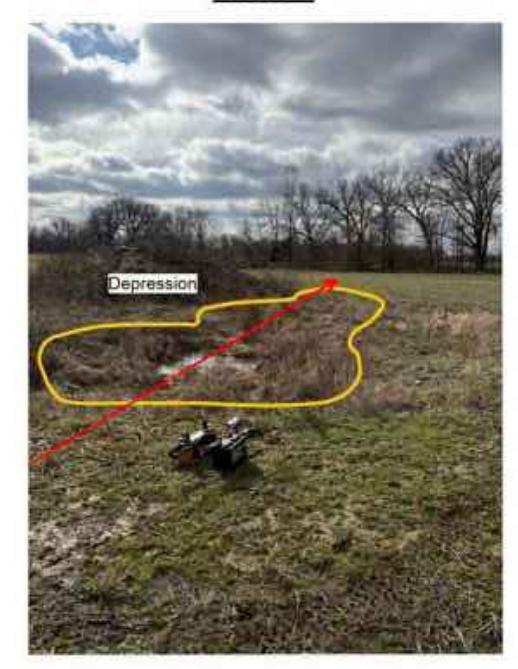
This profile measured very low apparent resistivities to depth interpreted as saturated soils. No rock is imaged in this profile. If rock is present, it is interpreted to be highly saturated. The source of the depression is unclear as rock is interpreted to be related to collapse of deeper limestone units. No air- or clay-filled voids or fractures are interpreted from this profile.
