Engineering Services
14713 Jersey Shore Drive
Houston, TX 77047
Phone 713-433-2155
Fax 713-433-2558
www.structural.net

**CONDITION SURVEY AND EVALUATION OF
THE CONCRETE HYPERBOLIC COOLING
TOWER SUPERSTRUCTURE SHELL IN UNIT
NO. 1 AT AEP'S BIG SANDY POWER PLANT**

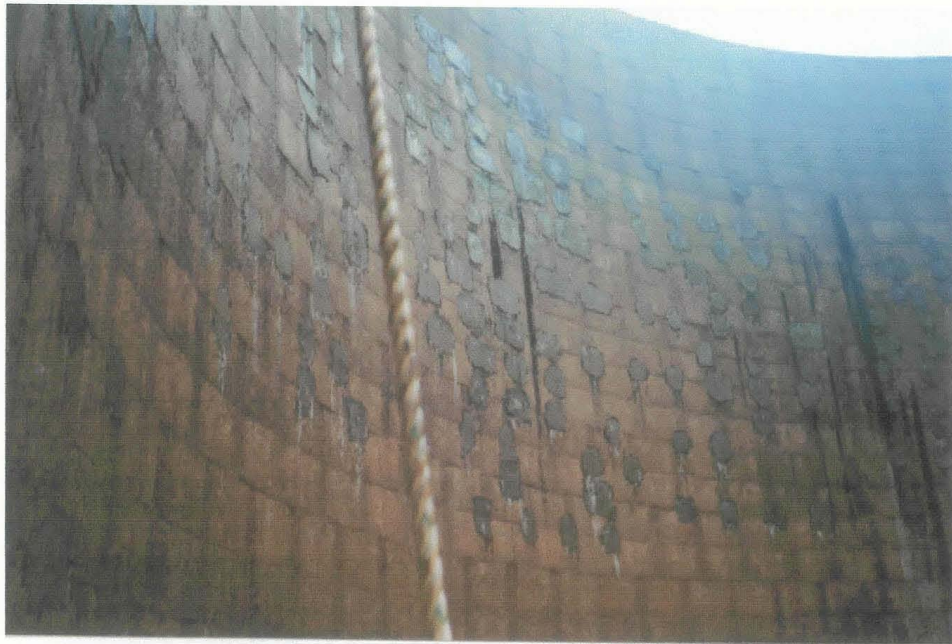
Site Photograph No. 6 Patch repairs on interior face of Cooling Tower Shell

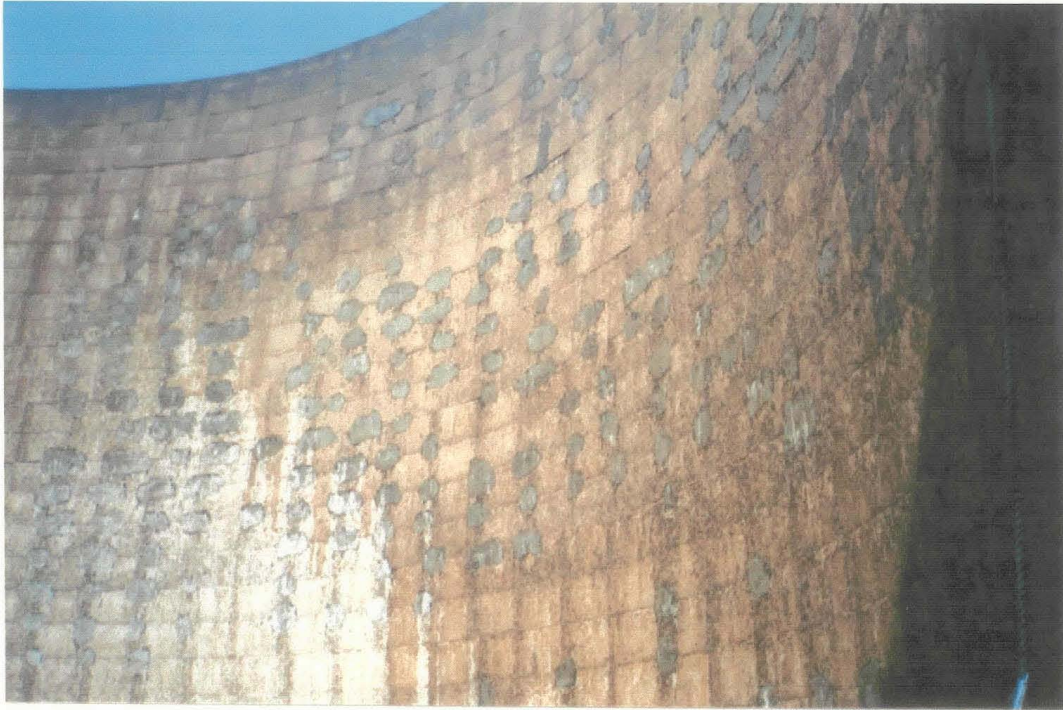
Specimen Photograph No. 7 Patch repairs on interior face on Cooling Tower Shell

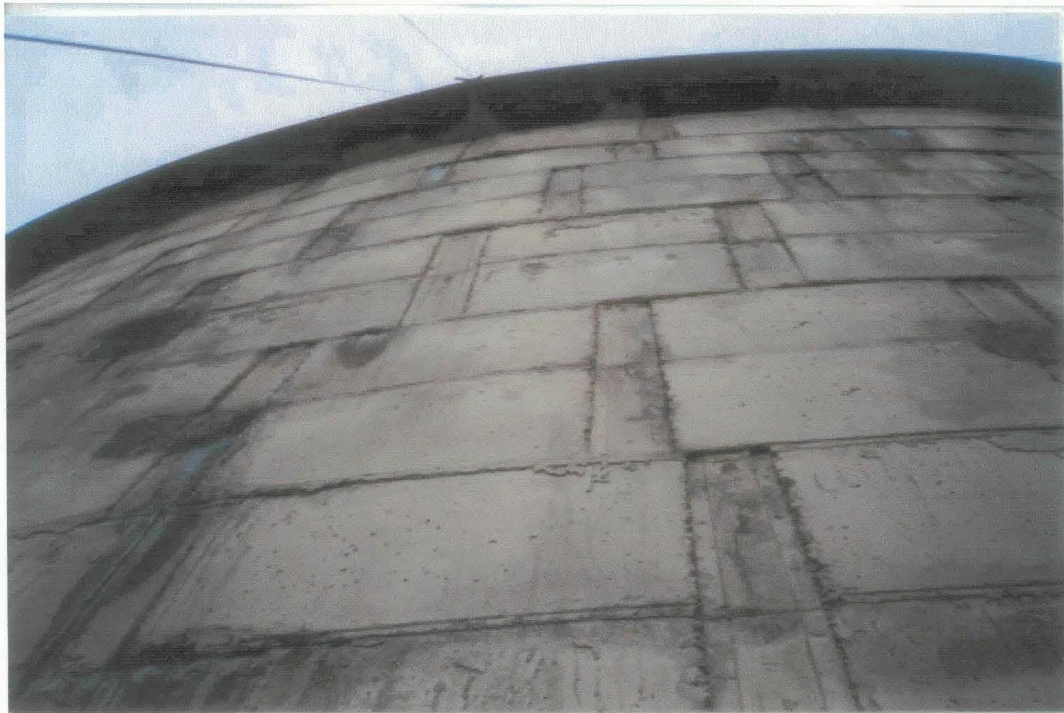
Site Photograph No. 8 Patch repairs and close-up of jump panel formwork impressions on exterior face on Cooling Tower Shell

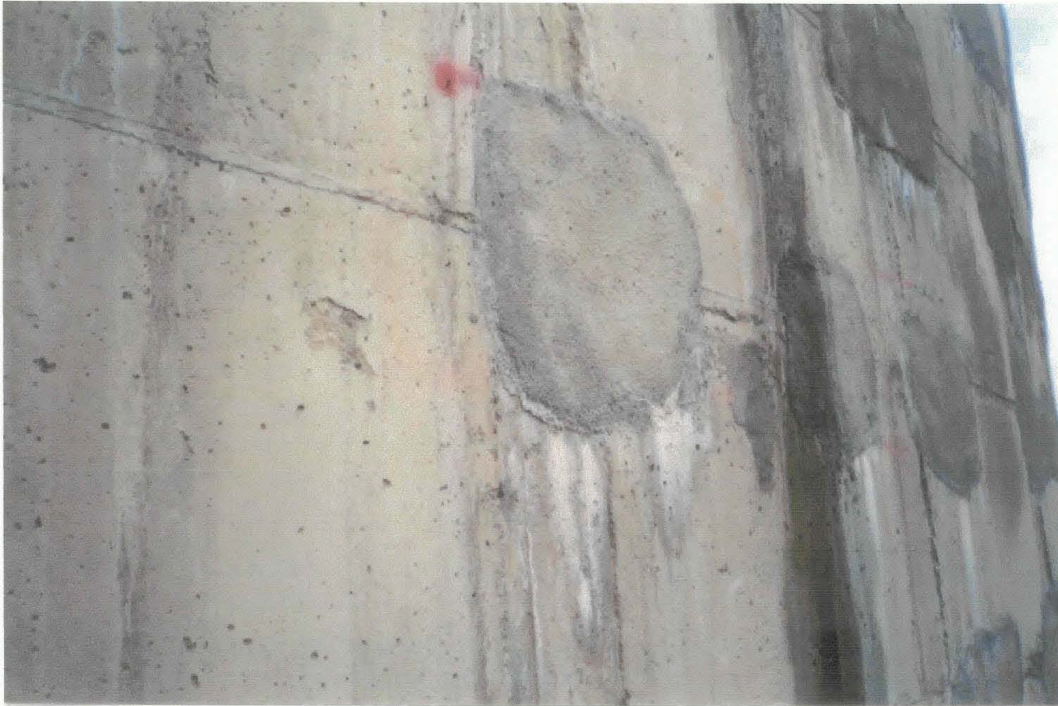
**Specimen Photograph No. 9 Patch repairs on exterior face of Cooling Tower Shell.
Note efflorescence and water leakage conditions along patch perimeter**

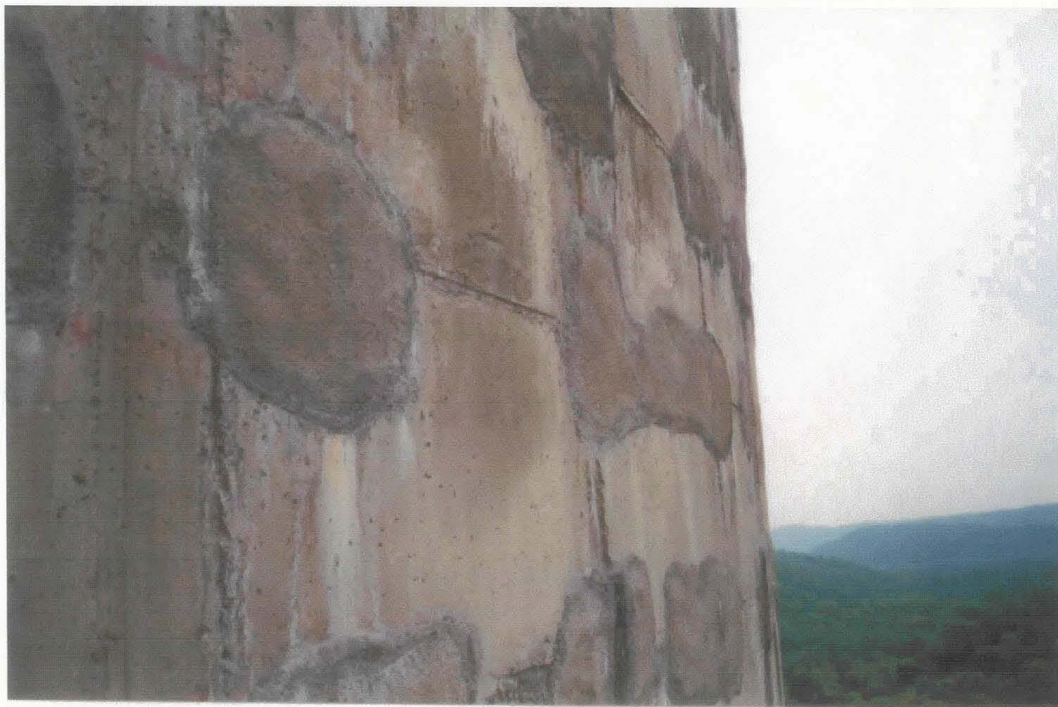
**Site Photograph No. 10 Patch repairs on exterior face of Cooling Tower Shell.
Note irregular patch repair configuration**

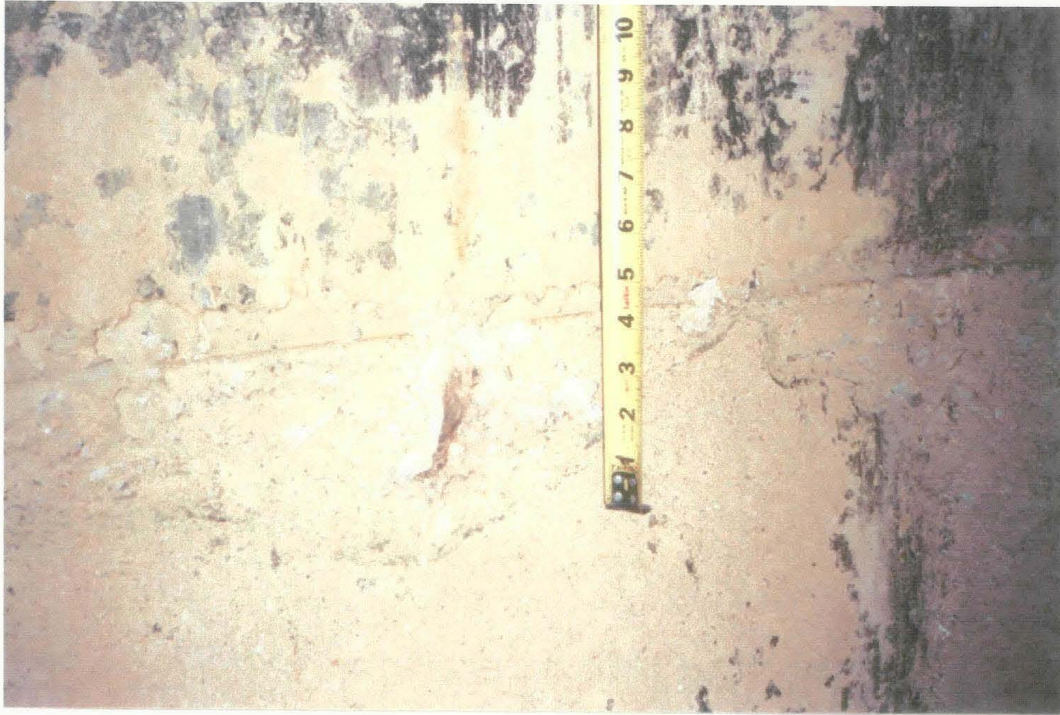
Specimen Photograph No. 11 Typical honeycomb at panel joint locations

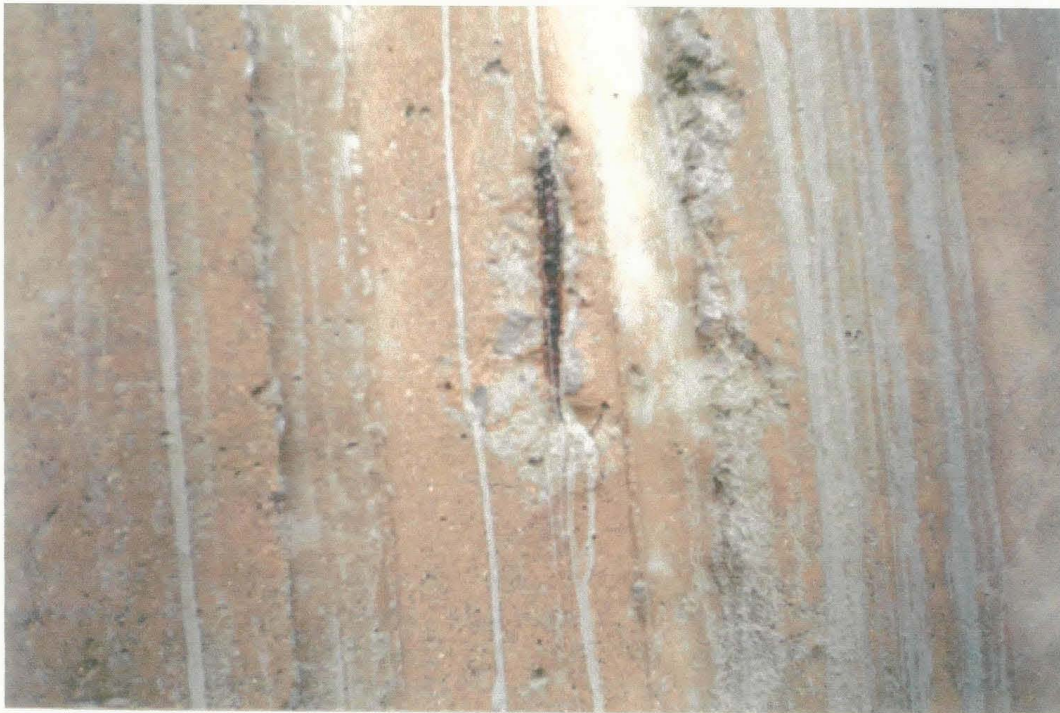
Specimen Photograph No. 12 Corroded rebar

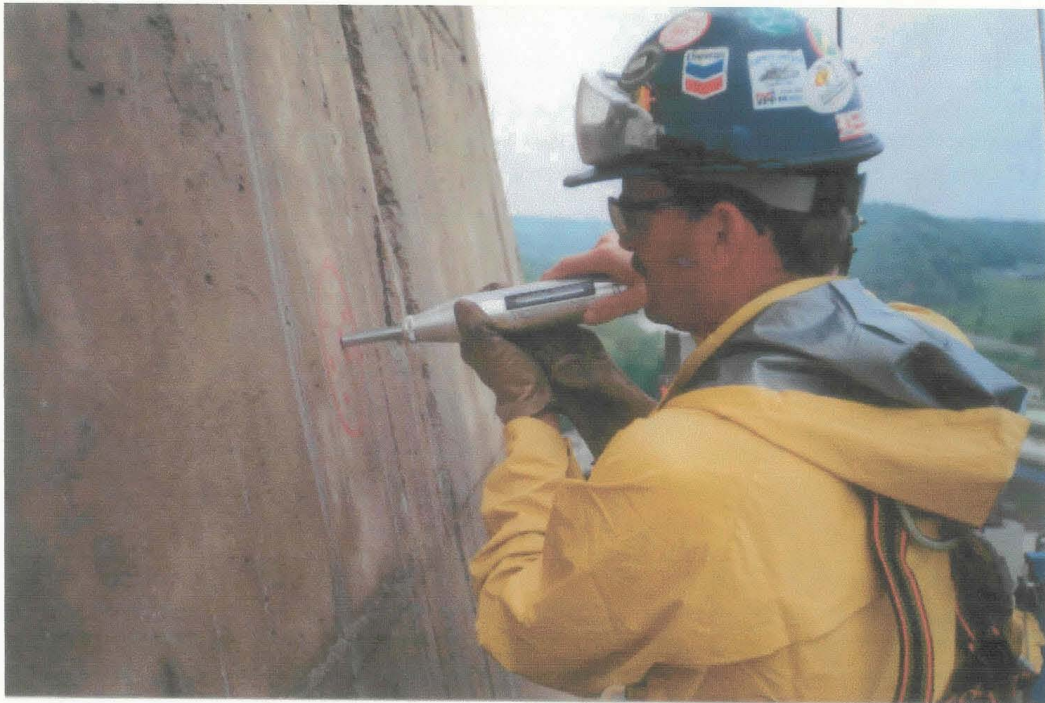
Specimen Photograph No. 13 Rebound hammer testing

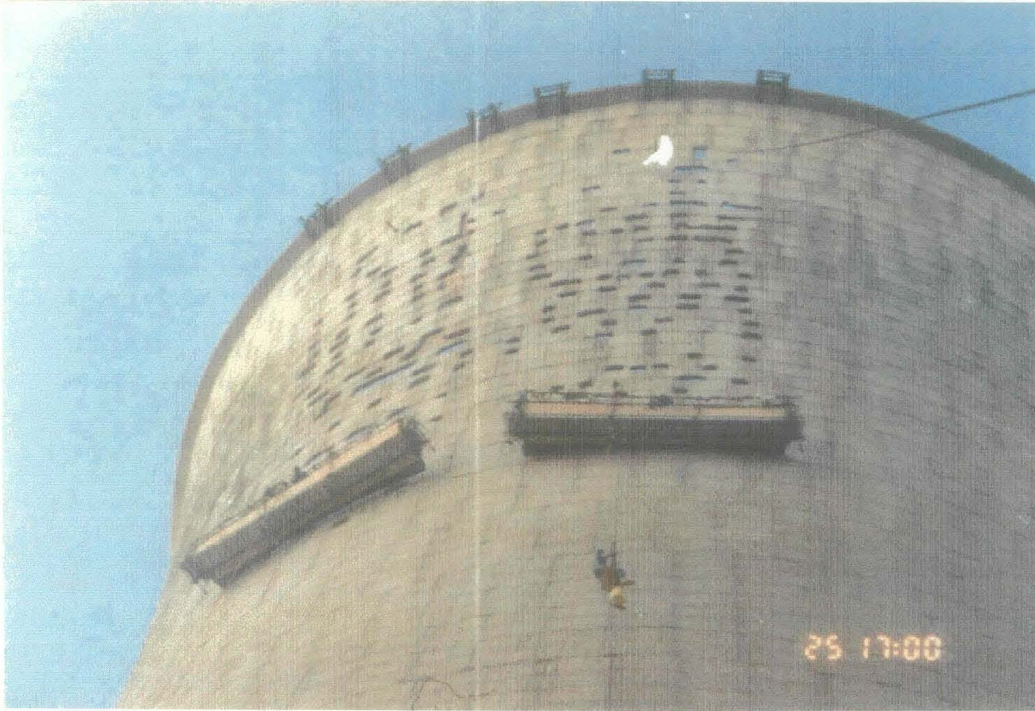
Repair process in progress

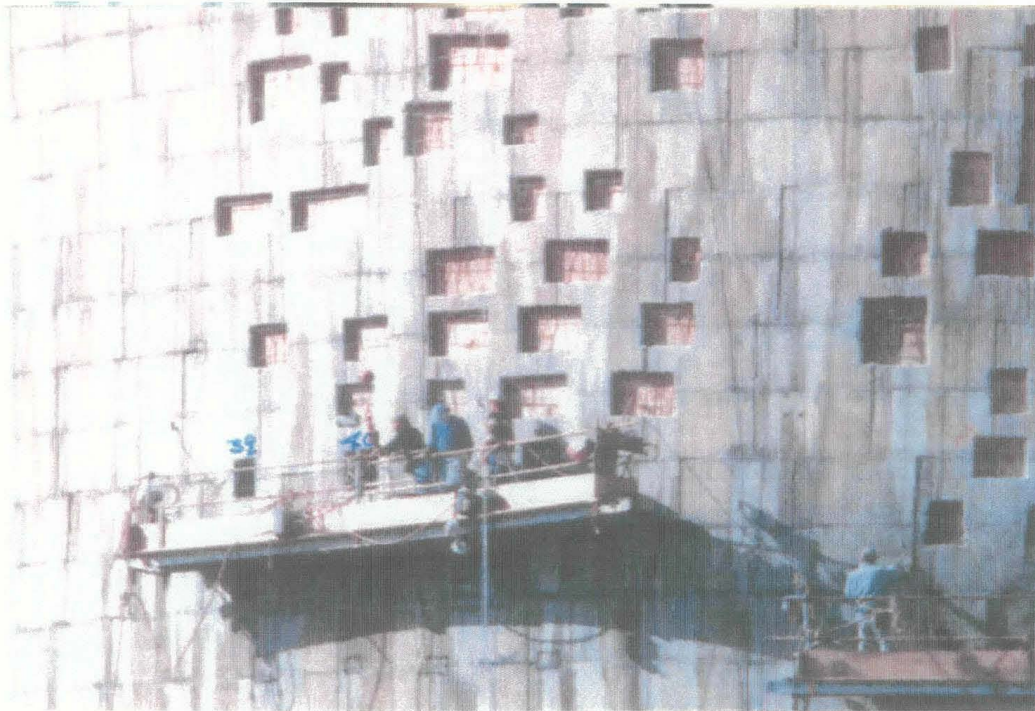
Close-up view of scaffold and formed repair areas

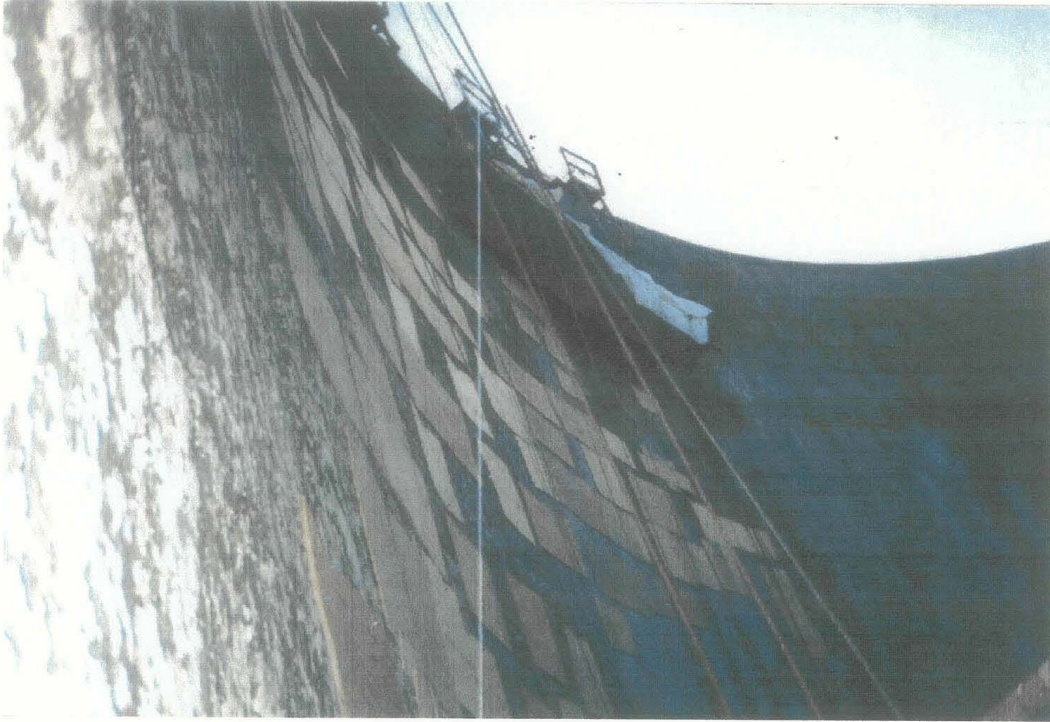
Forms on interior of shell

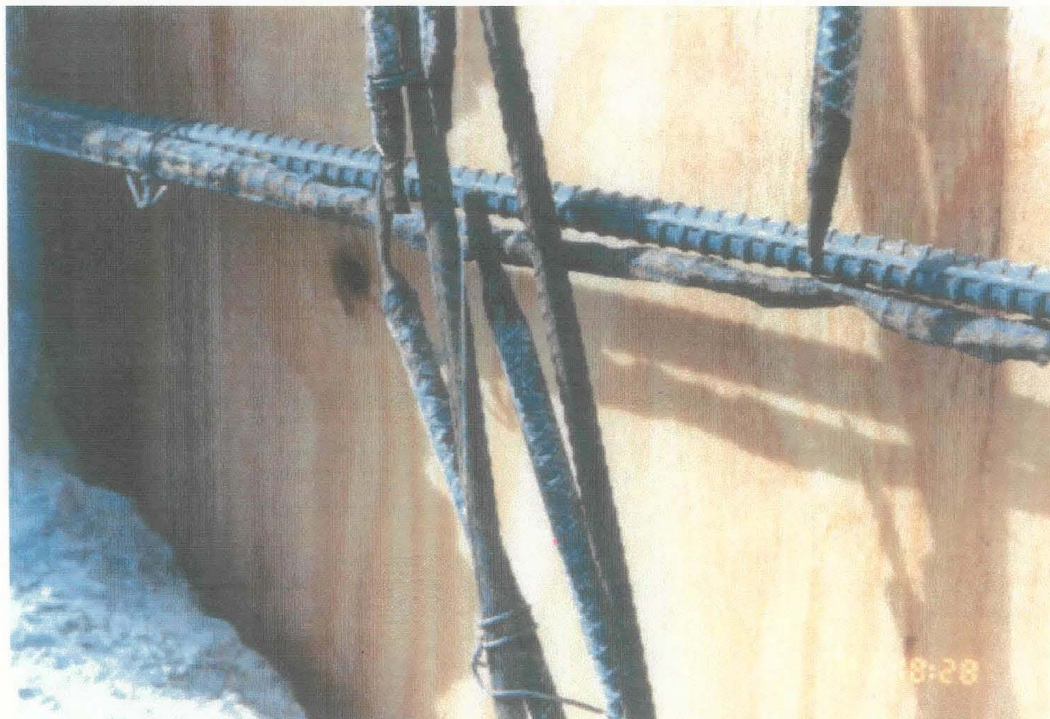
Reinforcement with corrosion - induced section losses

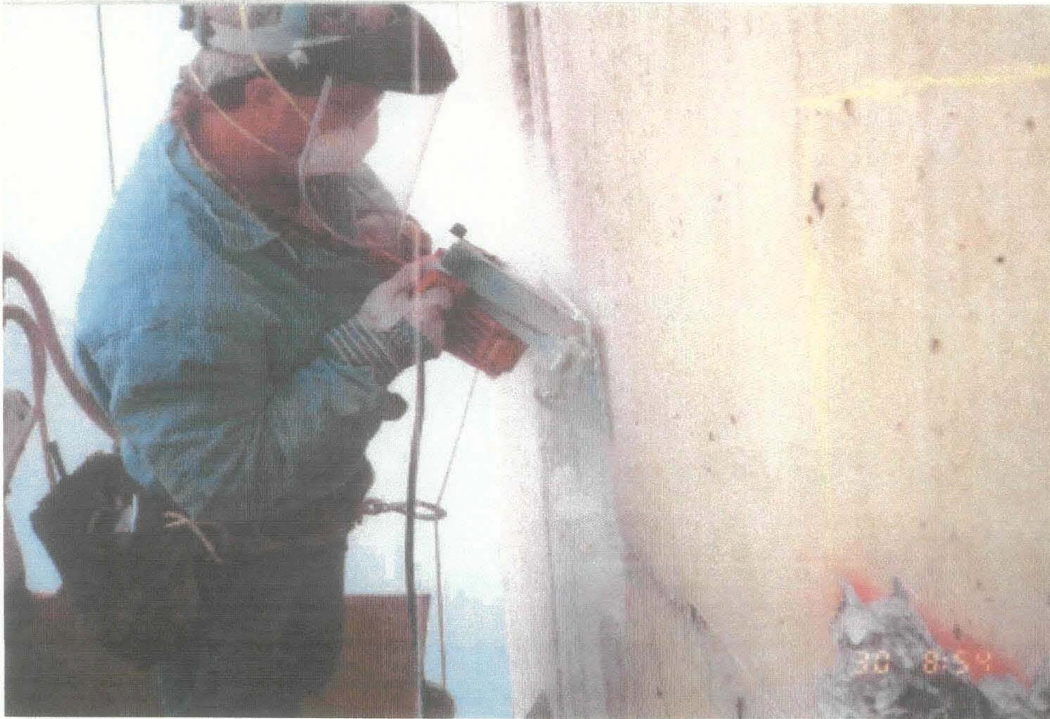
Saw-cutting around perimeter of repair areas

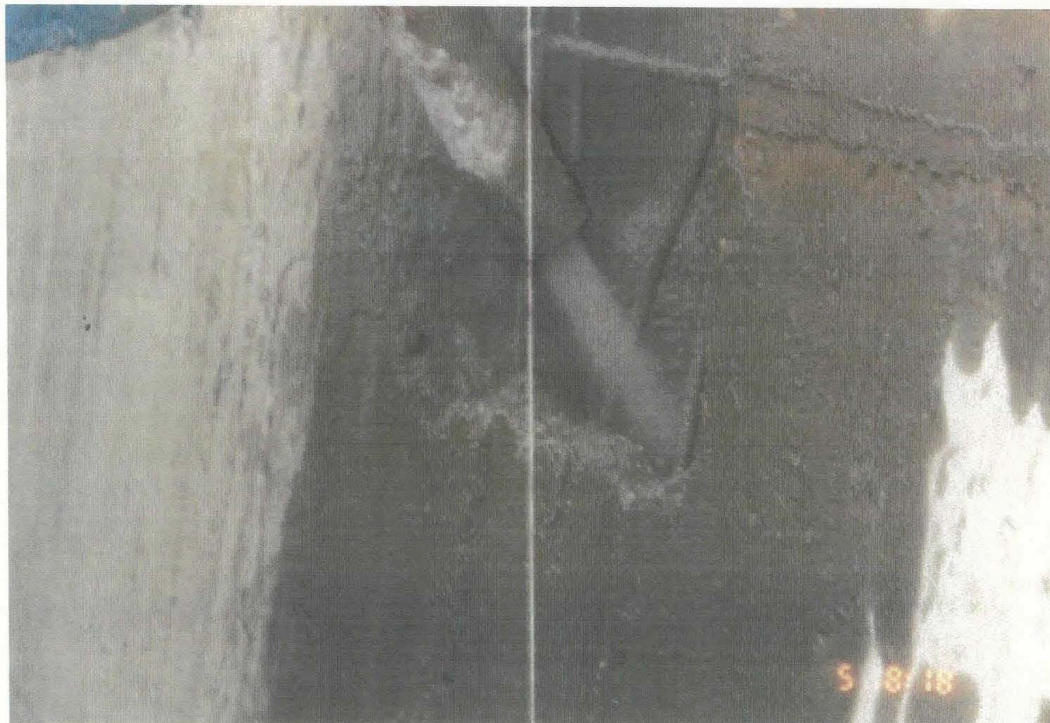
Shotcrete repair in progress

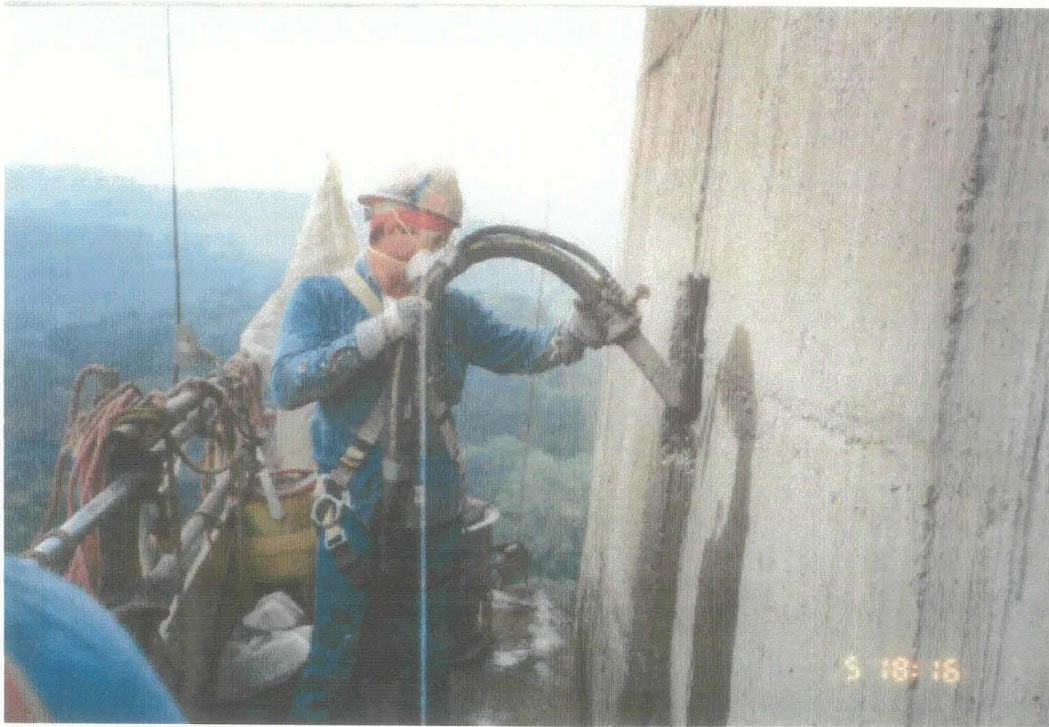
Shotcrete repair in progress

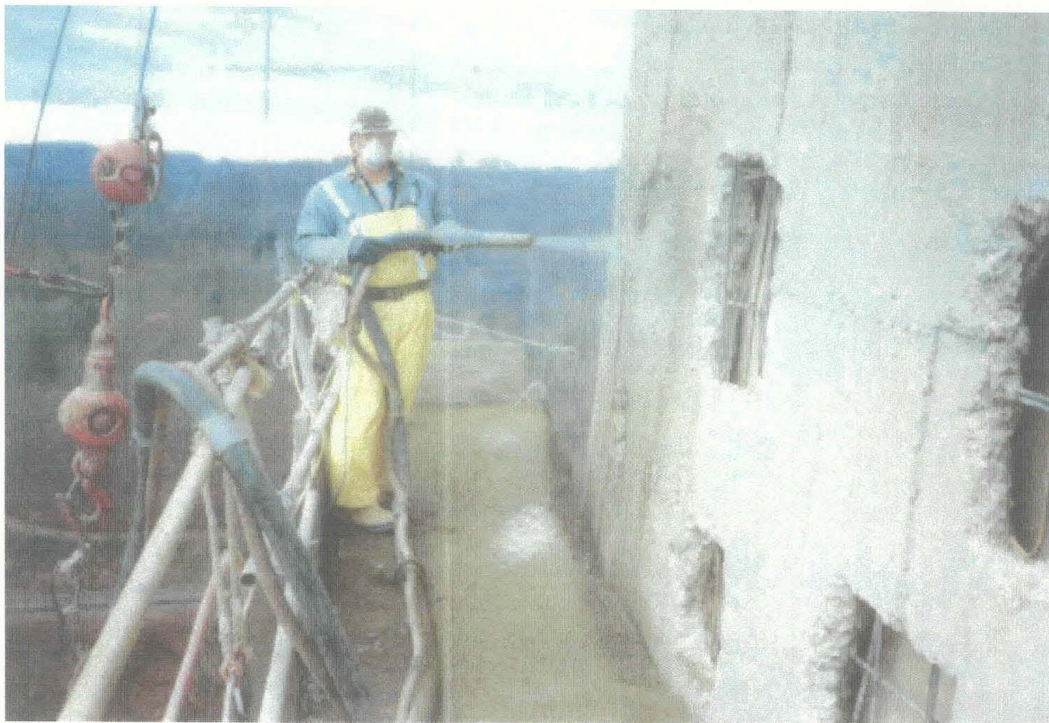
Shotcrete repair in progress

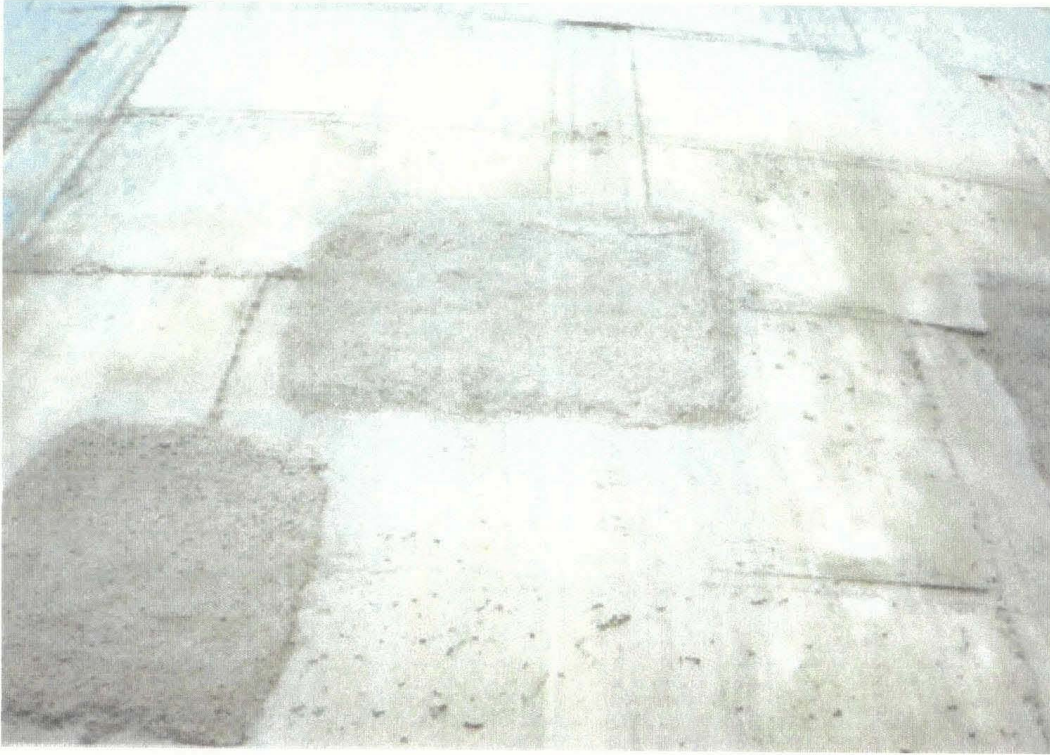
Completed patch repairs

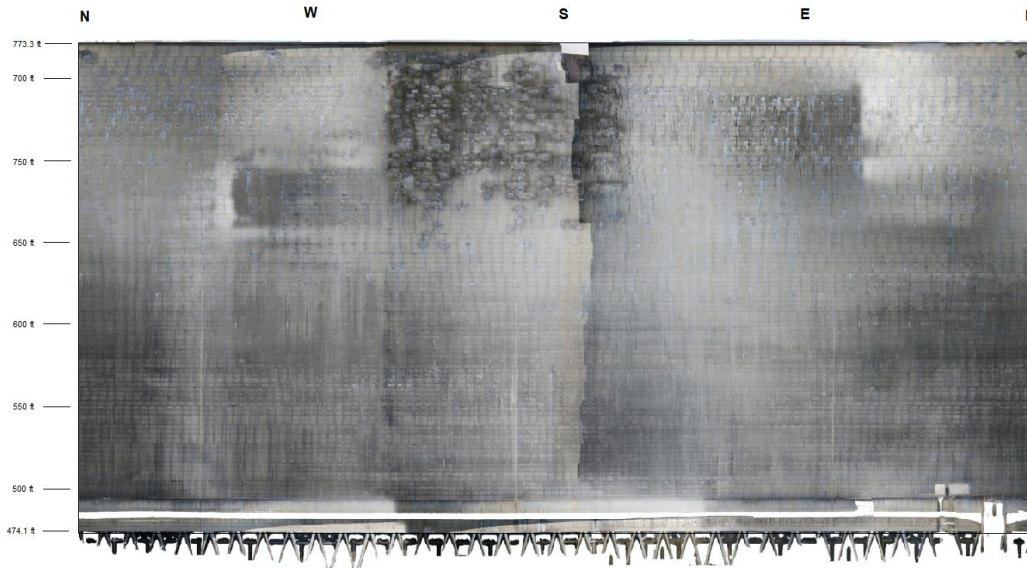
Cylindrical unwrapping

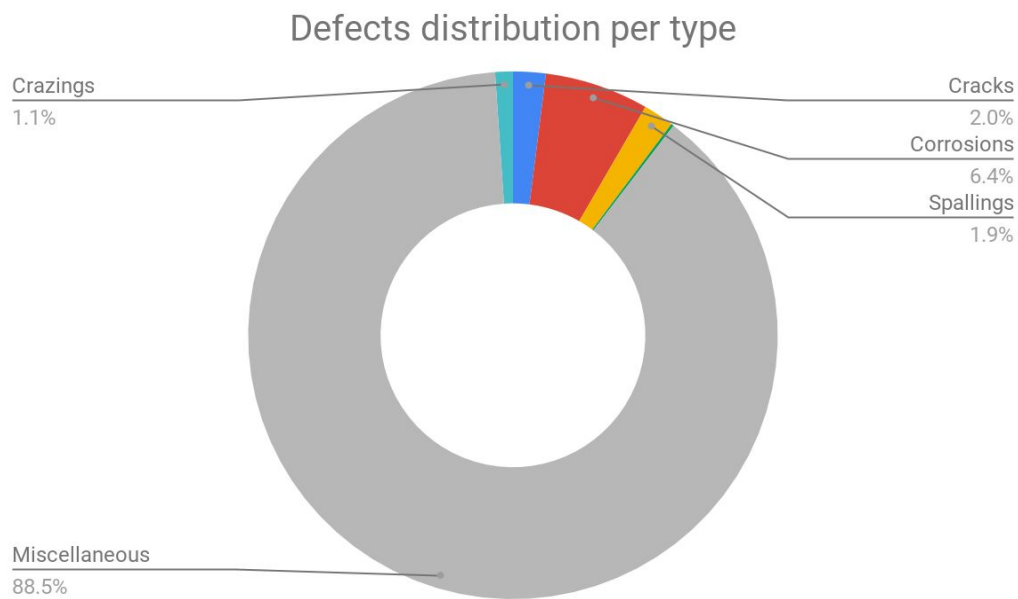
Defects are spread all over the tower, except on the upper southwest part, which has undergone repairs in 2010. Other quadrants were repaired in the late 80's early 90's.

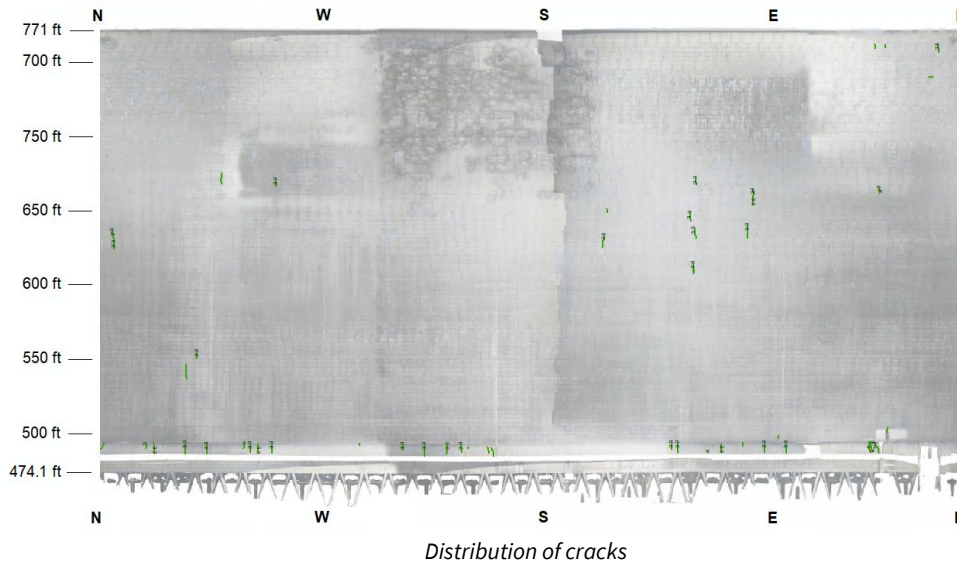
7.2.1. Crack distribution and histogram per length classification

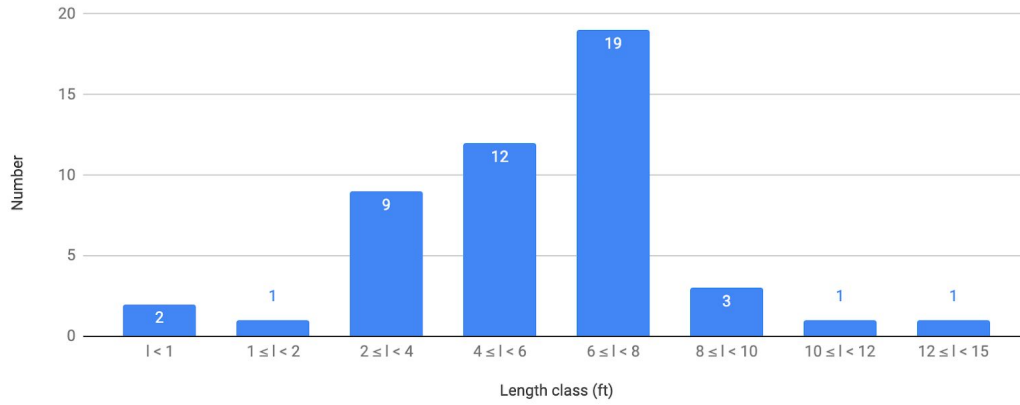
Cracks distribution per length

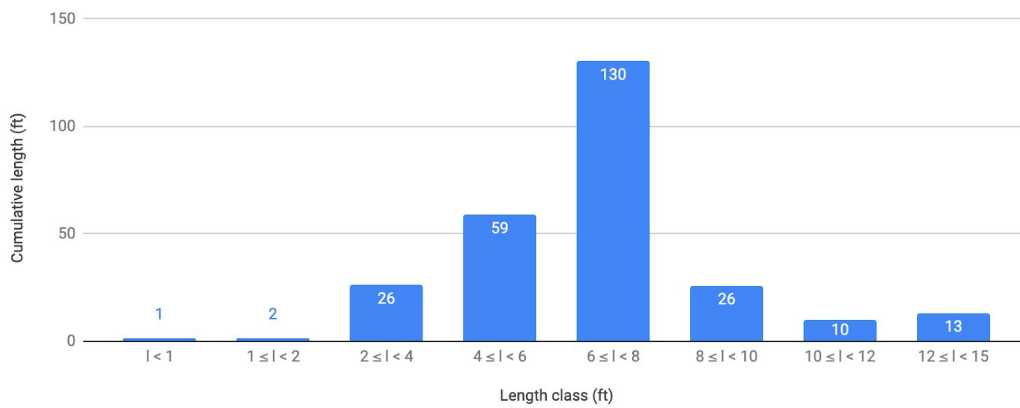
7.2.2. Crack distribution and histogram per opening classification (mm)

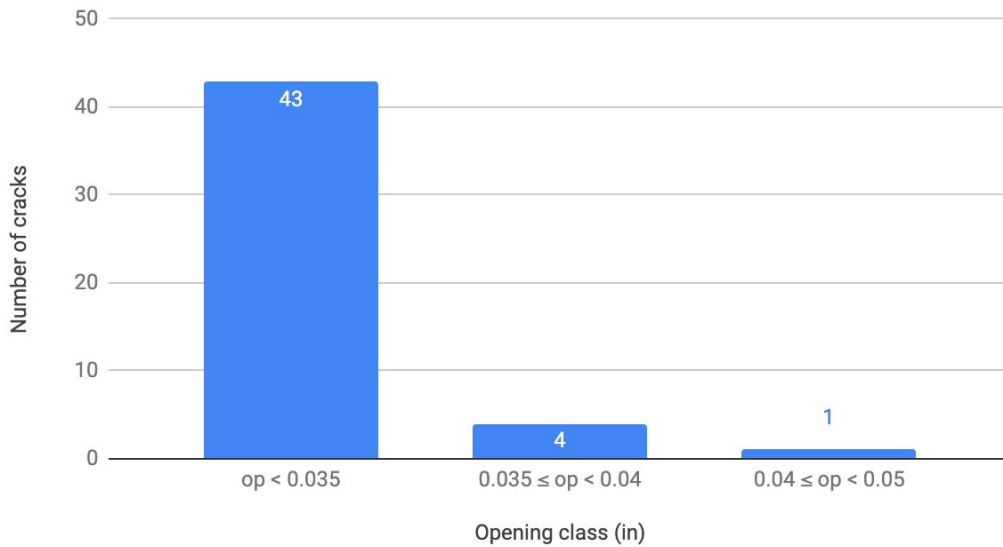
Cracks distribution per opening

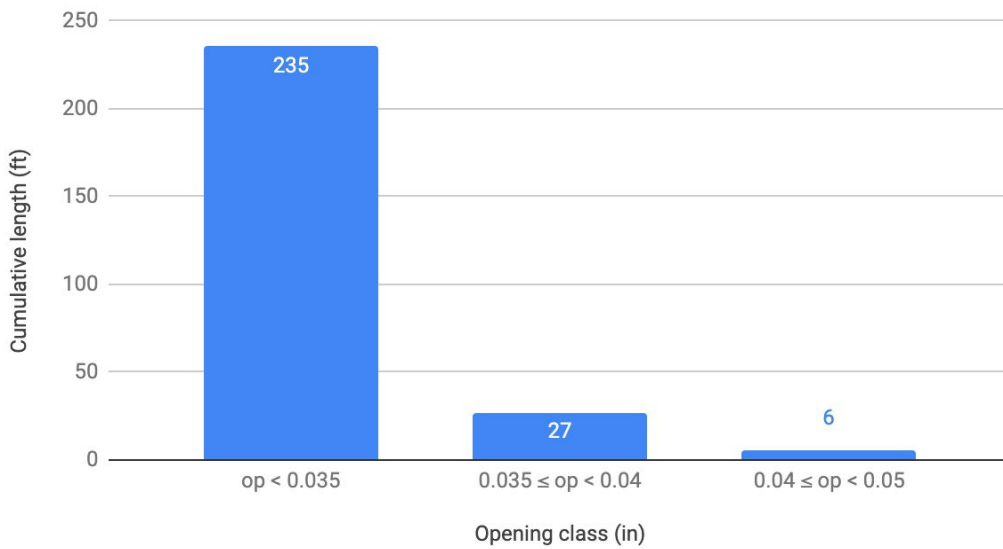
7.2.3. Crack distribution per orientation

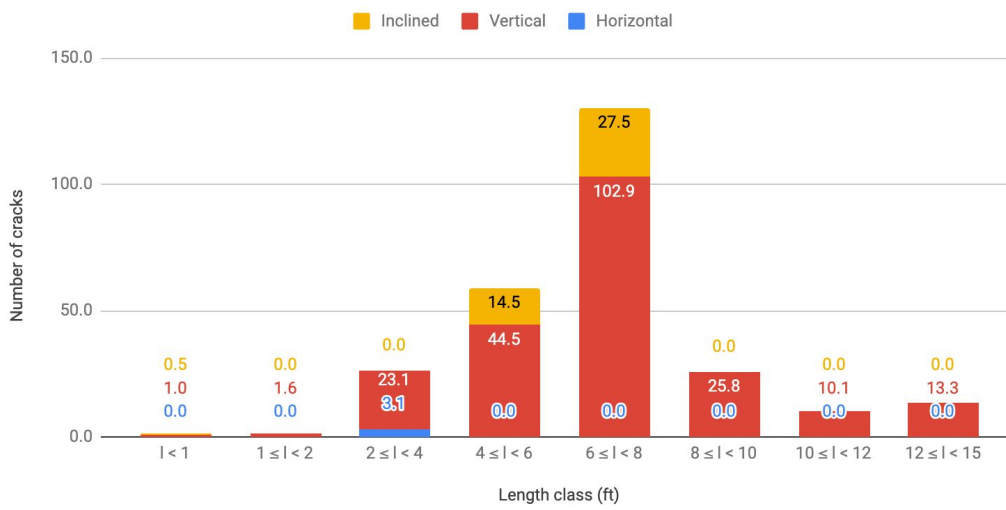
7.3. Seepage and efflorescence

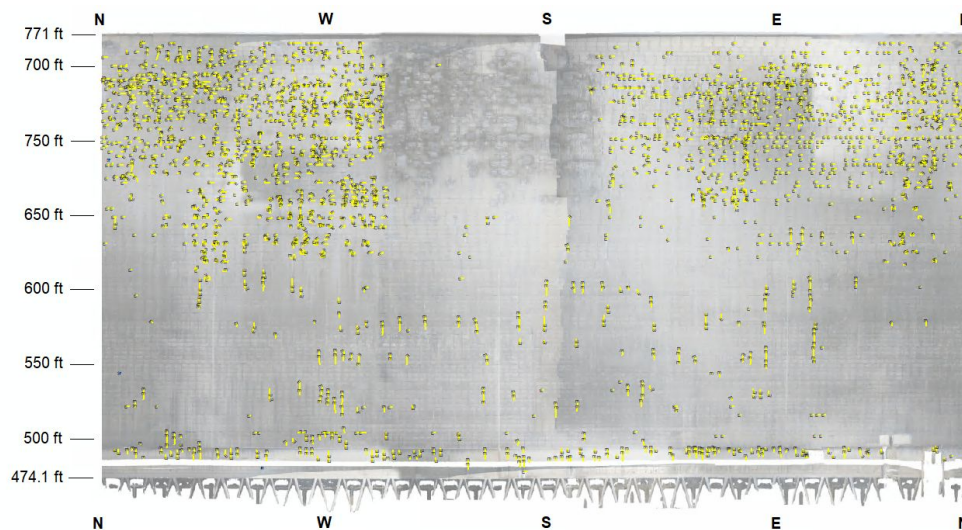
Distribution of seepage and efflorescence

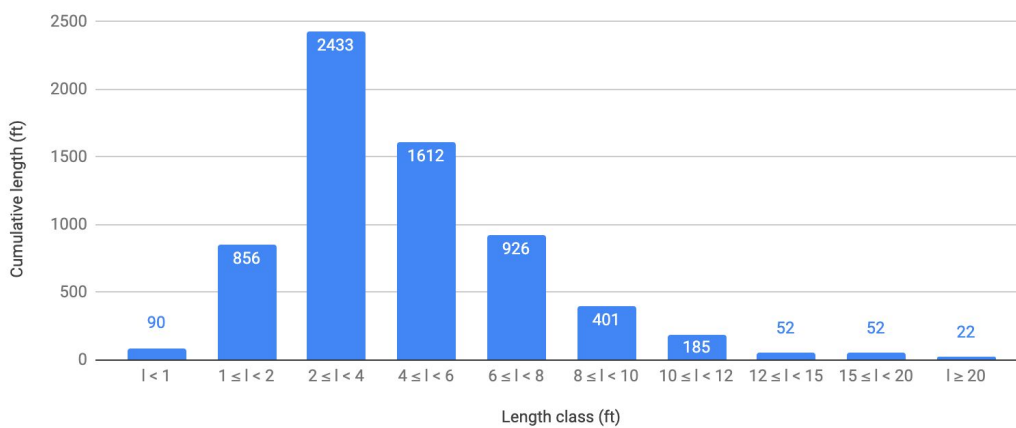
7.4. Holes and falling risk

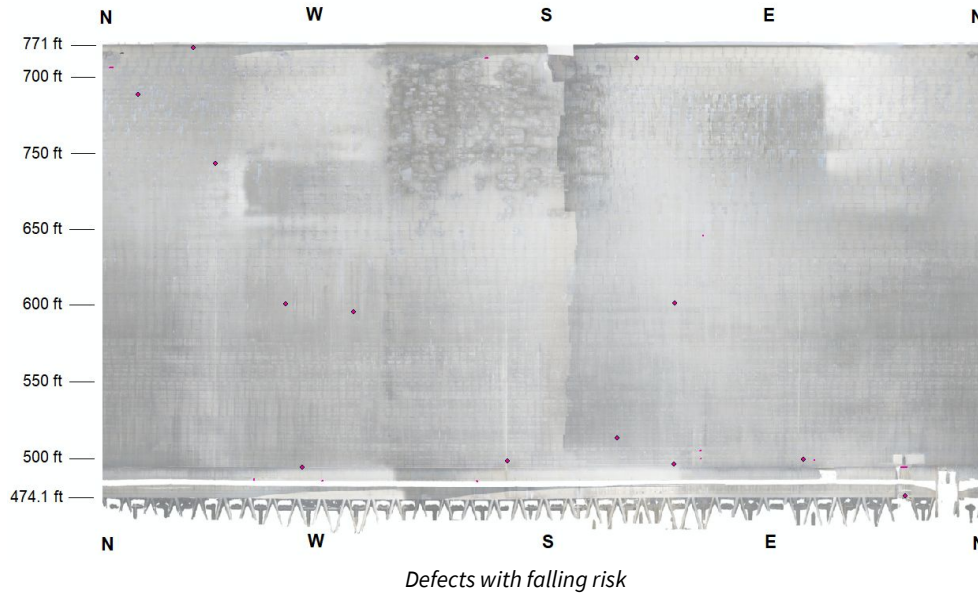
Defects with falling risks are represented on the figure above by pink dots and lines. Please refer to the 2d files + QGIS to precisely locate defects on the tower. The following captures show examples of these spalling defects with falling risks.

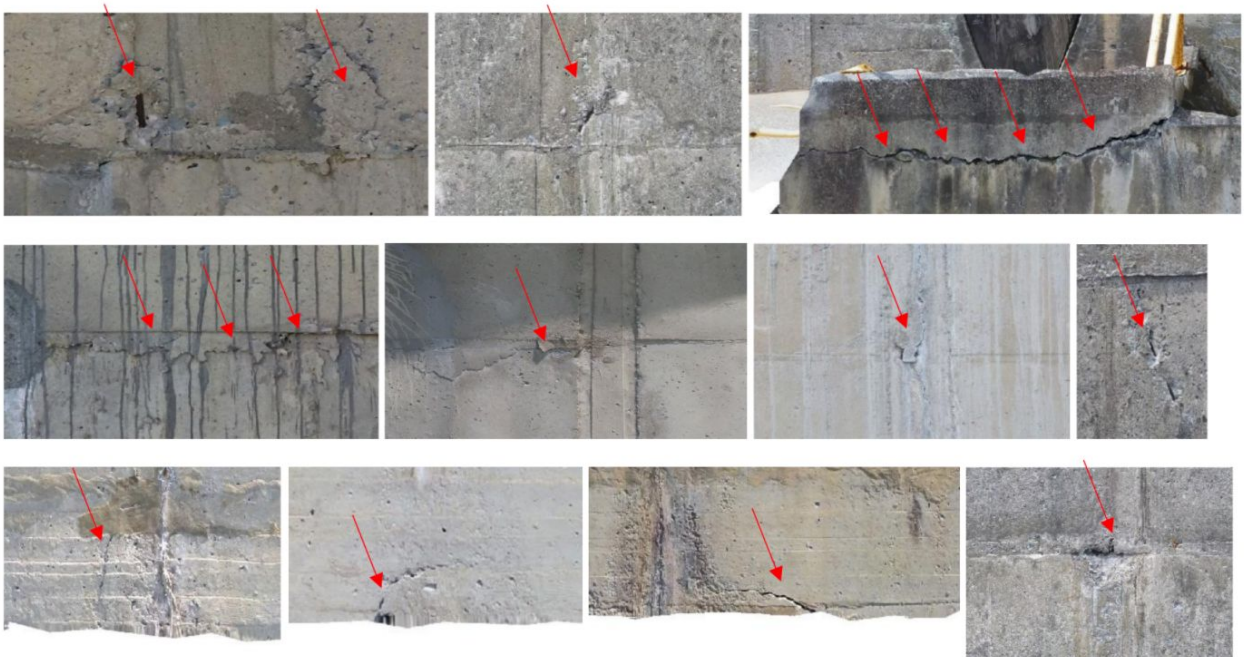
Defects with falling risk

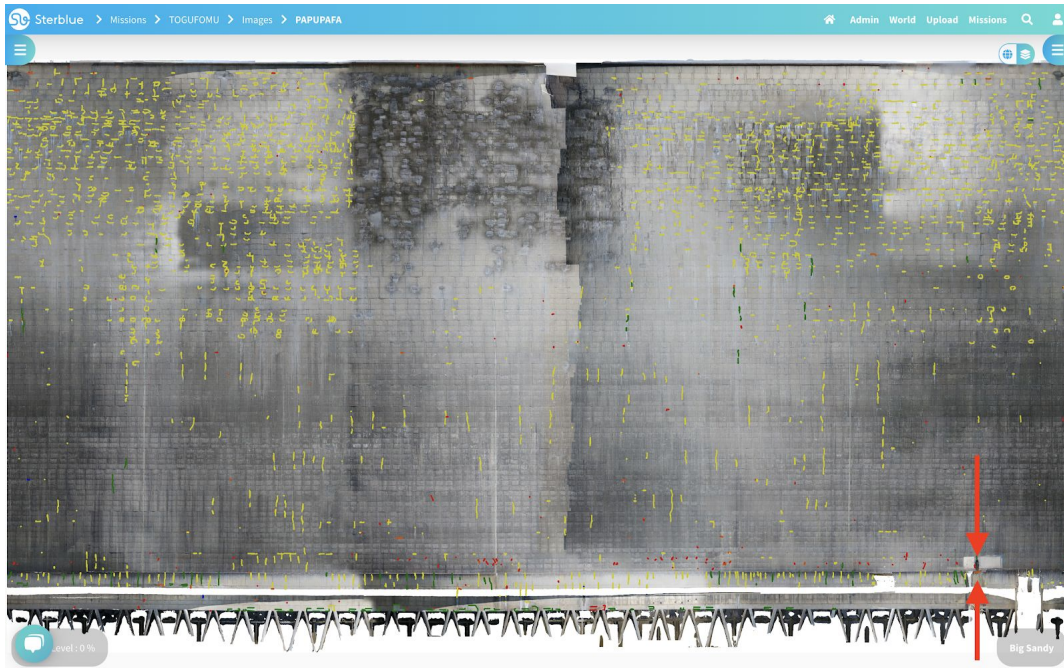
8. Inspection synthesis

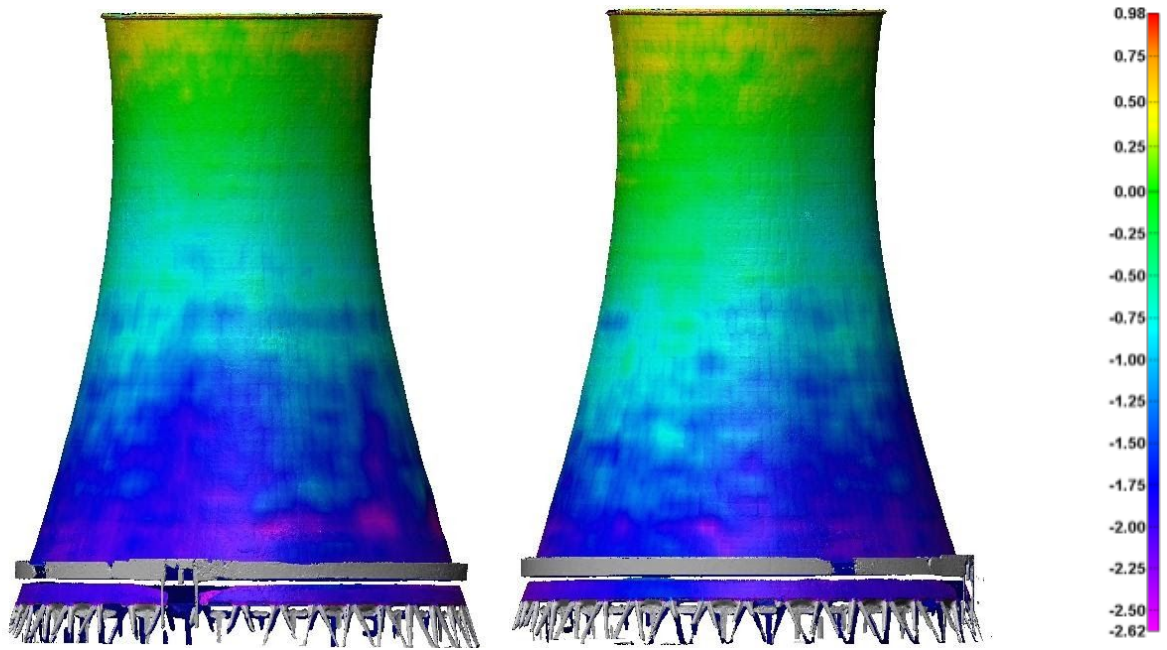
Views from North and East (scale in foot)

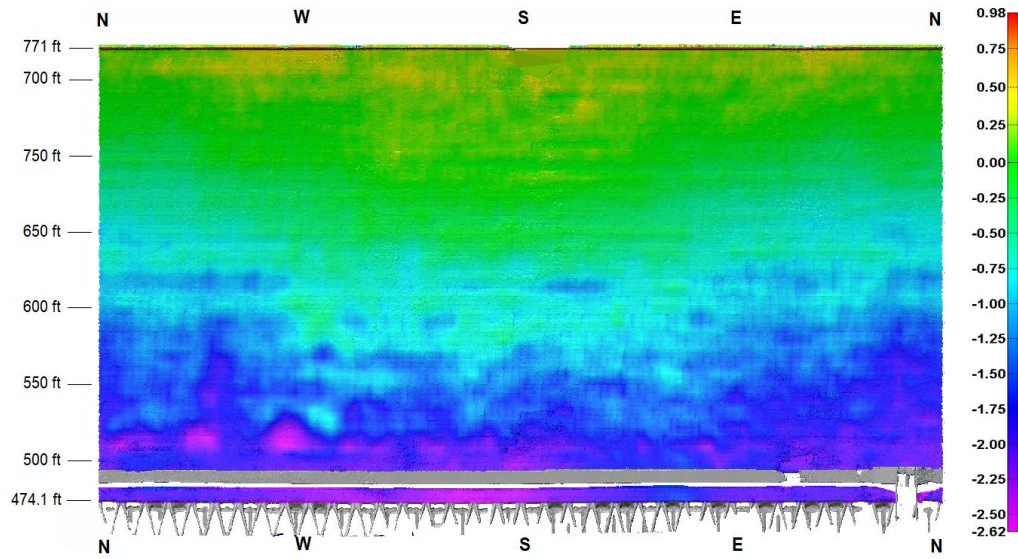
Cylindrical unwrapping of the distortions (scale in feet)

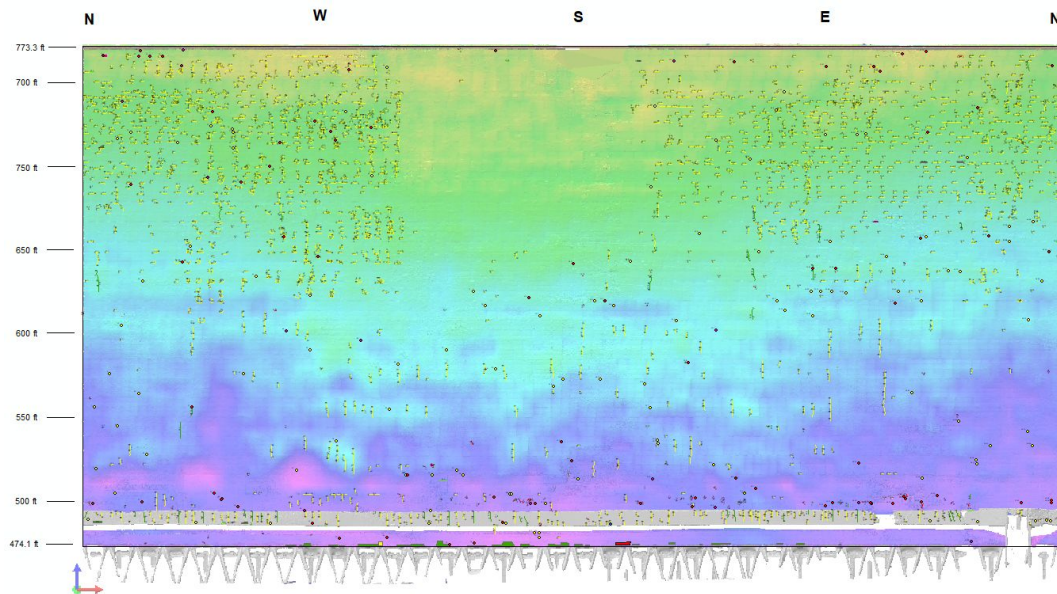
There is no obvious correlation between defects and distortions.
