Engineering Services
14713 Jersey Shore Drive
Houston, TX 77047
Phone 713-433-2155
Fax 713-433-2558
www.structural.net

**CONDITION SURVEY AND EVALUATION OF
THE CONCRETE HYPERBOLIC COOLING
TOWER SUPERSTRUCTURE SHELL IN UNIT
NO. 1 AT AEP'S BIG SANDY POWER PLANT**

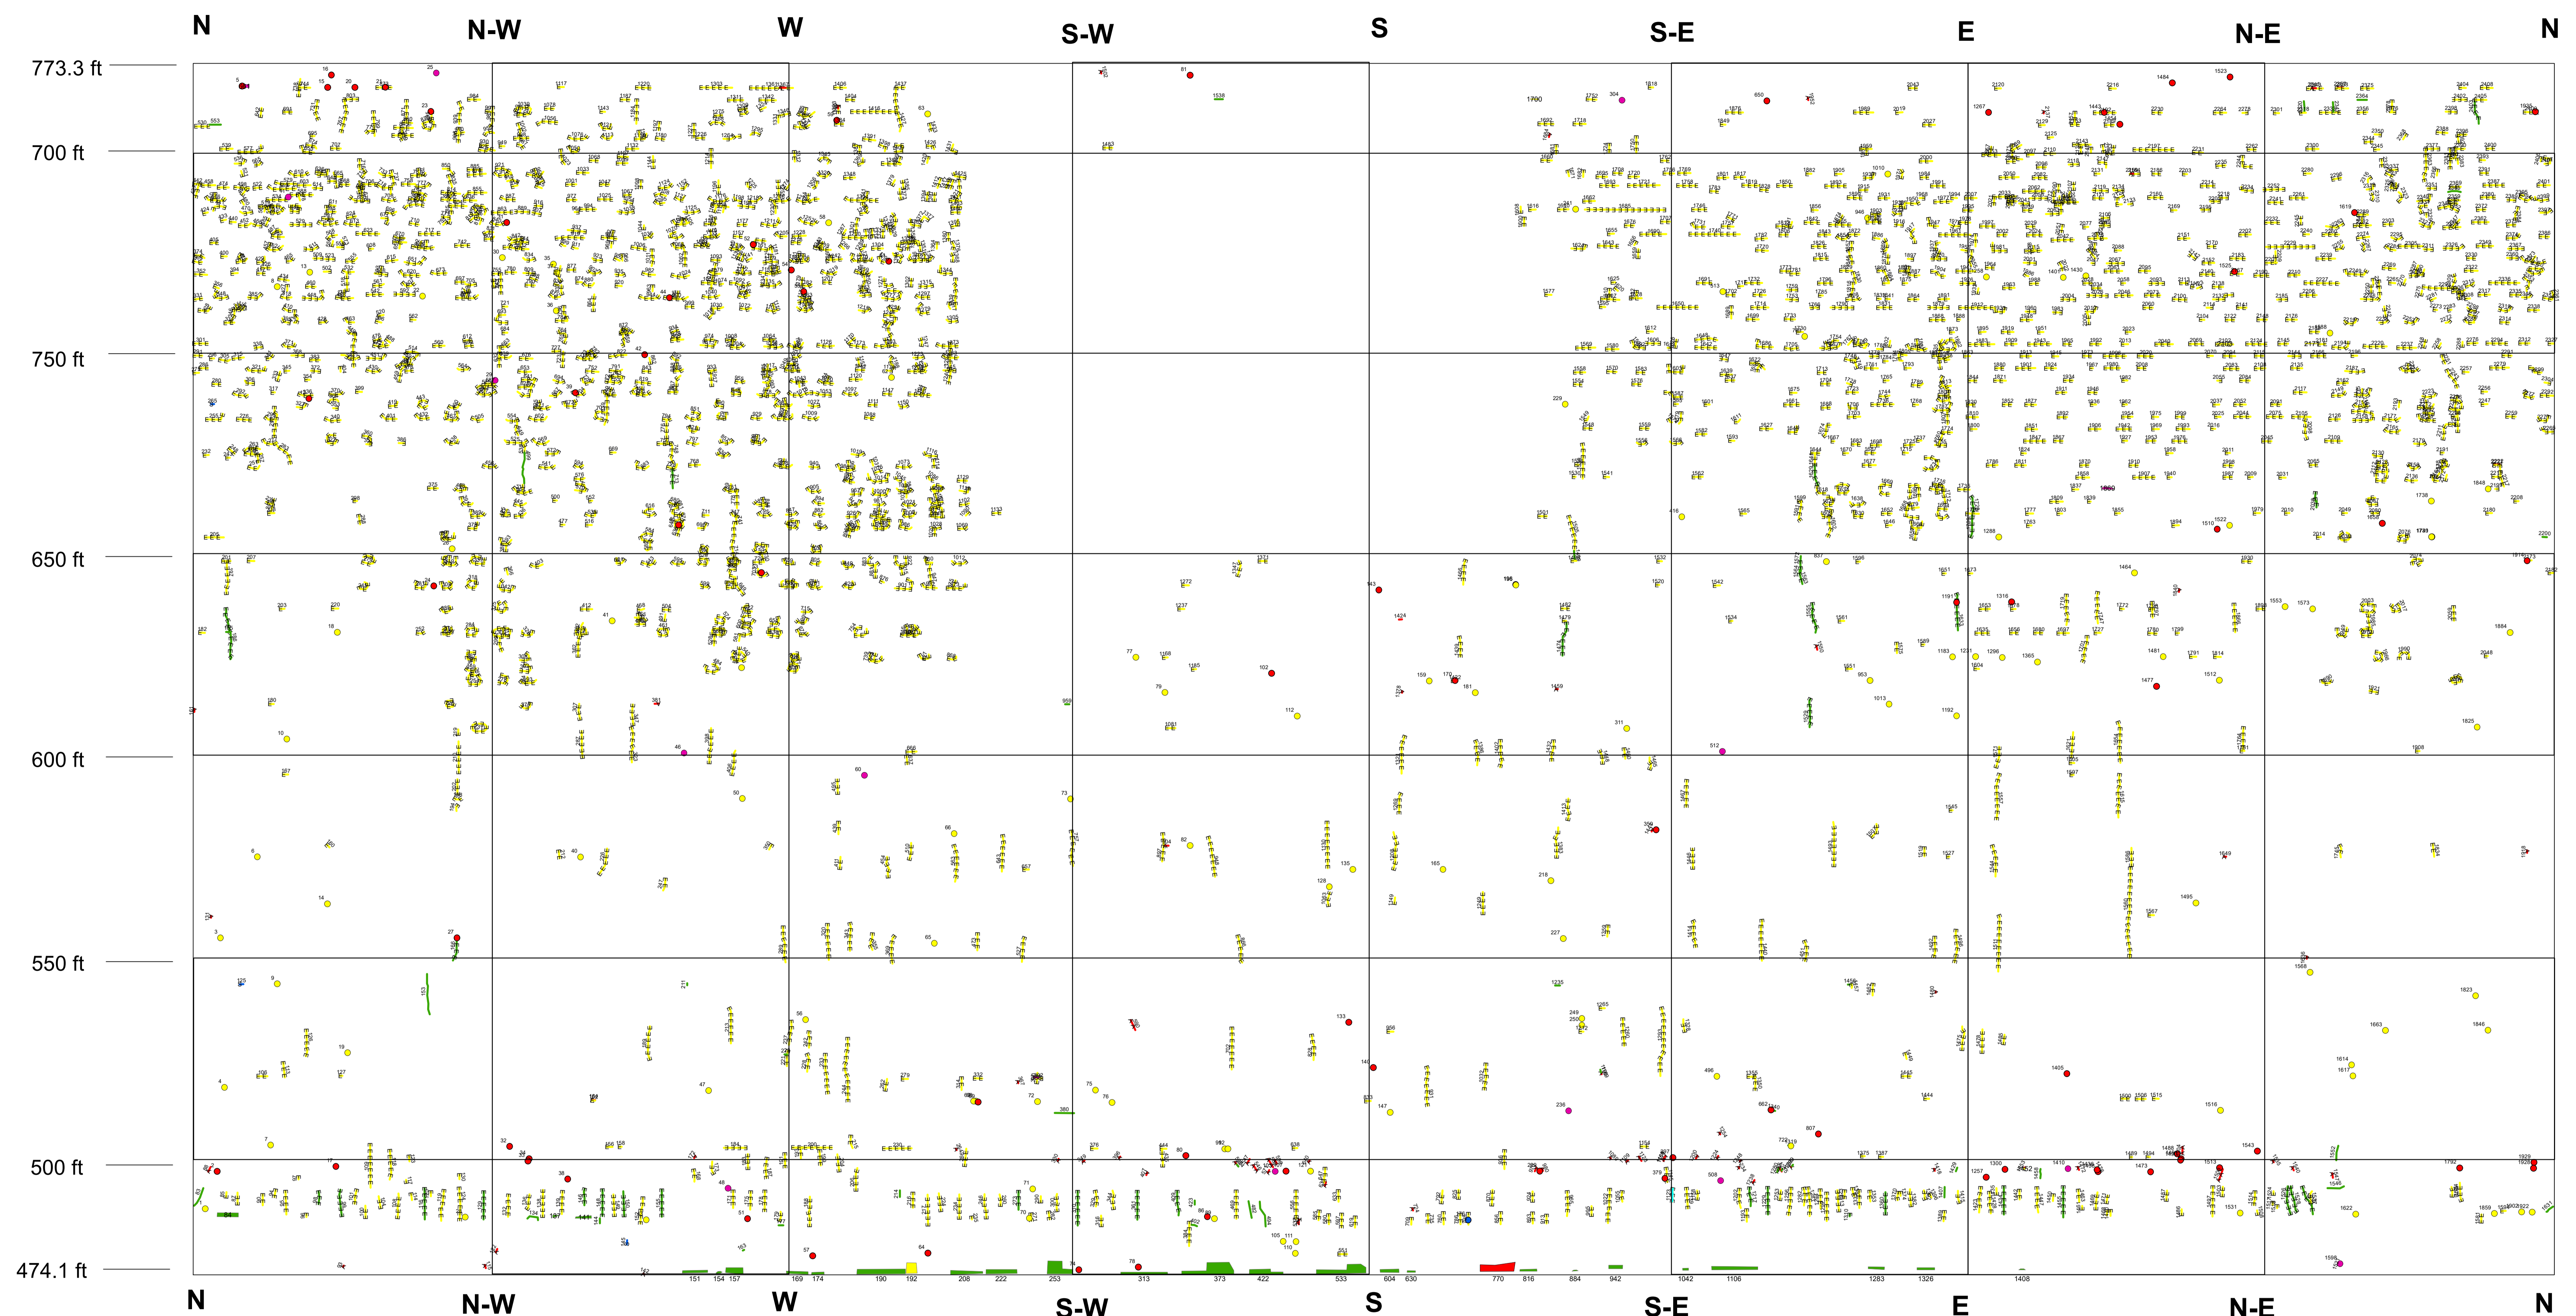
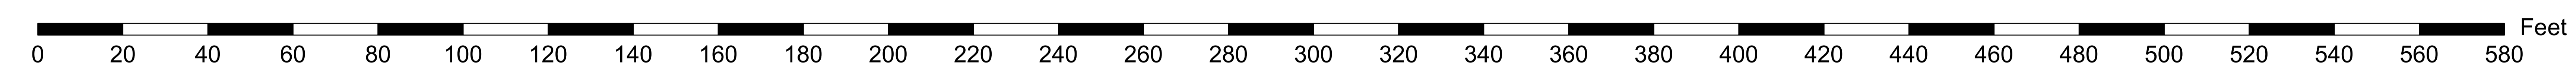
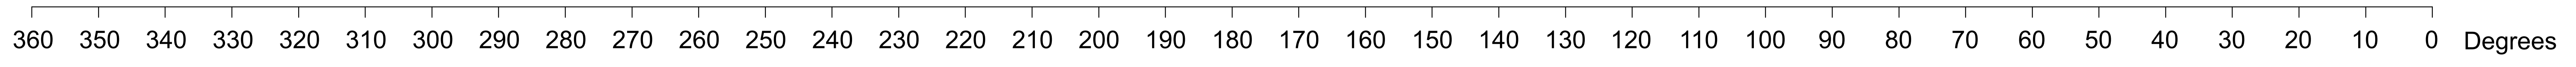
SITES SAS
 5 route du Pérollier
 69570 DARDILLY (FRANCE)
 Tel : (+33) (0)4 78 33 80 00

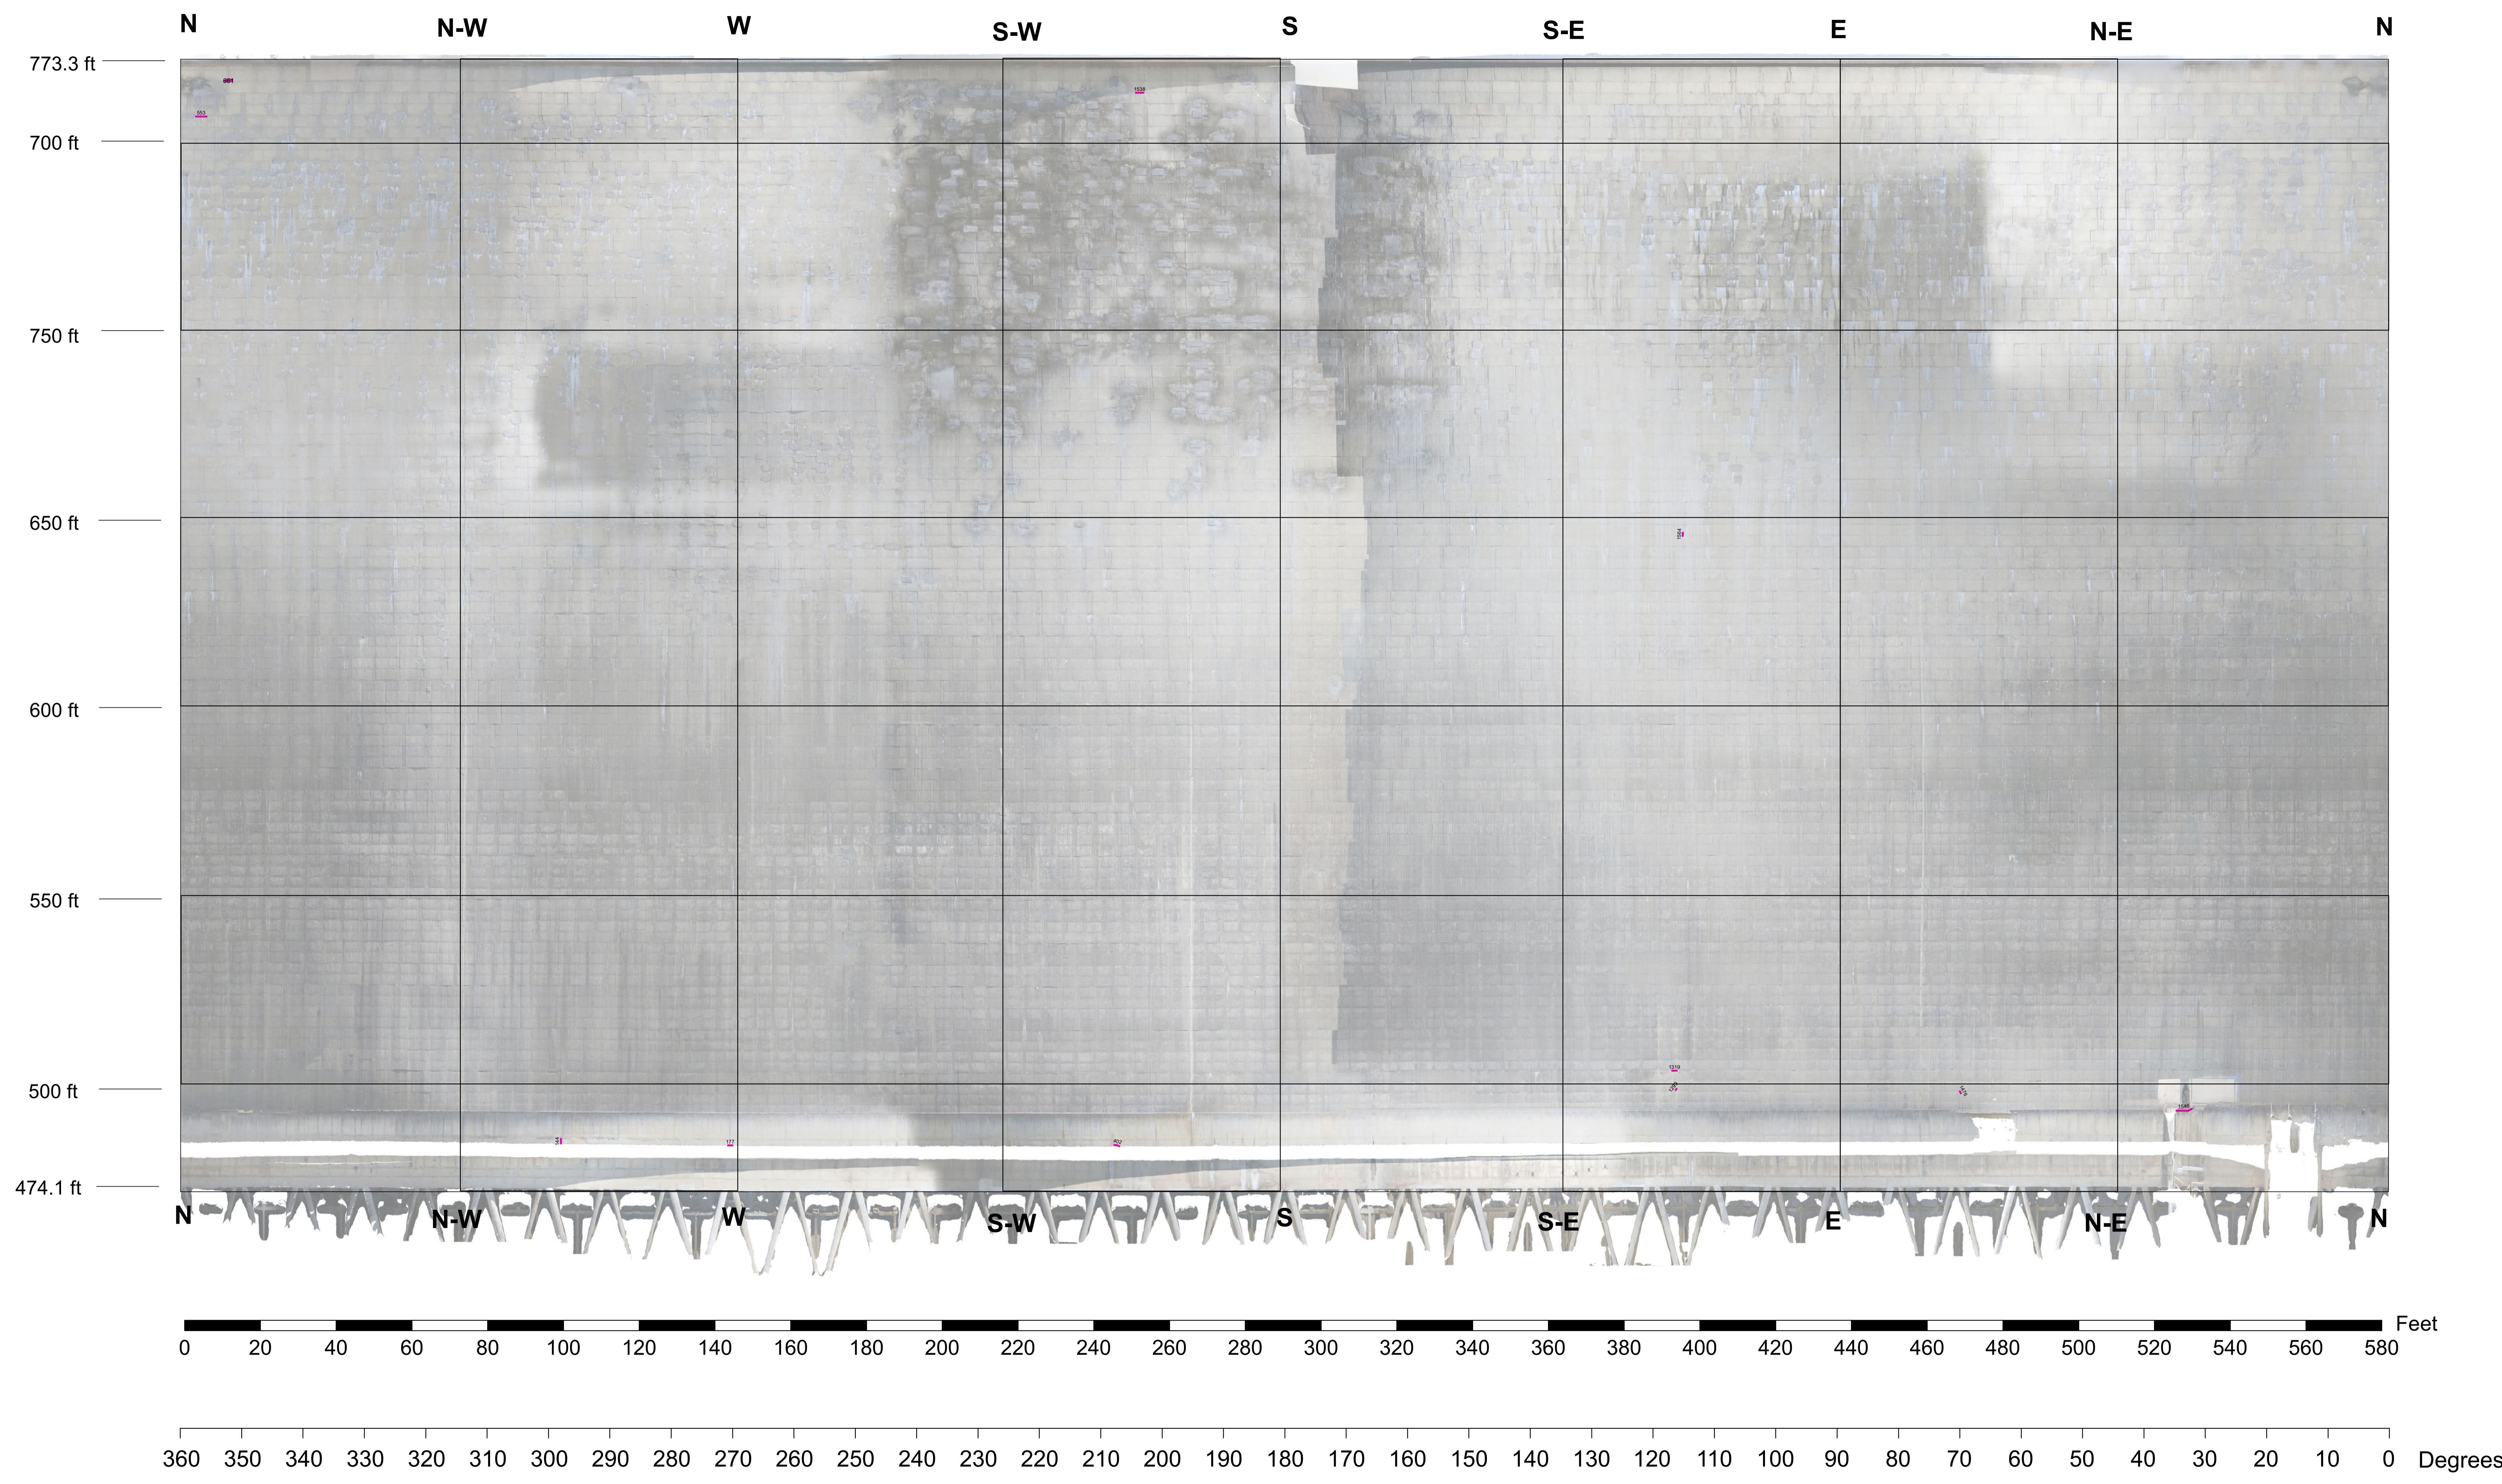
SITES SAS
 5 route du Pérollier
 69570 DARDILLY (FRANCE)
 Tel : (+33) (0)4 78 33 80 00

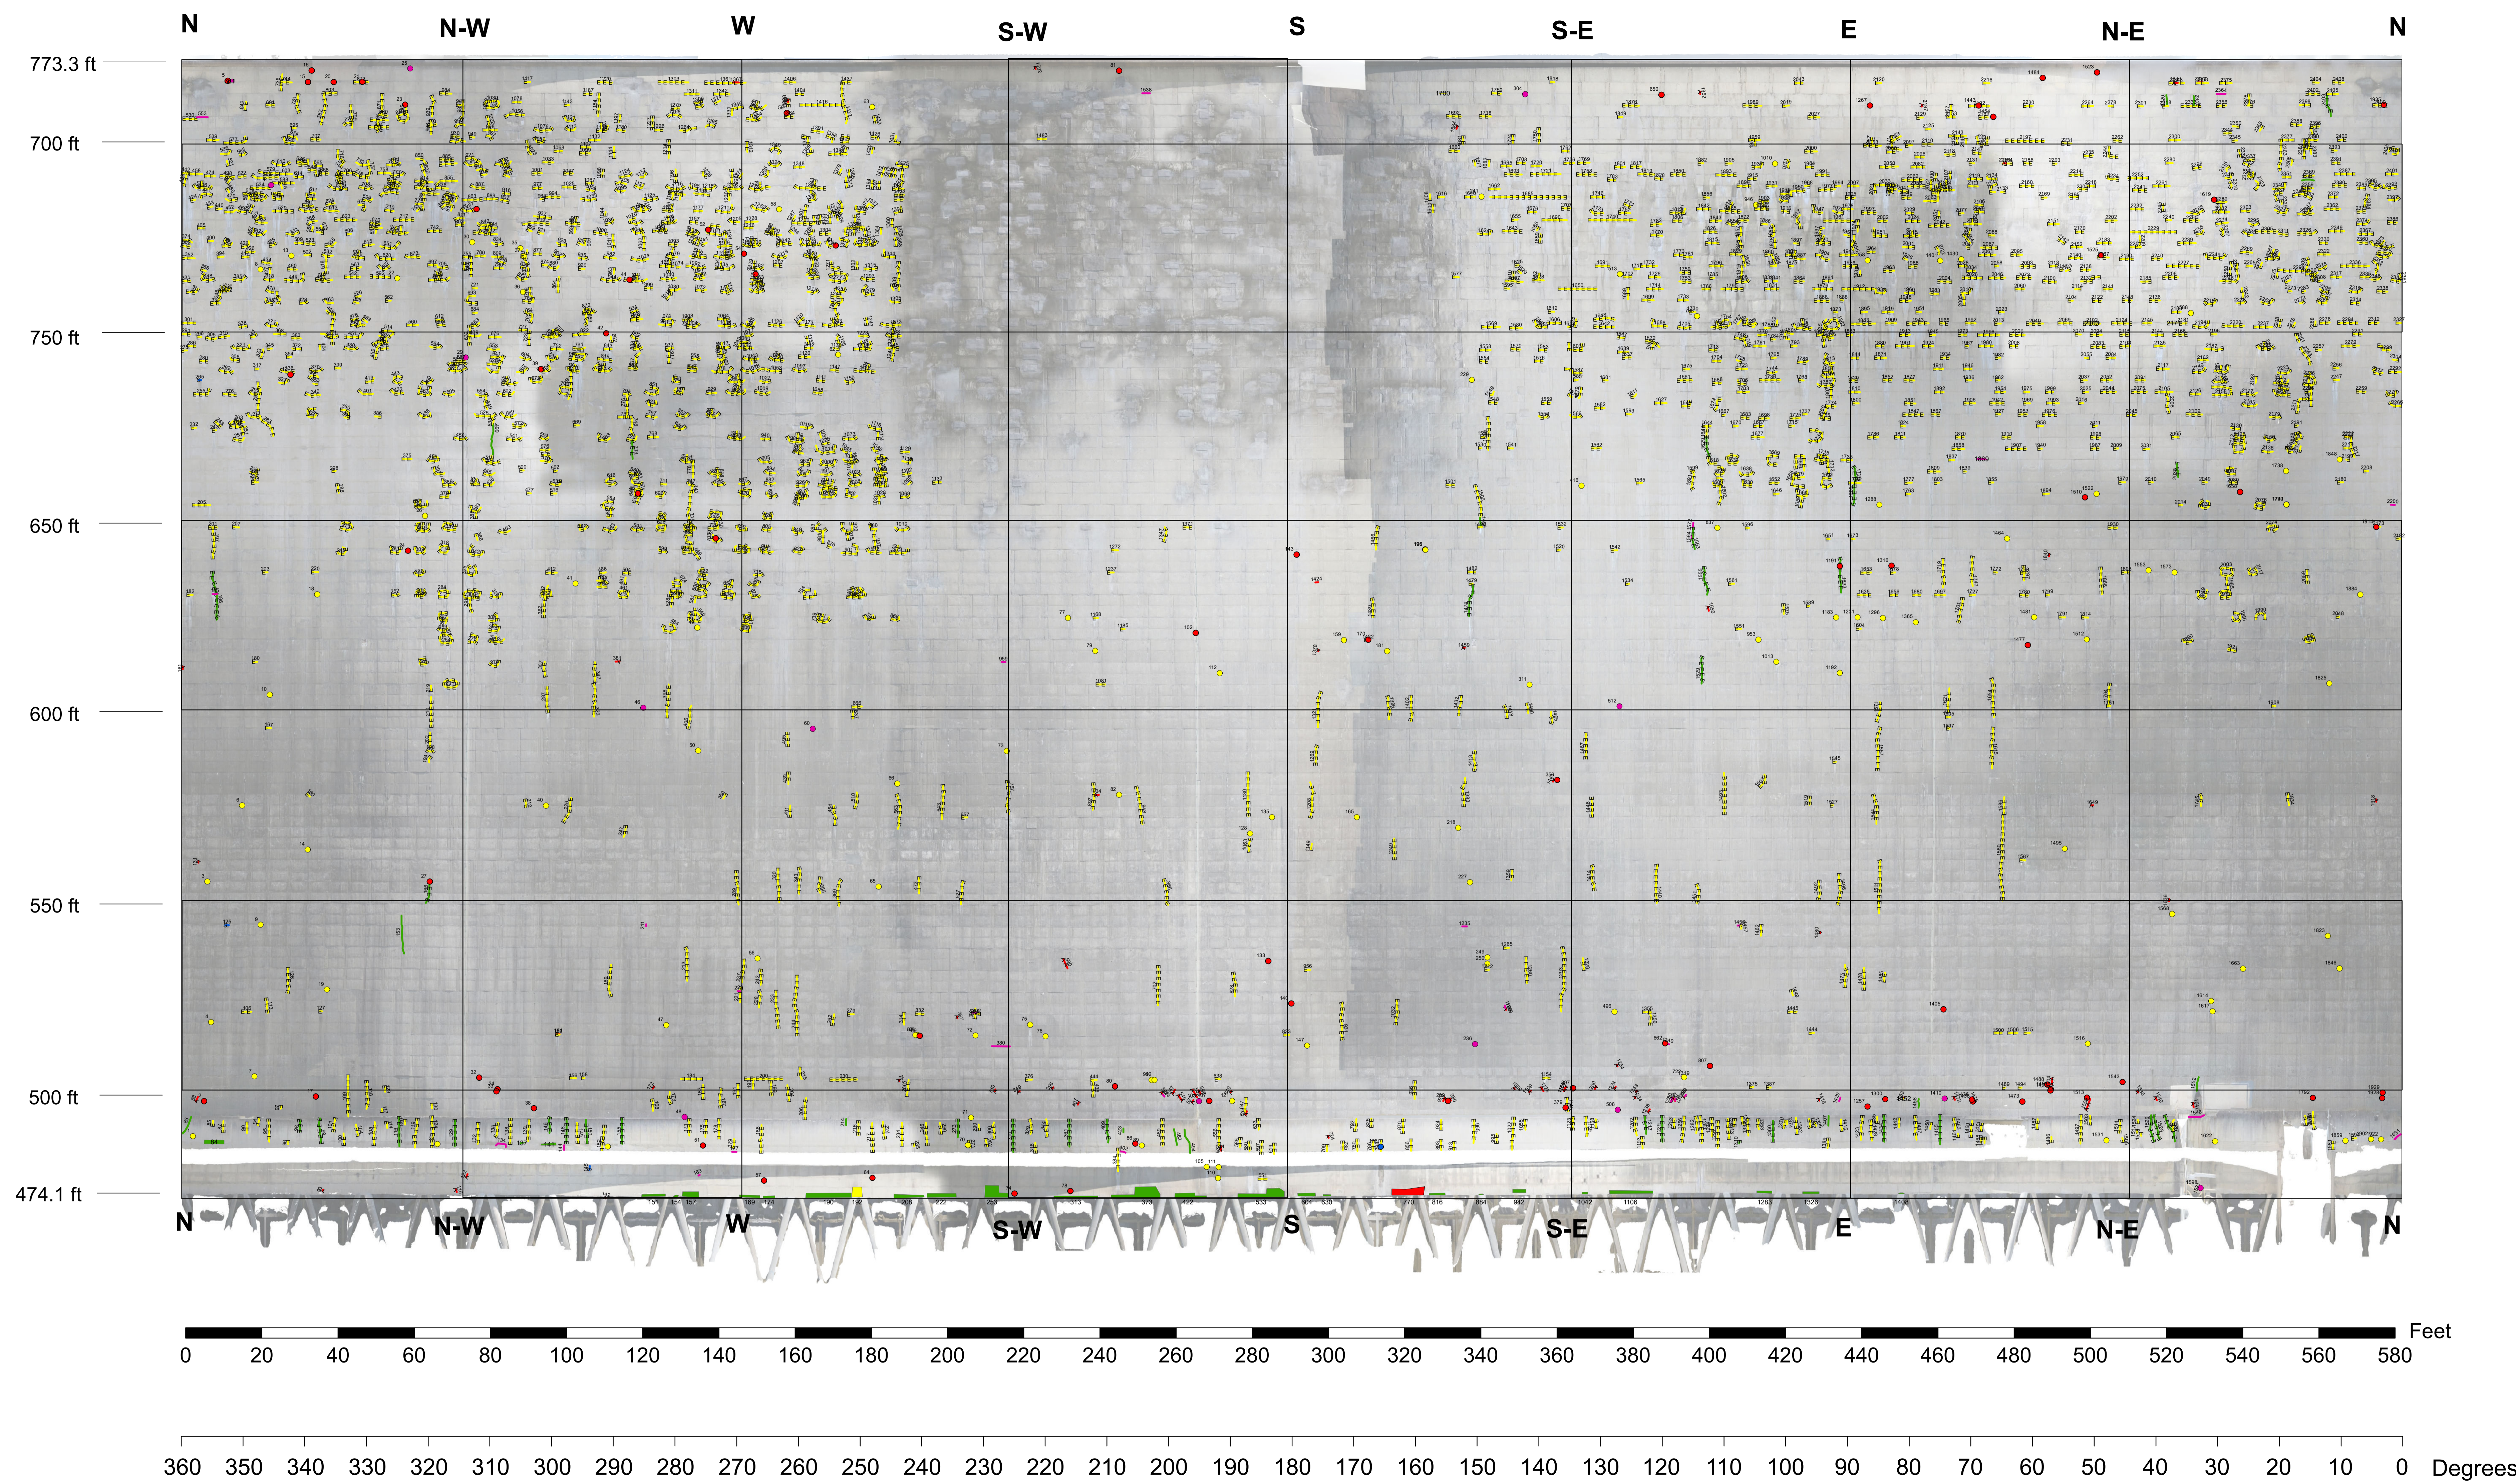
SITES SAS
 5 route du Pérollier
 69570 DARDILLY (FRANCE)
 Tel : (+33) (0)4 78 33 80 00

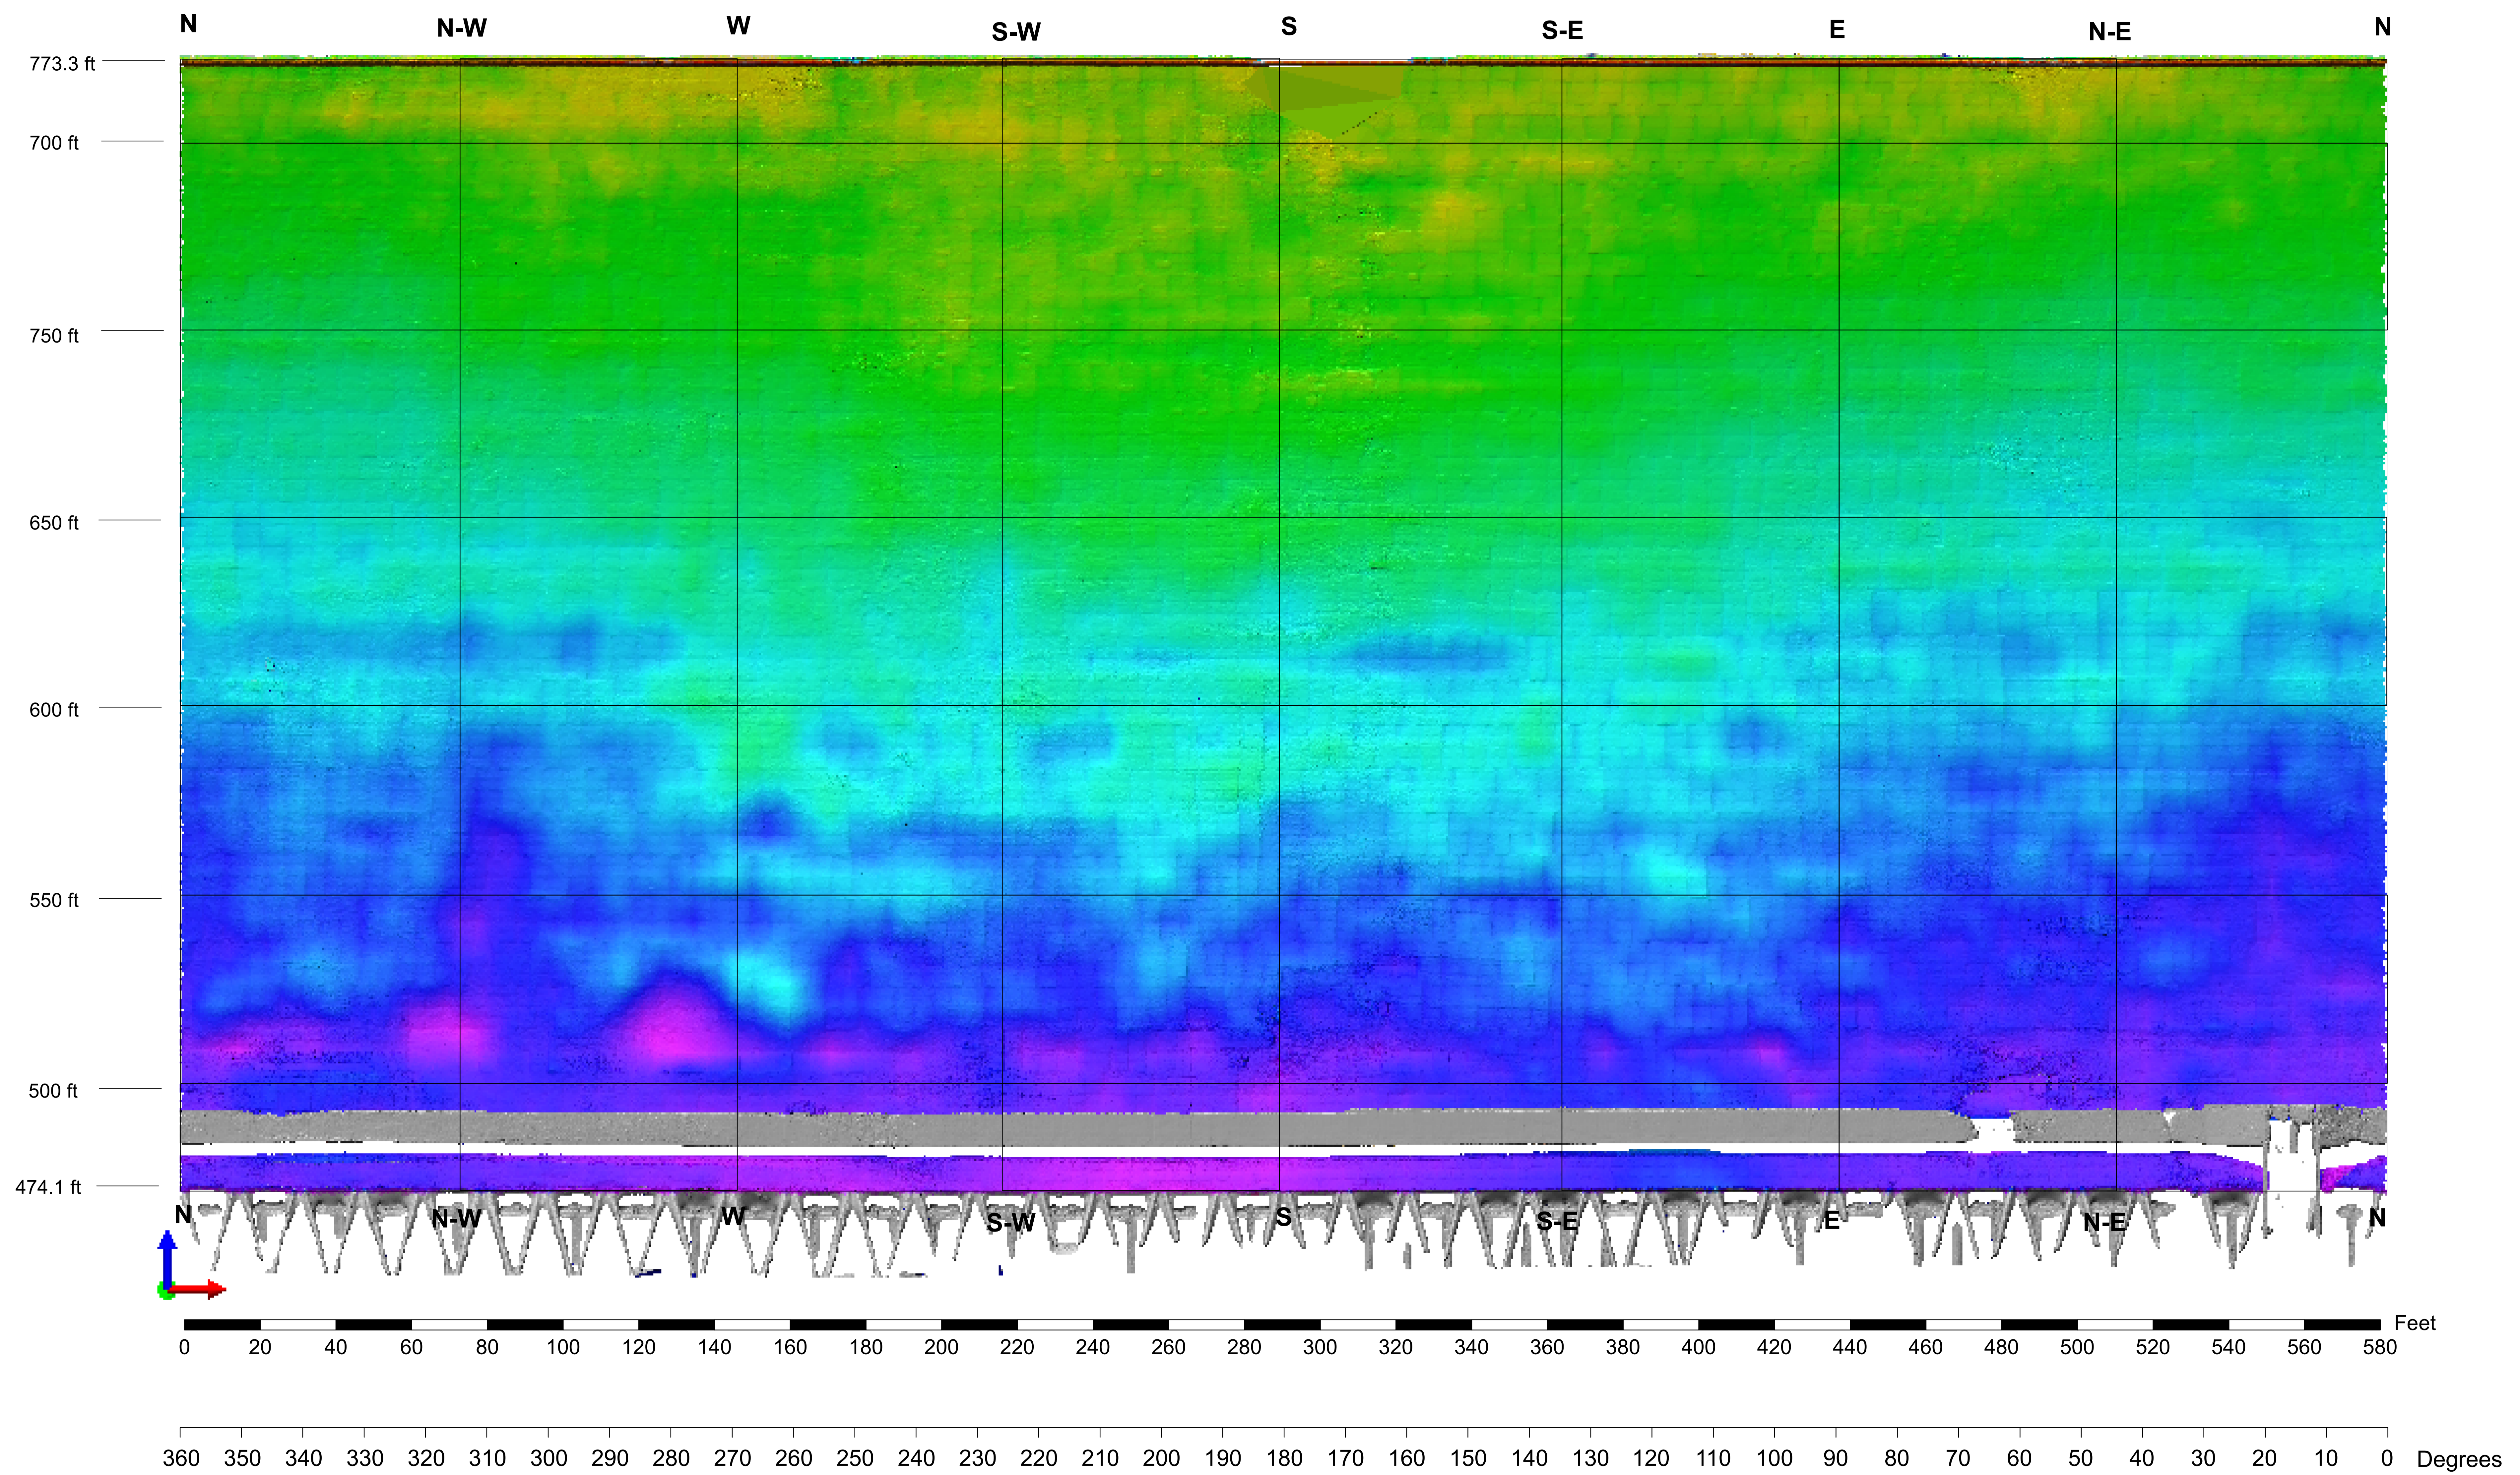
SITES SAS
 5 route du Pérollier
 69570 DARDILLY (FRANCE)
 Tel : (+33) (0)4 78 33 80 00

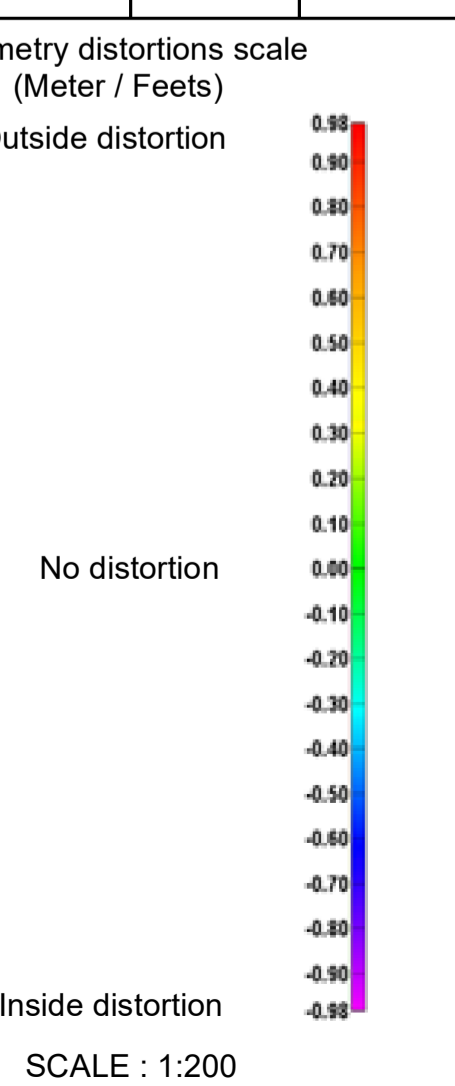
Type of defect		Abbreviation	Symbol	Update	
Family				Inspection number	Date
Crack	CR			0	20/04/2020
Corrosion	CO				
Seepage	SE				
Unsticking	US				
Miscellaneous	DX				
Secondary features :					
Efflorescence	EF	E			
Seepage	SE	S			
Rust trace	RT	T			
Geometry of the defects:					
Points					
Lines					
Surfaces					
Report R 20 LY 1942

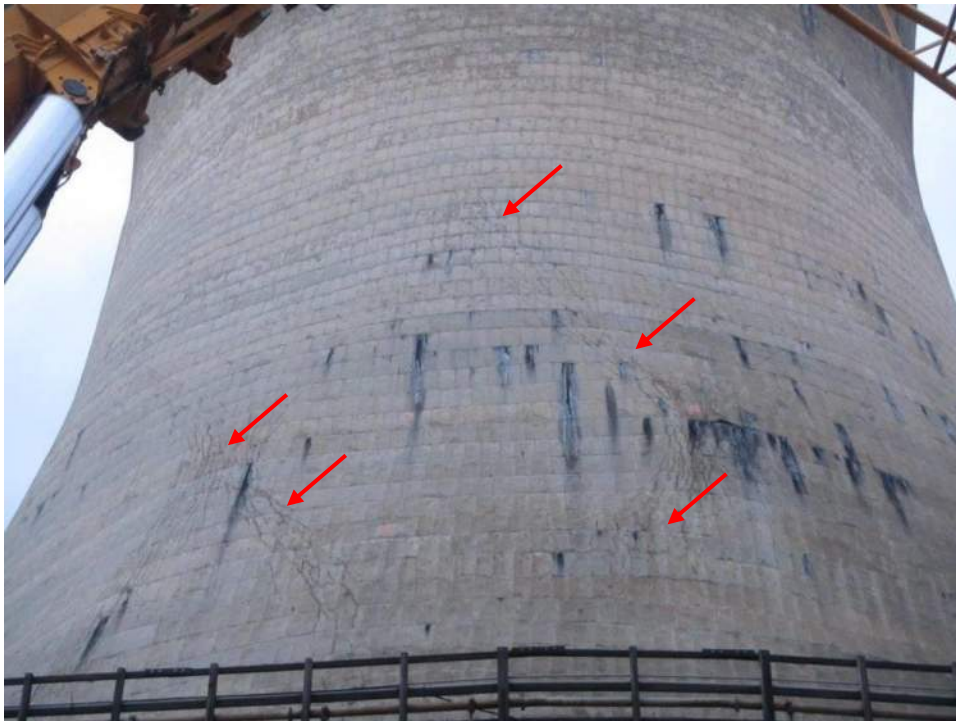
Photo 4. Visible cracking in the concrete veil

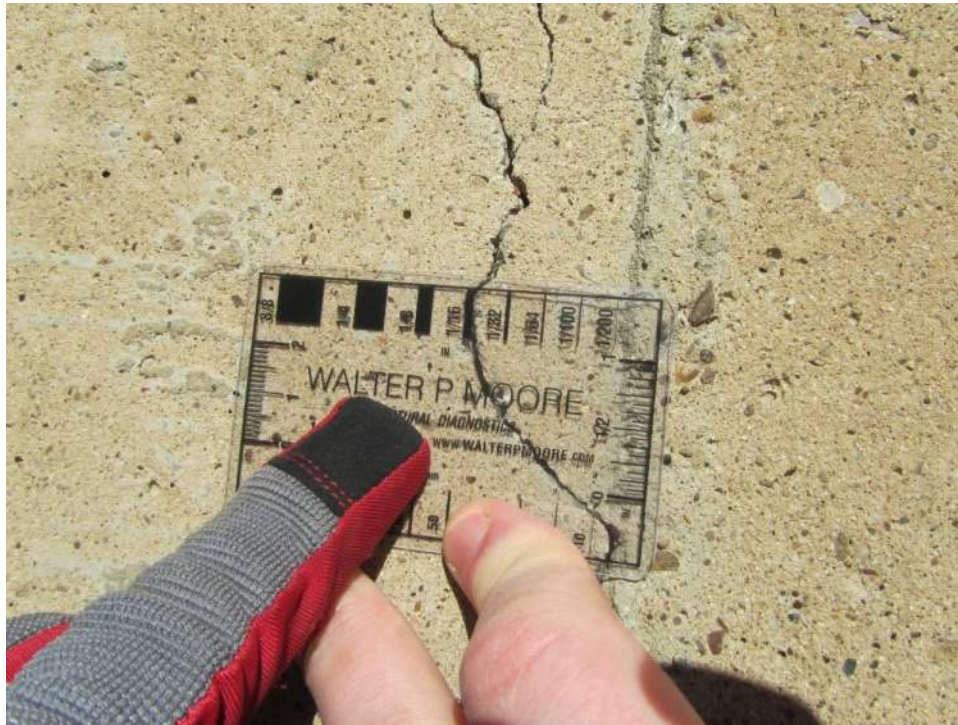
Photo 5. Close-up view of a crack in concrete veil

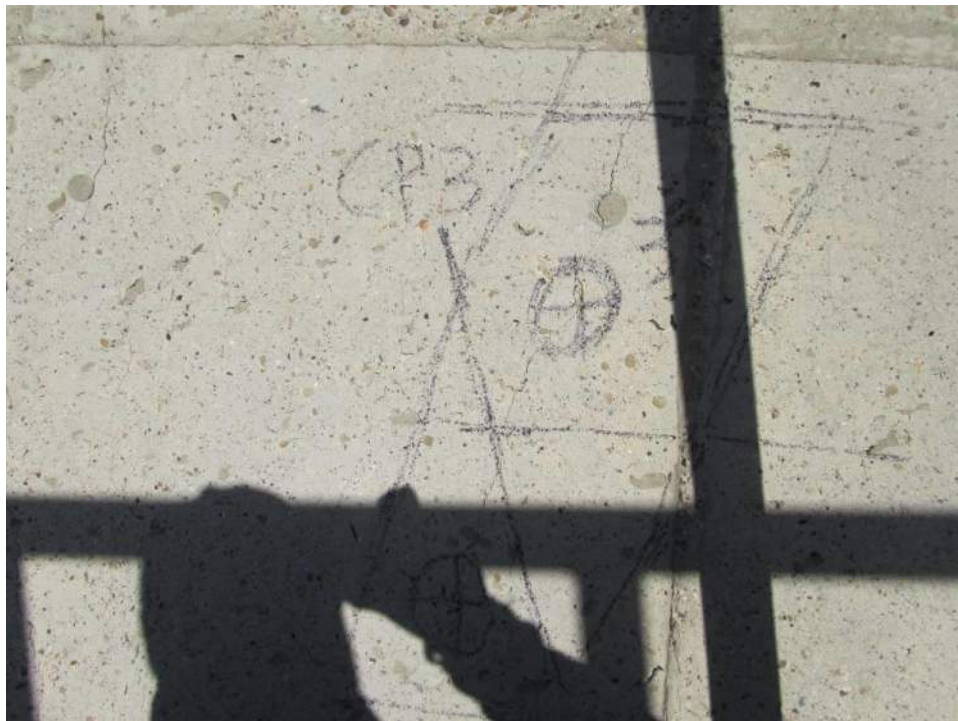
Photo 6. Location marked for a petrography core crossed by a crack

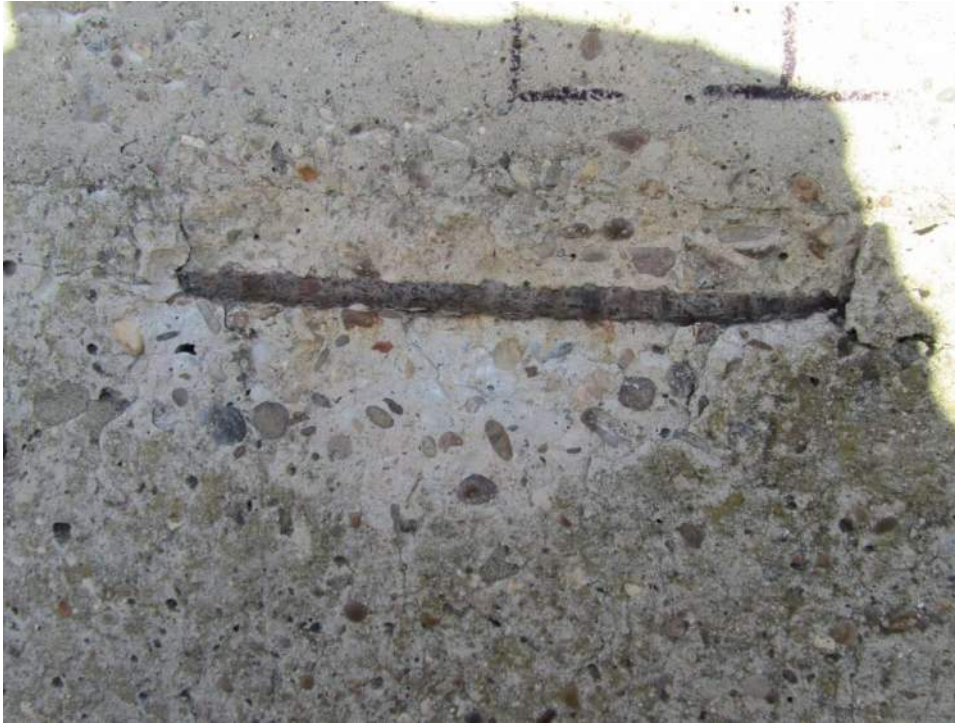
Photo 7. Concrete spall and exposed reinforcement

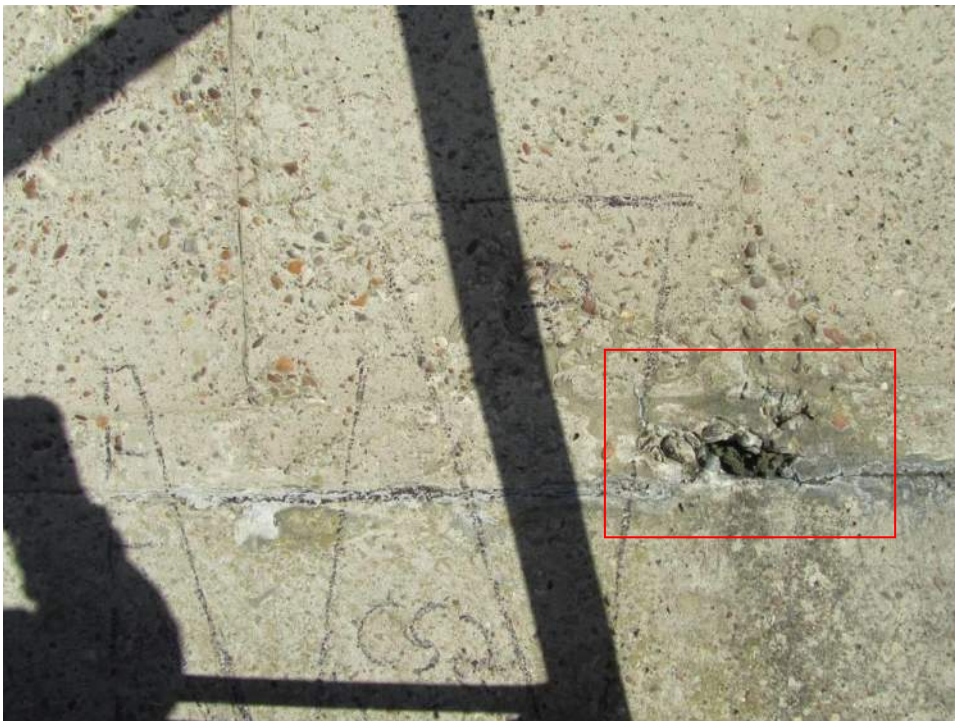
Photo 7. Unconsolidated concrete at a construction joint

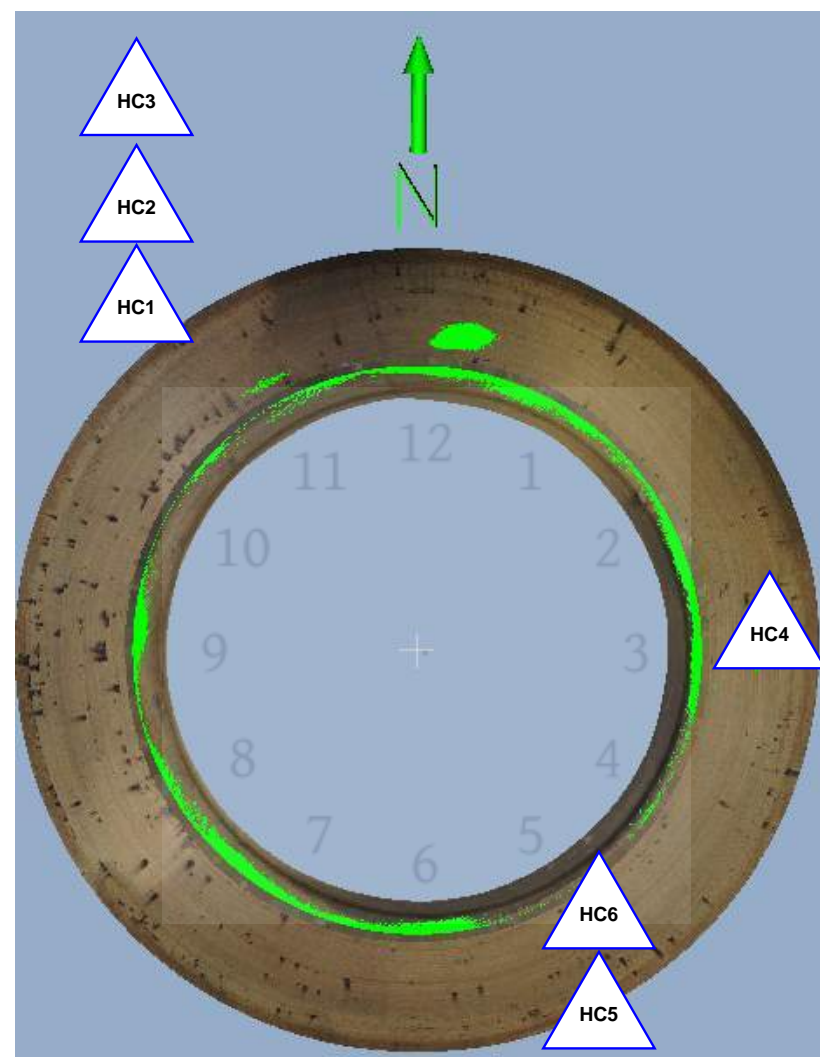
AREA ID	LOCATION
HC1	NW (11:00)
HC2	NW (11:00)
HC3	NW (11:00)
HC4	SE (5:00)
HC5	SE (5:00)
HC6	SE (5:00)

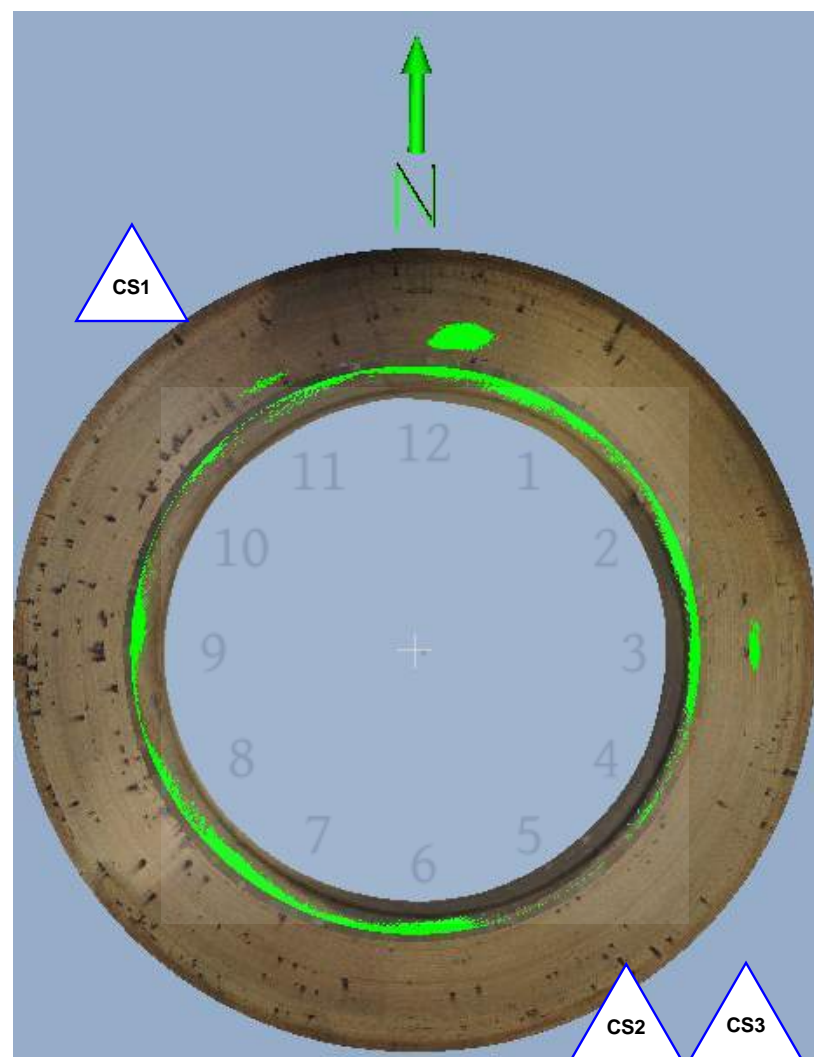
CORE ID	LOCATION
CS1	NW (11:00)
CS2	SE (5:00)
CS3	SE (5:00)

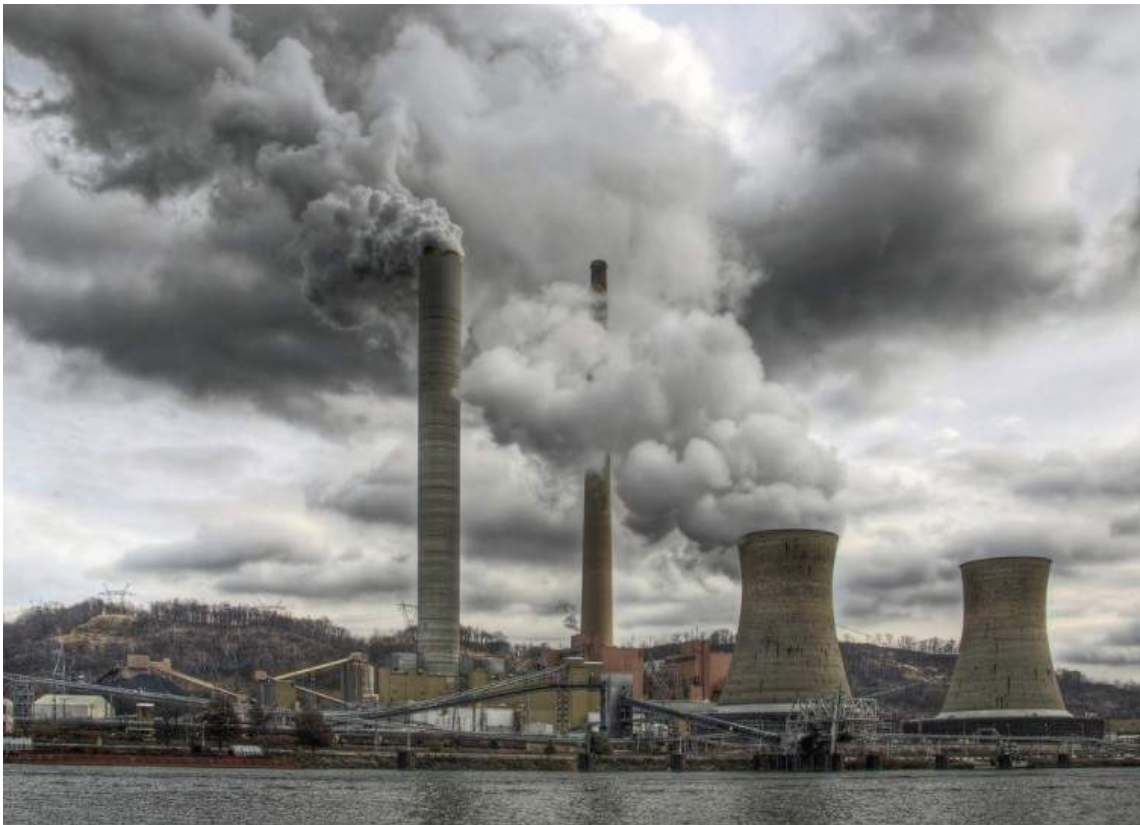
PROJECT NUMBER: RV7352		PAGE 4
PROJECT NAME: Concrete Condition Assessment Testing		
DATE: 4/3 – 4/6 and 4/25-4/28, 2018

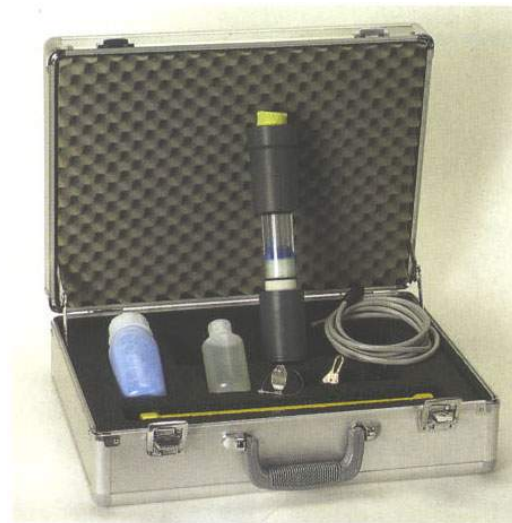
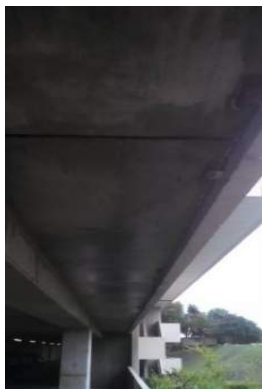
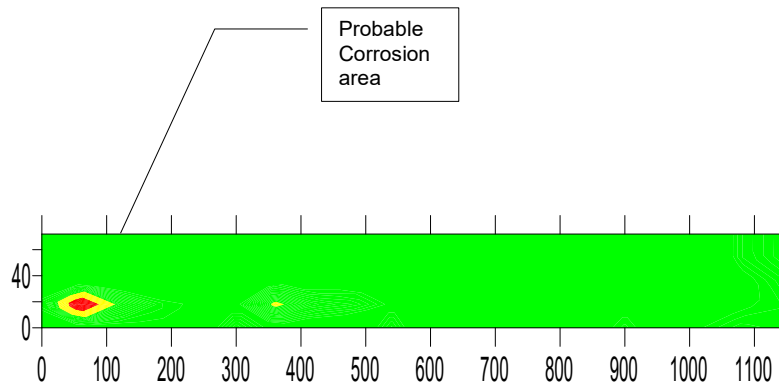
PROJECT NUMBER:	RV7352	PAGE 5
PROJECT NAME:	Concrete Condition Assessment Testing	
DATE:	4/3 – 4/6 and 4/25-4/28, 2018
