Engineering Services
14713 Jersey Shore Drive
Houston, TX 77047
Phone 713-433-2155
Fax 713-433-2558
www.structural.net

**CONDITION SURVEY AND EVALUATION OF
THE CONCRETE HYPERBOLIC COOLING
TOWER SUPERSTRUCTURE SHELL IN UNIT
NO. 1 AT AEP'S BIG SANDY POWER PLANT**

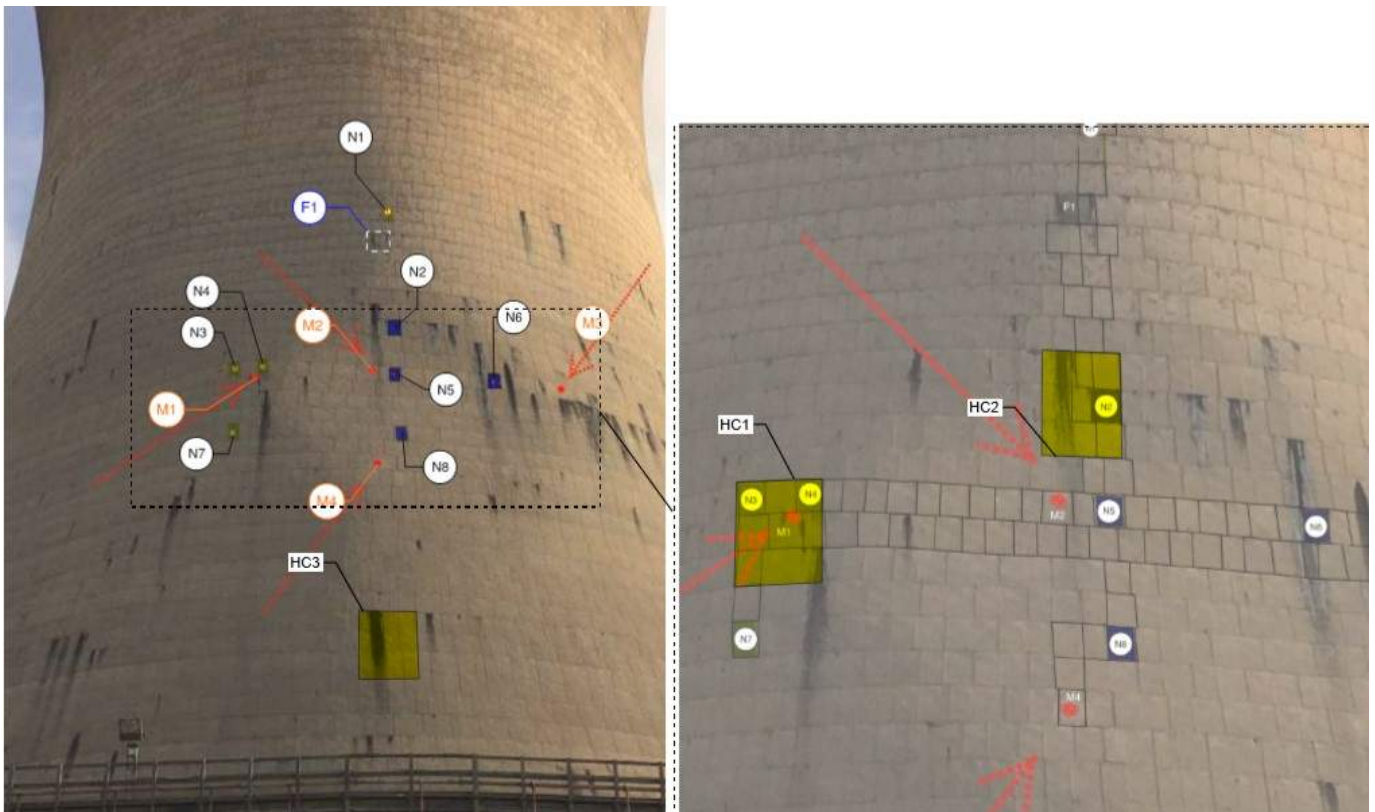
PROJECT NUMBER:	RV7352	PAGE 6
PROJECT NAME:	Concrete Condition Assessment Testing	
DATE:	4/3 – 4/6 and 4/25-4/28, 2018

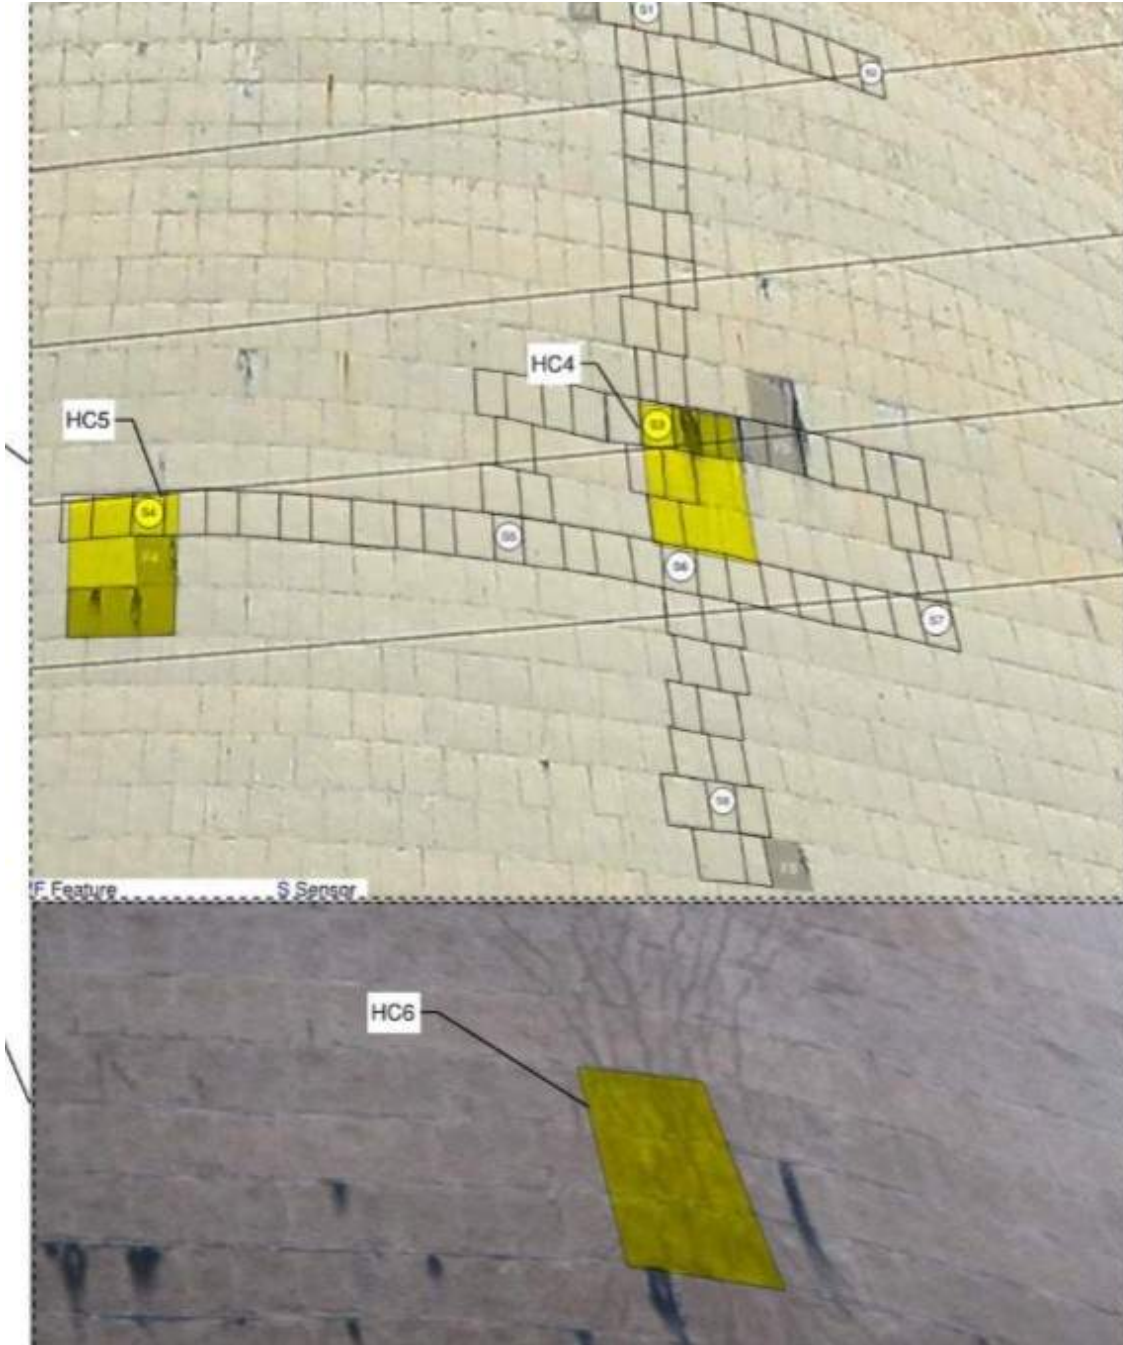
PROJECT NUMBER:	RV7352	PAGE 7
PROJECT NAME:	Concrete Condition Assessment Testing	
DATE:	4/3 – 4/6 and 4/25-4/28, 2018

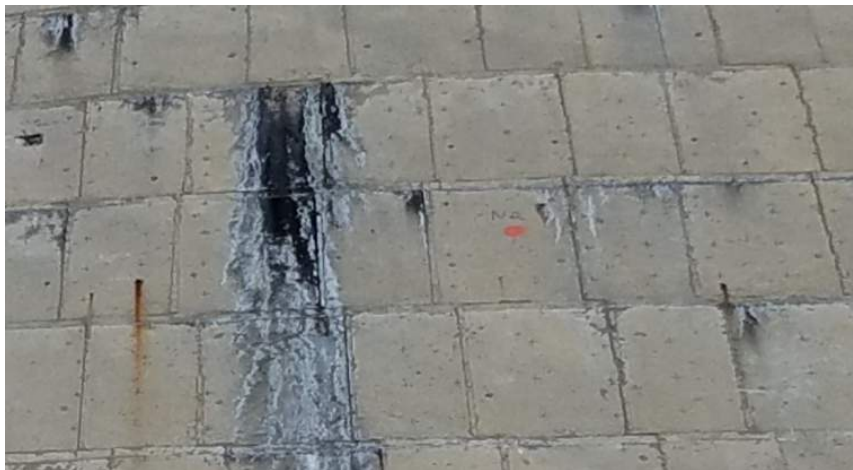
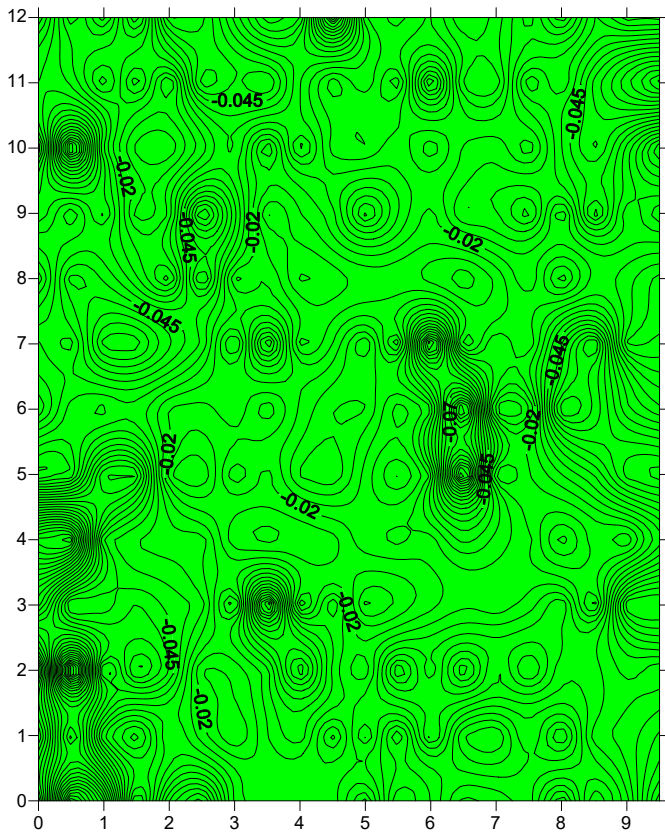
Half-Cell Reading Results:	
A=	-0.420
B=	-0.350
C=	-0.280
D=	-0.210
E=	-0.140
F=	-0.070
G=	-0.000
A&B = 90% chance corrosion is occurring in this area.	
C&D = Corrosion activity over this area is uncertain	
E-G = 90% chance that no corrosion activity is present over this area.	
Red = A&B	
Yellow = C&D	
Green = E-G	
Samples were taken on a 9.5' by 12' grid.	
The area that was examined showed a 90% chance that no corrosion activity is present.

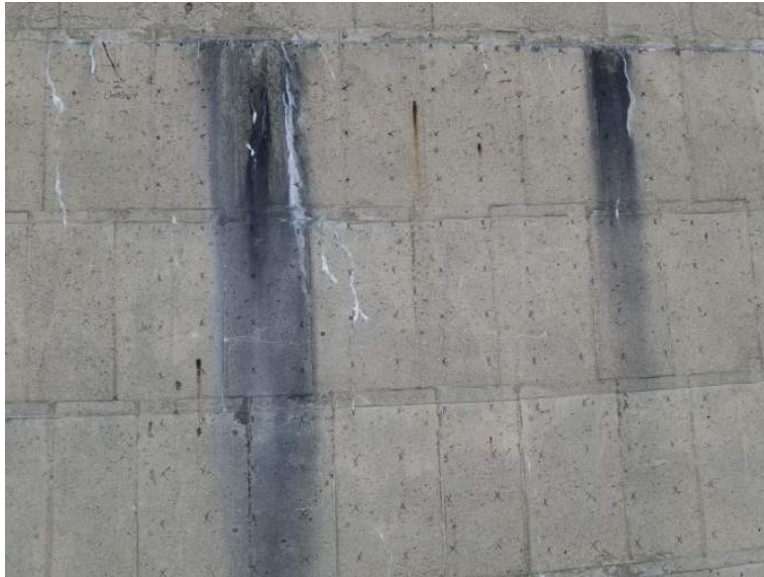
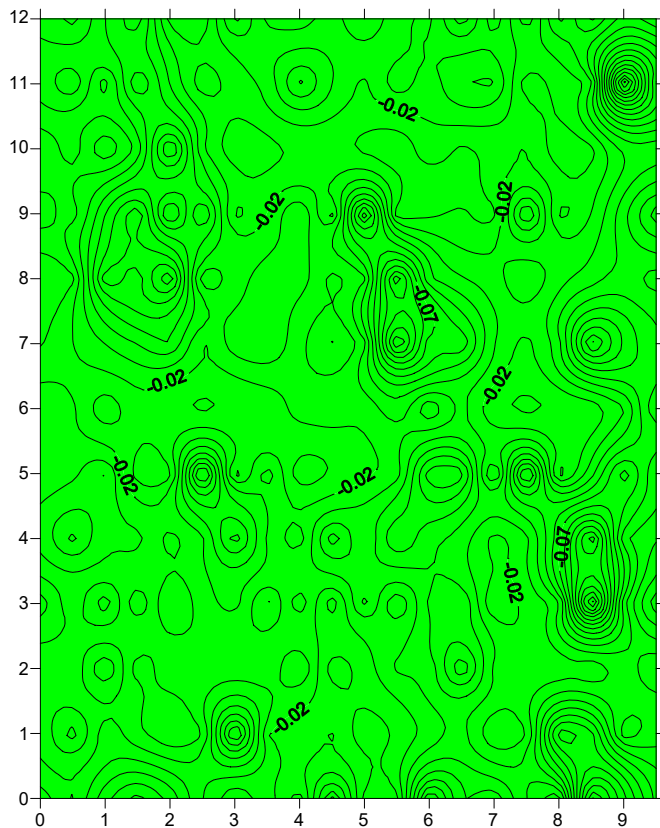
<p>Half-Cell Reading Results:</p> <p>A= -.420 B= -.350 C= -.280 D= -.210 E= -.140 F= -.070 G= -.000</p> <p>A&B = 90% chance corrosion is occurring in this area. C&D = Corrosion activity over this area is uncertain E-G = 90% chance that no corrosion activity is present over this area.</p> <p>Red = A&B Yellow = C&D Green = E-G</p> <p>Samples were taken on a 9.5' by 12' grid. The area that was examined showed a 90% chance that no corrosion activity is present.</p>
--	--

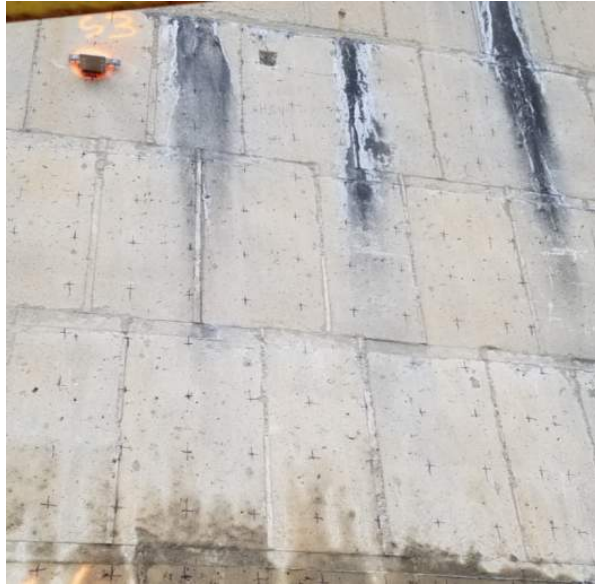
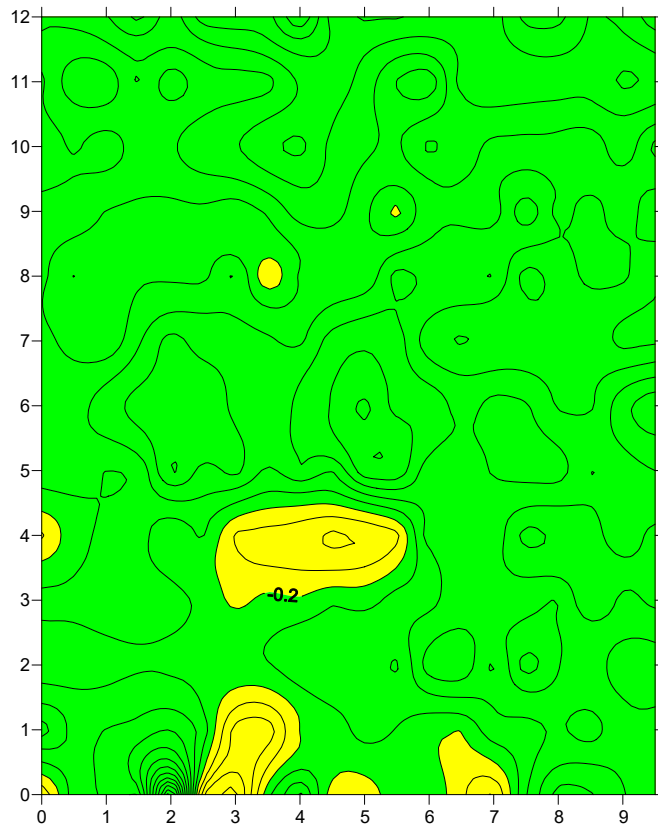
Half-Cell Reading Results:	
A=	-.420
B=	-.350
C=	-.280
D=	-.210
E=	-.140
F=	-.070
G=	-.000
A&B = 90% chance corrosion is occurring in this area.	
C&D = Corrosion activity over this area is uncertain	
E-G = 90% chance that no corrosion activity is present over this area.	
Red = A&B	
Yellow = C&D	
Green = E-G	
Samples were taken on a 9.5' by 12' grid.	
There are a few areas that show an increasing probability of corrosion.

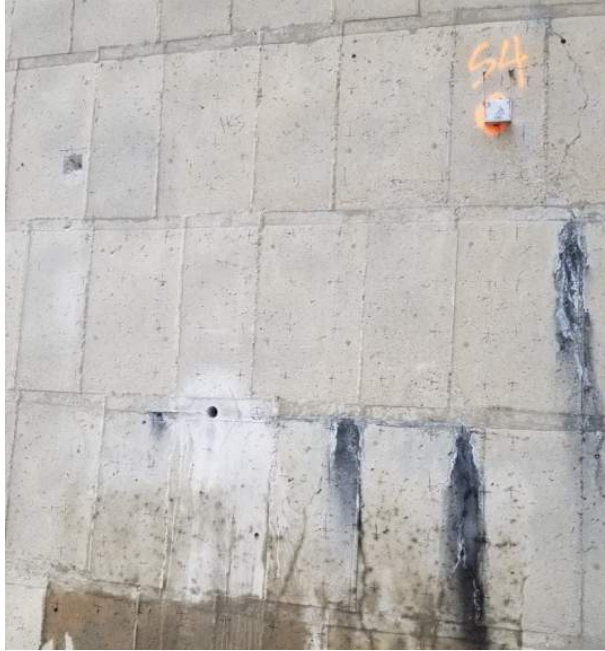
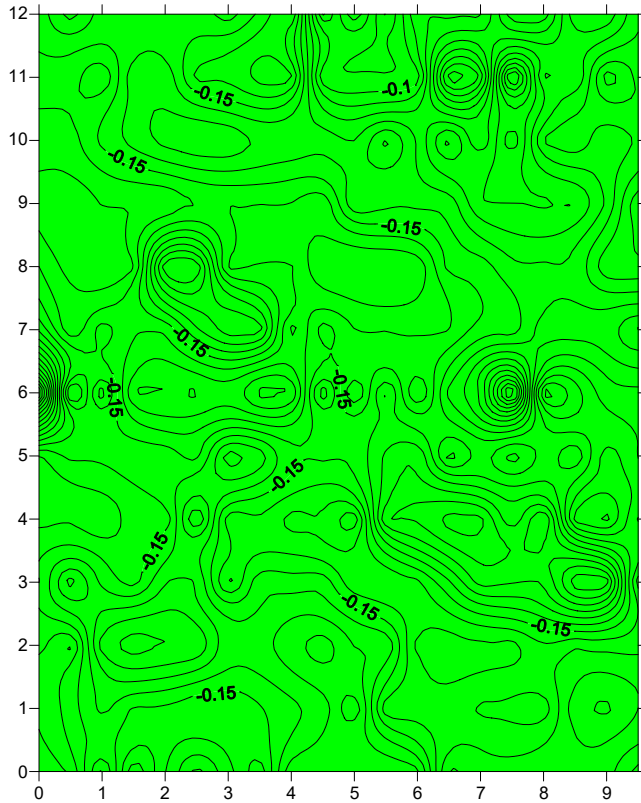
Half-Cell Reading Results:	
A=	-.420
B=	-.350
C=	-.280
D=	-.210
E=	-.140
F=	-.070
G=	-.000
A&B = 90% chance corrosion is occurring in this area.	
C&D = Corrosion activity over this area is uncertain	
E-G = 90% chance that no corrosion activity is present over this area.	
Red = A&B	
Yellow = C&D	
Green = E-G	
Samples were taken on a 9.5' by 12' grid.	
The area that was examined showed a 90% chance that no corrosion activity is present.

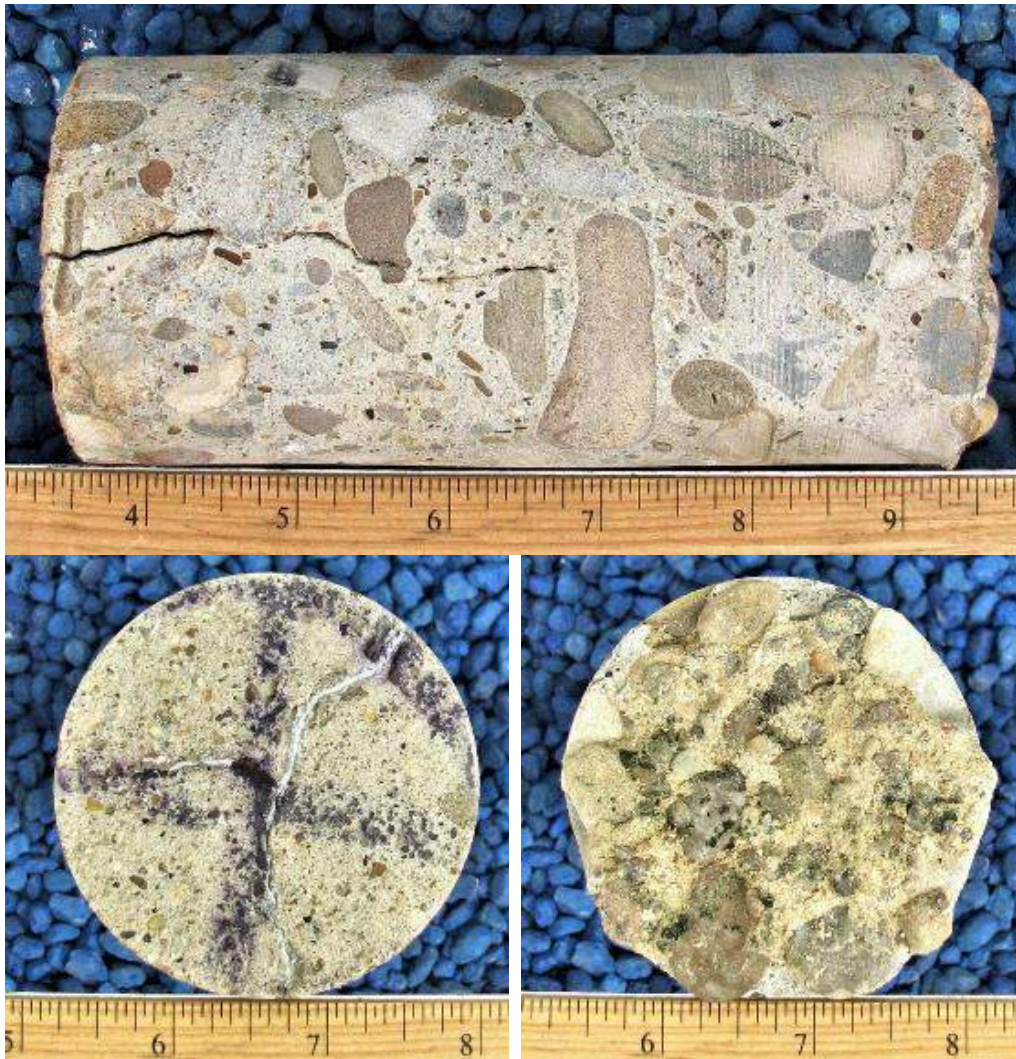
Figure 1 – Core CP1 as received for examination (exterior surface oriented to the left).

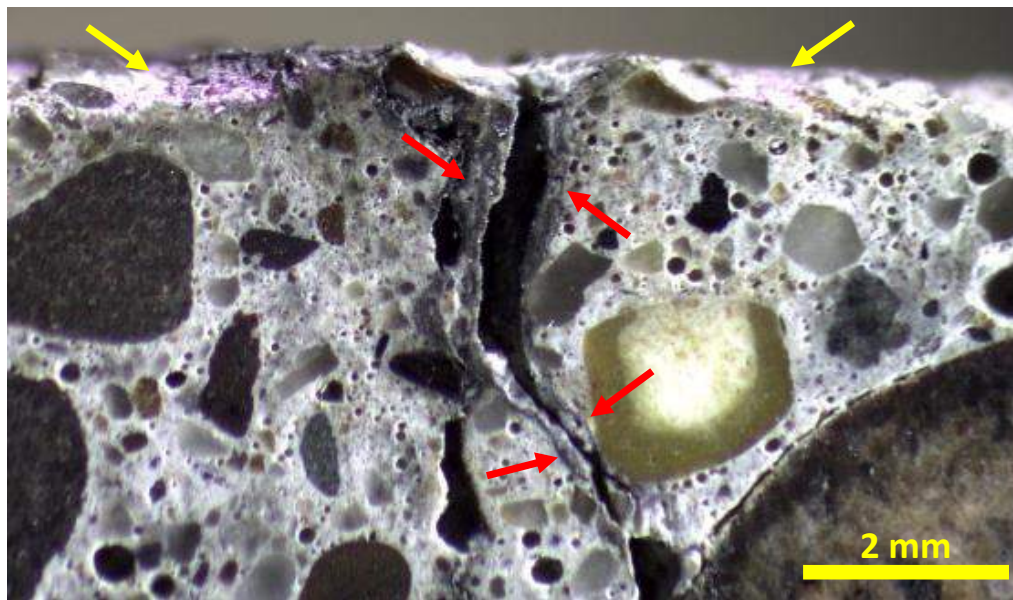
Figure 2 – Photomicrograph illustrating a portion of the full-depth crack in Core CP1. Yellow arrows denote exterior surface of the core. Red arrows indication crack-filler lining the crack surfaces.

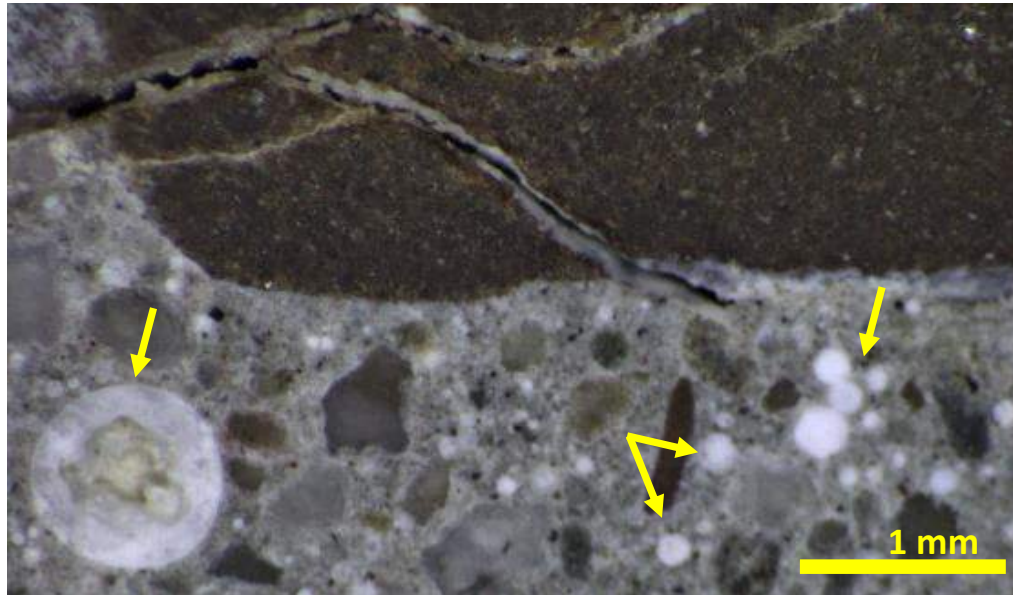
Figure 3 – Photomicrograph illustrating air-voids located along the full-depth crack in Core CP1 filled with white, secondary deposits (yellow arrows).

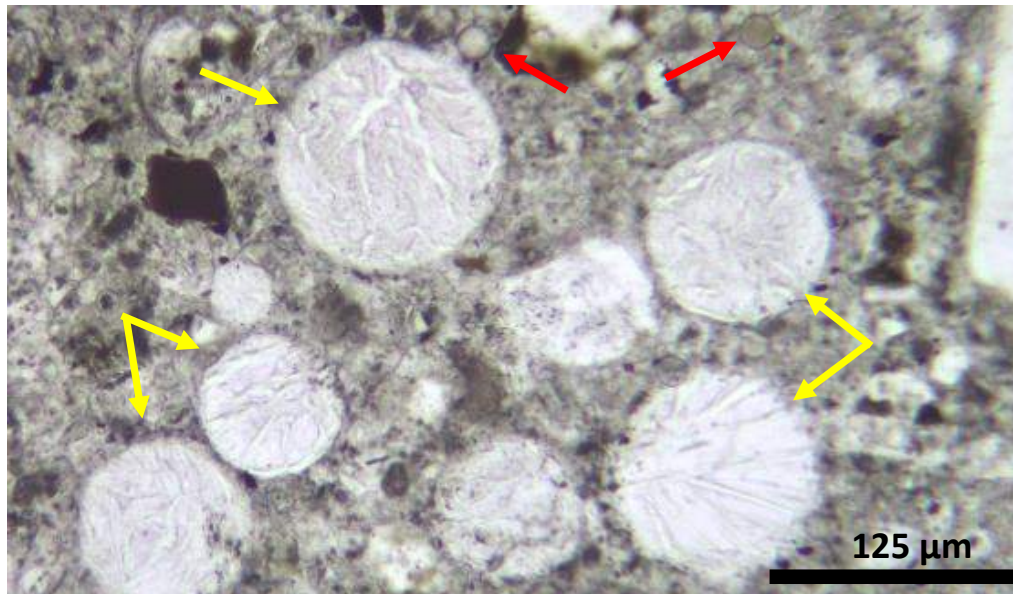
Figure 4 – Thin-section photomicrograph illustrating the hardened cementitious-paste microstructure in Core CP1 (200X magnification, plane-polarized light). Red arrows indicate fly ash particles. Yellow arrows indicate air-voids filled with secondary deposits.

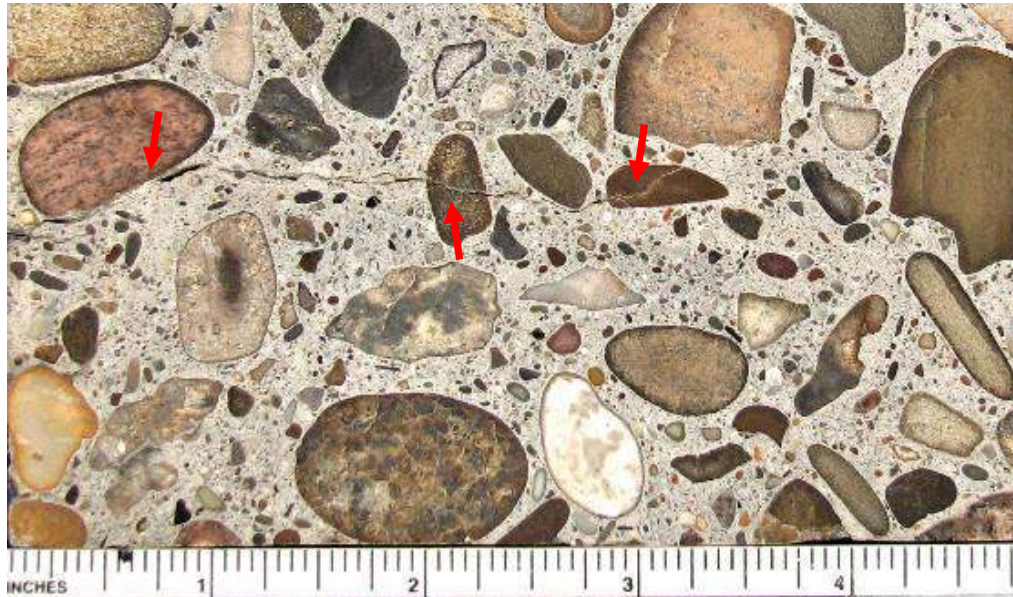
Figure 5 – Photomicrograph illustrating the condition and distribution of the aggregate in Core CP1 (exterior surface oriented to the left). Note full-depth crack that bisects the core and passes through and around coarse aggregate particles (red arrows).

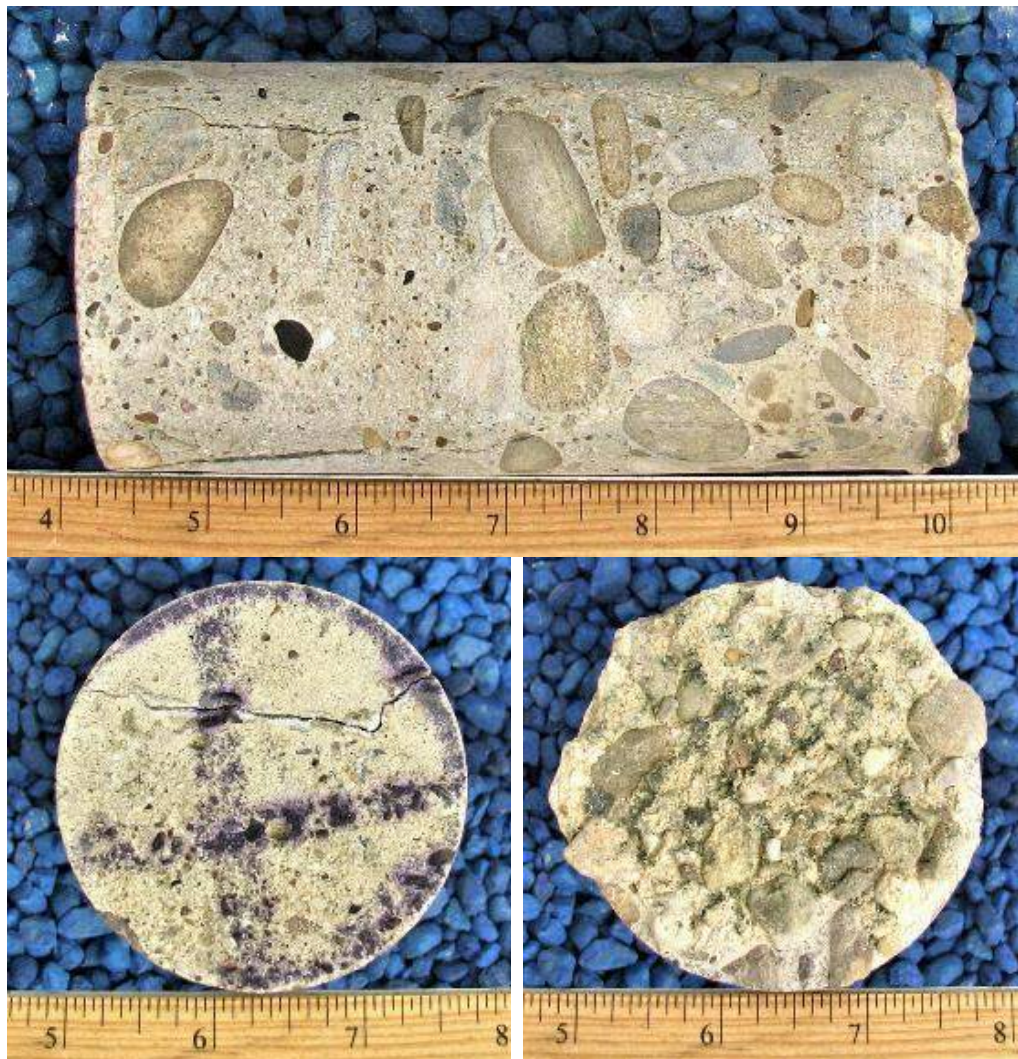
Figure 6 – Core CP2 as received for examination (exterior surface oriented to the left).

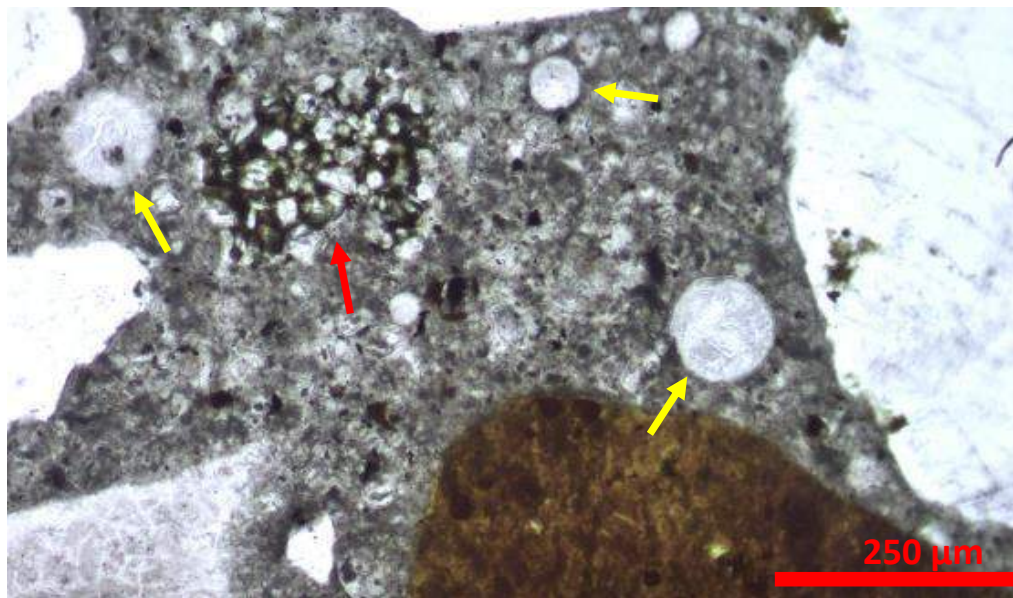
Figure 7 – Thin-section photomicrograph showing the hardened cementitious-paste microstructure in Core CP2 (100X magnification, plane-polarized light). Red arrow indicates residual cement grain. Yellow arrows indicate voids filled with secondary deposits.

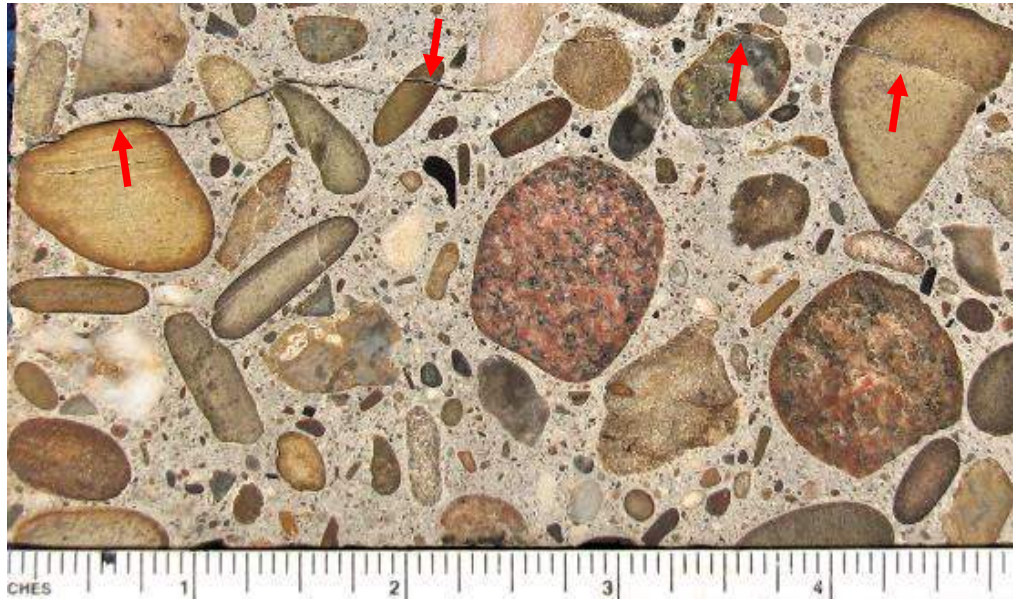
Figure 8 – Photomicrograph illustrating the condition and distribution of the aggregate in Core CP2 (exterior surface oriented to the left). Note full-depth crack that bisects the core and passes through and around coarse aggregate particles (red arrows).

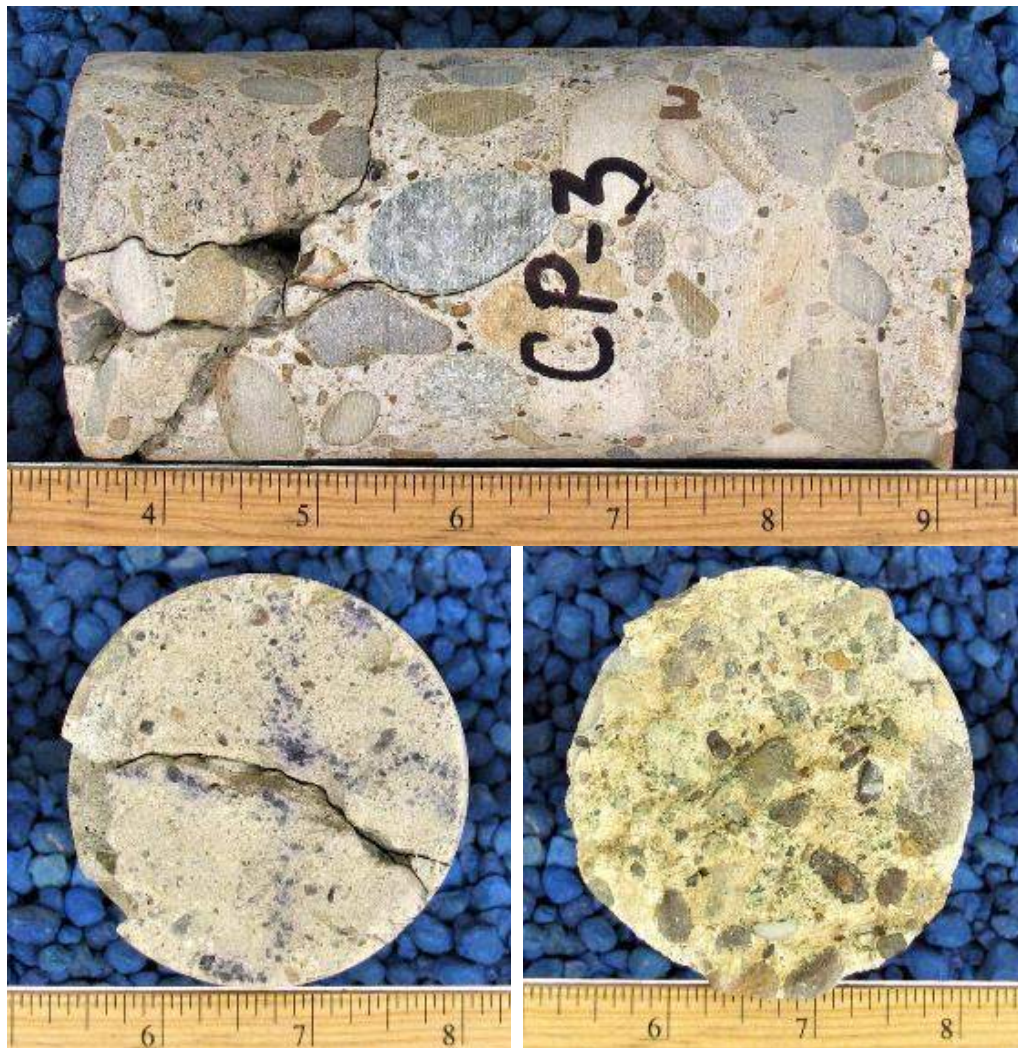
Figure 9 – Core CP3 as received for examination (exterior surface oriented to the left).

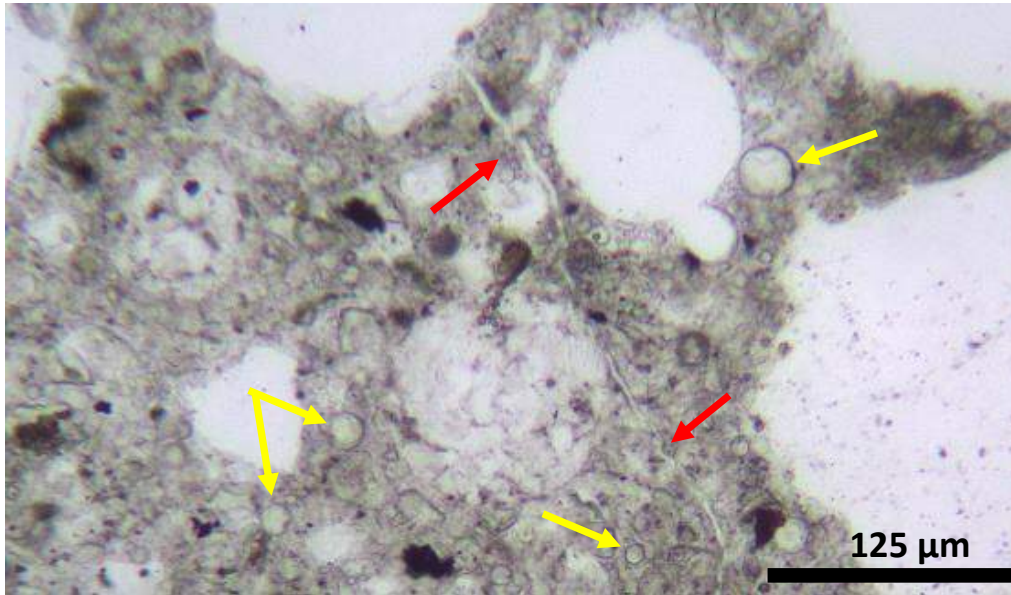
Figure 11 – Thin-section photomicrograph illustrating the hardened cementitious-paste microstructure in Core CP3 (200X magnification, plane-polarized light). Red arrows indicate micro-cracking within the paste. Yellow arrows indicate fly ash particles.

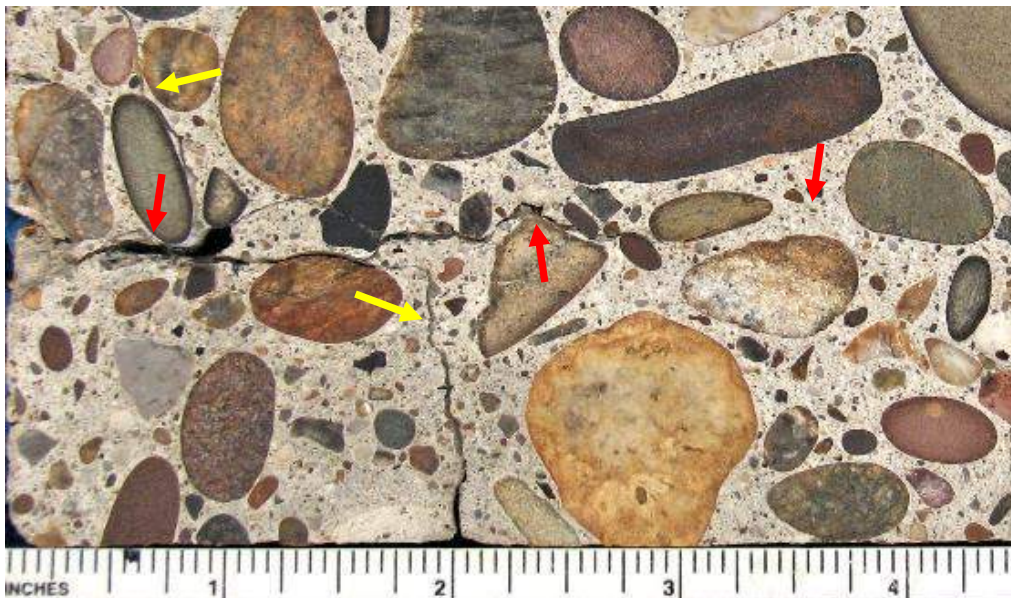
Figure 12 – Photomicrograph illustrating the condition and distribution of the aggregate in Core CP3 (exterior surface oriented to the left). Note cracking that bisects the core and passes through and around coarse aggregate particles (red arrows), as well as horizontal cracking (yellow arrows).

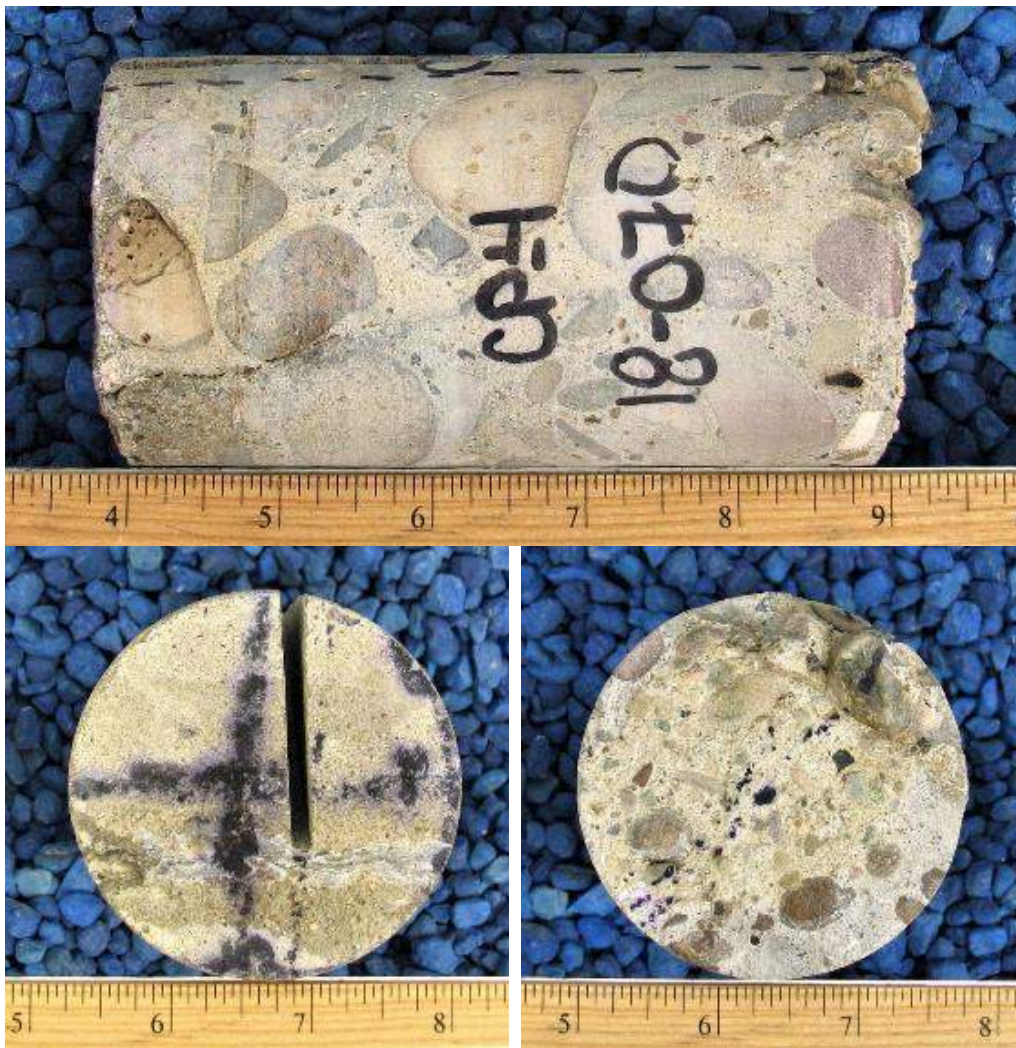
Figure 13 – Core CP4 as received for examination (exterior surface oriented to the left).

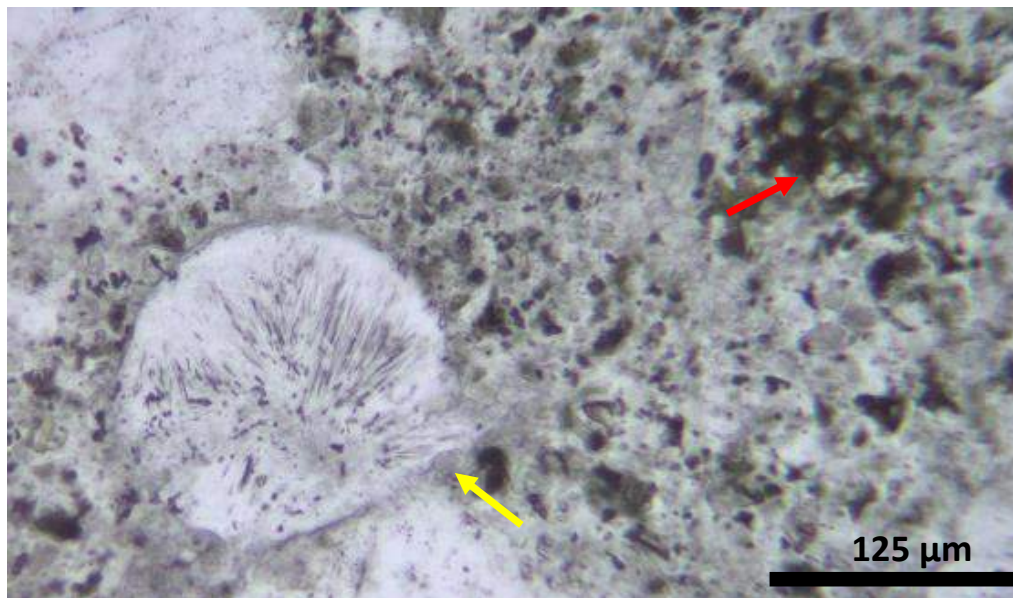
Figure 14 – Thin-section photomicrograph illustrating the hardened cementitious-paste microstructure in Core CP4 (200X magnification, plane-polarized light). Red arrow indicates residual cement grain. Yellow arrow indicates air-void filled with secondary deposits.

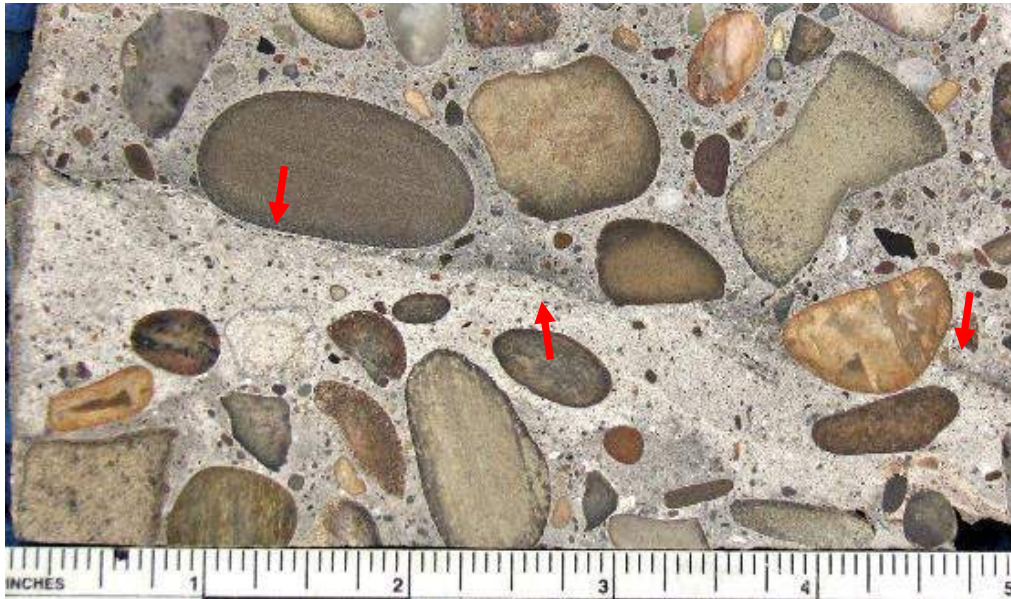
Figure 15 – Photomicrograph illustrating the condition and distribution of the aggregate in Core CP4 (exterior surface oriented to the left). Note lift-line bisecting the full-depth of the core (red arrows).

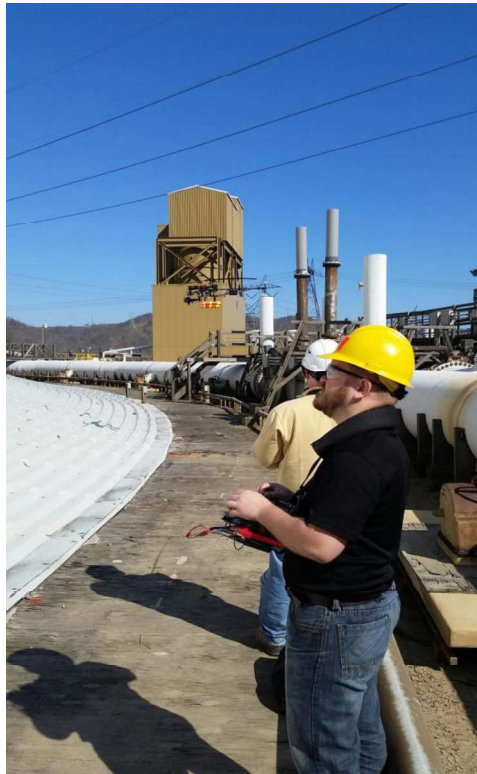
Drone Pilot and Payload Operator

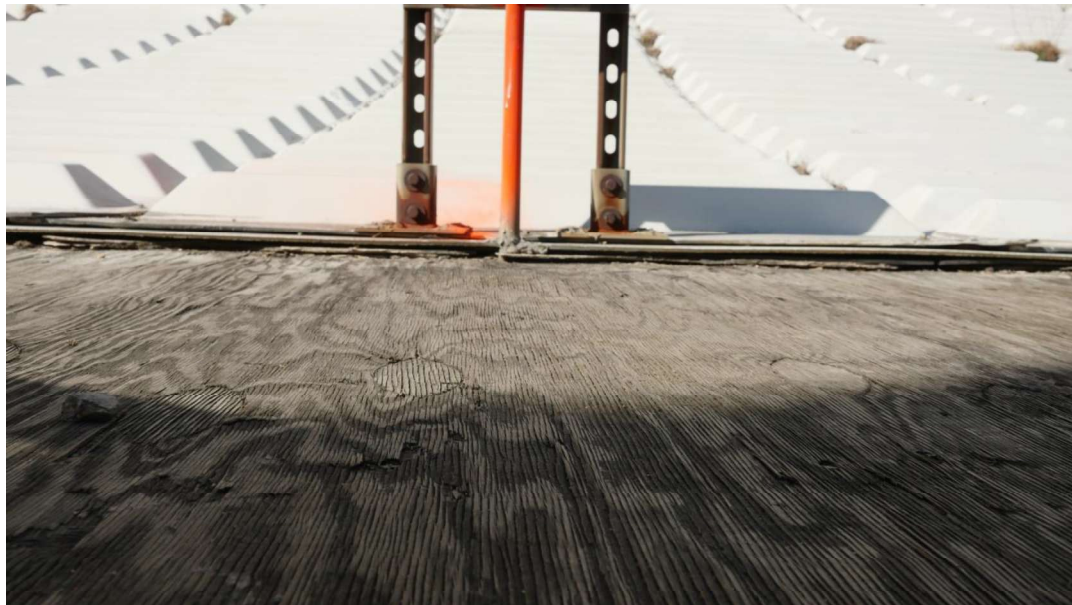
Figure 1 - Run 1 Reference Marking

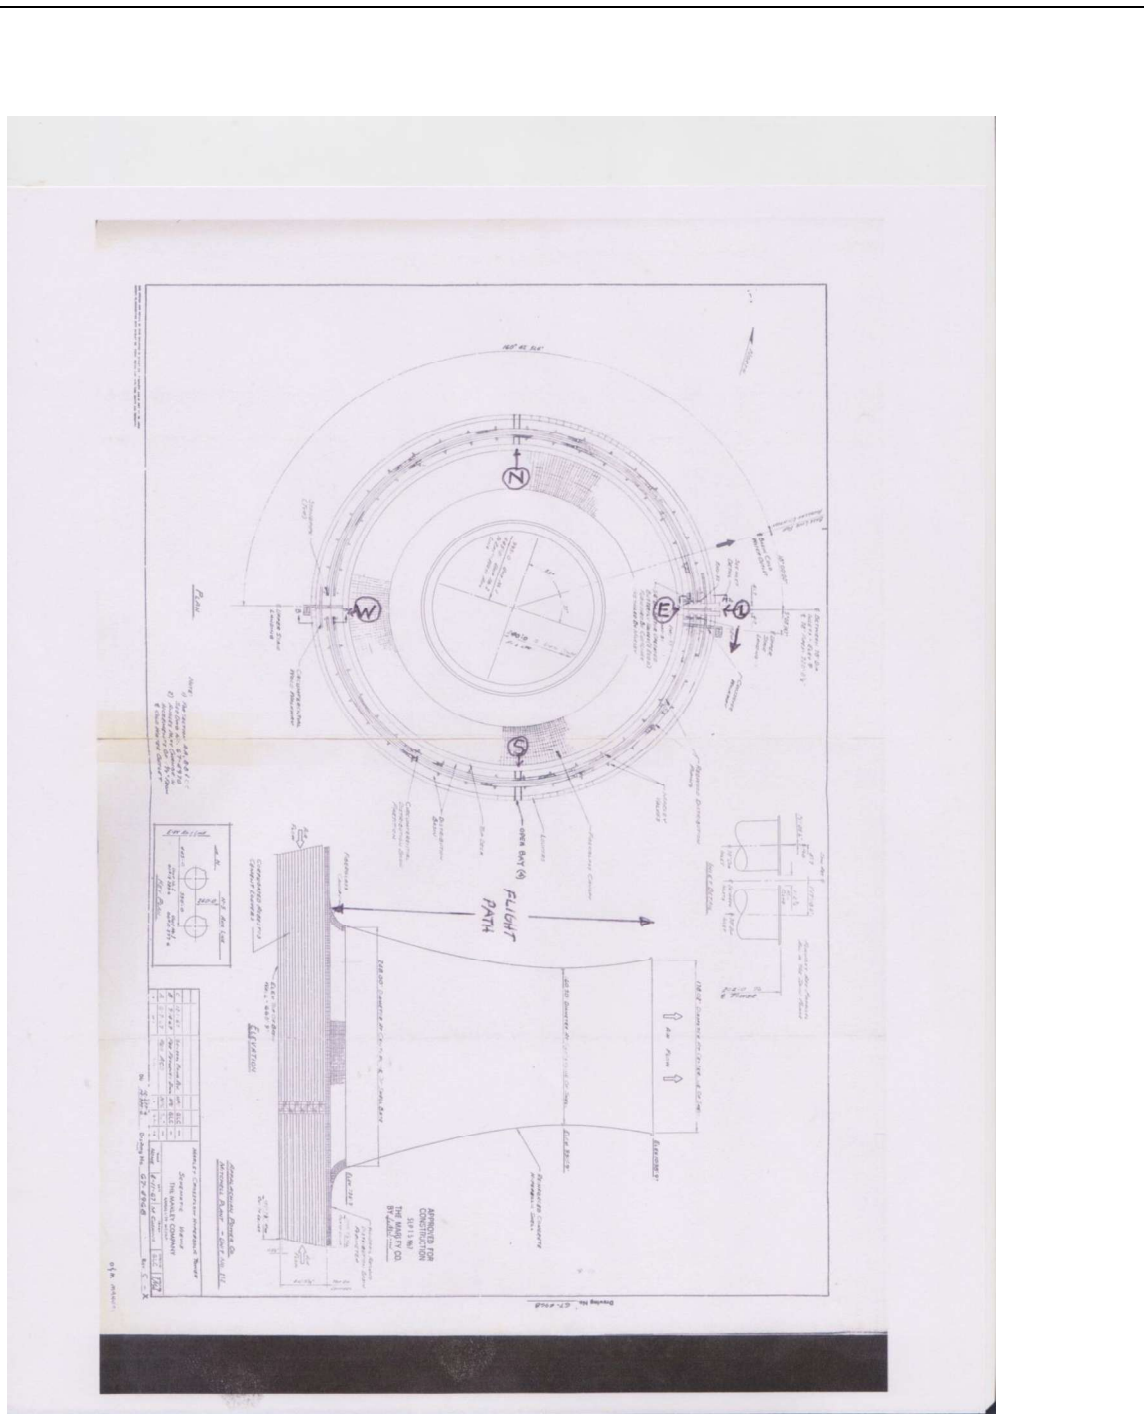
Figure 2 - Reference Marking

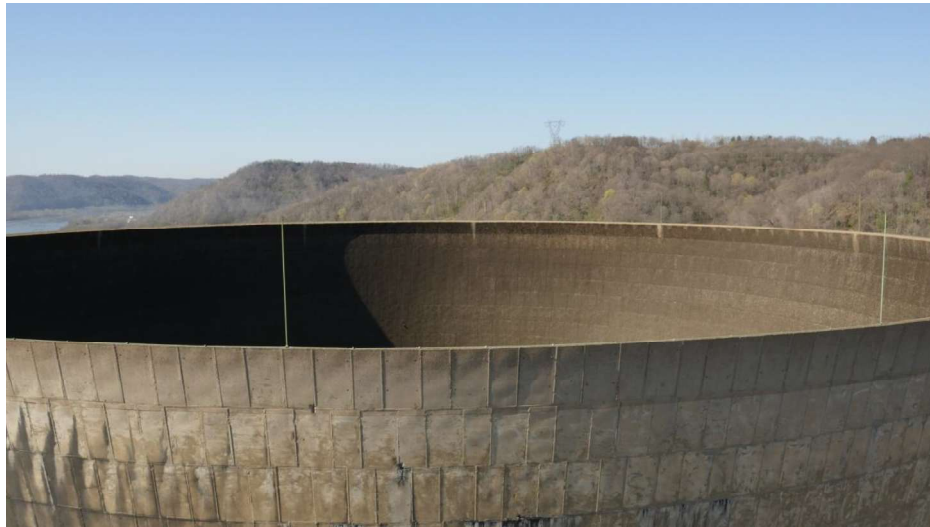
Misc Lightning protection system intact.

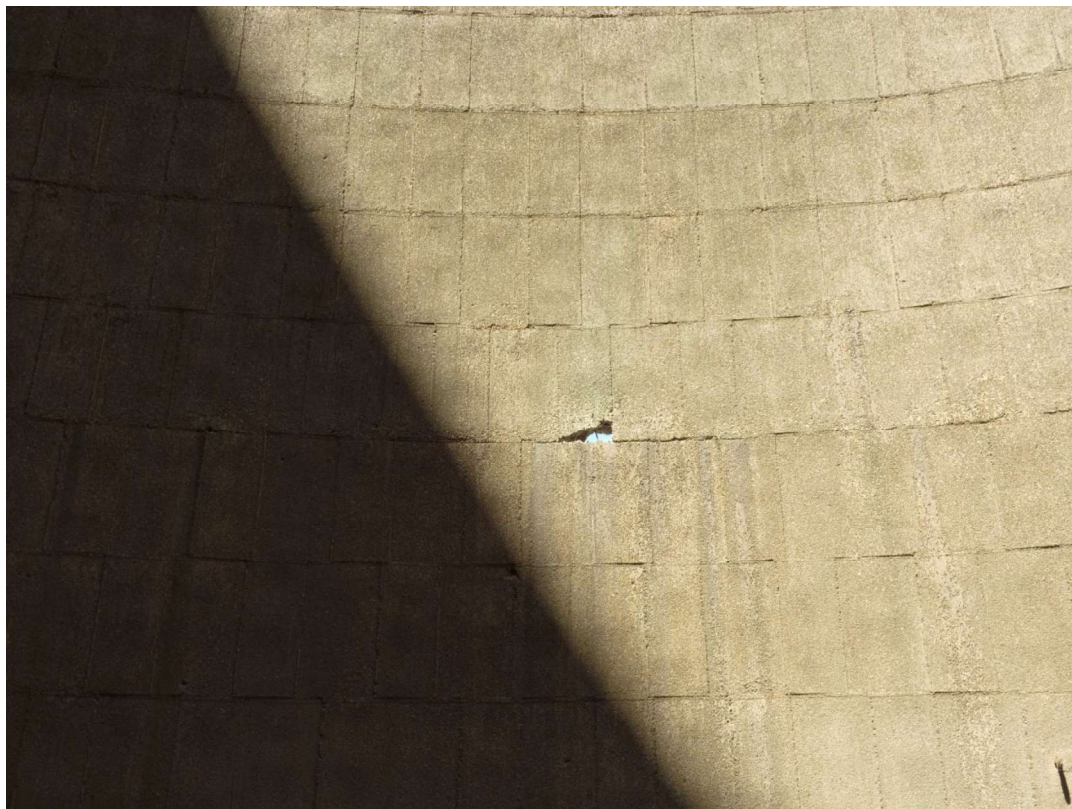
Figure 3 - Hole in North run

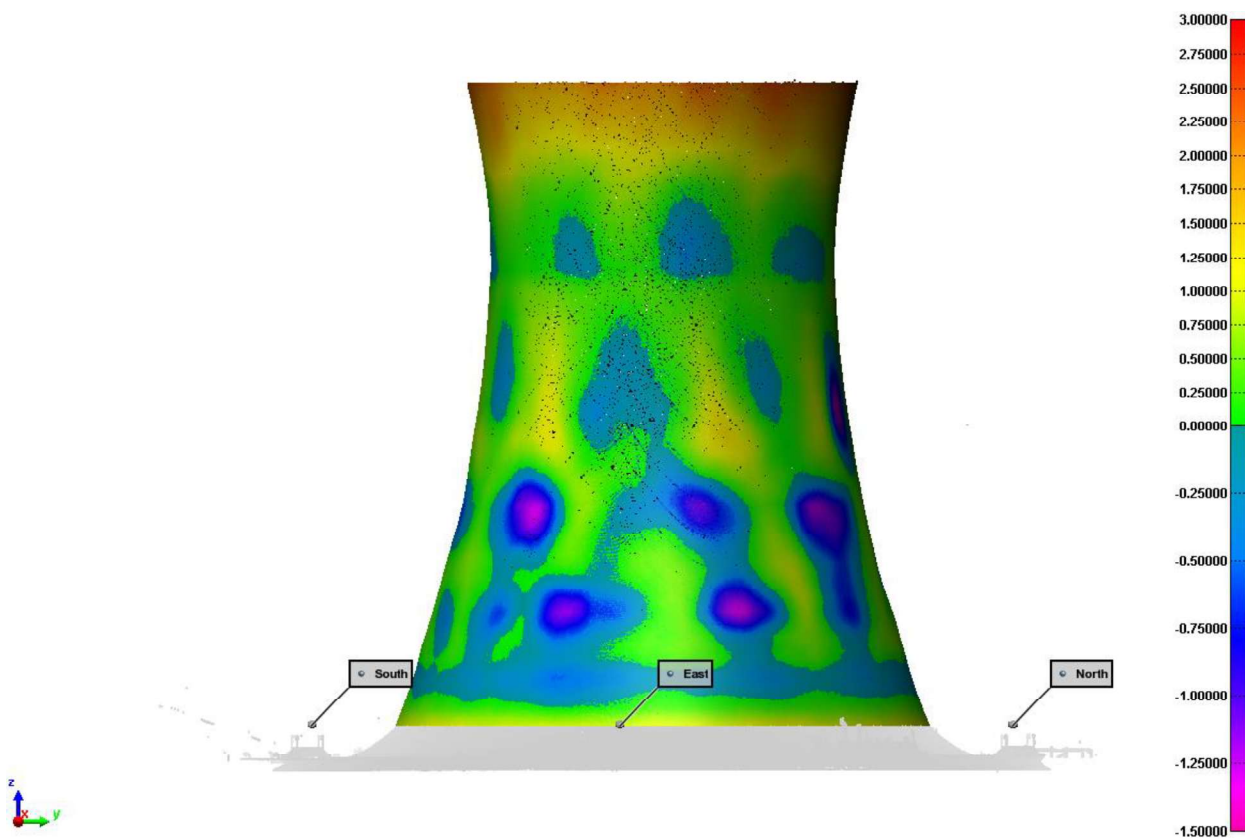
10597 Chester Rd
Cincinnati, OH 45215
Phone: 513.771.7710
Fax: 513.771.2120
nmanning@3d-engineering.net
